July 15, 2024

**CON0022160 Central Region GRMP Instrumentation Monitoring  
Site C017-3; H575:04, km 26.631 Truckstop Slide  
Section C – 2024 Spring Readings**

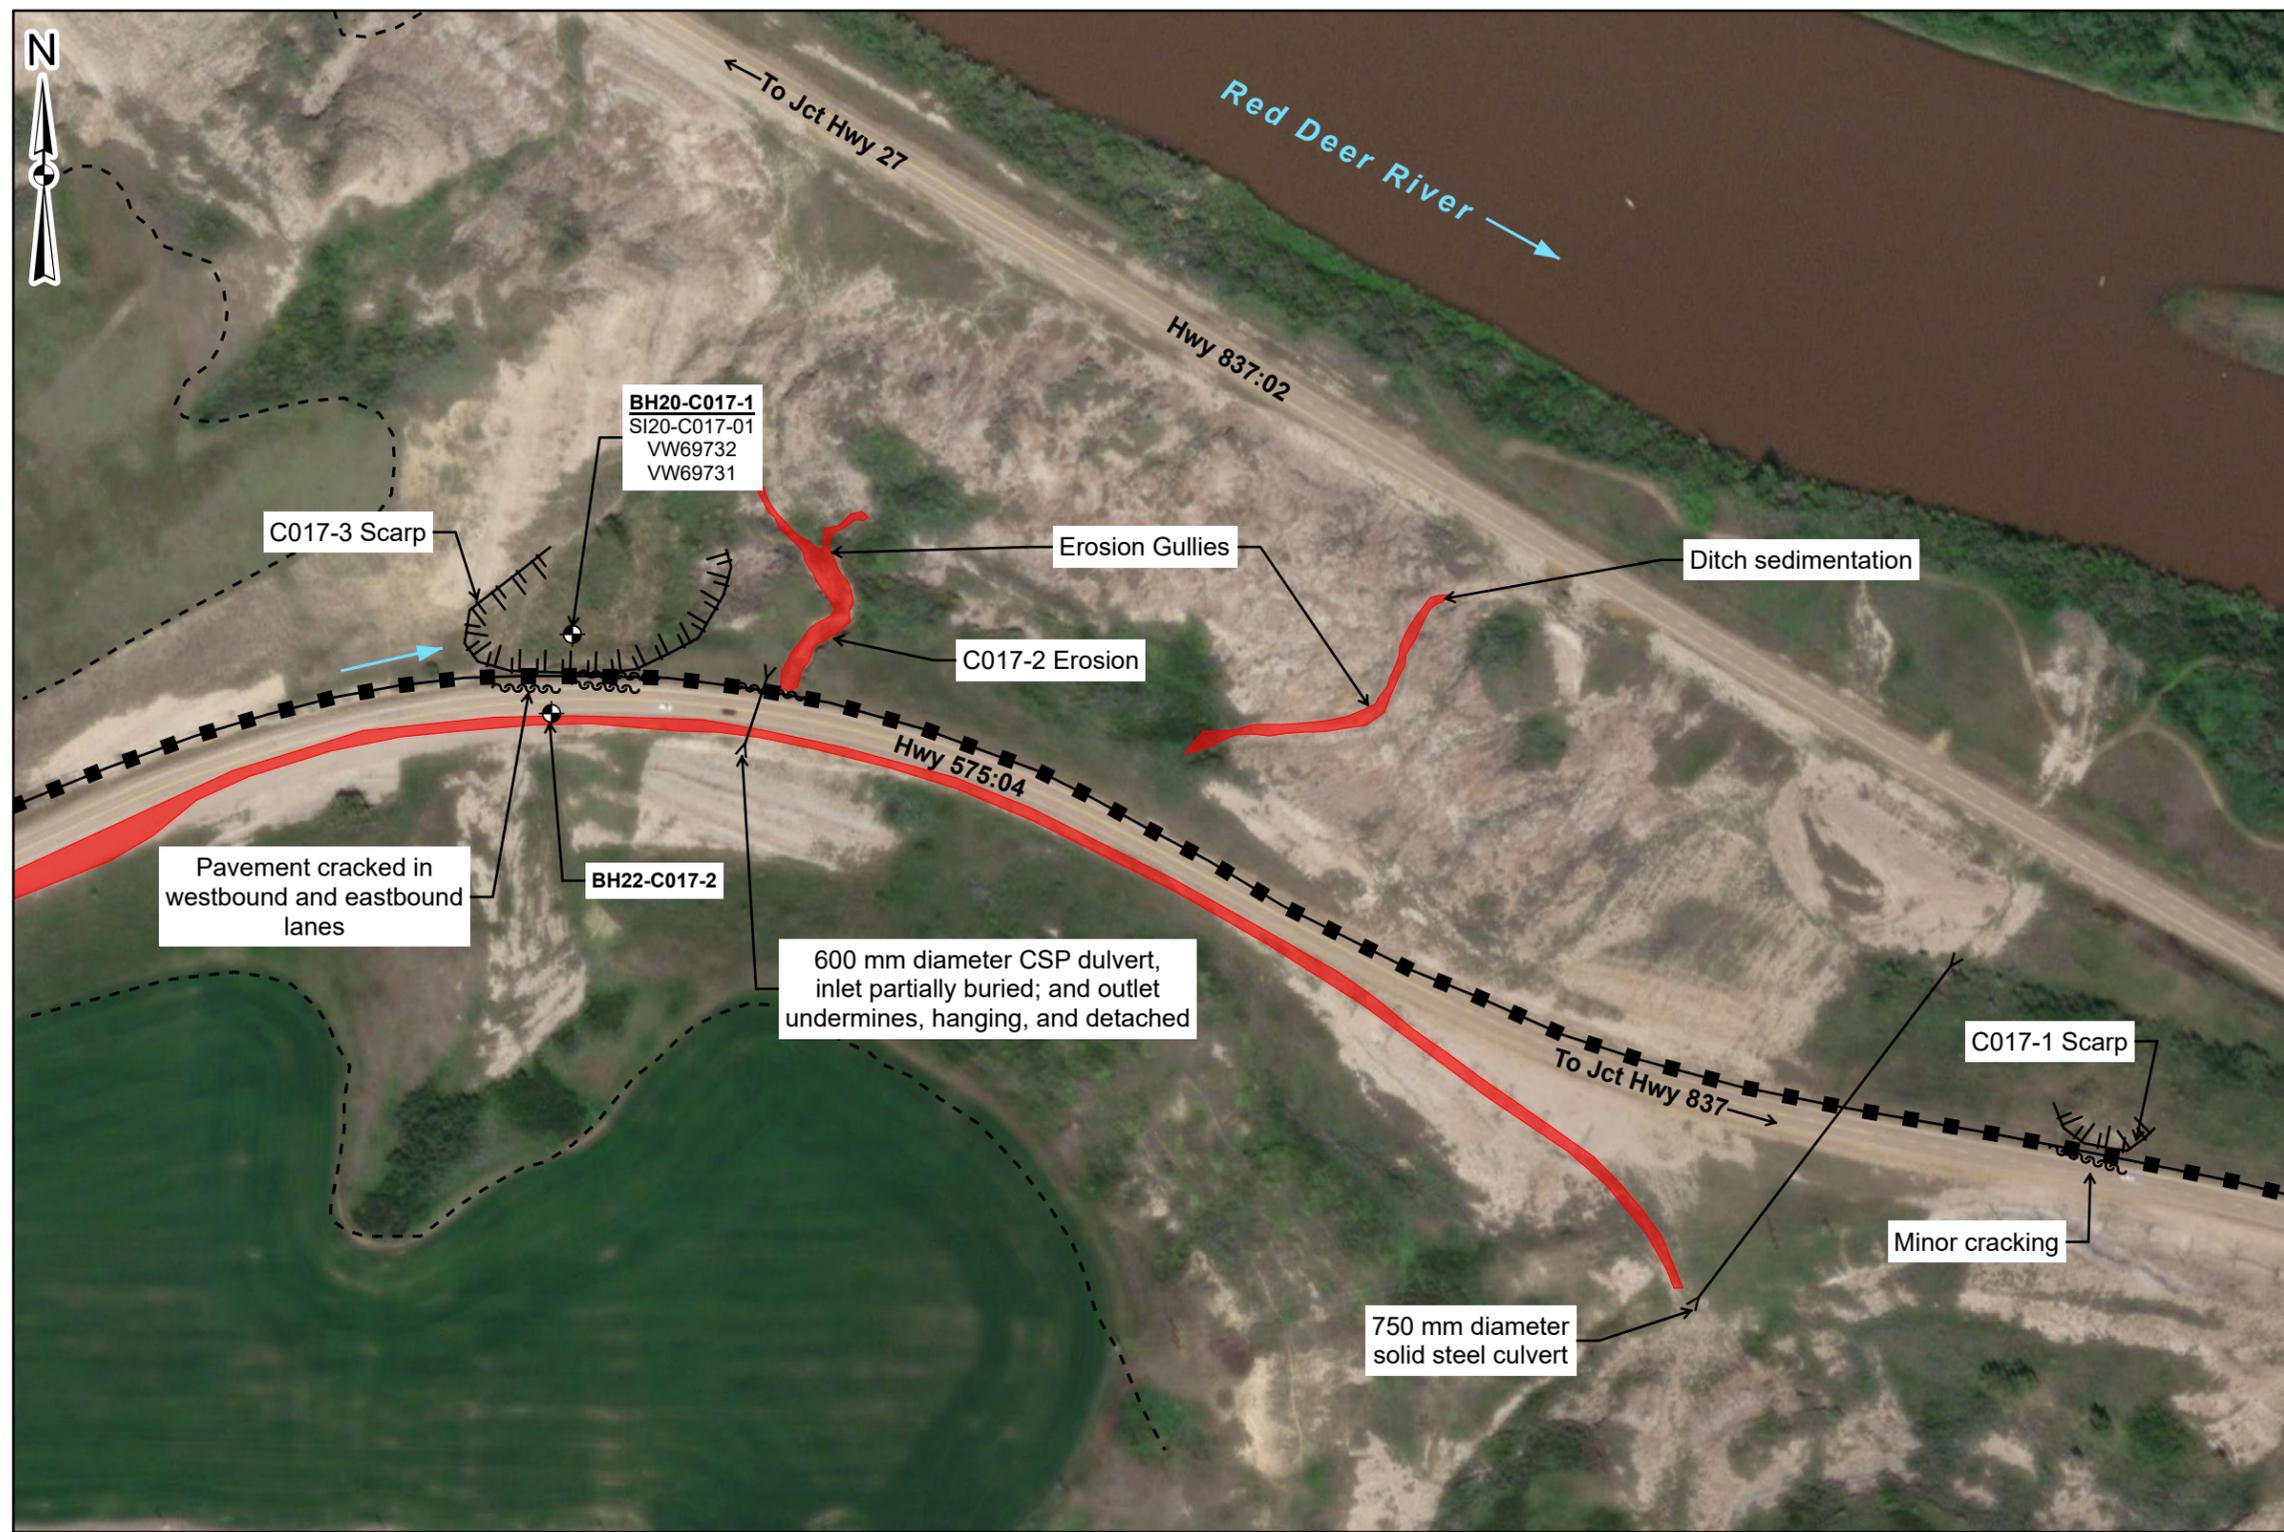
TITLE  
 Site Plan  
 C017-1, -2, and -3 Truckstop Slide  
 Hwy 575:04, km 26.631

- C017-1: a shallow embankment slope failure on the north side (westbound lane) of Hwy 575:04,
- C017-2: an erosion gully that has formed downslope of a culvert outlet on the north side (westbound lane) of Hwy 575:04, and
- C017-3: a moderately deep-seated slide on the north side (westbound lane) of Hwy 575:04 where the highway crosses a creek and enters a cut section in the valley wall.

Construction for the repair of the C017-1 and -3 sites is scheduled for summer or fall 2024 (Tender No. TND0022533). The instrumentation should be read throughout construction to monitor the porewater pressure and movement in response to construction activities.

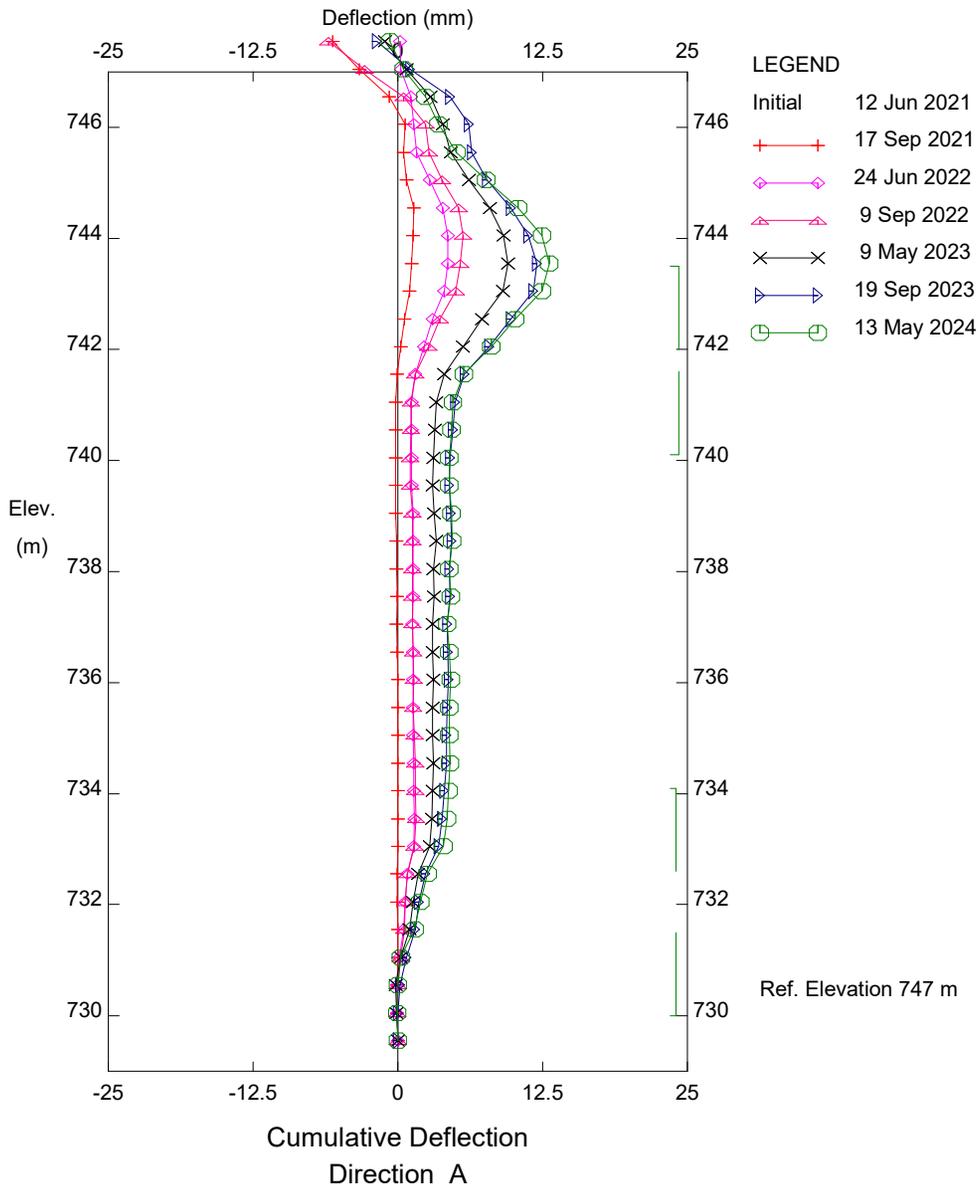
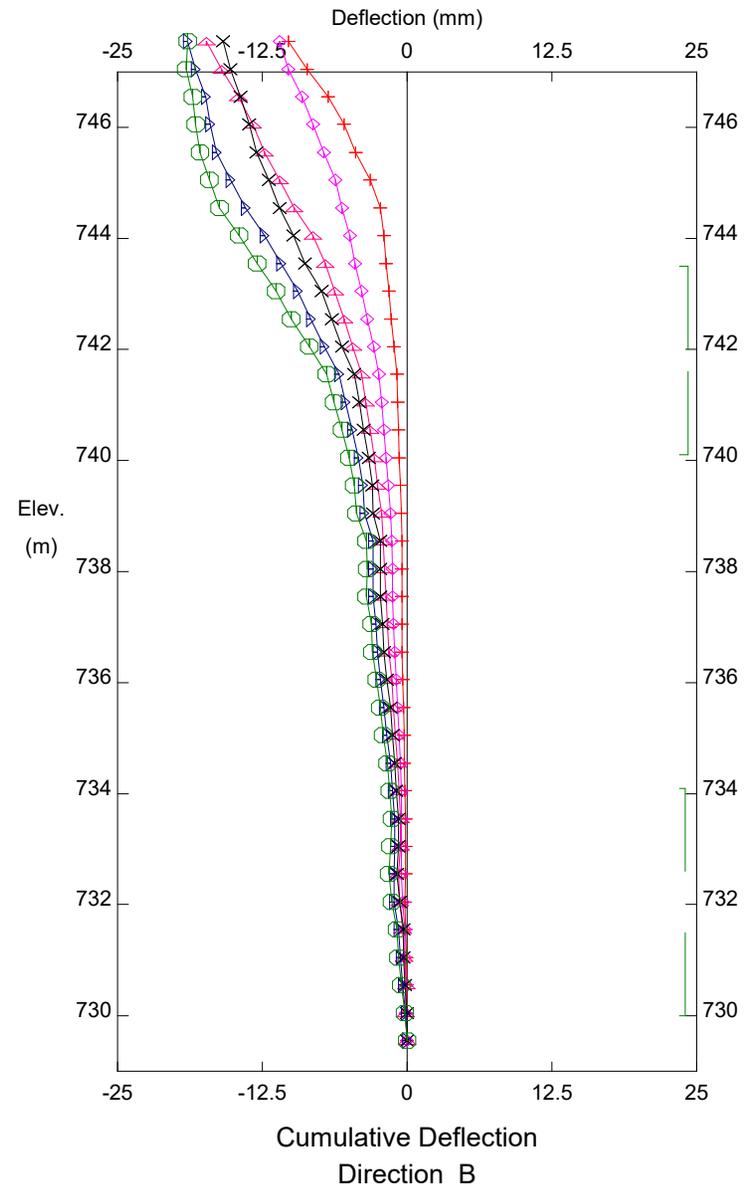
C017-III; H575:04; Truckstop Slide, Inclinometer SI20-01  
 Alberta Transportation

Distributed movement is being recorded in SI20-C017-01 in the upper 6 m and from approximately 14 m to 16 m below ground surface.

Based on the stratigraphy encountered during the 2020 drilling investigation, the upper and lower zones of movement recorded in SI20-C017-01 appear to be occurring in a soft zone in the embankment fill (silty clay and sand) and in the underlying foundation material (sandy silt), respectively.

An overall relatively slow rate of movement (approximately 3 mm/year) has been recorded in the SI since June 2021, excluding an increased rate of movement (approximately 6 mm/year) recorded in fall 2022 after wet weather in June and July 2022. Increased movement may occur in response to periods of heavy or prolonged rainfall or freshet infiltration, resulting in a higher groundwater level.

All operable instruments should continue to be read twice per year (spring and fall).

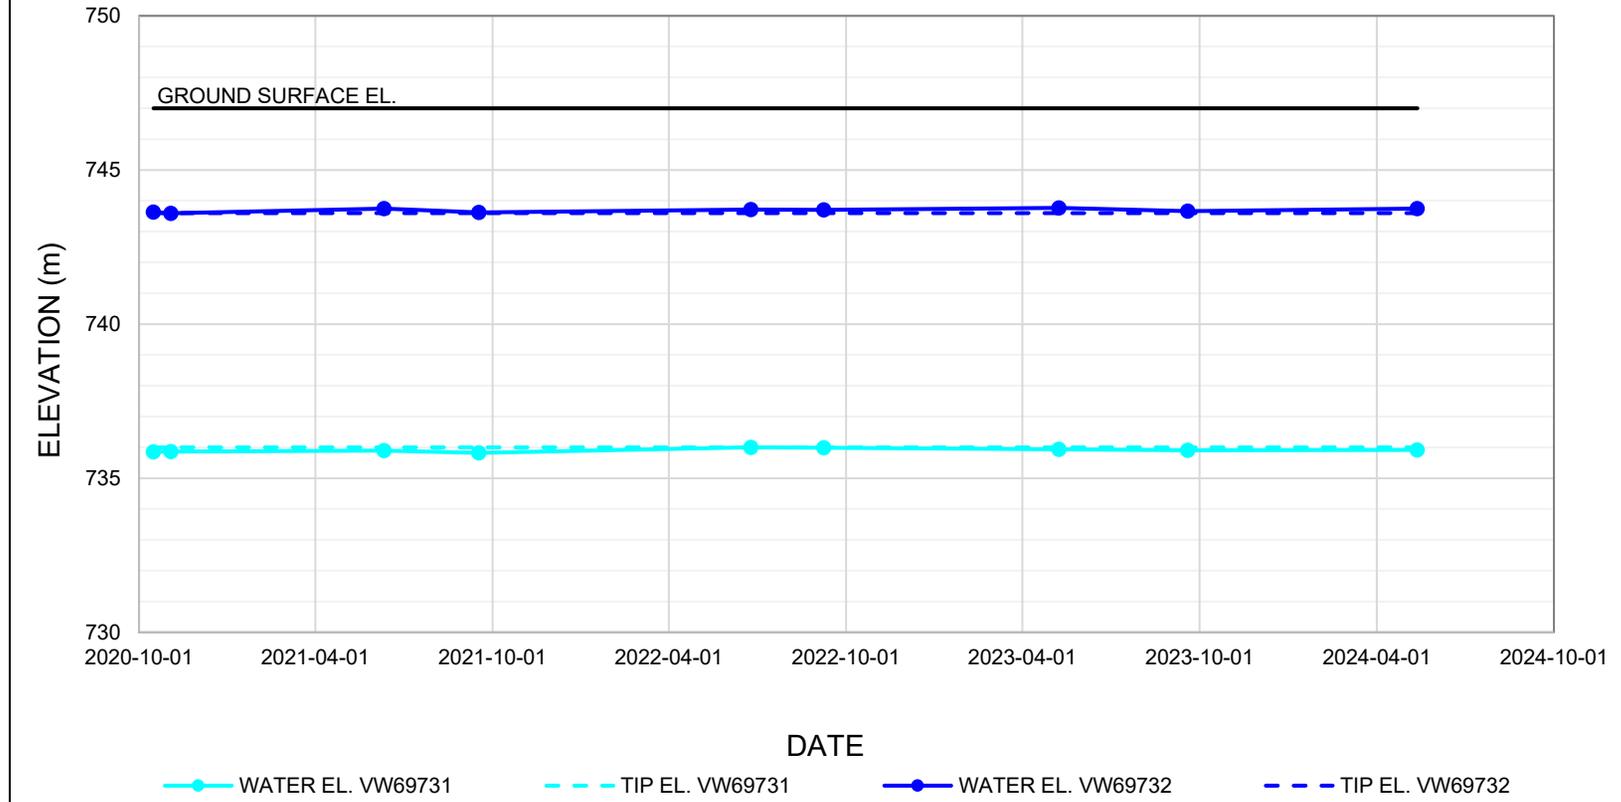
CENTRAL REGION GEOHAZARD RISK MANAGEMENT PROGRAM	
		TITLE Piezometer Data C017-3 - Truck Stop Slide Hwy 575:04, km 26.341	
SCALE	N/A	PROJECT No.	A05116A02
			FIG No. I-4

Since installation in October 2020, porewater pressures recorded in the two VVPs (VW69731 and VW69732) have been within  $\pm 0.2$  m of the tip elevation for each instrument, indicating these instruments are dry. Since an elevated groundwater level is believed to be one of the factors driving instability of the slide at the C017-3 site, KCB believes the piezometers may have been installed at depths that do not record transient changes in groundwater or that the current bi-annual reading frequency of the instruments does not capture short-term fluctuations (i.e., increases and decreases) in water level that could be occurring in response to heavy rainfall events or freshet infiltration between readings.

No instrument repairs or maintenance is required. However, installation of a data logger on one or more of the VVPs may be beneficial, as more frequent readings may capture short-term fluctuations (i.e., increases and decreases) in groundwater level that could be occurring in response to periods of heavy or prolonged rainfall or freshet infiltration between readings.
