SITE NUMBER AND NAME: C017 Truckstop Slide	HIGHWAY & KM: 575:04, 26.040 to 26.650	PREVIOUS INSPECTION DATE: June 18, 2024	INSPECTION DATE: June 10, 2025
LEGAL DESCRIPTION: C017-1 04-26-29-21 W4M C017-2 01-27-29-21 W4M C017-3 01-27-29-21 W4M	NAD 83 COORDINATES: UTM Northing Easting 12 5707574 370869 12 5707733 370415 12 5707738 370340	RISK ASSESSMENT: C017-1 PF: 1 CF: 4 TOTAL: 4 C017-2 PF: 10 CF: 3 TOTAL: 30 C017-3 PF: 2 CF: 4 TOTAL: 8	
HIGHWAY SERVICE CLASSIFICATION: 3		CONTRACT MAINTENANCE AREA (CMA): 517	
AVERAGE ANNUAL DAILY TRAFFIC (AADT): 930 (east) and 1000 (west) (Ref No. 105240 & 106230)

PRIMARY SITE ISSUE: C017-1: a shallow embankment slope failure on the north side (westbound lane) of Hwy 575:04; C017-2: an erosion gully that has formed downslope of a culvert outlet on the north side of Hwy 575:04 and there is ditch erosion in the south (eastbound) ditch extending from C017-3 to just west of C017-1; and C017-3: a moderately deep-seated slide (5 m to 6 m deep based on an SI installed in 2020) on the north side of Hwy 575:04 where the highway crosses a creek and enters a cut section in the valley wall.
APPROXIMATE DIMENSIONS: The slides at C017-1 and -3 are approximately 2

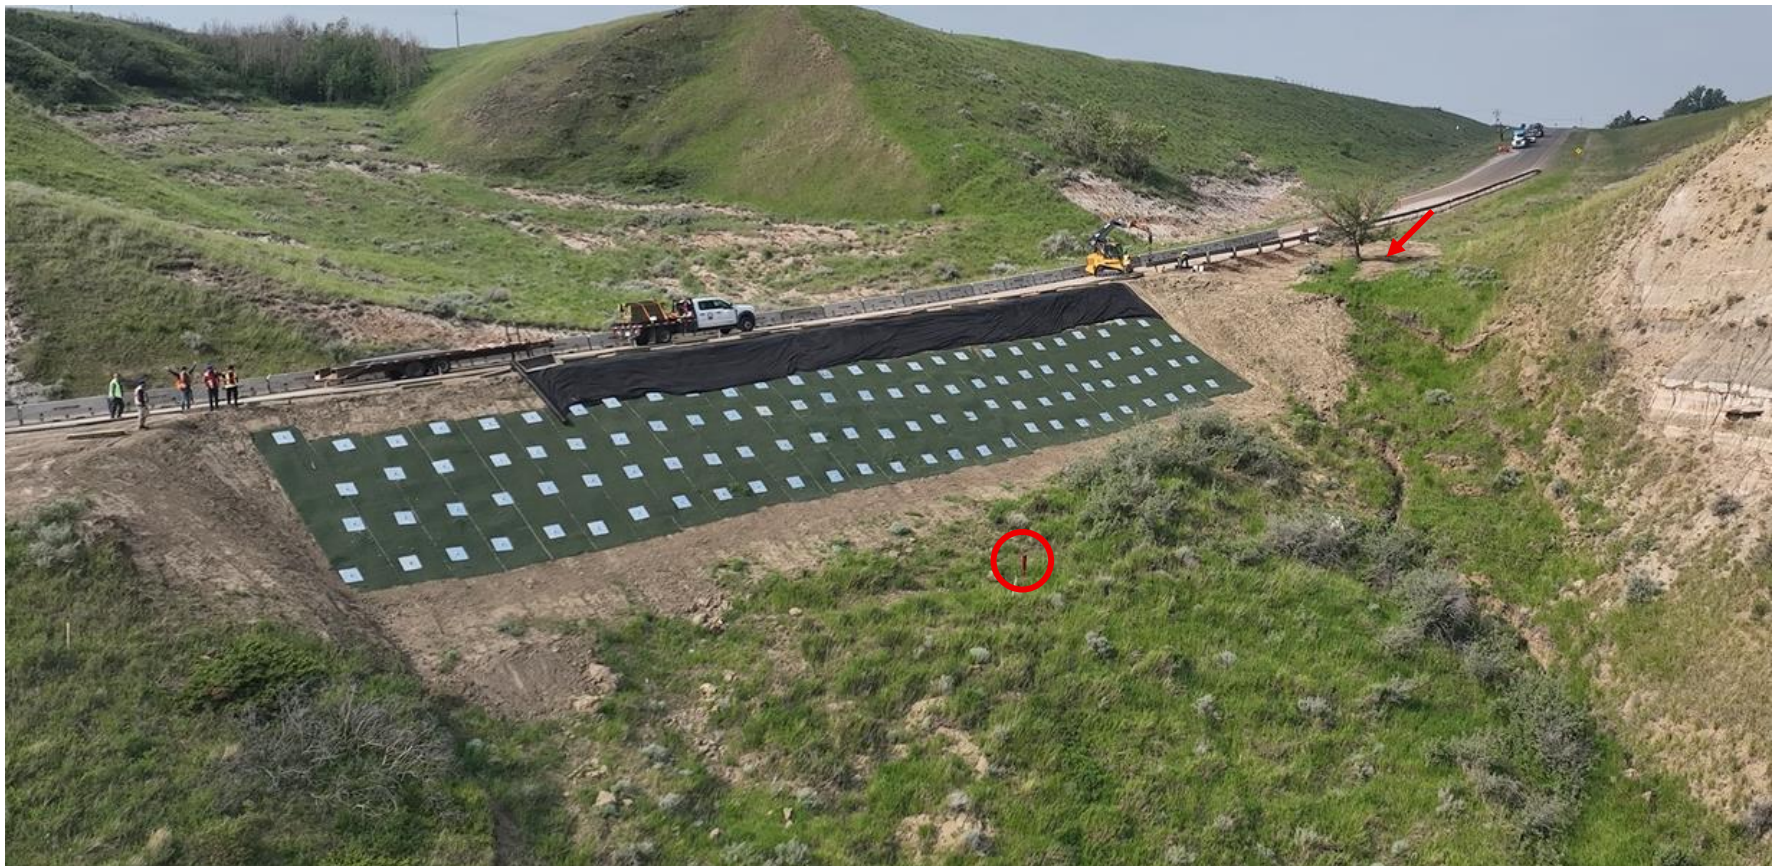
- The slide was repaired in 2025 as part of CON0022533. The repair consisted of slope grading and installing soil nails (4 rows of 26 or 27 soil nails approximately 14 m long), slope stabilization product, rolled erosion control product, seeding, and replacing the guardrail (Photo 1 and 2).

- The repair was substantially completed during the 2025 inspection. The erosion control product and guardrail were to be installed the week of June 9, 2025. During the inspection, the contractor was installing non-woven geotextile instead of the rolled erosion control product specified by KCB (Photo 1 and 2). Upon discussion with TEC and the KCB Project Manager, this was corrected and the correct material was installed after the inspection.

- The steel headbox installed to protect instrumentation (SI and two VWP) in BH20-C017-01, located downslope (north) of the C017-3 slide, was protected from damage during 2025 construction (Photos 1 through 3). The instruments were read in May 2025 and no increased rate of movement or porewater pressure increase in response to construction were recorded.

- The previous erosion gully, located at the west extent of the slide, was backfilled with material salvaged from the slope as part of 2025 construction (Photo 1). However, the slope was not armoured and is susceptible to erosion from surface water flow from the north (westbound) ditch (Photo 1).

- During 2025 construction, an approximate 0.2 m high earthfill berm was constructed in the north (westbound) ditch upstream of the C017-3 site to divert ditch flow further north and away from the repaired slope (Photo 1). The berm was constructed from material salvaged during slope grading and was not armoured. The berm was constructed (low height, relatively flat slopes) to still allow mowing of the north ditch as part of ongoing maintenance operations.

- Photo 1** Aerial photo of the C017-3 site showing the 2025 graded slope, soil nails, base plates, slope stabilization product, and 2020 instrumentation headbox downslope of the repair (indicated by red circle). An earthfill berm was also constructed in the north ditch upslope of the repair to divert surface water flows further north (indicated by red arrow). Non-woven geotextile had been erroneously installed by the contractor at the crest of the slope. The non-woven geotextile was removed and replaced with the correct material after the inspection. Photo taken June 10, 2025 facing southwest.

- The west (upslope) extent of the repair and the earthfill berm in the ditch should be monitored to assess the performance of the berm. If surface water flows are overtopping or bypassing the berm, or if erosion begins at the west extent of the repaired slope, KCB and TEC should discuss alternative drainage improvement measures.

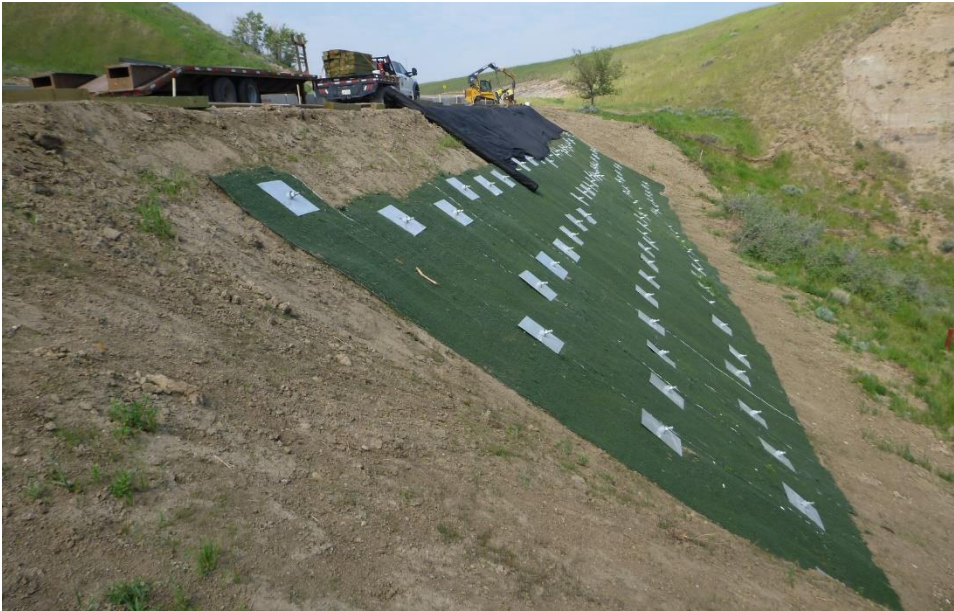
Photo 2 **Regraded slope, soil nails, base plates, and slope stabilization product at C017-3. Non-woven geotextile being installed during the inspection was replaced with the correct rolled erosion control product after the inspection. Photo taken June 10, 2025 facing west.**

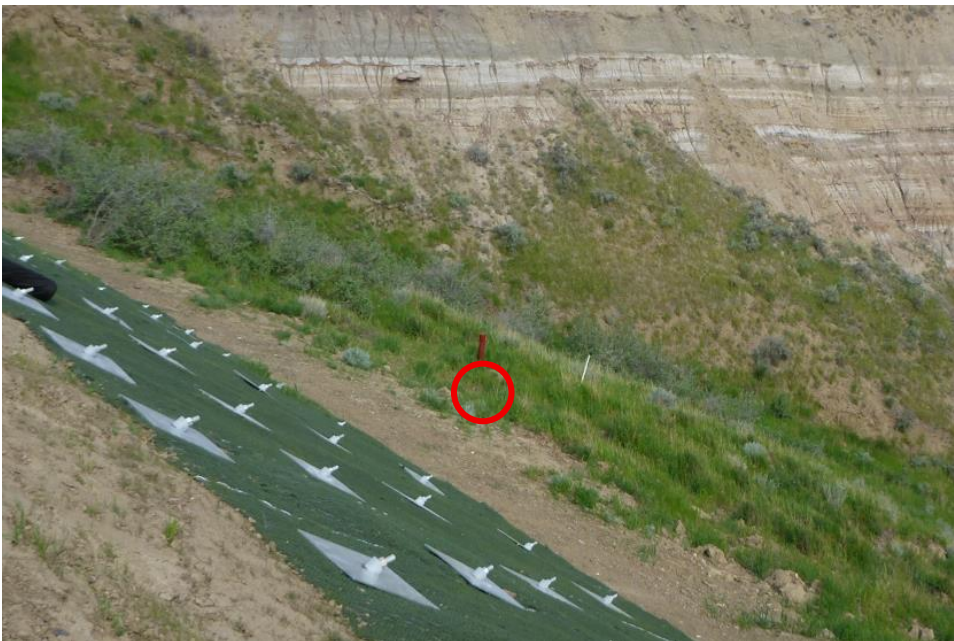
Photo 3 **Protective headbox located downslope of the 2025 repair (indicated by red circle). Photo taken June 10, 2025 facing northwest.**

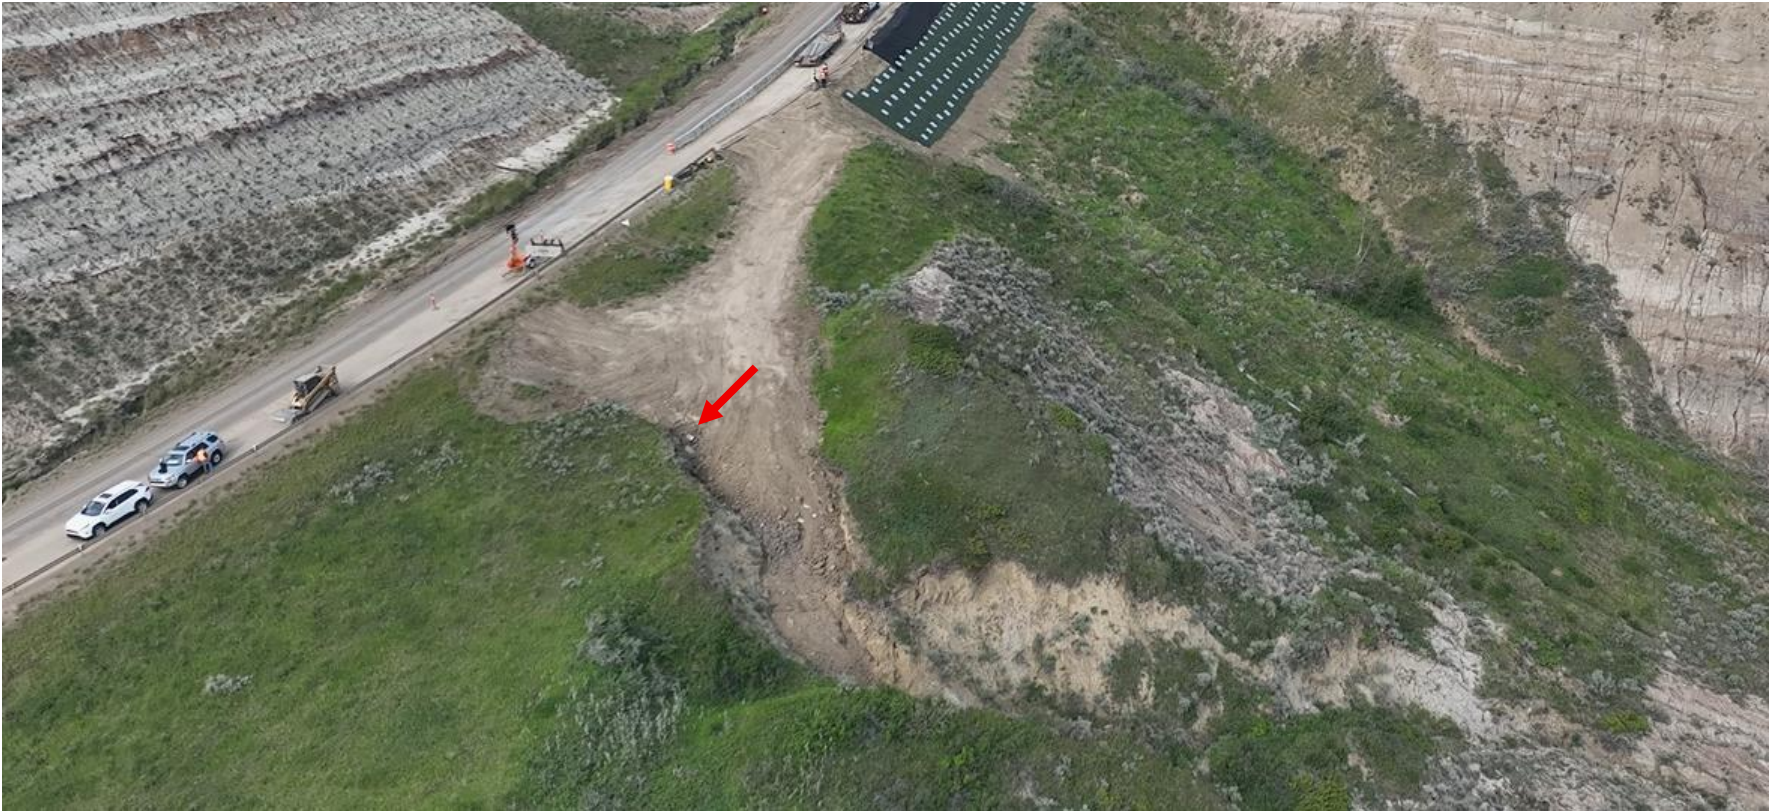
- In 2020, the erosion gully downstream of the corrugated-steel-pipe (CSP) culvert was partially backfilled to allow access for the excavator completing test pits at the C017-3 site (monitored by KCB). During 2025

construction, an additional 20 m (along the length of the erosion gully) was backfilled (Photo 4 and 6, see bullet below).

- During 2025 construction, the CSP culvert inlet on the south side of the highway was plugged with foam and buried. The CSP culvert outlet was also extended approximately 20 m downslope (north) and then buried with material salvaged during C017-1 and -3 grading work.

Photo 4 Aerial oblique photo of the C017-2 site. Approximately 20 m of the erosion gully north of the highway backfilled during 2025 construction after extending CSP culvert (outlet indicated by red arrow). Photo taken June 10, 2025 facing west.

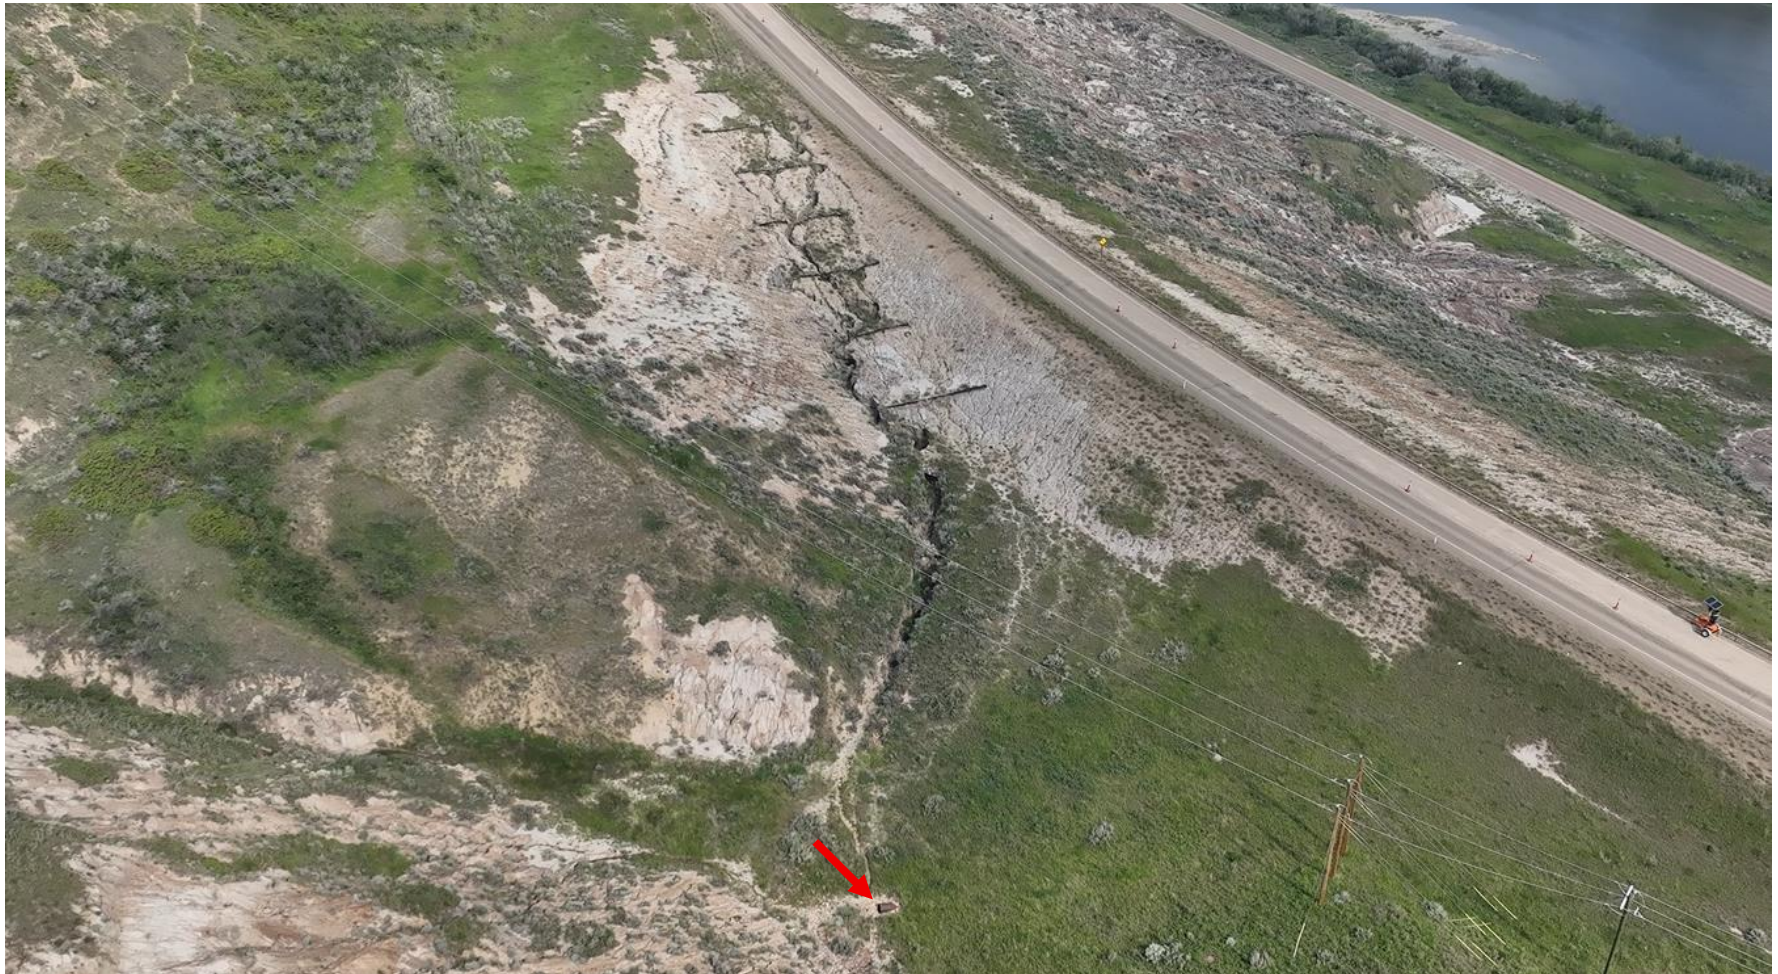
- The ongoing erosion in the south (eastbound) ditch does not appear to have changed significantly between the 2024 and 2025 inspections (Photo 5 and 7). The erosion gullies are 1.0 m to 1.5 m deep and 1 m to 2 m wide.

- Near the midpoint of the site, the erosion is within approximately 2 m from the edge of pavement.
 - The fill placed between the 2020 and 2021 inspections (removed from the C018 geohazard site) continues to erode and is progressing uphill (west).

Photo 5 **Aerial photo showing the lower (east) extent of the C017-2 site where the ditch grade increases to between approximately 15% and 20%. Inlet of culvert underlying Hwy 575:04 indicated by red arrow. Photo taken June 10, 2025 facing northwest.**

- In 2022, KCB proposed backfilling the ditch erosion and armouring the ditch with Class 1 and 2 riprap (overlying bedding material and non-woven geotextile, with regular check trenches). However, the repair was not approved due to the high cost of armouring the ditch with riprap.
- During the 2025 site inspection, an alternative approach was discussed of backfilling the erosion gullies with granular fill via a conveyor belt truck (a "stone slinger") to reduce disturbance to the existing

vegetation already established in the ditch. This option would not be as robust as armouring the ditch with riprap, but it could act as a temporary repair that could be maintained by TEC's HMC by adding more granular fill on an as-needed basis.

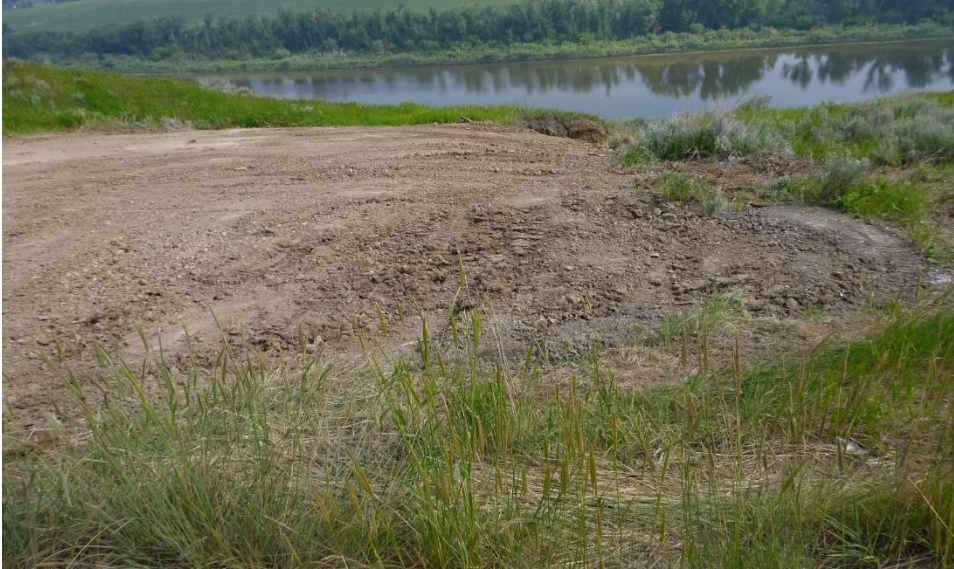
Photo 6 **Erosion gully north of Hwy 575:04 at C017-2 partially backfilled during 2025 construction after extending CSP culvert approximately 20 m (outlet not shown). Photo taken June 10, 2025 facing north.**

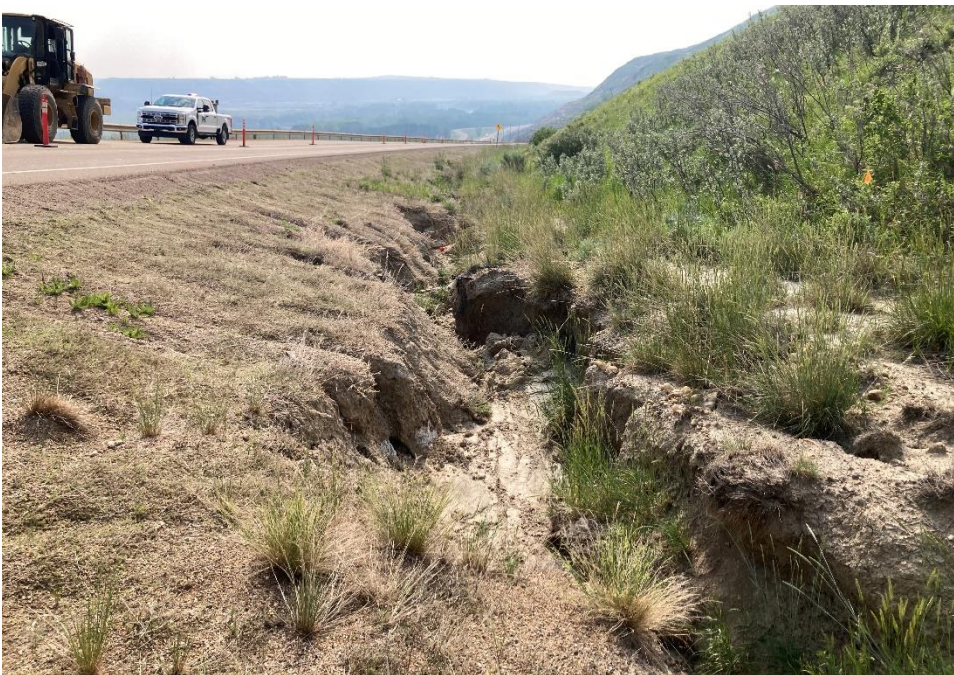
Photo 7 **Ditch erosion in south (eastbound) ditch does not appear to have worsened between the 2024 and 2025 inspections. Photo taken June 10, 2025 facing east.**

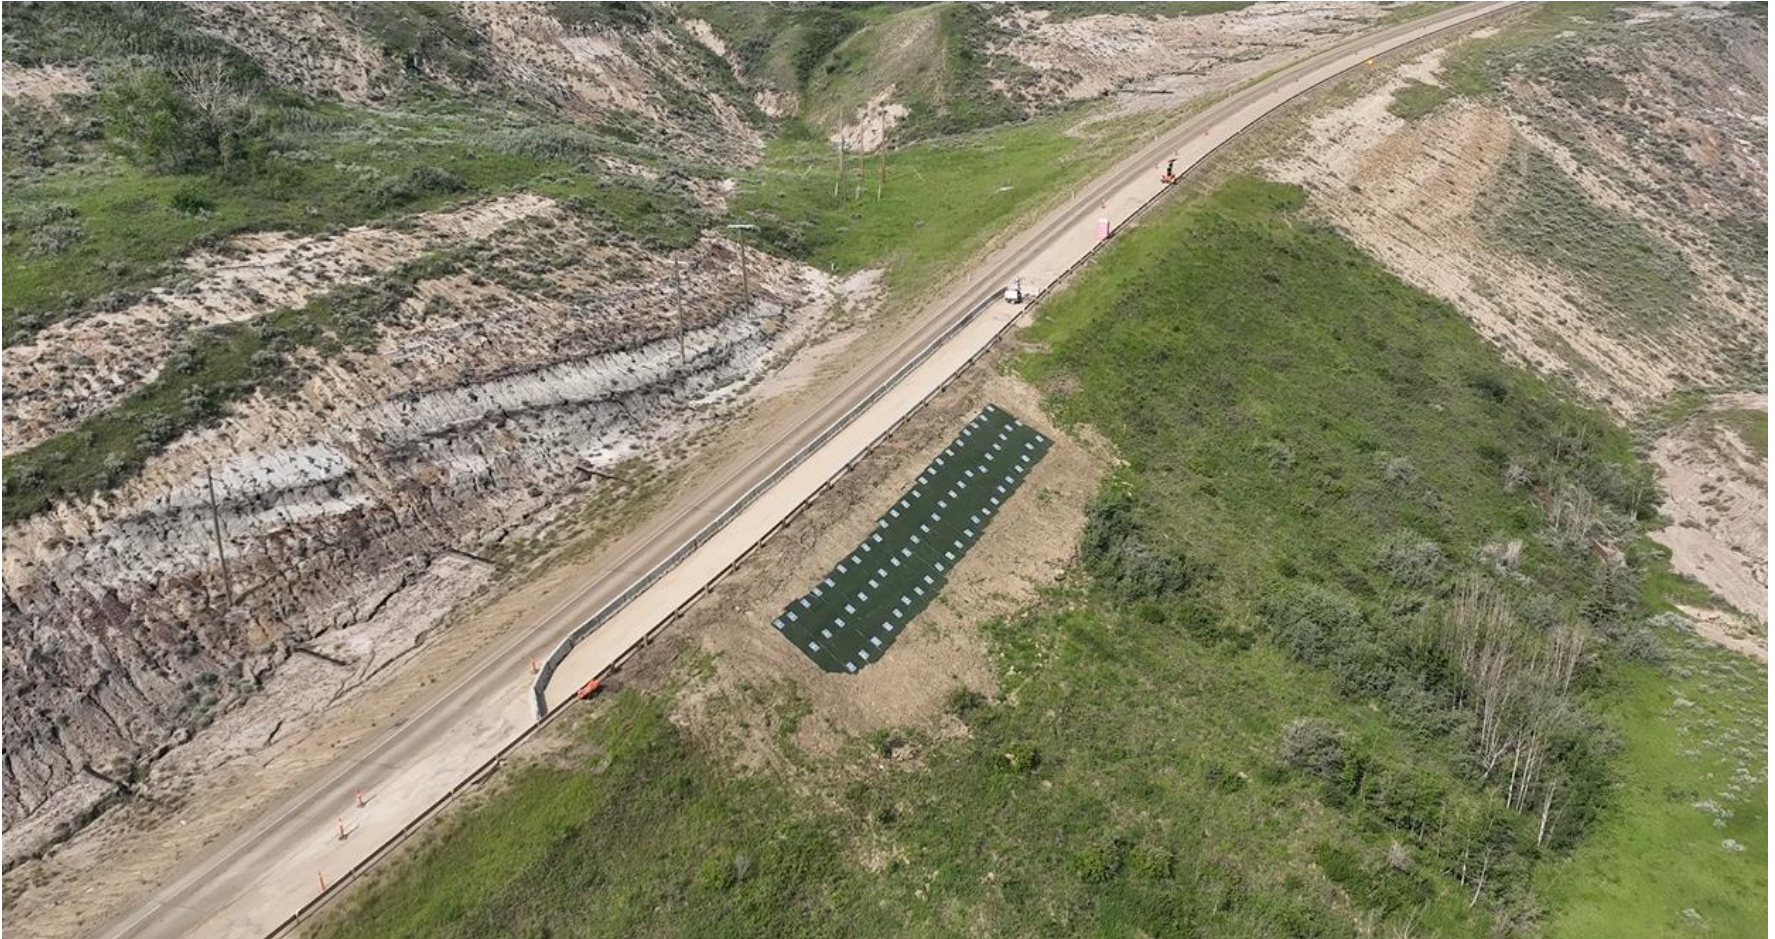
- The slide was repaired in 2025 as part of CON0022533. The repair consisted of slope grading and installing soil nails (3 rows of 21 soil nails approximately 14 m long), slope stabilization product (wire mesh facing with built in geomat), rolled erosion control product, seeding, and replacing the guardrail (Photo 8).

- The pavement crack observed at the site appeared similar to previous inspections, indicating construction did not trigger additional movements at the site (Photo 8).

Photo 8 **Aerial photo of the C017-1 site. Photo taken June 10, 2025 facing southwest.**

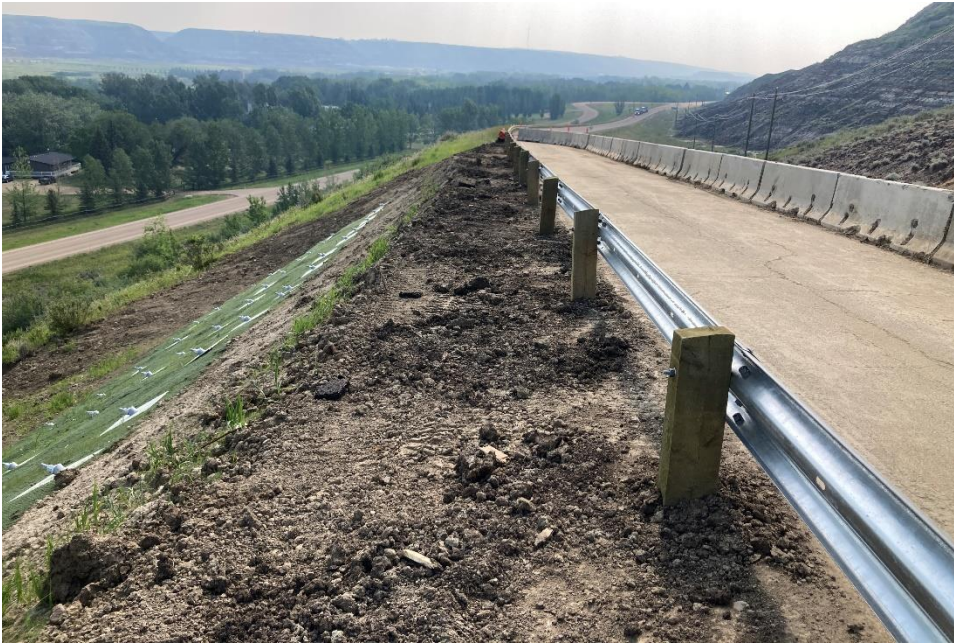
- The new guardrail and guardrail posts appeared to be in good condition (Photo 9).
- The crest and upper portion of the slope were graded as part of 2025 construction, but the erosion control product had not yet been installed (Photo 9 and 10). The erosion control product was scheduled to be installed within the week. Some vegetation (grass) regrowth was observed during the 2025 inspection.

Photo 9 Crest of slope and new guardrail along C017-1. Photo taken June 10, 2025 facing east.

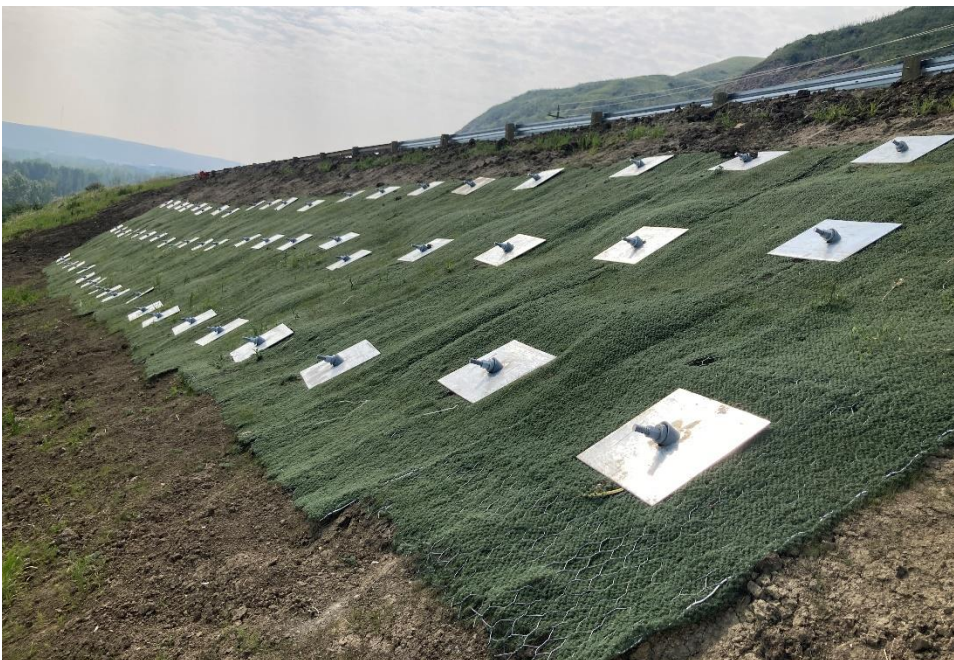
- In general, the slope was even, but there were some undulations observed along the graded slope below the slope stabilization product (Photo 10). The slope stabilization product could be stapled in place to reduce the voids between it and ground surface.

- The base plates were generally flush with the slope (Photo 10). However, there were several base plates with small gaps between them and the slope stabilization product.

Photo 10 Soil nails, base plates, and slope stabilization product installed in 2025 at C017-1. Photo taken June 10, 2025 facing east.
