July 15, 2025

Alberta Transportation and Economic Corridors
4th Floor, Provincial Building
4920 – 51st Street
Red Deer, Alberta
T4N 6K8

CON0022160 Central Region GRMP Instrumentation Monitoring
Site C017-3; H575:04, km 26.631 Truckstop Slide
Section C – 2025 Spring Readings

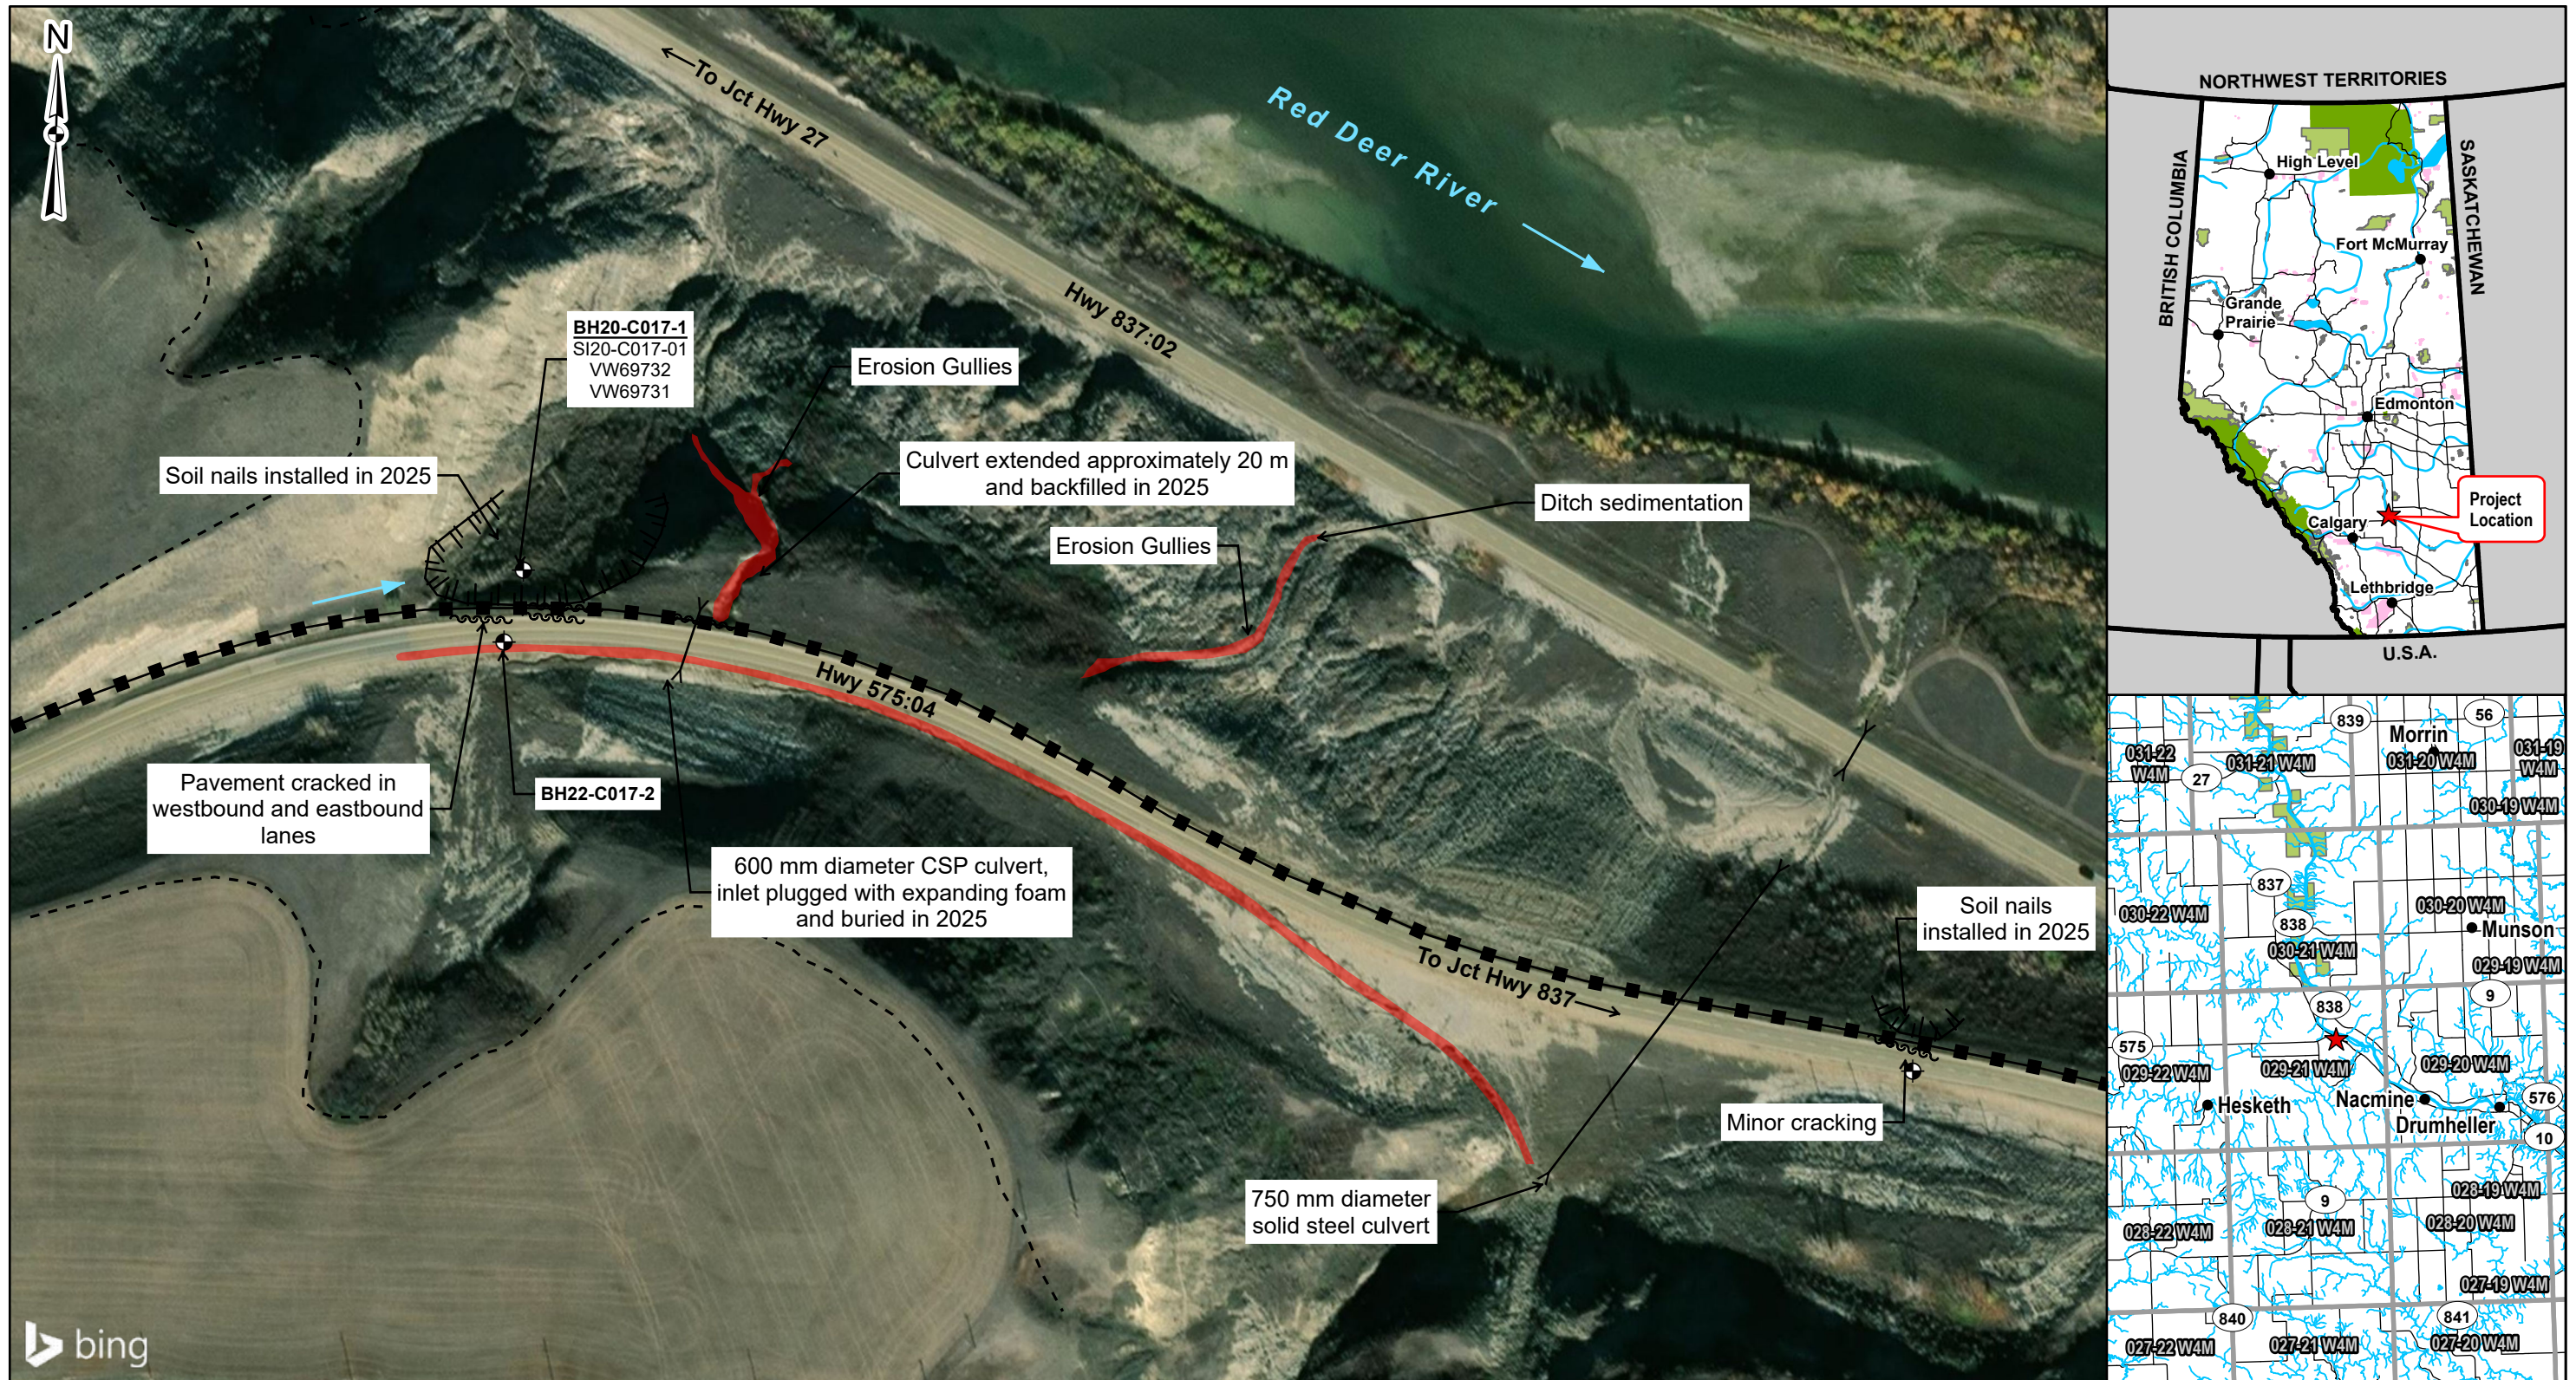
FIG No. 1

- C017-1: a shallow embankment slope failure on the north side (westbound lane) of Hwy 575:04,
- C017-2: an erosion gully that has formed downslope of a culvert outlet on the north side (westbound lane) of Hwy 575:04, and
- C017-3: a moderately deep-seated slide on the north side (westbound lane) of Hwy 575:04 where the highway crosses a creek and enters a cut section in the valley wall.

In October 2020, KCB installed one SI (SI20-C017-01) and two VWP (VW69731 and VW69732) to monitor depth of movement and groundwater conditions, respectively. The instruments were installed in borehole BH20-C017-1, located on the north (downslope) side of Hwy 575:04, within the C017-3 slide mass.

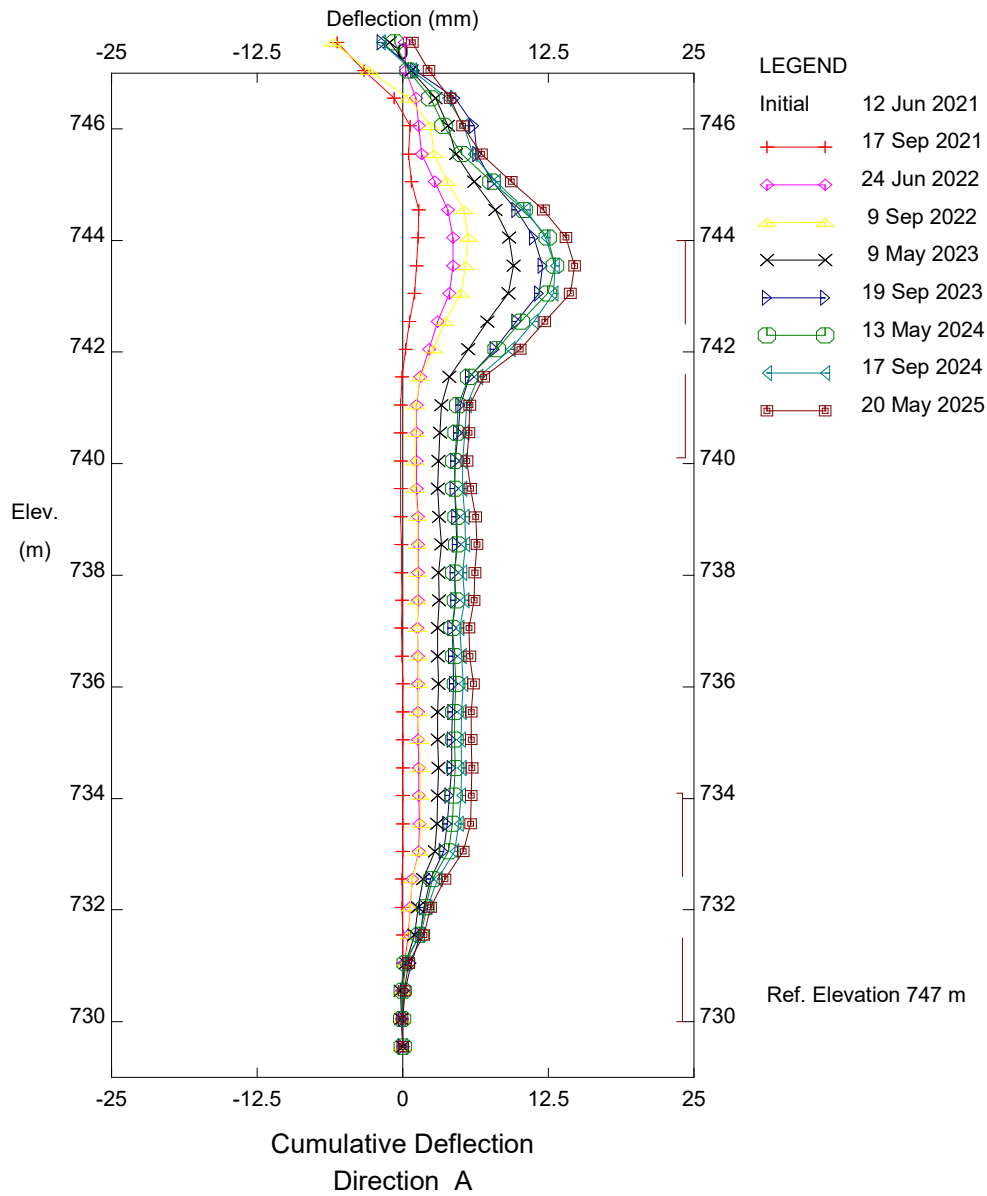
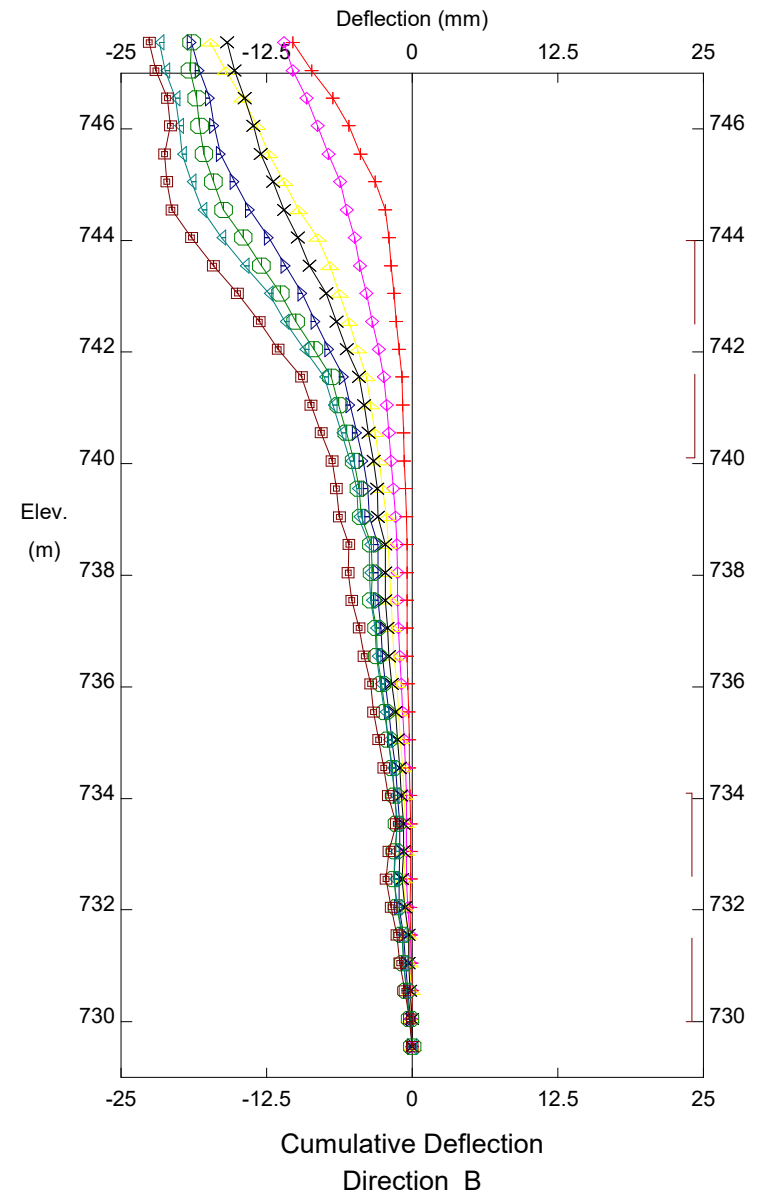
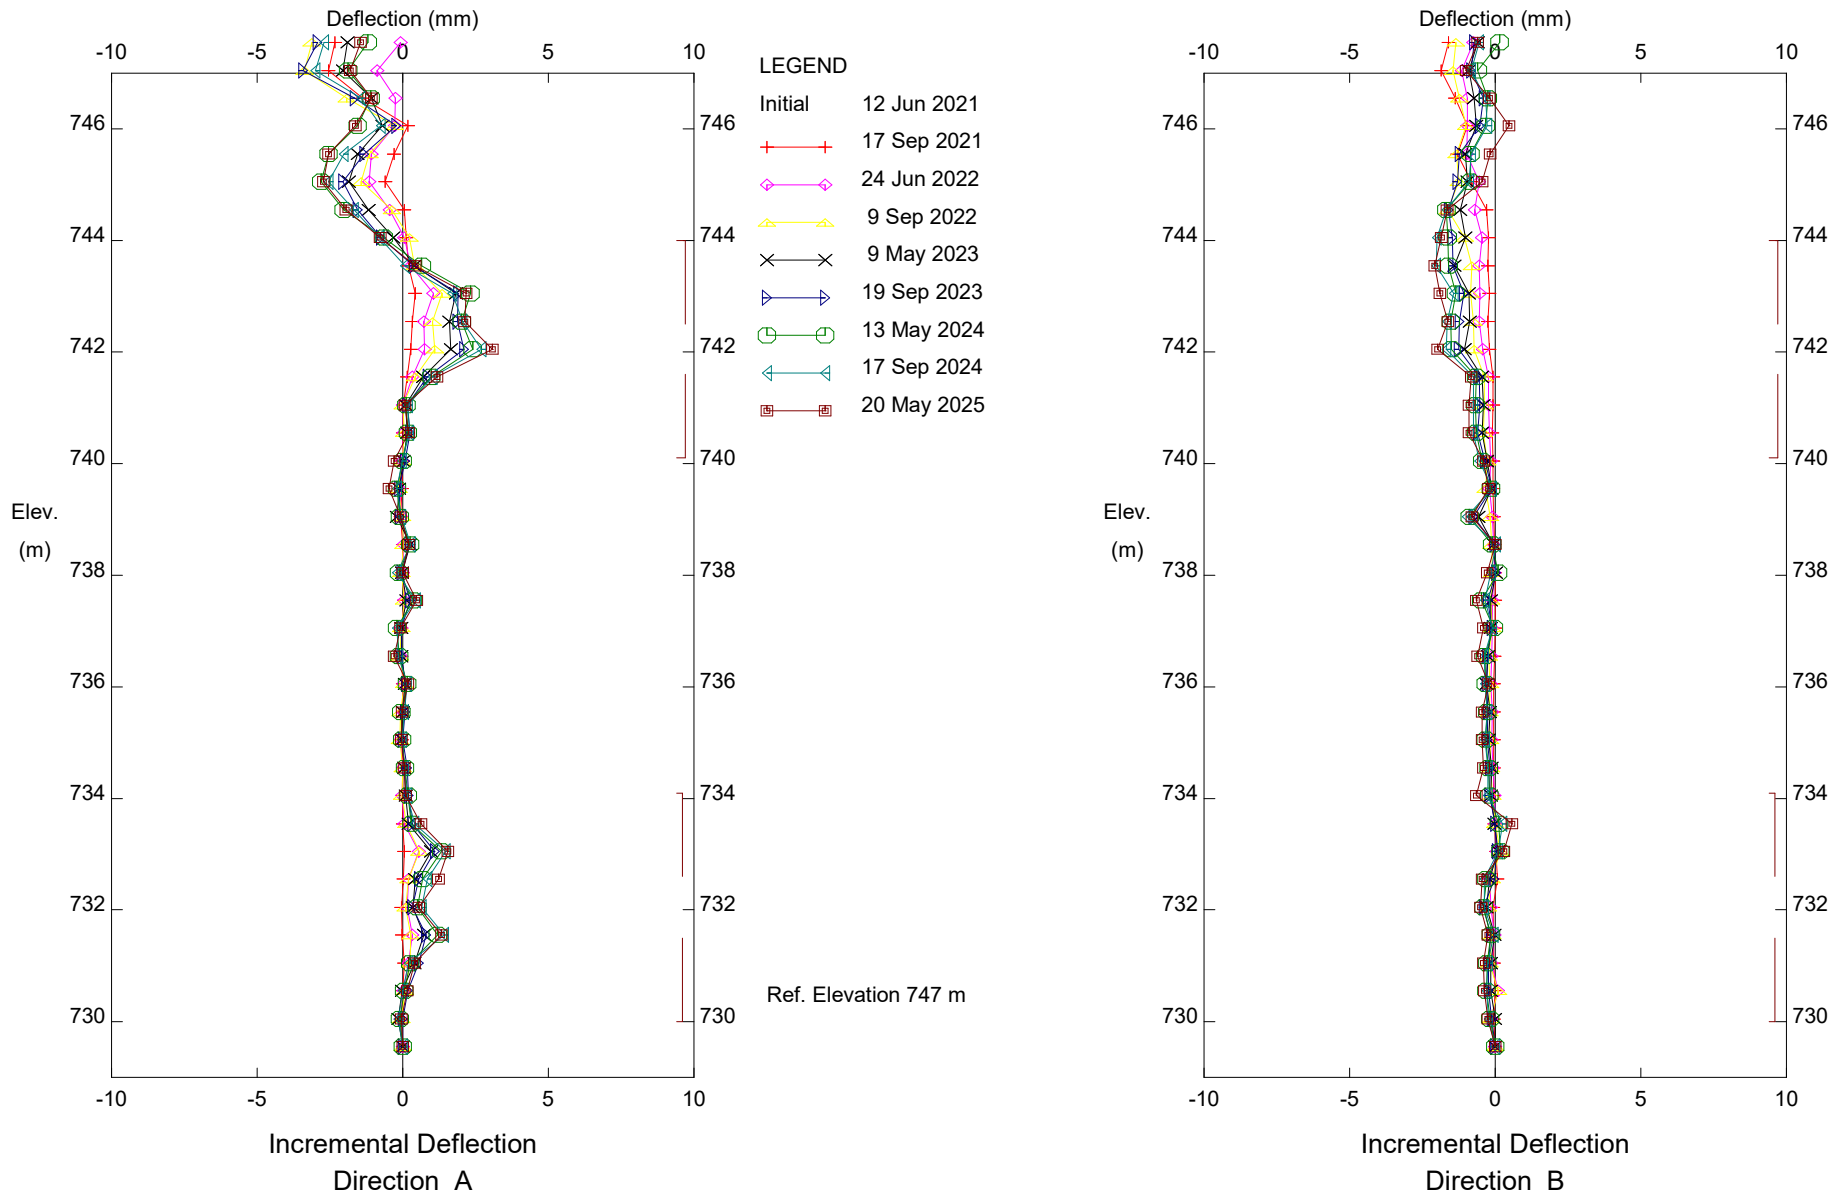
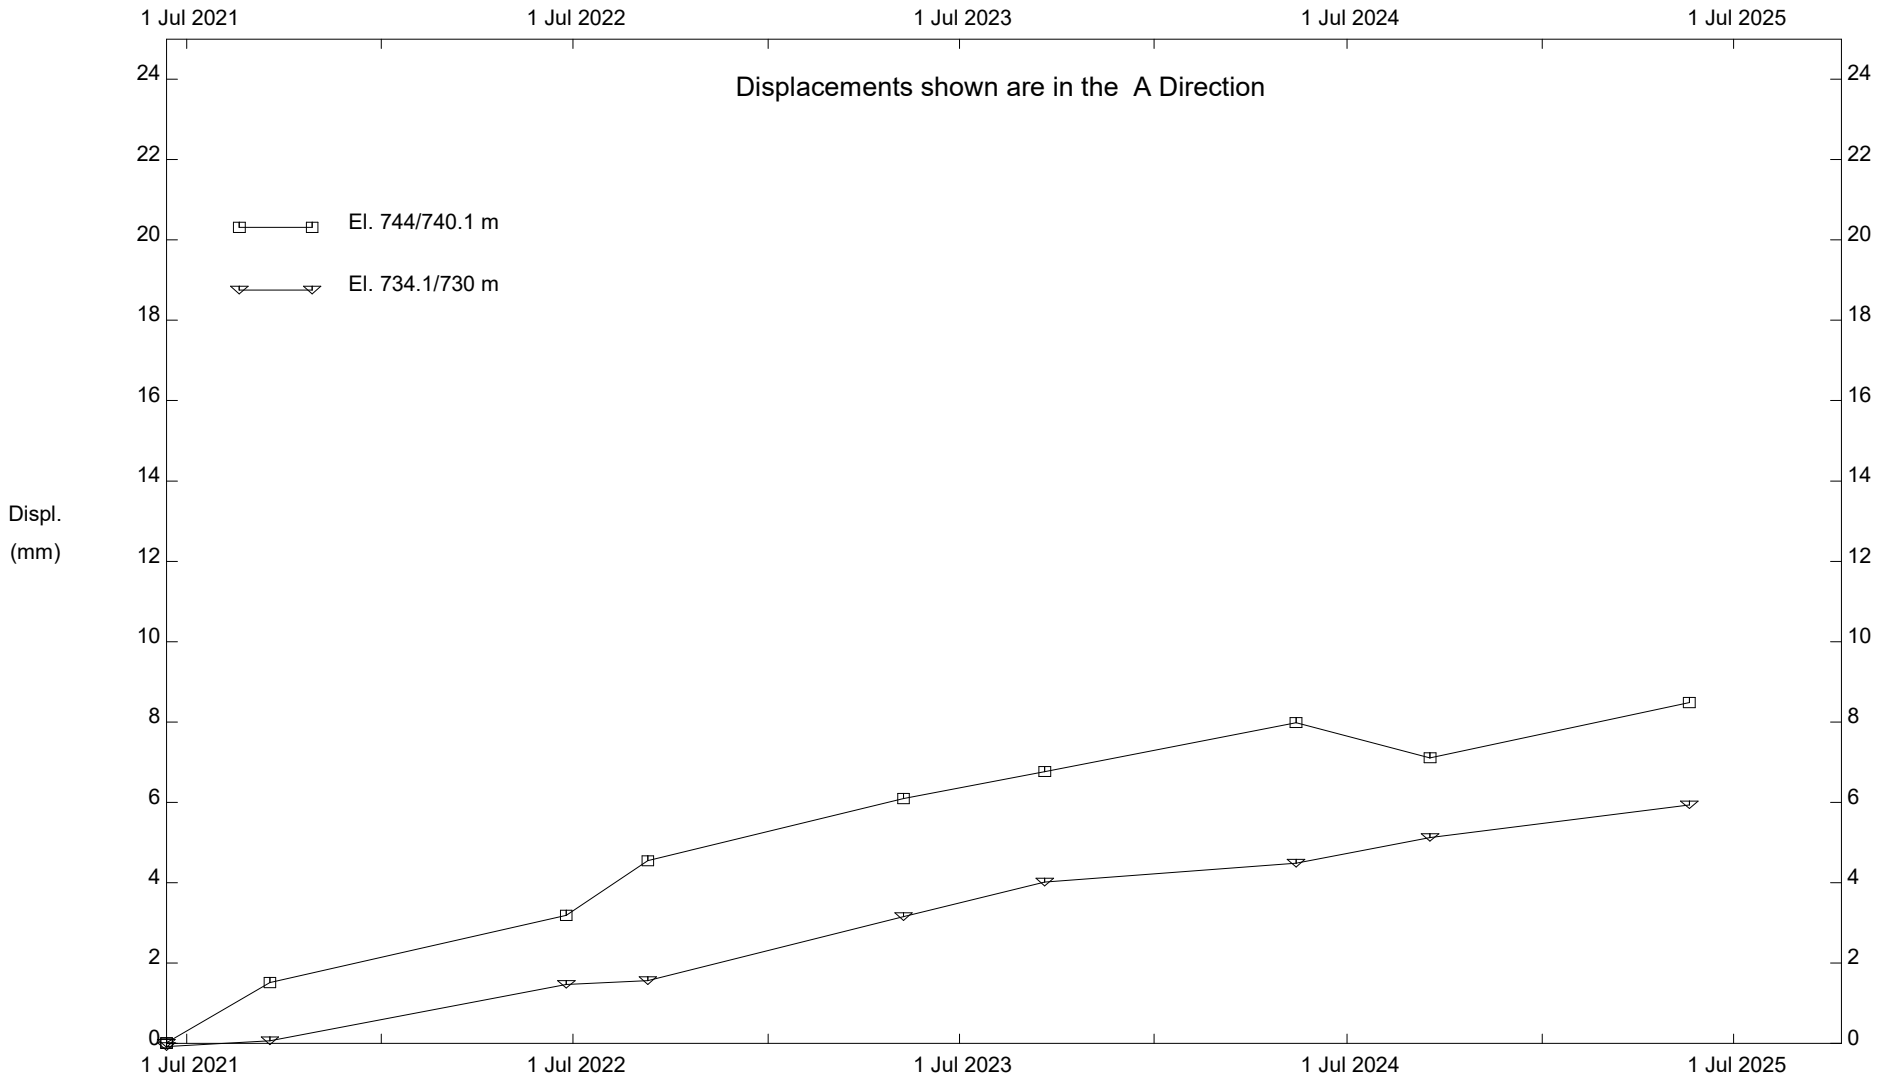
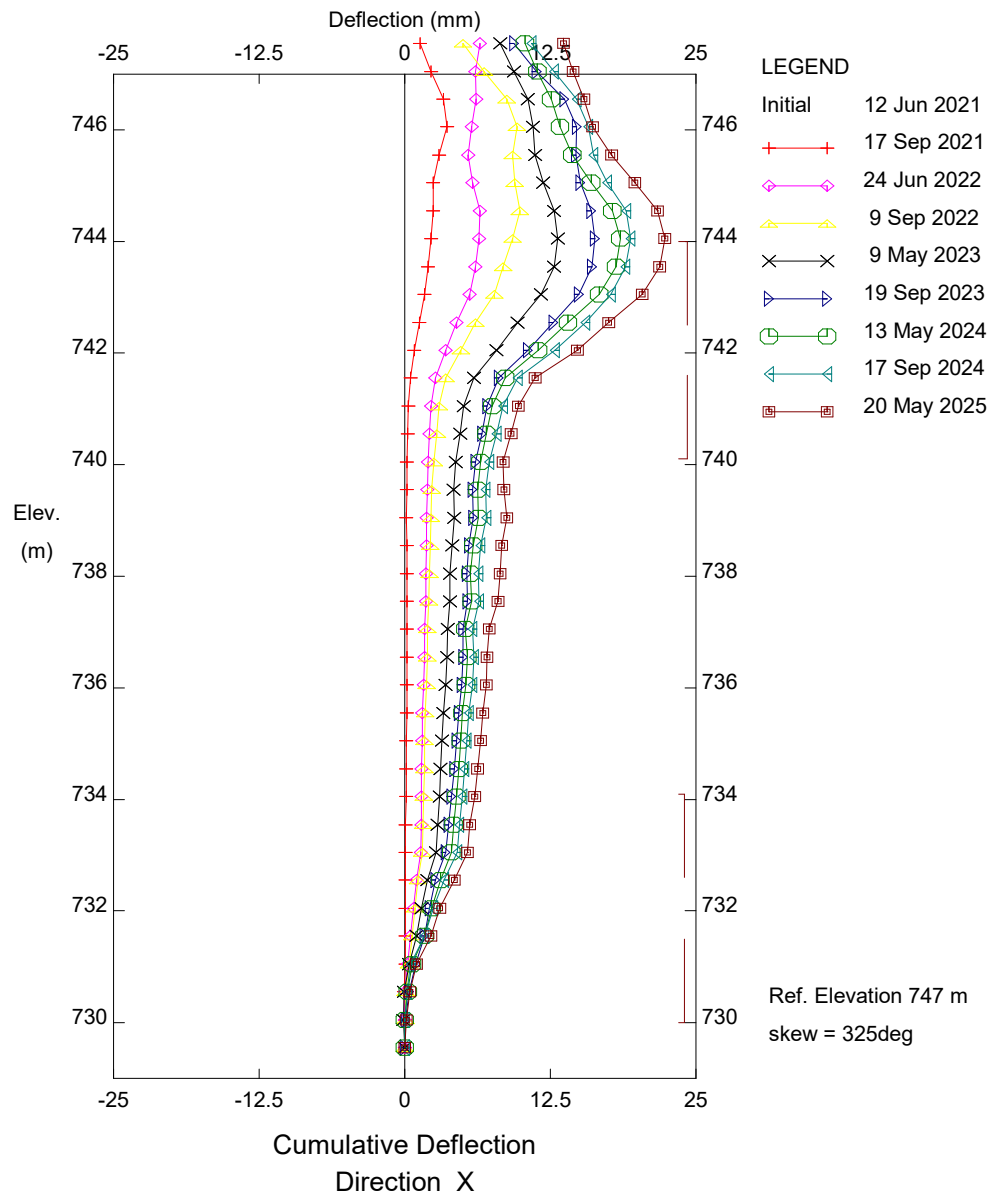
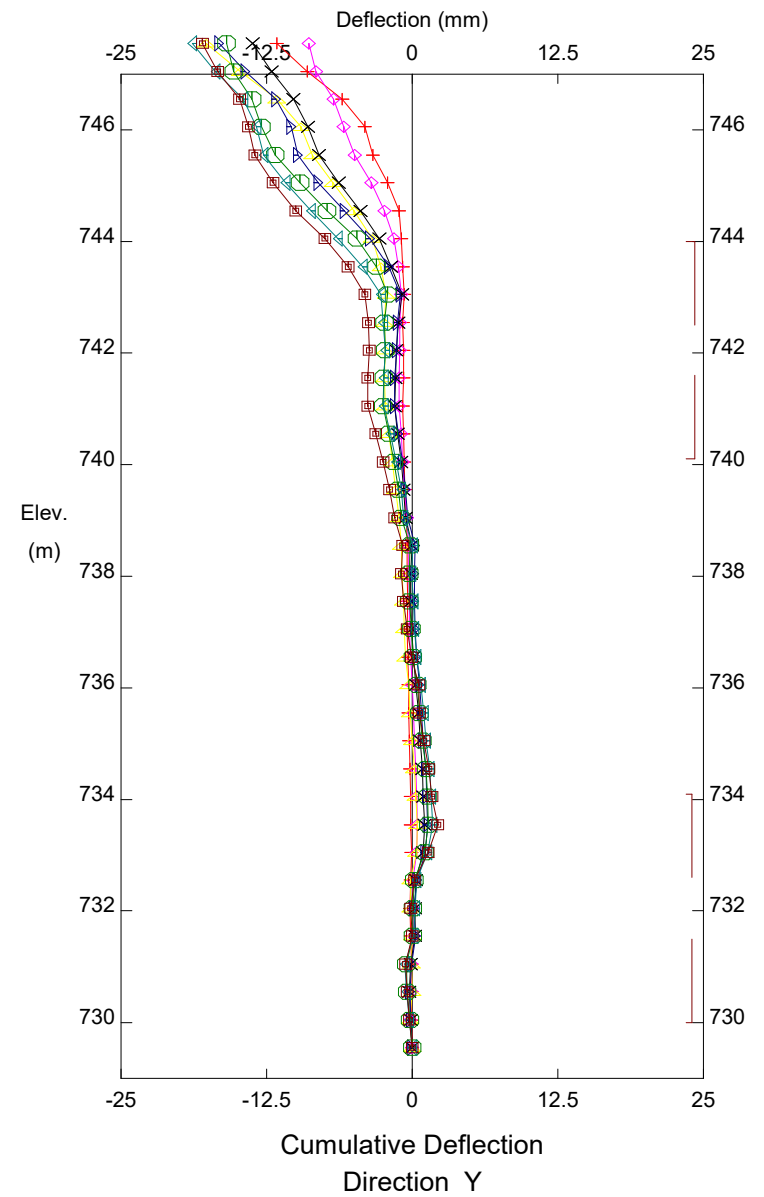
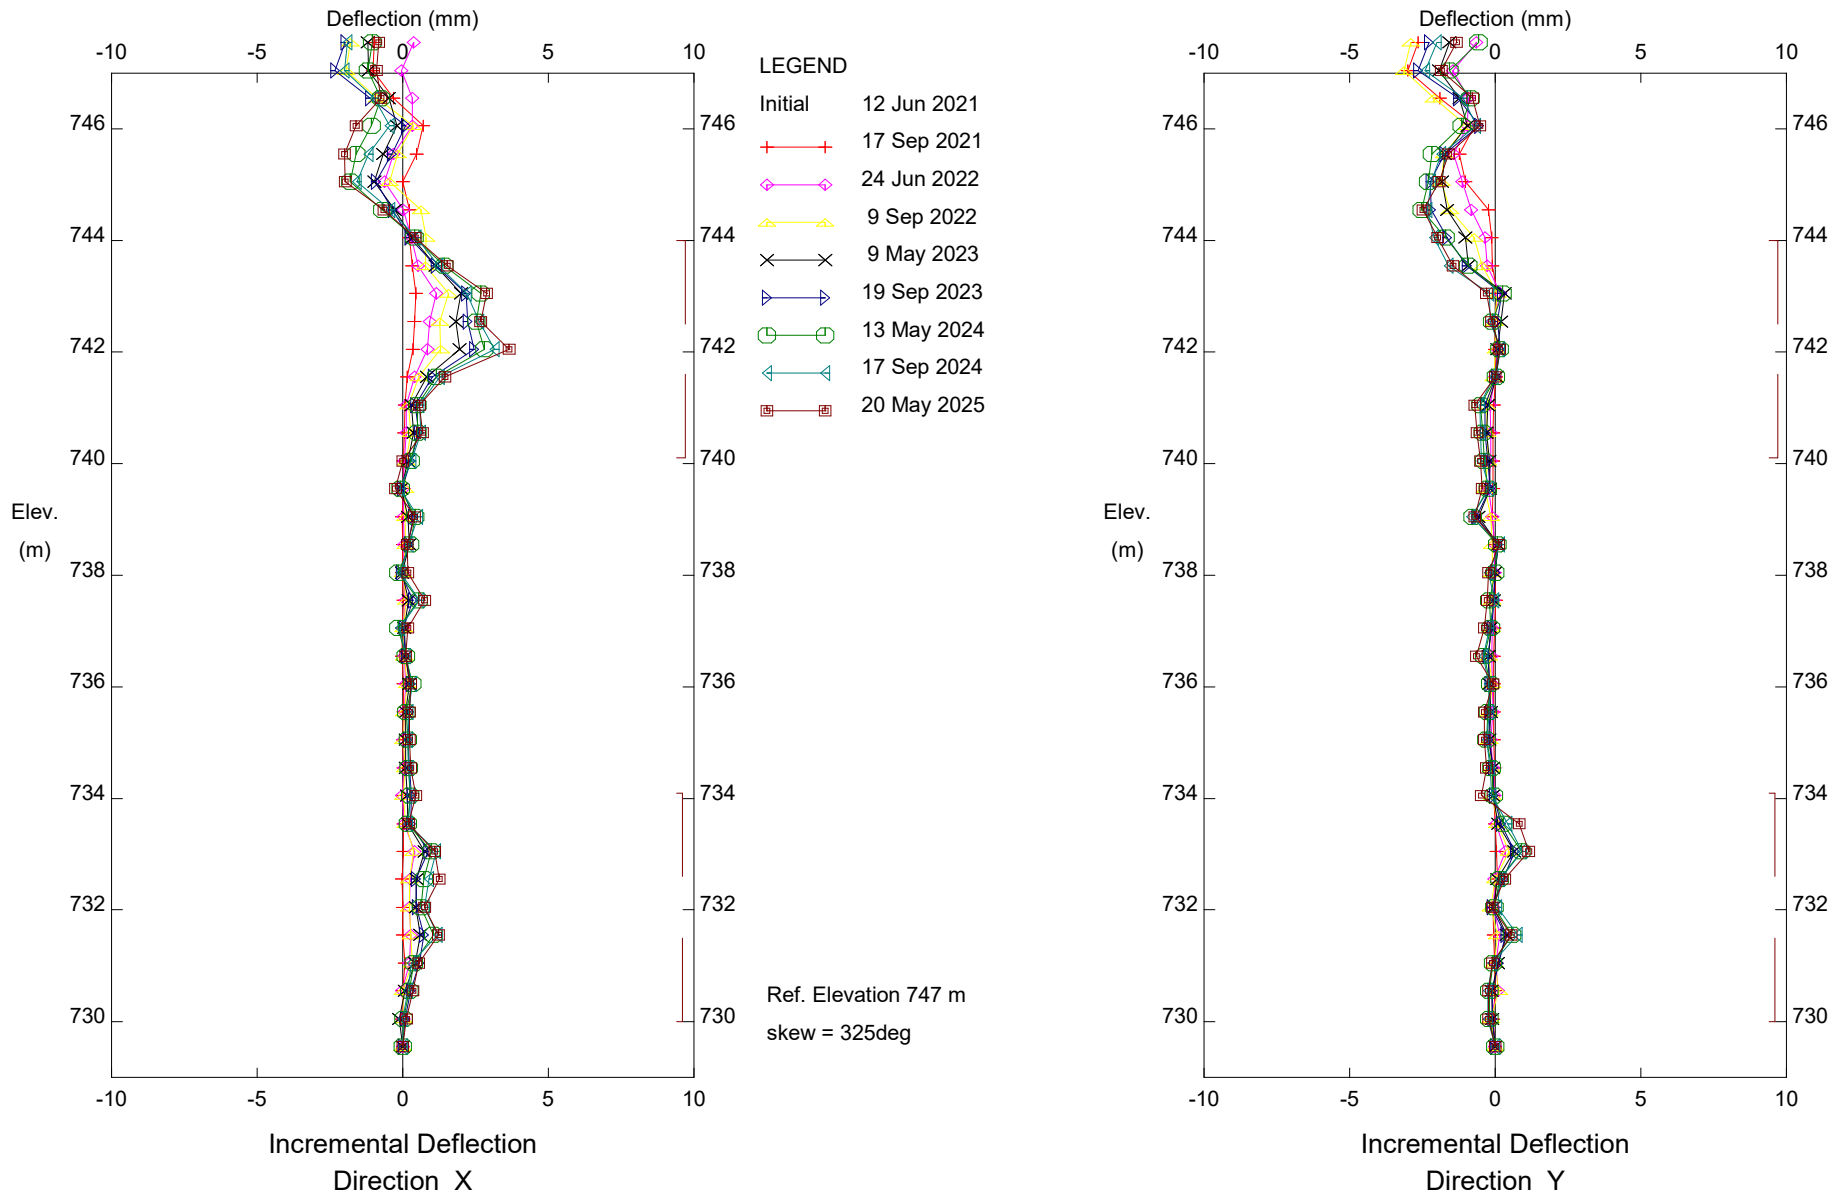
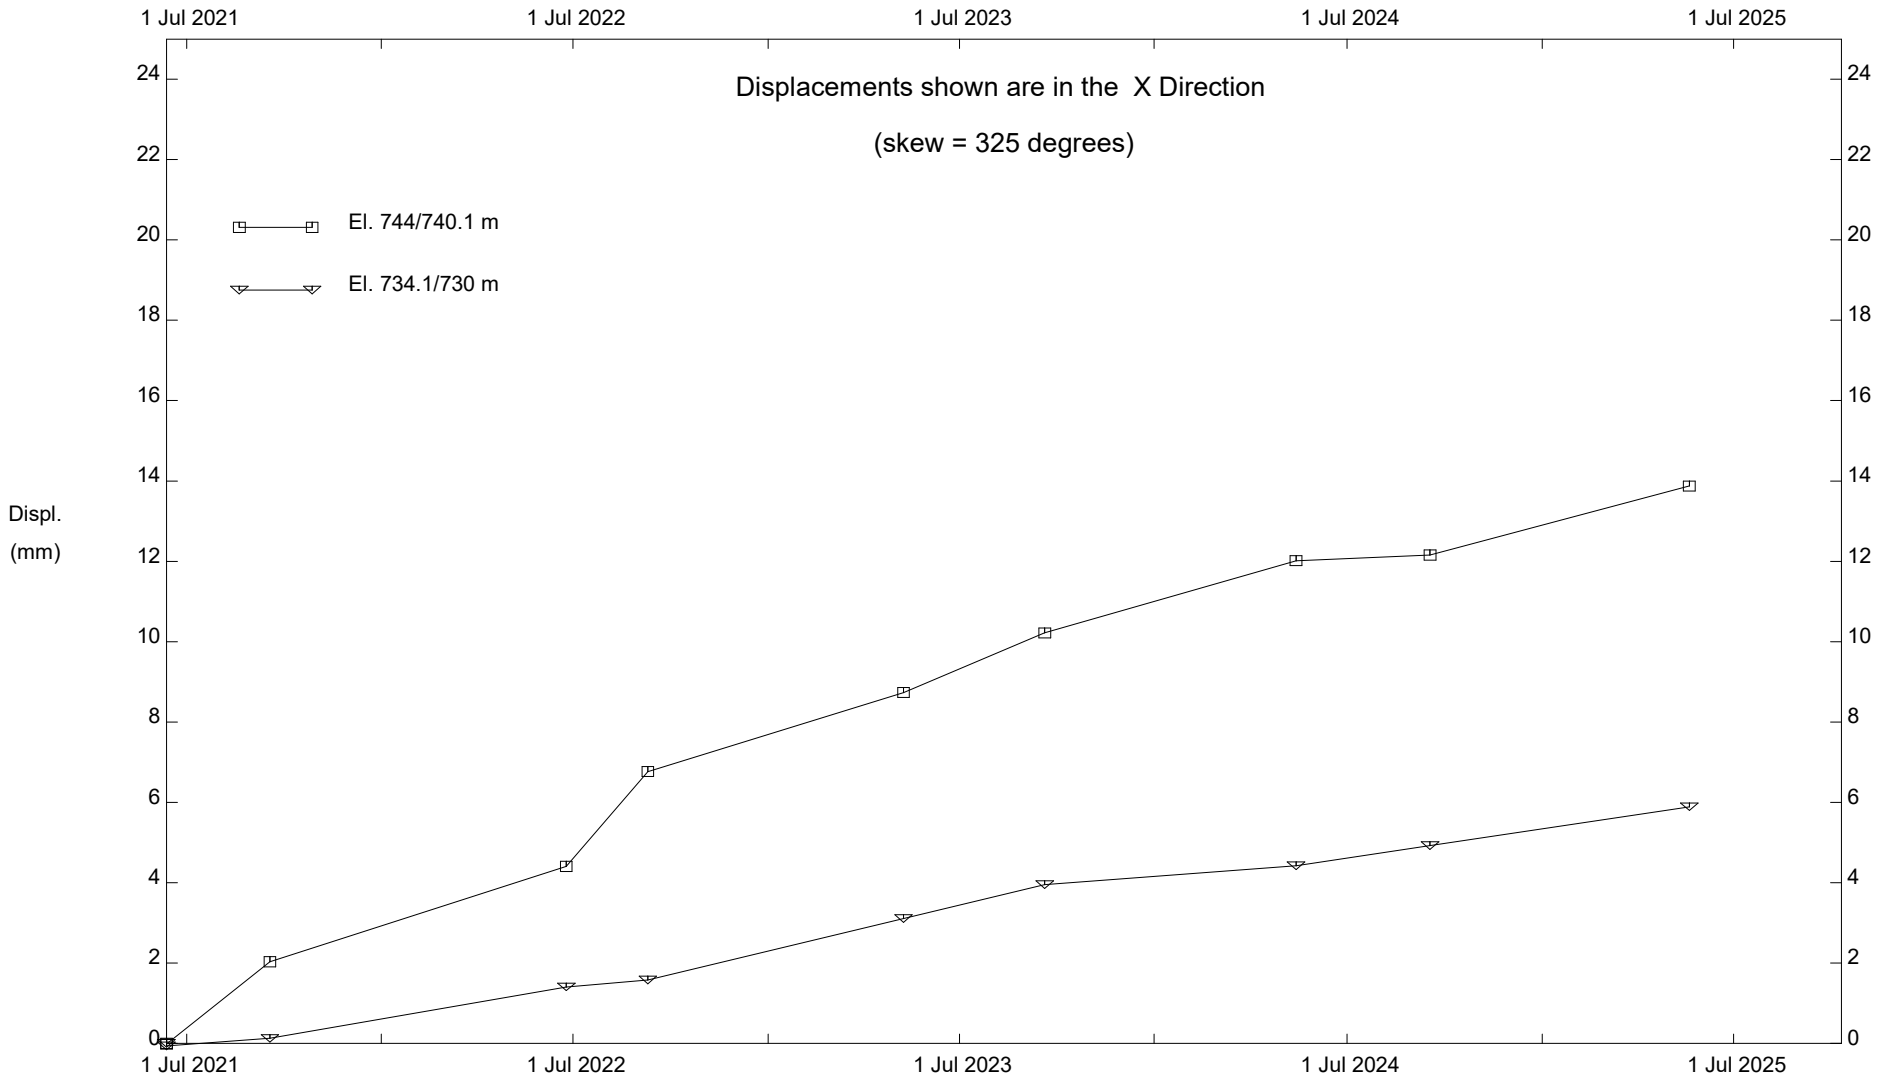
C017-III; H575:04; Truckstop Slide, Inclinator SI20-01
Alberta Transportation

Distributed movement is being recorded in SI20-C017-01 in the upper 6 m and from approximately 14 m to 16 m below ground surface.

Based on the stratigraphy encountered during the 2020 drilling investigation, the upper and lower zones of movement recorded in SI20-C017-01 appear to be occurring in a soft zone in the embankment fill (silty clay and sand) and in the underlying foundation material (sandy silt), respectively.

An overall relatively slow rate of movement (less than approximately 3 mm/year) has been recorded in the SI since June 2021, excluding an increased rate of movement (approximately 6 mm/year) recorded in fall 2022 after wet weather in summer 2022. There was a relatively small increased rate of movement recorded in the shallow zone of movement (approximately 8 mm/year) between the fall 2024 and spring 2025 readings, which may be attributed to construction activities at the site as part of C017-1 and -3 repair work (increased truck traffic and earthworks at the C017-3 site). Increased movement may occur in response to higher groundwater level caused by periods of heavy or prolonged rainfall or freshet infiltration.

All operable instruments should continue to be read twice per year (spring and fall).

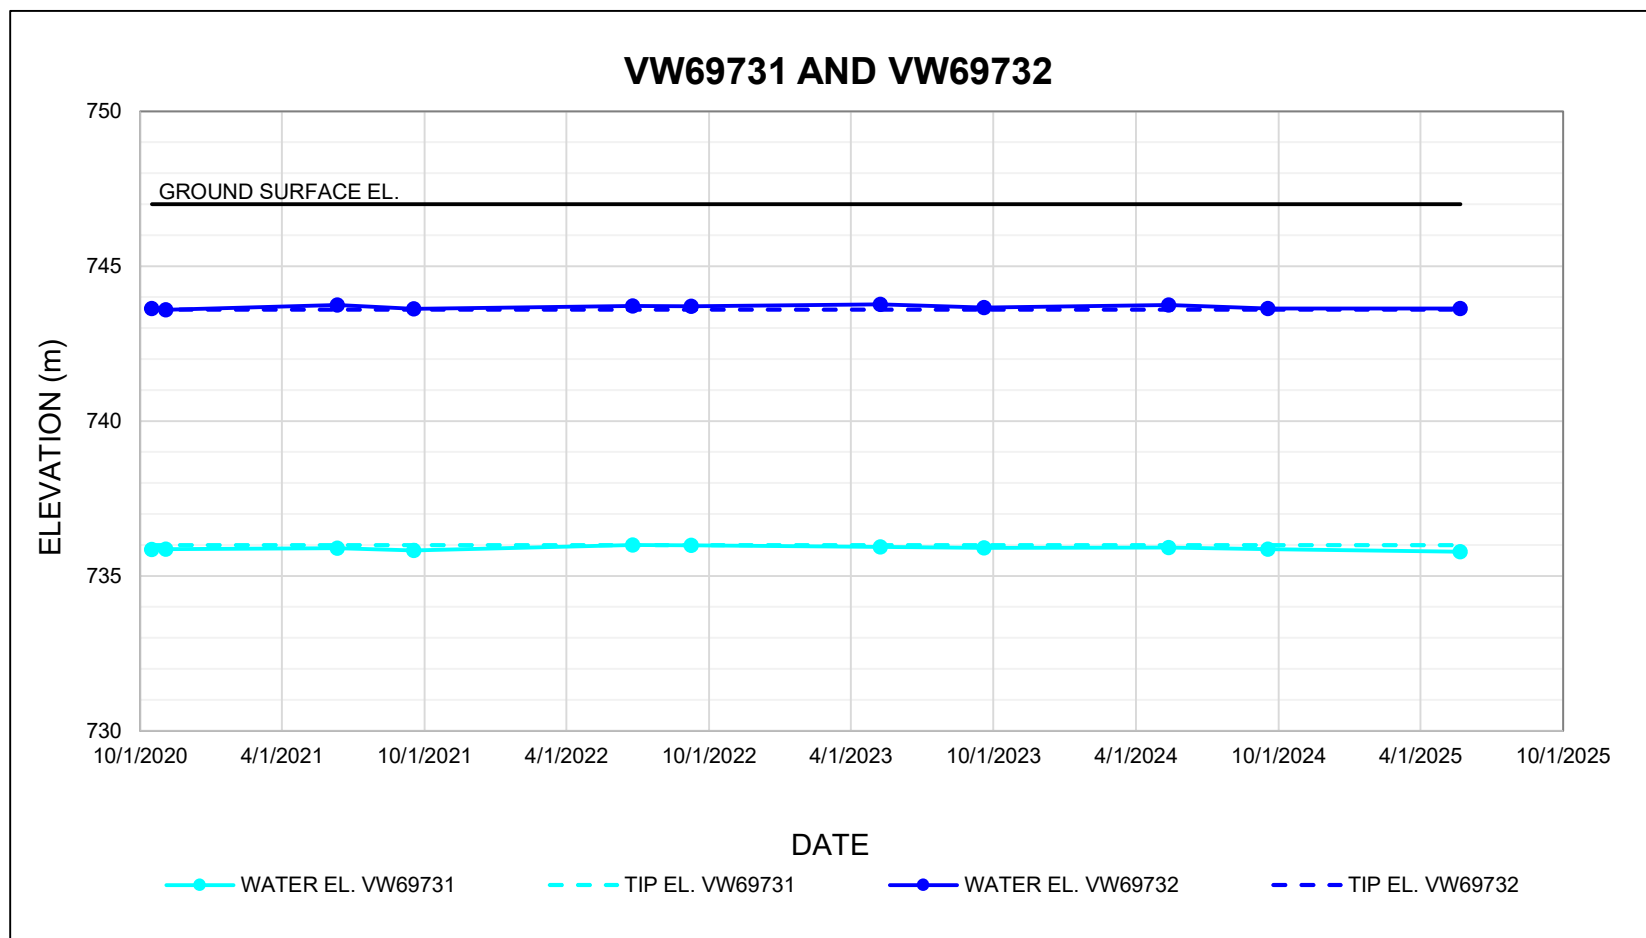
</div>	<div>PROJECT</div> <div>CENTRAL REGION GEOHAZARD RISK MANAGEMENT PROGRAM</div>		
	<div>TITLE</div> <div>Piezometer Data C017-3 - Truck Stop Slide Hwy 575:04, km 26.341</div>		
SCALE	N/A	PROJECT No.	A05116A02
FIG No.			I-7

Since installation in October 2020, porewater pressures recorded in the two VWPs (VW69731 and VW69732) have been within ± 0.2 m of the tip elevation for each instrument, indicating these instruments are dry. Since an elevated groundwater level is believed to be one of the factors driving instability of the slide at the C017-3 site, KCB believes the piezometers may have been installed at depths that do not record transient changes in groundwater or that the current bi-annual reading frequency of the instruments does not capture short-term fluctuations (i.e., increases and decreases) in water level that could be occurring in response to heavy rainfall events or freshet infiltration between readings.

No instrument repairs or maintenance is required. However, installation of a data logger with one or more of the VWP's may be beneficial, as more frequent readings may capture short-term fluctuations (i.e., increases and decreases) in groundwater level that could be occurring in response to periods of heavy or prolonged rainfall or freshet infiltration between readings.
