SITE NUMBER AND NAME: C019 Upper Slide		HIGHWAY & KM: 575:04, 25.654	PREVIOUS INSPECTION DATE: June 12, 2018	INSPECTION DATE: May 30, 2022
LEGAL DESCRIPTION: 02-27-29-21-W4M	NAD 83 COORDINATES: UTM Northing Easting 12 5707581 369918		RISK ASSESSMENT: PF: 5 CF: 4 TOTAL: 20	
AVERAGE ANNUAL DAILY TRAFFIC (AADT): 980 (west) & 1170 (east) (Reference No. 106230)			CONTRACT MAINTENANCE AREA (CMA): 517

PROJECT
 CENTRAL REGION GEOHAZARD RISK MANAGEMENT PROGRAM

TITLE
 Site Plan
 C019 - Upper Slide
 Hwy 575:04, km 25.654

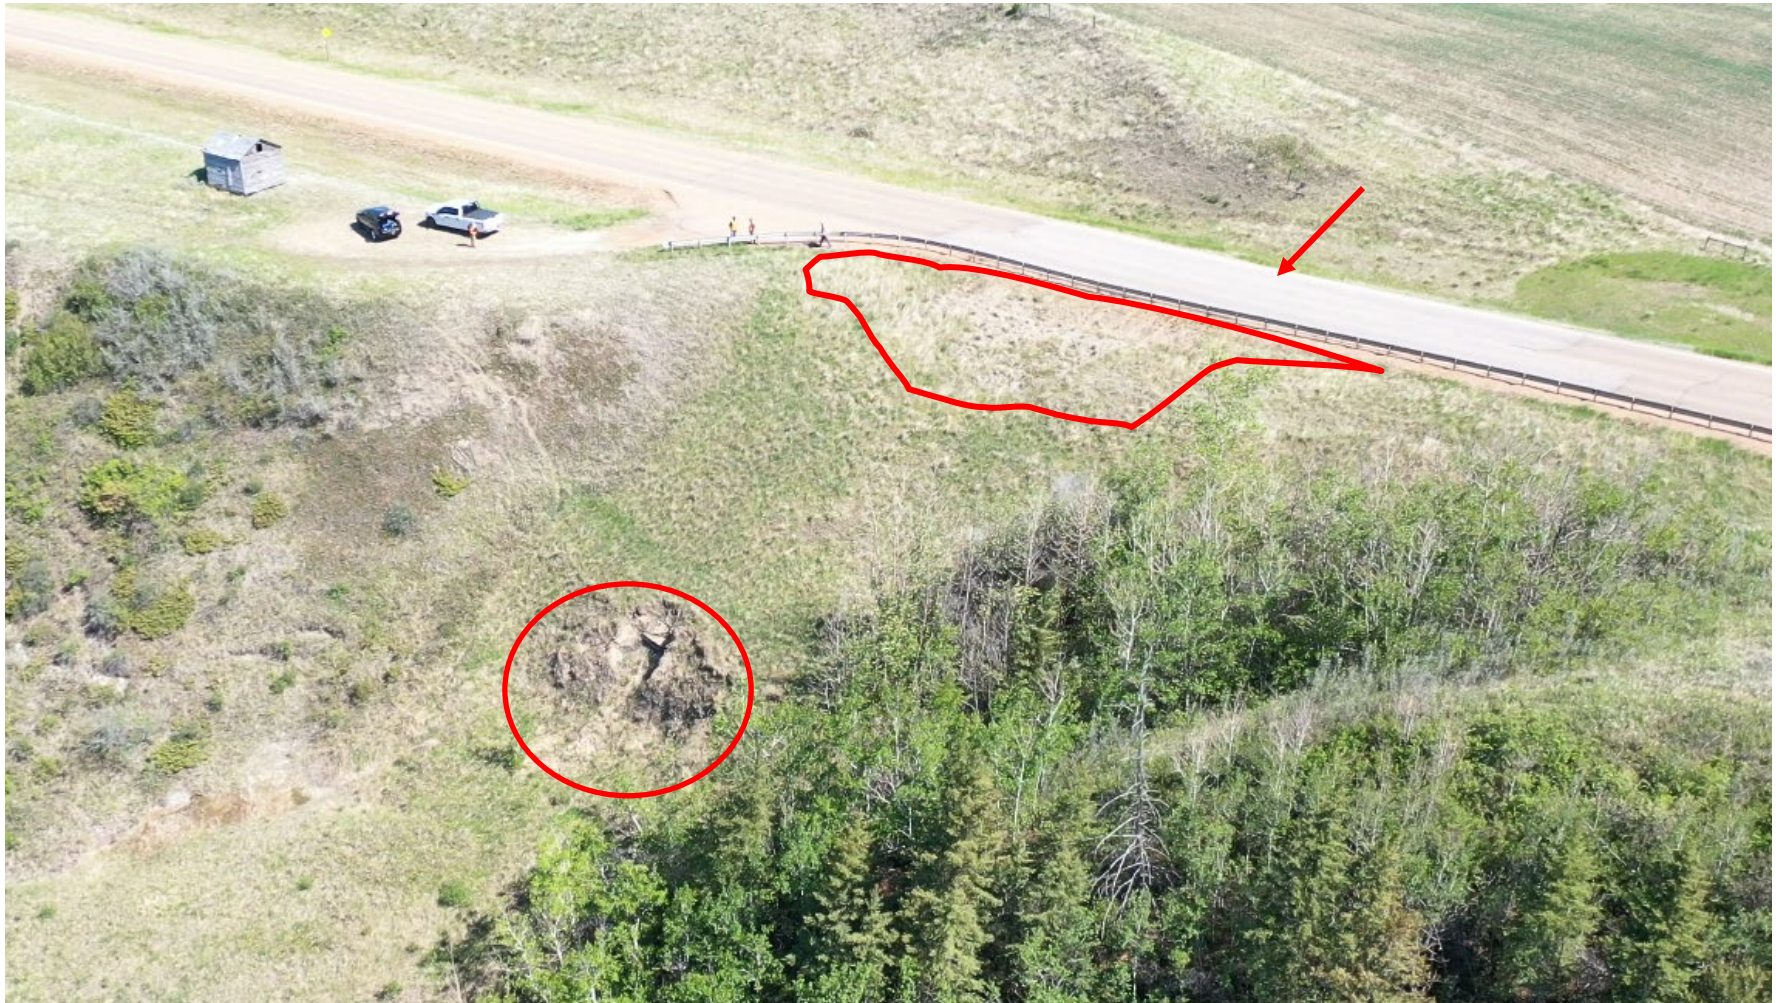
COMMENTS
Exposed geogrid is located at the lower portion of the slide (northwest of WP 148) (Photo 1 and 3). The exposed geogrid is from a previous repair near the toe of the slope and is approximately 20 m to 25 m from the existing creek and the embankment is approximately 8 m in height. The exposed material appeared to be sand and rounded gravel and some cobbles. The rounded granular material does not provide a strong interlock with geogrid.
The lower slide repair is not seated against the west (left) abutment.
The slide appears to be deforming along the valley slope towards the northeast and existing creek near the toe of the slope (Photo 1 and 2). Visible movement was observed at the toe of the slide, but no visible cracks were observed at the head of the slide of along the slope. However, evidence of movement (i.e., ground cracks) may have been obscured by tall grass.
The pavement patch completed in 2016 and the north (westbound) guardrail has settled since the 2018 inspection (Photo 4). The guardrail also appears low due to the regular pavement patching completed at the site. The MCI told KCB that he has had reports of several vehicles going off the road at the site in the winter due to the pavement settlement (i.e., dip).

The vegetation cover near the top of the slope is poor (Photo 1).

Photo 1 Oblique view of the C019 site, indicating poor vegetation cover at the top of the highway embankment (indicated by red polyline), the failing geogrid reinforced lower slide completed in late-2010 or early-2011 (indicated by red circle), and previous pavement patch (indicated by red arrow). Photo taken May 30, 2022, facing southeast.

- Previous repairs at the site include soil nails and geogrid reinforced fill. However, both options appear unsuccessful. KCB believes the next repair should include a steel H-pile wall installed along the north (westbound) edge of the highway. Additionally, KCB believes drainage improvements are required to help stabilize the slope. However, with high pressure water main in upslope ditch approximately 7 m below ground surface, this limits the drainage repair options (e.g., a cutoff trench located in the south (eastbound) ditch).
- One borehole could be drilled through the highway surface to assess ground conditions and to install instruments to monitor ground water and slope movement. Assessing the depth of movement would be used to determine the installation depth of a H-pile wall to attempt to intercept the existing failure plane.

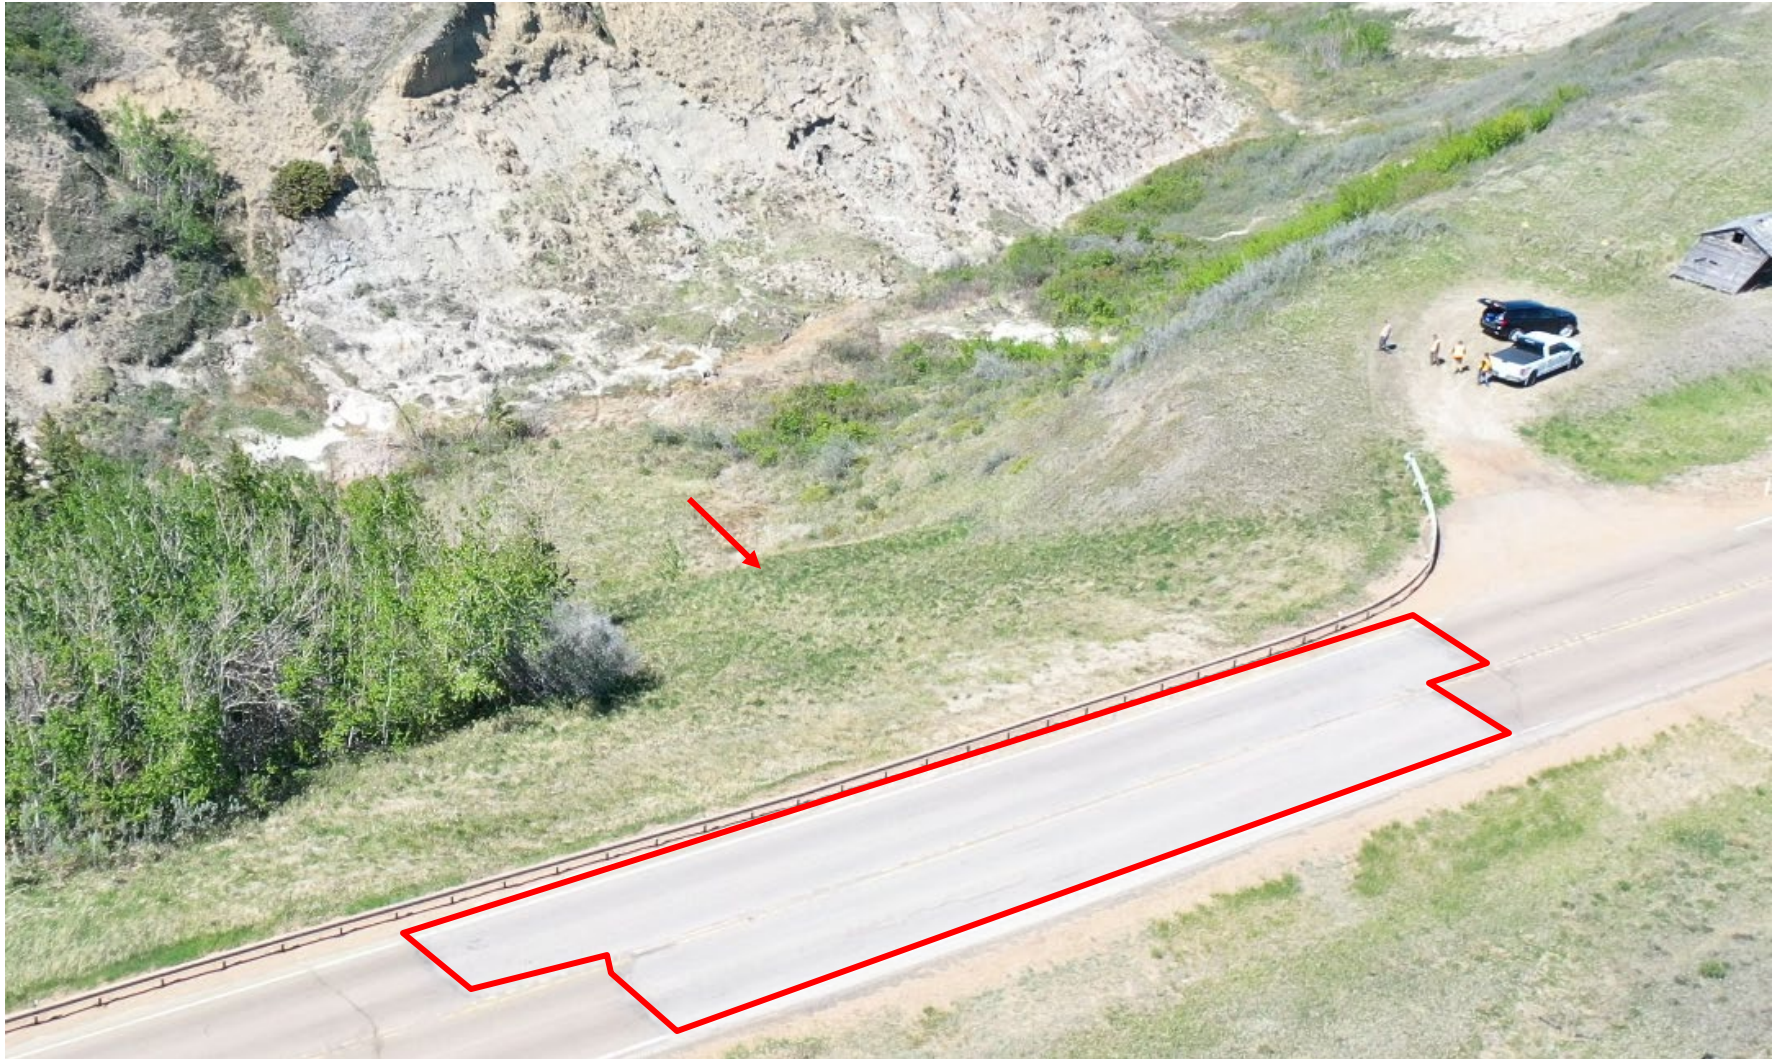
Photo 2 Aerial photo of the C019 site from the upslope (south) side of Hwy 575:04, showing the failing geogrid reinforced lower slide (indicated by red arrow) and pavement patch (indicated by red polyline). Photo taken May 30, 2022, facing north.

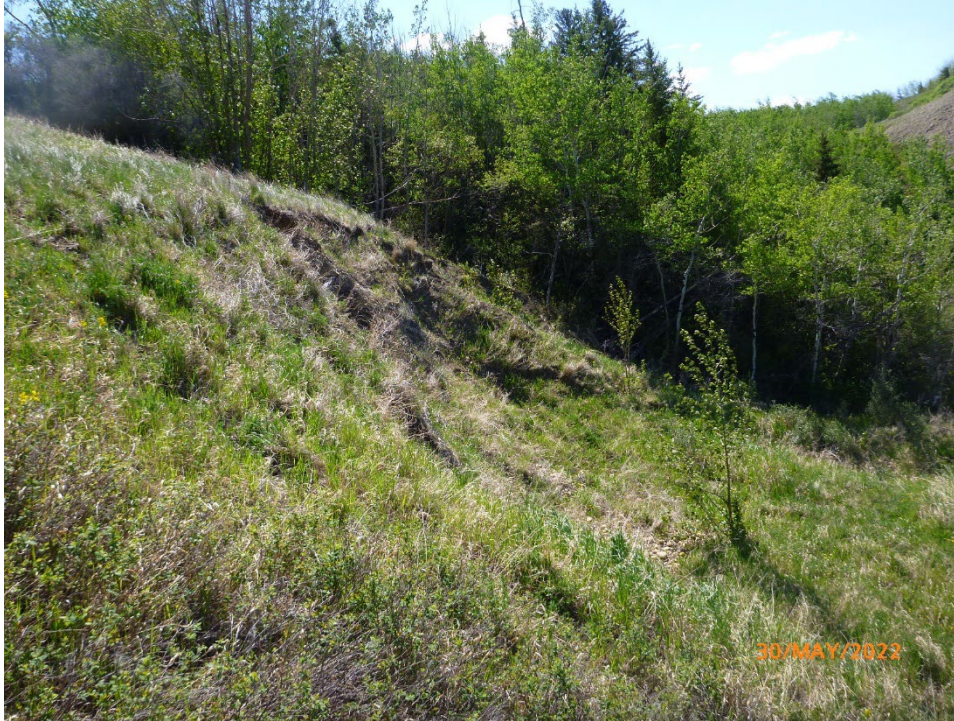
Photo 3 Failed geogrid reinforcement at the lower portion of the slide (northwest of WP 148). The slope is located approximately 20 m to 25 m from the creek and is approximately 8 m in height. Photo taken May 30, 2022, facing northwest.

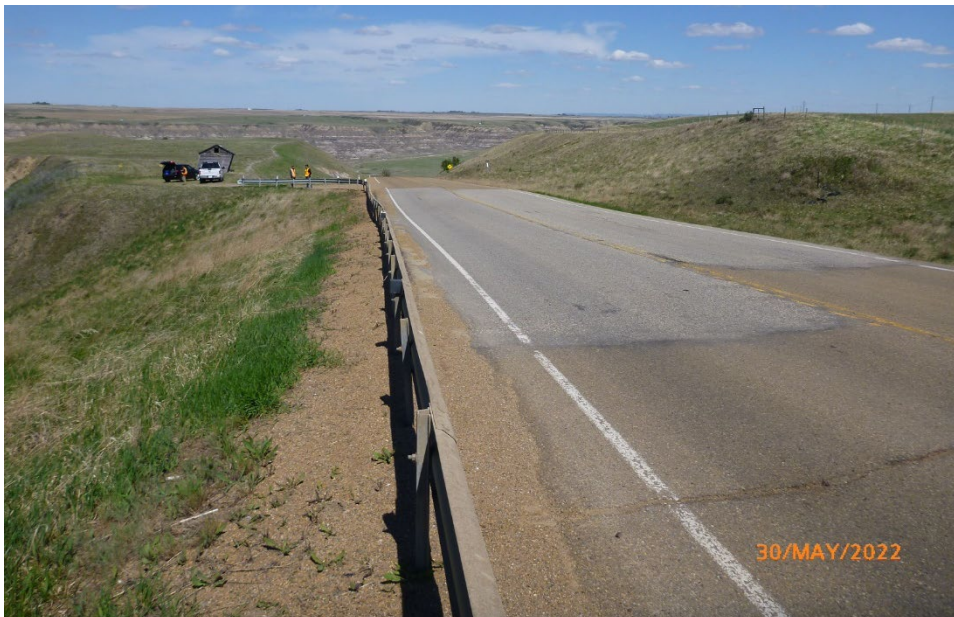
Photo 4 The pavement and guardrail have continued to settle since the 2018 inspection. The guardrail is low due to the regular pavement patching. Photo taken May 30, 2022, facing southeast.
