SITE NUMBER AND NAME: <b>C048 – I &amp; III Slides</b>		HIGHWAY & KM: 575:04, 14.5	PREVIOUS INSPECTION DATE: July 11, 2019	INSPECTION DATE: <b>June 09, 2020</b>
LEGAL DESCRIPTION:	NAD 83 COORDINATES: UTM Northing Easting		RISK ASSESSMENT:	
<b>C048-I</b> 03-28-029-22 W4M	12	5707777 358483	PF: 10	CF: 4 TOTAL: 40
<b>C048-III</b> 14-21-029-22 W4M	12	5707780 358250	PF: 10	CF: 4 TOTAL: 40
AVERAGE ANNUAL DAILY TRAFFIC (AADT): 980 (west) and 940 (east) (Ref No. 106230 & 105240)			CONTRACT MAINTENANCE AREA (CMA): 517

PRIMARY SITE ISSUE: C048 – I and III: two shallow slides in the highway embankment fill. Both slides are located on the south side (eastbound lane) of Hwy 575 near the east and west abutments, respectively.

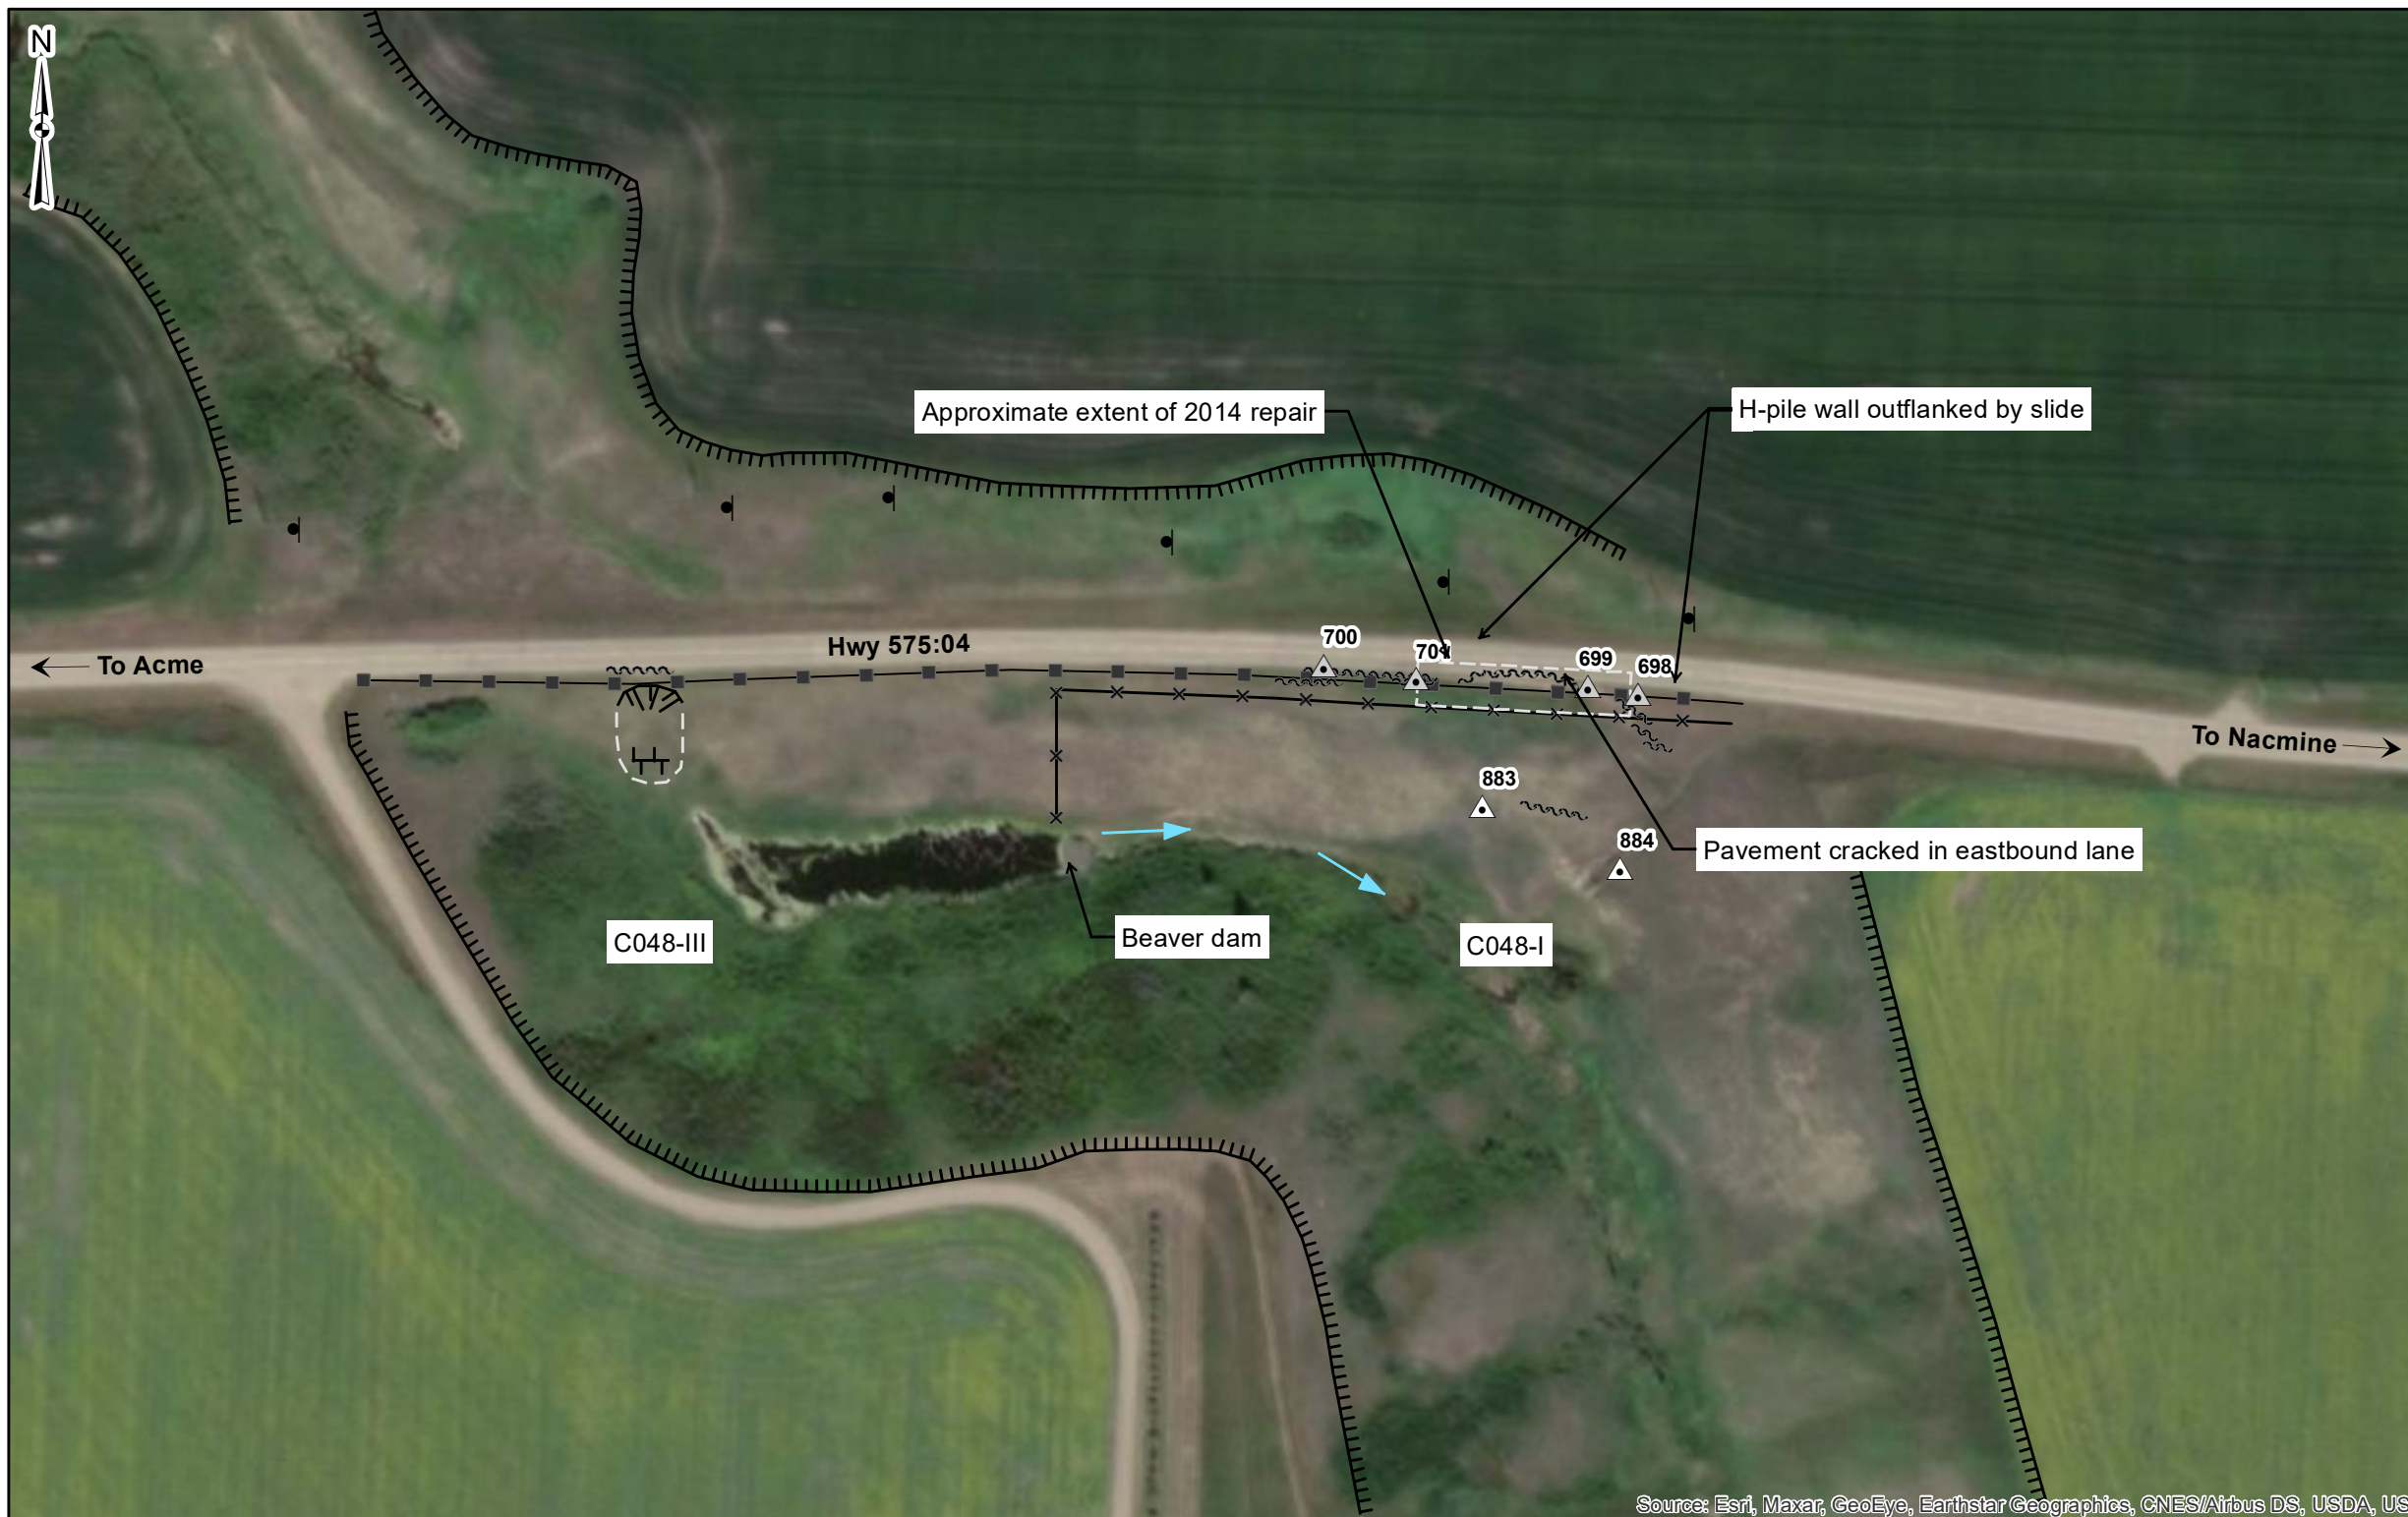
NOTES: 1. HORIZONTAL DATUM: NAD83 2. GRID ZONE: UTM Zone 12N 3. IMAGE SOURCE: World Imagery, ESRI ArcGIS Online Source date July 22, 2019	CLIENT 	PROJECT CENTRAL REGION GEOHAZARD RISK MANAGEMENT PROGRAM
		TITLE Site Plan C048 - I and III Slides Hwy 575:04, km 14.5
SCALE 1:2,000	PROJECT No. A05115A02	FIG No. 1

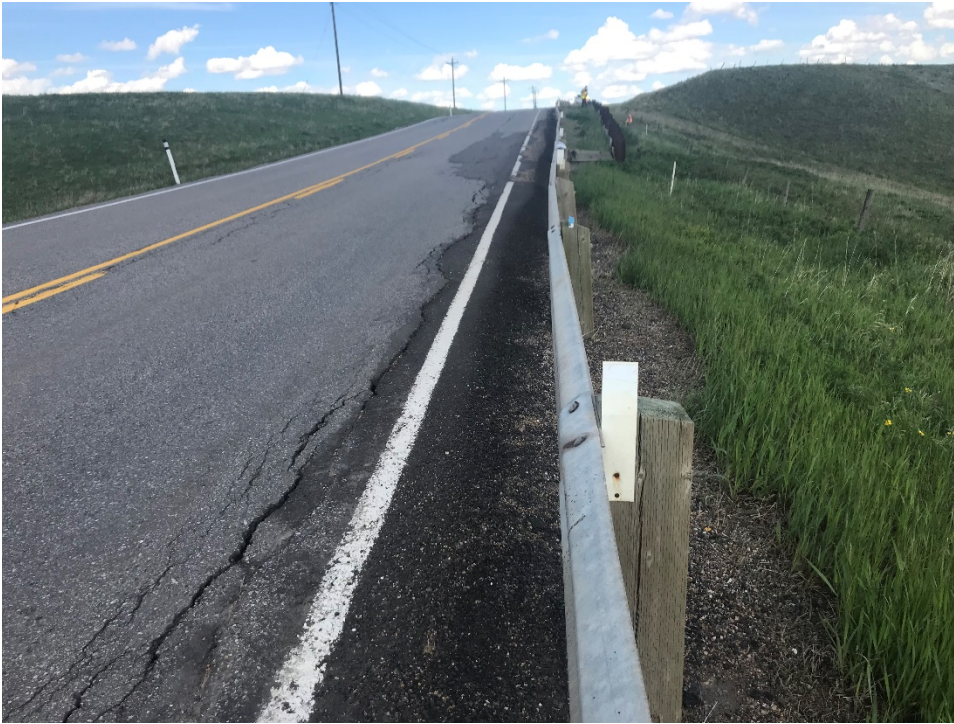
**Photo 1** Cracking of the pavement upslope of the C048-I slide area. Pavement cracks appear to be wider since the 2019 inspection. Photo taken June 9, 2020 facing east.

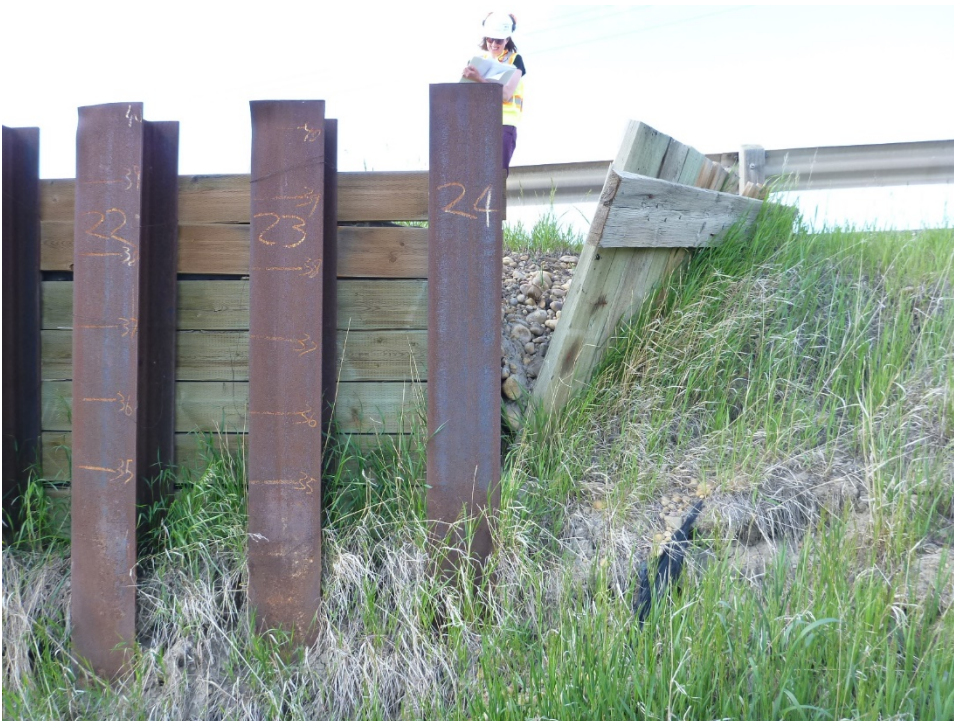
- The pile wall has been outflanked to the east and west by slide movement. Ground cracking extends 10 m to 15 m beyond the east end of pile wall (end of cracking at Waypoint 698, east end of pile wall at Waypoint 699, west end of pile wall at Waypoint 701, and west limit of pavement cracking at Waypoint 700).
- Settlement of the slide in front of the pile wall has exposed 1.0 m to 1.8 m of soil below the final row of lagging. Soil is eroding from behind the piles. Soil nails that were installed in July 2010 are becoming exposed.
- Some of the piles are deflected or misaligned, which may be a result of collision with the soil nails during installation.
- The fill behind the H-pile wall is retained at the flanks by unsupported 2” x 10” planks which are held in

place by corroded wire fastened to guardrail posts. The planks are starting to separate allowing fill to erode through the gaps in the planks. The planks will continue to collapse if left unrepaired.

**Photo 2** Wooden retaining structure at east end of pile wall has deflected more since the 2019 inspection. Photo taken June 9, 2020 facing north.

- Reconstruct the highway. Grade line redesign may reduce load on the slide.
- Extend the H-pile wall to address movements to the east and west. Thicker section timbers more suited as lagging to retain the gravel backfill should be installed between the piles.
- A tender for multiple pile walls on four sites will be released in the fall of 2020 that will include the C048-I site.

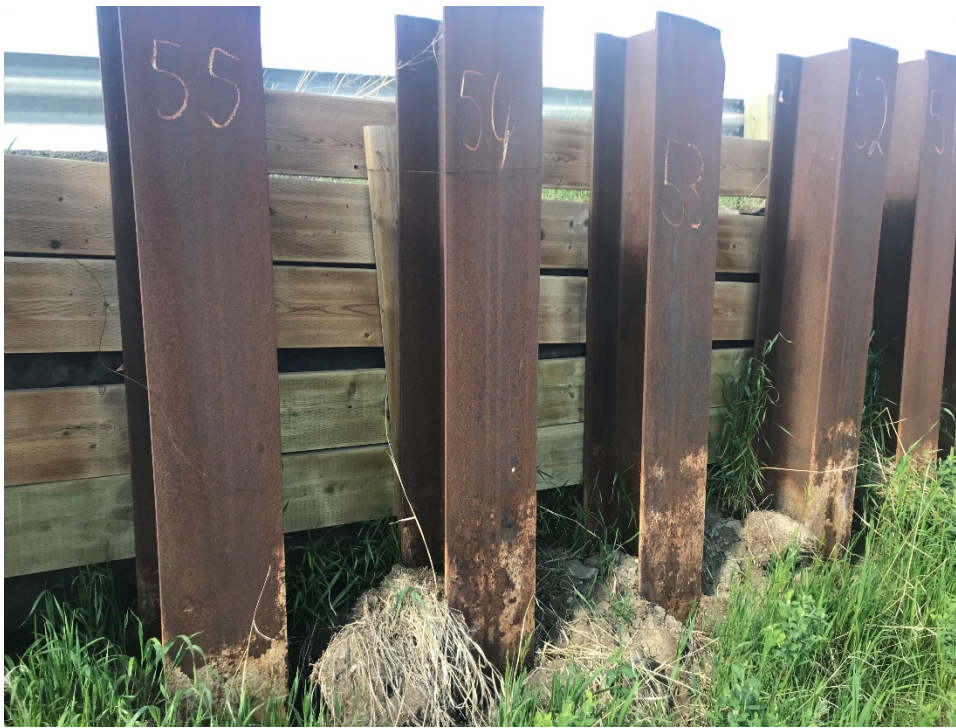
**Photo 3** Slow rate of material loss through the bottom of the retaining structure under the geotextile and wooden planks. Photo taken June 9, 2020 facing northeast.

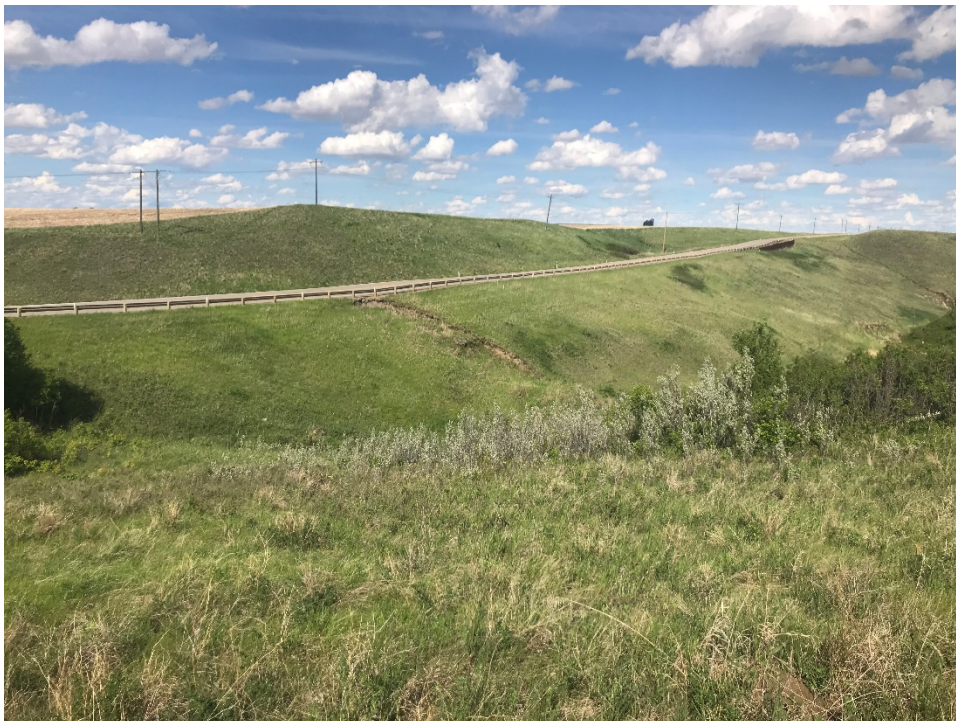
**Photo 4** C048-III slide viewed from the roadway just south of Hwy 575. Photo taken June 9, 2020 facing northeast.

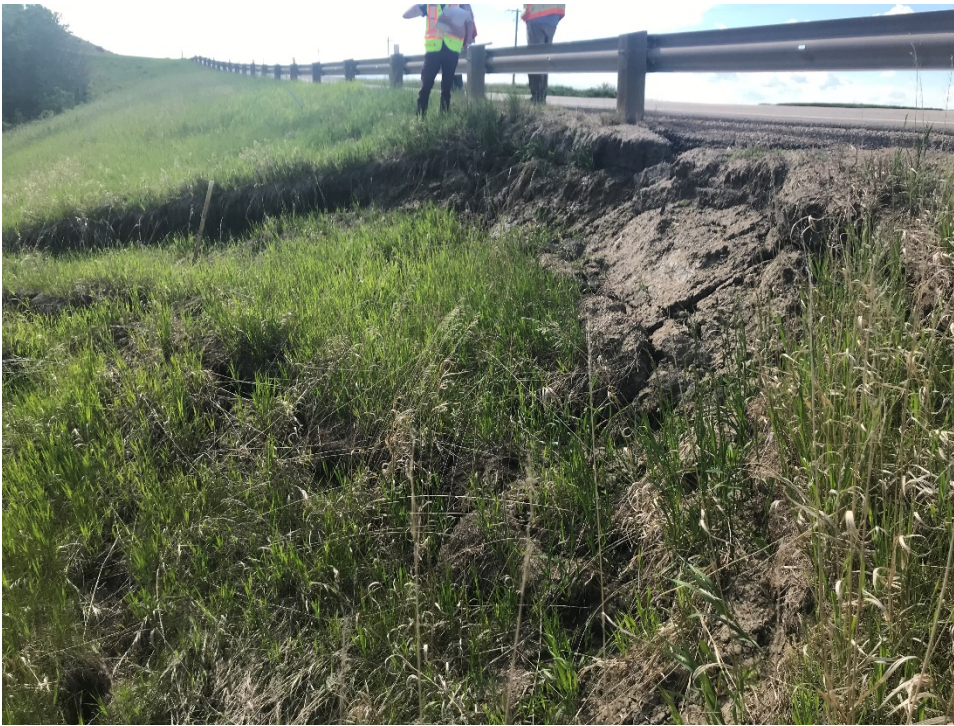
- Slide does not appear to have widened since the 2019 inspection.
- The backscarp of the slide remains within 2 m of the pavement edge, with cracking in the eastbound shoulder. The width of the pavement cracks appears to be similar than during the 2019 inspection.
- A beaver pond is located at the toe of the slope.
- The highway surface near the C048-III site is poorly drained during heavy rainfall.

**Photo 5** Head of slide at C048-III has changed little since 2019 inspection. Photo taken June 9, 2020 looking northwest.

- Option I: Excavate and replace failed slope with granular fill wrapped in non-woven geotextile. The backslope of the excavation would need to be reinforced with soil nails to achieve a short-term FOS of 1.1.
- Option II: Install a wire mesh over the soil-nail reinforced excavation and infill the wire mesh with a bonded fibre matrix hydromulch, soil amendments, and approved seed mix to improve revegetation and reduce erosion.
- Option III: Assess stability of backslope with panel excavation and, if backslope remains stable, execute Option I without soil nails

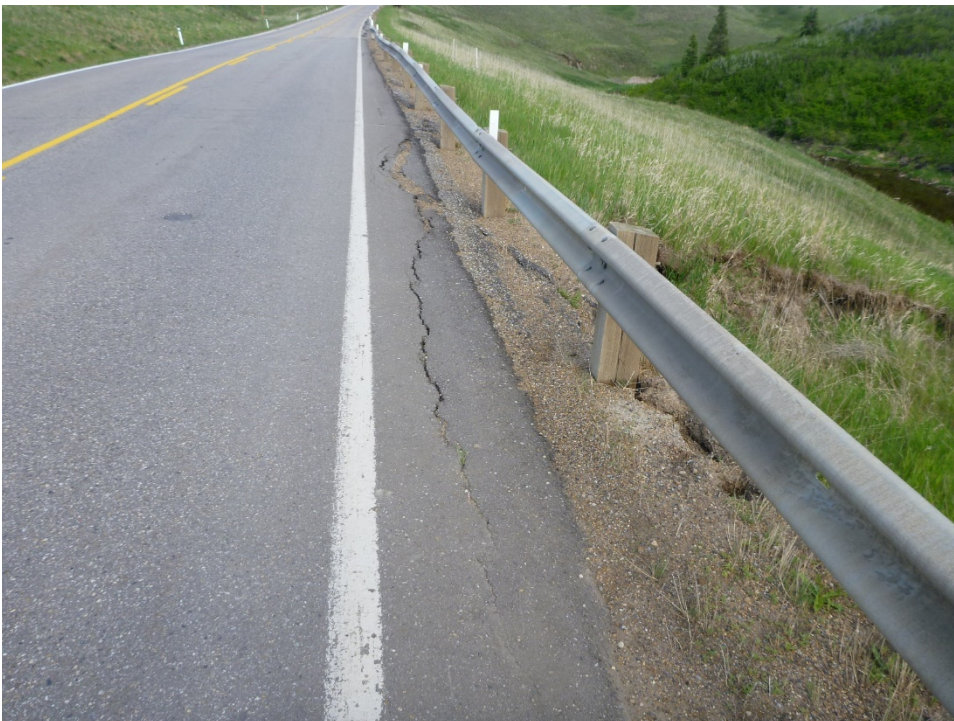
**Photo 6** Pavement cracking in eastbound lane above head of slide at C048-III. Cracks appear to have expanded slightly since 2019. Photo taken June 6, 2020 facing east.
