| SITE NUMBER AND NAME: C048-I & -III Slides | | HIGHWAY & KM: 575:04, 14.5 | PREVIOUS INSPECTION DATE: June 9, 2020 | INSPECTION DATE: June 23, 2021 |

| PRIMARY SITE ISSUE: C048-I and -III: two shallow slides in the highway embankment fill. Both slides are located on the south side (eastbound lane) of Hwy 575 near the east and west abutments, respectively. | |

Inspection Photographs

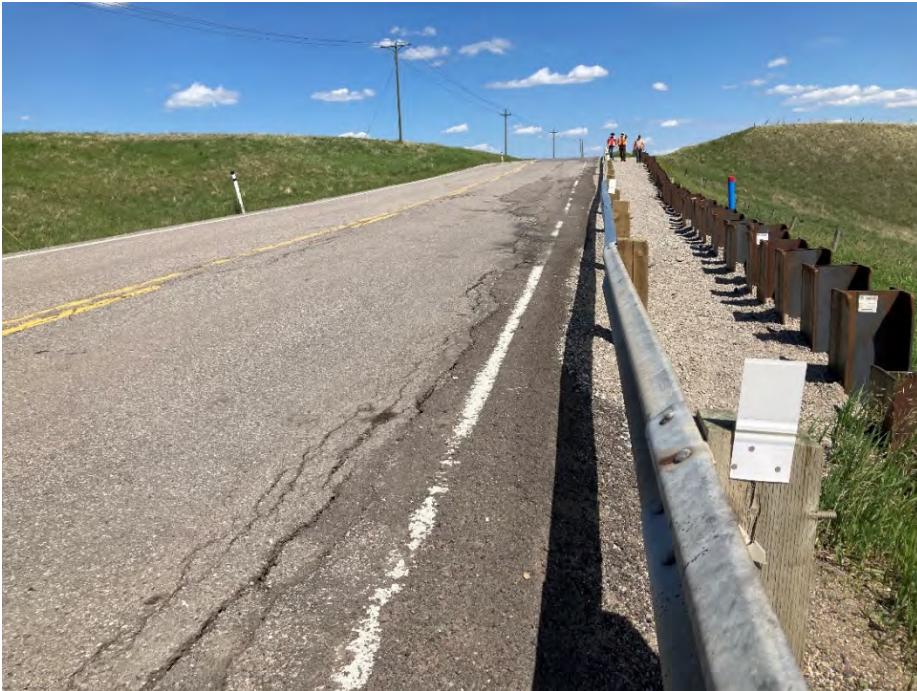
| ITEM | CONDITION EXISTS | | DESCRIPTION AND LOCATION | NOTICABLE CHANGE FROM LAST INSPECTION | |
|---|---|---|--|---|---|
| Pavement Distress | X | | C048-I: pavement subsided and cracked C048-II: pavement cracks in eastbound lane have expanded. | X | |

Photo 1 Cracking of the pavement upslope of the C048-I slide area. Pavement cracks appear to be similar since the 2020 inspection. Photo taken June 23, 2021 facing east.

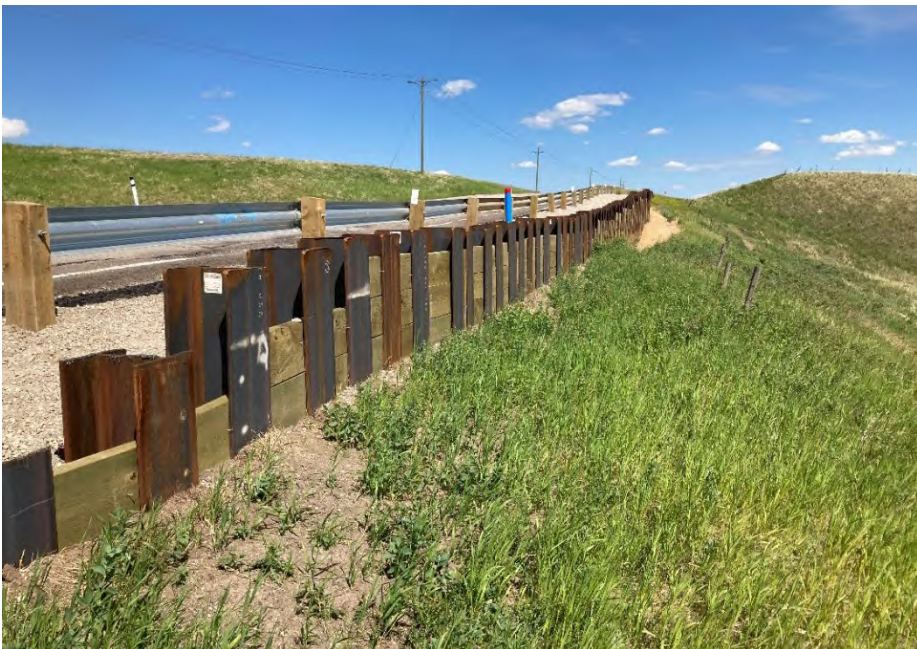
| In early-2021, the existing pile wall installed at the C048-I site was extended to the east and west, as the slide had begun to outflank the existing pile wall. Wooden planks were installed between the piles and space between the highway and pile wall was backfilled with granular material. A second pile wall was installed downslope of the existing pile wall. Three SIs were installed, one in the west extension of the existing pile wall and two SIs in the |

Photo 2 West pile wall extension and wooden planks installed in early-2021. Photo taken June 23, 2021 facing east.

new pile wall. A casing protector should be installed for the SI installed in the west pile wall extension (e.g., sleeved with a 6" length of PVC pipe).

- The piles should be cut-off to ground surface and the guardrail should be replaced. AT wants the work to be completed during the fall or winter due to the dry condition of the site.

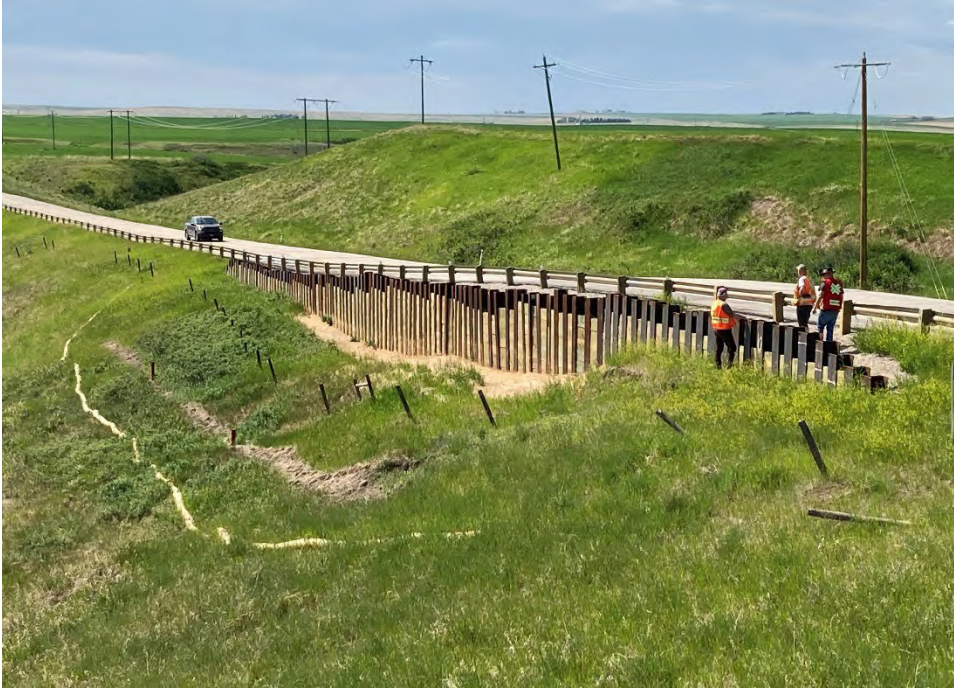
| ITEM | CONDITION EXISTS | | DESCRIPTION AND LOCATION | NOTICABLE CHANGE FROM LAST INSPECTION | |
|---|---|---|--|---|---|
| Slope Movement | X | | C048-I: there appears to be movement east of the pile wall | X | |

Photo 3 Upper pile wall (2015 pile wall was extended east and west in 2021) and lower pile wall (installed in 2021) south of Hwy 575. Photo taken June 23, 2021 facing northwest.

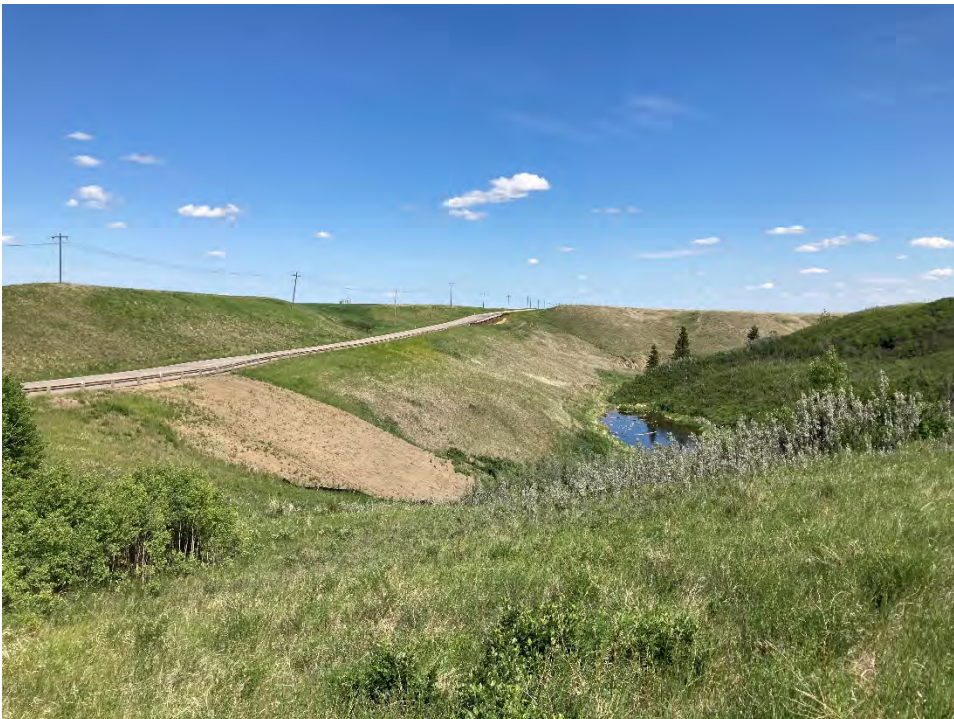
Photo 4 C048-III slide viewed from the roadway just south of Hwy 575. Photo taken June 23, 2021 facing northeast.

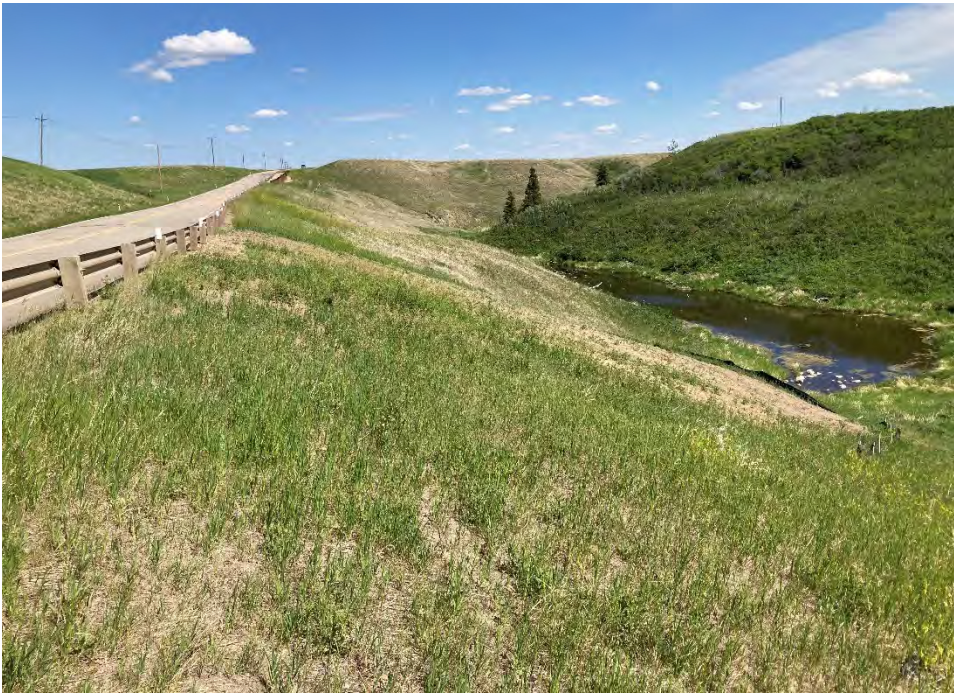
| C048-III was repaired in 2020. The embankment slope was rebuilt using geogrid-reinforced fill. The repaired slope does not match the existing highway embankment, particularly near the toe of the embankment (repaired slope “sticks out” from existing slope and was not graded properly during the repair work). The silt fencing at the toe of the slope has collapsed due to fill placed against the silt fence. |

Photo 5 The C048-III slide was repaired in 2020. Photo taken June 23, 2021 looking east.

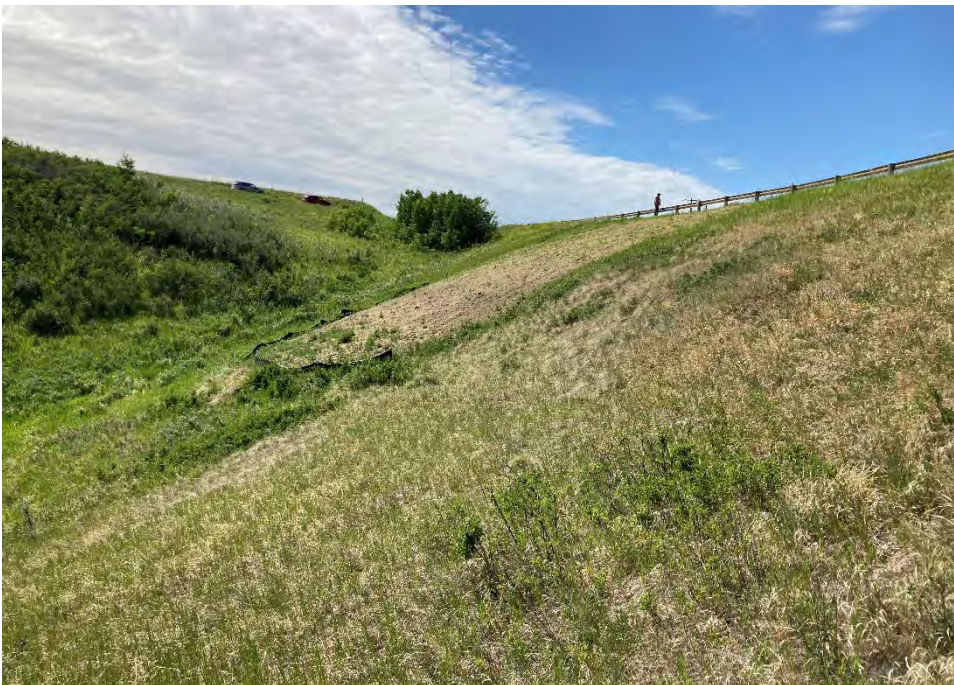
Photo 6 C048-III repair was not graded to match the existing highway embankment slope and there is little to no vegetation (required reseeding). Photo taken June 23, 2021 facing west.

- There is poor vegetation cover for the repaired slope and it requires reseeding.
- Fill is piled up against the silt fencing and requires regrading to match the existing highway embankment slope.
- The silt fence has collapsed at the lower portions of the repair due to fill being placed against the silt fence. The slope should be regraded as soon as possible due to the creek's proximity to the repair area.
