November 29, 2022

Alberta Transportation  
4<sup>th</sup> Floor, Provincial Building  
4920 – 51<sup>st</sup> Street  
Red Deer, Alberta  
T4N 6K8

**CON0022160 Central Region GRMP Instrumentation Monitoring  
Site C048-I; H575:04, km 14.500 Slide West of Carbon Creek  
Section C – 2022 Fall Readings**

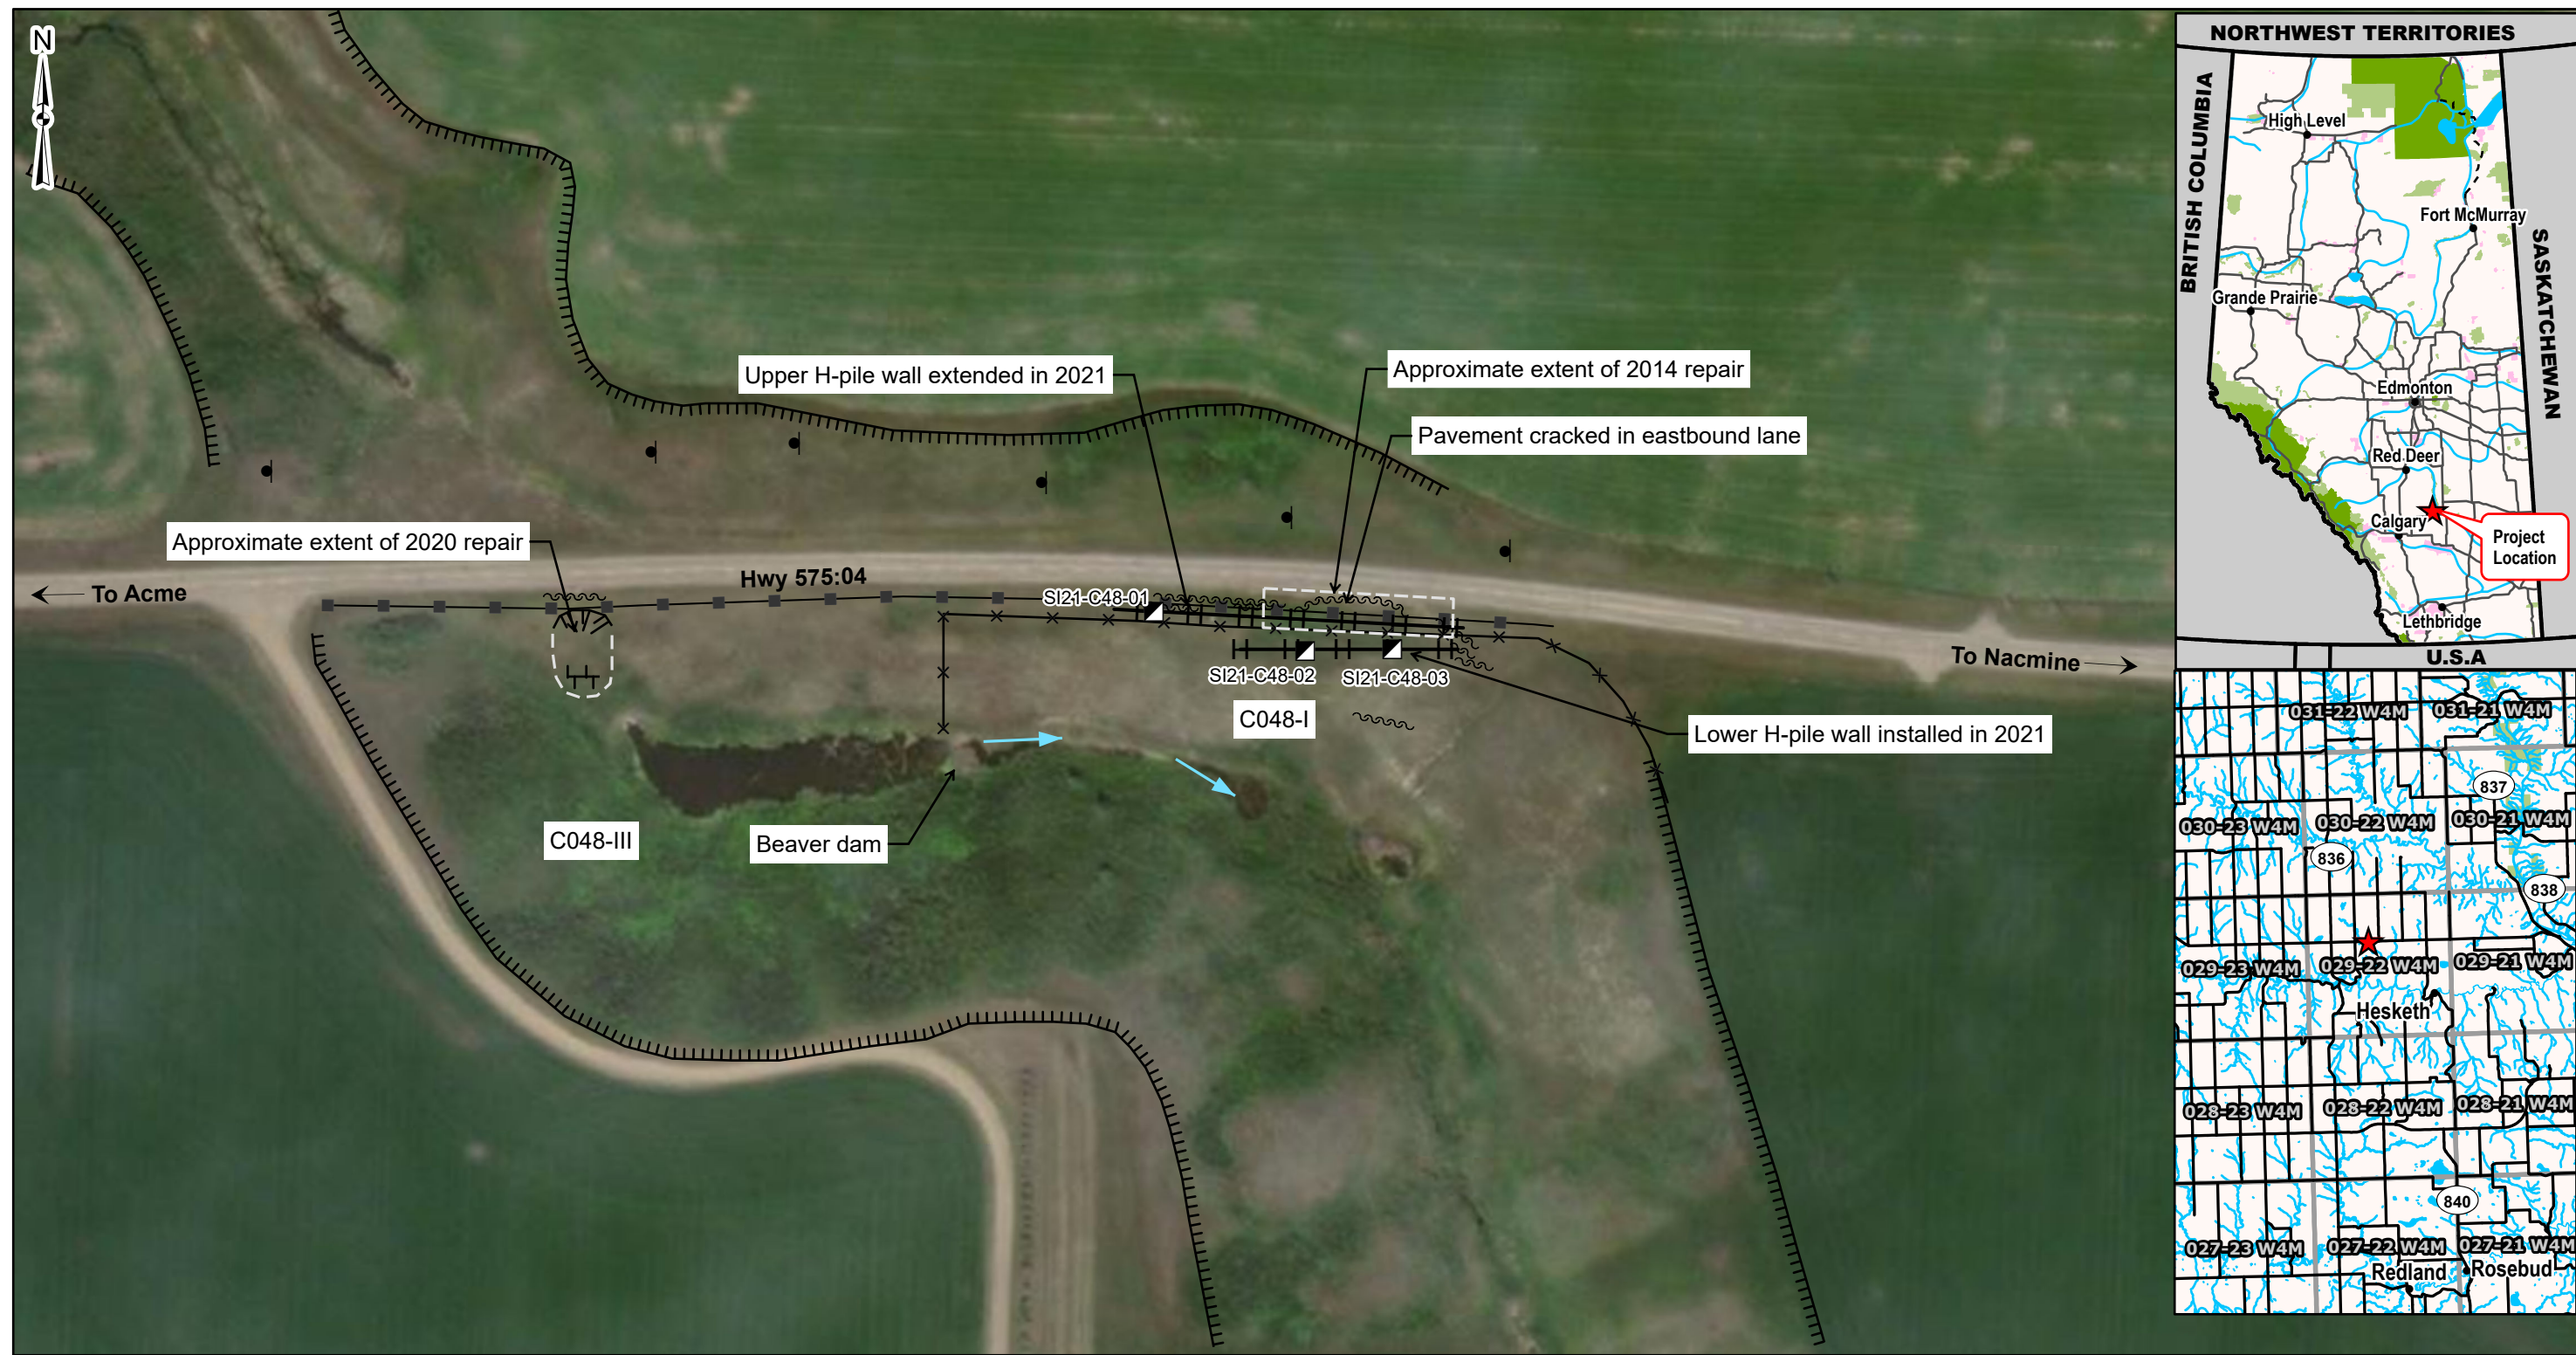
PROJECT CENTRAL REGION GEOHAZARD RISK MANAGEMENT PROGRAM		
TITLE Site Plan C048 - I and -III Slides Hwy 575:04, km 14.5		
SCALE 1:2,000	PROJECT No. A05116A02	FIG No. 1

The C048 site consists of two active geohazard subsites, C048-I and C048-III, along an approximate 250 m length of Hwy 575:04. Another subsite C048-II site located to the west of C048-I and C048-III was repaired in 2012 and removed from the Central Region GRMP. The geohazard at each subsite includes a shallow slide in the highway embankment fill on either the south (C048-I and C048-III) or north (C048-II) slope of Hwy 575:04.

On March 25, 2021, three SIs (SI21-C48-01 through SI21-C48 -03) were installed in the H-pile walls at the C048-I site to monitor deflection of the H-pile walls. SI21-C48-01 is located approximately 20 m from the west end of the upper H-pile wall. SI21-C48-02 and SI21-C48-03 are located approximately one-third (22 m) from either end of the lower H-pile wall. Each SI was installed in the H-pile wall, in a rectangular opening created by tack-welding an L-shaped bracket (L102X102X6.4) to the web and flange of an H-pile. The space between the SI casing and rectangular opening was backfilled with fine-grained sand.

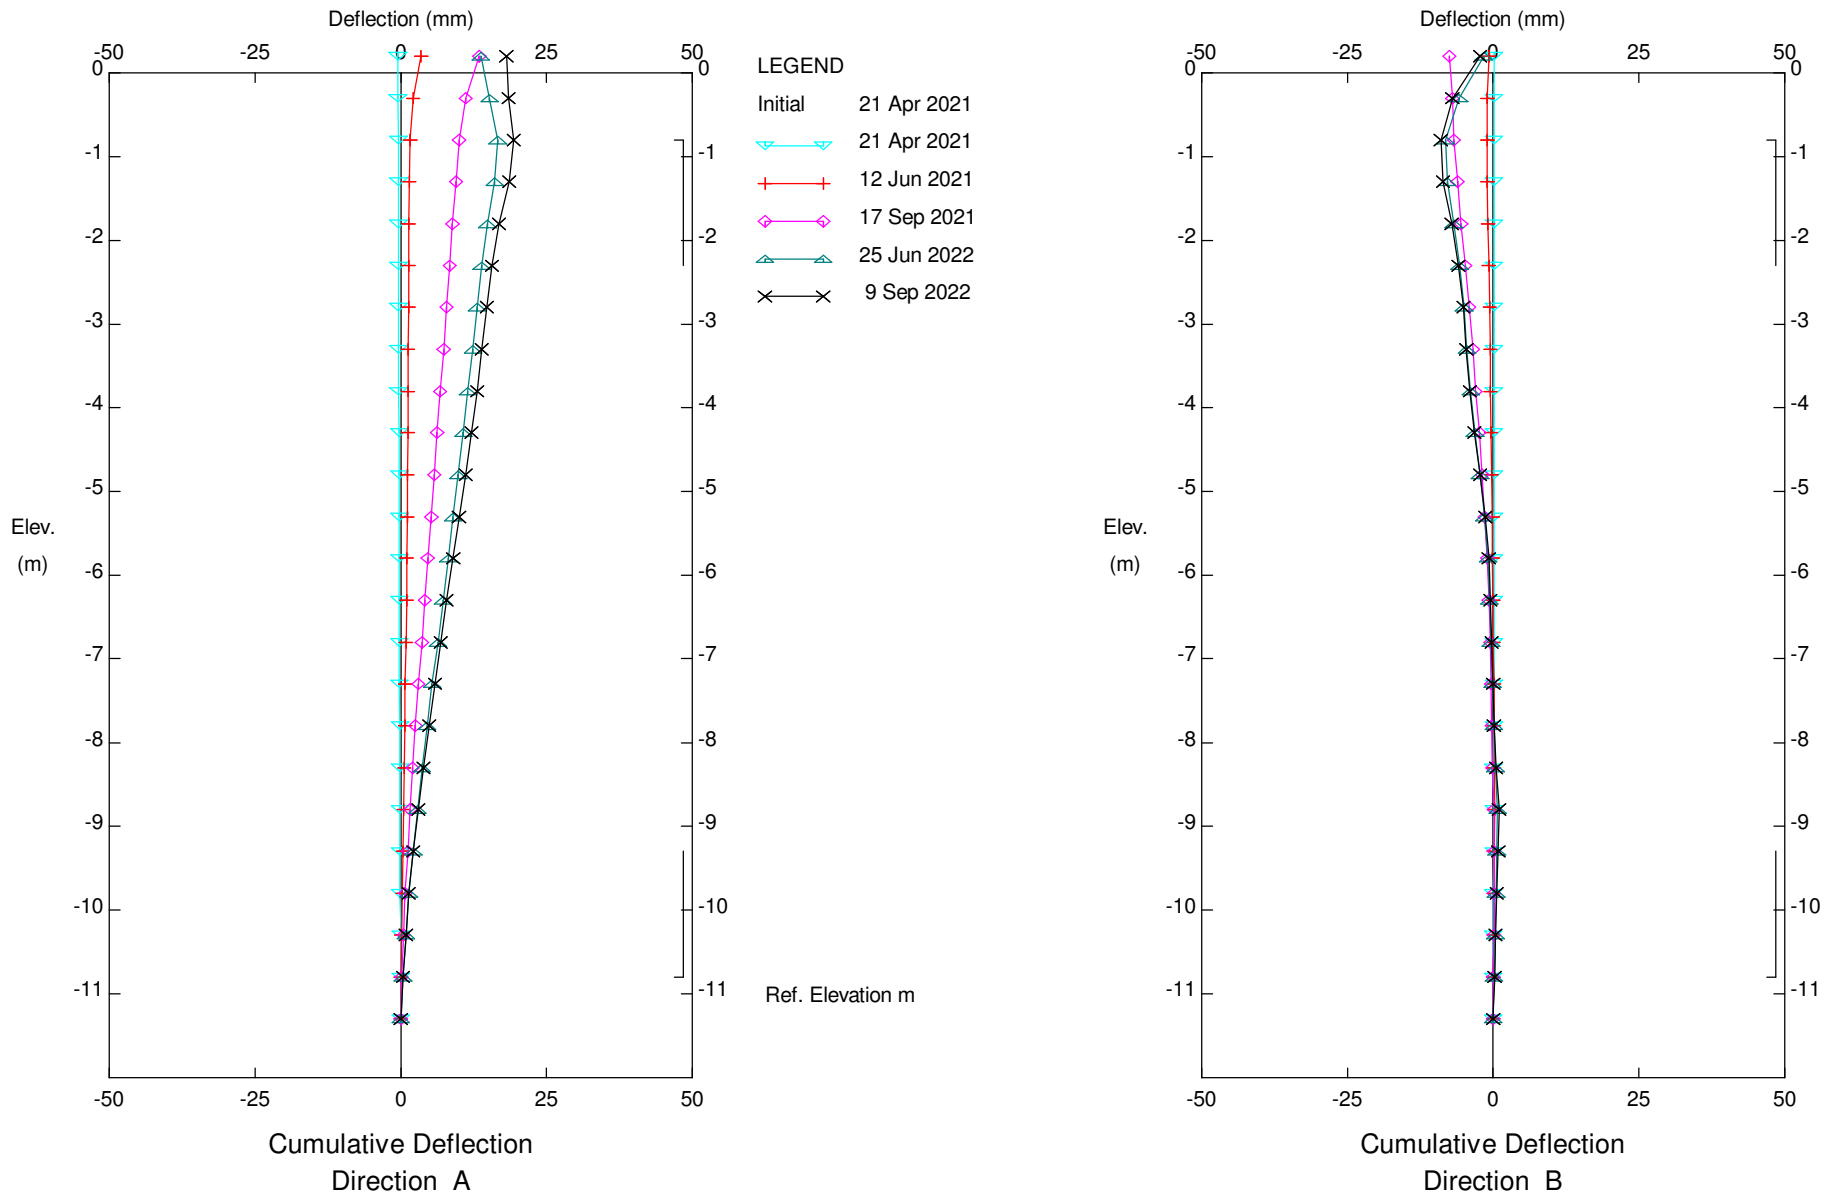
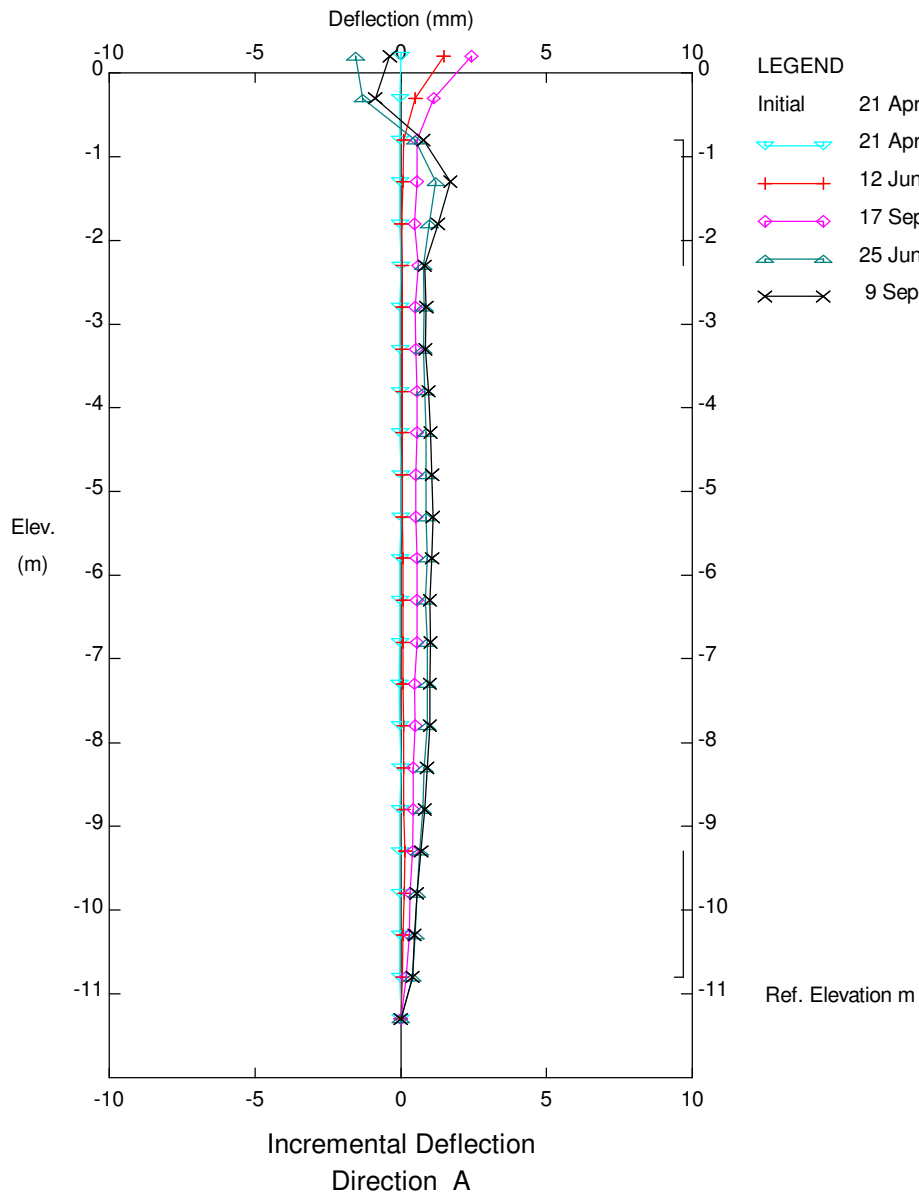
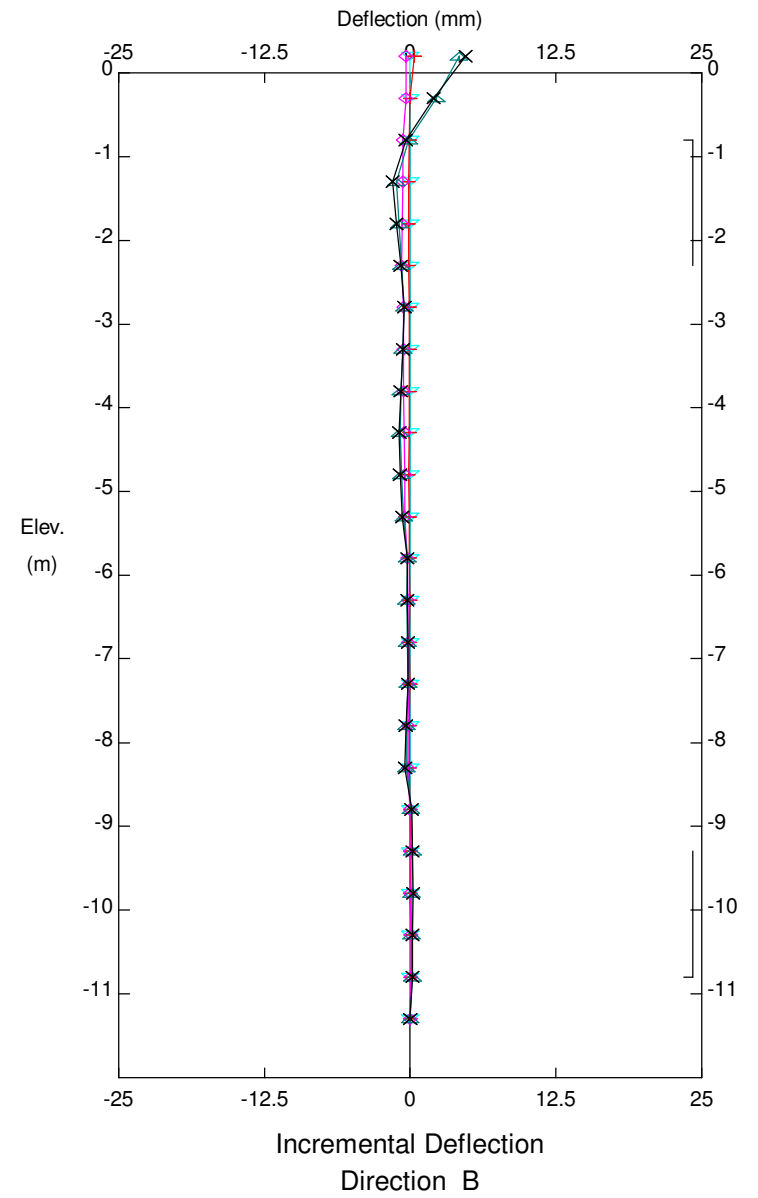
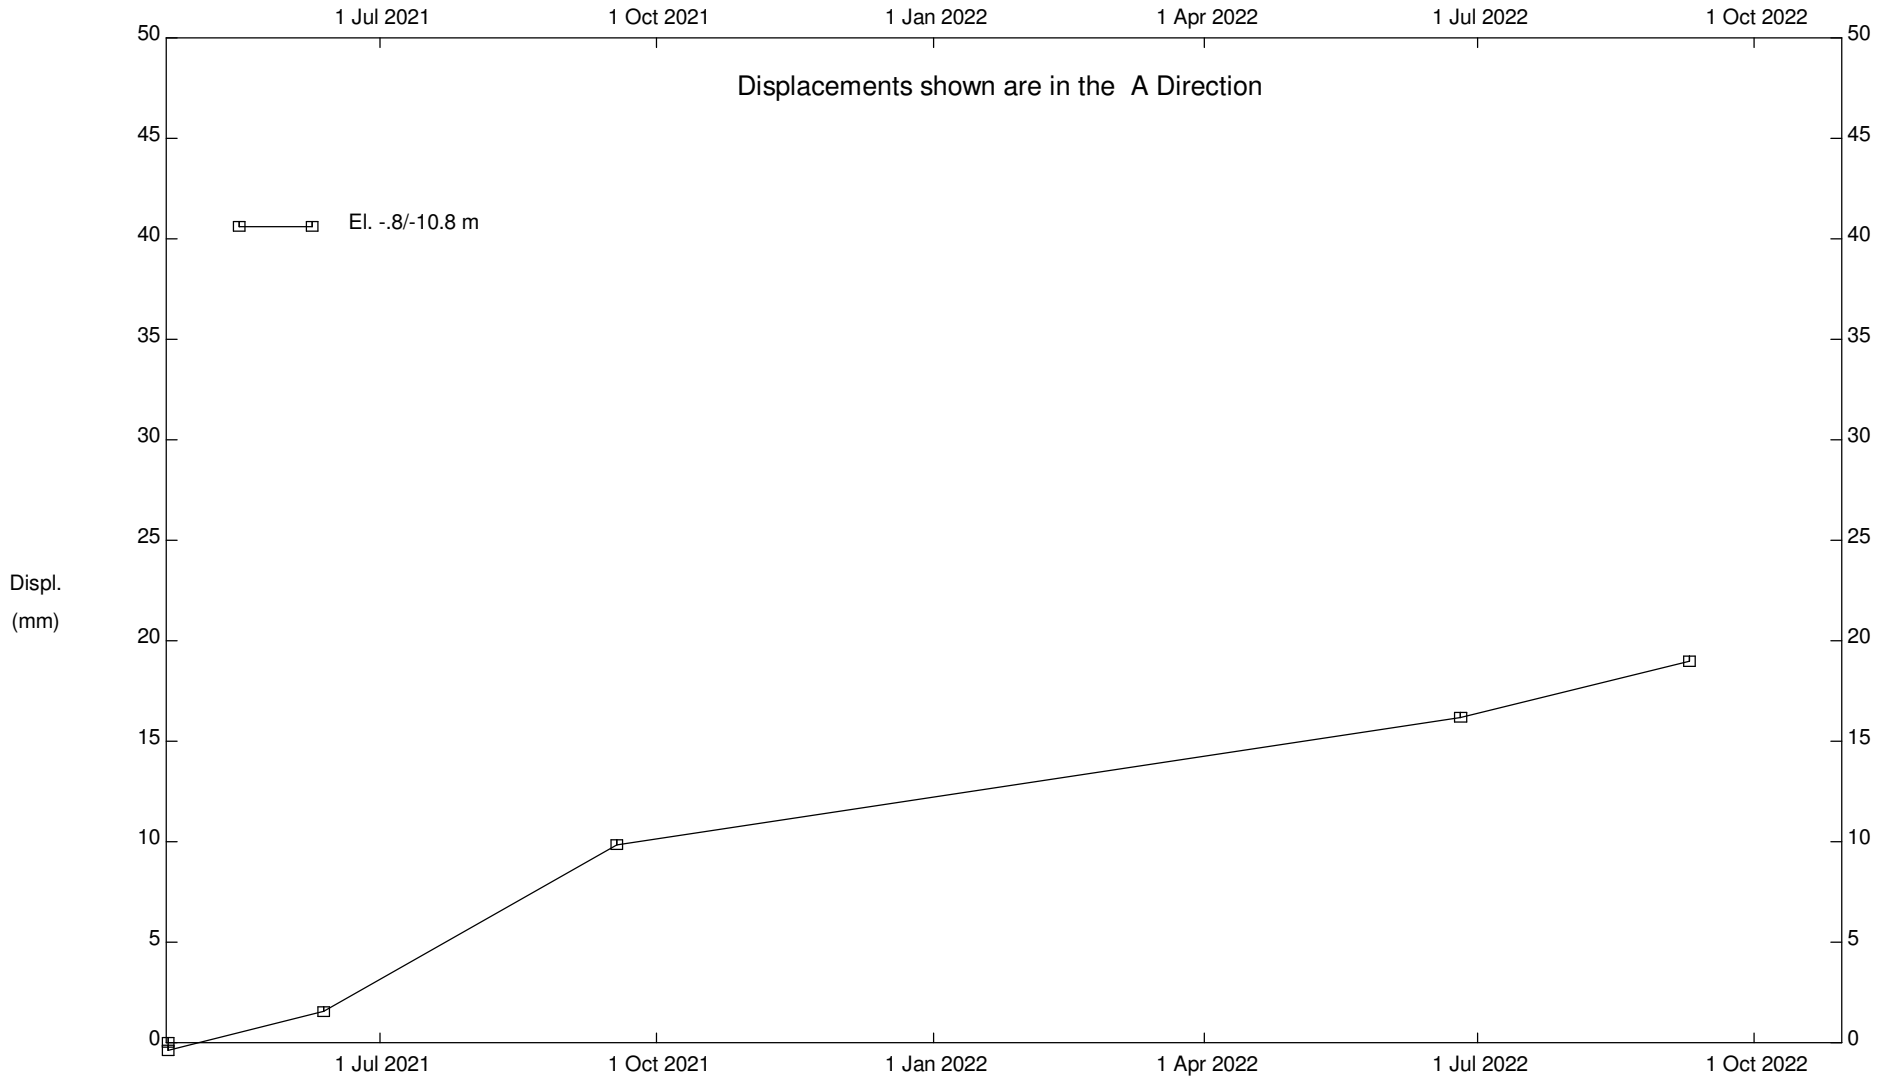
C048; H575:04; Slide W of Carbon Creek, Inclinator SI21-C48-01

The lowest depth of movement being recorded in SI21-C48-01 (upper H-pile wall) is approximately 10 m below ground surface. The lowest depth of movement being recorded in SI21-C48-02 and SI21-C48-03 (lower H-pile wall) is approximately 8.5 m below ground surface. The H-pile walls are 12 m deep, and the SIs are approximately 11.0 m to 11.3 m deep.

The depth of movement being recorded in the pile-wall SIs appears to be occurring approximately 2 m above the base of the H-pile walls. This indicates that the H-pile walls have intercepted the failure surface and are continuing to deflect, transferring load to depths below the failure plane as the piles stabilize the slide mass.

The September 2022 data obtained from the pile-wall SIs indicates that the tops of the upper and lower H-pile walls have deflected up to approximately 19 mm and 37 mm, respectively, since installation. In the spring of 2021, shortly after construction of the H-pile walls, the maximum rate of movement recorded in these SIs was between 28 mm/year and 59 mm/year. The rate of movement has since decreased and is now less than 30 mm/year. KCB anticipated that the rate of movement shortly after installation would be highest and would decrease as the H-pile wall picked up load stabilizing the sliding mass.
