<b>SITE NUMBER AND NAME:</b> <b>C048-1 and -3 West of Drumheller Slides</b>	<b>HIGHWAY &amp; KM:</b> 575:04, 14.5	<b>PREVIOUS INSPECTION DATE:</b> June 26, 2023	<b>INSPECTION DATE:</b> <b>June 10, 2025</b>
<b>LEGAL DESCRIPTION:</b>  C048-1 03-28-29-22 W4M C048-3 14-21-29-22 W4M	<b>NAD 83 COORDINATES:</b> UTM Northing Easting 12 5707777 358483 12 5707780 358250	<b>RISK ASSESSMENT:</b>  C048-1: PF: 1 CF: 3 TOTAL: 3 C048-3: PF: 1 CF: 3 TOTAL: 3	
<b>HIGHWAY CLASSIFICATION NUMBER:</b> 3		<b>CONTRACT MAINTENANCE AREA (CMA):</b> 517	
<b>AVERAGE ANNUAL DAILY TRAFFIC (AADT):</b> 920 (west) and 860 (east) (Ref No. 106230 & 105240)

<b>PRIMARY SITE ISSUE:</b> C048-1 and -3: two shallow slides in the highway embankment fill. Both slides are located on the south side (eastbound lane) of Hwy 575 near the east and west abutments, respectively.
<b>APPROXIMATE DIMENSIONS:</b> C048-1 and -3 are approximately 100 m and 20 m wide, respectively.
<b>DATE OF ANY REMEDIAL ACTION:</b> C048-1: July 2010 – soil nails launched (52 nails, 4 rows); July 2014 – H-pile wall installed (65 HP310 X 93 piles, 0.75 m spacing, 48 m long, 12 m deep); “retaining wall” constructed behind the H-pile wall, by excavating to

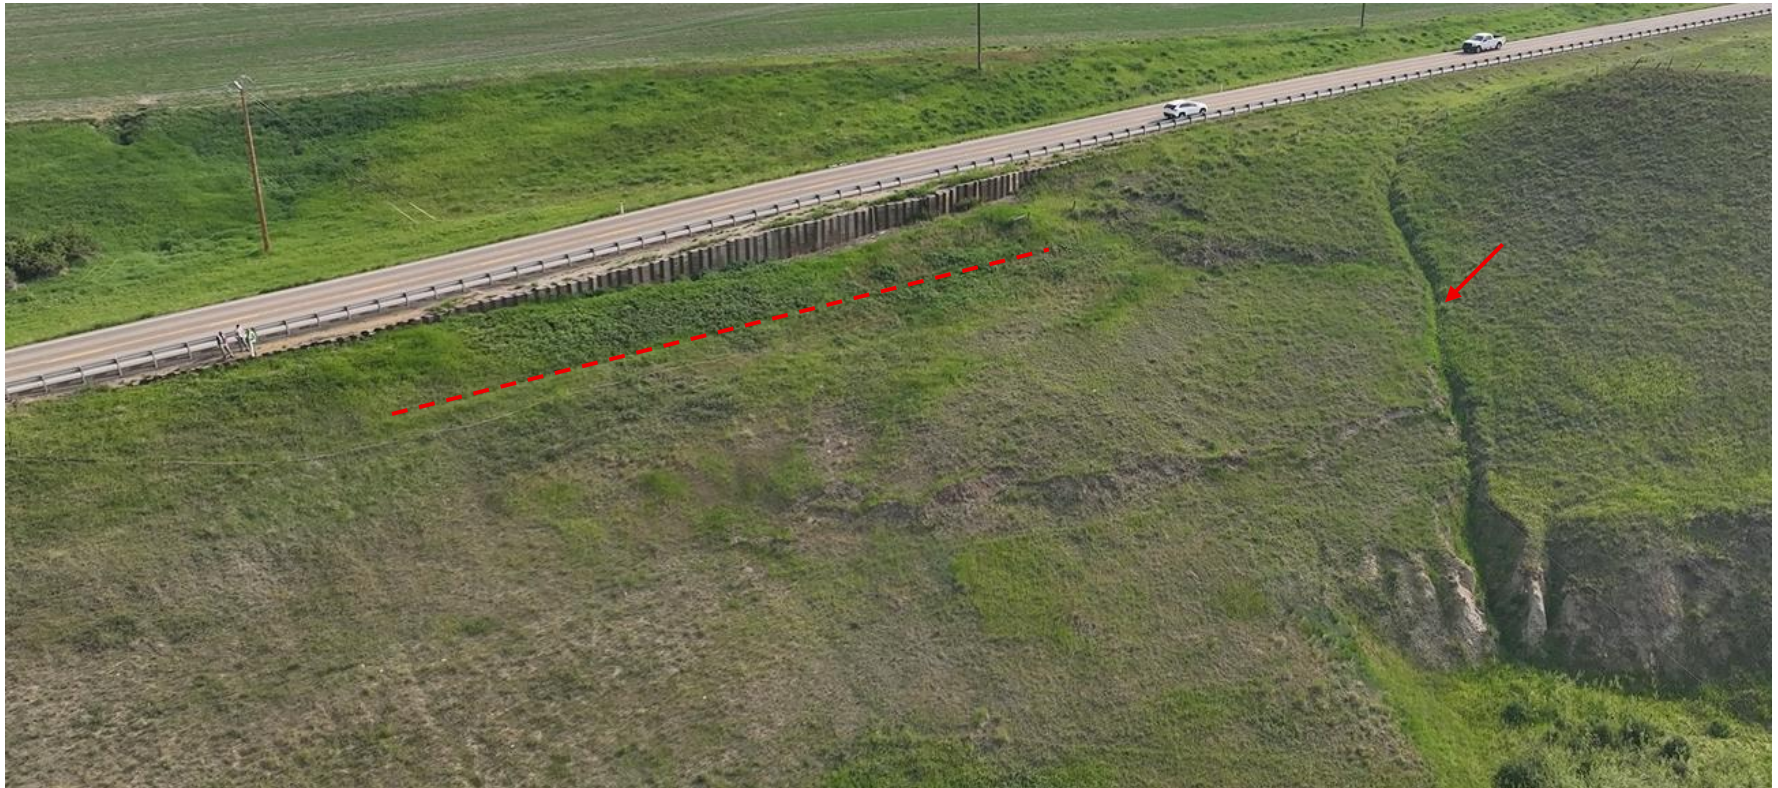
- There was an erosion gully at the east extent of the site, extending from the south (eastbound) ditch to the creek downslope of the site (Photo 1). The rate of erosion appeared to be slow since the erosion gully base and side slopes were vegetated with grass. No plume was observed at the downstream limit of the erosion gully.

**Photo 1** Aerial photo of the C048-3 site. Upper H-pile wall extension and timber lagging just downslope of the highway was installed in 2021. Lower H-pile wall (approximate location indicated by red dashed line) was installed downslope of the upper H-pile wall in 2021. Erosion gully between south ditch and creek downslope of the site indicated by red arrow. Photo taken June 10, 2025 facing northeast.

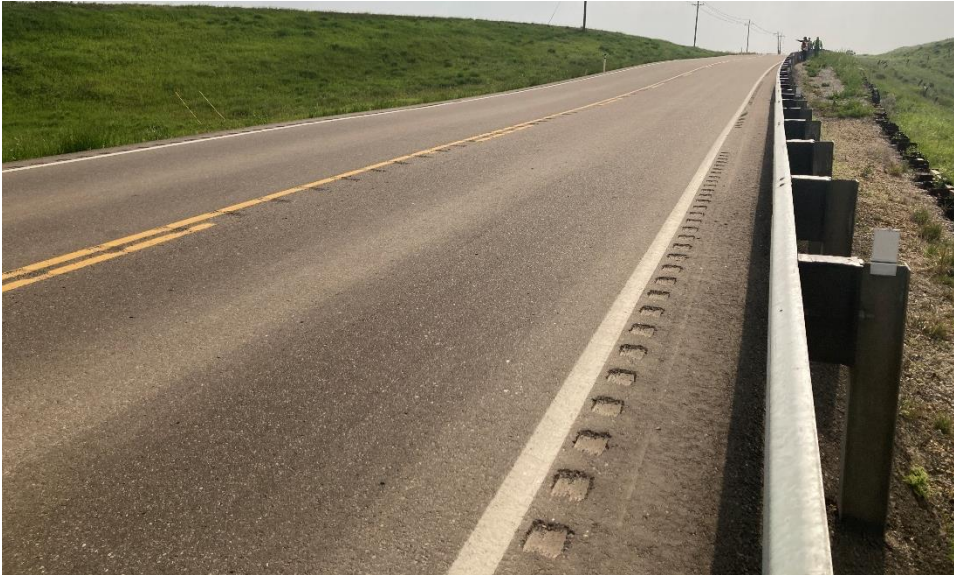
- The highway surface and new guardrail appeared to be in good condition (Photo 2).
- During previous inspections, longitudinal pavement cracking and settlement (i.e., dip) in the south (eastbound) lane was observed near the east extent of the upper H-pile wall. During the 2025 inspection, pavement distress was not observed, and the highway surface was in good condition. It appeared that with the combination of the 2021 pile wall extension, 2021 lower pile wall installation, and 2023 highway improvements, the rate of movement at the site has decreased.

**Photo 2** New highway surface and guardrail was installed during summer 2023 construction when the highway surface was lowered and upper portion of the subgrade was replaced. Photo taken June 10, 2025 facing east.

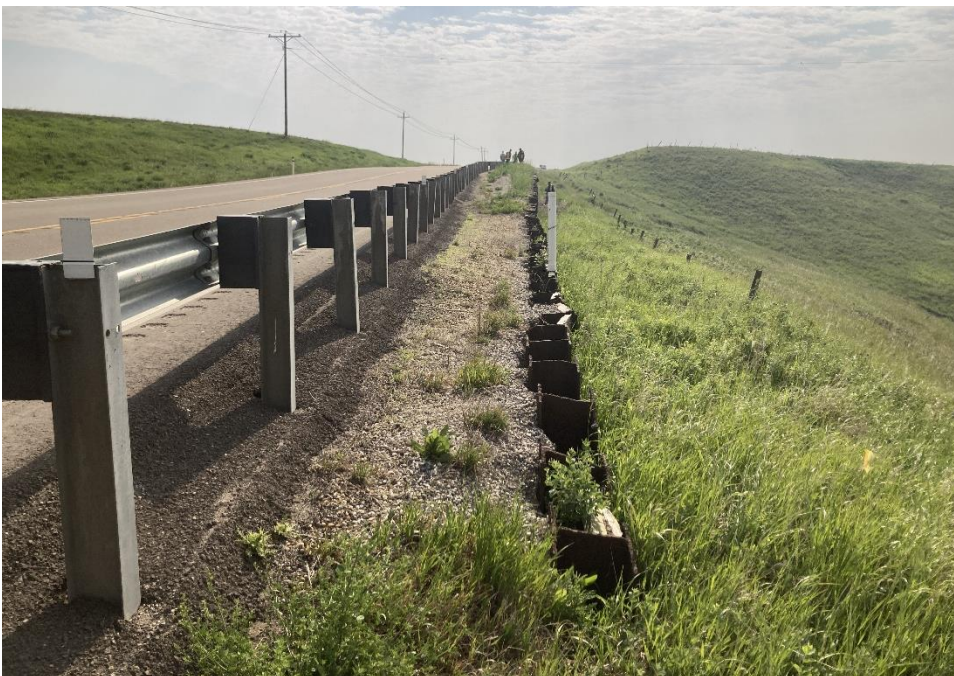
- The above-ground portions of the 2021 H-piles at the upper pile wall were cut off at ground surface between the 2021 and 2023 inspections. Since construction, the upper portion of the pile wall (above ground surface) appeared to have been deflecting (Photo 3).

**Photo 3** The upper H-pile wall has continued to deflect since the 2023 inspection. Photo taken June 10, 2025 facing east.

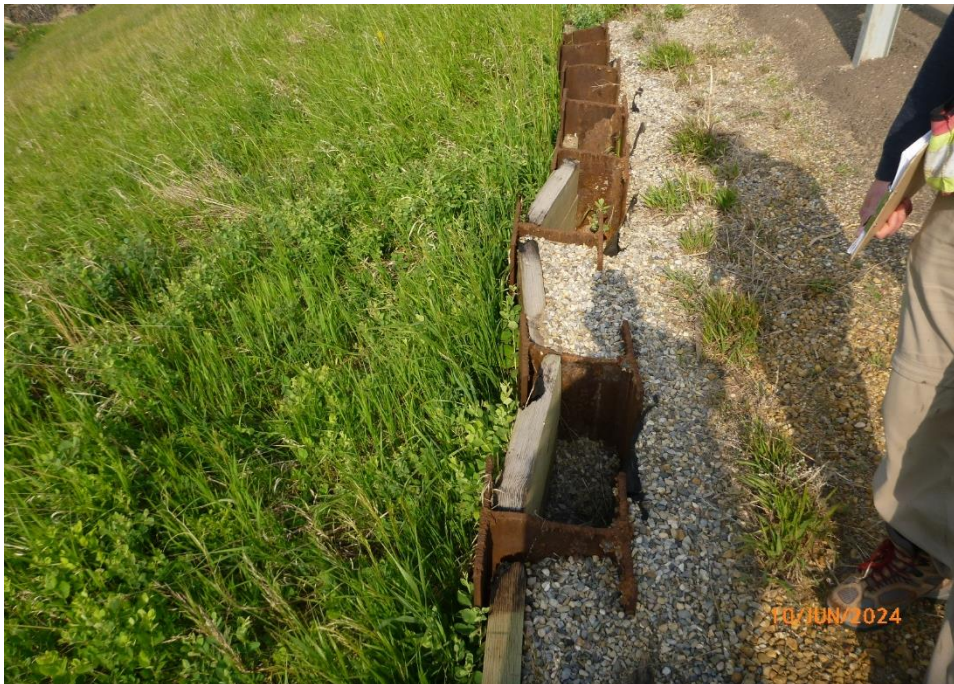
- Voids have been observed between the timber lagging and H-piles, particularly along the west length of the H-pile wall. Voids were observed between approximately 10 to 15 locations in the upper pile wall (Photo 3 and 4).

**Photo 4** Voids have formed between H-piles and timber lagging. Photo taken June 10, 2025 facing west.

- The voids between the timber lagging and H-piles in the upper pile wall should be backfilled with sand and gravel.

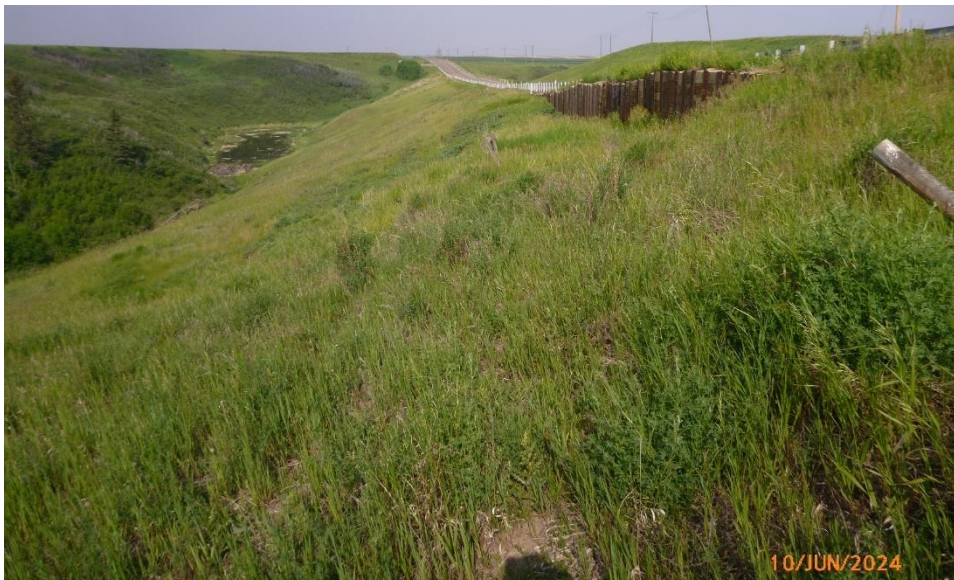
**Photo 5** H-pile wall extension, timber lagging, and lower H-pile wall installed in 2021. Downslope of the H-pile walls is well vegetated and in good condition. Photo taken June 10, 2025 facing west.

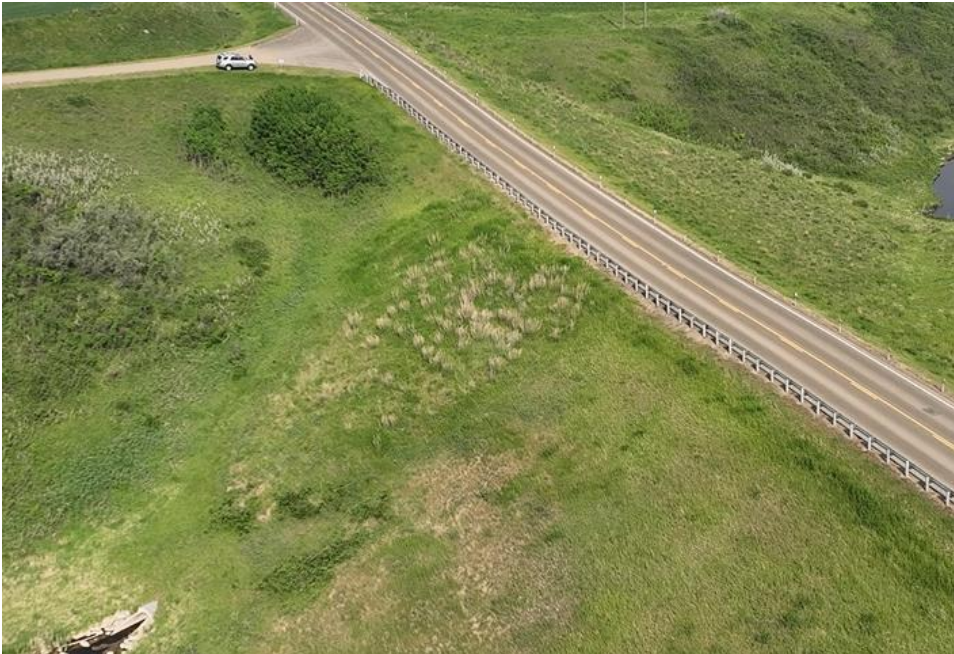
**Photo 6**      The repair completed at C048-3 in fall of 2020 appears to be performing well and the slope is well vegetated. Photo taken June 10, 2025 facing northwest.

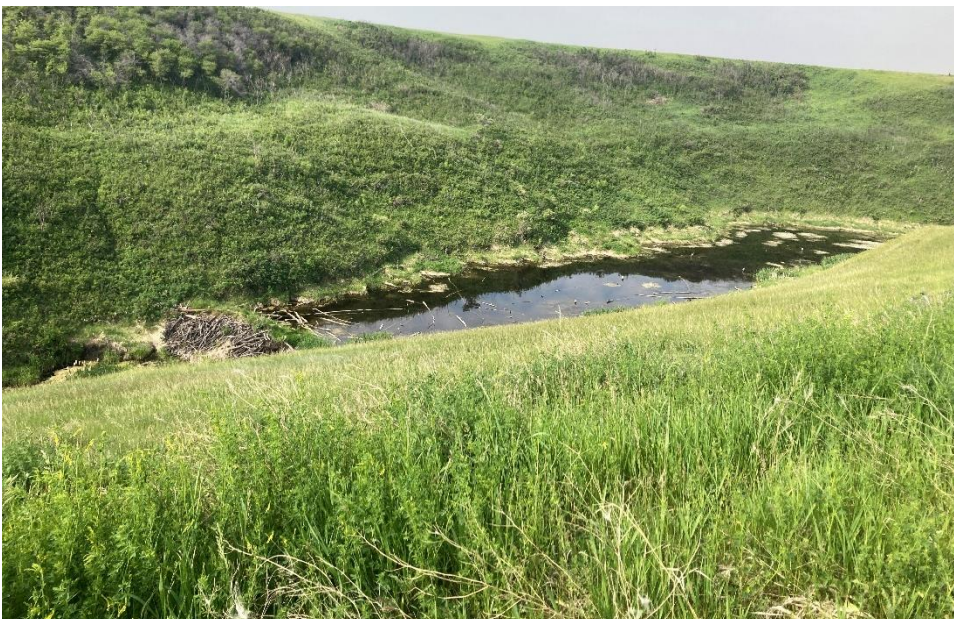
- The site was repaired in 2020 using geogrid-reinforced granular fill. The repaired slope was not tied in well to match the existing highway embankment, particularly near the toe of the embankment (repaired slope "sticks out" from existing slope and was not graded properly during the repair work).
- The silt fencing at the toe of the slope has collapsed due to fill placed against the silt fence.
- The vegetation cover has improved since construction and the repair appears to be performing well (Photo 6).
- Beaver damming of the creek at the toe of the south (eastbound) highway embankment has been observed since the 2021 inspection (Photo 7).

**Photo 7**      Beaver dam located at the toe of the south highway embankment slope downslope of the C048-3 site. Photo taken June 10, 2025 facing southwest.

- The beaver dam at the toe of the slope at C048-3 should be removed, as the ponded water could saturate and soften the toe of the highway embankment, potentially resulting in increased rates of movement which could impact the highway surface.
- The silt fencing at the downslope extent of the repair should be removed.
