September 29, 2025

Alberta Transportation and Economic Corridors  
4<sup>th</sup> Floor, Provincial Building  
4920 – 51<sup>st</sup> Street  
Red Deer, Alberta  
T4N 6K8

**CON0022160 Central Region GRMP Instrumentation Monitoring**  
**Site C048-1; H575:04, km 14.500 Slide West of Carbon Creek**  
**Section C – 2025 Fall Readings**

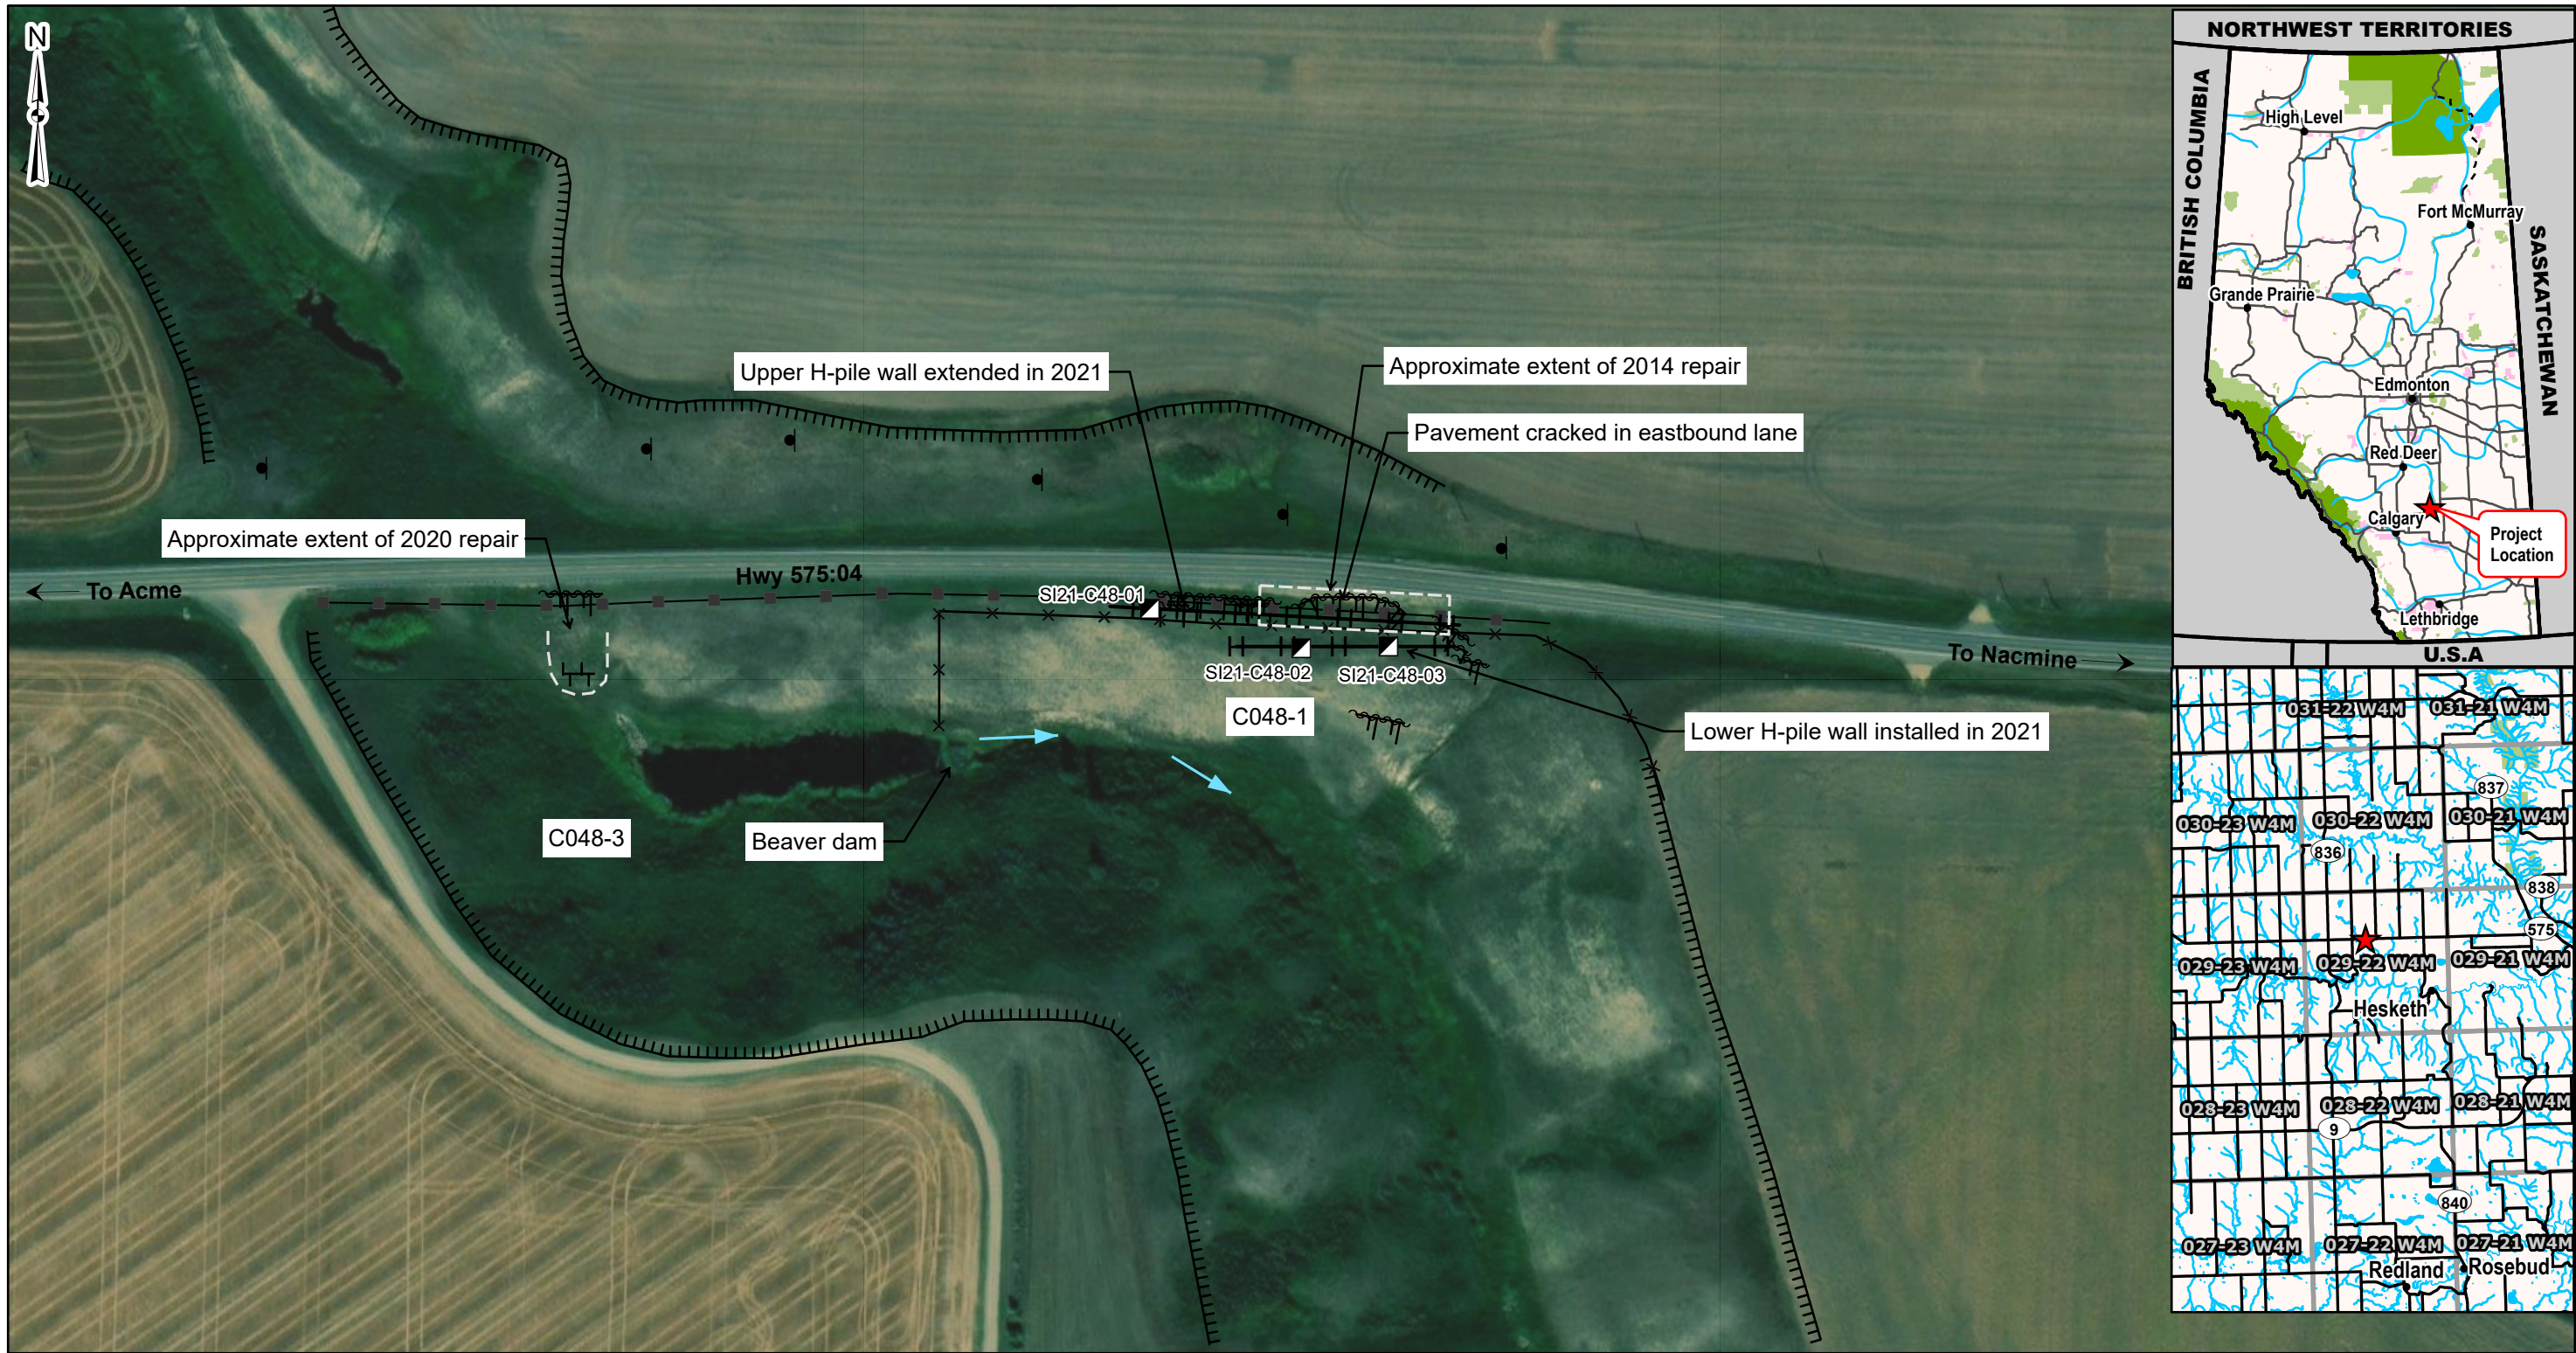
FIG No.  
1

Site Plan  
C048-1 and -3 Slides  
Hwy 575:04, km 14.5

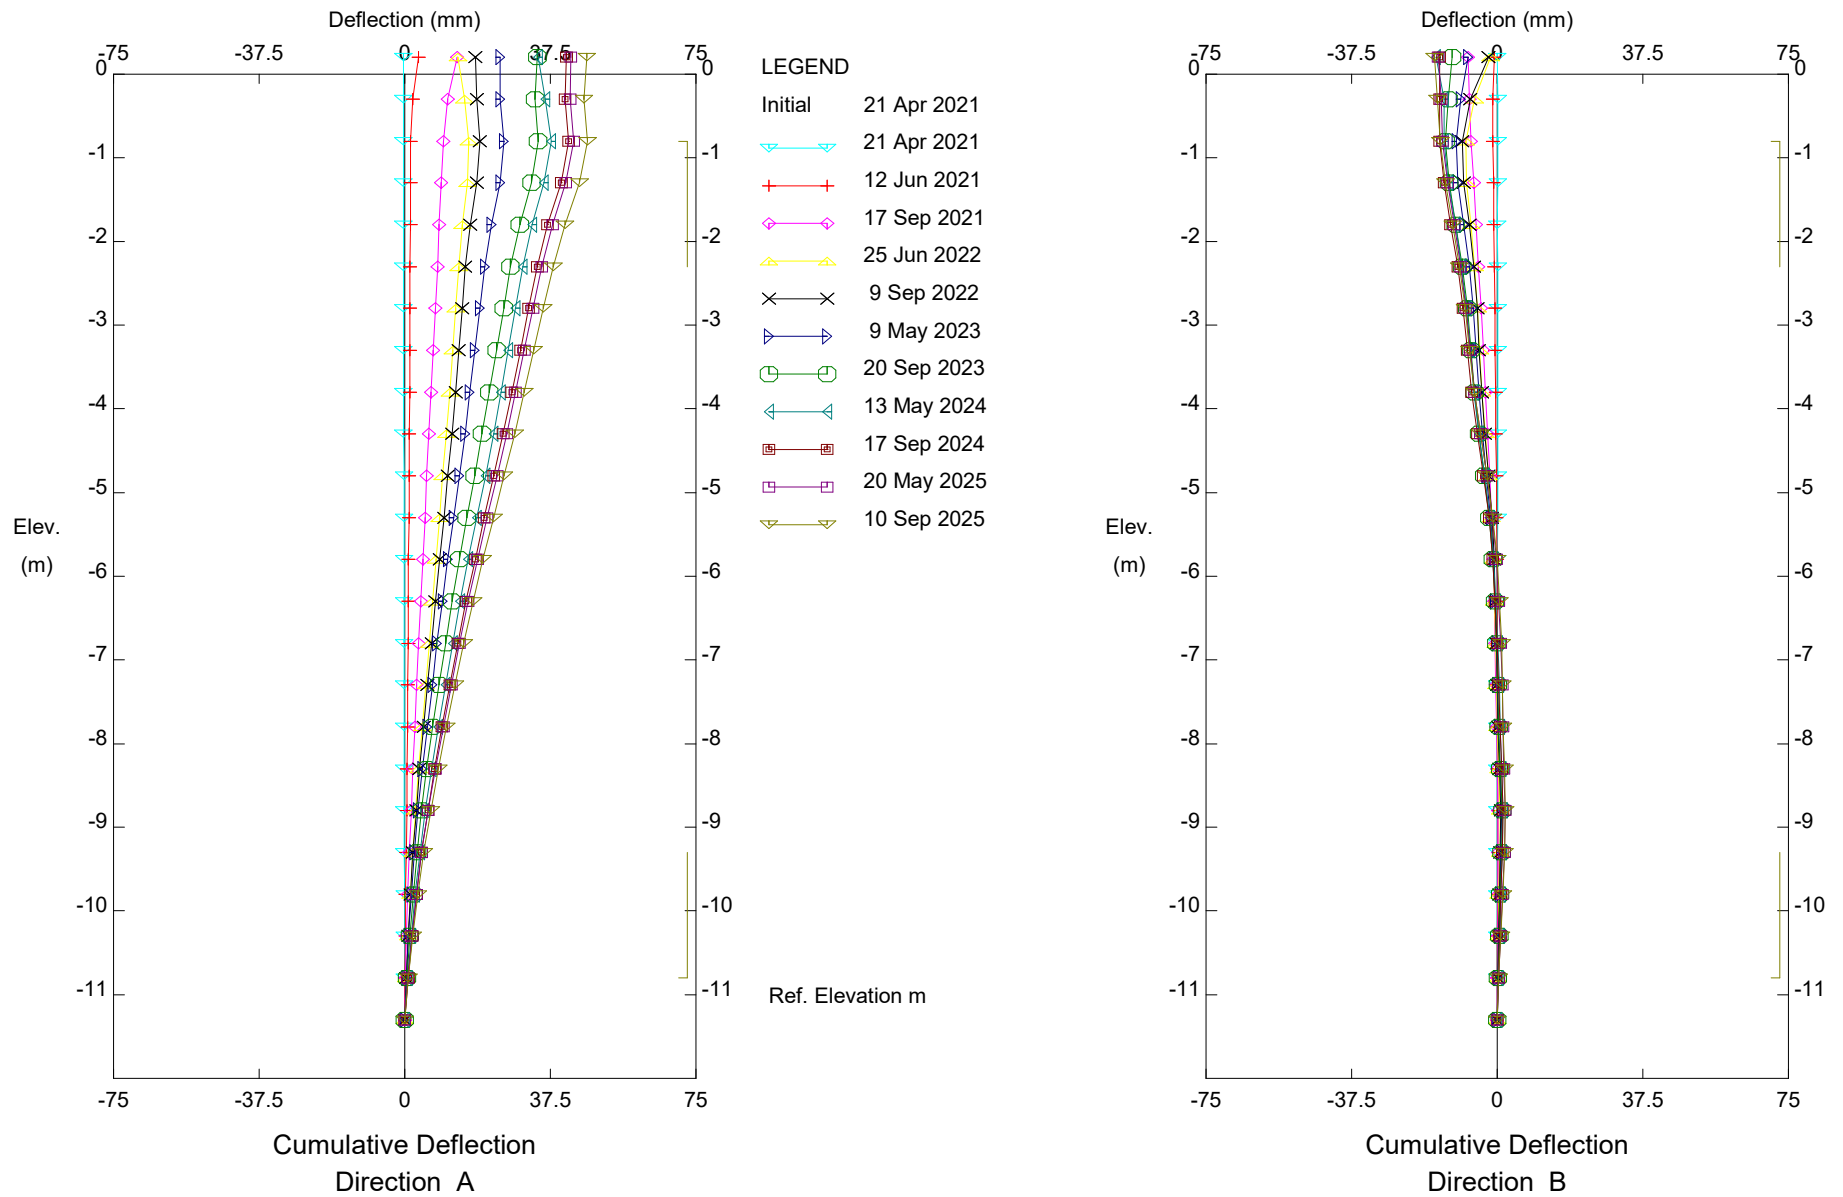
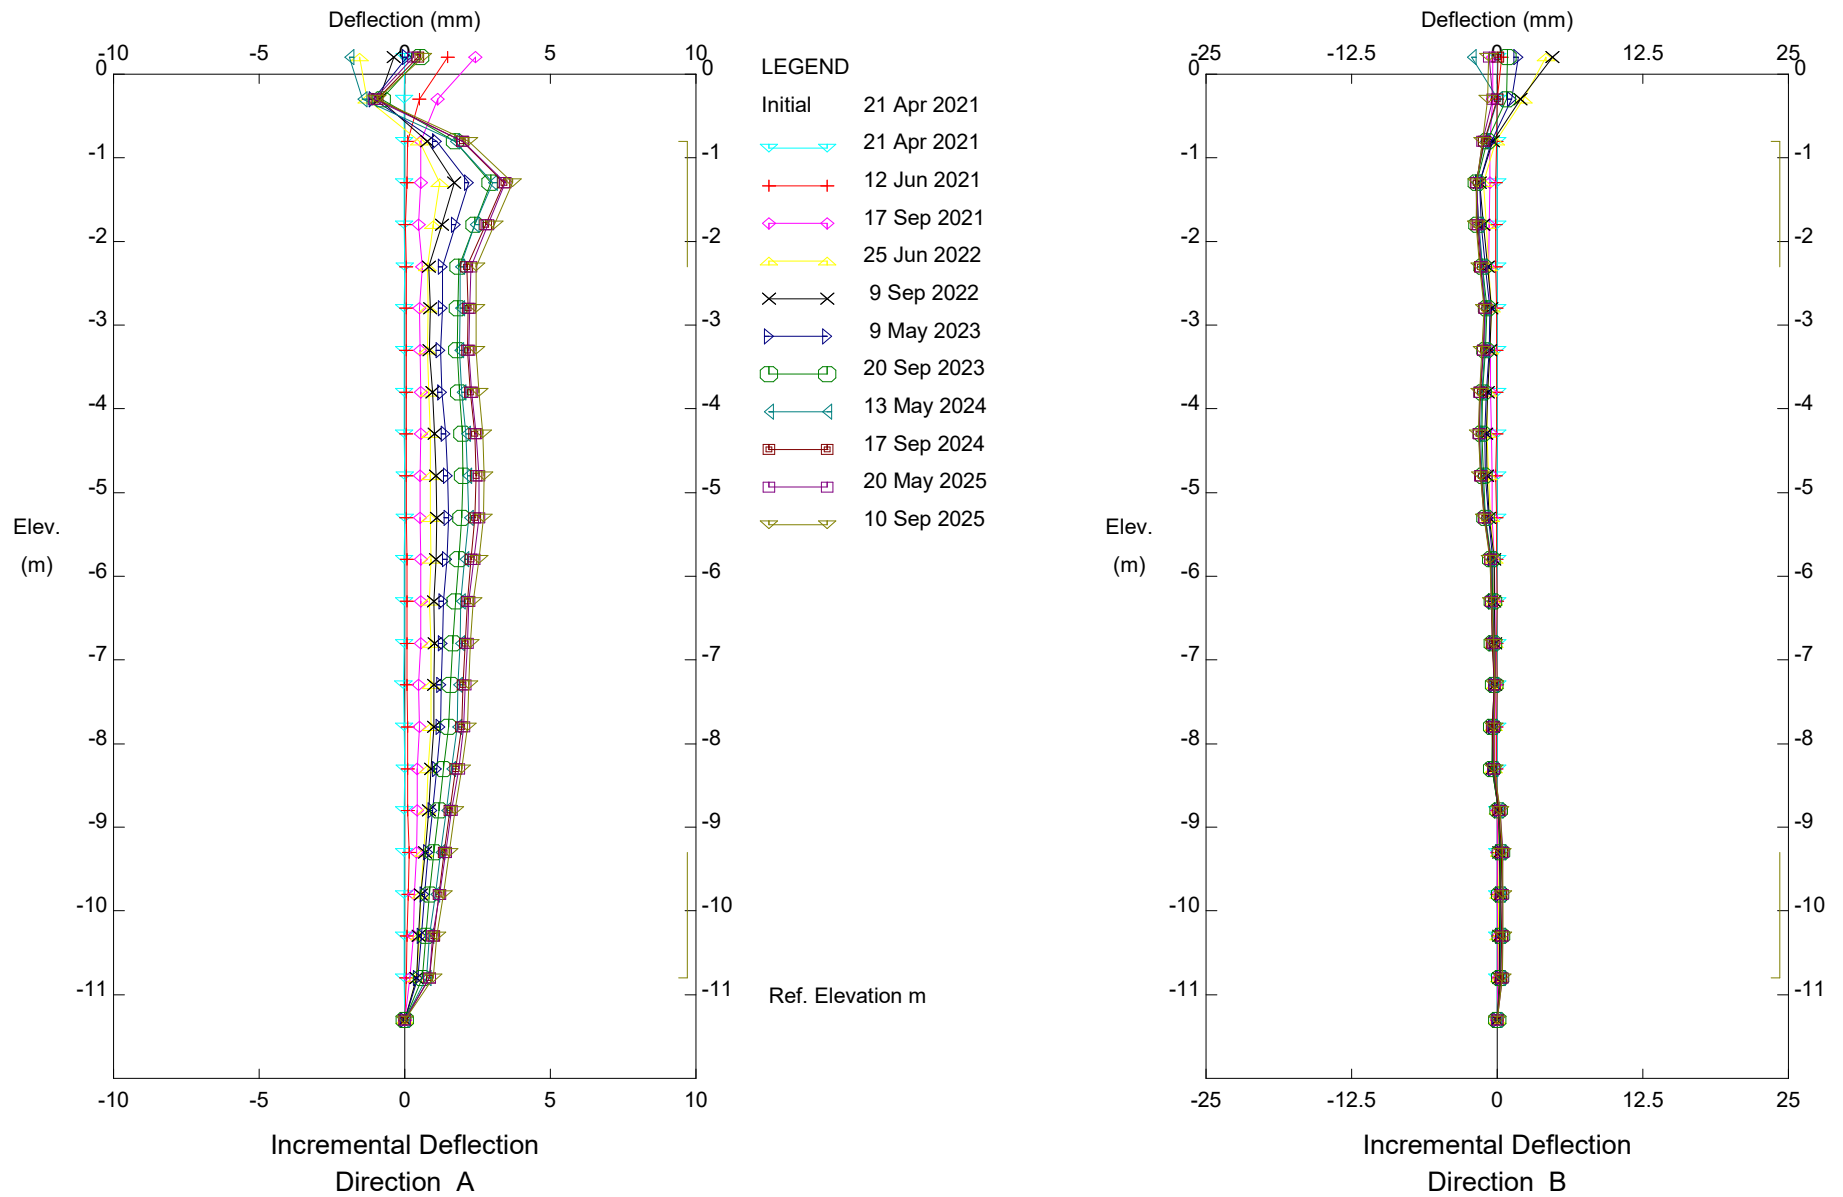
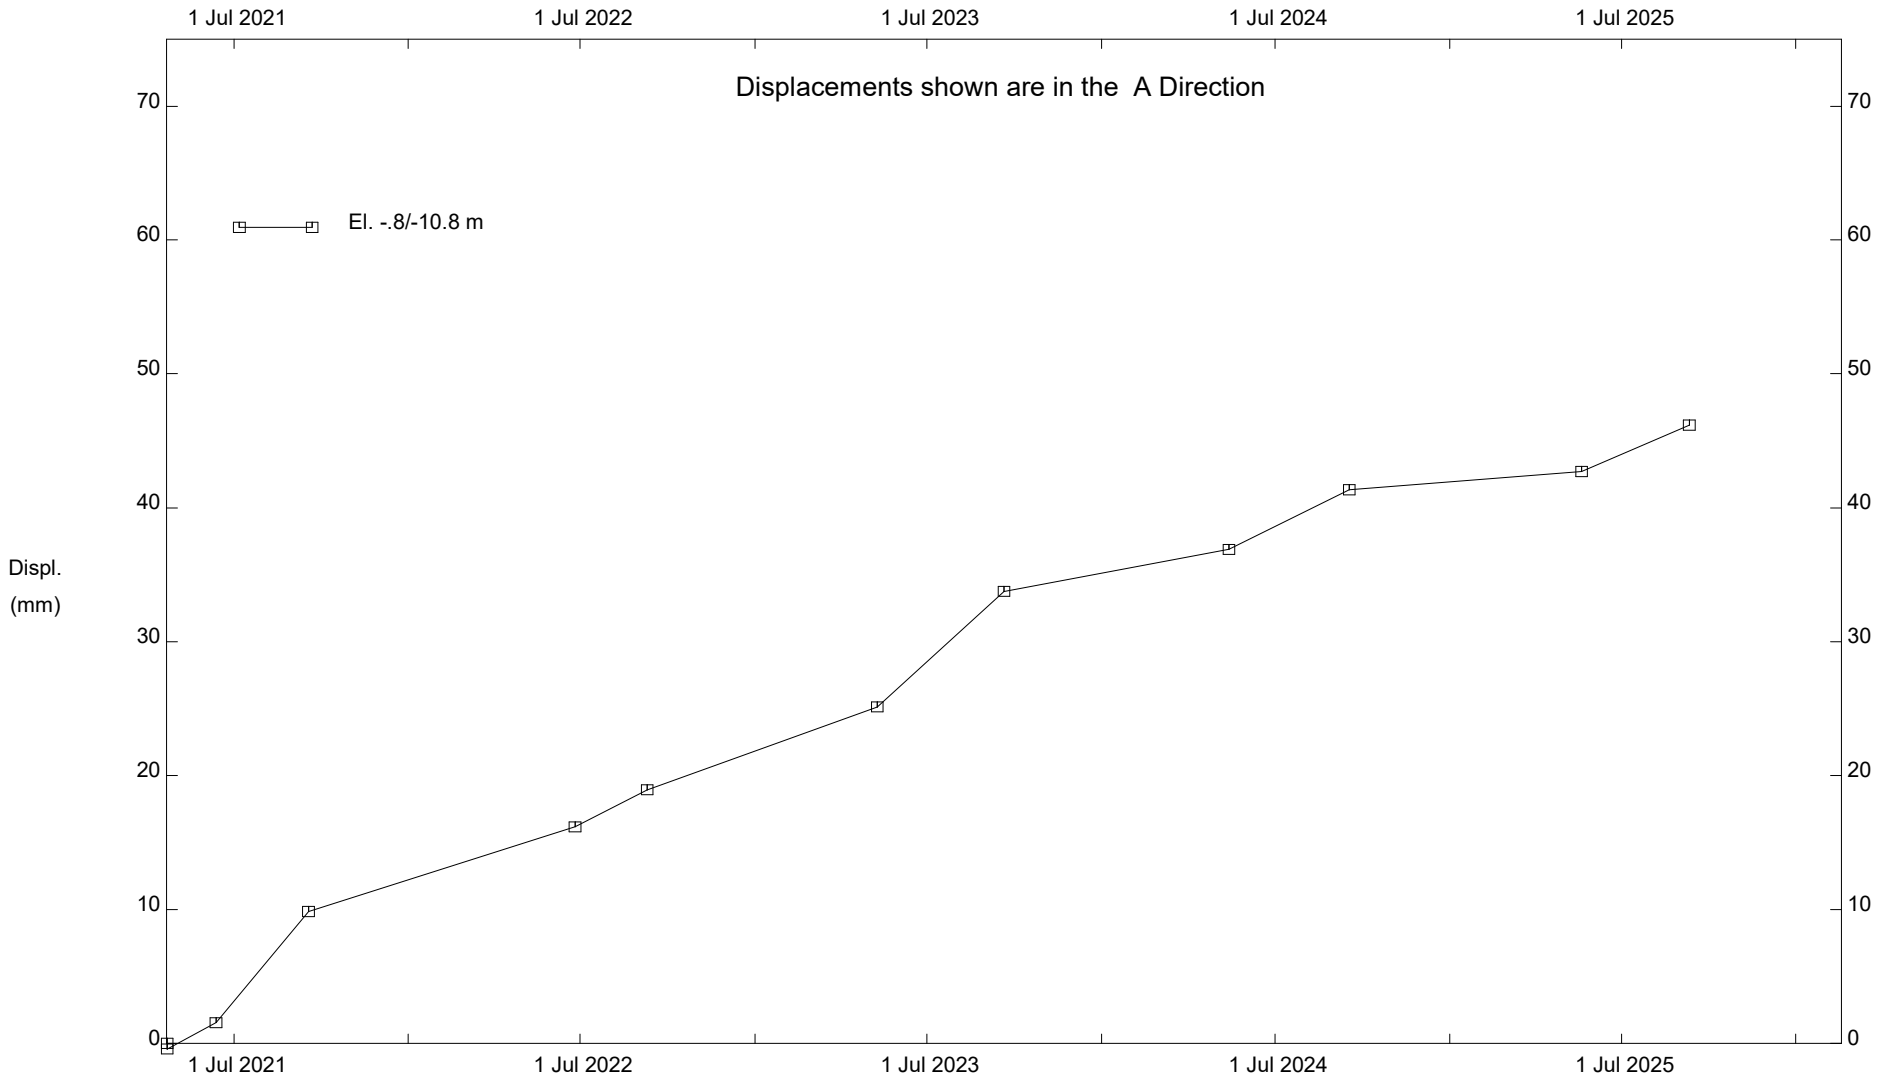
C048; H575:04; Slide W of Carbon Creek, Inclinometer SI21-C48-01  
 Alberta Transportation

Distributed movement is being recorded in SI21-C48-01 (upper H-pile wall) along the length of the instrument from near ground surface to approximately 11 m below ground surface.

The depth of movement being recorded in the upper H-pile wall SI appears to be occurring near the base of the H-pile wall, while the movement recorded in the lower H-pile wall appears to be occurring between 2 m and 3 m above the base of the H-pile walls. This indicates that the H-pile walls have intercepted the failure surface and have transferred the load to depths below the failure plane as the piles stabilize the slide mass. The fall 2025 data obtained from the pile-wall SIs indicates that the tops of the upper and lower H-pile walls have deflected up to approximately 46 mm and 63 mm, respectively, since installation.

After the initial movement recorded in the H-pile walls shortly after installation as the H-pile walls took up load from the highway embankment, the movement recorded in SI21-C48-01 and -03 appears to fluctuate seasonally (decreases and increases recorded in the spring and fall, respectively). The rate of movement recorded in SI21-C48-01 and -03 fluctuates between approximately 2 mm/year and 26 mm/year and approximately 3 mm/year and 29 mm/year, respectively. The maximum rate of movement recorded in SI21-C48-01 and SI21-C48-03 was approximately 31 mm/year and 59 mm/year, respectively. The overall average rate of movement for both instruments is less than approximately 10 mm/year since installation. Increased rate of movement in fall of 2023 may also be attributed to construction activities performed in summer of 2023.

The movement recorded in SI21-C48-01 and SI21-C48-03 in fall of 2025 are consistent with historical trends for the instruments (i.e., relatively steady or fluctuating seasonally).

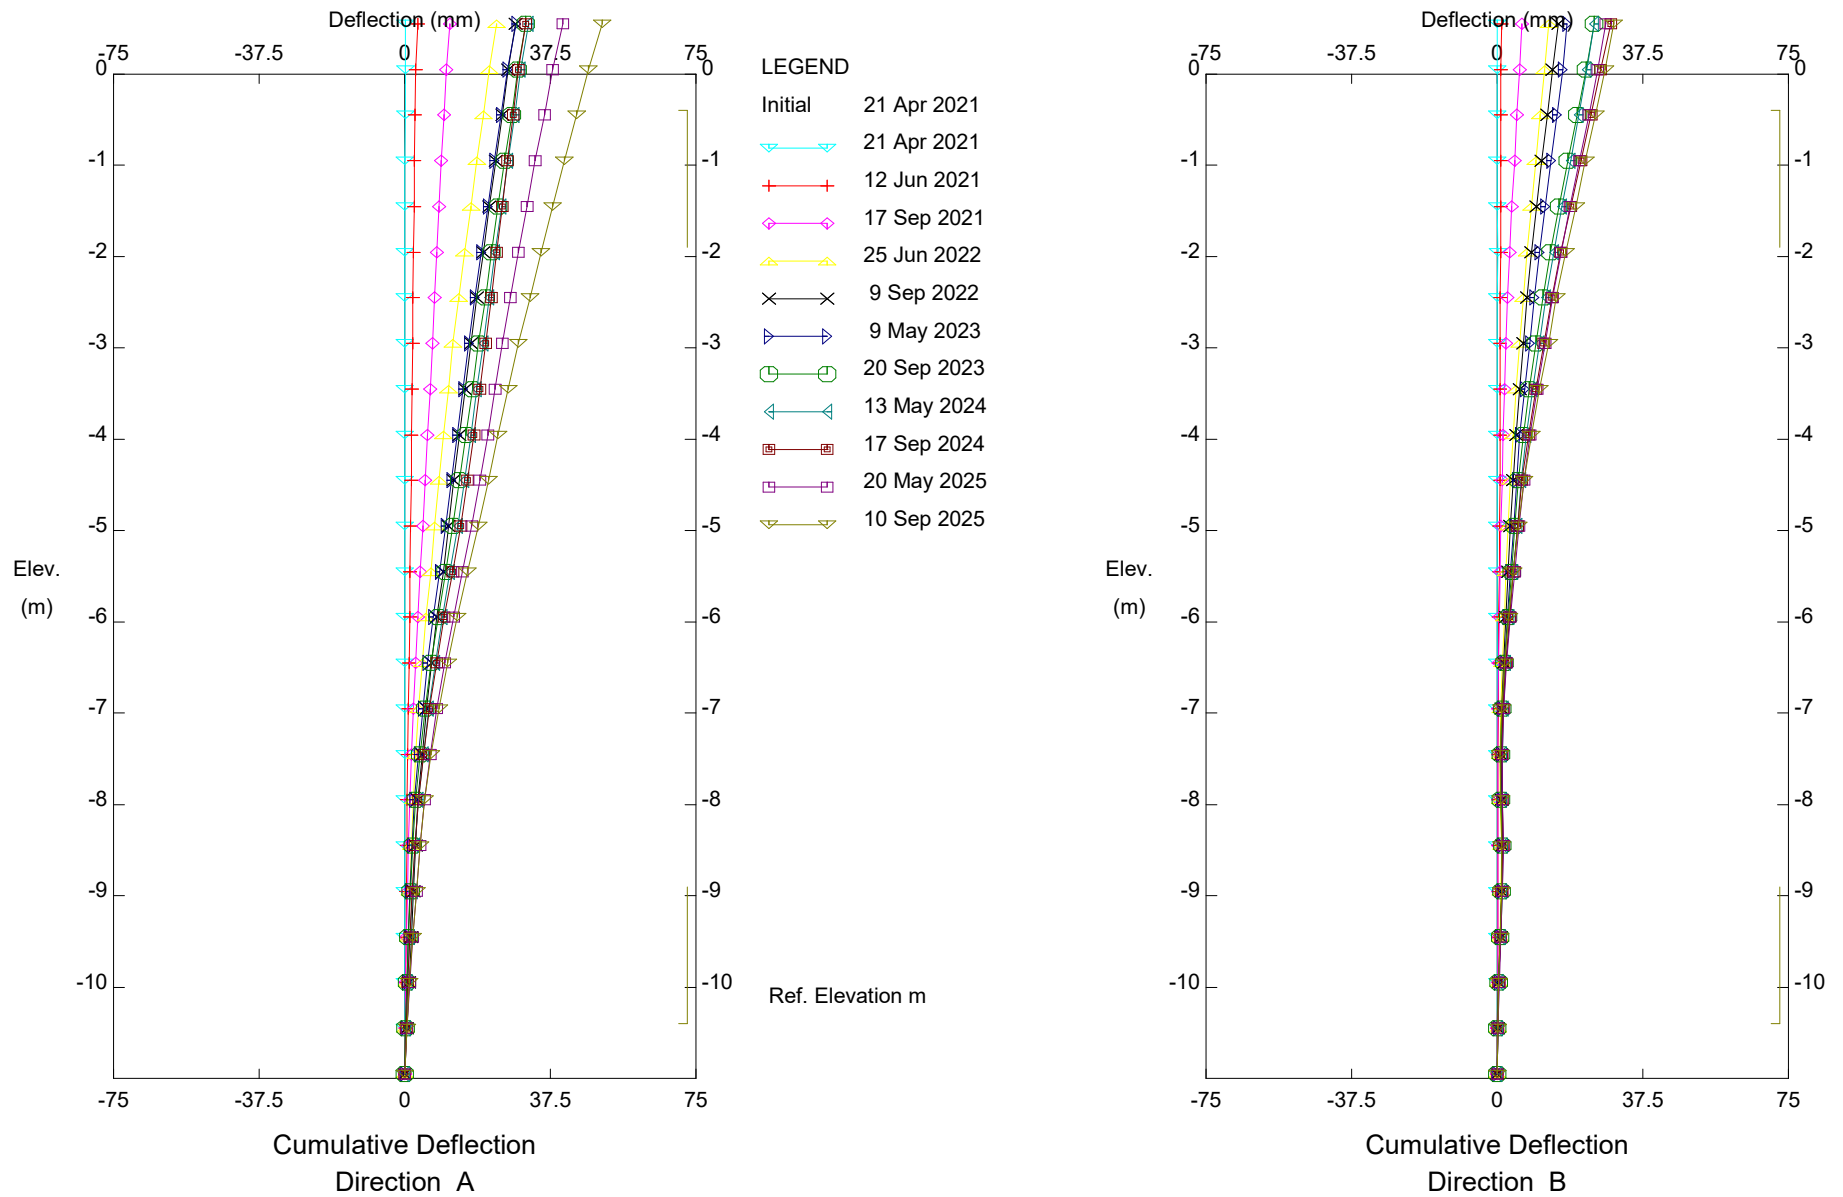
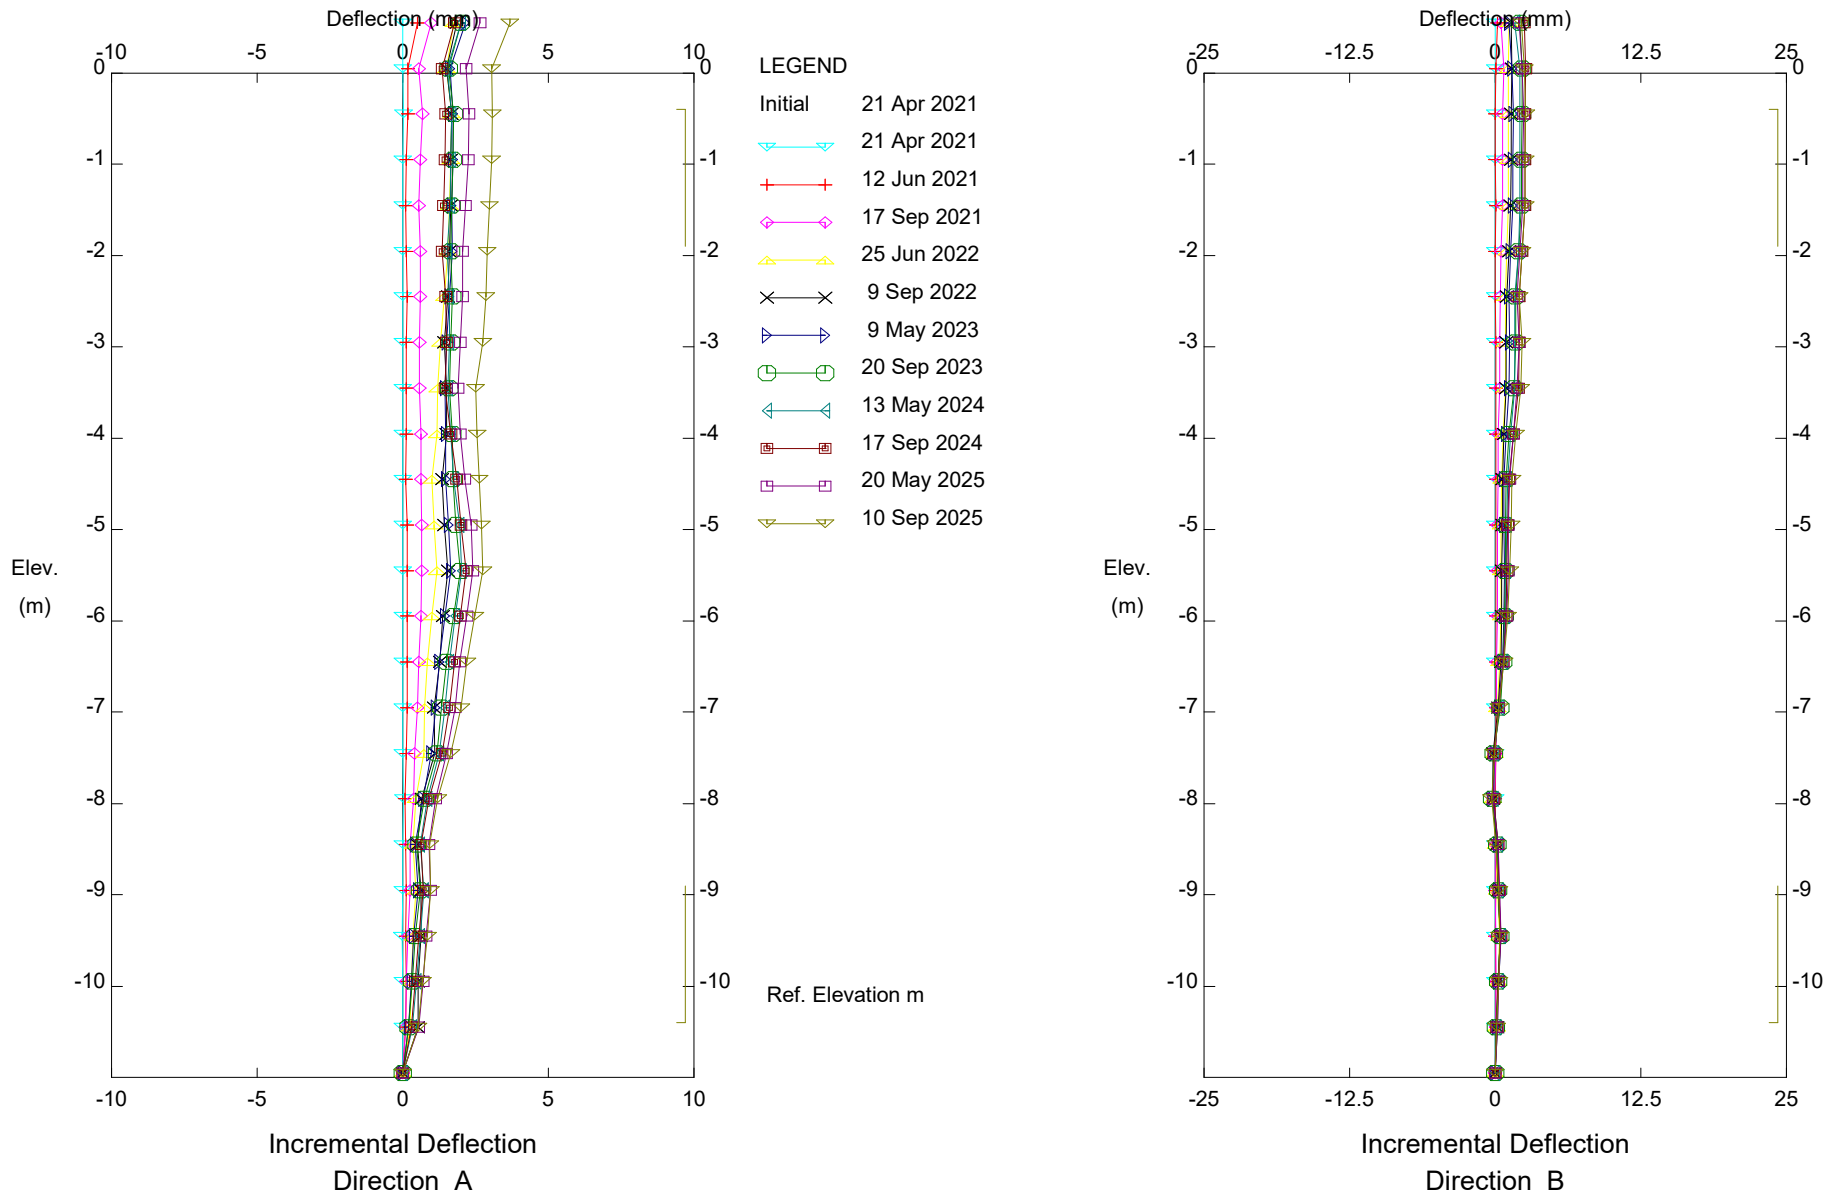
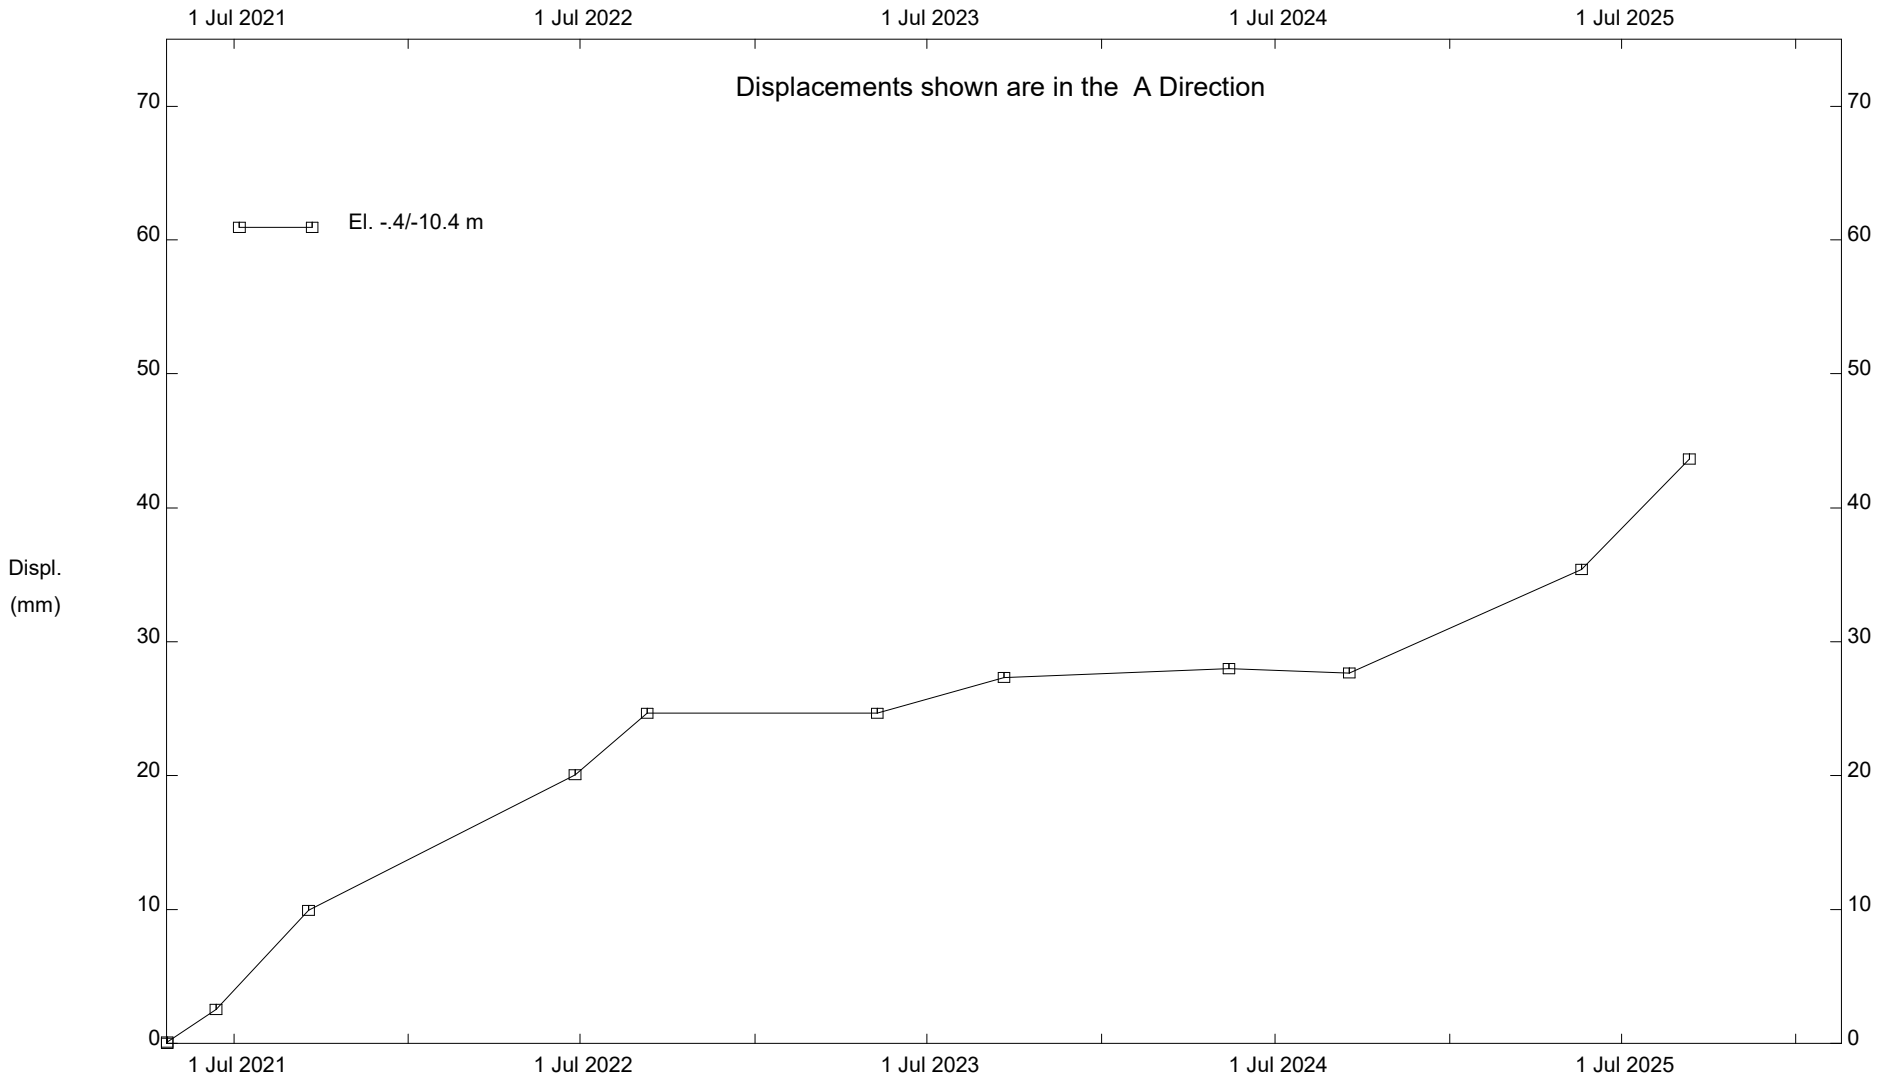
C048; H575:04; Slide W of Carbon Creek, Inclinometer SI21-C48-02

Distributed movement is being recorded in SI21-C48-02 and SI21-C48-03 (lower H-pile wall) along the length of the instruments from near ground surface to approximately 9 m below ground surface.

In the fall of 2021, shortly after construction of the H-pile walls, the maximum rate of movement recorded in SI21-C48-02 (lower H-pile wall) was approximately 28 mm/year. Between fall of 2022 and fall of 2024, the rate of movement recorded in SI21-C48-02 was slow (approximately 1 mm/year), excluding a small increase recorded in fall of 2023 (approximately 7 mm/year), likely in response to summer of 2023 construction activities. The rate of movement increased in 2025, with recorded movement of approximately 12 mm/year and approximately 27 mm/year in the spring and fall, respectively. The increased rate of movement in 2025 may be attributed to the lower H-pile wall taking up load from movement in the upper embankment slope as the upper H-pile wall deforms.
