September 29, 2025

Alberta Transportation and Economic Corridors  
4<sup>th</sup> Floor, Provincial Building  
4920 – 51<sup>st</sup> Street  
Red Deer, Alberta  
T4N 6K8

**CON0022160 Central Region GRMP Instrumentation Monitoring**  
**Site C048-1; H575:04, km 14.500 Slide West of Carbon Creek**  
**Section C – 2025 Fall Readings**

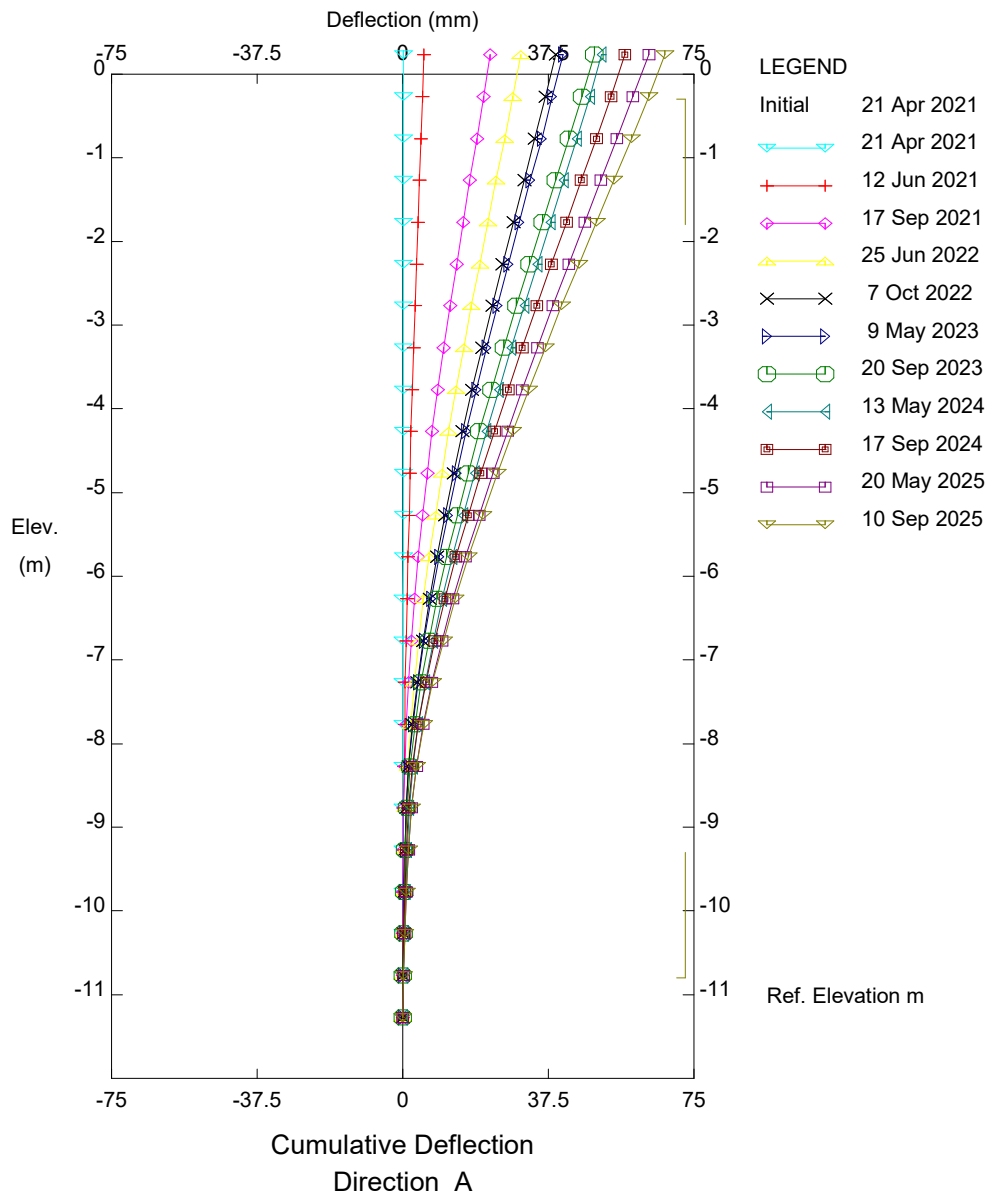
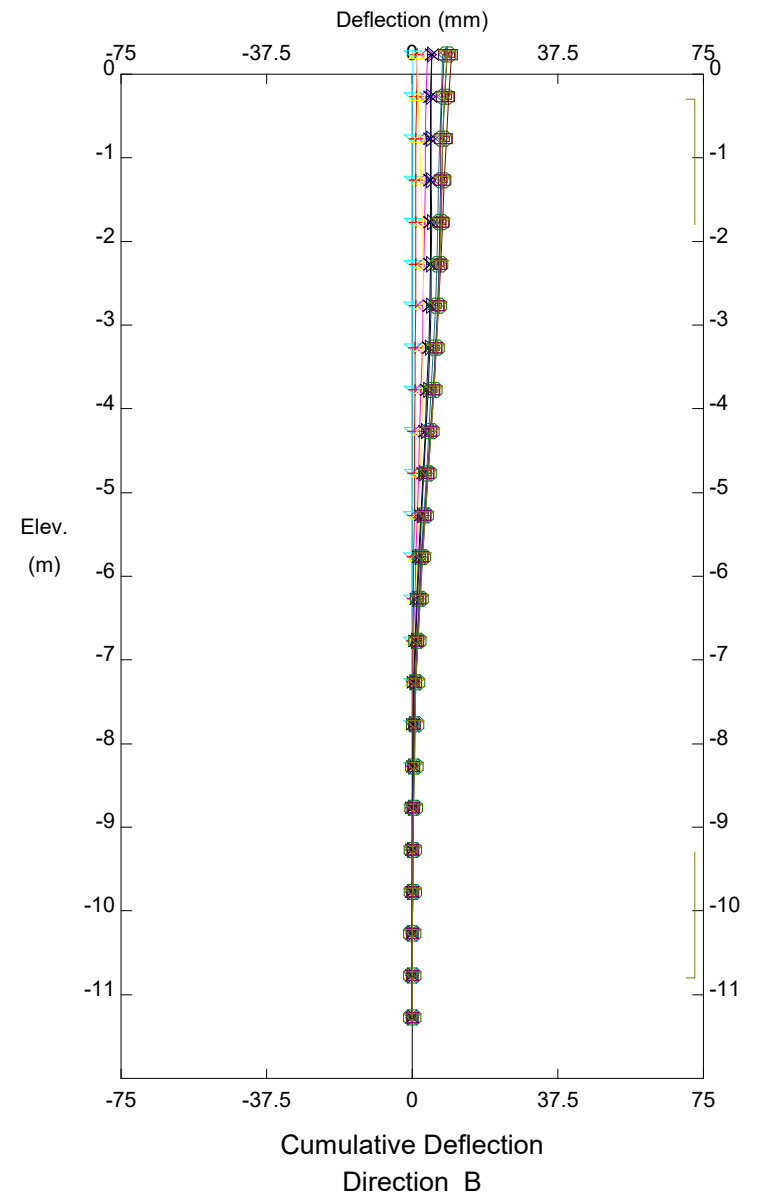
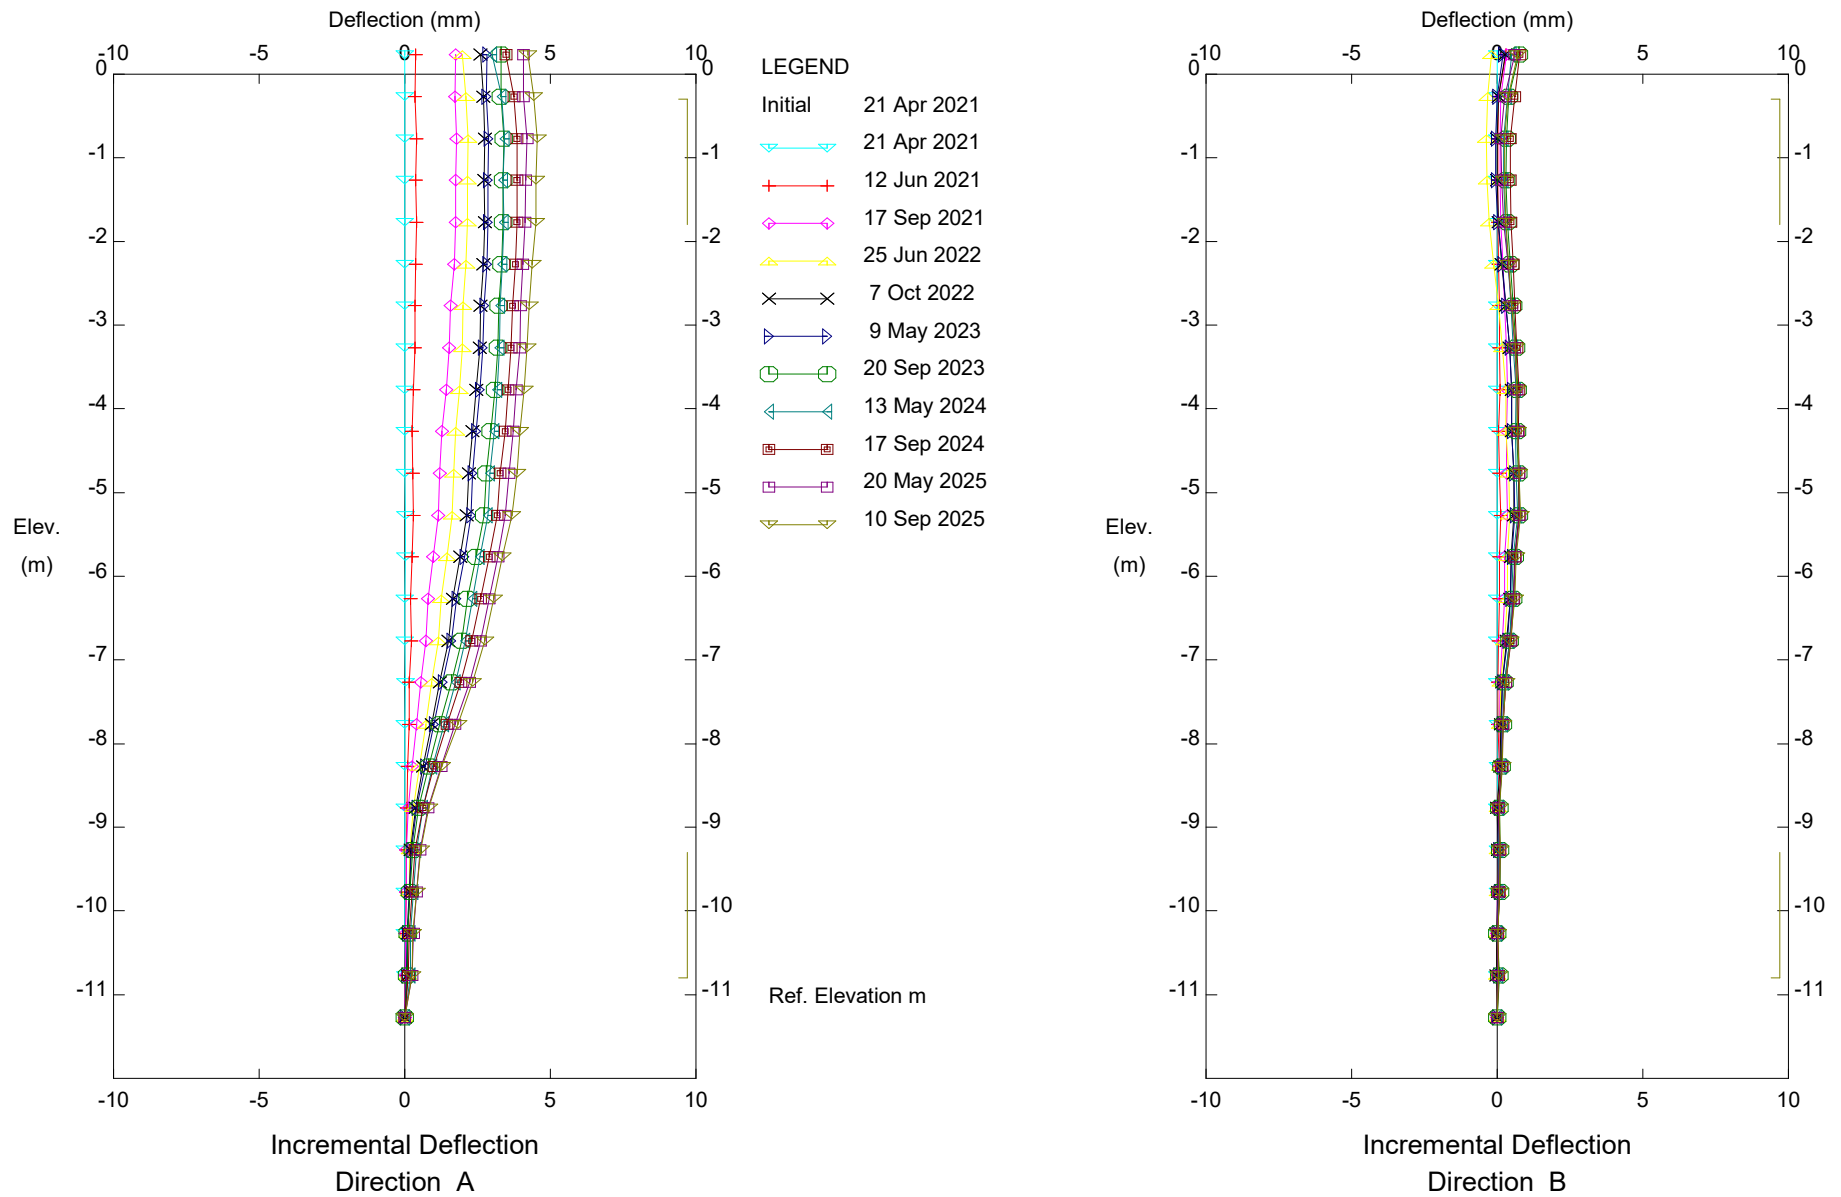
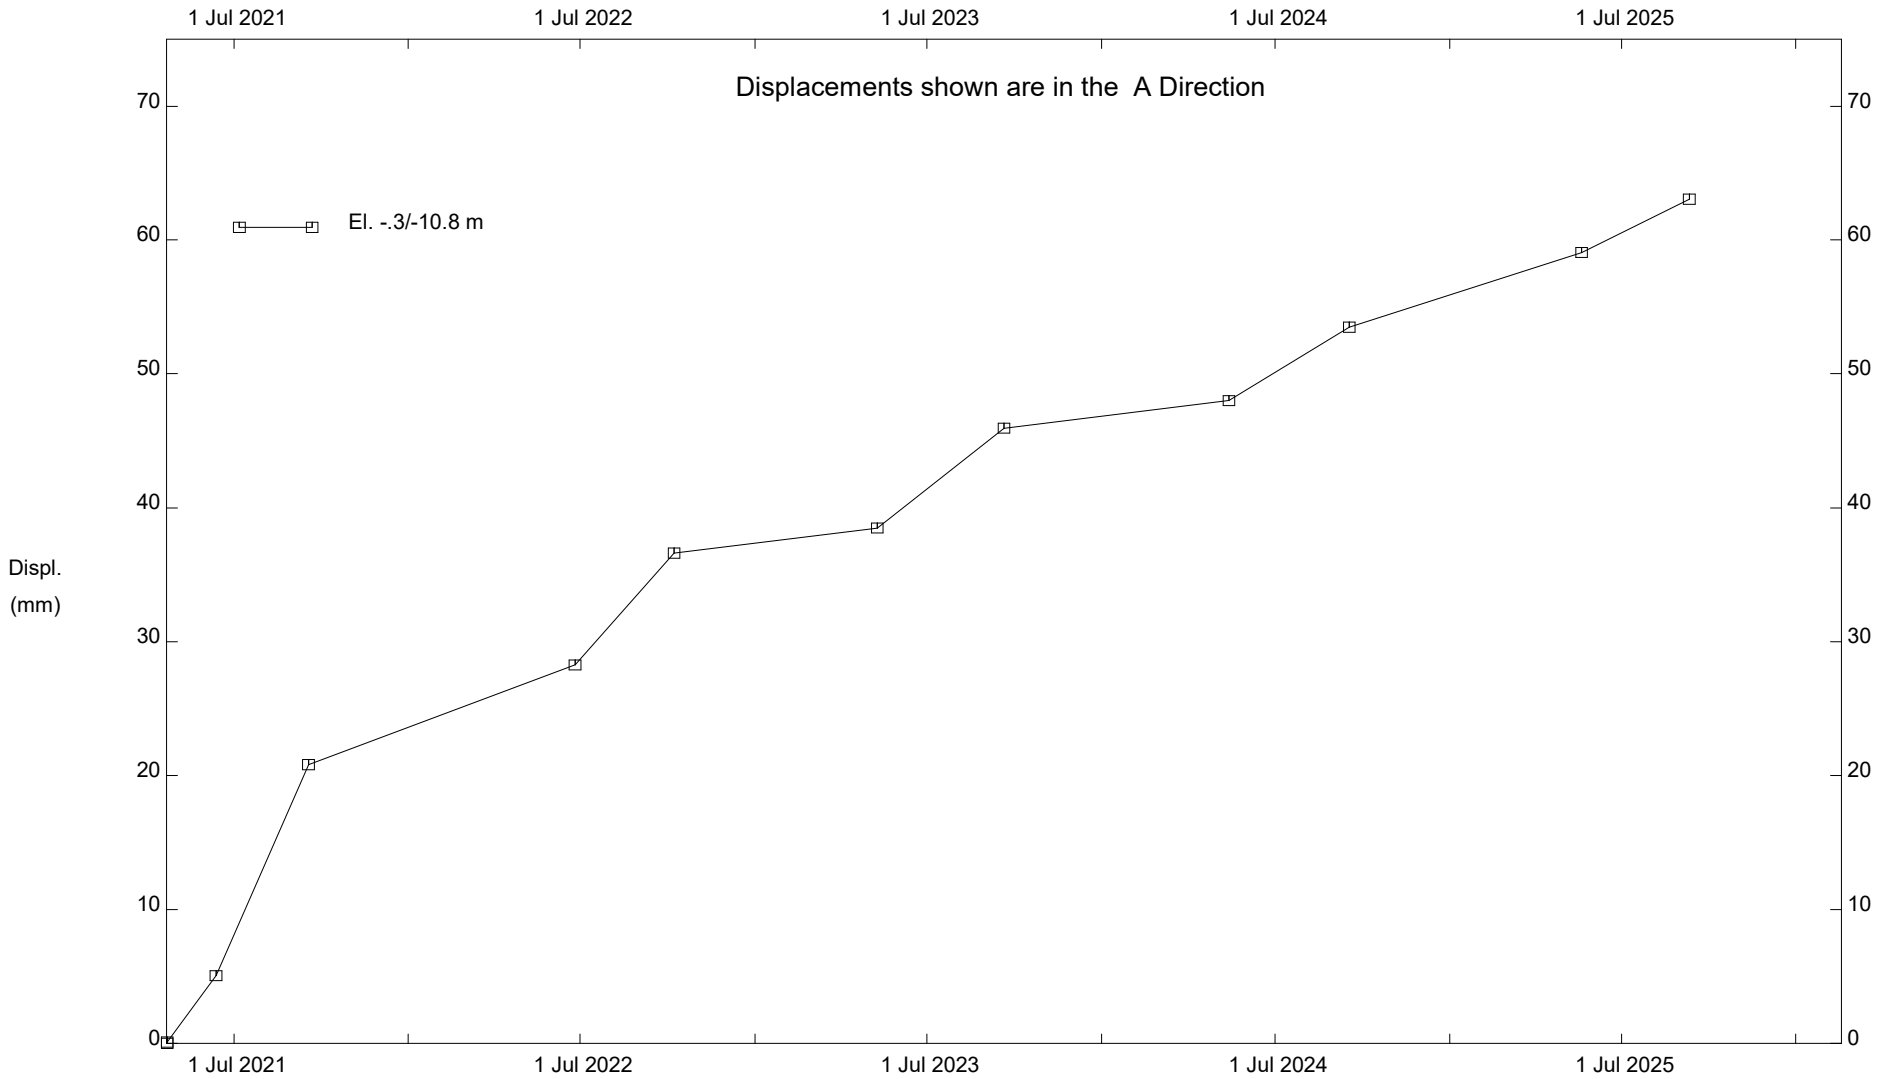
C048; H575:04; Slide W of Carbon Creek, Inclinator SI21-C48-03  
Alberta Transportation

Distributed movement is being recorded in SI21-C48-02 and SI21-C48-03 (lower H-pile wall) along the length of the instruments from near ground surface to approximately 9 m below ground surface.

After the initial movement recorded in the H-pile walls shortly after installation as the H-pile walls took up load from the highway embankment, the movement recorded in SI21-C48-01 and -03 appears to fluctuate seasonally (decreases and increases recorded in the spring and fall, respectively). The rate of movement recorded in SI21-C48-01 and -03 fluctuates between approximately 2 mm/year and 26 mm/year and approximately 3 mm/year and 29 mm/year, respectively. The maximum rate of movement recorded in SI21-C48-01 and SI21-C48-03 was approximately 31 mm/year and 59 mm/year, respectively. The overall average rate of movement for both instruments is less than approximately 10 mm/year since installation. Increased rate of movement in fall of 2023 may also be attributed to construction activities performed in summer of 2023.

The movement recorded in SI21-C48-01 and SI21-C48-03 in fall of 2025 are consistent with historical trends for the instruments (i.e., relatively steady or fluctuating seasonally).
