July 15, 2025

Alberta Transportation and Economic Corridors
4th Floor, Provincial Building
4920 – 51st Street
Red Deer, Alberta
T4N 6K8

CON0022160 Central Region GRMP Instrumentation Monitoring
Site C048-1; H575:04, km 14.500 Slide West of Carbon Creek
Section C – 2025 Spring Readings

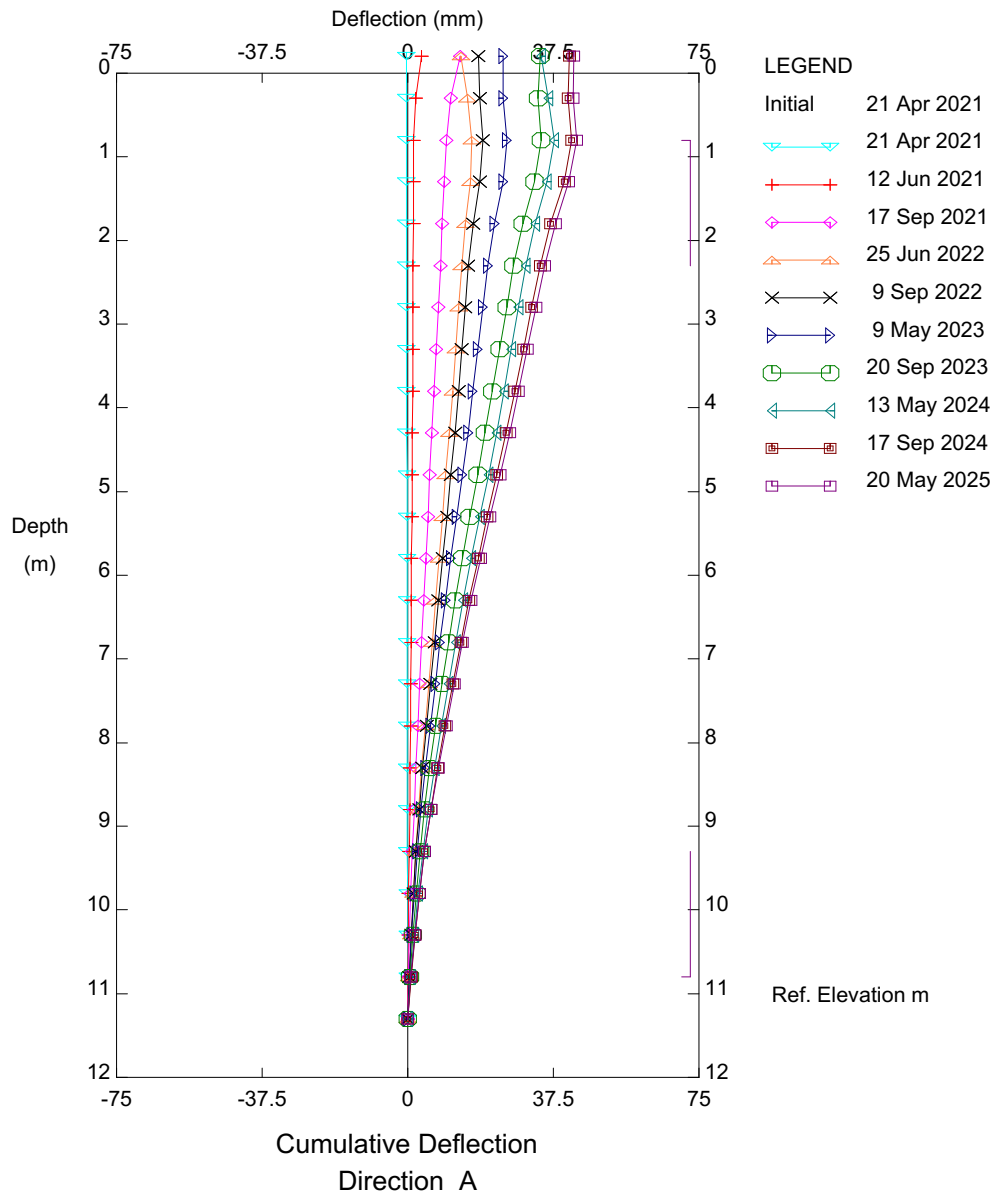
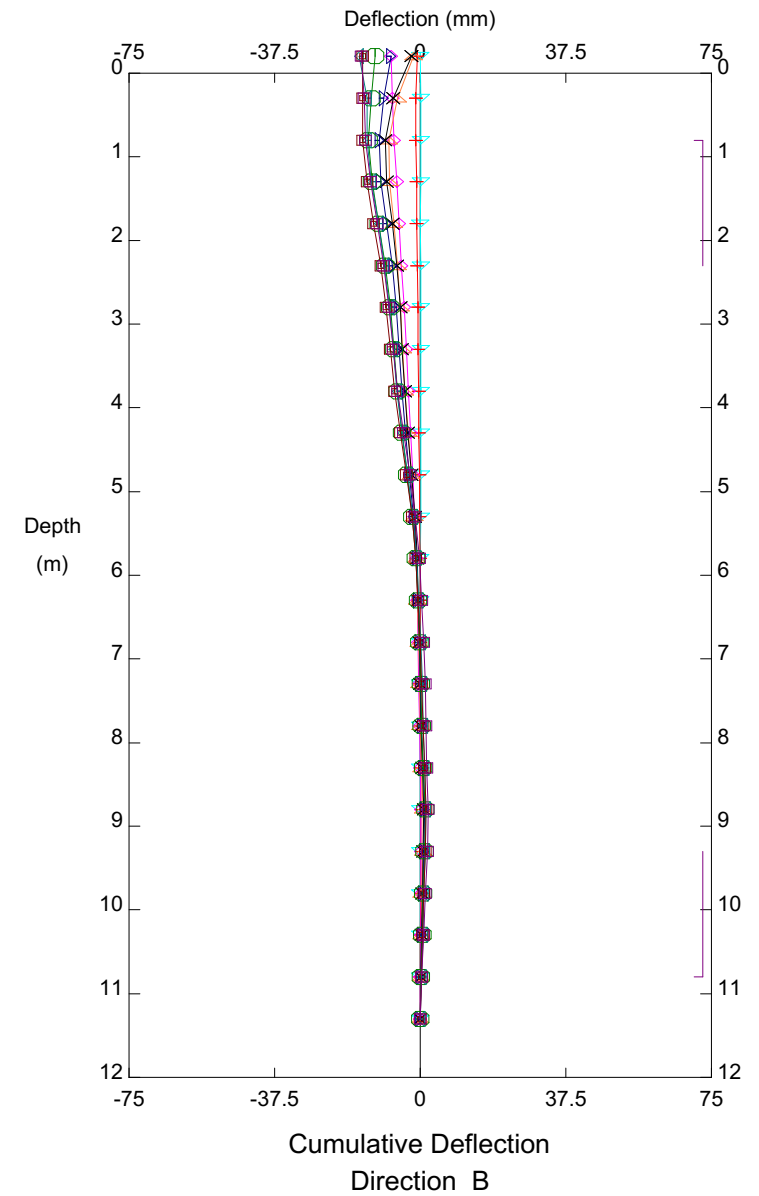
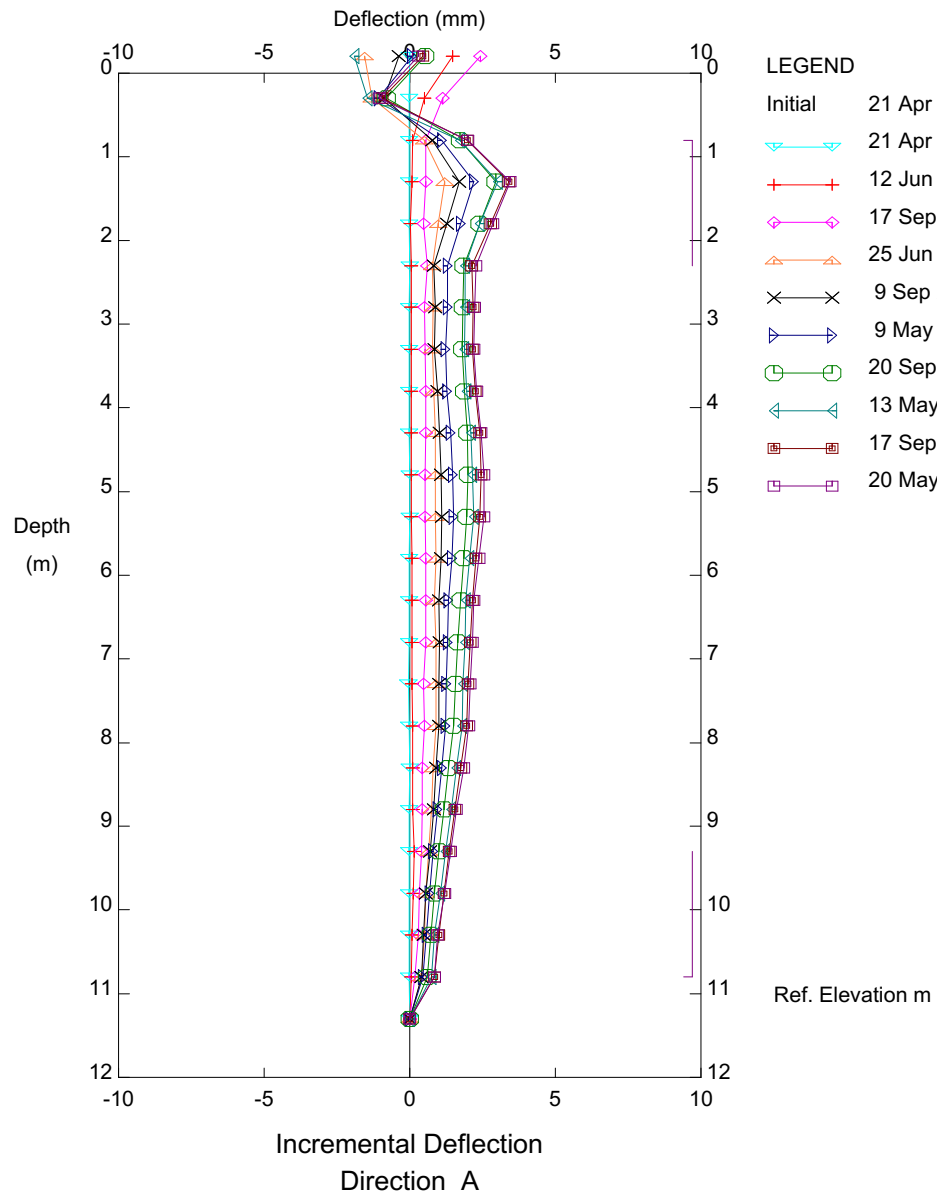
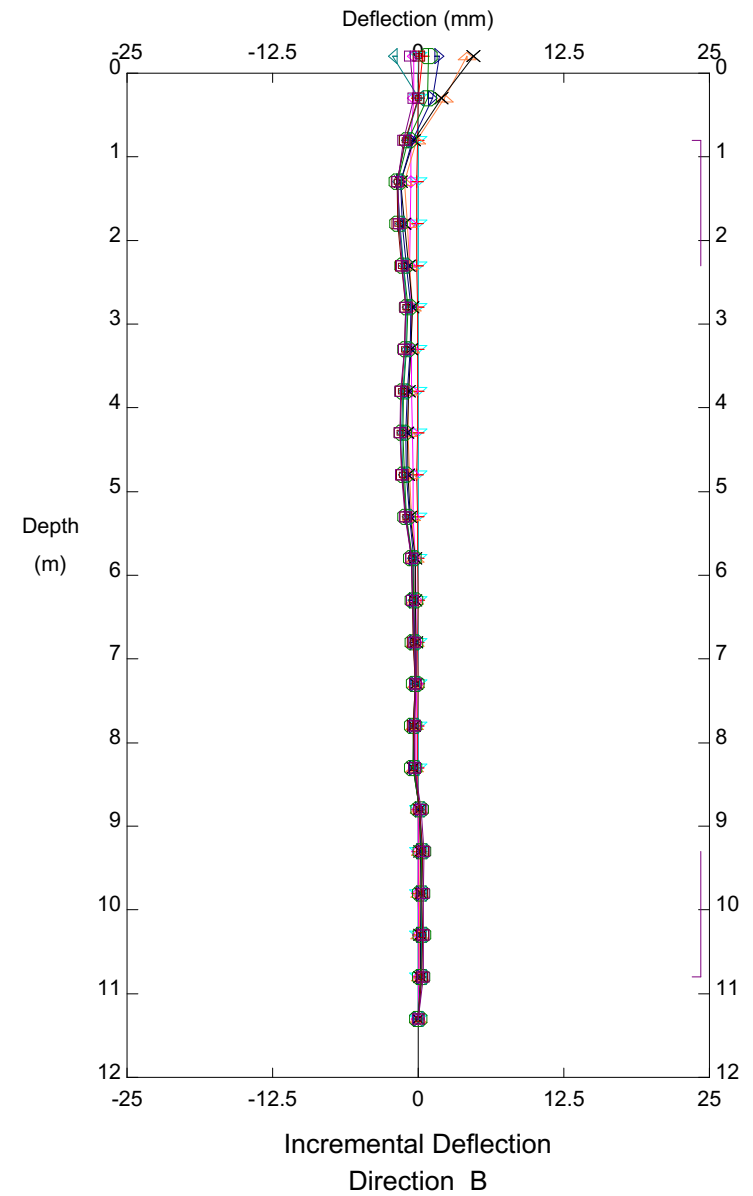
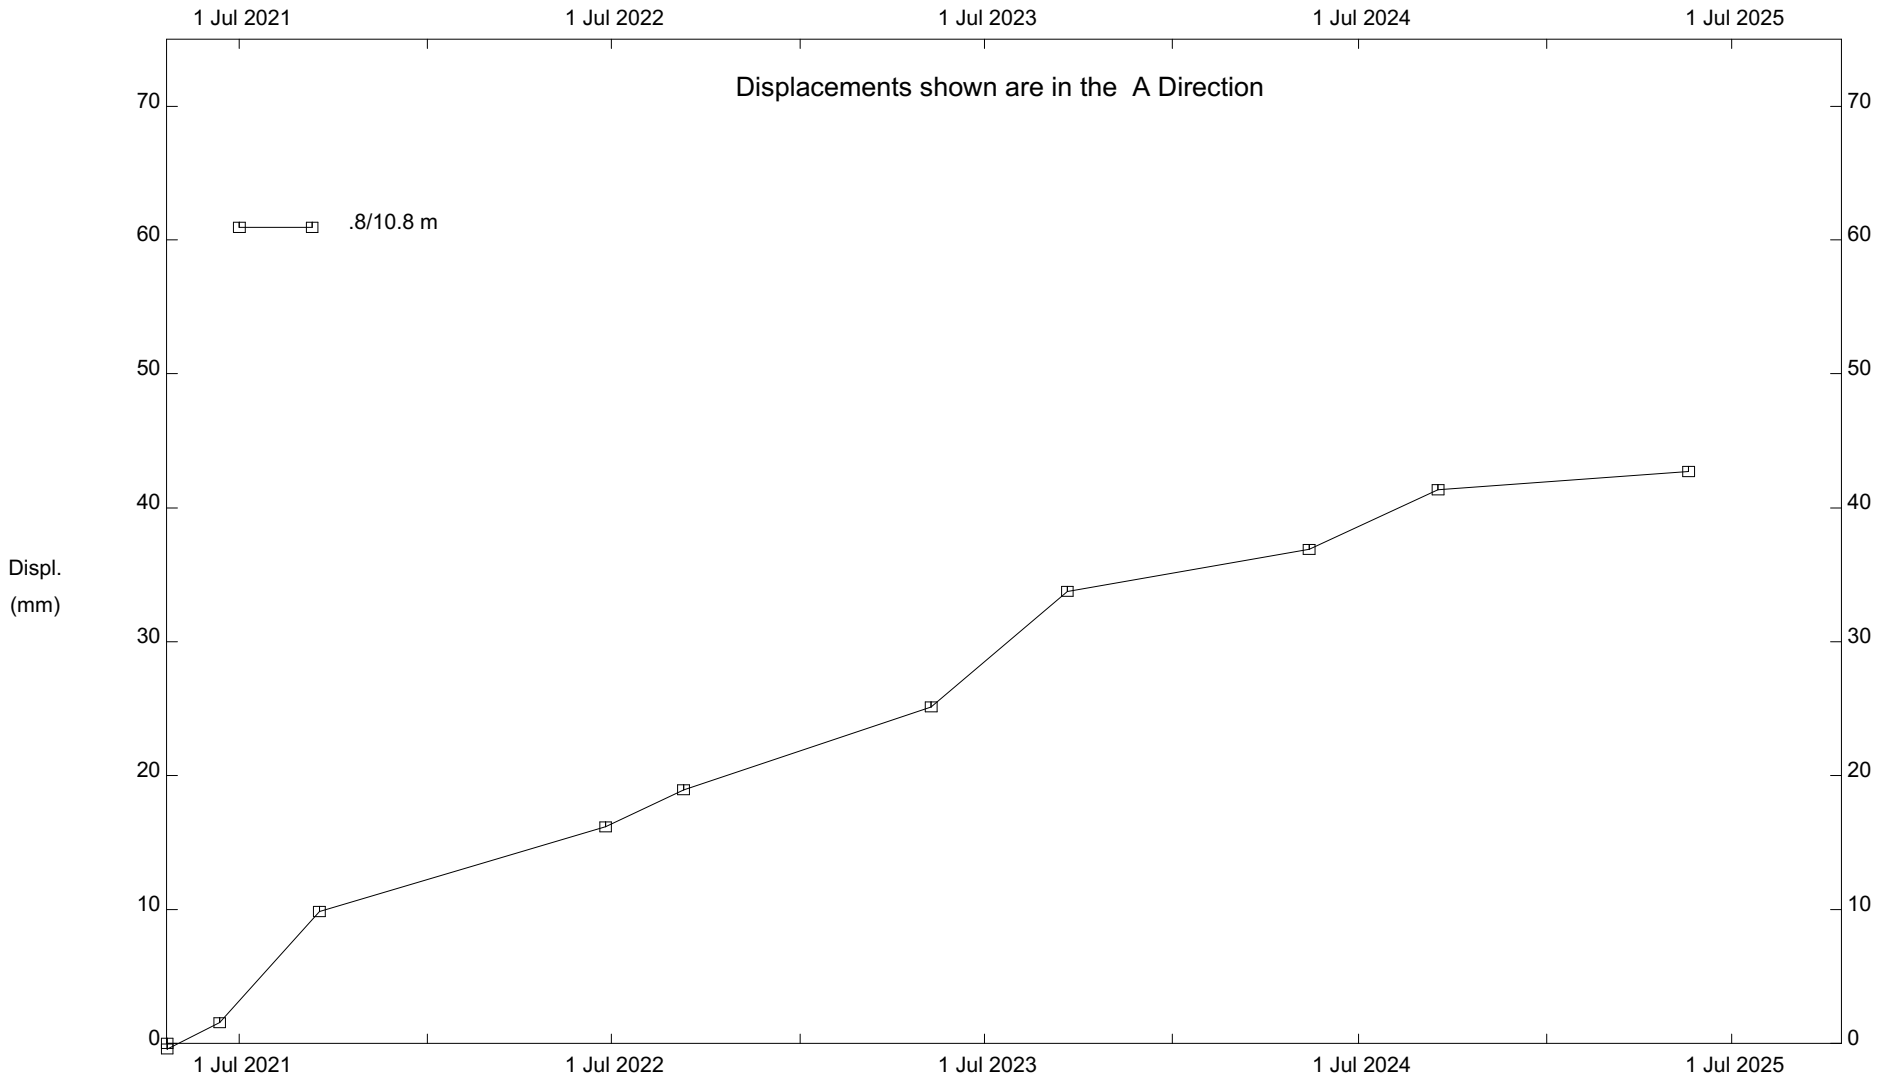
C048; H575:04; Slide W of Carbon Creek, Inclinator SI21-C48-01
 Alberta Transportation

Distributed movement is being recorded in SI21-C48-01 (upper H-pile wall) along the length of the instrument from near ground surface to approximately 11 m below ground surface.

The depth of movement being recorded in the upper H-pile wall SI appears to be occurring near the base of the H-pile wall, while the movement recorded in the lower H-pile wall appears to be occurring between 2 m and 3 m above the base of the H-pile walls. This indicates that the H-pile walls have intercepted the failure surface and have transferred the load to depths below the failure plane as the piles stabilize the slide mass. The spring 2025 data obtained from the pile-wall SIs indicates that the tops of the upper and lower H-pile walls have deflected up to approximately 43 mm and 59 mm, respectively, since installation.

In the fall of 2021, shortly after construction of the H-pile walls, the maximum rate of movement recorded in SI21-C48-01 (upper H-pile wall) was approximately 31 mm/year. Since fall of 2021, the rate of movement recorded in SI21-C48-01 has been relatively steady (less than approximately 10 mm/year) excluding increases recorded in fall of 2023 and 2024. The increased rate of movement recorded in fall of 2023 (approximately 24 mm/year) is likely attributed to construction activities completed in summer 2023. The increased rate of movement recorded in fall of 2024 (approximately 13 mm/year) may be attributed to a small increase in precipitation in August 2024 (55 mm versus the historic average of 45 mm recorded between 2015 and 2024) or a delayed response after summer 2023 construction.

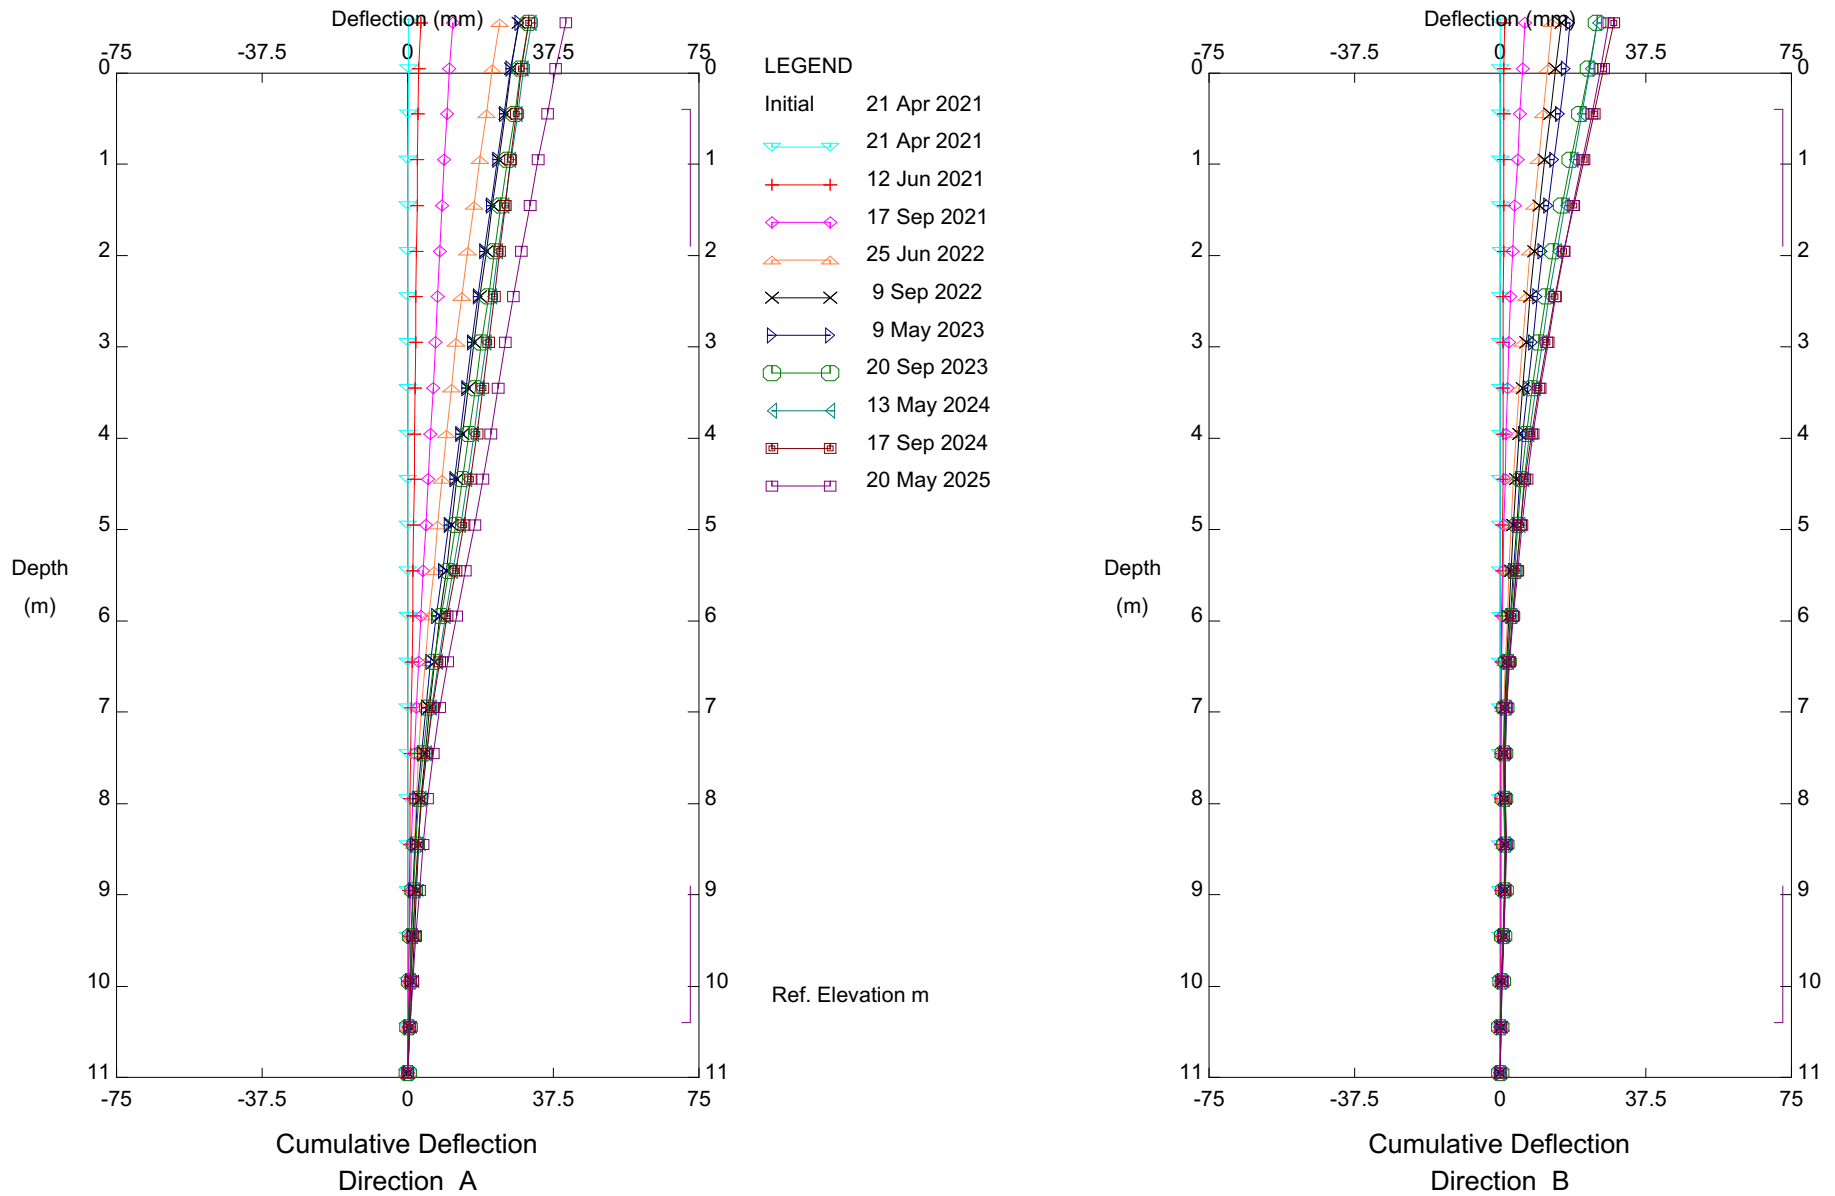
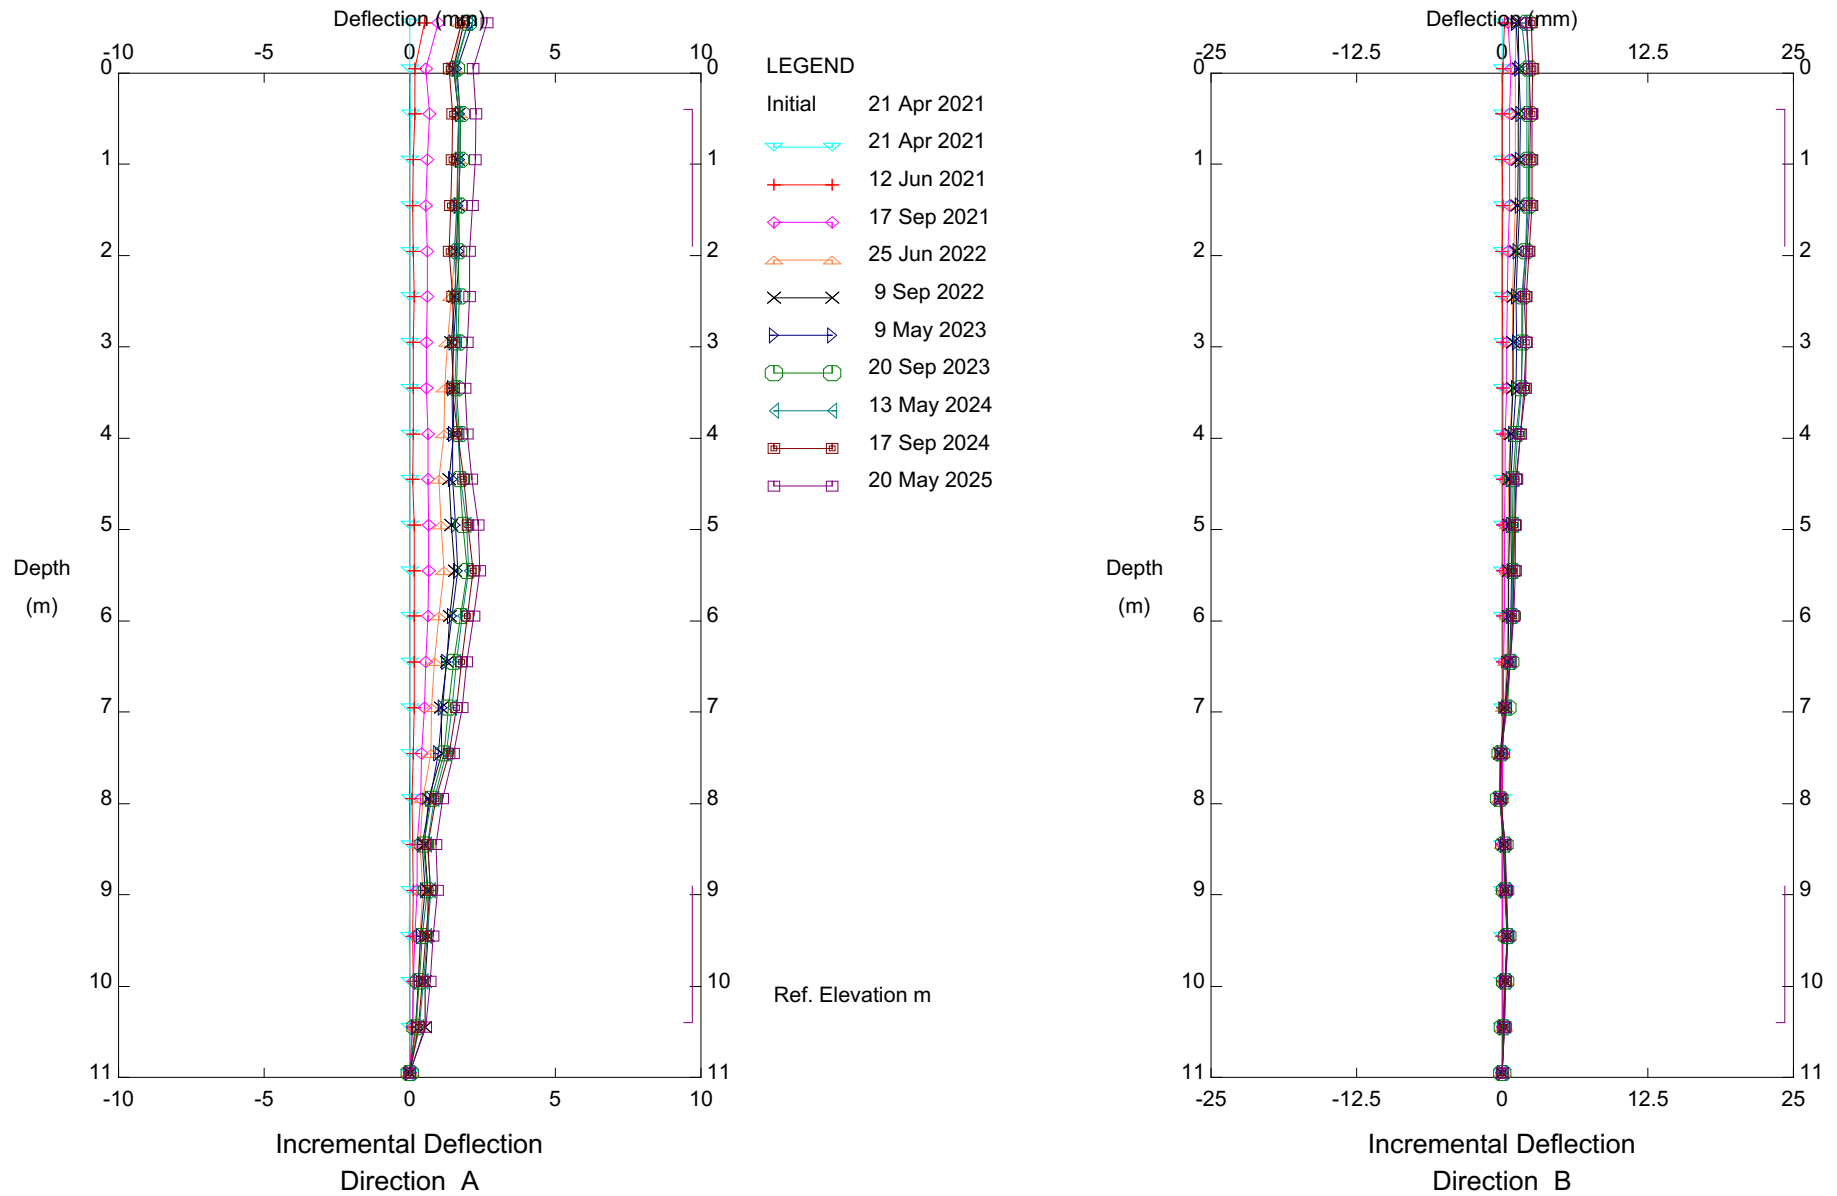
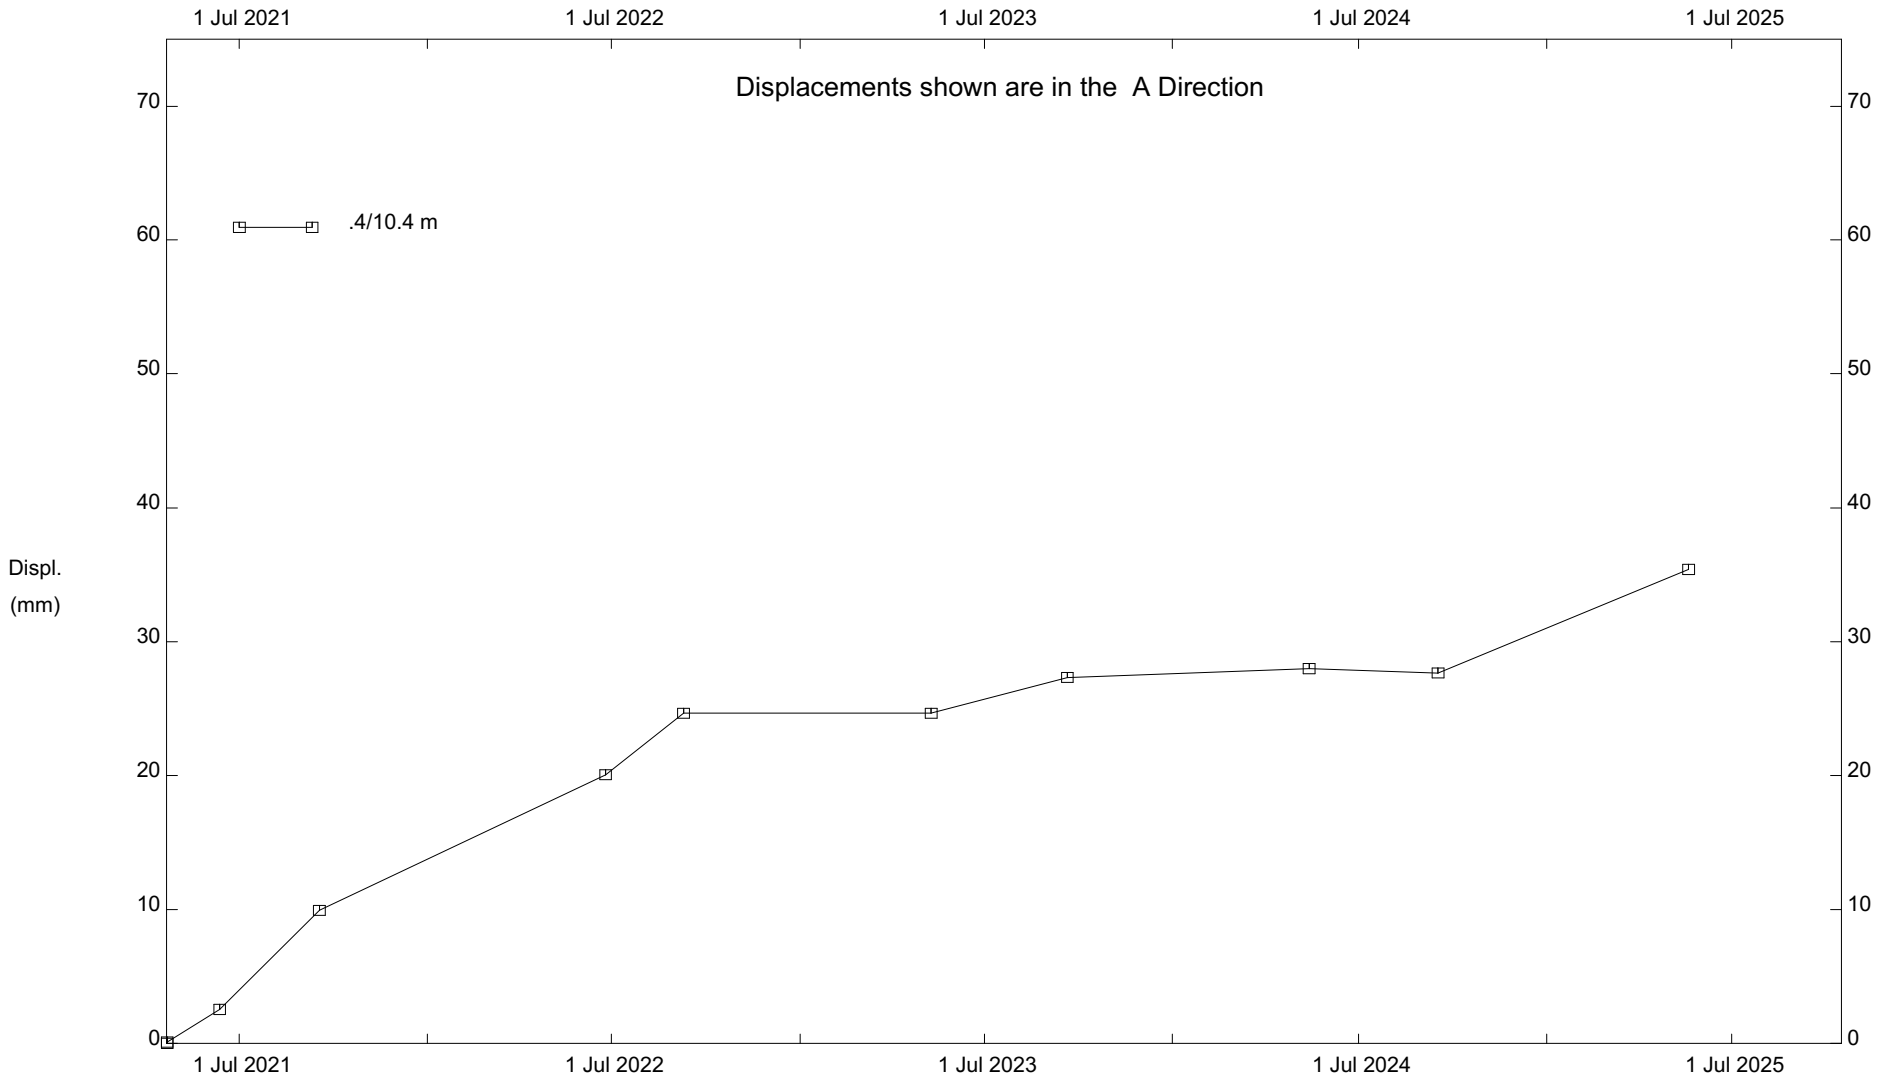
C048; H575:04; Slide W of Carbon Creek, Inclinator SI21-C48-02

Distributed movement is being recorded in SI21-C48-02 and SI21-C48-03 (lower H-pile wall) along the length of the instruments from near ground surface to approximately 9 m below ground surface.

In the fall of 2021, shortly after construction of the H-pile walls, the maximum rate of movement recorded in SI21-C48-02 and -03 (lower H-pile wall) was 28 mm/year and 59 mm/year, respectively. Since fall of 2022, the rate of movement recorded in SI21-C48-02 has been slow (approximately 1 mm/year) excluding an increased rate of movement recorded in fall of 2023 of 7 mm/year and in spring 2025 of 11.5 mm/year. The increased movement in fall 2023 was likely attributed to construction activities completed in summer 2023. The increased rate of movement in spring 2025 may be attributed to increased precipitation in April 2025 compared to April 2024 (40 mm versus 9 mm, respectively) or the lower H-pile wall taking up load from recent movement in the upper embankment slope, as increased movement was recorded in SI21-C48-01 (upslope of SI21-C48-02) in the fall of 2024.

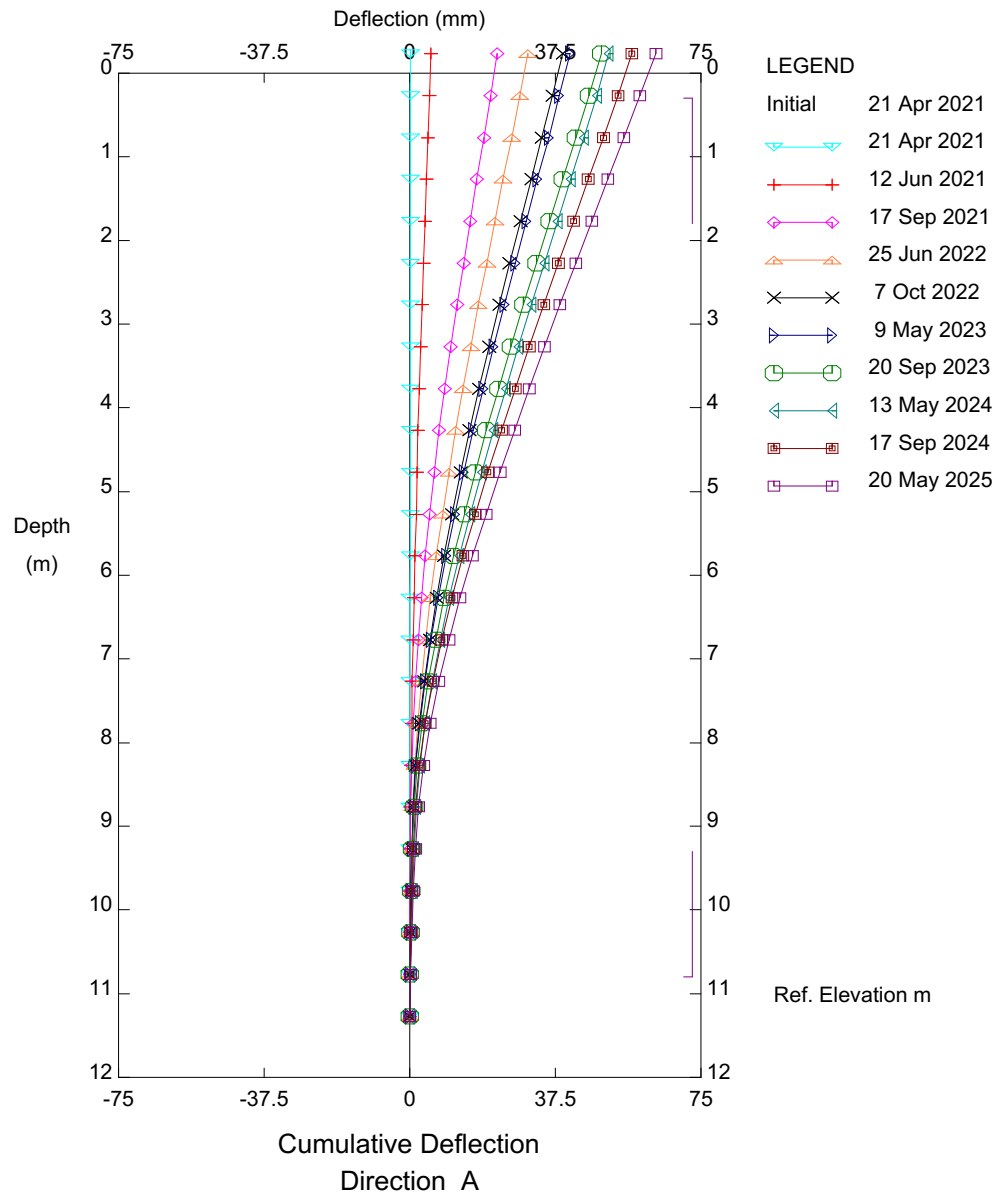
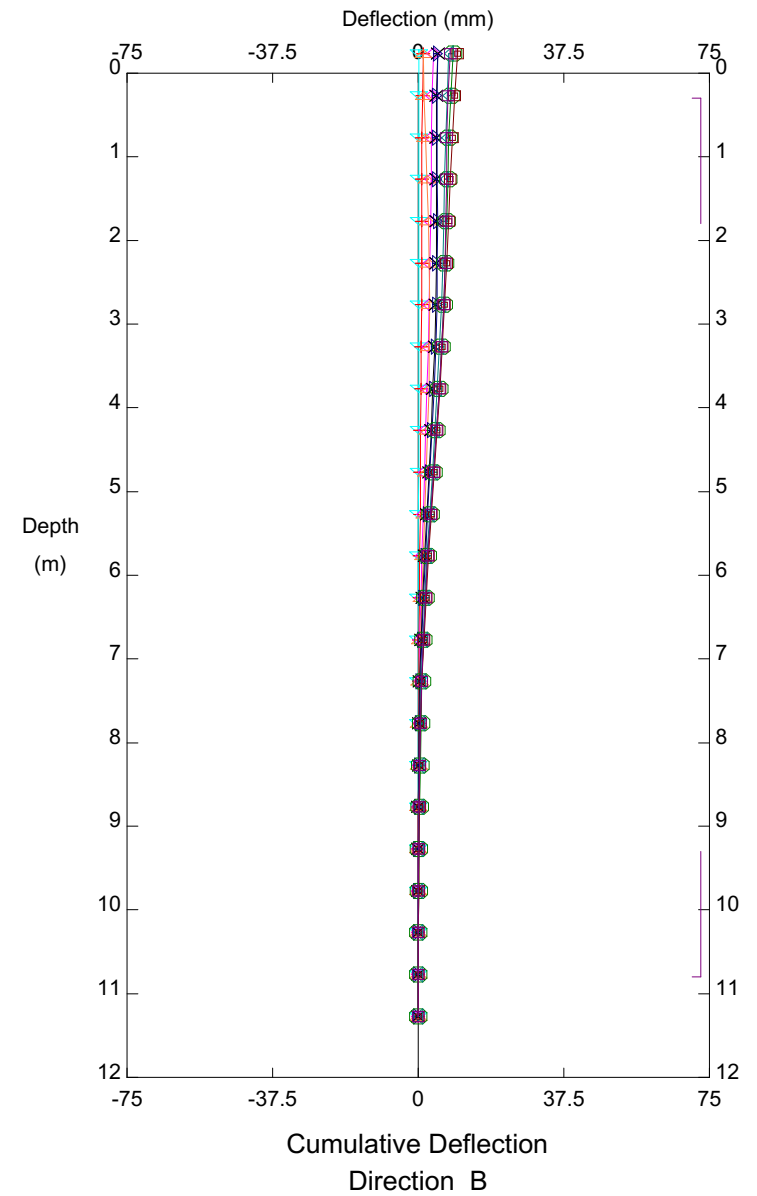
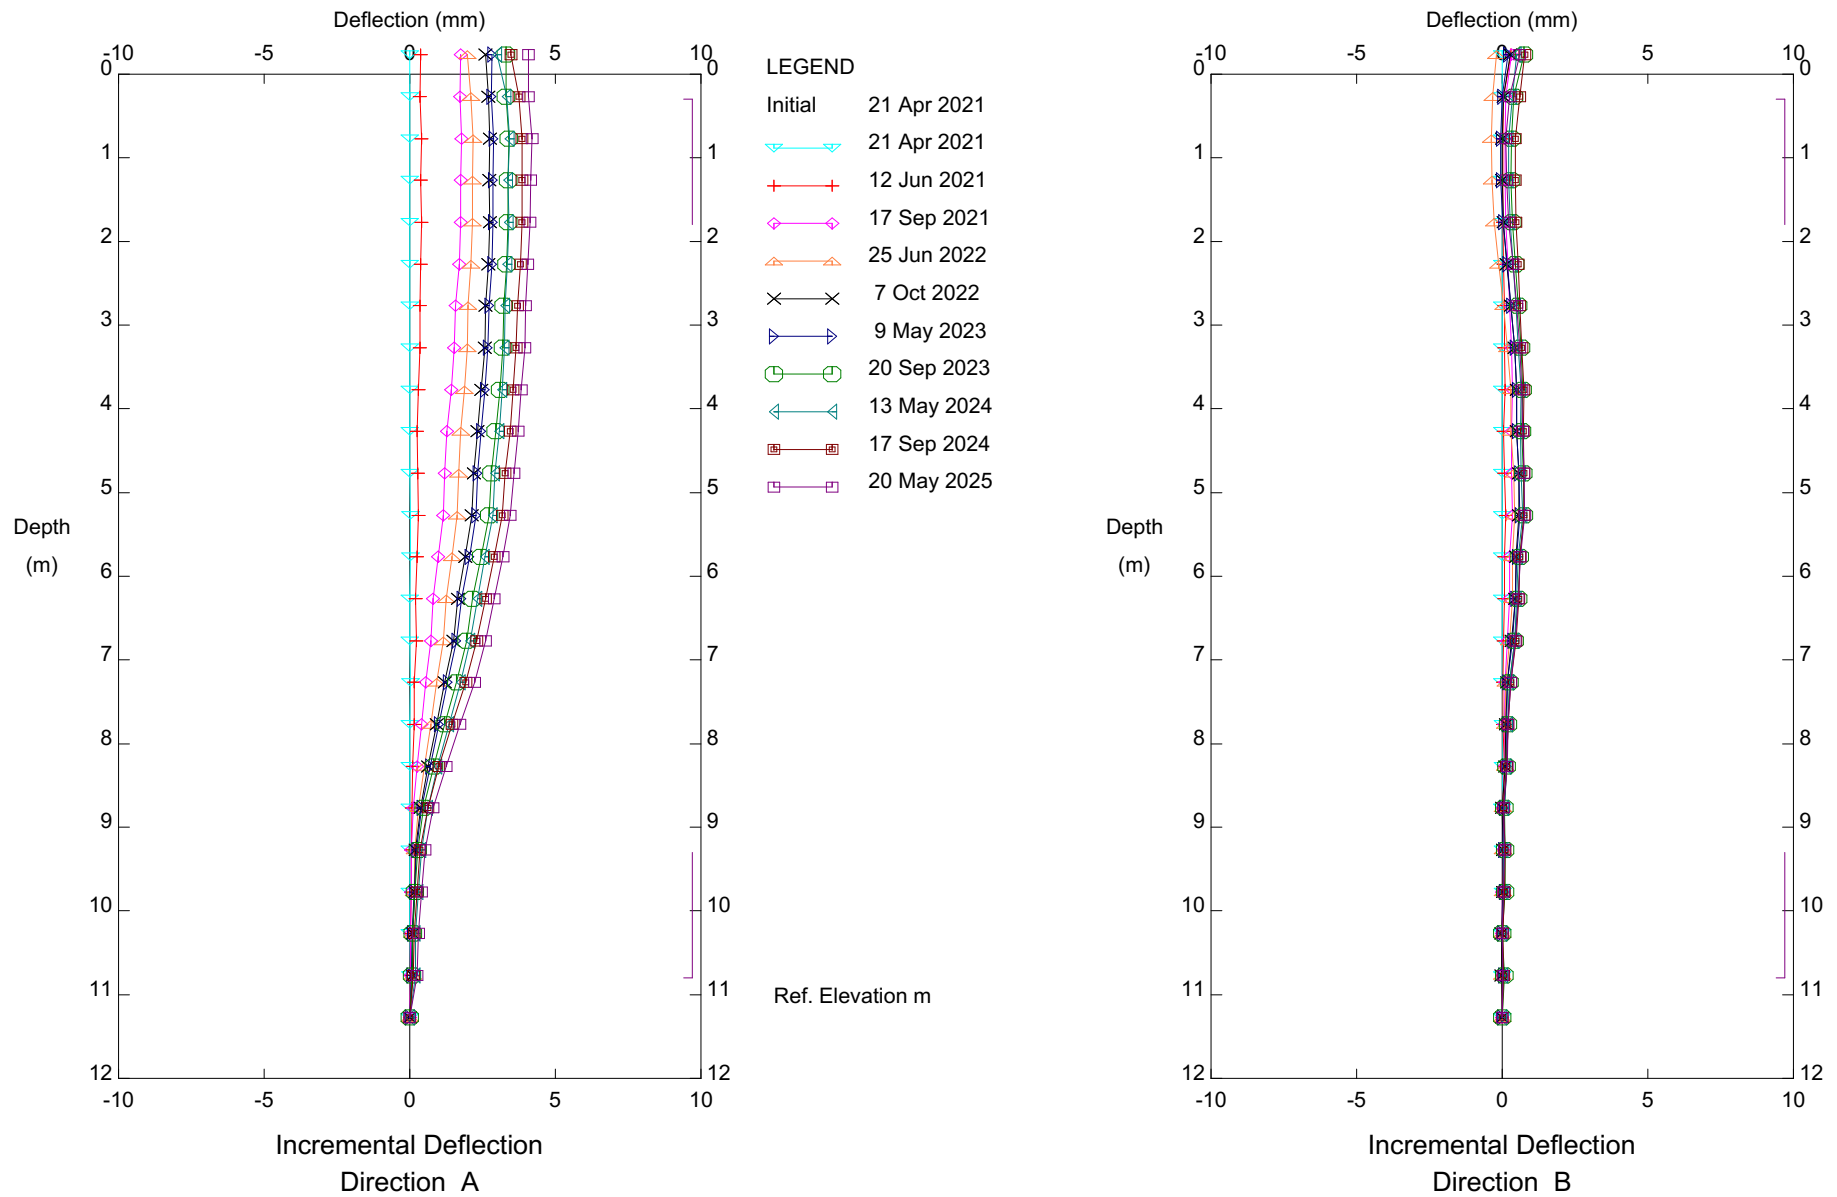
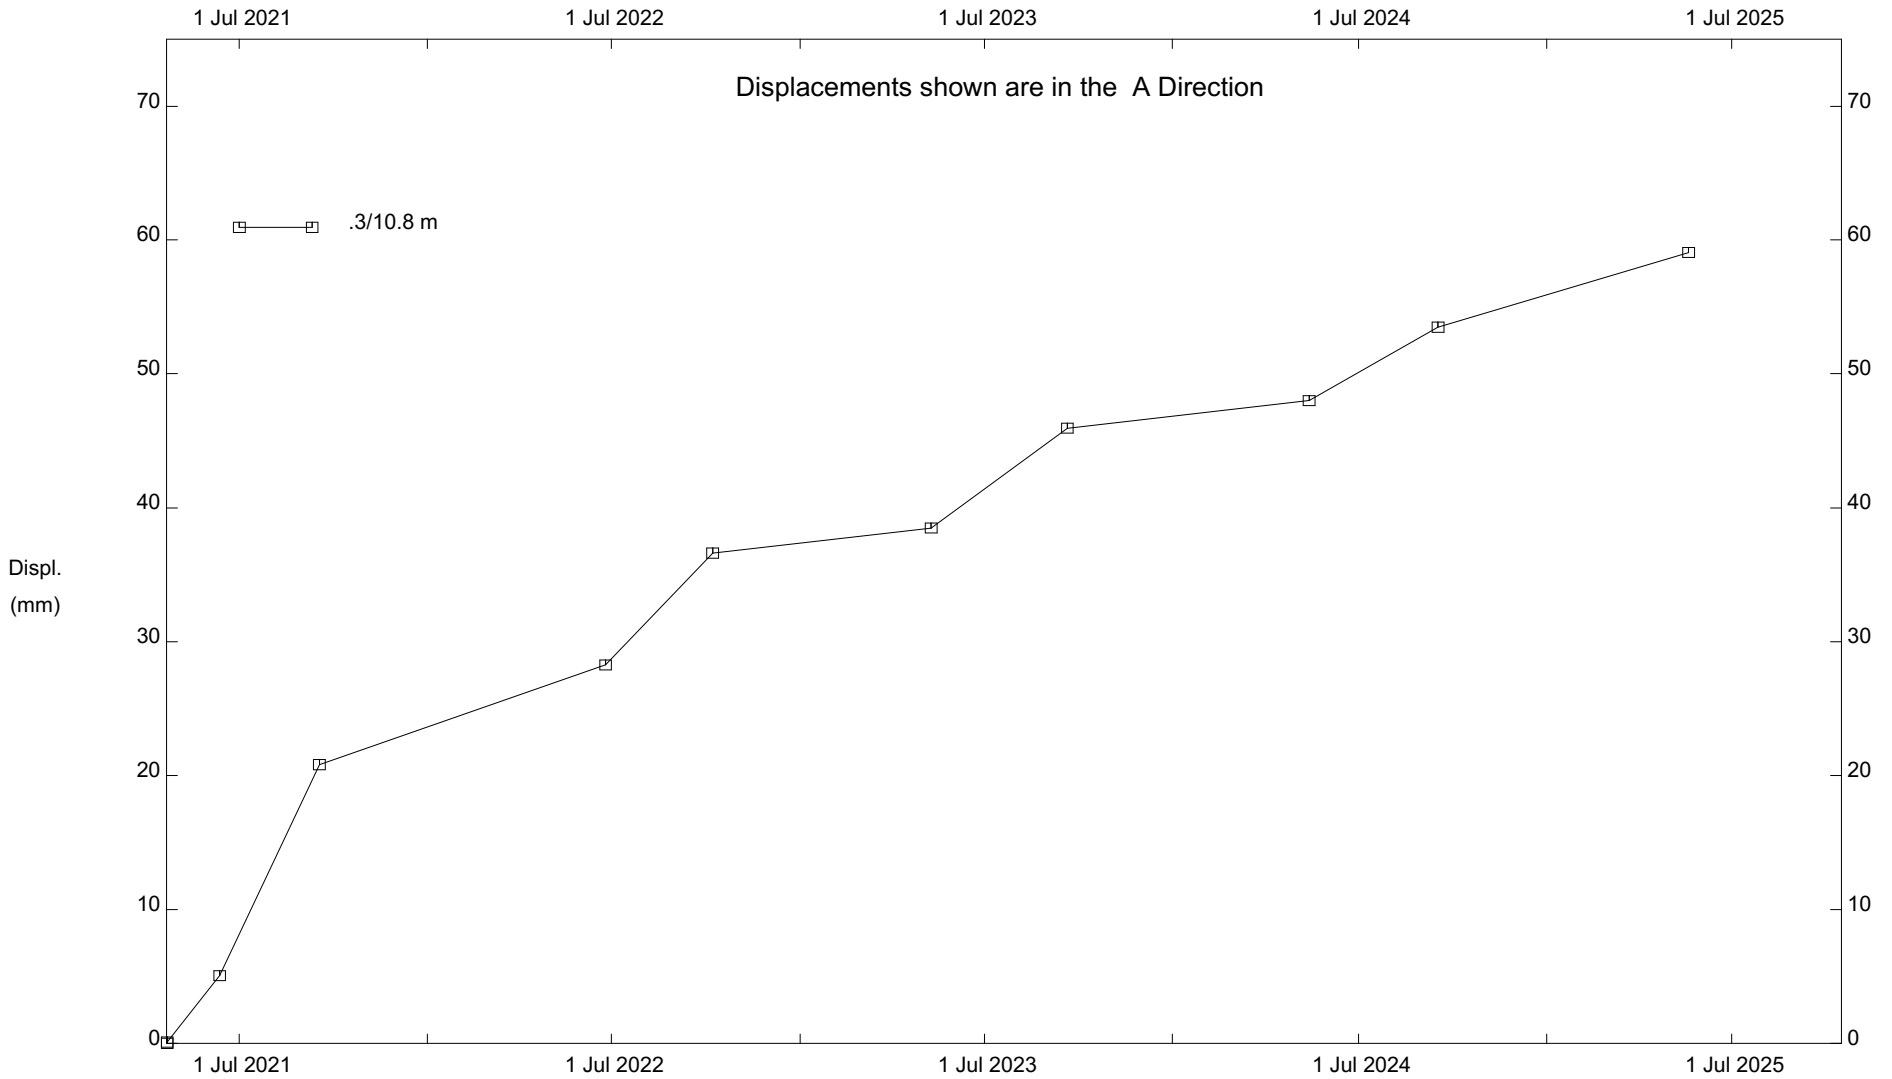
C048; H575:04; Slide W of Carbon Creek, Inclinator SI21-C48-03

The movement recorded in SI21-C48-01 and -03 appears to fluctuate seasonally (decreases and increases recorded in the spring and fall, respectively). The rate of movement recorded in SI21-C48-01 and -03 fluctuates between approximately 6 mm/year and 26 mm/year and approximately 3 mm/year and 29 mm/year, respectively. The overall rate of movement for both instruments is generally less than approximately 10 mm/year.
