SITE NUMBER AND NAME: C042 Water Valley Slide		HIGHWAY & KM: 579:02, 36.540	PREVIOUS INSPECTION DATE: June 11, 2018	INSPECTION DATE: July 10, 2019
LEGAL DESCRIPTION: 06/07-29-029-05 W5M	NAD 83 COORDINATES: UTM Northing Easting 11 5709031 661849		RISK ASSESSMENT: PF: 8 CF: 4 TOTAL: 32	
AVERAGE ANNUAL DAILY TRAFFIC (AADT): 1250 (west) and 240 (east) (Ref No. 997242 & 70000145)			CONTRACT MAINTENANCE AREA (CMA): 28

PROJECT CENTRAL REGION GEOHAZARD RISK MANAGEMENT PROGRAM		
TITLE Site Plan C042 - West of Water Valley Slide H579:02, km 36.540		
SCALE 1:2,500	PROJECT No. A05115A02	FIG No. 1

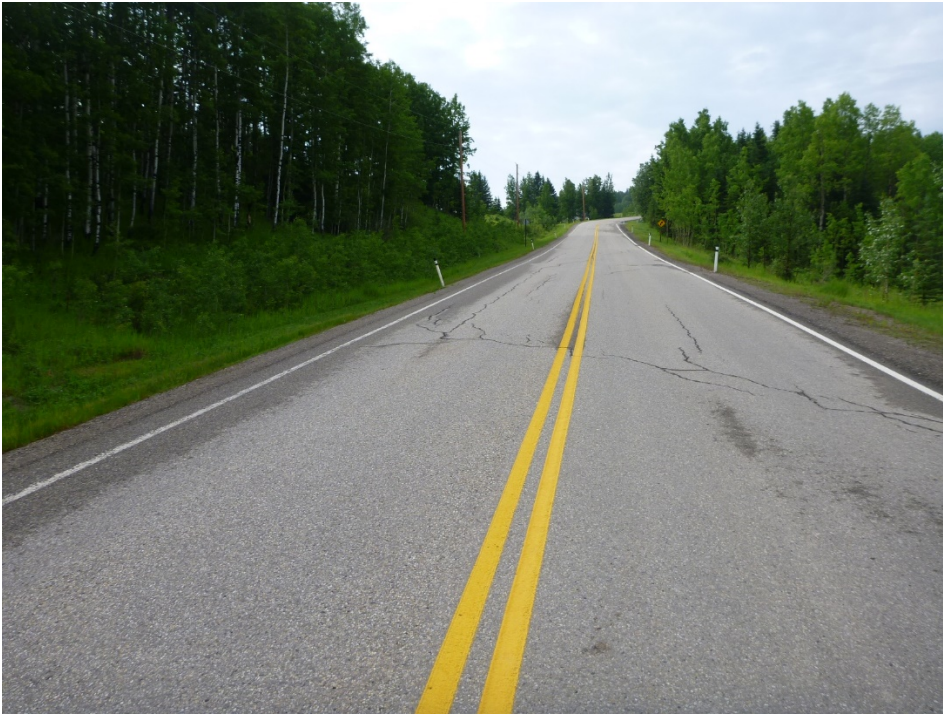
COMMENTS On the south side (eastbound lane) of the highway: <u>Slide area #1</u> <ul style="list-style-type: none"> A pavement crack approximately 56 m long was observed at the halfway point of the westbound lane during the 2018 inspection. Crack has not expanded since 2018 inspection. The toes of the slides extend to the creek at the toe of the slope. The toes of the slides are being eroded by the creek, creating steep and high erosion slopes that are 4 m to 5 m high. Pavement runoff is discharging onto the slope failure. At this site and all others on the south side of the highway.

Photo 1 **Severity of pavement cracking above slide area #1 appears unchanged from 2018 inspection. Photo taken July 10, 2019 looking southeast.**

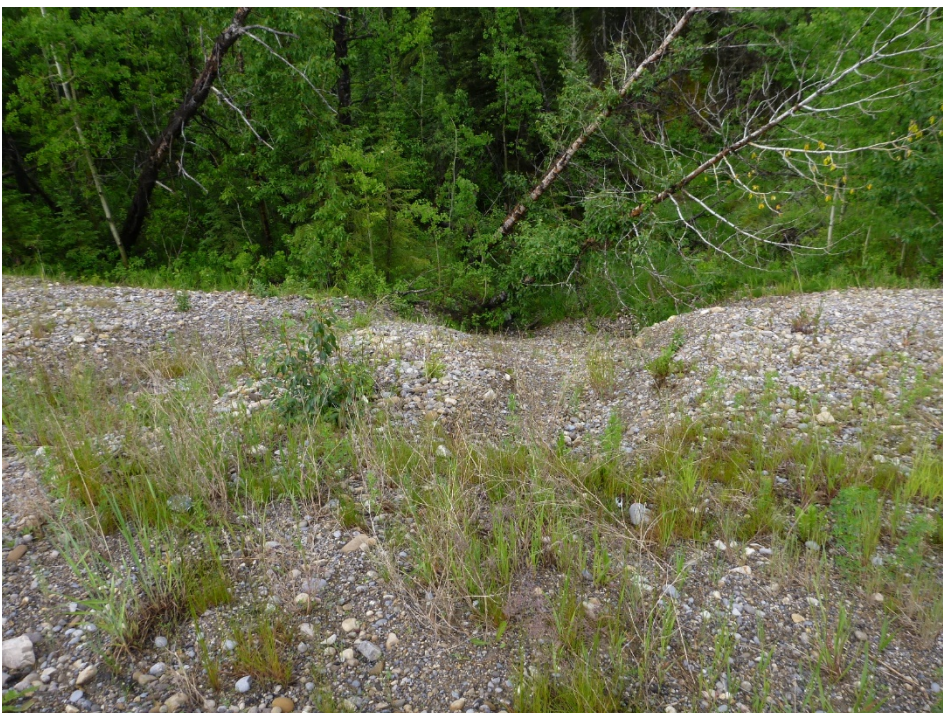
- Seepage observed in erosion gully approximately 8 m below edge of highway in 2018 (waypoint 678). Embankment slope not inspected during 2019 inspection.
- Slide appears to be inactive but could reactivate following heavy rainfall events for a prolonged period of wet weather.

Photo 2 **Erosion gullies continue to form in gravel fill below slide area # 2. Photo taken July 10, 2019 looking southwest.**

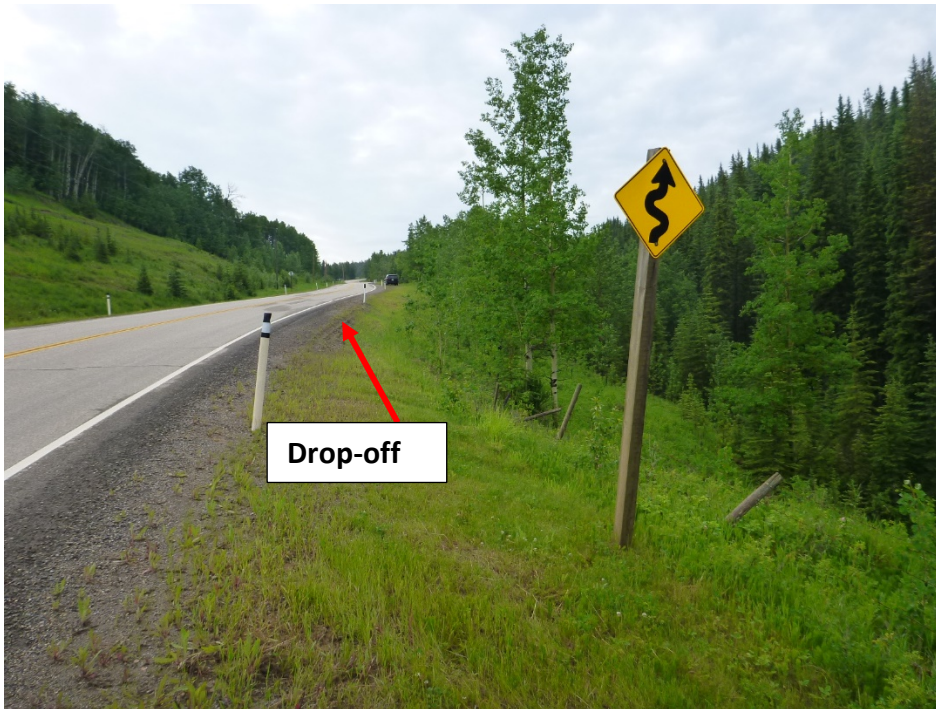
- There is a steep drop off at the edge of pavement (photo 3).
- Upslope of the slide area, an arc-shaped crack extends across the centerline into the westbound lane.

Photo 3 Photo showing steep drop off below edge of pavement in slide area #3. Photo taken July 10, 2019 looking southeast.

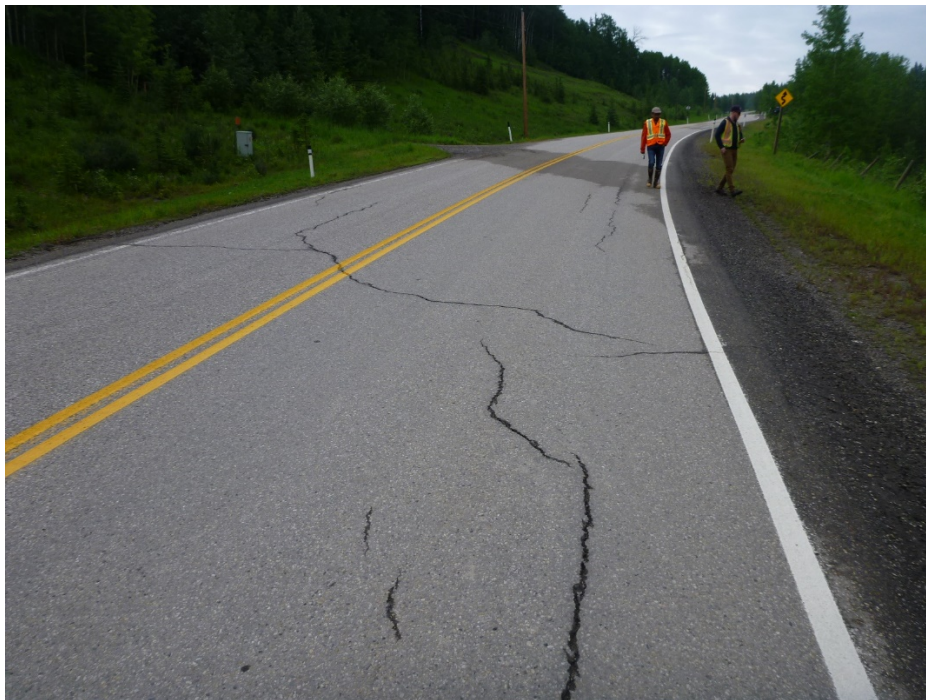
- The slide area appears to have moved somewhat since 2018. Vegetation on the slope obscures the condition of the slope.
- CSP slope drain below "Curve in Road" sign is corroded, sinkhole has formed at the fence line (waypoint 677) indicating that the culvert has either partially collapsed, or has a separated joint
- Erosion gullies continue to form in the gravel at the crest of the embankment, likely due to surface flows and seepage.
- Minimal deterioration of slide since 2018. Valley slopes north and south of the creek are failing.
- The slide area extends past fence line and is within 10 m of the edge of pavement.

Photo 4 Pavement cracking in eastbound lane in slide area #4. Photo taken July 10, 2019 looking southeast.

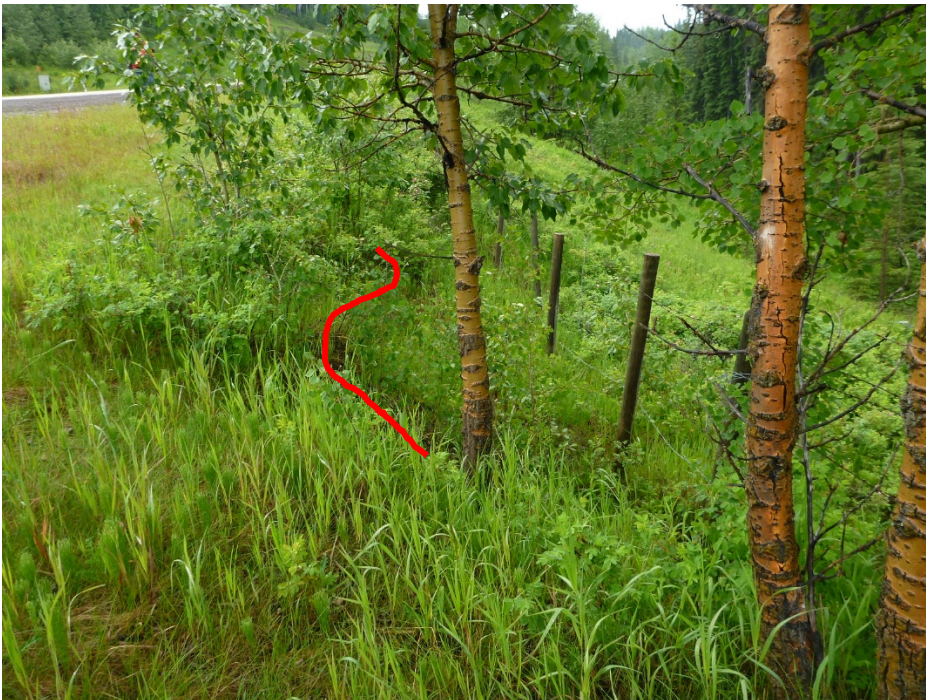
Photo 5 Scarp near fence line in slide area #4 (indicated by red line). Photo taken July 10, 2019 looking southeast.
