SITE NUMBER AND NAME: C042 Water Valley Slide		HIGHWAY & KM: 579:02, 36.540	PREVIOUS INSPECTION DATE: July 10, 2019	INSPECTION DATE: June 23, 2021
LEGAL DESCRIPTION: 06/07-29-029-05 W5M	NAD 83 COORDINATES: UTM Northing Easting 11 5709031 661849		RISK ASSESSMENT: PF: 6 CF: 4 TOTAL: 24	
AVERAGE ANNUAL DAILY TRAFFIC (AADT): 1140 (west) and 240 (east) (Ref No. 997242 & 70000145)			CONTRACT MAINTENANCE AREA (CMA): 514

PROJECT: CENTRAL REGION GEOHAZARD RISK MANAGEMENT PROGRAM

TITLE: Site Plan
C042 - West of Water Valley Slide
H579:02, km 36.540

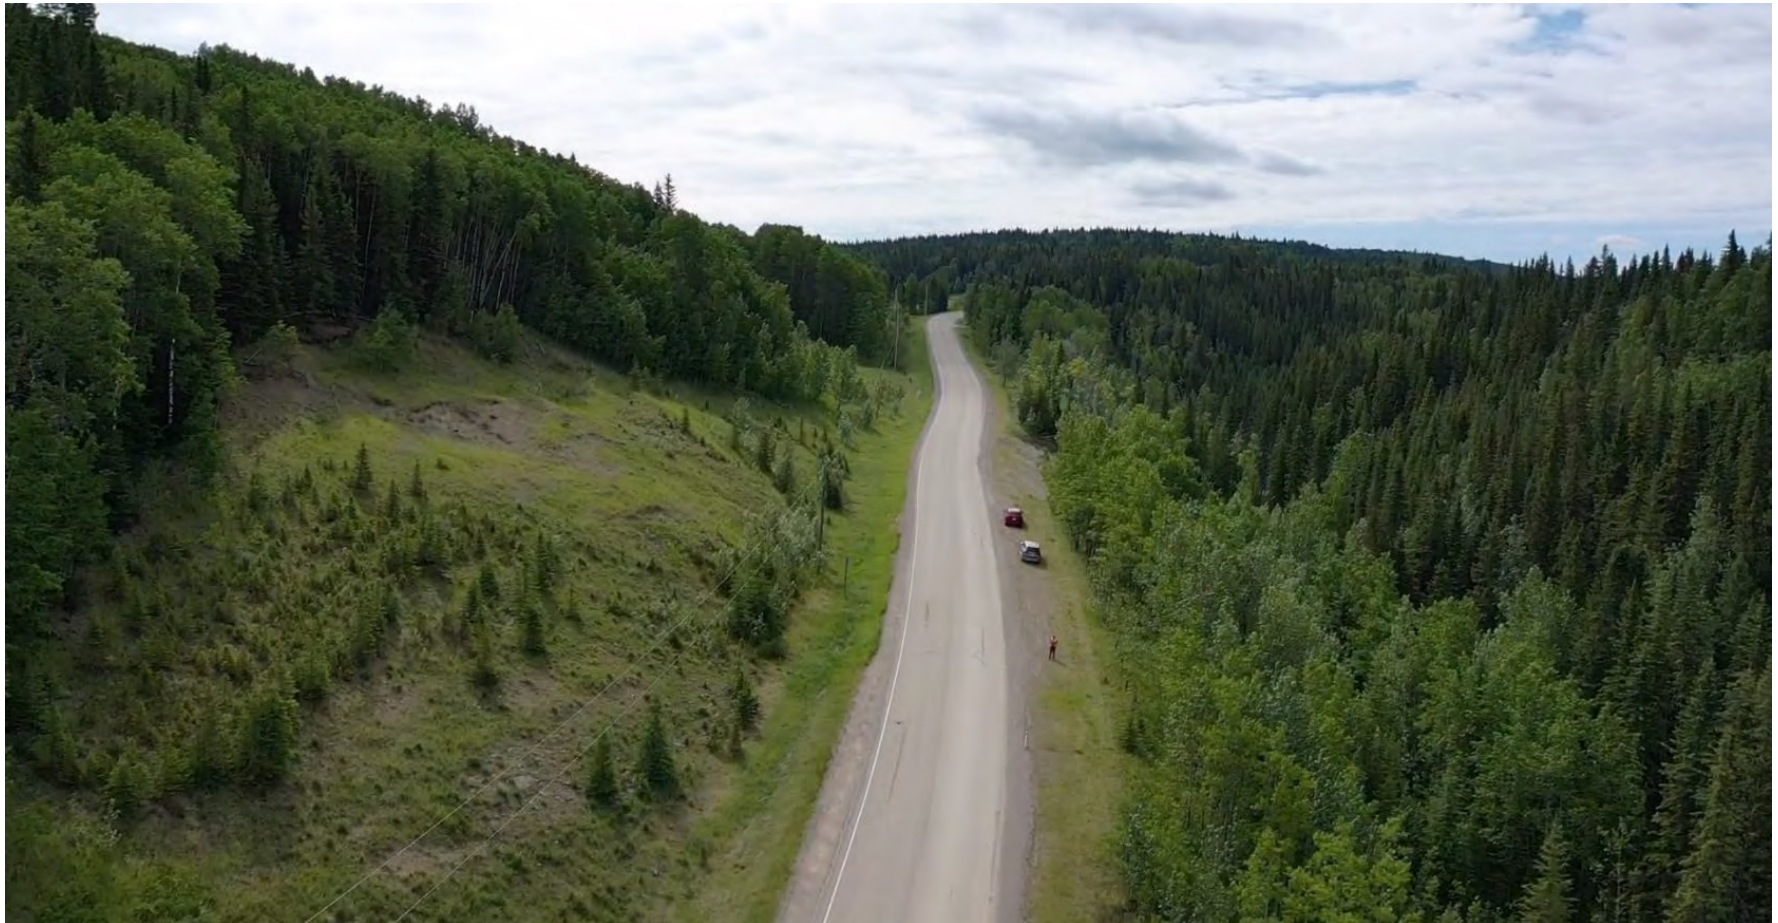
Photo 1 **Oblique air photo of the C042 site, showing Slide No. 1, 2, and 3 locations (refer to figure for extents). Slide No. 4 is located west, past the bottom of photo. Photo taken June 23, 2021 facing east.**

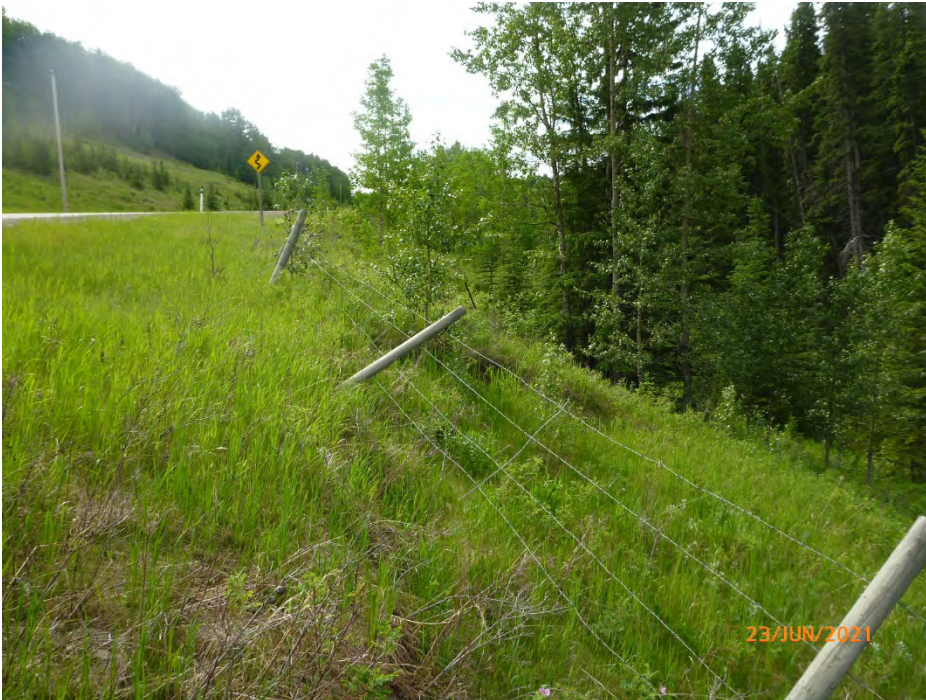
- The slide area extends past the fence line and is within 10 m of the edge of pavement. The fence has tipped over since the 2019 inspection.
- The backscarp is approximately 0.7 m high, and the roadway appears unaffected by the slide.

Photo 2 Fence downslope of Slide Area No. 4 has tipped over (roadway remains unaffected). Photo taken June 23, 2021 facing east.

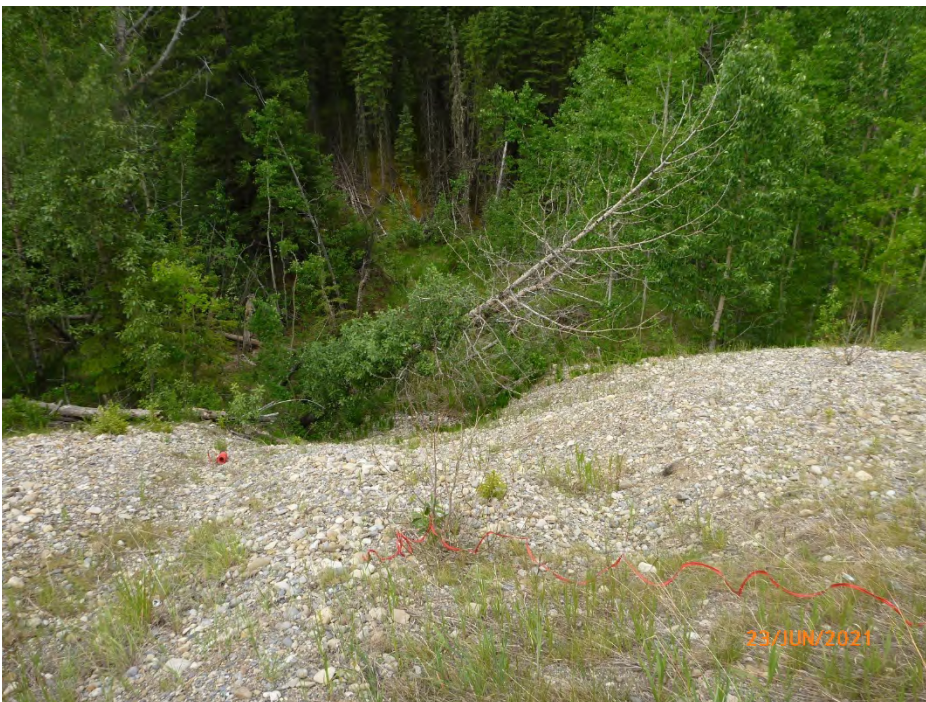
- There is a steep drop off at the edge of pavement (Photo 3).
- Upslope of the slide area, an arc-shaped crack extends across the centerline into the westbound lane.

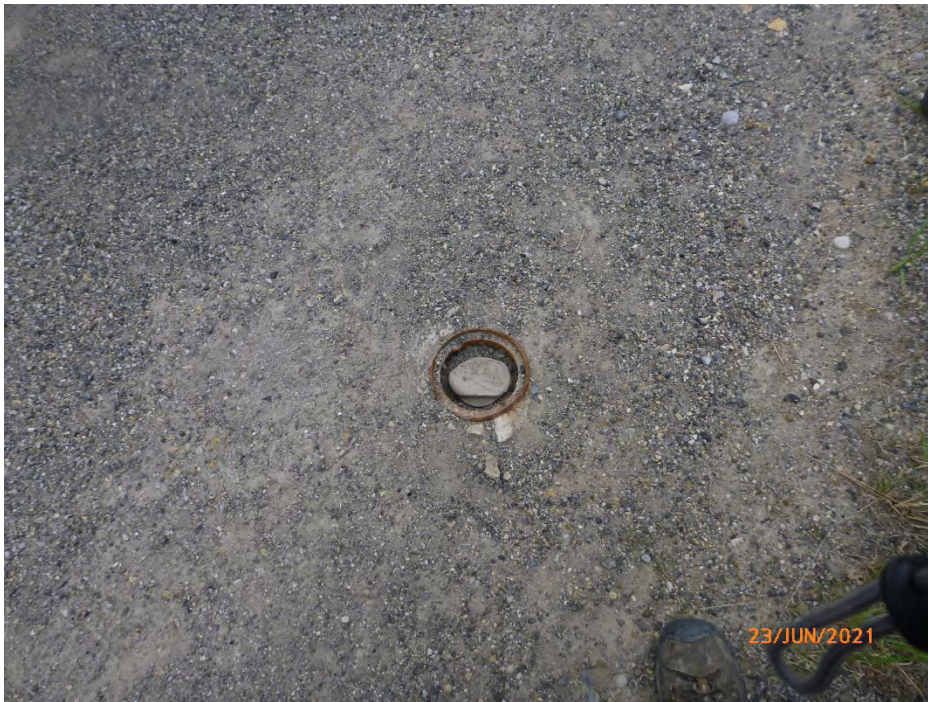
- Seepage observed in erosion gully approximately 8 m below edge of highway has not changed since the 2019 inspection.
- Slide appears to be inactive but could reactivate following heavy rainfall events for a prolonged period of wet weather.
- The flush-mounted headbox (installed in the gravel shoulder) was covered with a rock because it was missing the headbox cap. The headbox should be replaced during the next set of instrumentation readings.

Photo 4 Flush-mounted headbox is missing its cap and require replacement. Photo taken June 23, 2021.

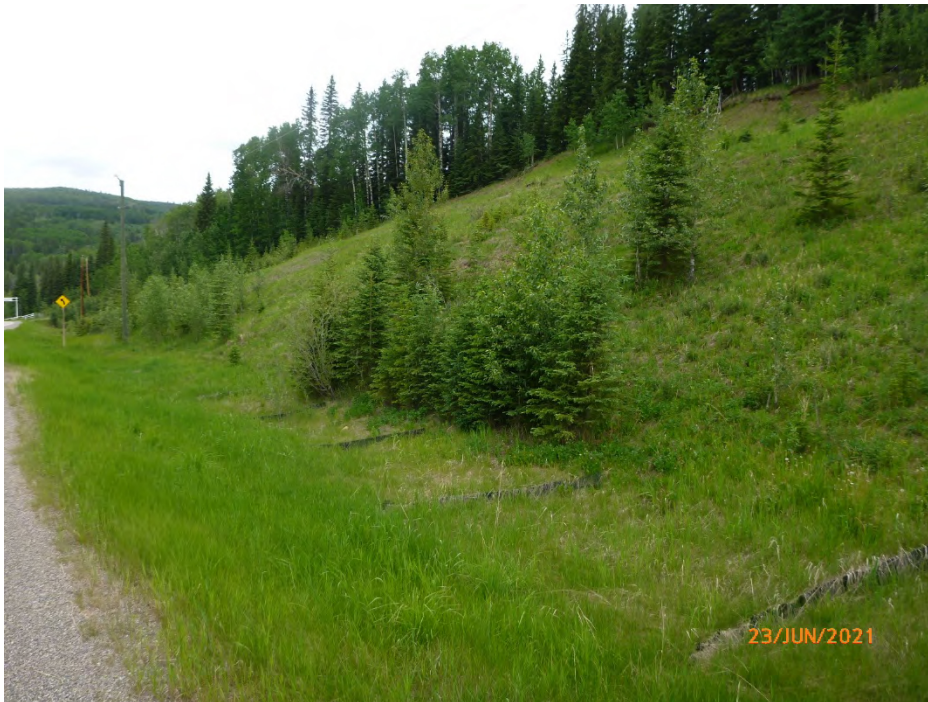
Photo 6 **Vegetation on slope and north (westbound) ditch bottom. Photo taken June 23, 2021 facing northwest.**
