September 12, 2022

Alberta Transportation
4th Floor, Provincial Building
4920 51 Street
Red Deer, Alberta
T4N 6K8

CON0022160 Central Region GRMP Instrumentation Monitoring
Site C042; H579:02 km 36.540 West of Water Valley Slide
Section C – 2022 Spring Readings

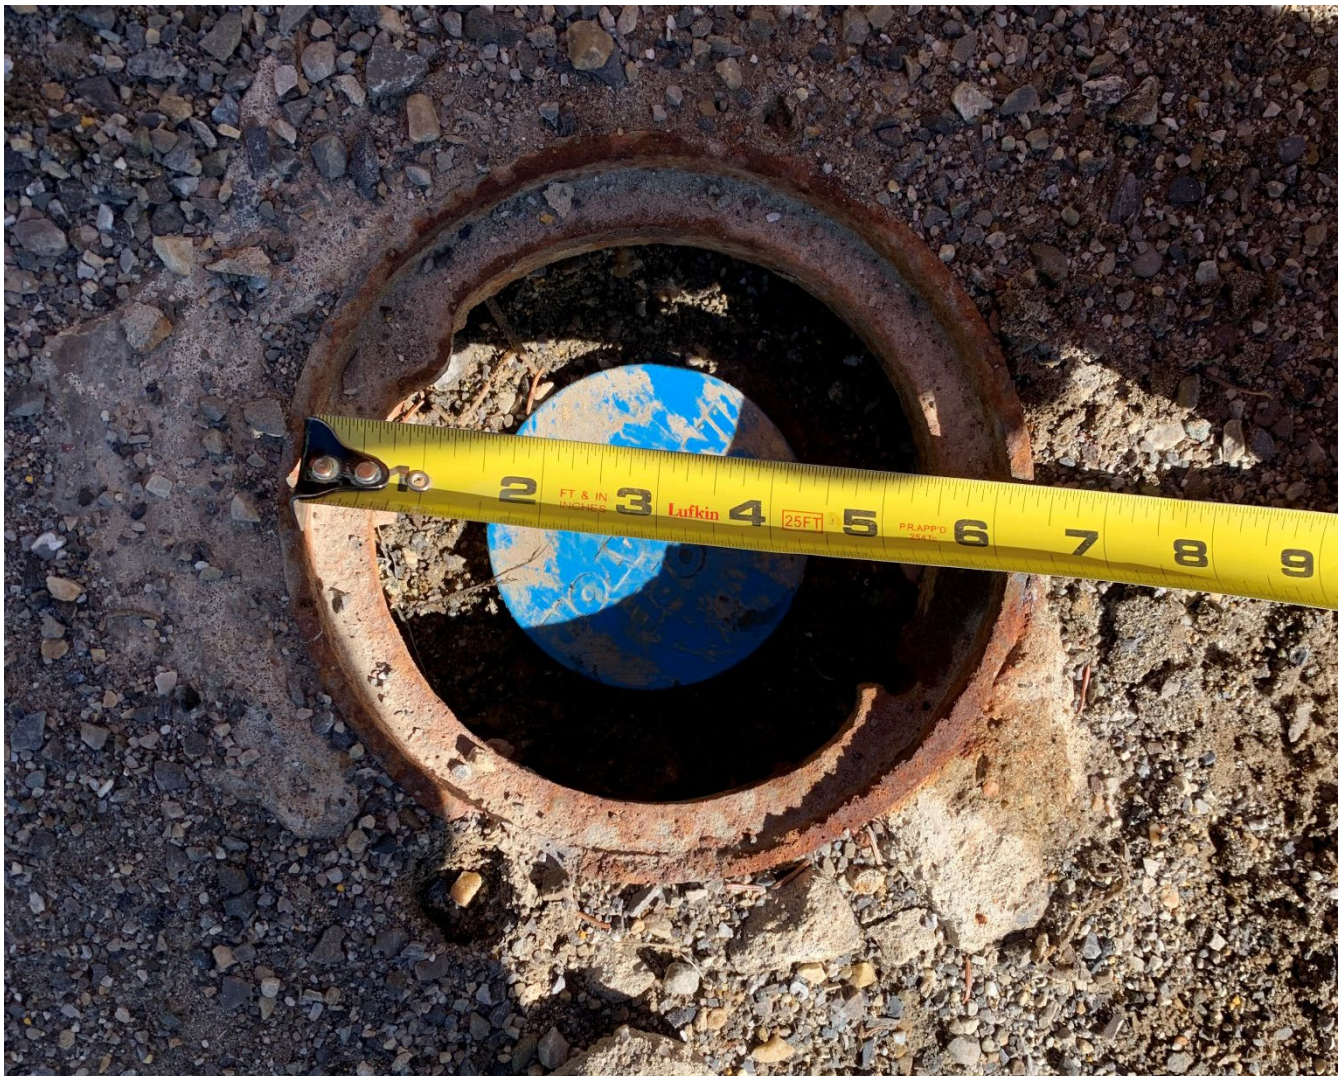
The flush-mounted casing protectors installed in the south shoulder of Hwy 579:02 to protect SI05-07 is missing a cover (Photo 1). KCB attempted to attach a new cover during the spring of 2022 reading; however, it could not be attached to the existing flush-mounted casing protector. The old flush-mounted casing protector should be removed and a new one installed during the next reading cycle.

Photo 1 Flush-mounted casing protector installed in the south shoulder of Hwy 579:02 to protect the SI05-07. Photo taken June 15, 2021.

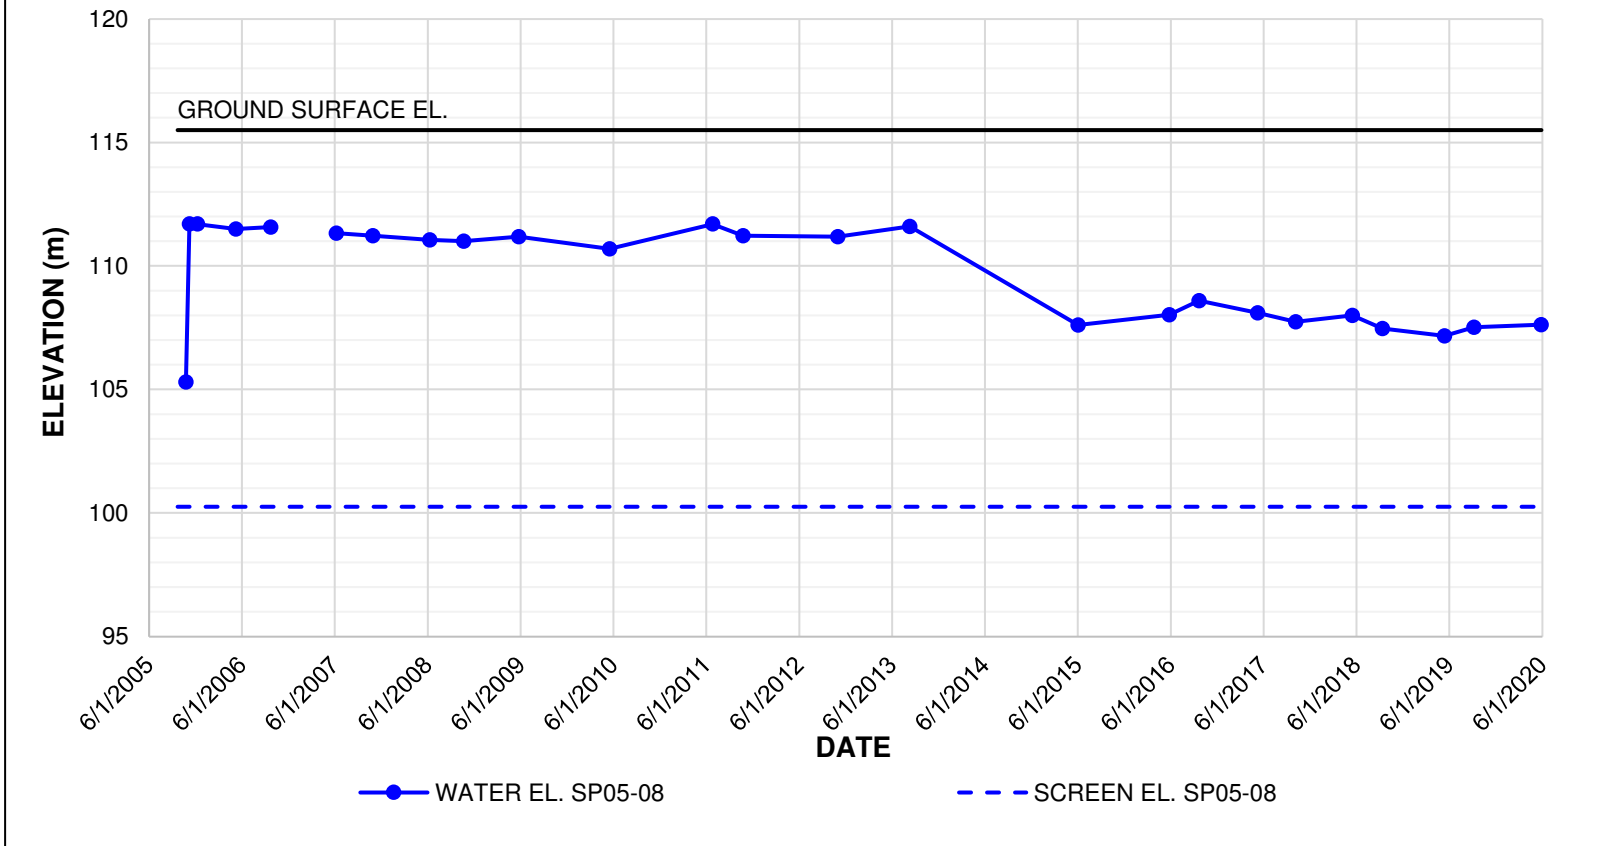
CENTRAL REGION GEOHAZARD RISK MANAGEMENT PROGRAM	
		TITLE Piezometer Data C042 - West of Water Valley Slide Hwy 579:02, km 36.540	
SCALE	PROJECT No.	A05116A02	FIG No.
			I

Upon review of the data obtained from the data logger between May 2020 and January 2022, there appears to be a relatively strong relationship between precipitation and water level response recorded in SP05-08 (i.e., water level increases in response to increased rainfall in September and October 2021). There are multiple precipitation events where there is no response recorded in SP05-08. However, these events were during winter months where the ground is frozen and there was no infiltration. The increase in April 2021 was most likely in response to snow melt (i.e., freshet).

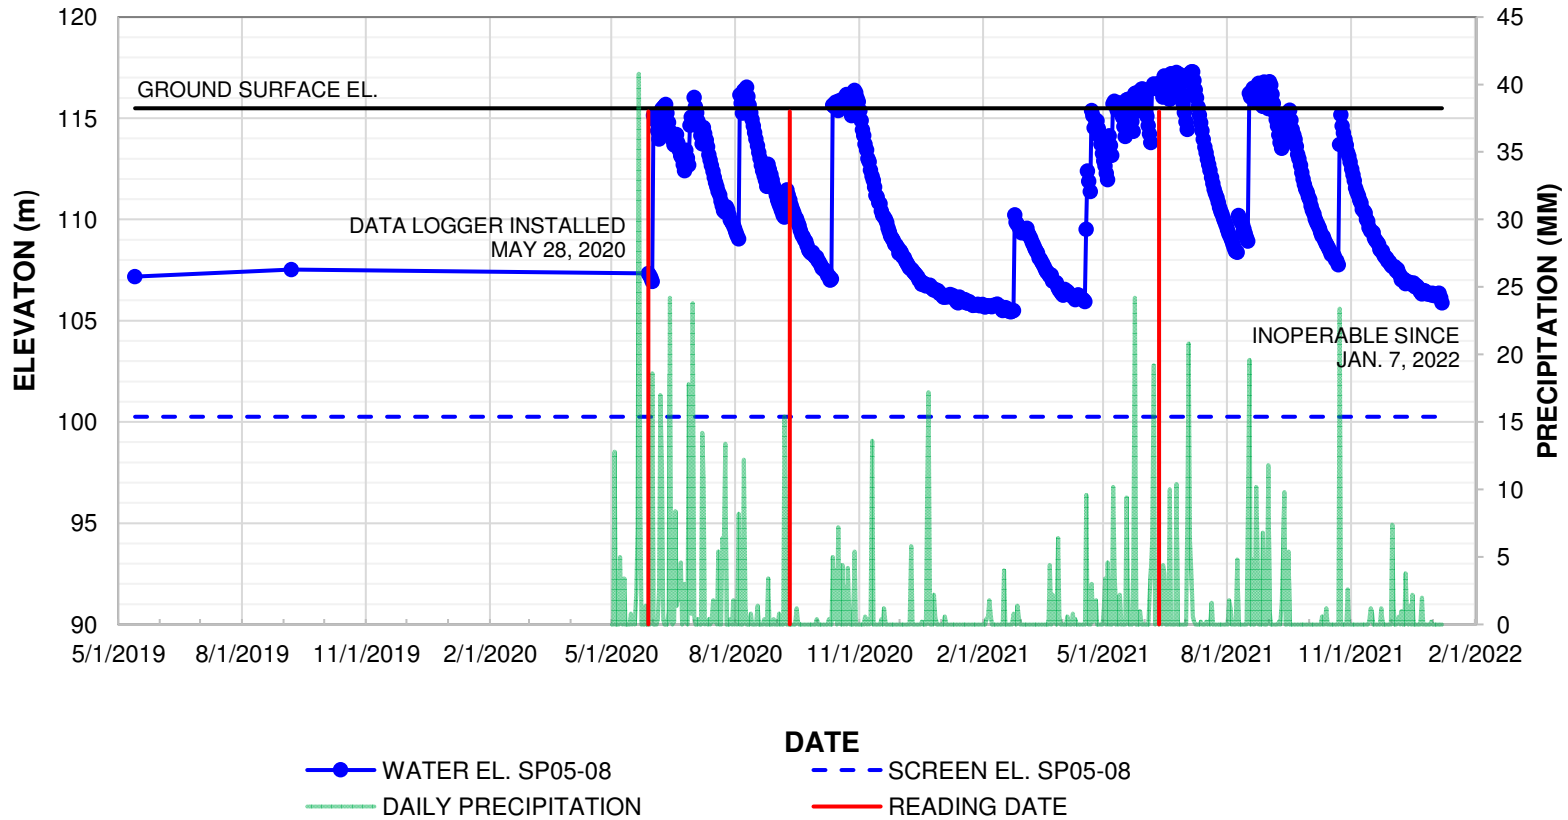
CENTRAL REGION GEOHAZARD RISK MANAGEMENT PROGRAM	
		TITLE Piezometer Data C042 - West of Water Valley Slide Hwy 579:02, km 36.540	
SCALE	PROJECT No.	A05116A02	FIG No. II

The water level fluctuations may be due to condensation in the venting of the instrument cap and modification to the vent cap will be considered to see if we get a more muted response in water level.

The replacement Heron data logger should be reinstalled, and troubleshooting of the data logger will be completed to confirm if increases in water level are real or a function of condensation in the venting of the instrument cap.

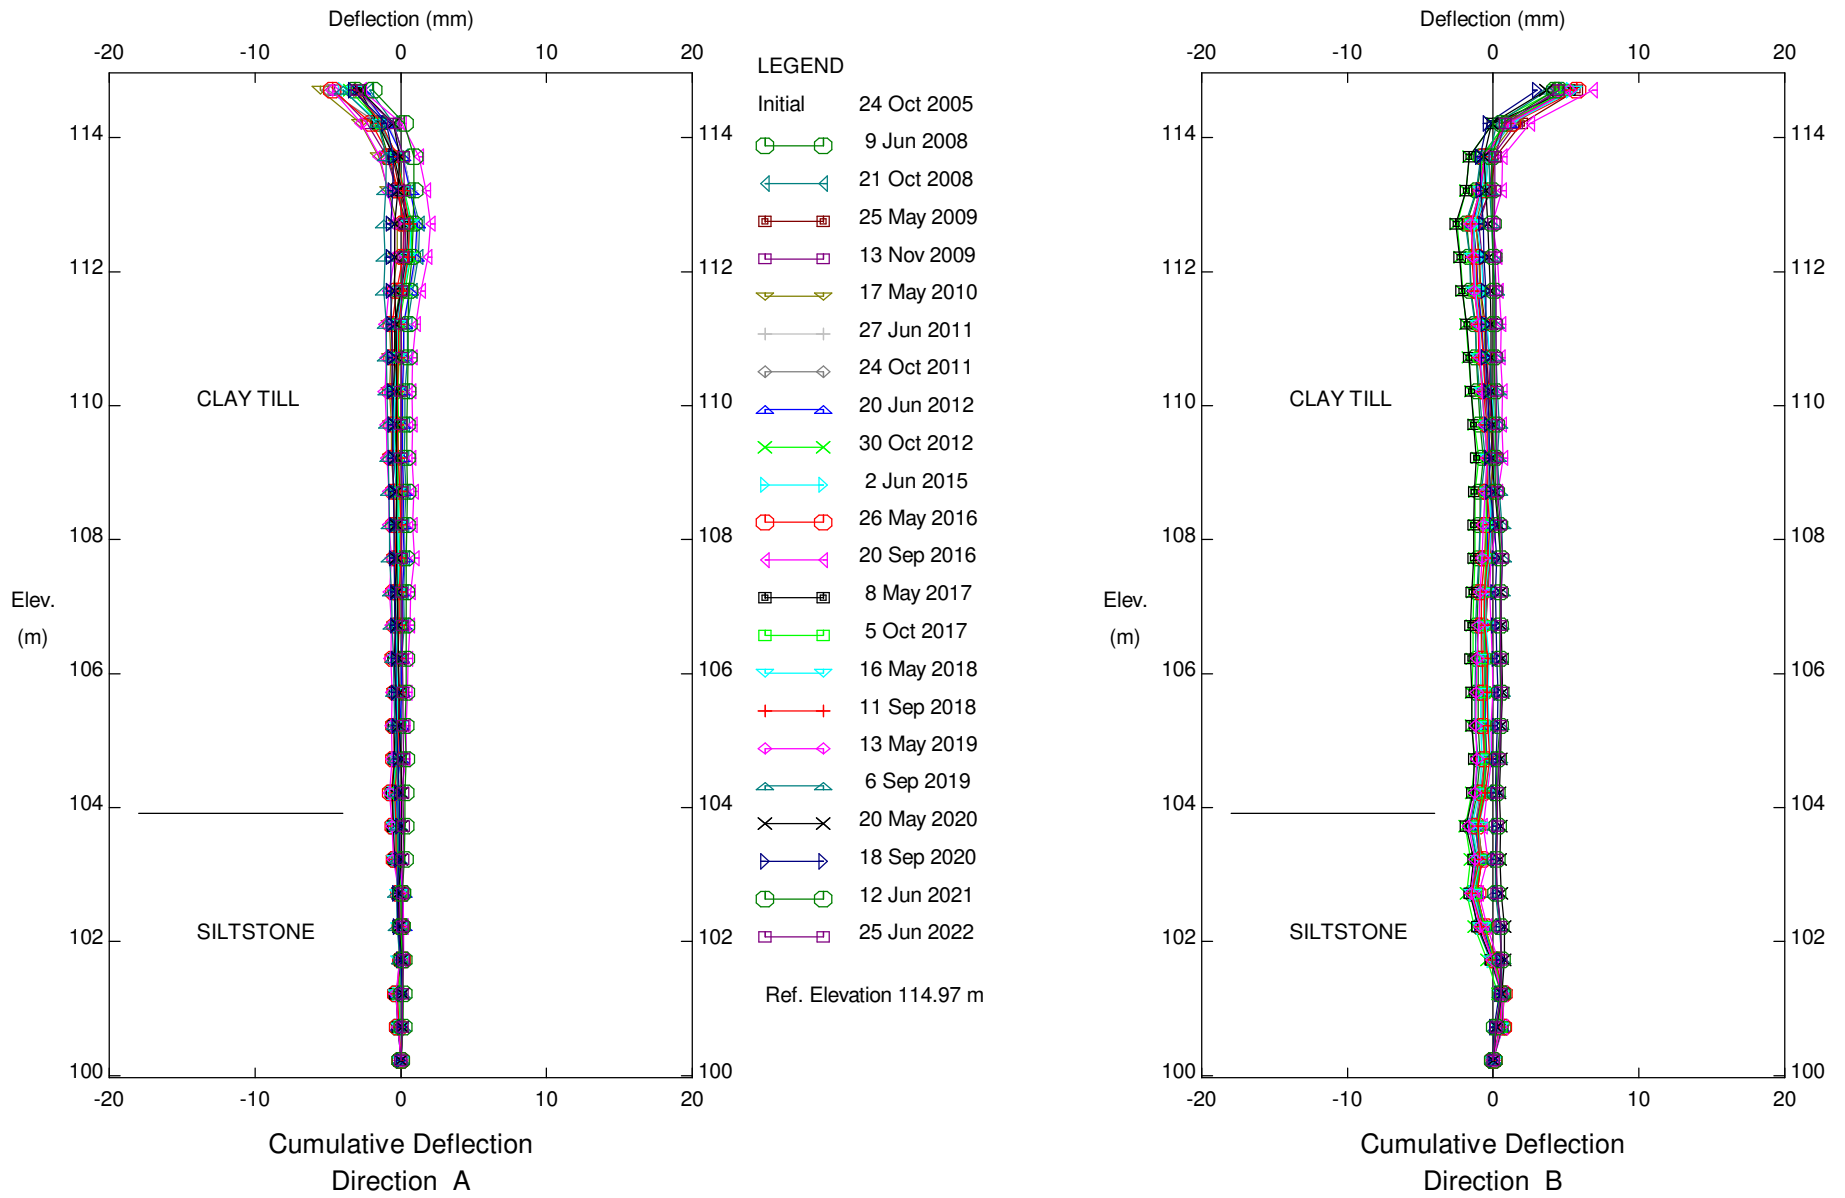
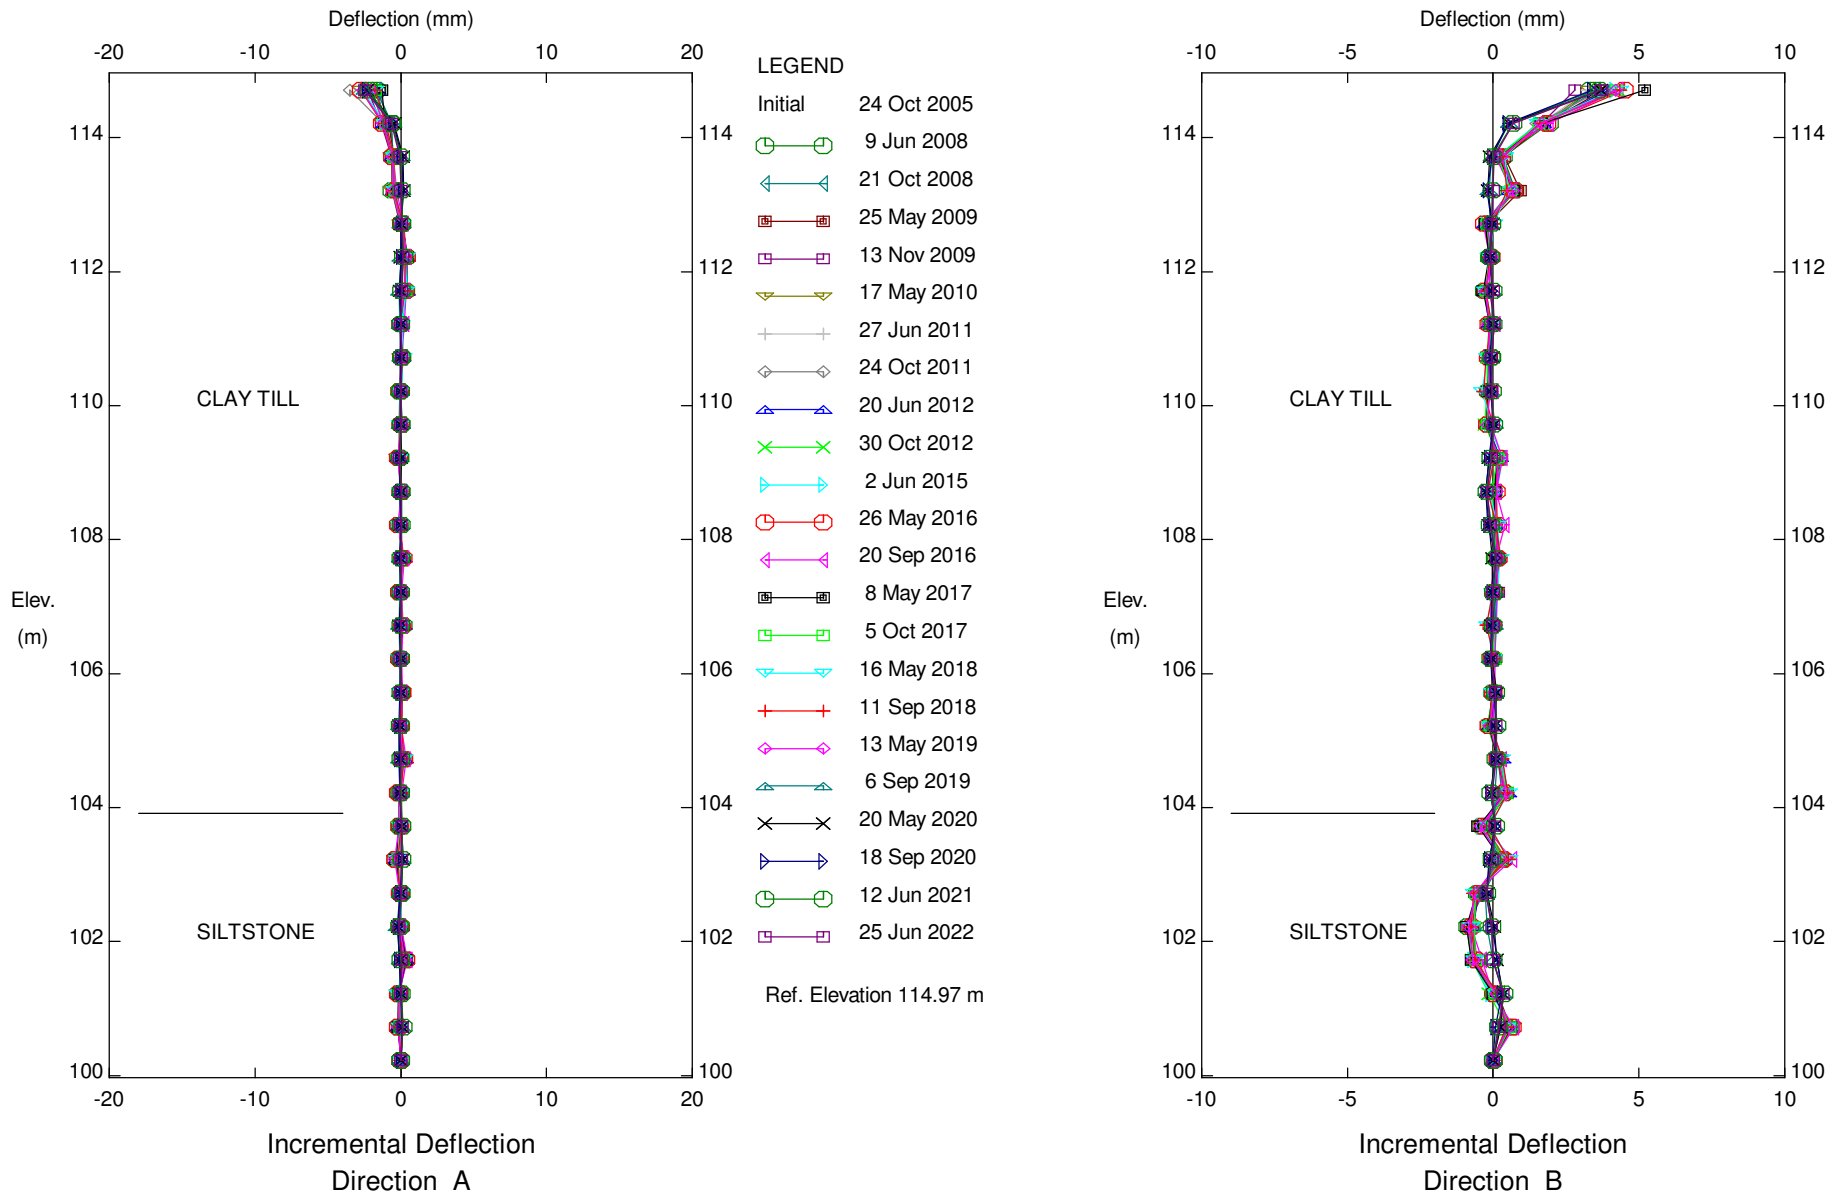
C042; H579:02, West of Water Valley Slide, Inclinometer SI05-05
 Alberta Transportation

No discernible movement has been recorded in SI05-05 since installation.

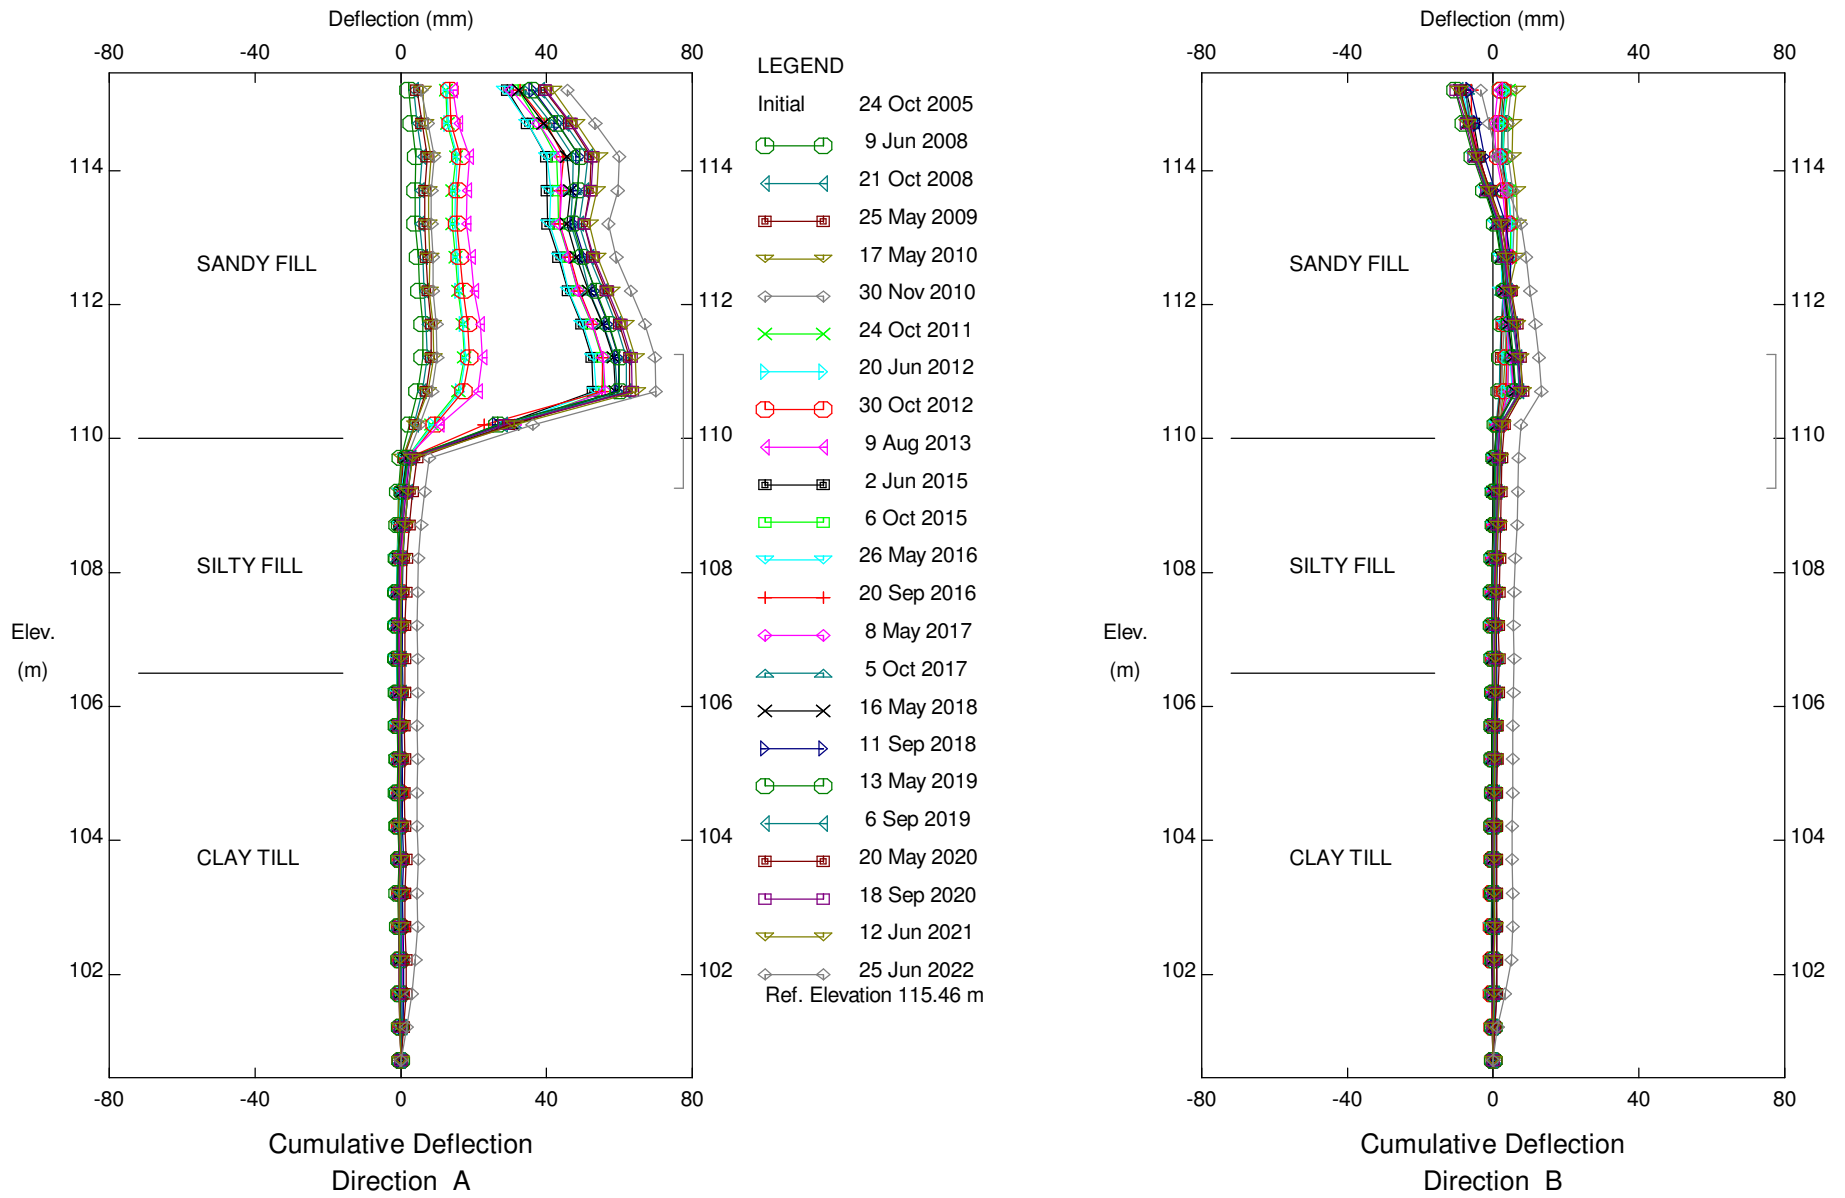
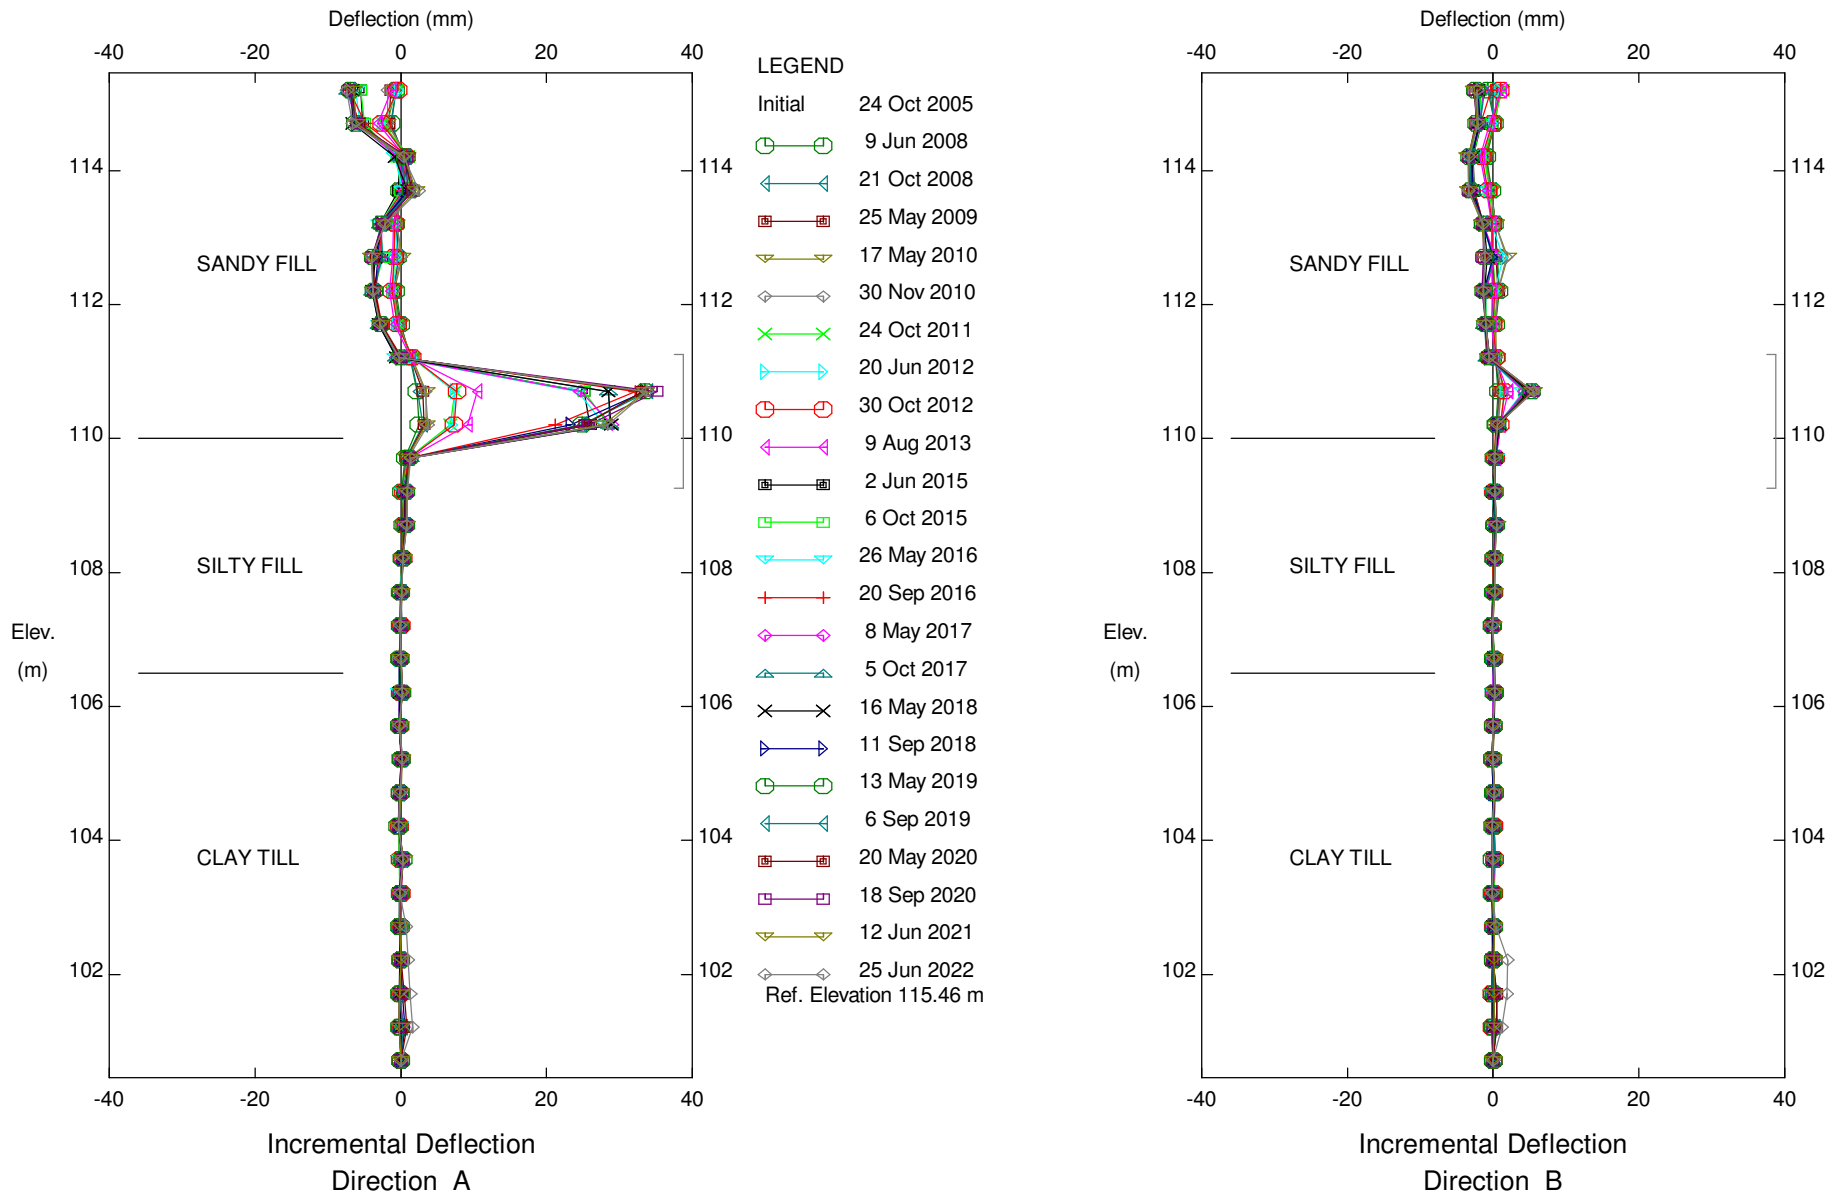
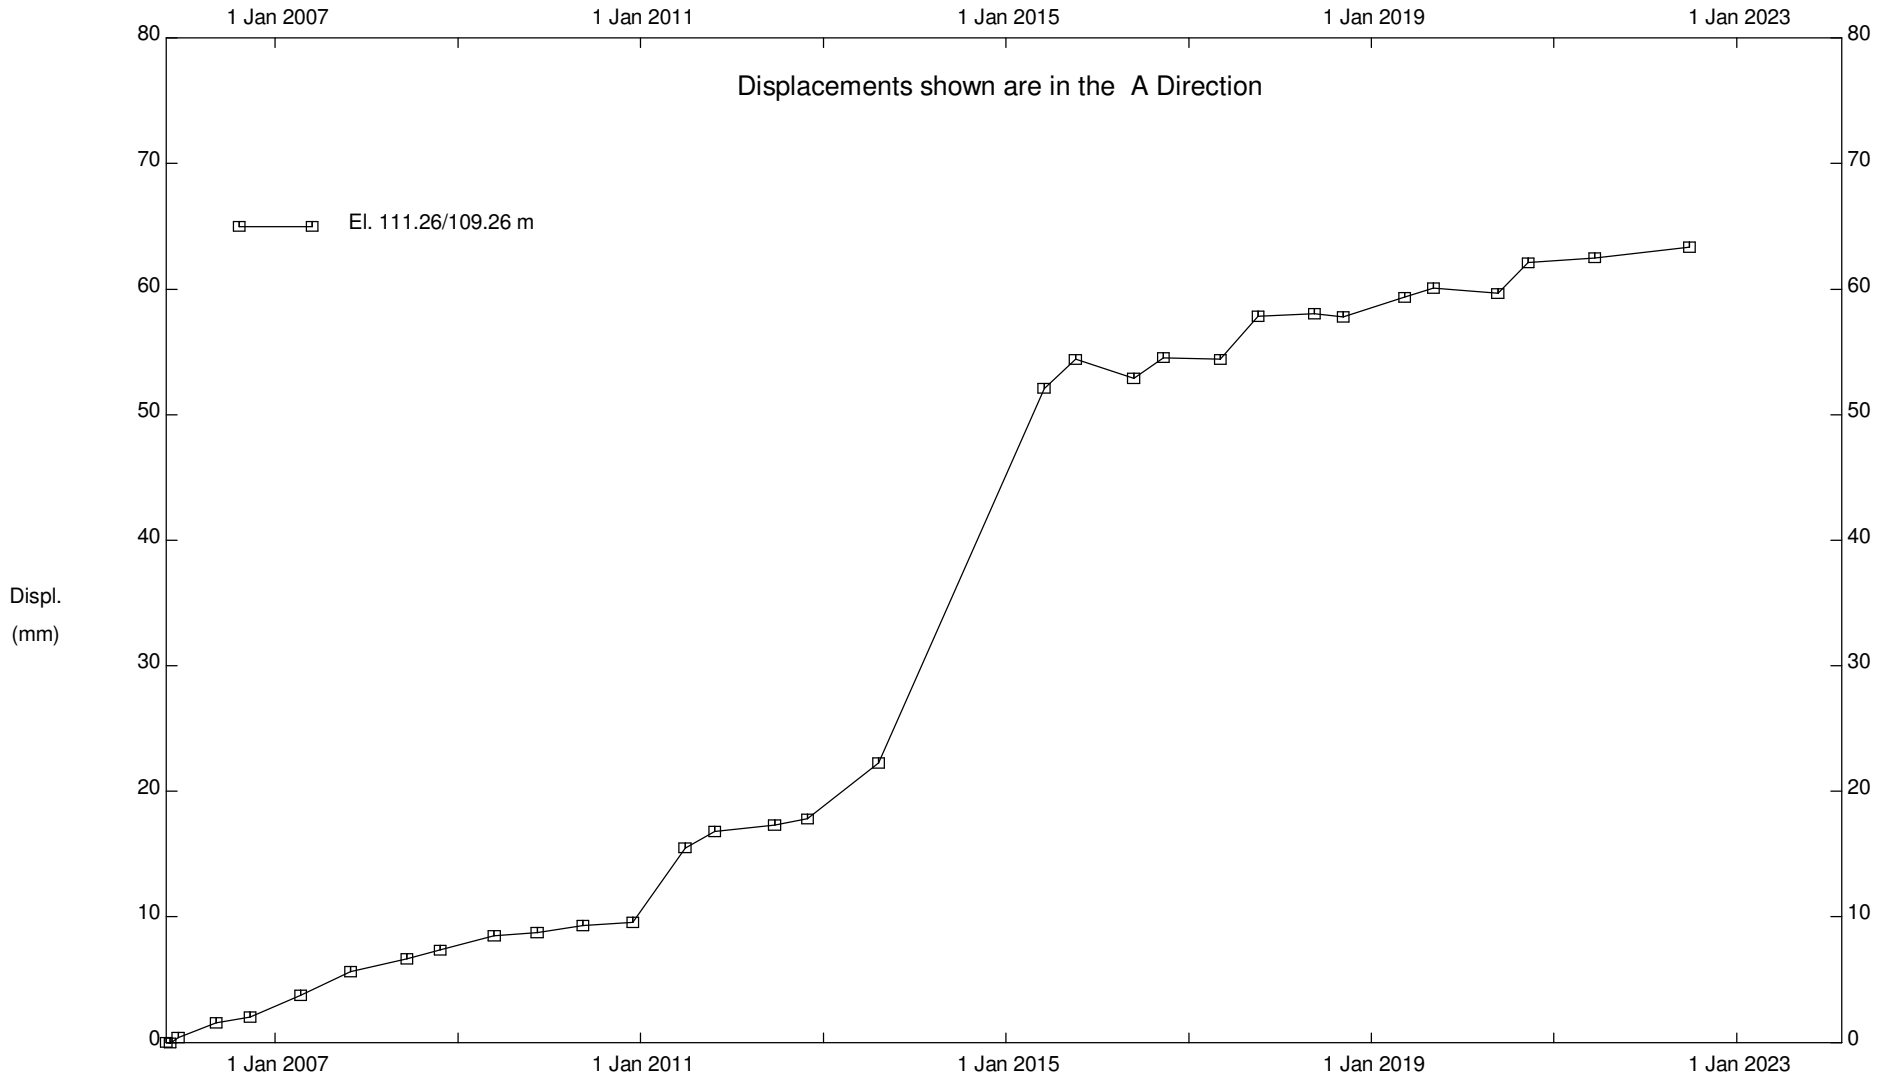
C042; H579:02, West of Water Valley Slide, Inclinometer SI05-07

Discrete movement is being recorded in SI05-07 at an approximate depth of 5.3 m below ground surface in the highway embankment fill.

Historically, movement was recorded in SI05-07 at a rate of less than 10 mm/year, except between August 2013 and June 2015, when the rate of movement increased to approximately 17.5 mm/year. Since June 2015, the rate of movement being recorded in SI05-07 is generally negligible during the winter months (i.e., between the fall and spring readings) and up to 10 mm/year (overall) during the summer months (i.e., between the spring and fall readings).

It is noted that the rate of movement recorded in the spring of 2021 and 2022 was very slow (less than 1 mm/year). This was likely due to dry weather last year and in the spring of 2022 (see the precipitation data plotted on the piezometer plots). For comparison, the rate of movement in the previous wet year (2020) was approximately 7 mm/year. Increased movement may occur in response to periods of heavy or prolonged rainfall, resulting in higher groundwater conditions.
