SITE NUMBER AND NAME: C069 East of Three Hills		HIGHWAY & KM: 583:02, 35.087	PREVIOUS INSPECTION DATE: July 20, 2016	INSPECTION DATE: June 13, 2017
LEGAL DESCRIPTION: 02-05-032-22 W4M	NAD 83 COORDINATES: UTM Northing Easting 12 5730540 355849		RISK ASSESSMENT: PF: 1 CF: 2 TOTAL: 2	
AVERAGE ANNUAL DAILY TRAFFIC (AADT): 200 (west) & 520 (east) (Ref No. 105260 & 103270)			CONTRACT MAINTENANCE AREA (CMA): 20

NOTES: 1. HORIZONTAL DATUM: NAD83 2. GRID ZONE: UTM Zone 12N 3. IMAGE SOURCE: Bing Maps 2016, Microsoft Corporation. Image dated August 2013 4. Location of instruments is approximate (not surveyed)	CLIENT 	PROJECT CENTRAL REGION GEOHAZARD RISK MANAGEMENT PROGRAM
		TITLE Site Plan C069 - East of Three Hills Hwy 583:02, km 35.087
	SCALE 1:500	PROJECT No. A05115A02
		FIG No. 1

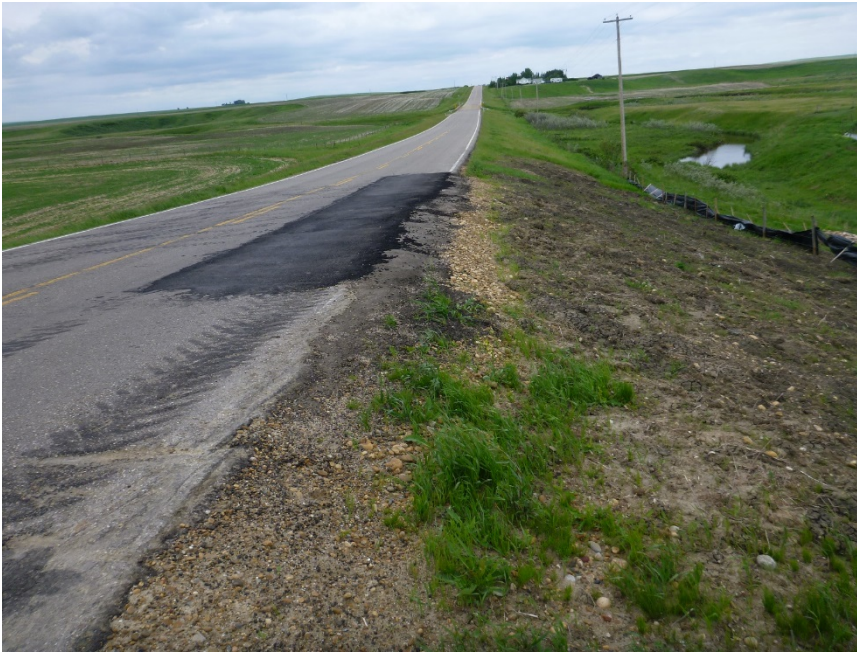
Photo 1 The repaired slope is poorly vegetated and susceptible to erosion. Photo taken June 13, 2017 looking west.

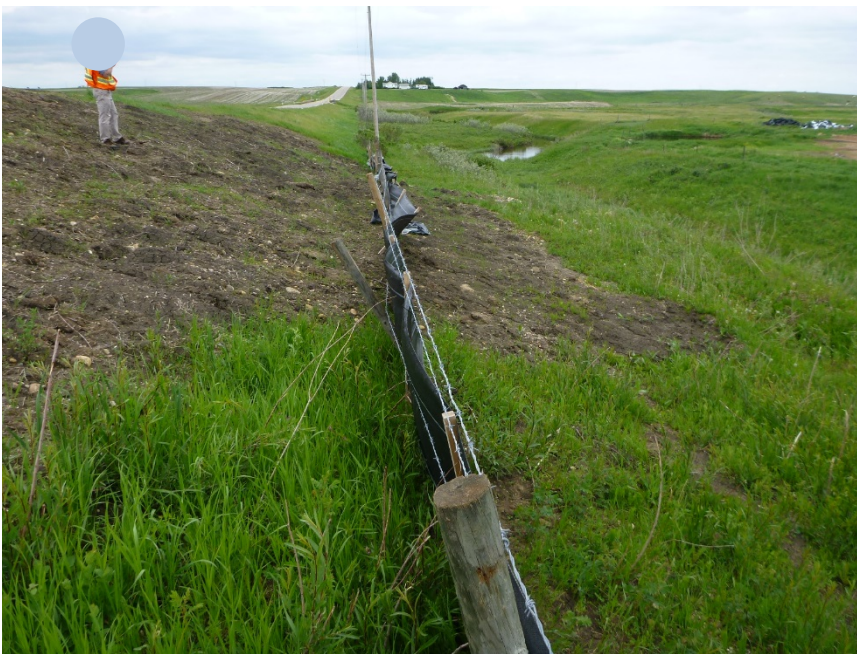
Photo 2 The fence is tilted and the silt fence is damaged. Photo taken June 13, 2017 looking west.
