**CON0017608 Central Region GRMP Instrumentation Monitoring  
Site C069; H583:02, km 35.087 East of Three Hills  
Section C – 2017 Spring Readings  
DRAFT**

PROJECT  
CENTRAL REGION GEOHAZARD RISK MANAGEMENT PROGRAM

TITLE  
Site Plan  
C069 - East of Three Hills  
Hwy 583:02, km 35.087

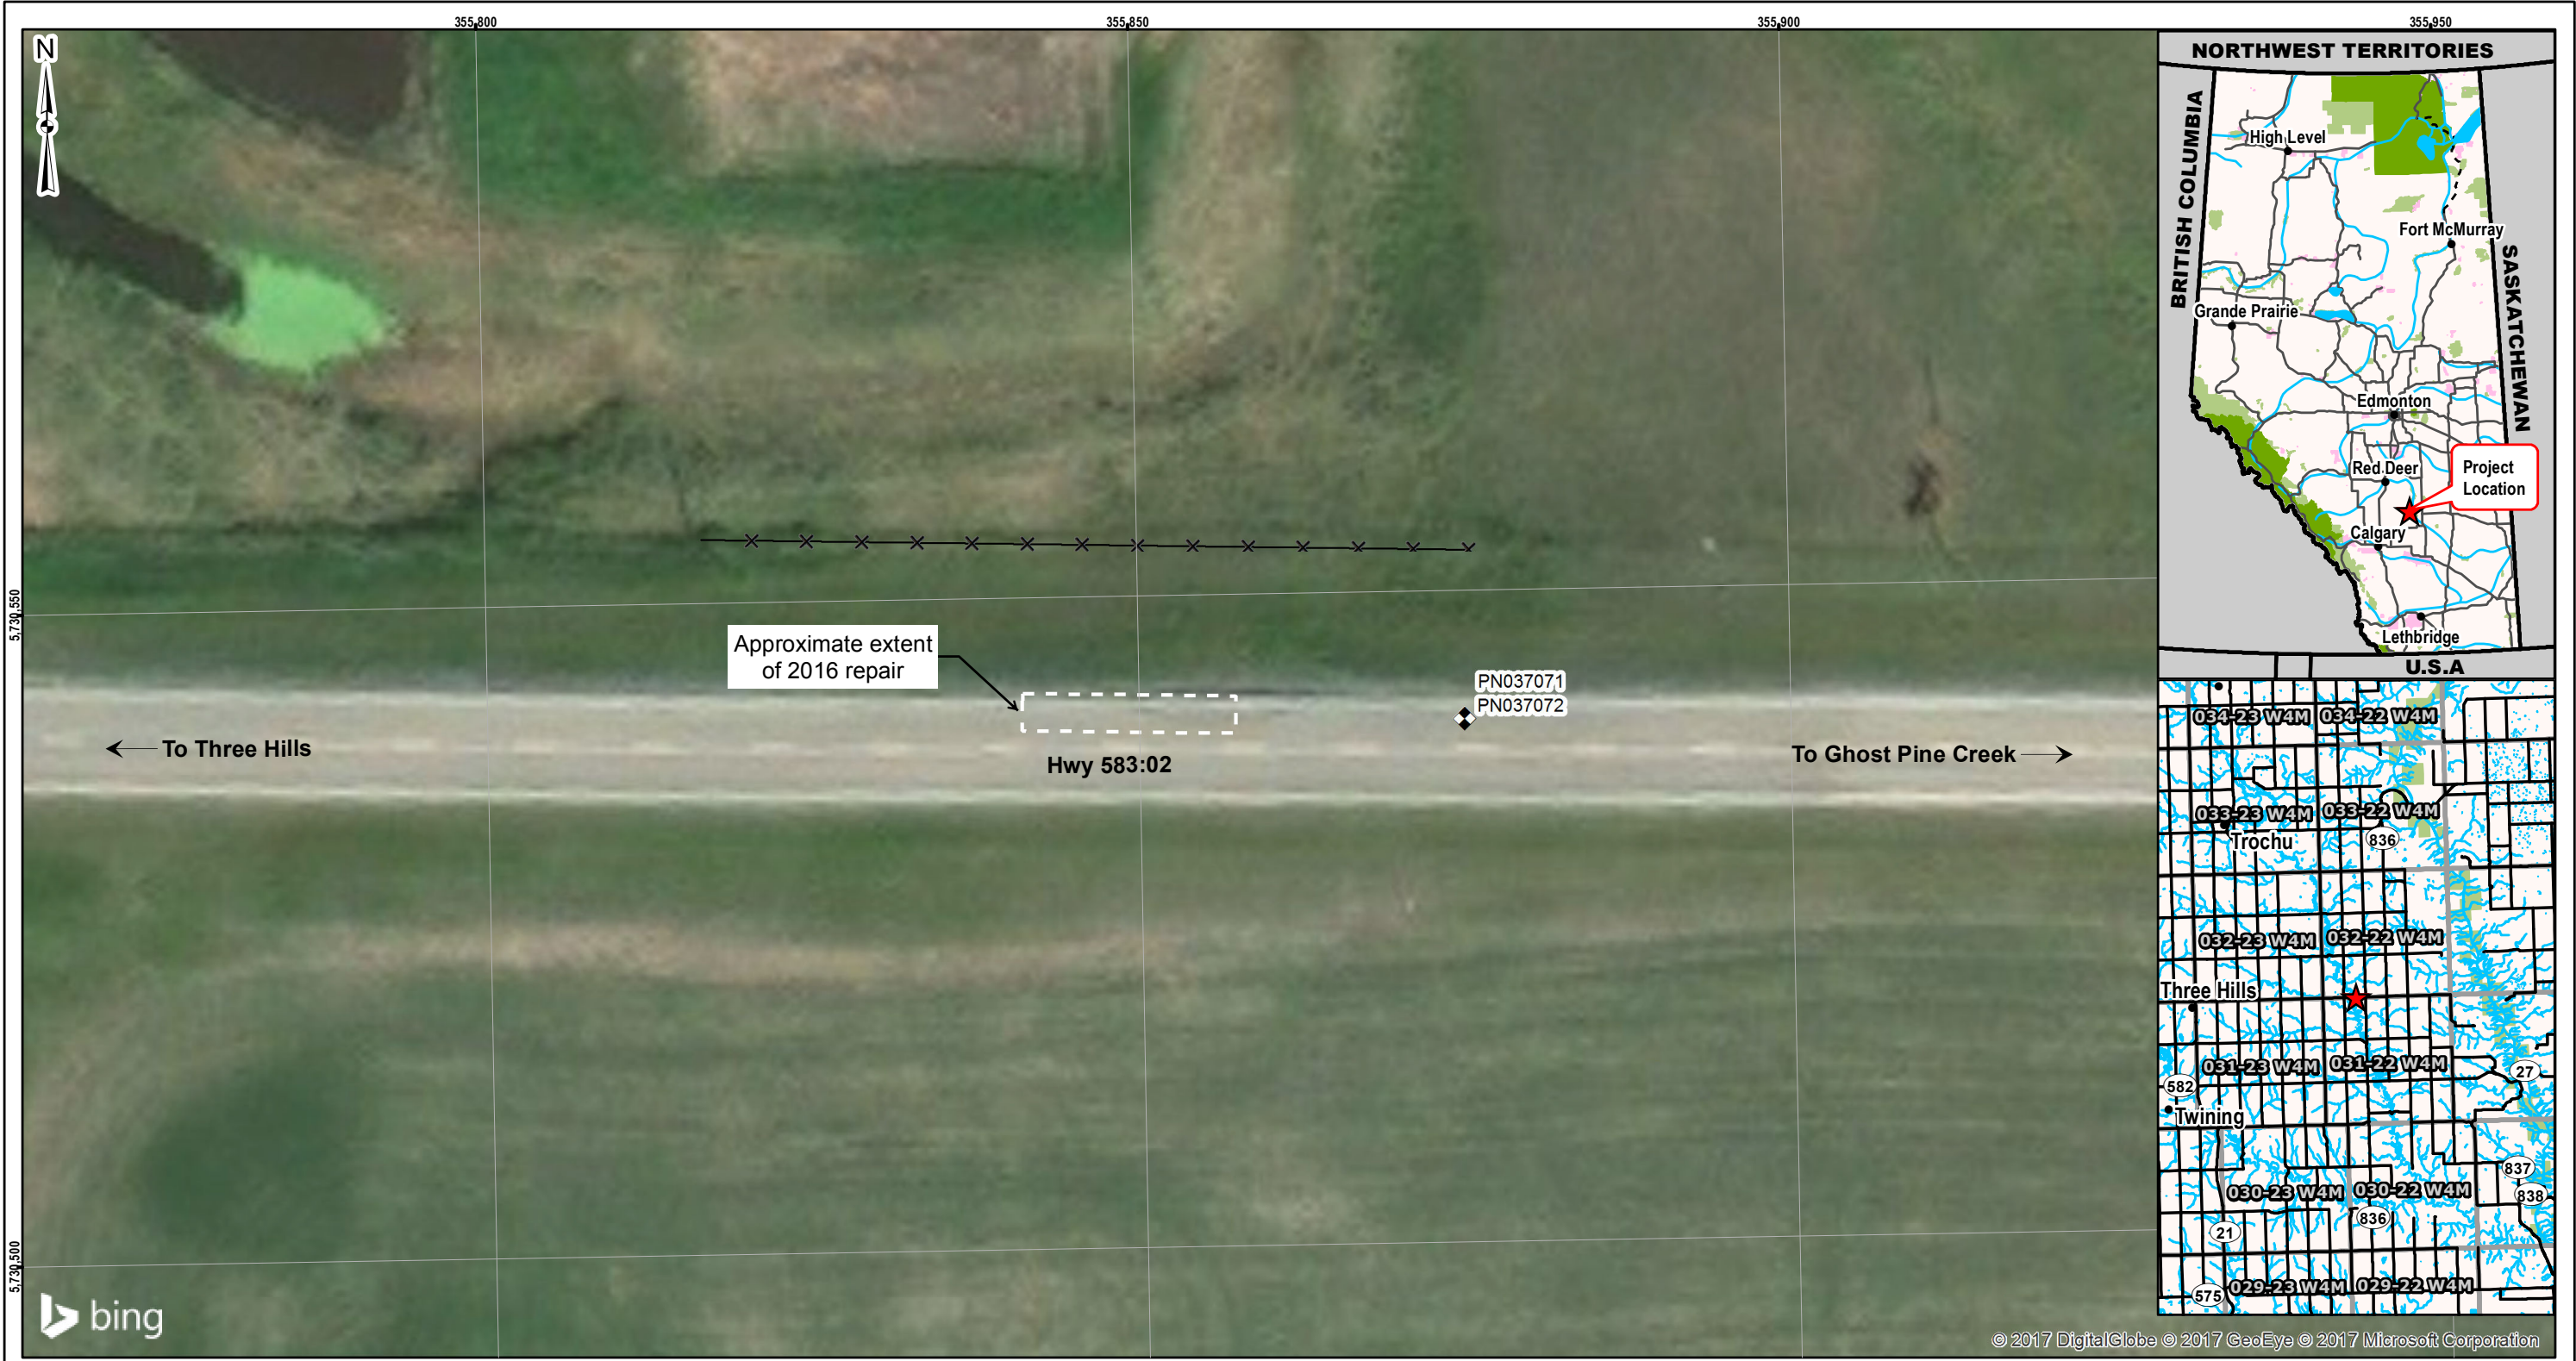
SCALE 1:500 PROJECT No. A05115A02 FIG No. 1

Two pneumatic piezometers (PN037071 and PN037072) were read at geohazard site C069 on May 11, 2017 by Ms. Courtney Mulhall, E.I.T. and Lekan Mitchell, E.I.T. of Klohn Crippen Berger Ltd. (KCB). The site is located on Hwy 583, km 35.087, approximately 11 km east of Three Hills, Alberta. The site coordinates are 52°42.438' N, 113°5.184' E (NAD 83). A site plan is presented in Figure 1.

Instrumentation installation details are tabulated in Table 1.1. Instrument locations are shown in Figure 1.
