SITE NUMBER AND NAME: C065 East of Trochu Slide		HIGHWAY & KM: 585:02, 16.136	PREVIOUS INSPECTION DATE: June 13, 2018	INSPECTION DATE: July 11, 2019
LEGAL DESCRIPTION: 11/12/14/15-22-033-22 W4M	NAD 83 COORDINATES: UTM Northing Easting 12 5746288 359329		RISK ASSESSMENT: PF: 13 CF: 8 TOTAL: 104	
AVERAGE ANNUAL DAILY TRAFFIC (AADT): 400 (east) (Ref No. 105290)			CONTRACT MAINTENANCE AREA (CMA): 20

PROJECT CENTRAL REGION GEOHAZARD RISK MANAGEMENT PROGRAM		
TITLE Site Plan C065 - East of Trochu Slides Hwy 585:02, km 16.136		
SCALE 1:3,000	PROJECT No. A05115A02	FIG No. 1

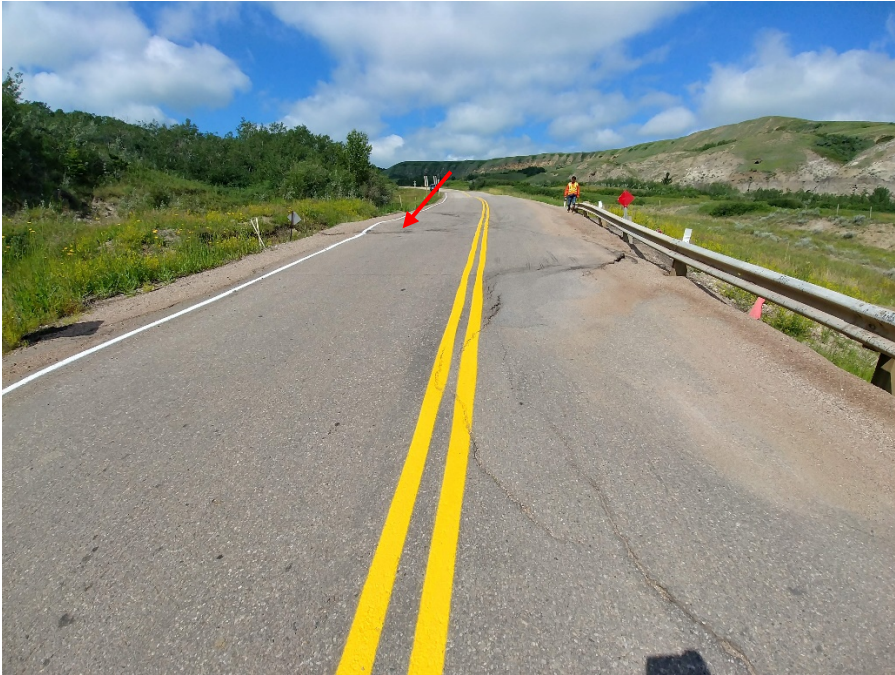
Photo 1 Pavement at the C065-I site continues to deflect and subside from slide movements and heavy truck traffic. A toe roll in the pavement has formed from heavy trucks braking in the eastbound lane (red arrow; photo 3). Photo taken July 11, 2019 looking west.

C065-I: Excavate and replace highway fill with free-draining gravel and install perforated drainage pipes at the base of the fill. AT has been offered shredded tire material as backfill at a price that could be lower than the cost of gravel. The use of shredded tire backfill should be reviewed further as it may offer cost savings to AT. AT has repaired other sites elsewhere in Alberta with shredded tire backfill.

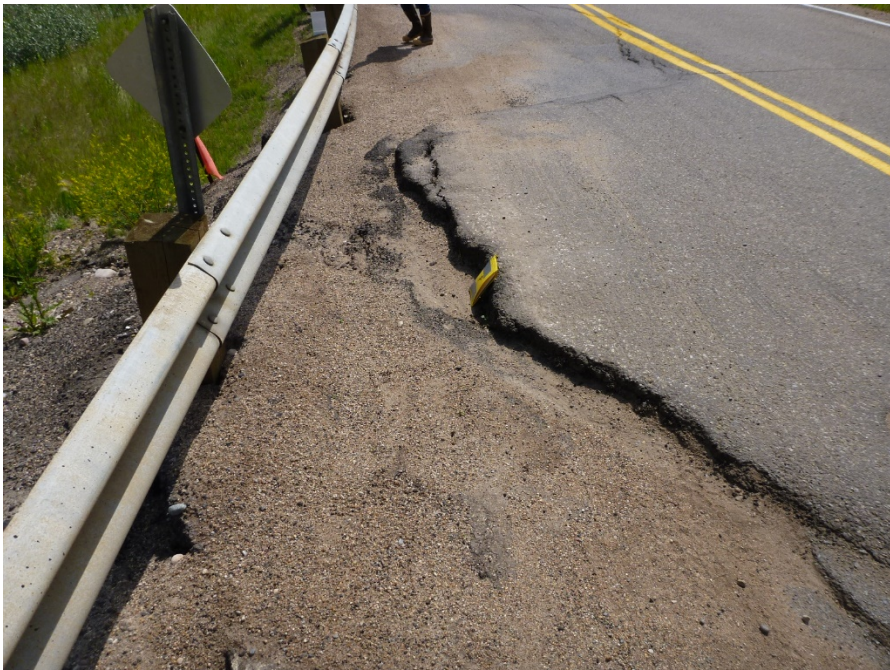
Photo 2 Close-up view showing the severity of pavement deflection in the westbound lane at C065-I. Pavement has deflected up to 4". Photo taken July 11, 2019 looking east.

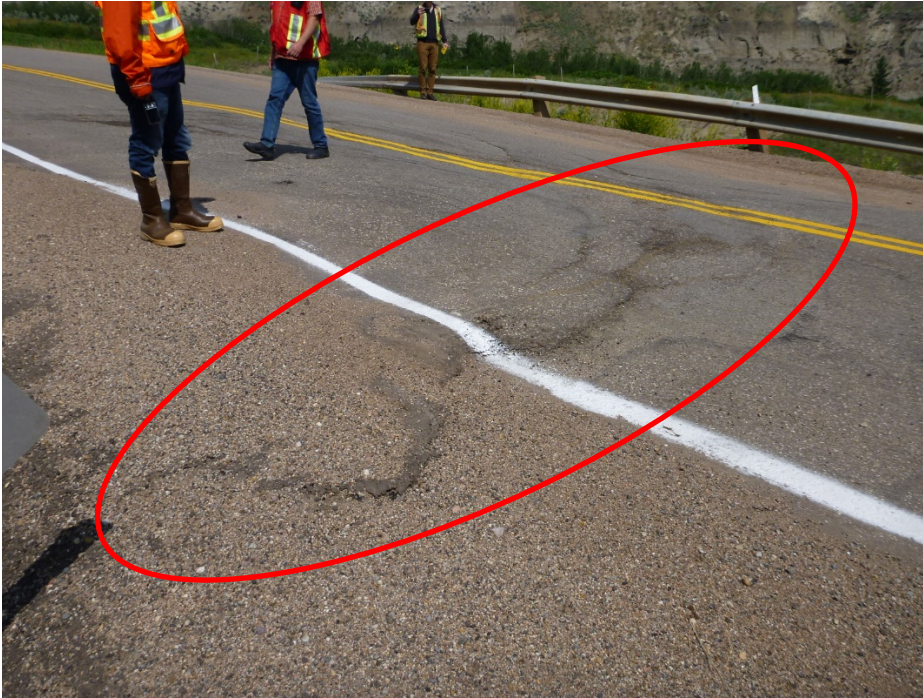
Photo 3 Close-up view of toe roll in pavement (red circle) caused by heavy trucks braking in the eastbound lane as they approach the C065-I site. Photo taken July 11, 2019 looking northwest.

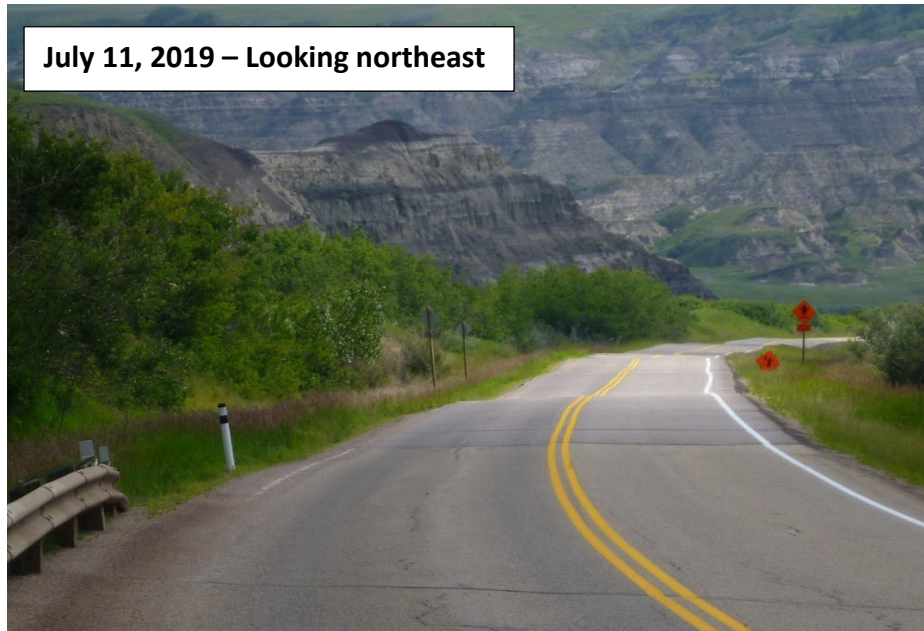
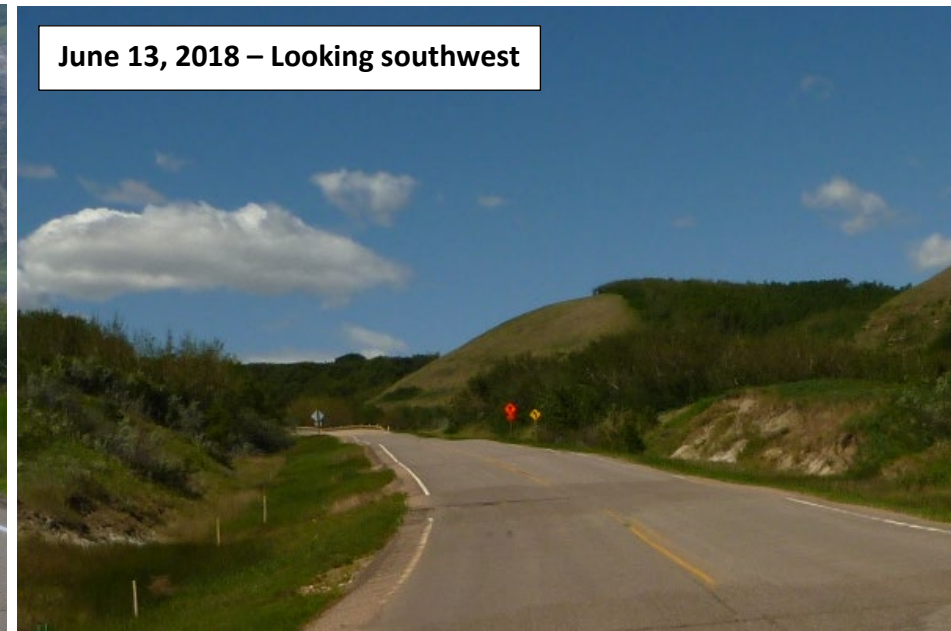
At the C065-II site, the pavement was milled at various locations in 2018. Pavement dips appear to have worsened since the 2018 inspection.

Photo 4 Photo showing the pavement dips at the C065-II site in 2018 and 2019 from opposite directions. Pavement dips appear to have worsened since 2018.

C065-II: The highway surface could be excavated at each dip location to expose and backfill voids with sand and gravel. Drainage pipes should be installed at the base of each excavation.

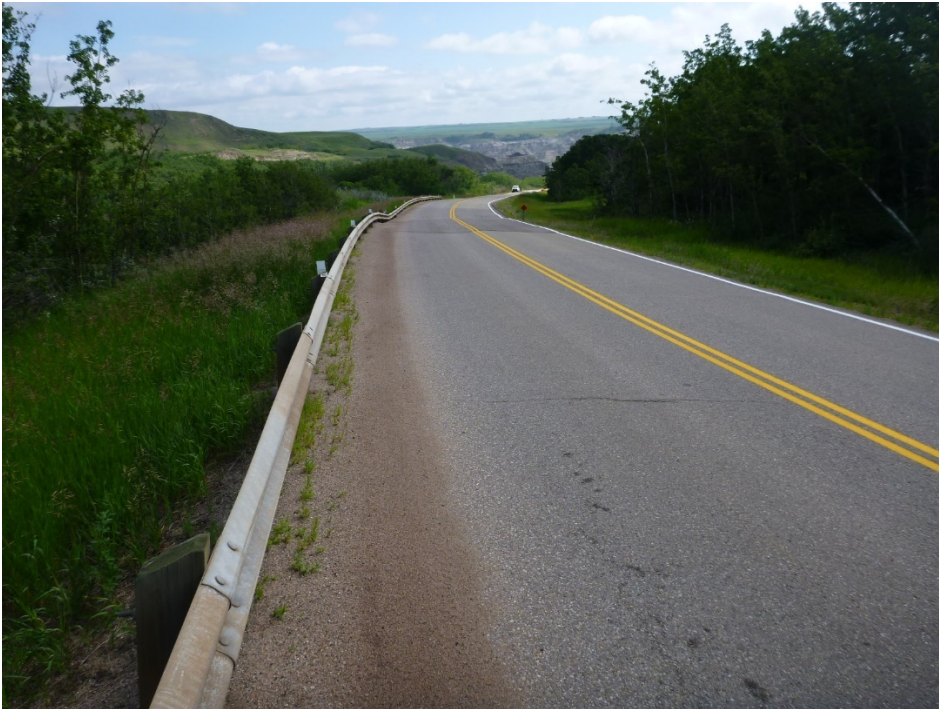
Photo 5 View of C065-III slide area showing the extent of guardrail settlement along the westbound lane. Photo taken July 11, 2019 looking northeast.

C065-III: Culvert below the highway should be replaced and a slope drain installed to convey water downslope to the creek below the highway and away from the slide area. Site could be repaired with either soil-nailing or a driven steel pile wall, with culvert repairs and a slope drain to drain water away from the slide area.

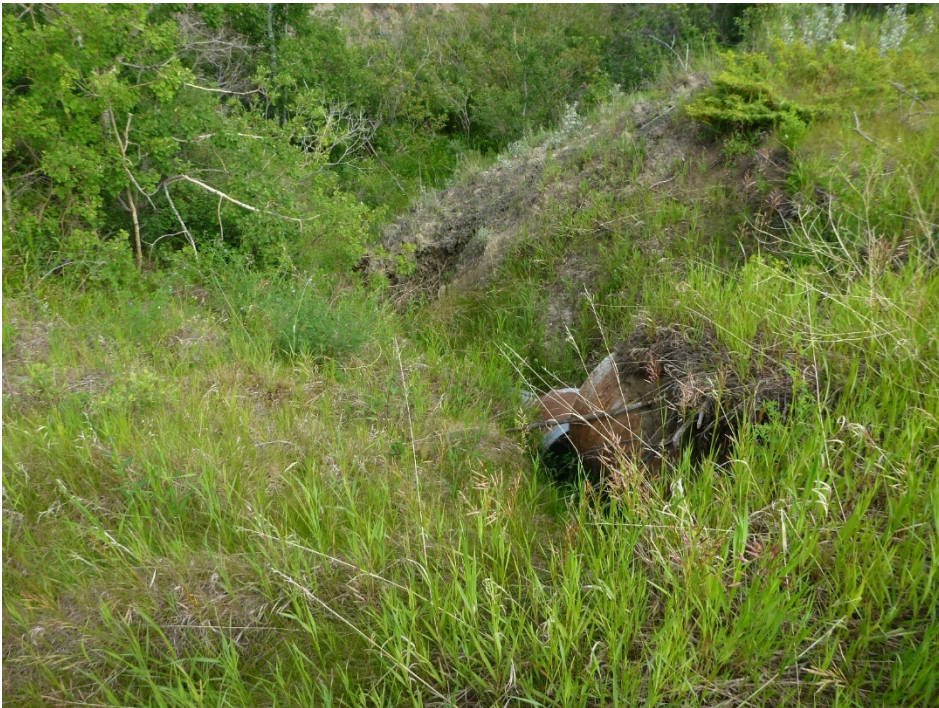
- Erosion gully below the culvert outlet has expanded since the 2018 inspection. Ground cracking was observed between the guardrail and the edge of the gully.
- Guardrail does not appear to have settled further since the 2018 inspection.
- Pavement cracking on the west flank of the slide looks unchanged. No cracking observed on east side.
- Guardrail posts are leaning towards the west along the pavement patch.

Photo 6 Erosion gully below the undermined culvert outlet at C065-III appears to have increased in size since 2018. Photo taken July 11, 2019 looking north.

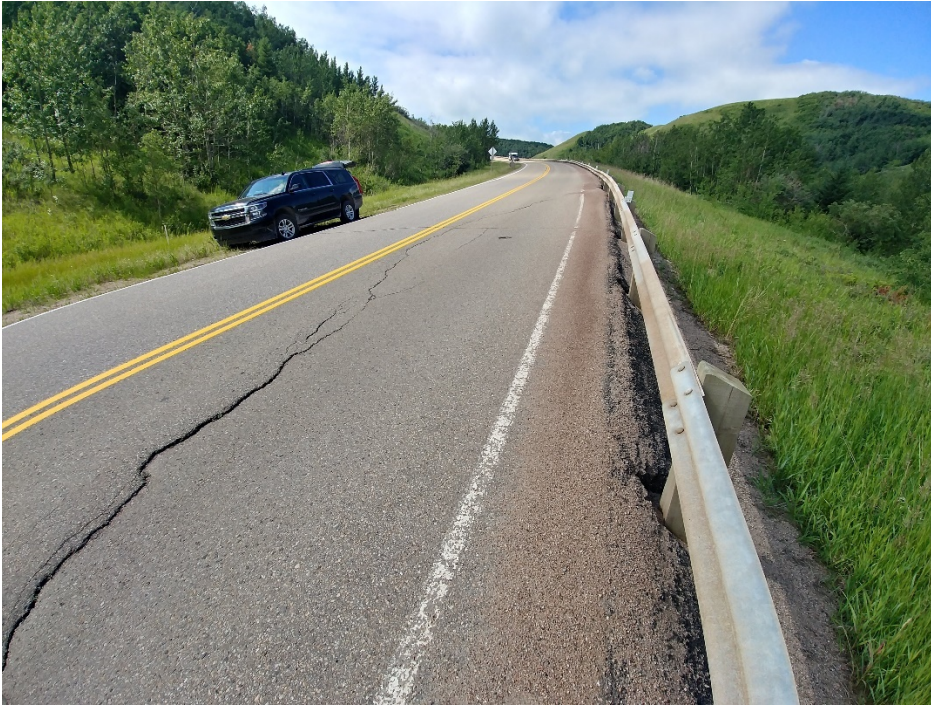
At the C065-IV site, a slight increase in pavement deflection since the 2018 inspection was observed. The slope failure at C065-IV involves pavement cracking that extends across the westbound lane to centreline. The bottom of the culvert is corroded, allowing surface water flow to infiltrate into the embankment near the slide.

Photo 7 View of the highway surface at the C065-IV site. Pavement deflection appears to have increased slightly since 2018 inspection. Photo taken July 11, 2019 looking southwest.

C065-IV: Install a driven steel H-pile wall to stabilize the slide.
