SITE NUMBER AND NAME: C065-I, -II, -III, and -IV East of Trochu Slide		HIGHWAY & KM: 585:02, 15.21 to 16.05	PREVIOUS INSPECTION DATE: July 11, 2019	INSPECTION DATE: June 9, 2020
LEGAL DESCRIPTION:	NAD 83 COORDINATES:		RISK ASSESSMENT:	
	UTM	Northing	Easting	PF: 13 CF: 8 TOTAL: 104
C065-I 15-22-33-22-W4M	12	5746278	359522	
C065-II 11/12/14-22-33-22-4WM	12	5746228	359147	
C065-III 12-22-33-22-W4M	12	5746079	358817	
C065-IV 12-22-33-22-W4M	12	5746031	358754	
AVERAGE ANNUAL DAILY TRAFFIC (AADT): 400 (east) (Ref No. 105290)			CONTRACT MAINTENANCE AREA (CMA): 517

PRIMARY SITE ISSUE: Several geohazard sites along a 1 km section of Hwy 585, on the west valley slope of the Red Deer River, that are causing pavement distress. The sites are located within a creek valley; and include valley slope and embankment fill slides, and potential dispersive soil voids beneath the highway. Four geohazard sites are located at the C065 site:

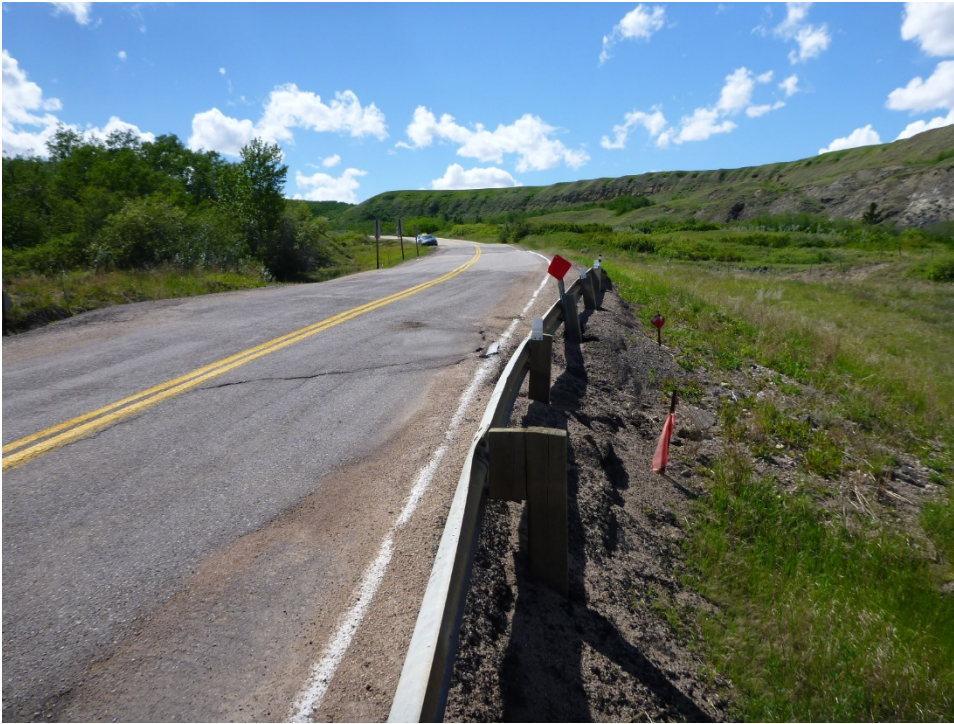
- The pavement in the eastbound and westbound lanes continue to deflect vertically and laterally from slide movements and heavy trucks braking. Pavement has deflected up to 4" in the westbound lane. A toe roll has formed in the pavement of the eastbound lane from heavy trucks braking due to the distortion of the road caused by the slide movements. The pavement in the eastbound lane may also be settling under traffic load due to a weak subgrade.

- New signage with reduced speed limit was installed above the slide site on the east approach in 2018.
- Ground cracks, toe roll, and seepage were observed at the toe of slide during the 2020 inspection.

Photo 1 Horizontal deflection of the guardrail due to the toe-roll occurring at C065-I. Photo taken June 9, 2020 facing northeast.

- Excavate and replace failed highway fill with a shear key, geogrid reinforced gravel and install perforated drainage pipes at the base of the fill.

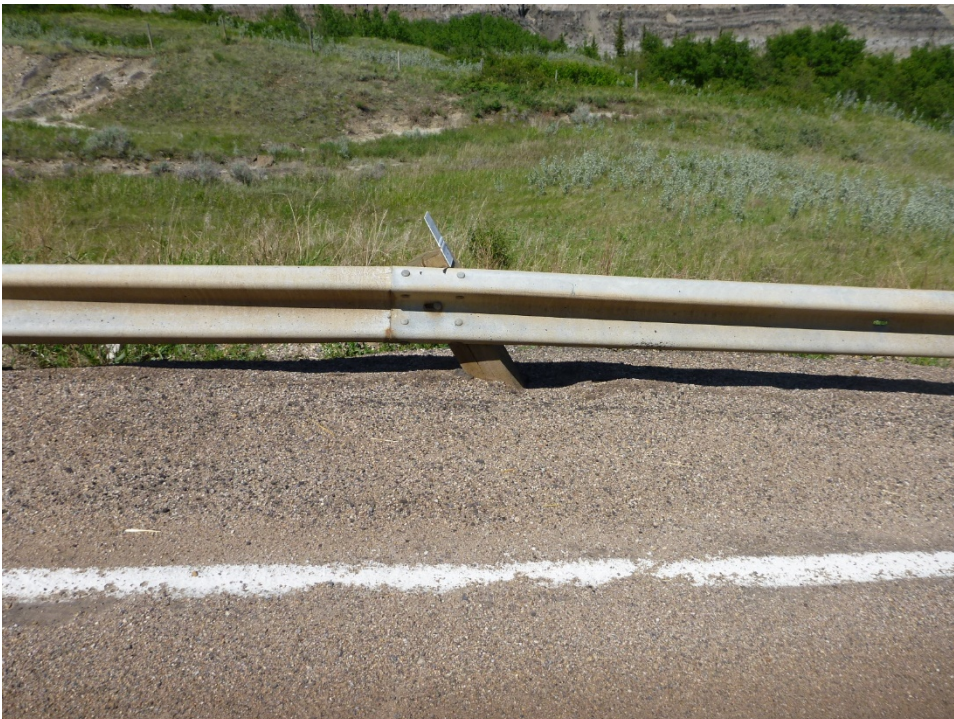
Photo 2 Wooden guardrail posts have deflected horizontally due to the movement of the highway. Photograph taken June 9, 2020 facing north.

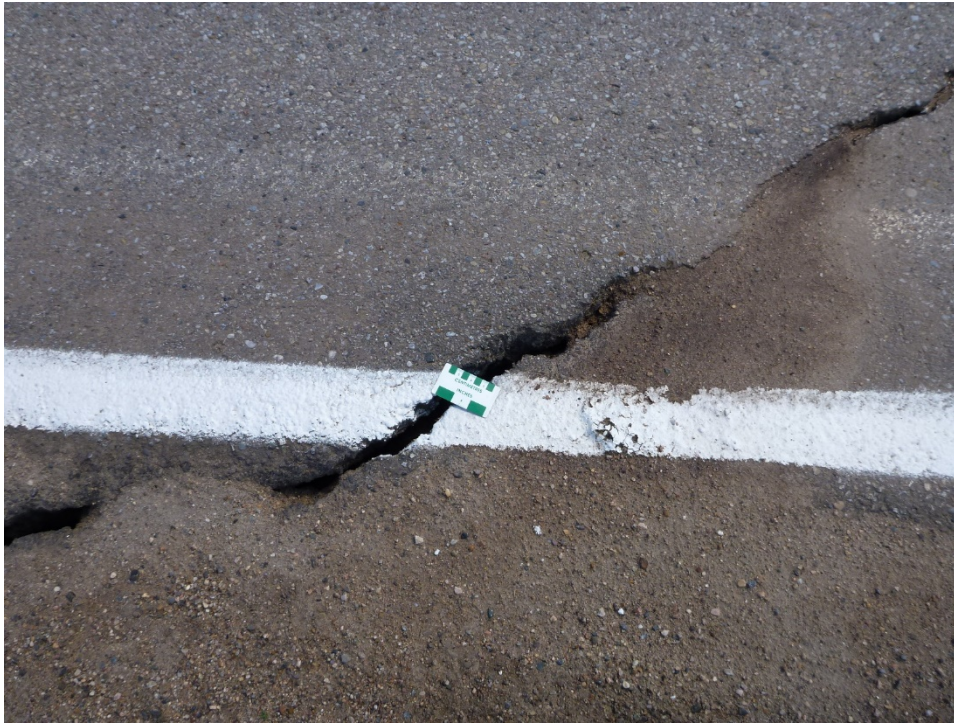
Photo 3 Close-up view showing the severity of pavement deflection in the westbound lane approximately 10 m east of C065-I. Photo taken June 6, 2020 facing south.

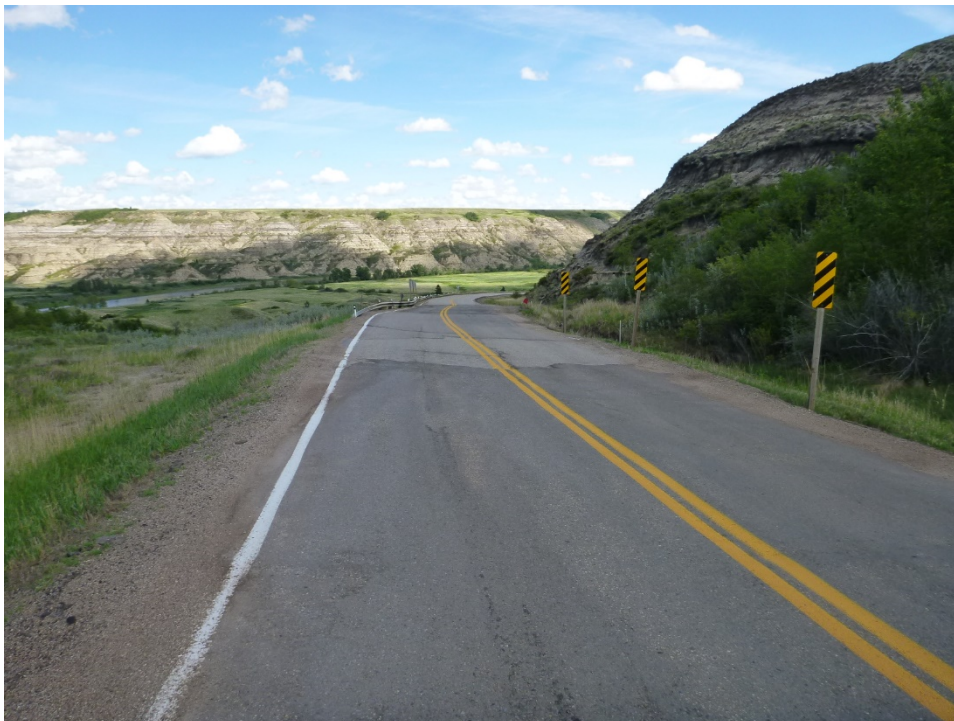
Photo 4 Toe roll in pavement (red circle) caused by heavy trucks braking at they approach the C065-I site. Photo taken June 9, 2020 facing east.

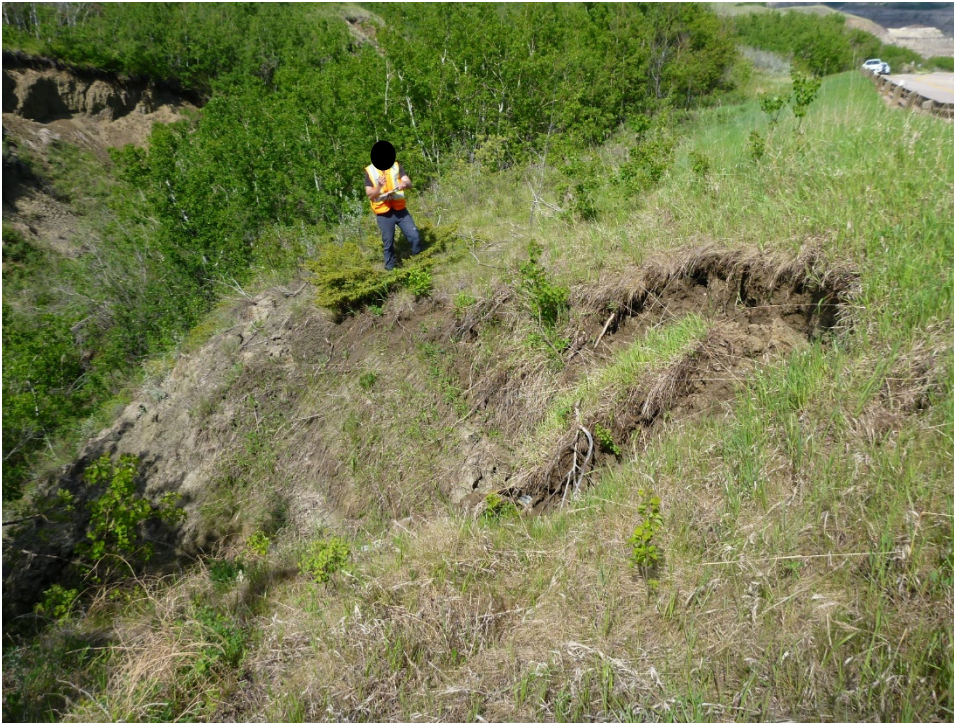
- Erosion gully below the culvert outlet has expanded since the 2019 inspection. Ground cracking was observed between the guardrail and the edge of the gully.
- Guardrail does not appear to have settled further since the 2019 inspection.
- Pavement cracking on the west flank of the slide looks unchanged. No cracking observed on east side.
- Guardrail posts are leaning towards the west along the pavement patch.
- The bottom of the culvert is corroded, allowing surface water flow to infiltrate into the embankment near the slide.

Photo 5 Erosion gully below the undermined culvert outlet at C065-III has increased in size since 2019. Photo taken June 9, 2020 facing east.

- Excavate and replace slide material with geogrid reinforced gravel. The culvert below the highway should be replaced and a riprap ramp installed to convey water downslope to the creek below the highway and away from the slide area. An energy dissipation structure should be constructed (requiring a hydrotechnical assessment) at the end of the slope drain.

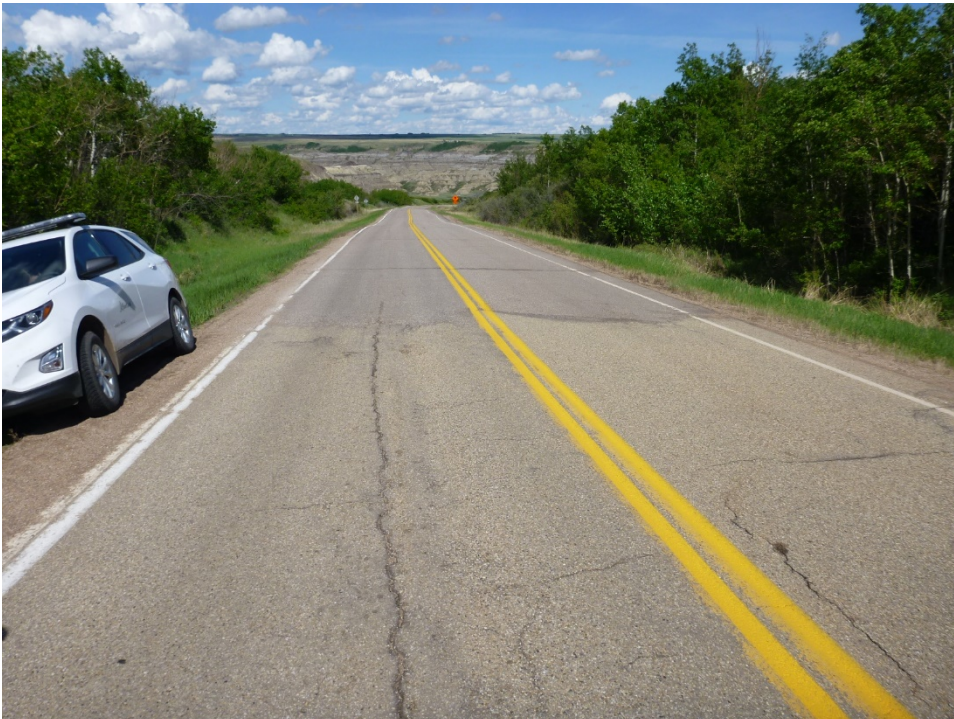
- A slight increase in pavement deflection since the 2019 inspection was observed.
- The slope failure at C065-IV involves pavement cracking that extends across the westbound lane to centreline.

Photo 6 View of the highway surface at the C065-IV site. Pavement deflection appears to have increased slightly since 2019 inspection. Photo taken June 9, 2020 facing east.

- Install a driven steel H-pile wall to stabilize the slide. A tender for multiple pile walls on four sites will be released in the fall of 2020 that will include the C065-IV site.
