**Tony Penney, P.Eng.**  
**Construction Engineer**

**CON0022160 Central Region GRMP Instrumentation Monitoring  
Site C065; H585:02, km 16.136 East of Trochu Slides  
Section C – 2022 Fall Readings**

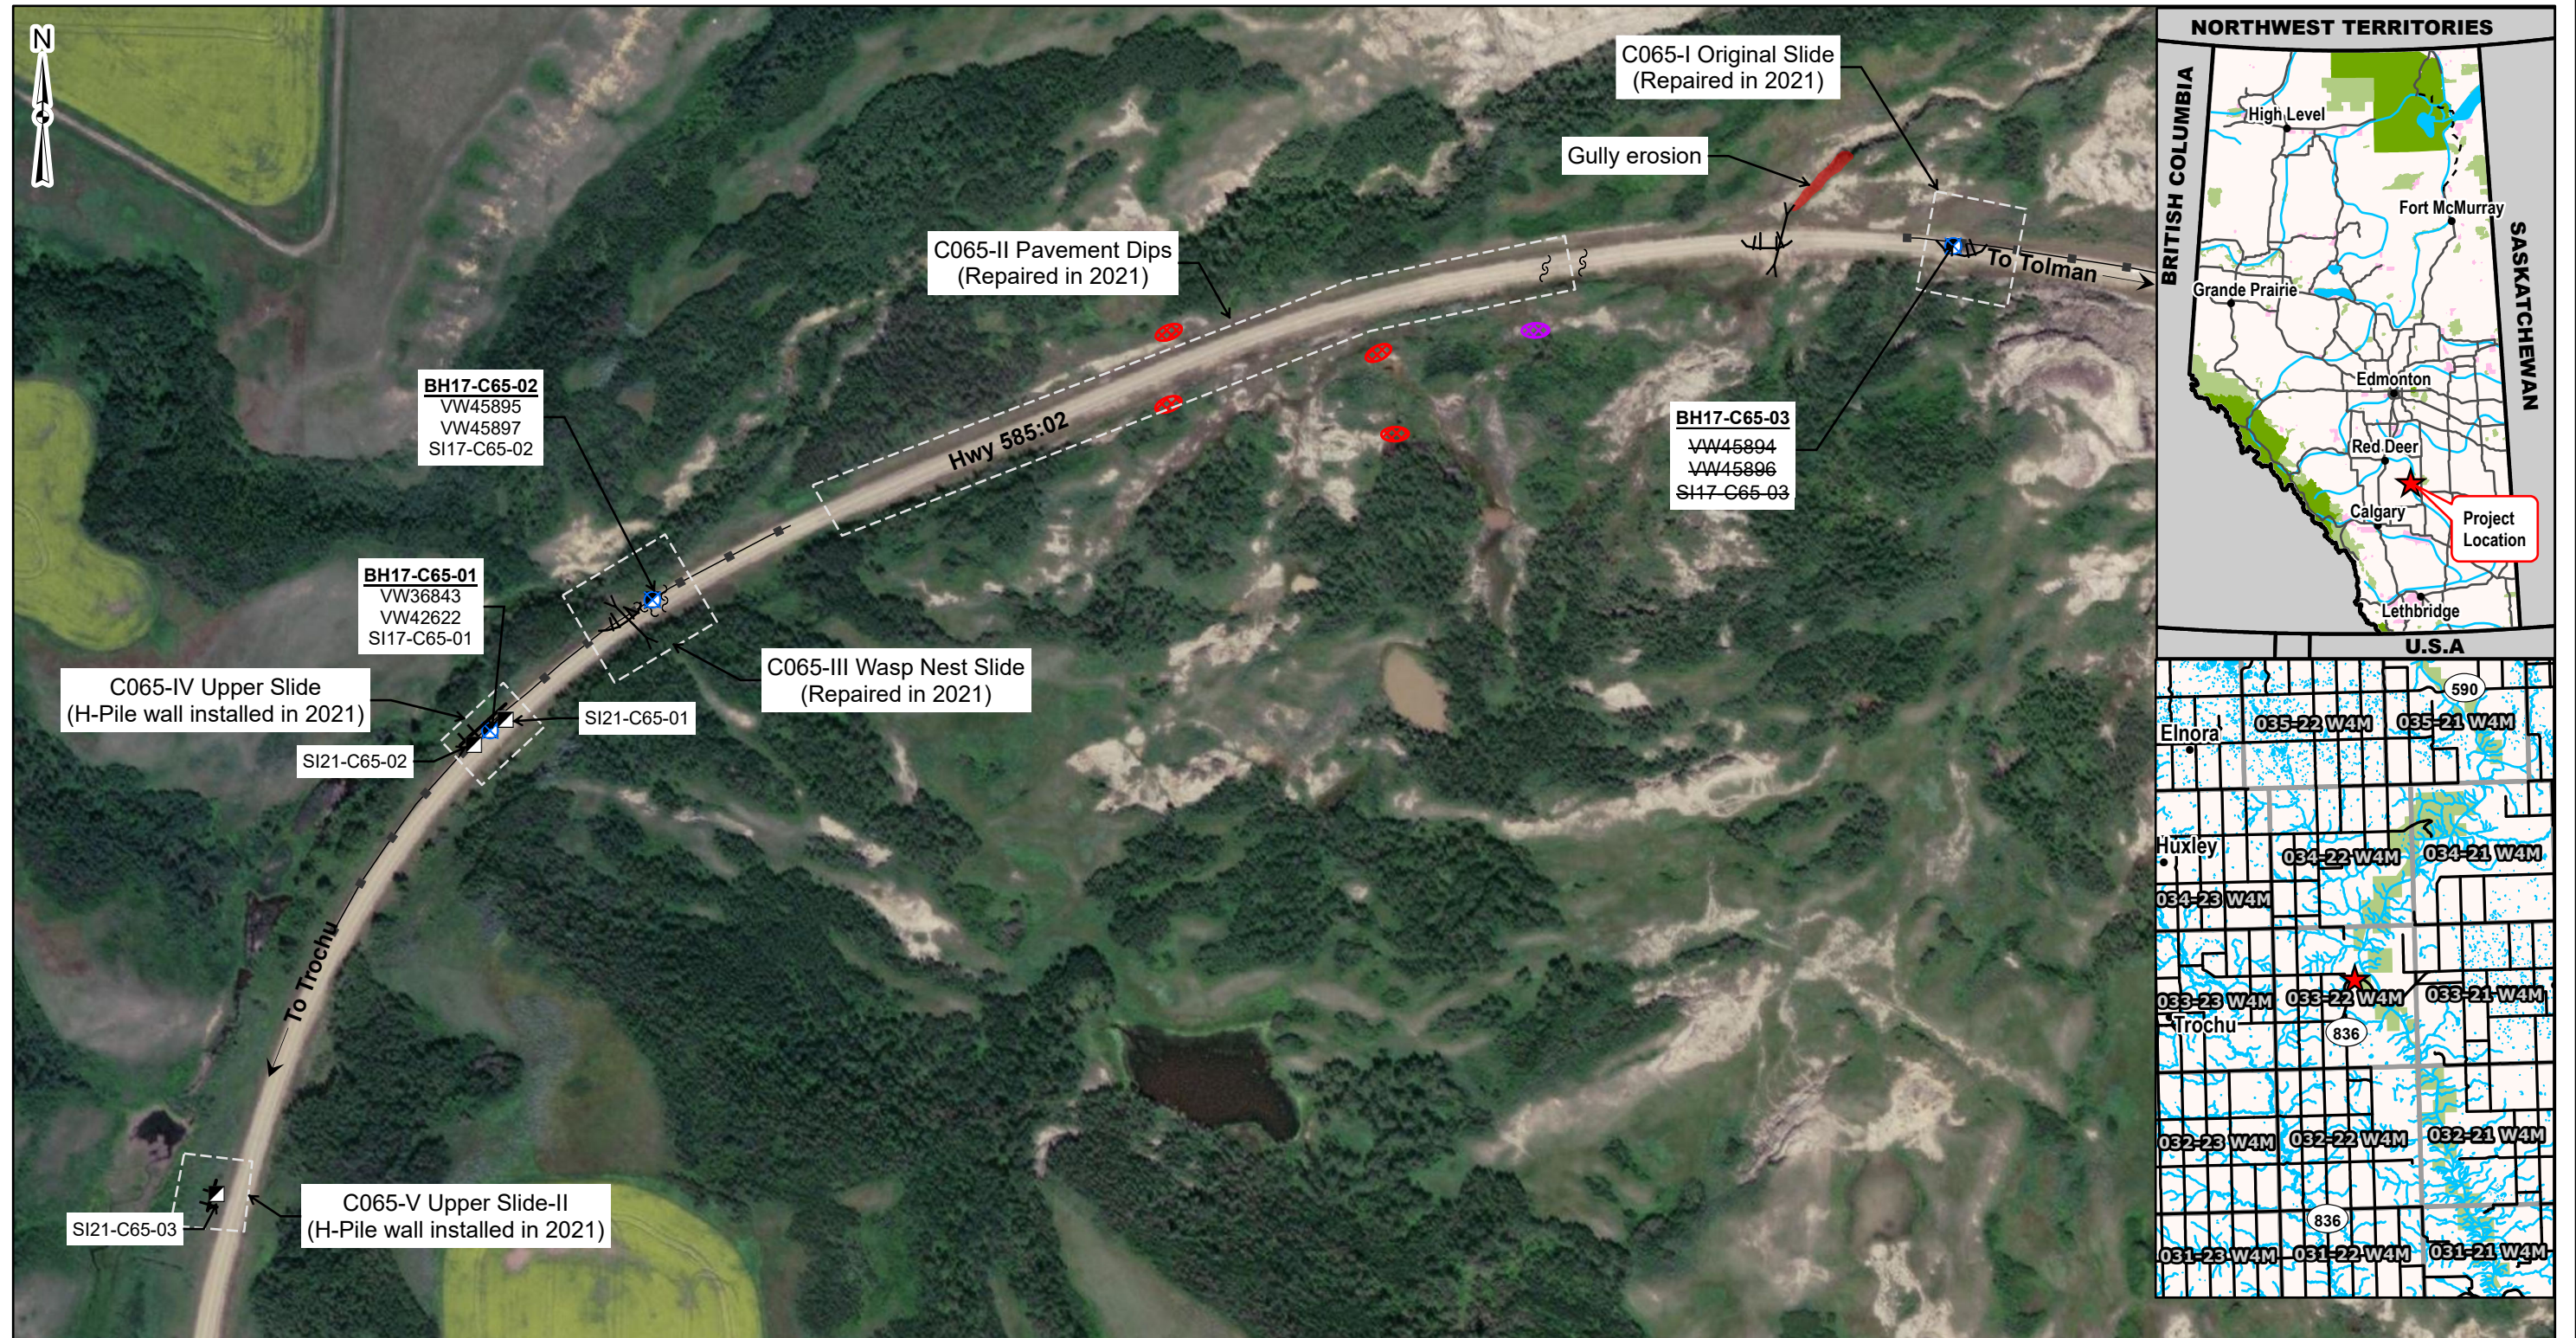
The C065 site consists of several geohazard subsites along an approximate 1 km length of Hwy 585:02. The subsites include: C065-I (Original Slide), C065-II (Pavement Dips), C065-III (Wasp Nest Slide), C065-IV (Upper Slide I), and C065-V (Upper Slide II). The geohazards consist of valley slope and embankment fill slides, and subsidence features associated with dispersive soils beneath the highway. Ongoing asphalt patching paving and guardrail maintenance has been required at the site.

Periodic MCI site visits should continue to assess if voids are still opening between the web and flanges of the H-piles. During the fall 2022 reading, several voids were observed at the top of the H-pile wall at the C065-IV site between SI21-C65-01 and SI21-C65-02. Additional sand backfill should be placed in the existing surface voids and any new surface voids that develop.

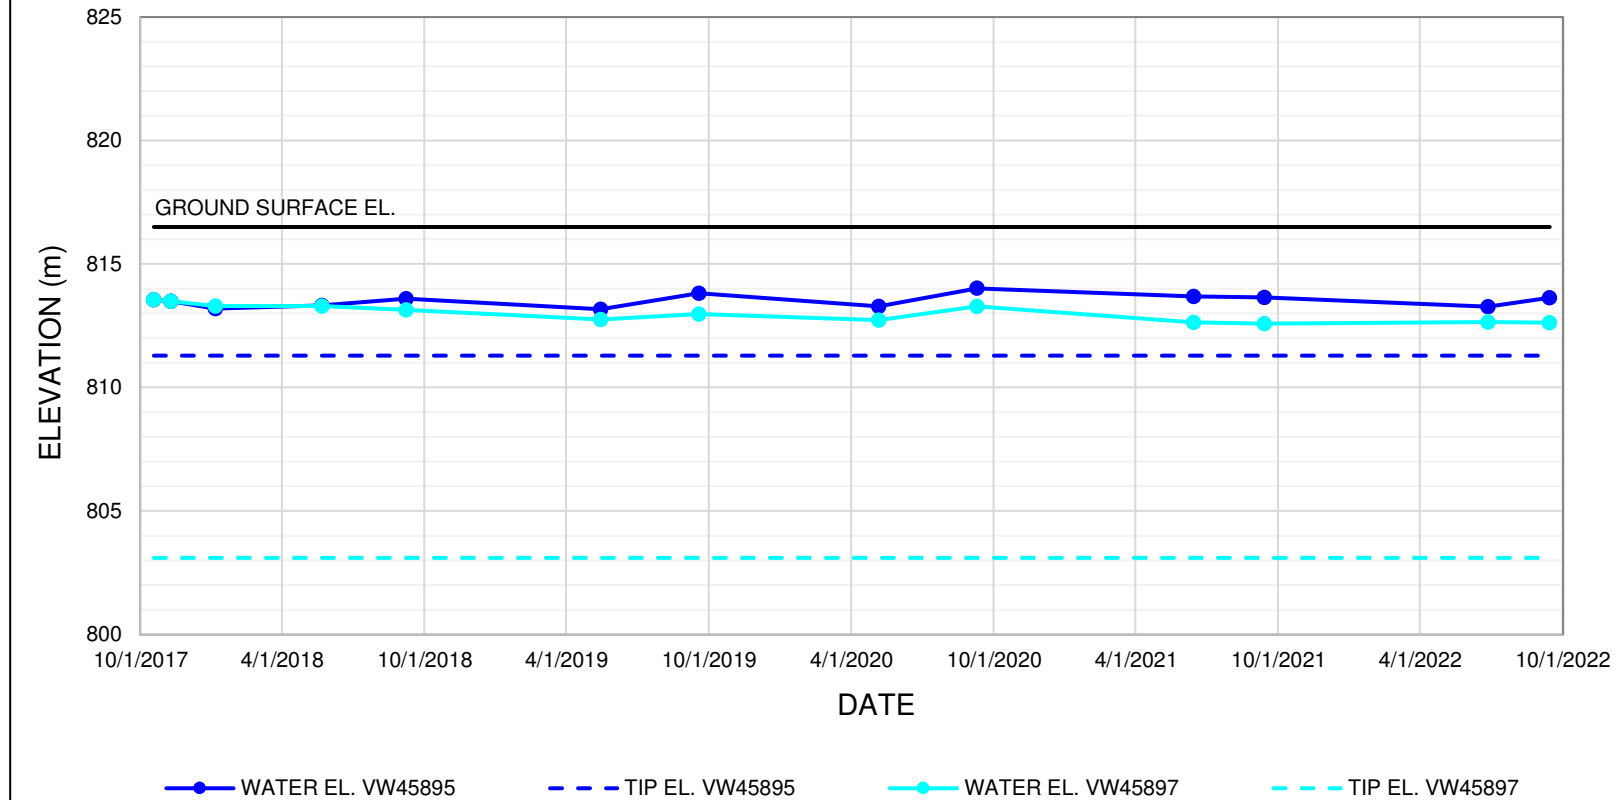
### VW45895 AND VW45897

Since installation in October 2017, water levels recorded in VW45895 and VW45897 have been relatively steady varying from 2.5 m to 3.3 m below ground surface and 2.9 m to 3.9 m below ground surface, respectively. The September 2022 readings of W45895 and VW45897 were consistent with historical trends observed in these instruments.

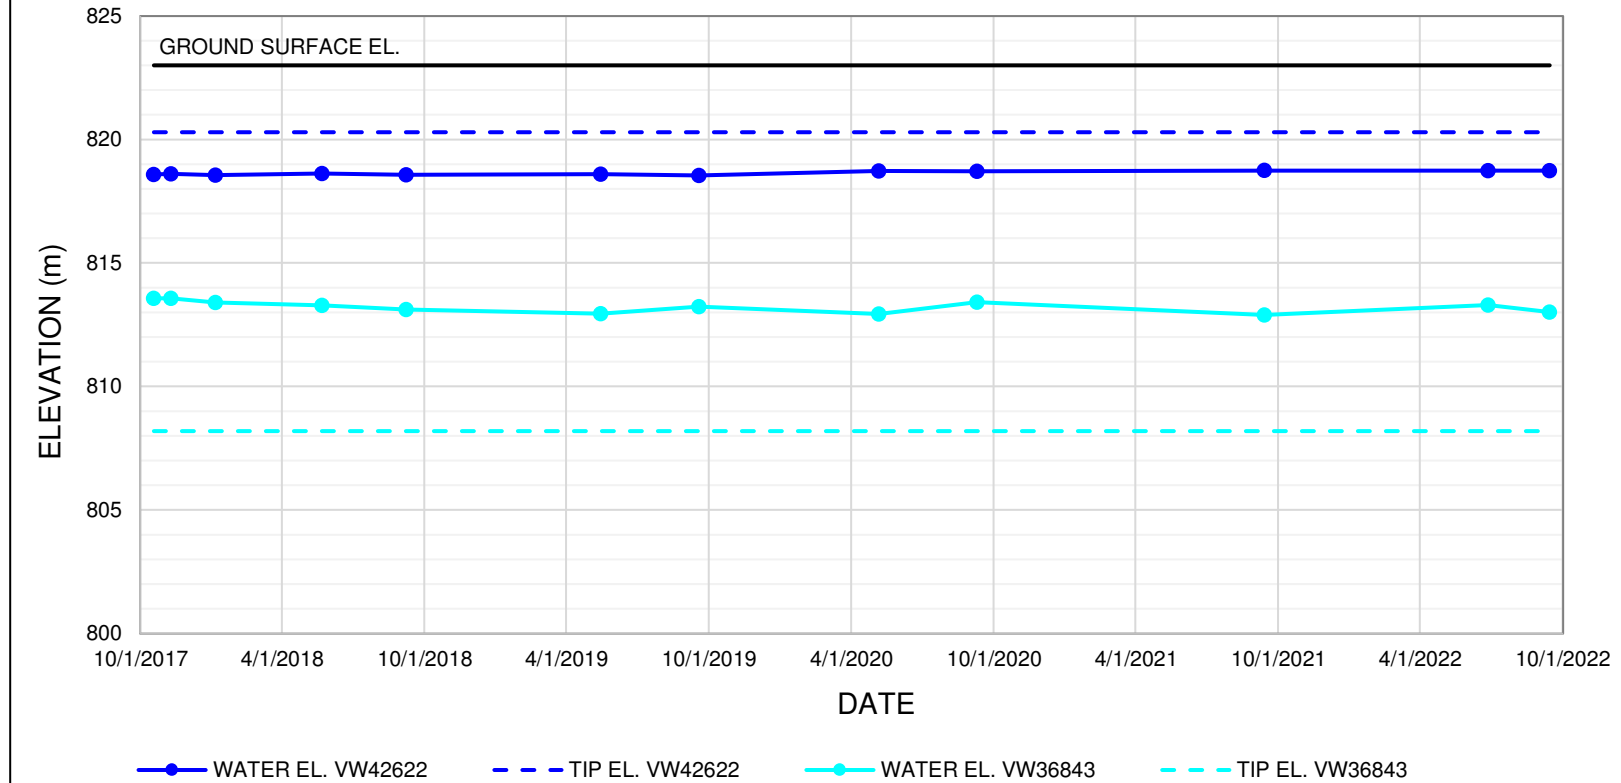
### VW42622 AND VW36843

Since installation in October 2017, water levels recorded in VW42622 and VW36843 have been relatively steady varying from 4.3 m to 4.5 m below ground surface and 9.4 m to 10.1 m below ground surface, respectively. The September 2022 readings of VW42622 and VW36843 were consistent with historical trends observed in these instruments.

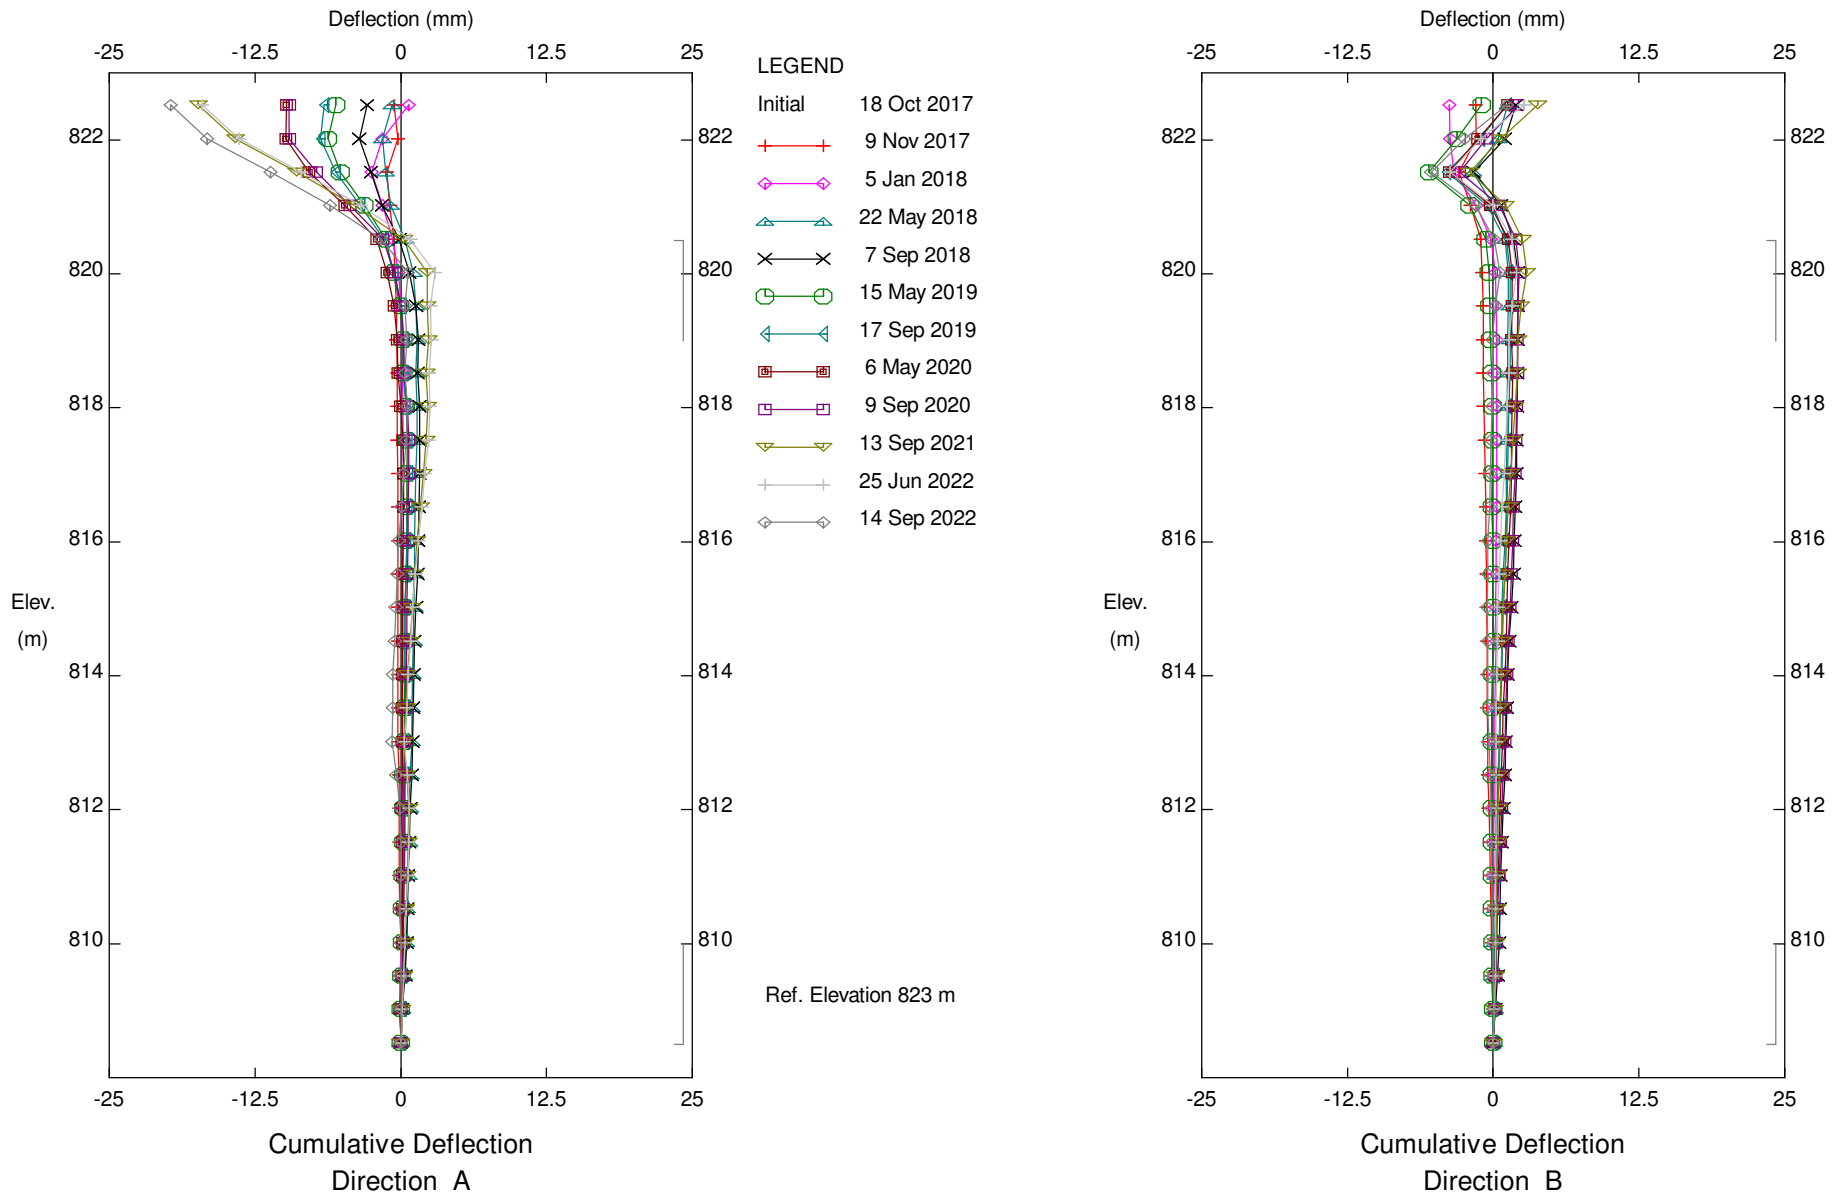
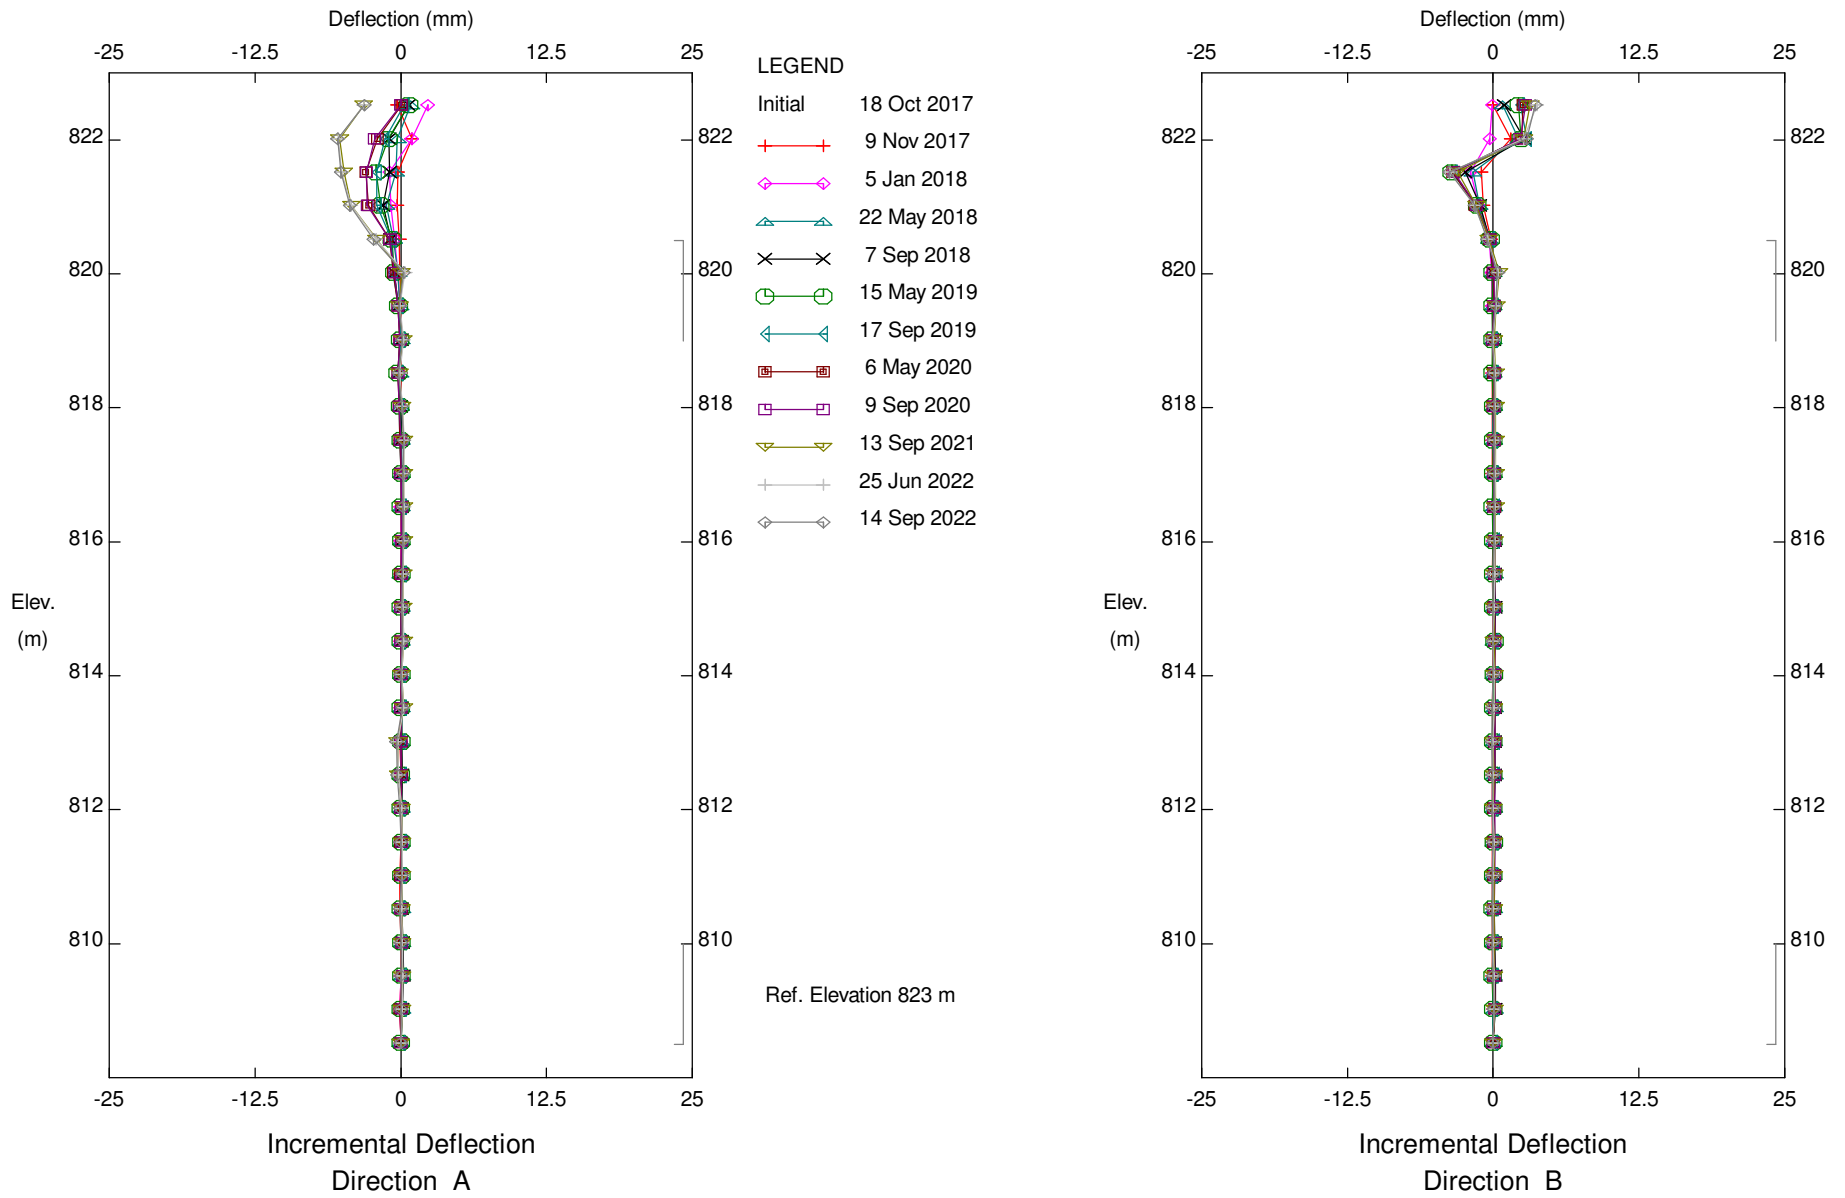
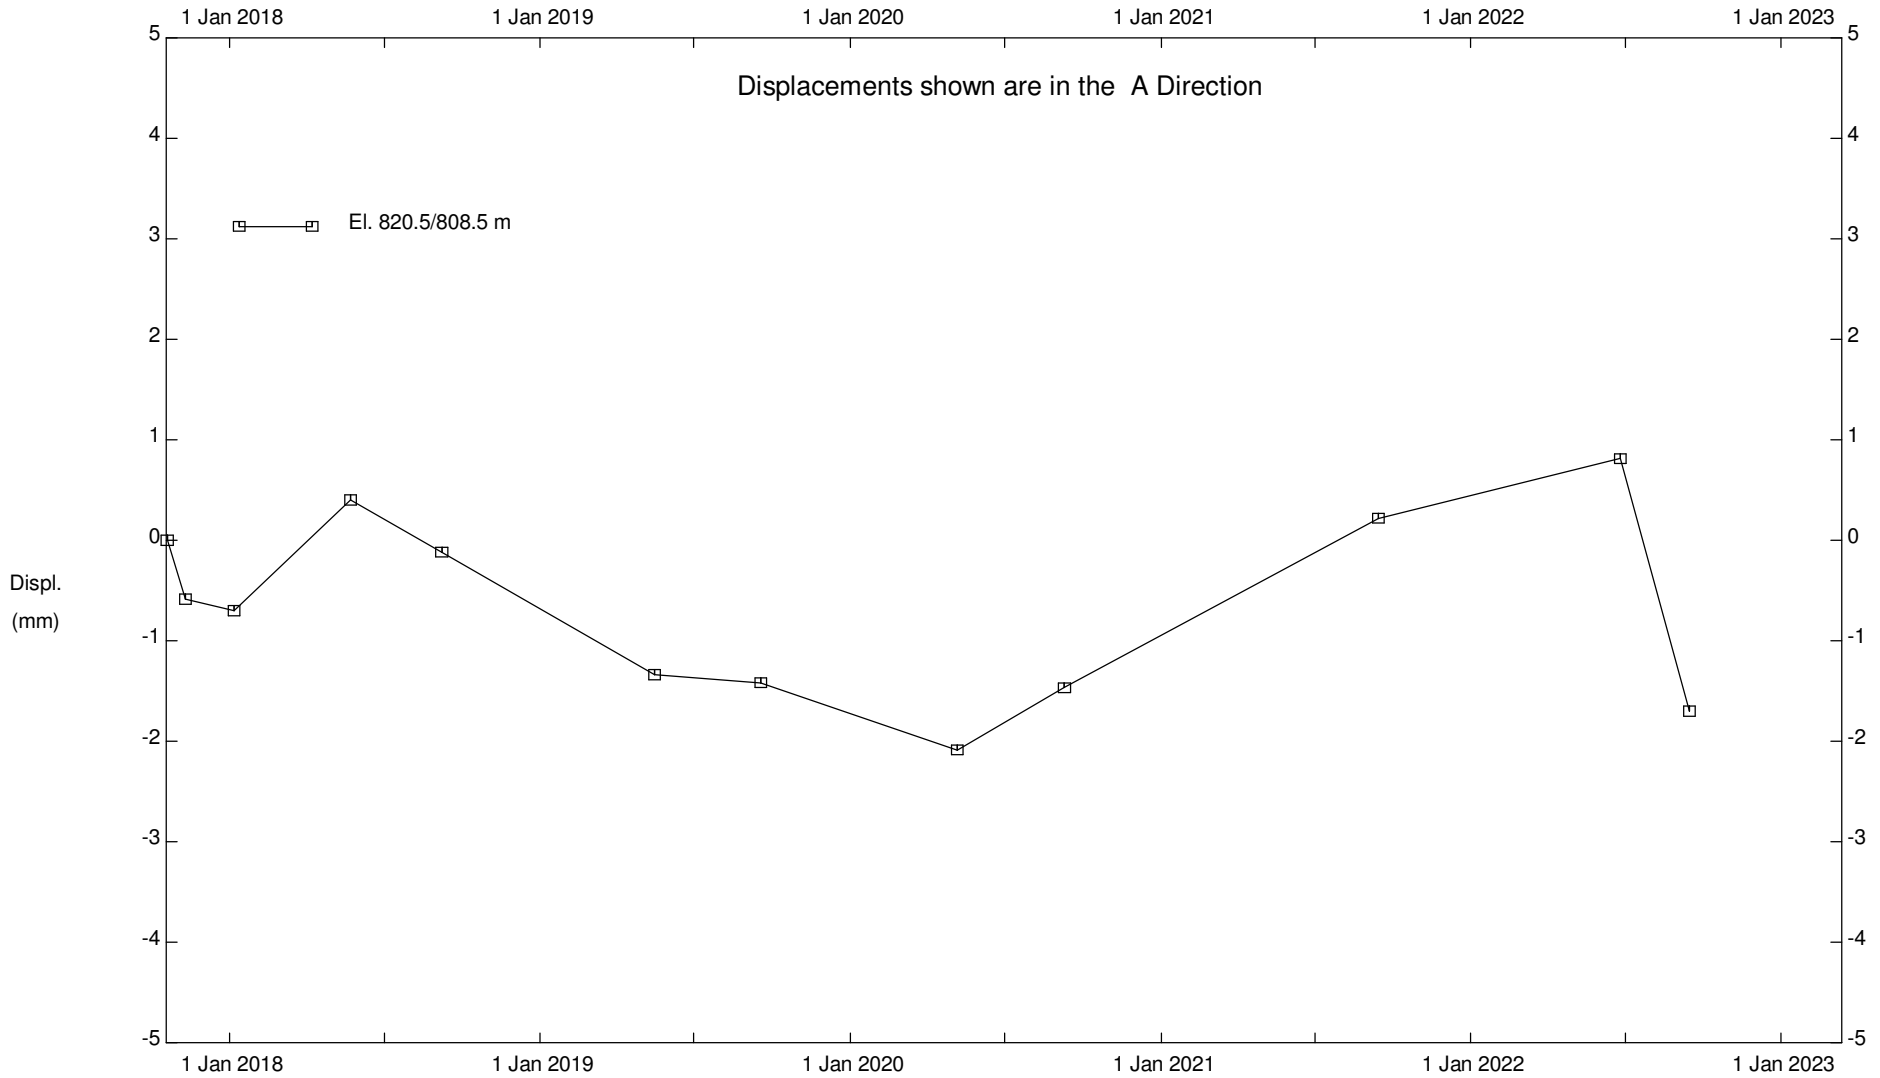
C065-IV; H585:02, East of Trochu, Inclinometer SI17-C65-01

No discernible movement has been recorded in SI17-C65-01 since installation.

No discernible movement has been recorded in SI17-C65-01 since installation, which indicates the slide is either inactive or moving at a very slow rate of movement.
