**Tony Penney, P.Eng.**  
**Construction Engineer**

**CON0022160 Central Region GRMP Instrumentation Monitoring  
Site C065; H585:02, km 16.136 East of Trochu Slides  
Section C – 2022 Fall Readings**

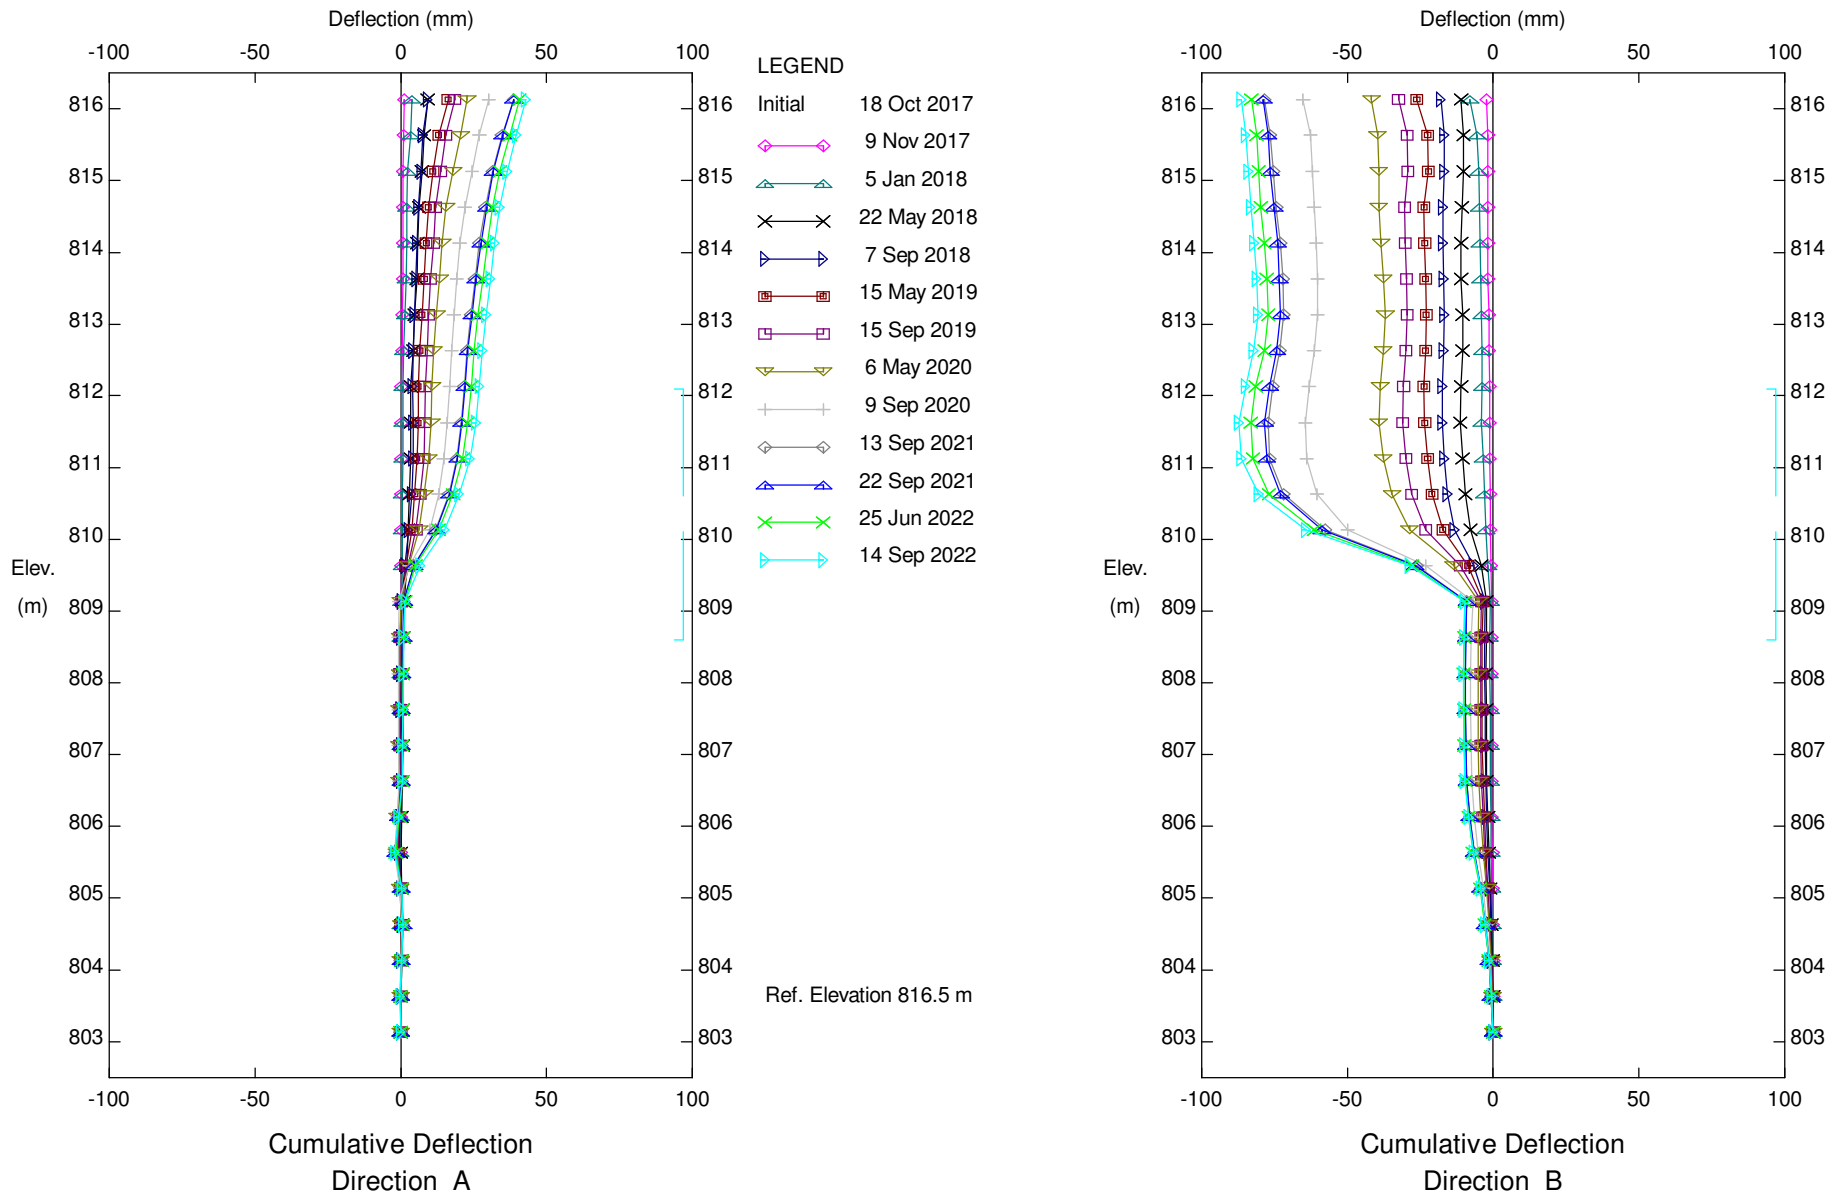
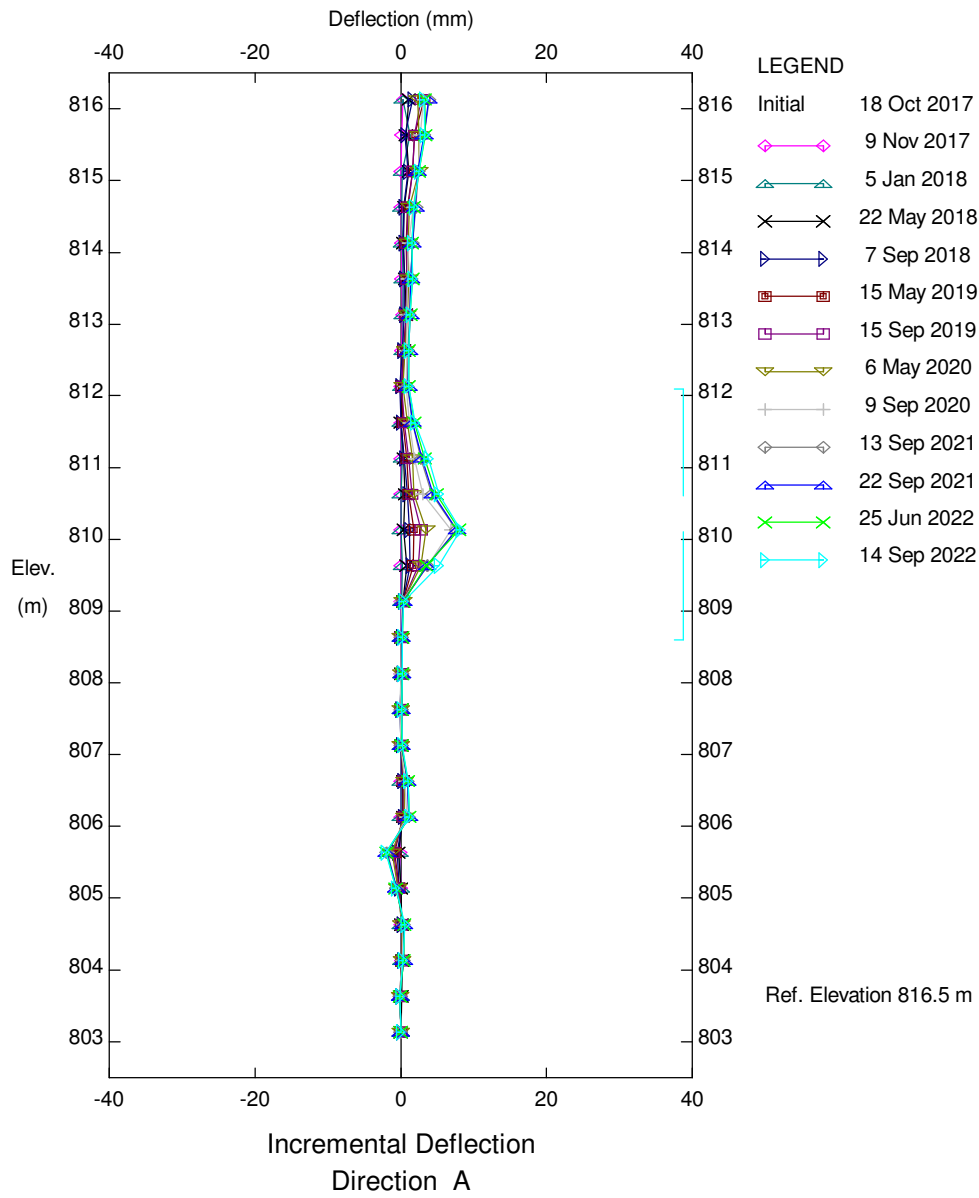
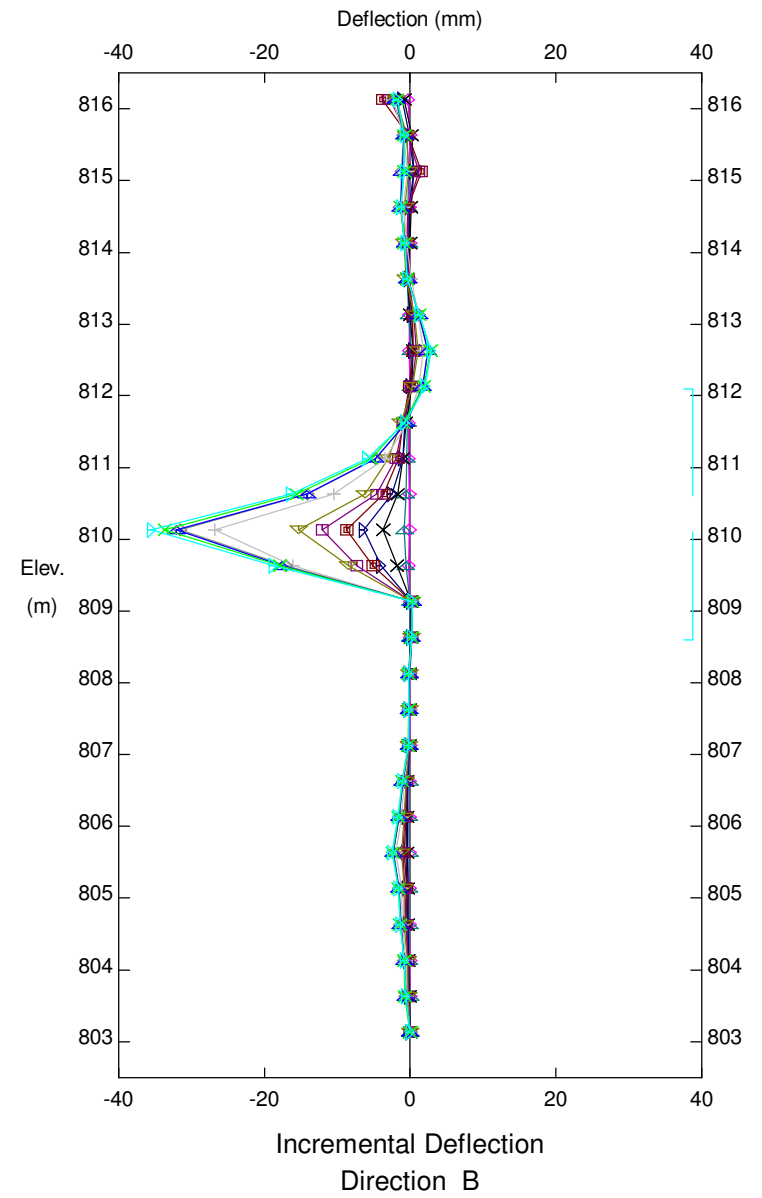
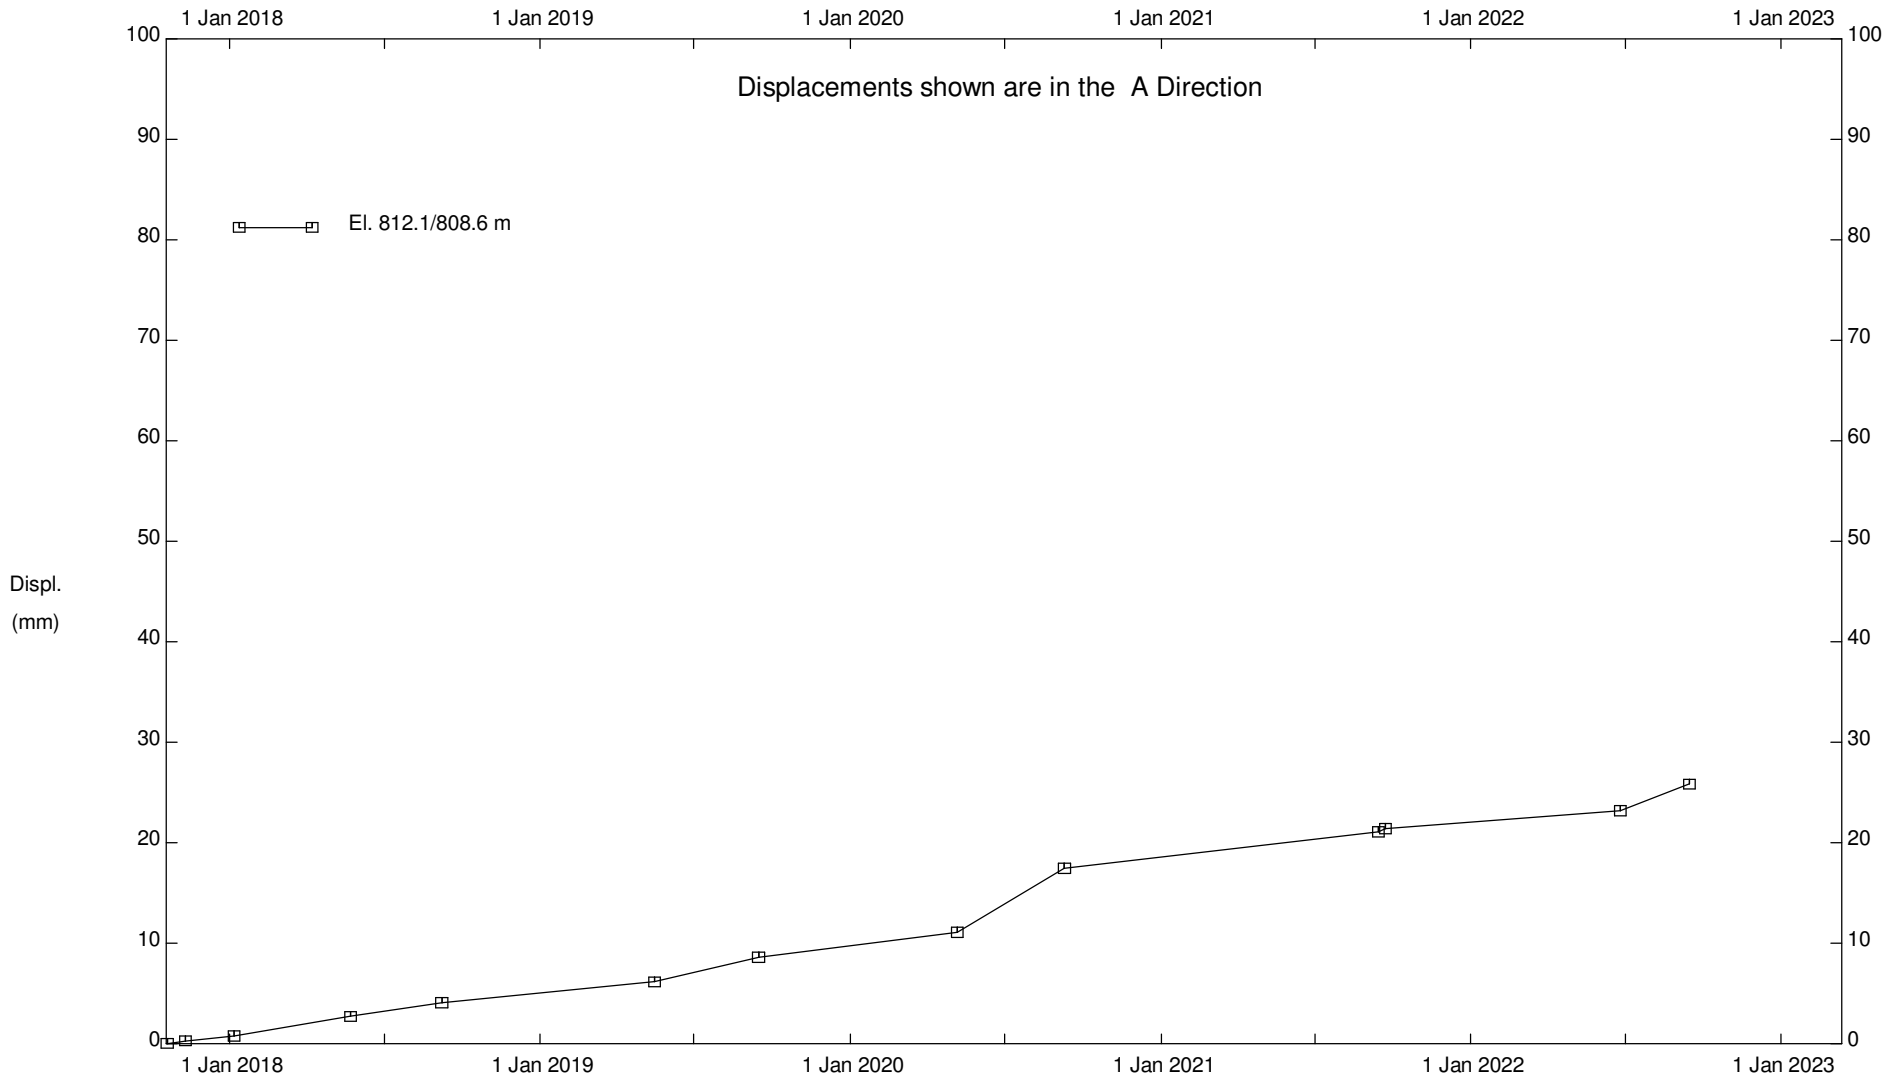
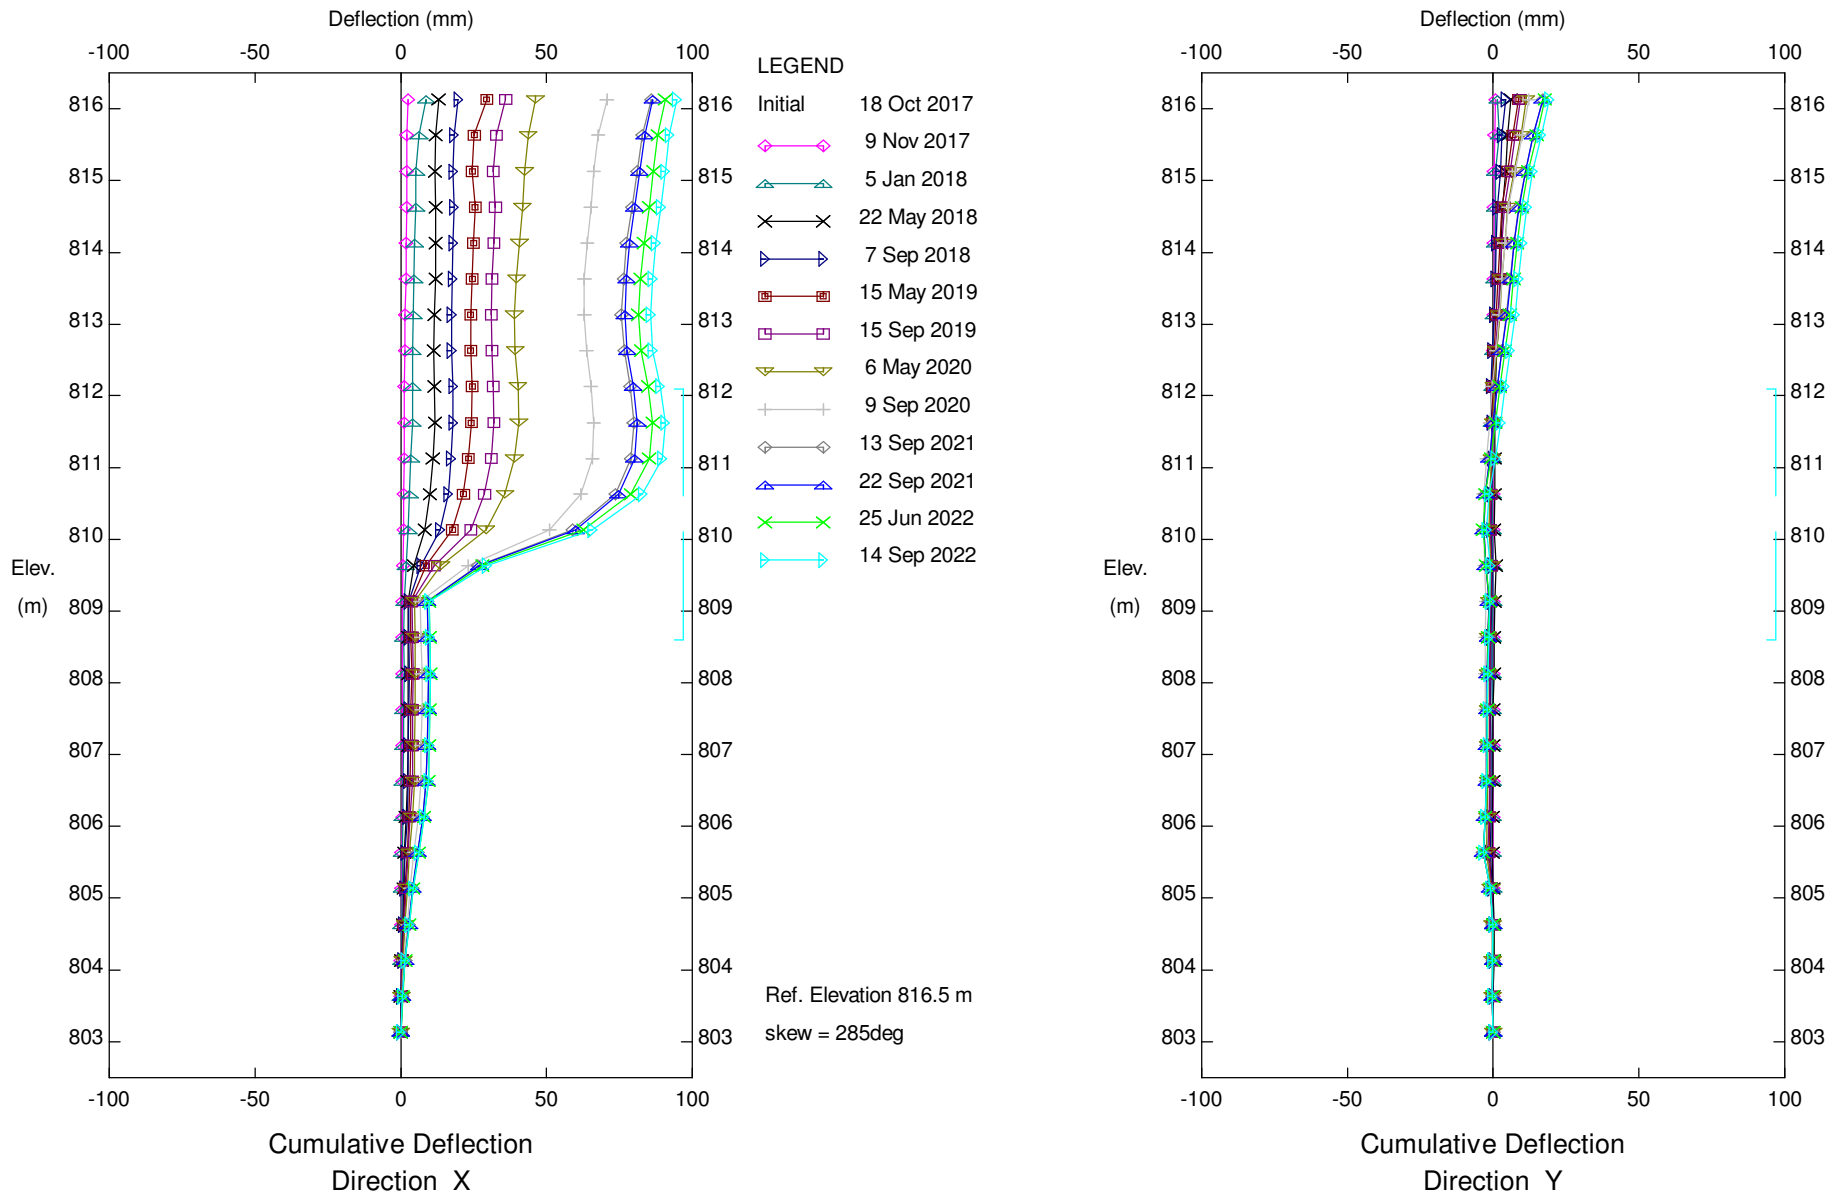
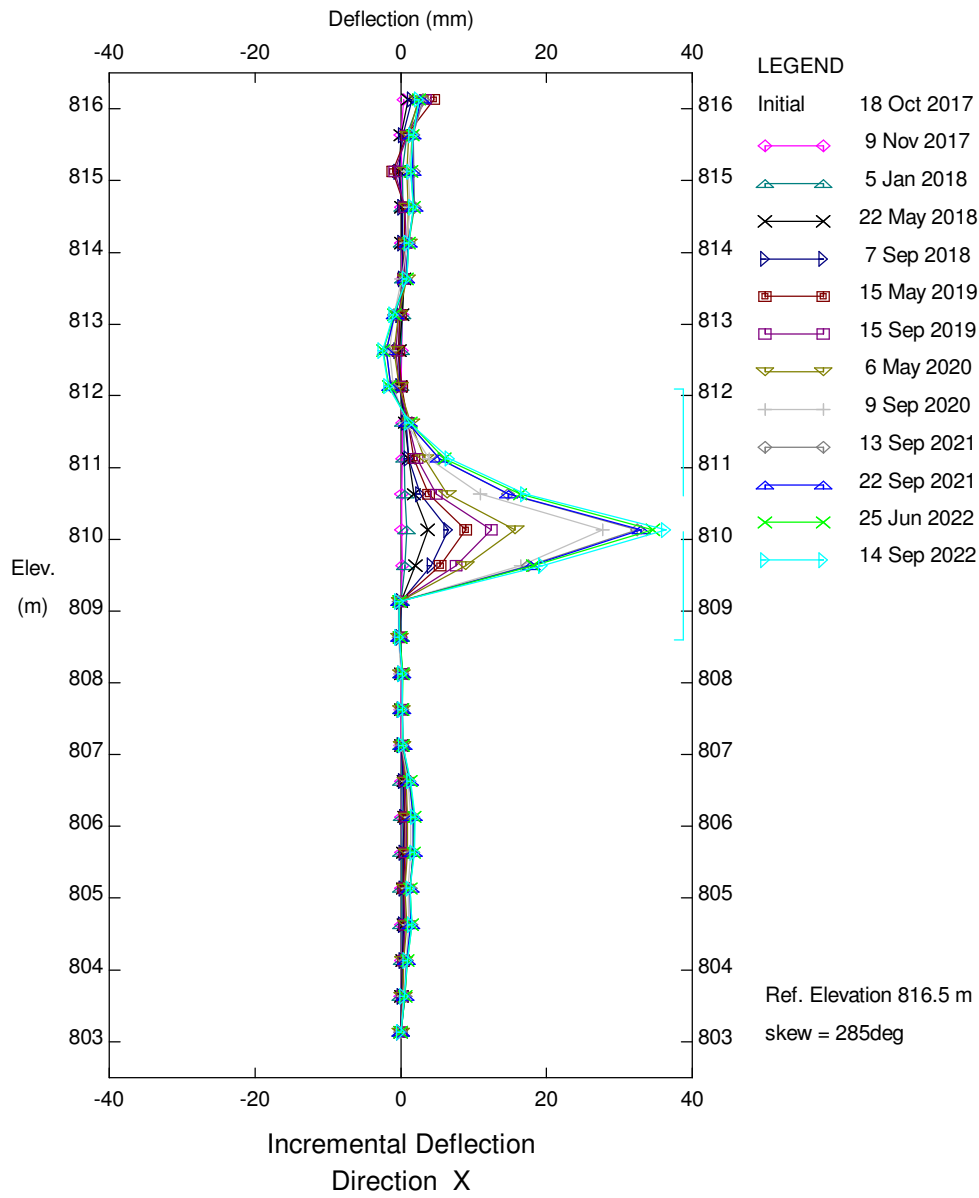
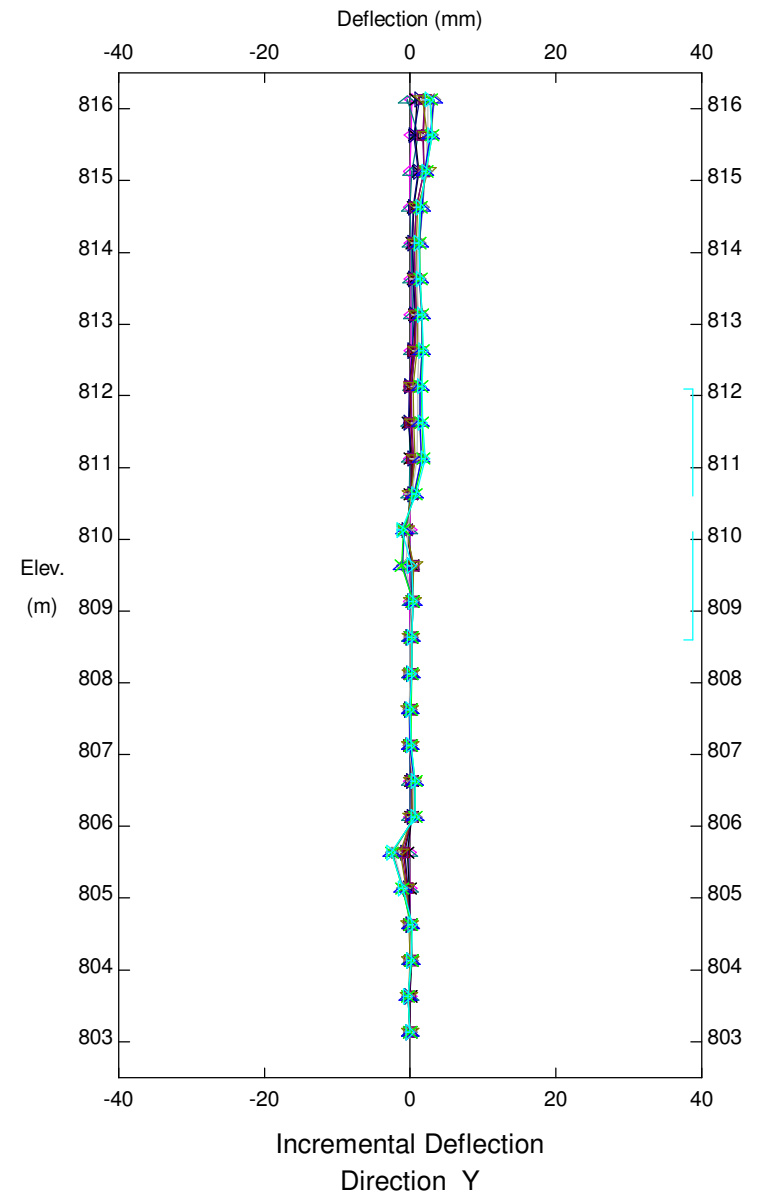
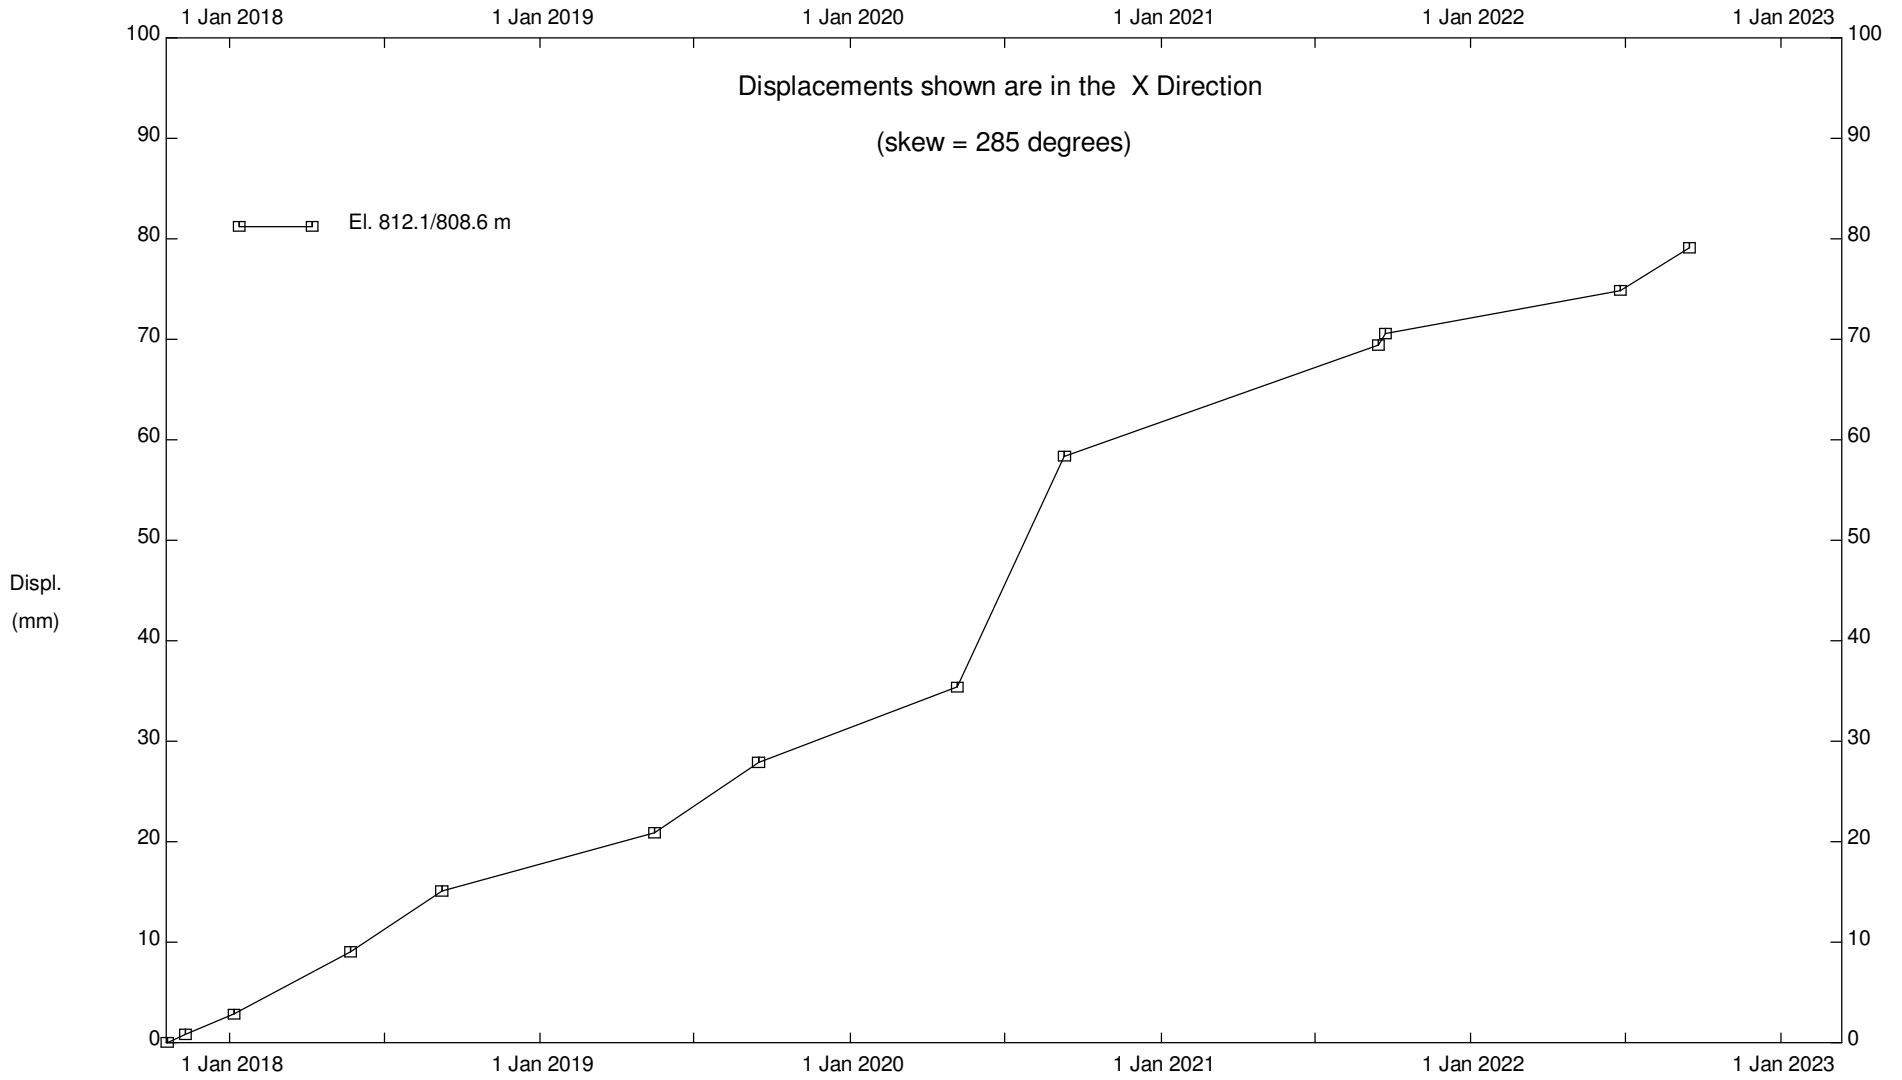
C065-III; H585:02, East of Trochu, Inclinometer SI17-C65-02

Discrete movement (i.e., movement occurring on a defined failure plane) is being recorded in SI17-C65-02 between an approximate depth of 6.0 m to 7.5 m below ground surface, at the interface between clay colluvium and bedrock. Since June 2021, a pinch has been felt in the SI casing at this depth.

In September 2020 and 2021, an increased rate of movement (approximately 67 mm/year and 44 mm/year, respectively) was recorded in SI17-C65-02. The increase in 2020 was most likely attributed to wetter weather, while the 2021 increase was likely due to construction activities at the C065 site (e.g., heavy truck traffic, increased traffic in the westbound lane during eastbound lane closures, and channel excavation at the C065-III site). The rate of movement has since decreased and is now less than 20 mm/year (similar to the rate of movement before construction). More data is

Between June and September 2022, an increased rate of movement (approximately 19 mm/year) was recorded in SI17-C65-02 likely in response to wet weather in June and July 2022. The previous year and the spring of 2022 were relatively dry.

Approximately 79 mm of movement has been recorded in SI17-C65-02 since installation. Since the spring of 2021, a zone of tightness has been observed during readings of this instrument at an approximate depth of 7 m below ground surface. This instrument could shear soon depending on post-construction movement rates.
