**Tony Penney, P.Eng.**  
**Construction Engineer**

**CON0022160 Central Region GRMP Instrumentation Monitoring  
Site C065; H585:02, km 16.136 East of Trochu Slides  
Section C – 2022 Fall Readings**

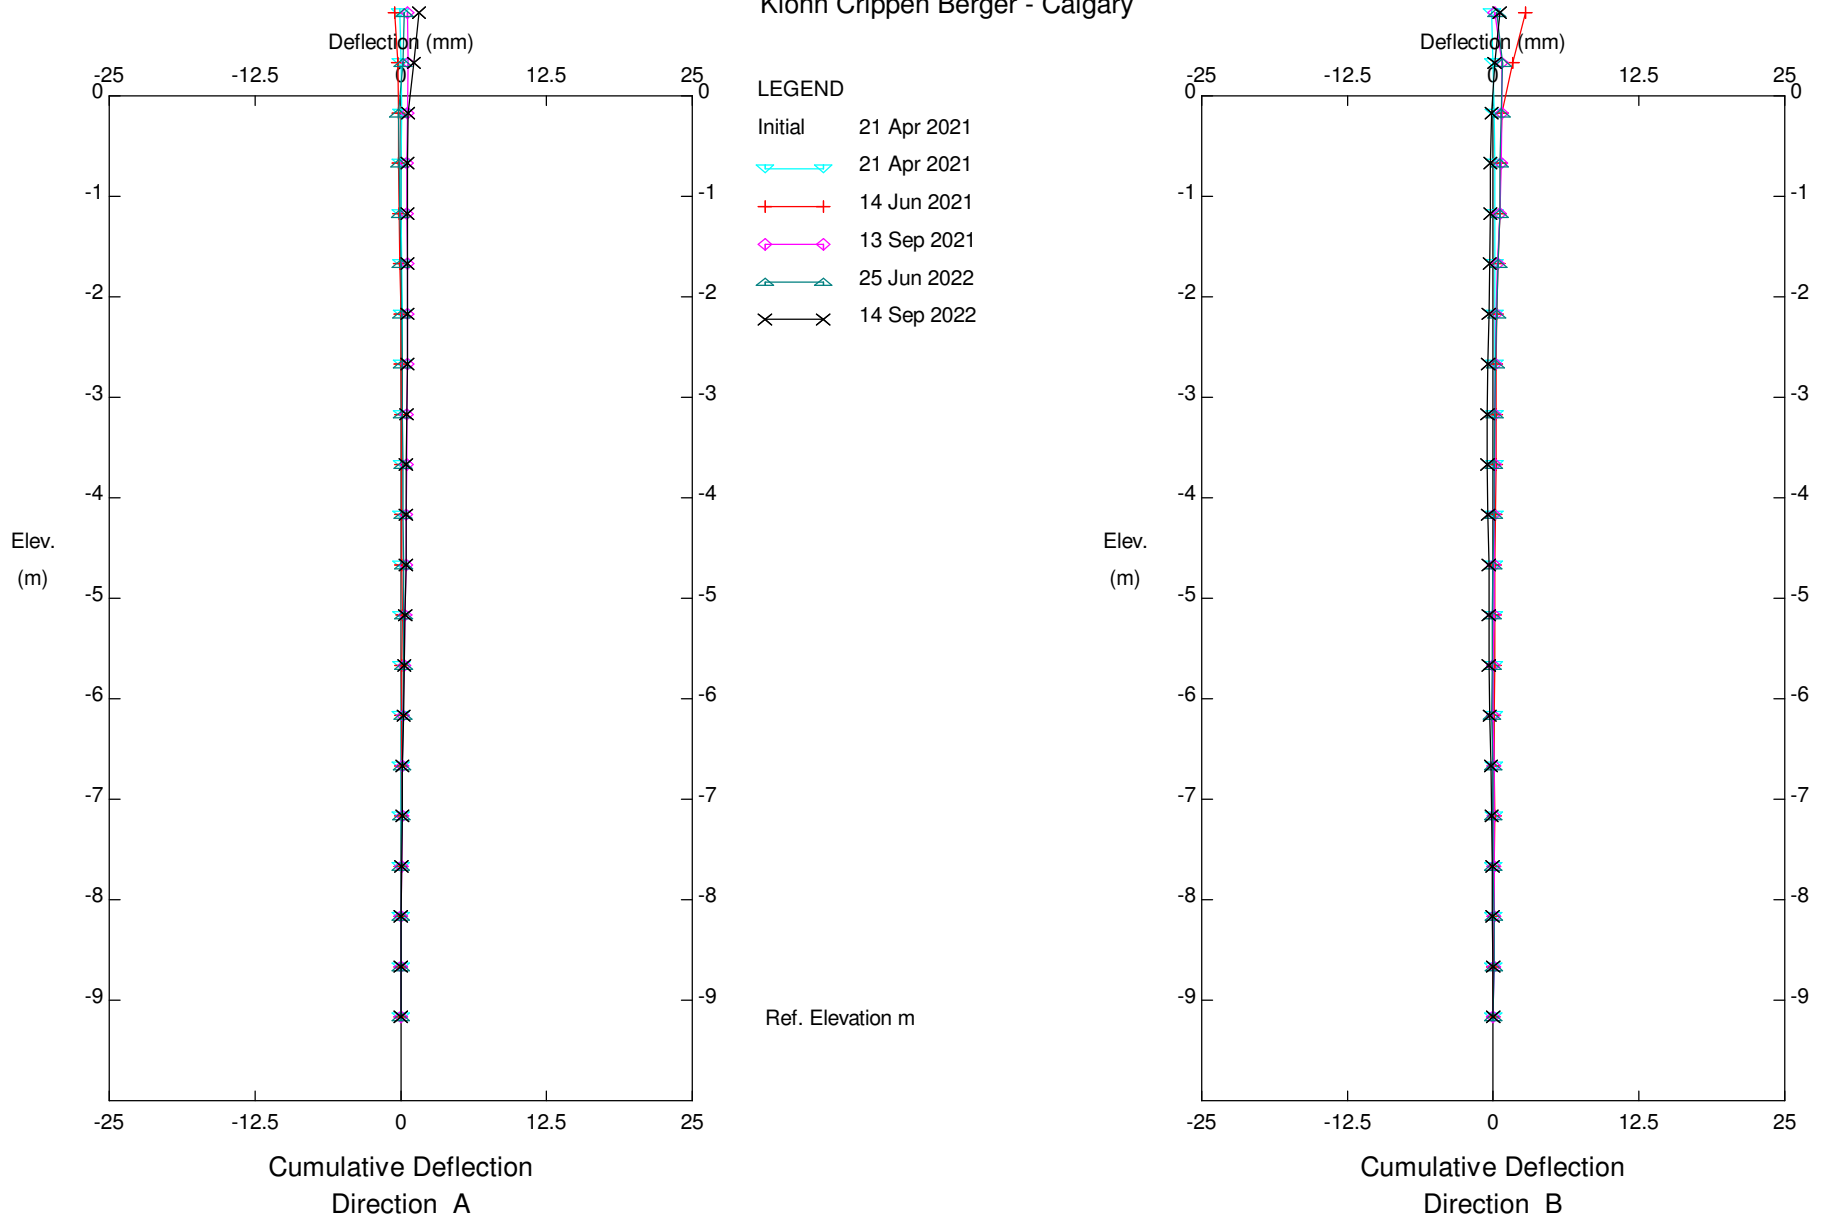
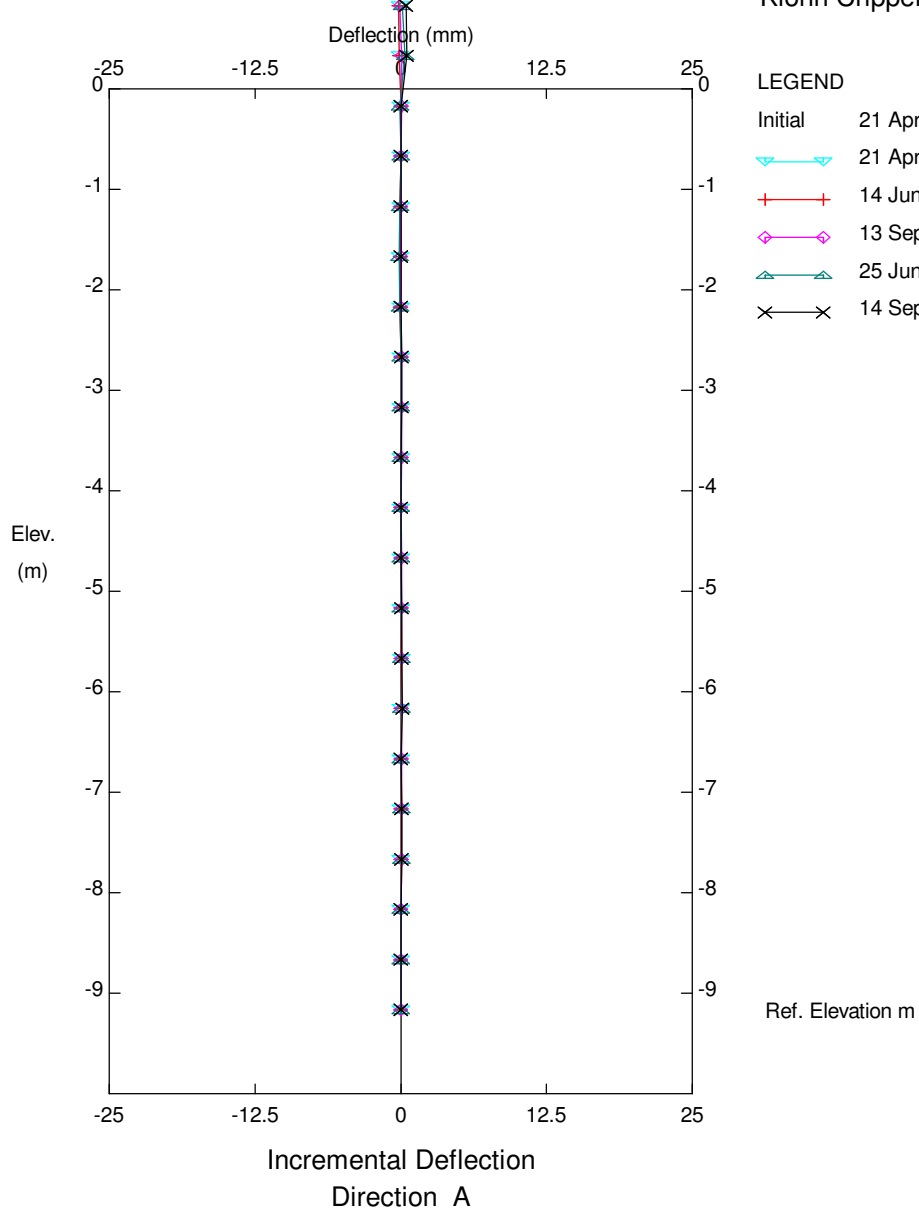
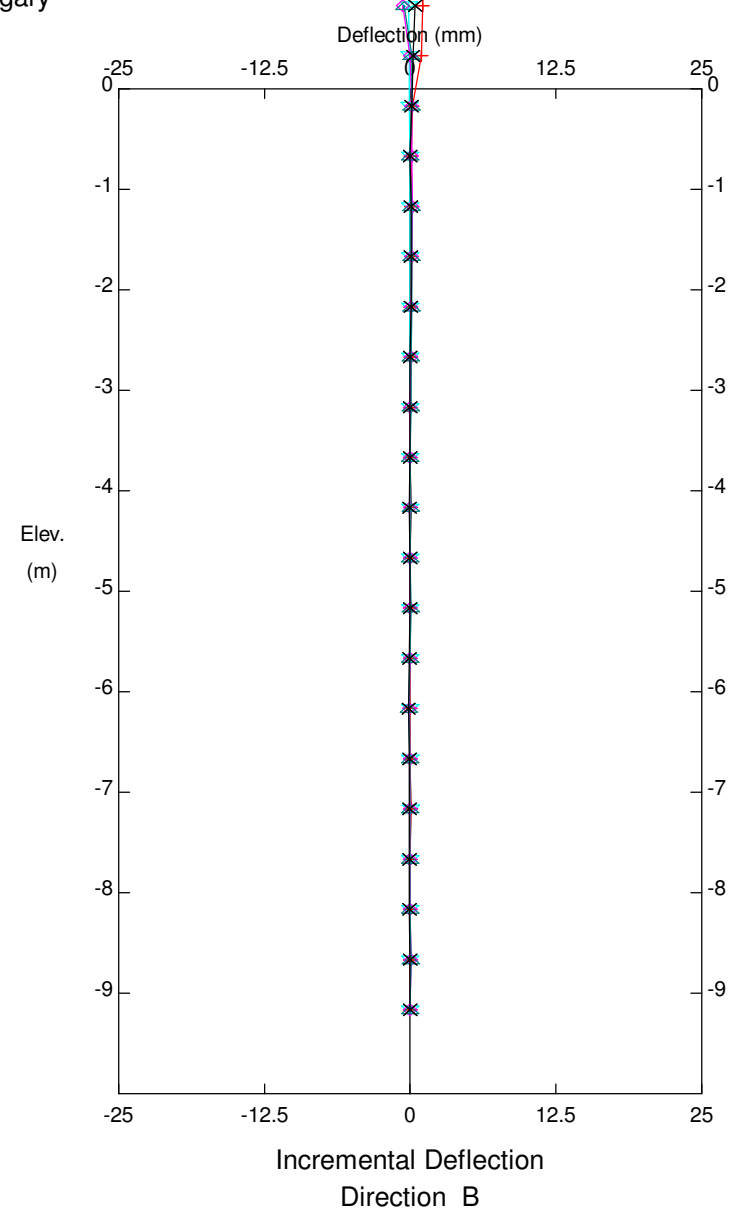
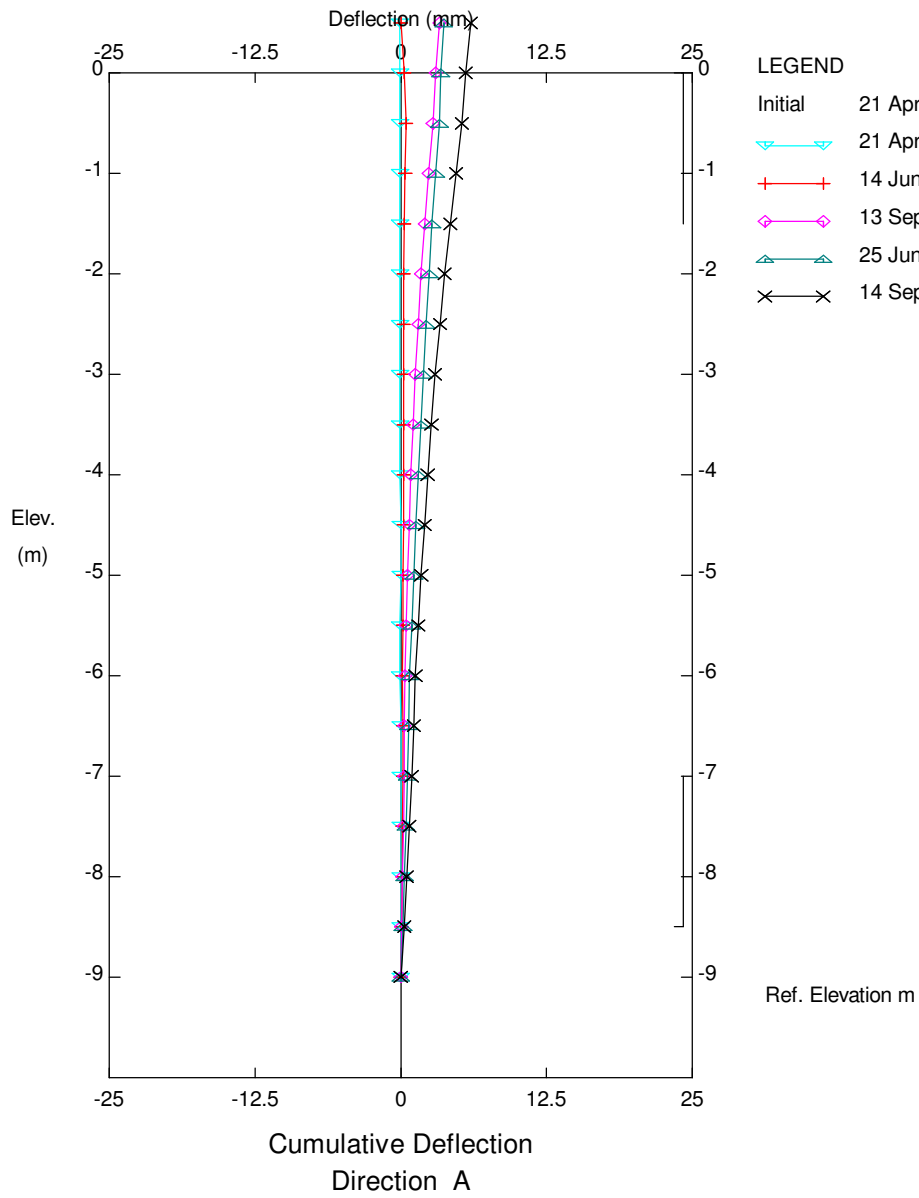
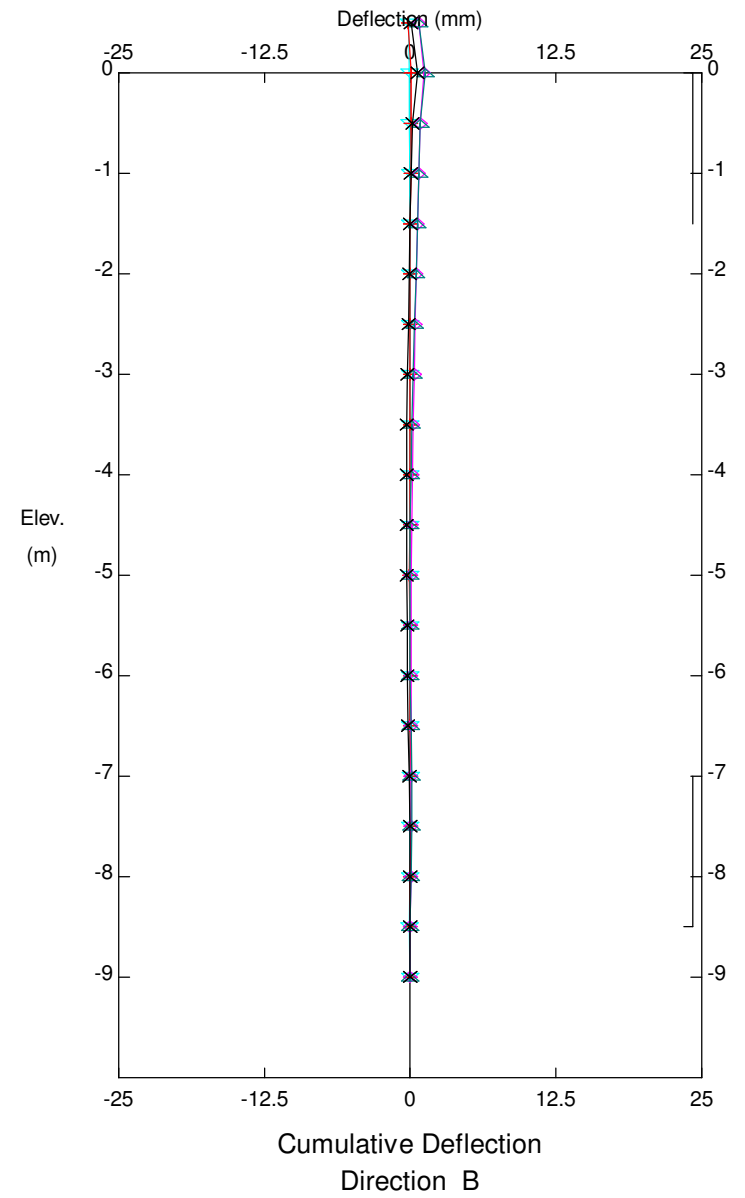
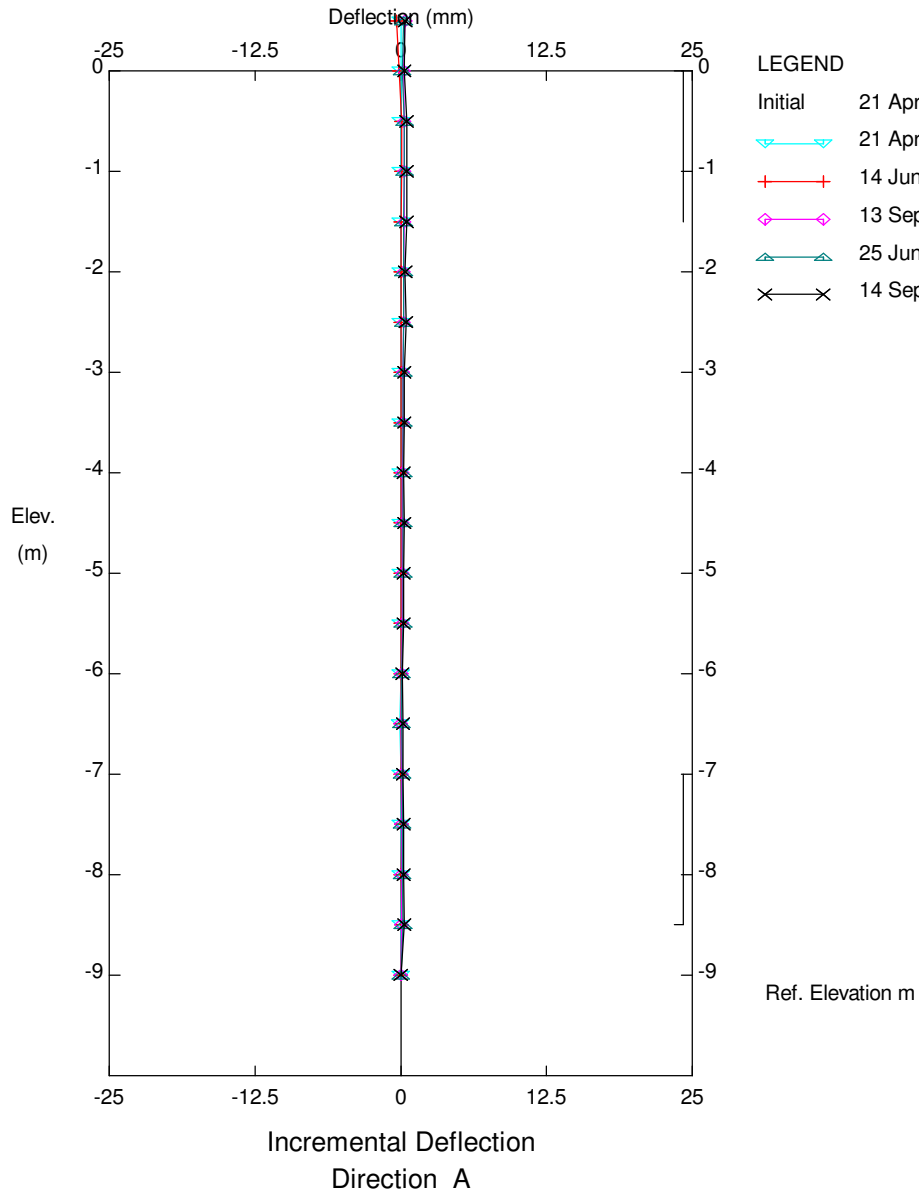
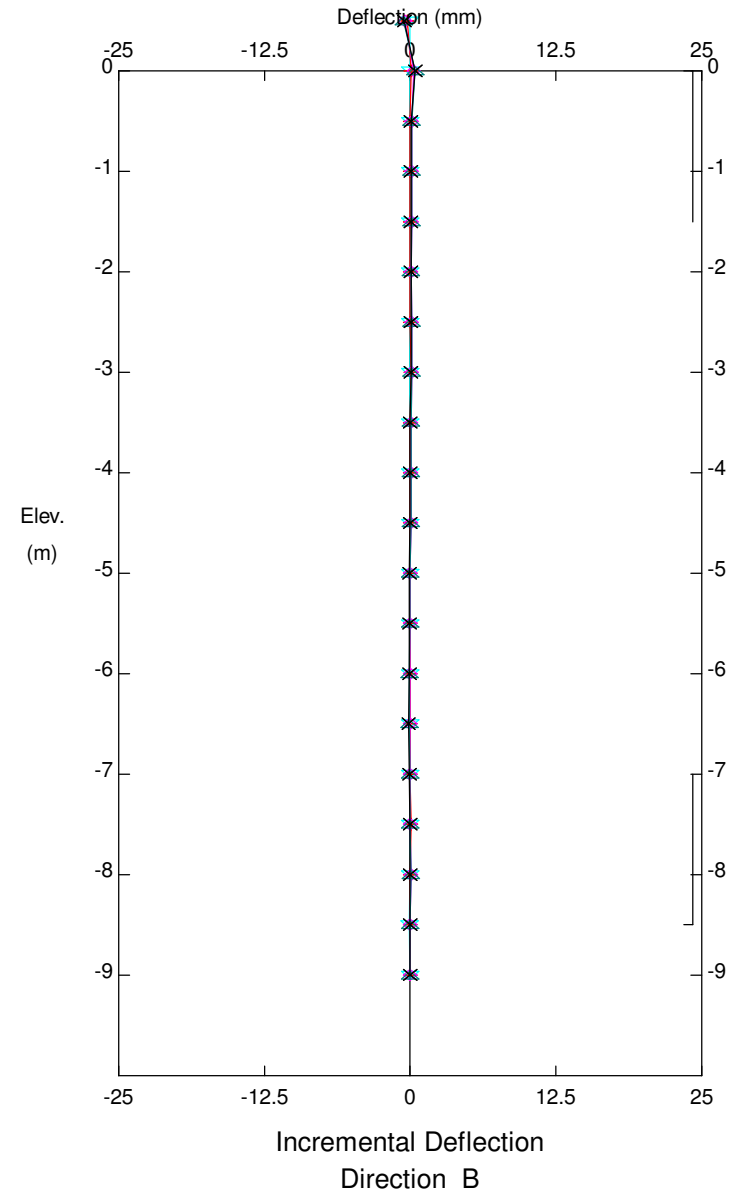
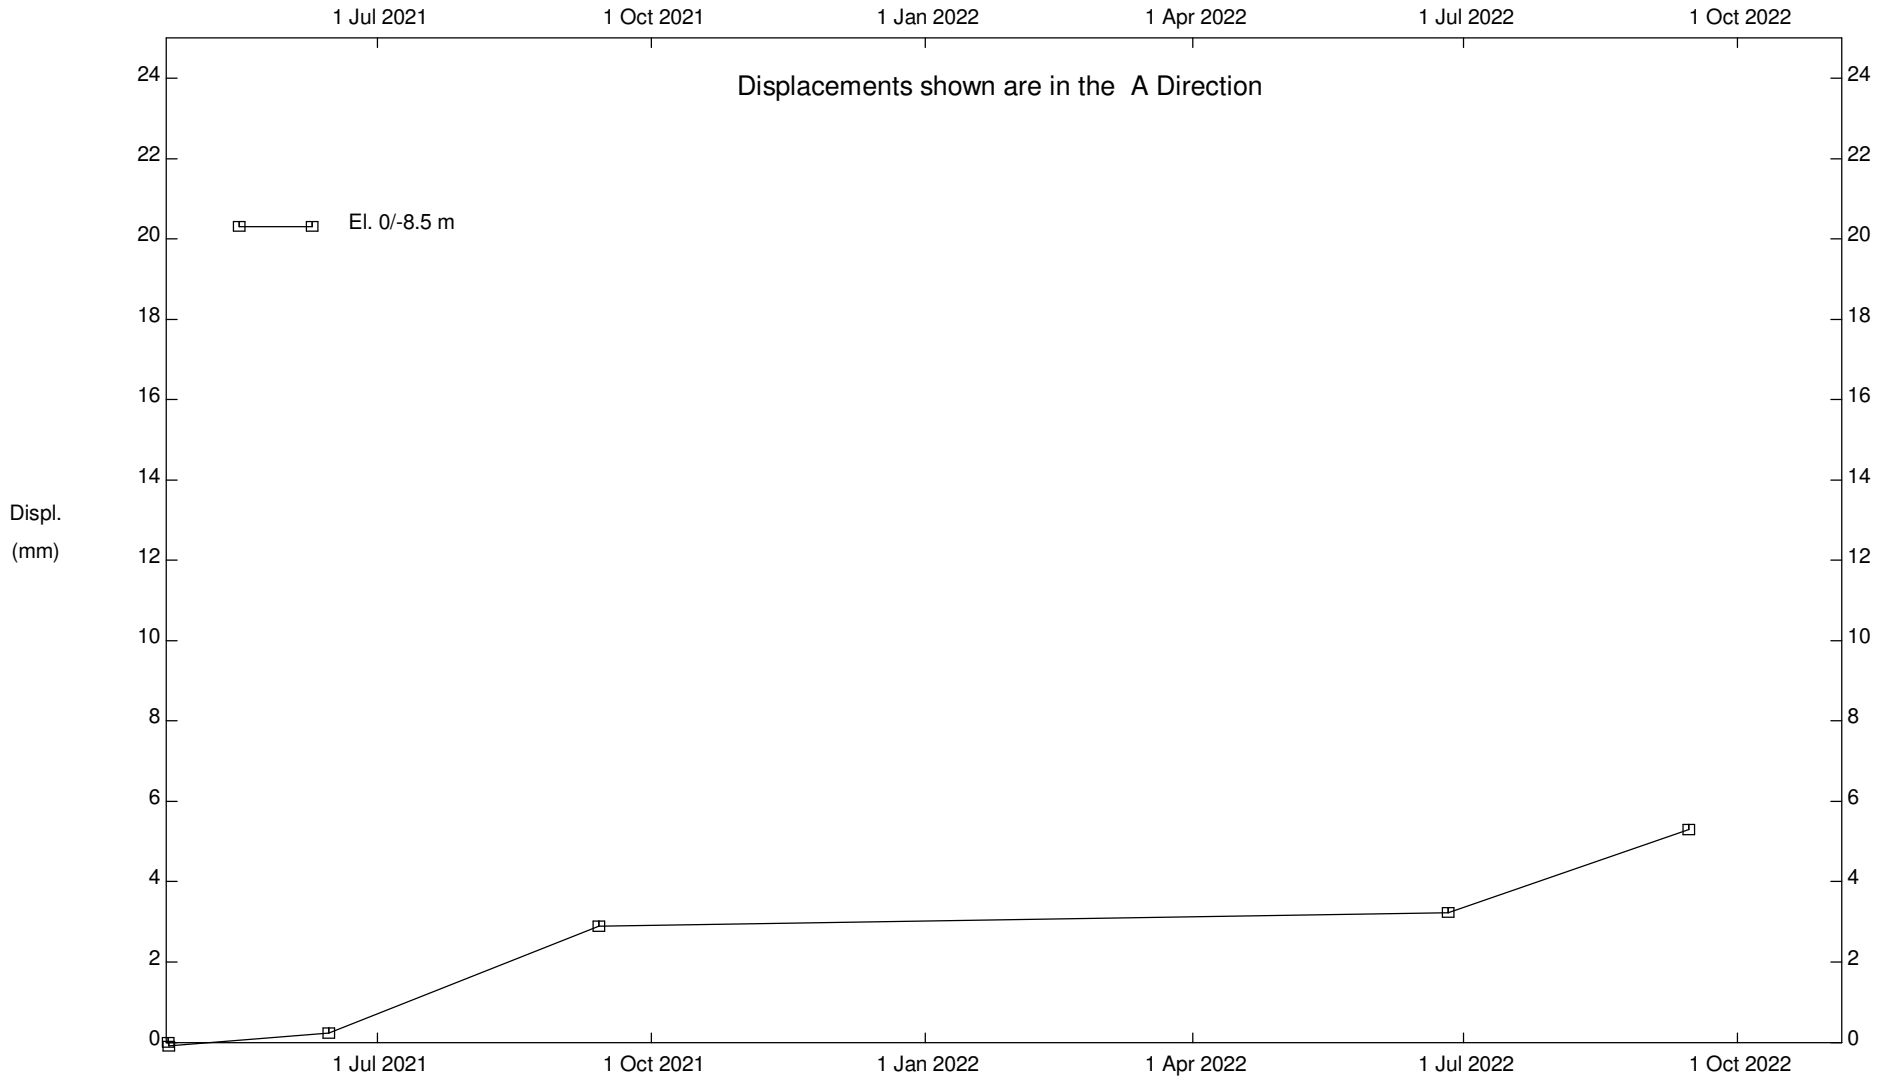
C065-IV; H585:02, East of Trochu, Inclinometer SI21-C65-02

The lowest depth of movement being recorded in one of the pile-wall SIs (SI21-C65-02) is near the base of the instrument. The H-pile wall is 10 m deep, and SI21-C65-01 and SI21-C65-02 are approximately 9.6 m and 9.4 m deep, respectively.

The depth of movement being recorded in SI21-C65-02 appears to be from ground surface to the base of the instrument (i.e., along the entire depth of the pile wall). This could indicate rotation around the toe of the pile-wall or that the pile-wall may not have intercepted a deeper failure plane. More data is needed to assess the movement trend for this instrument.

The September 2022 data obtained from the pile-wall SIs indicates that the top of the H-pile wall has deflected up to approximately 3 mm since installation. In the spring of 2021, shortly after construction of the H-pile wall, the maximum rate of movement recorded in these SIs was between approximately 3 mm/year and 11 mm/year. Between June and September 2022, an increased rate of movement (approximately 9 mm/year) was recorded in SI17-C65-02, likely in response to wet weather in June and July 2022. The previous year and the spring of 2022 were relatively dry.

Periodic MCI site visits should continue to assess if voids are still opening between the web and flanges of the H-piles. During the fall 2022 reading, several voids were observed at the top of the H-pile wall at the C065-IV site between SI21-C65-01 and SI21-C65-02. Additional sand backfill should be placed in the existing surface voids and any new surface voids that develop.

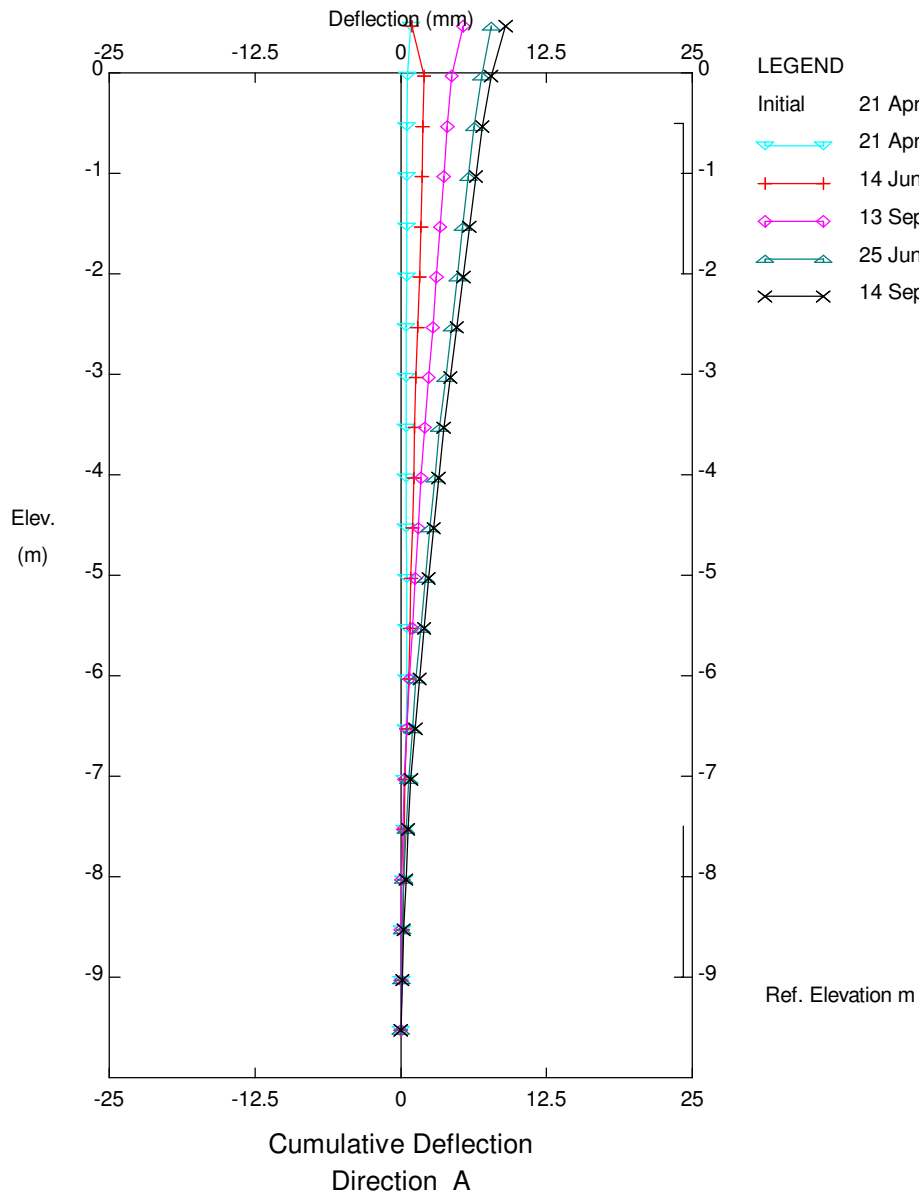
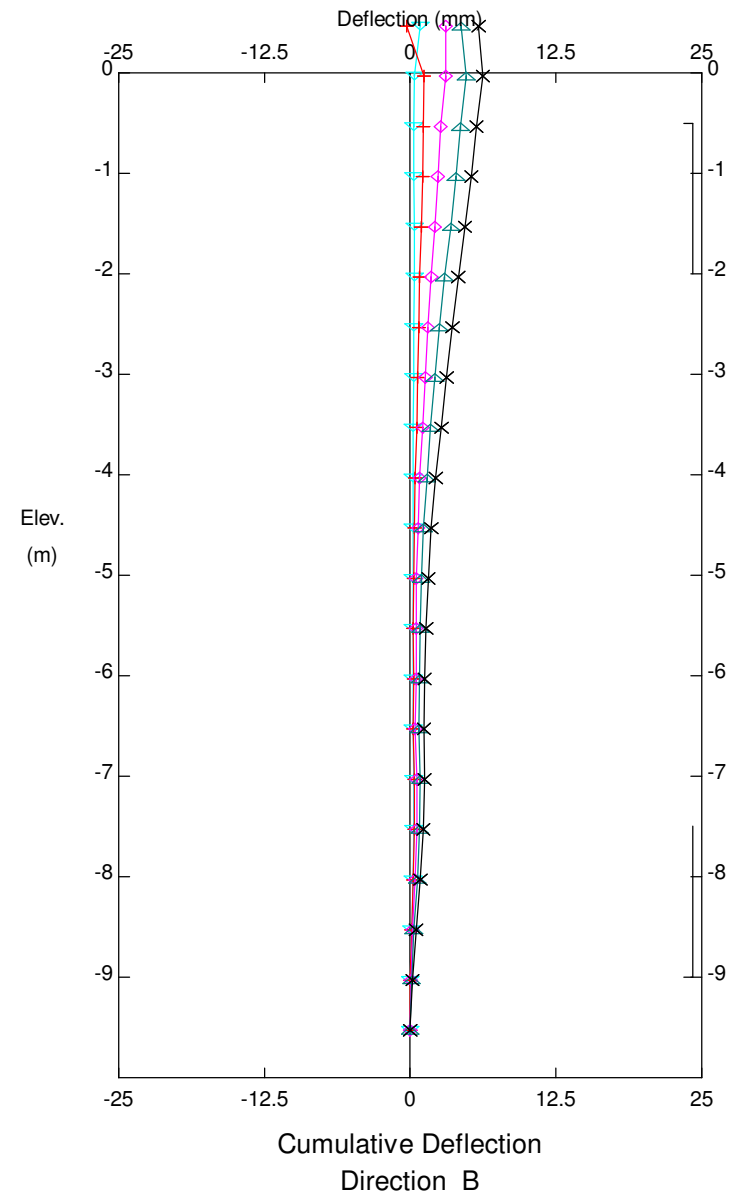
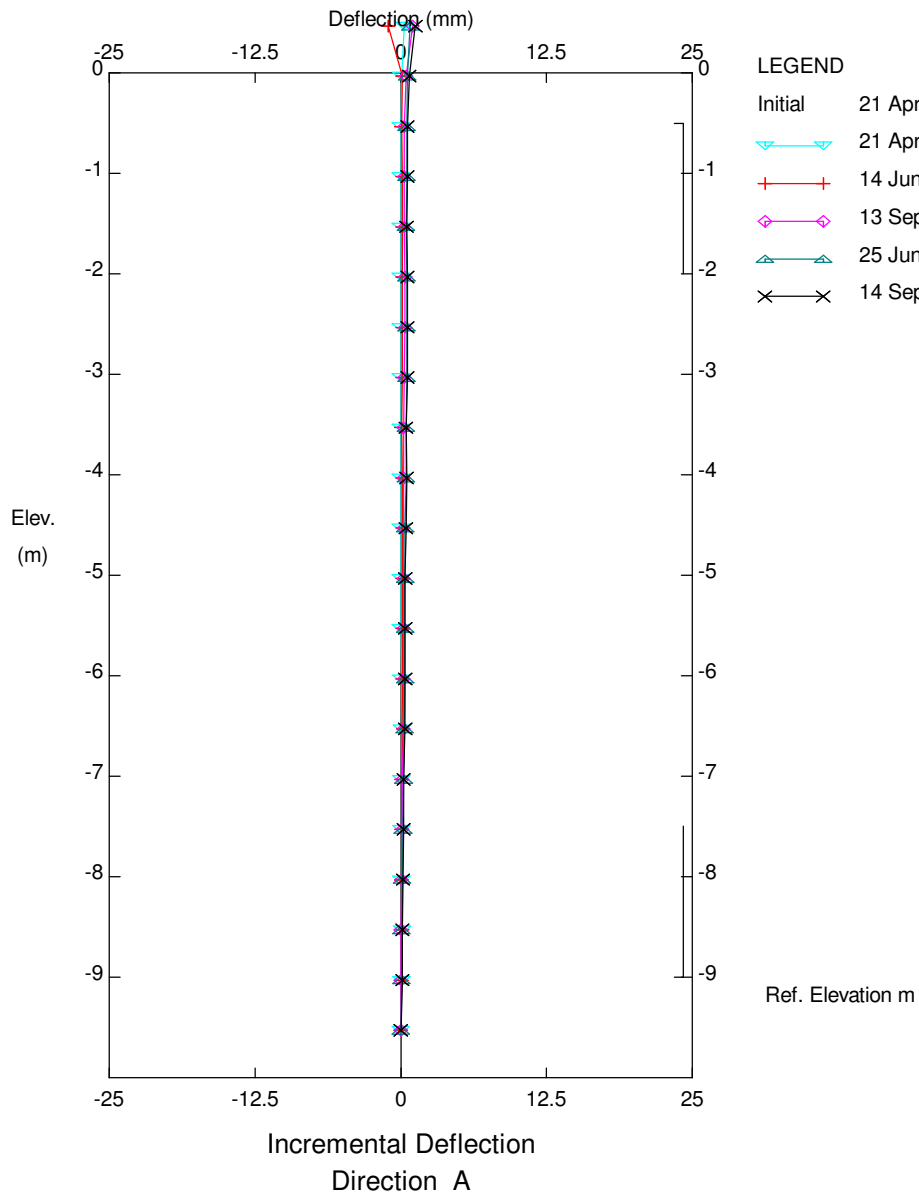
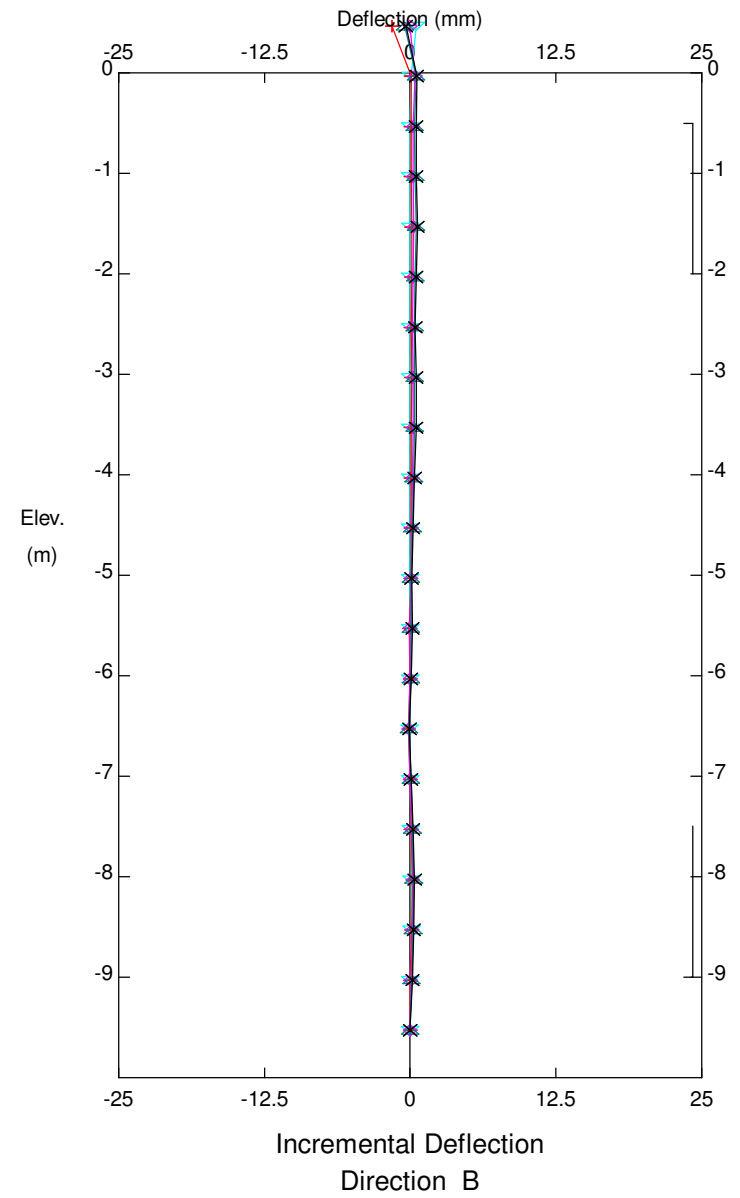
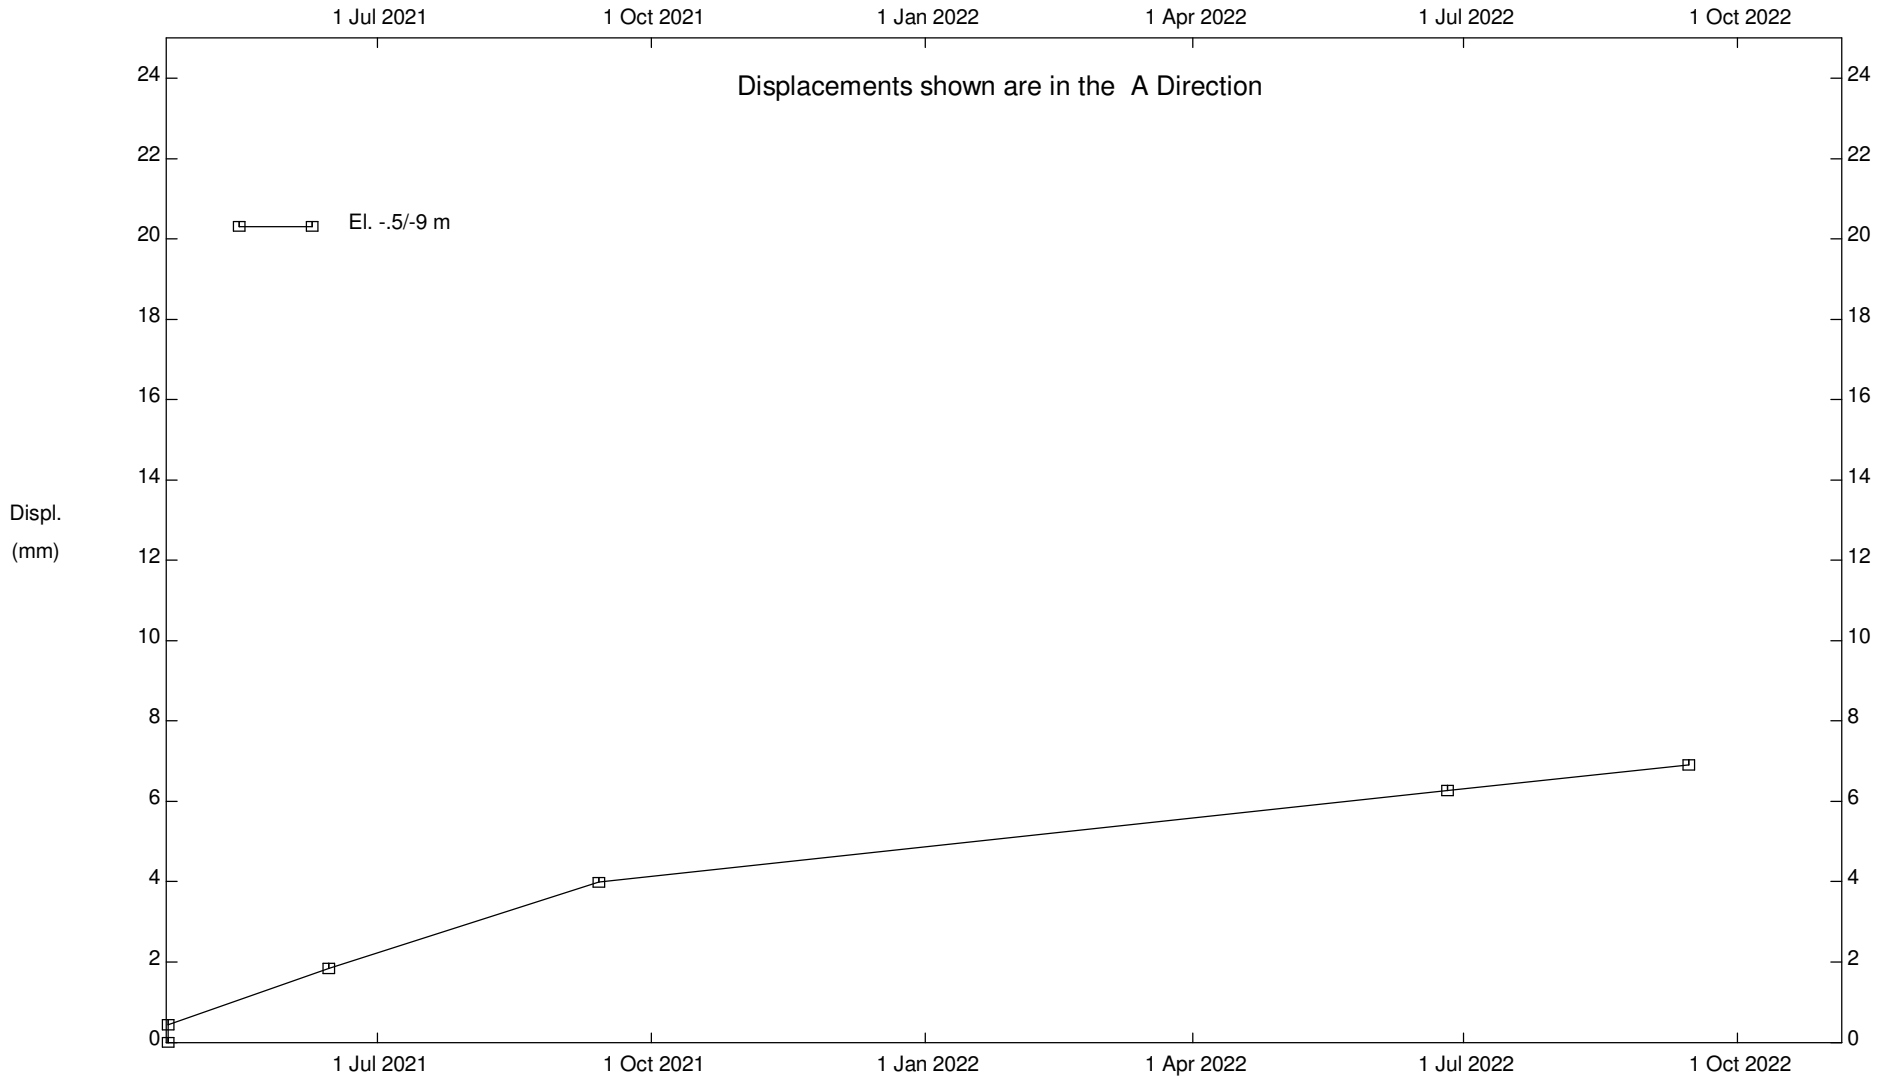
C065-V; H585:02, East of Trochu, Inclinator SI21-C65-03  
Alberta Transportation

The lowest depth of movement being recorded in the pile-wall SI (SI21-C65-03) is near the base of the instrument. The H-pile wall and SI21-C65-03 are both 10 m deep.

The depth of movement being recorded in the pile-wall SI (SI21-C65-03) appears to be occurring from ground surface to near the base of the H-pile wall. This could indicate rotation around the toe of the

The September 2022 data obtained from the pile-wall SI indicates that the top of the H-pile wall has deflected up to approximately 6 mm since installation. In the spring of 2021, shortly after construction of the H-pile wall, the maximum rate of movement recorded in this SI was approximately 10 mm/year. The rate of movement has since decreased and is now approximately 3 mm/year (unchanged between the spring and fall 2022 readings). KCB anticipated that the rate of movement shortly after installation would be highest and would decrease as the H-pile wall picked up load stabilizing the sliding mass.

Distributed movement (i.e., from top to bottom of casing) up to 5 mm has also been recorded in the B-direction of SI21-C65-03. It is unknown if this movement is due to post installation SI casing flexure, shifting in the steel pocket the SIs are installed in, or flexure/twist of the H-piles that is occurring due to the H-pile wall picking up load from the sliding mass. The rate of movement being recorded in the B-direction is slow (less than 5 mm/year).
