July 15, 2025

Alberta Transportation and Economic Corridors
4th Floor, Provincial Building
4920 – 51st Street
Red Deer, Alberta
T4N 6K8

CON0022160 Central Region GRMP Instrumentation Monitoring
Site C065; H585:02, km 16.136 East of Trochu Slides
Section C – 2025 Spring Readings

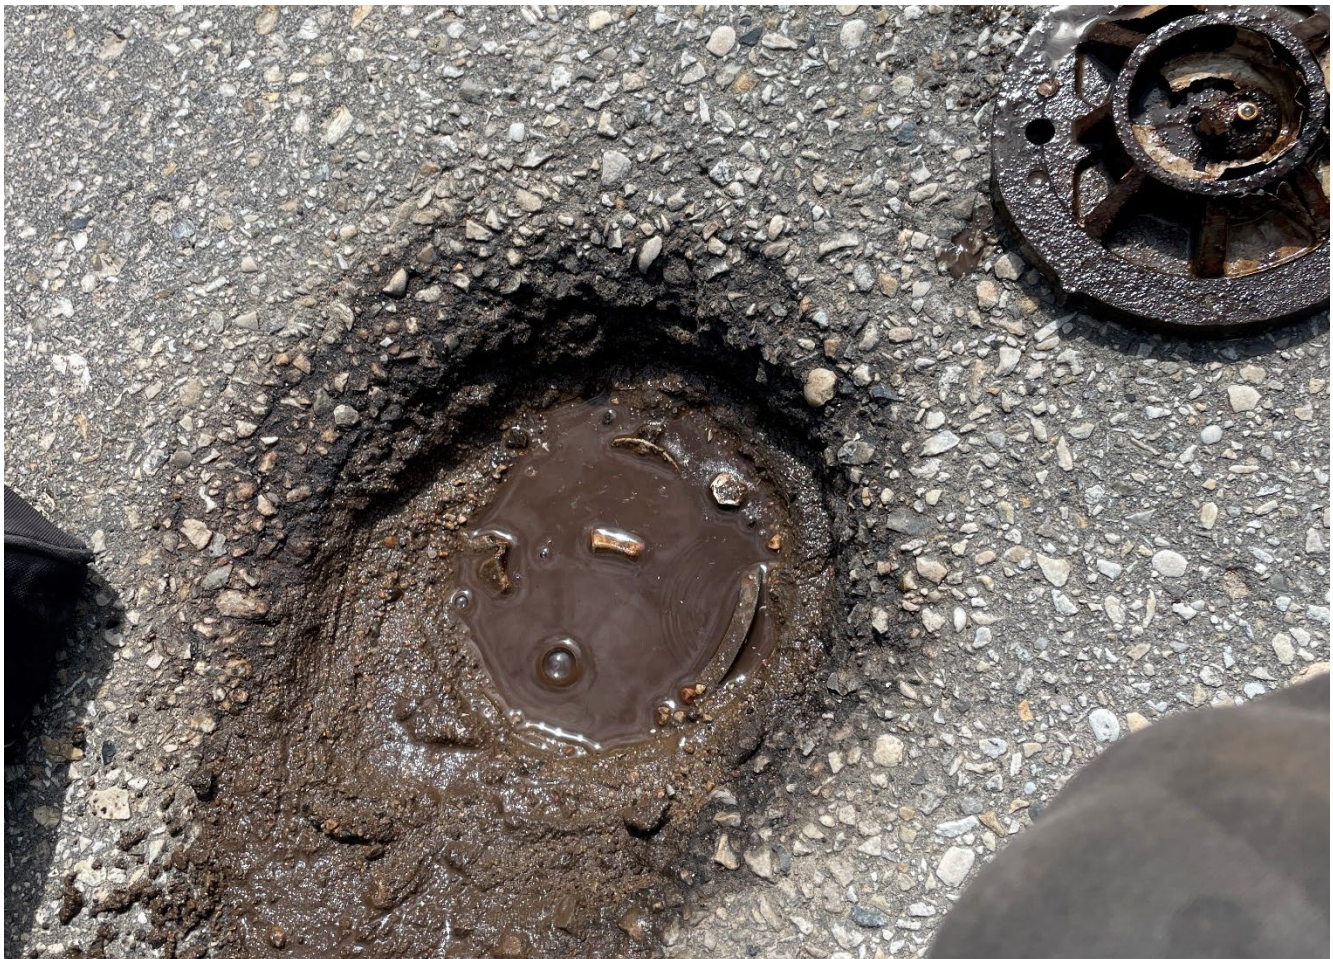
No instrumentation repairs are required. However, during the May 2025 readings, sand and turbid water were observed inside the flush-mounted headbox and SI casing, respectively, at the C065-3 subsite. KCB cleaned out the headbox. However, the SI casing should be flushed to remove any sediment that has settled to the bottom of the casing and the headbox cap should be installed so sand cannot enter the headbox.

Photo 3.1 Sand and turbid water inside the flush-mounted headbox at the C065-3 subsite.

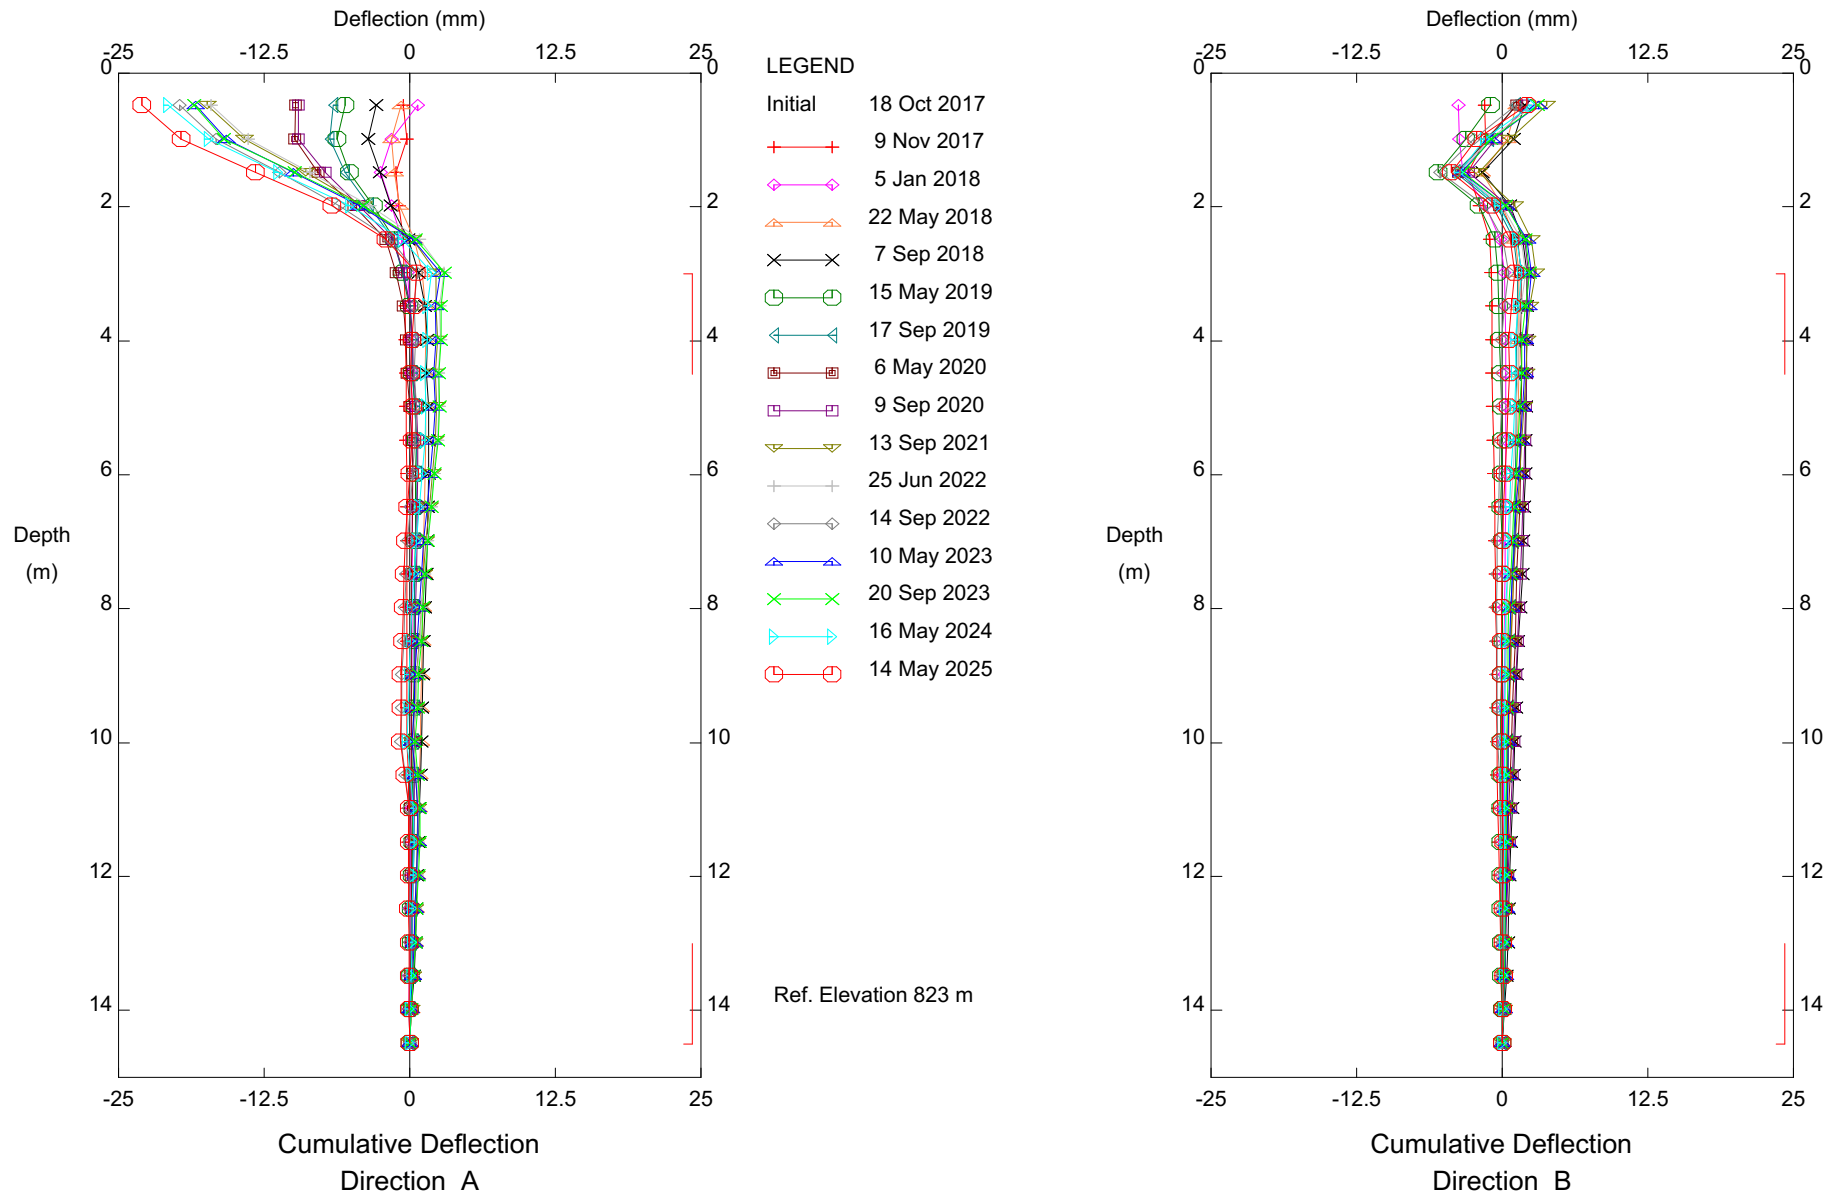
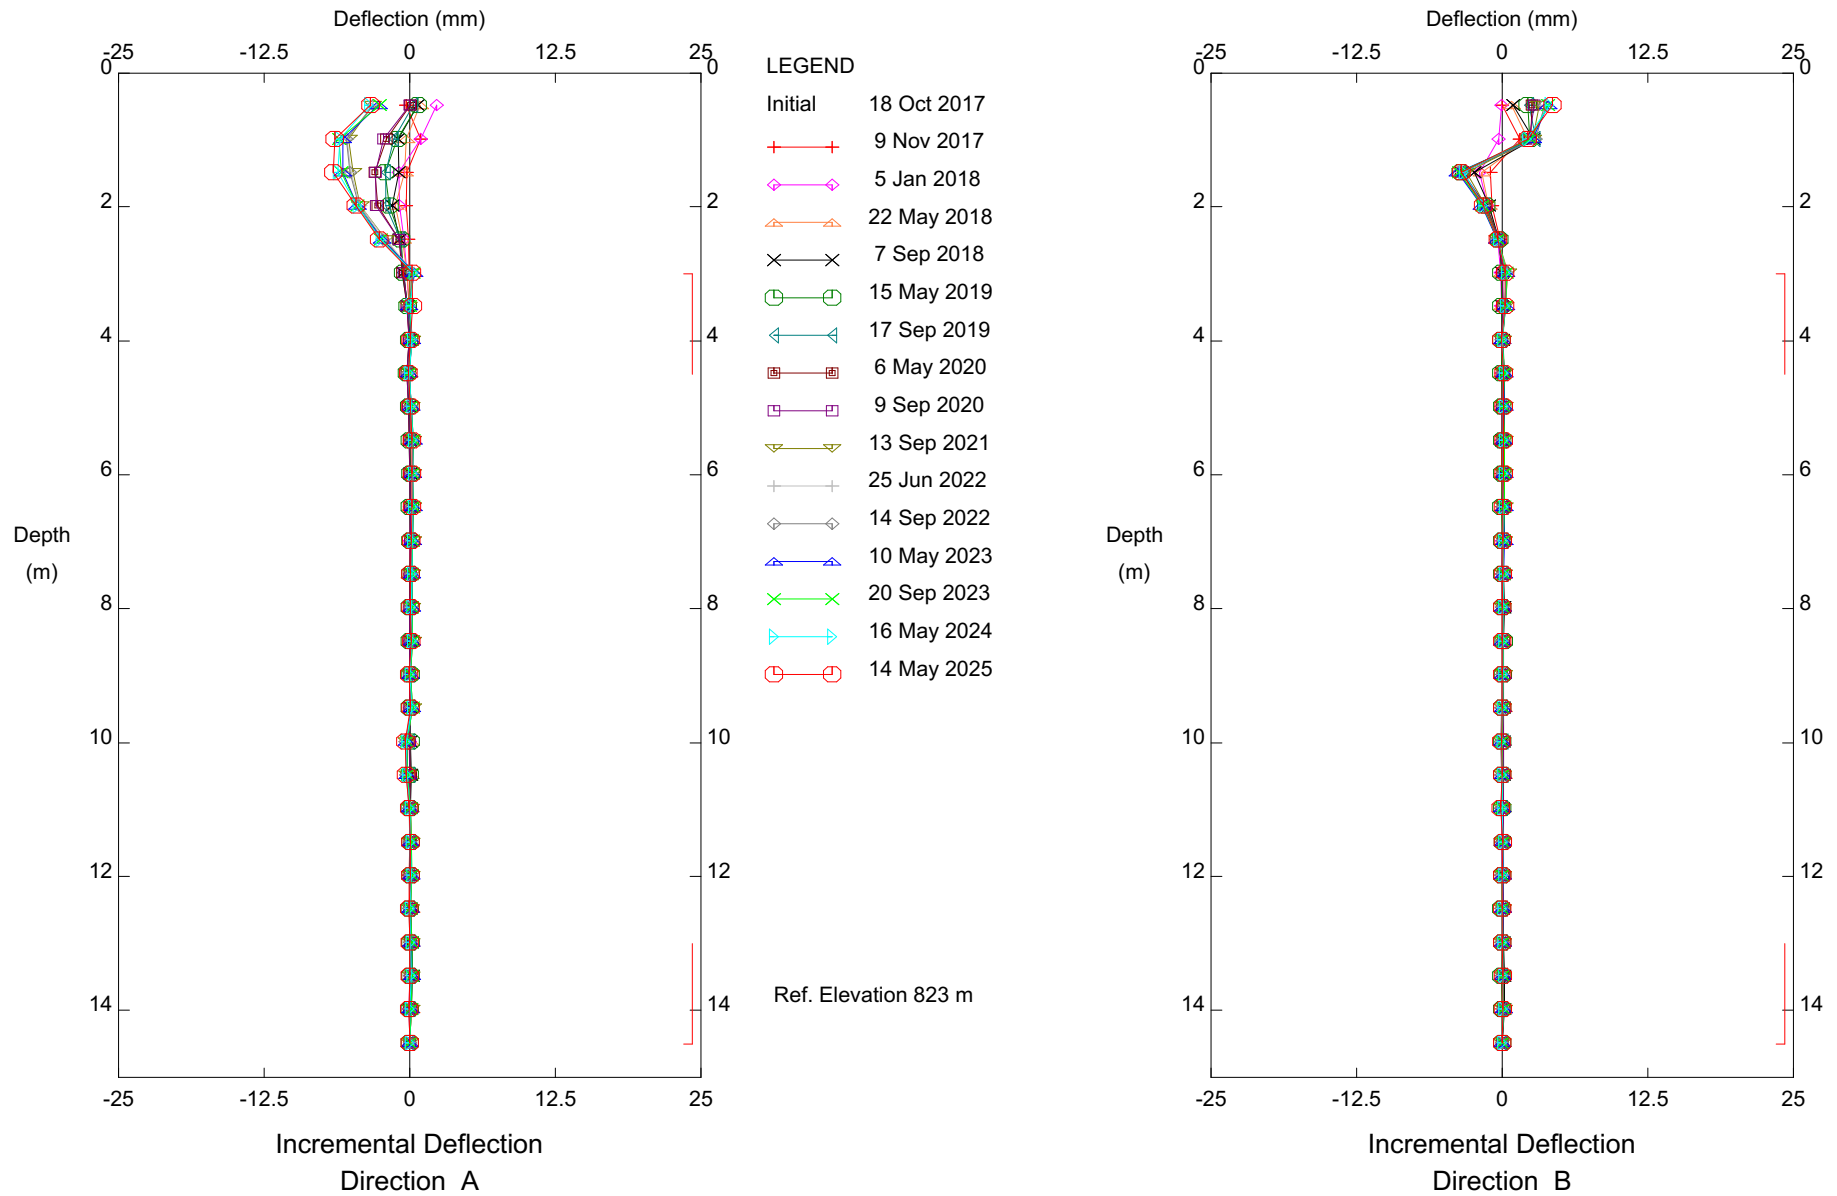
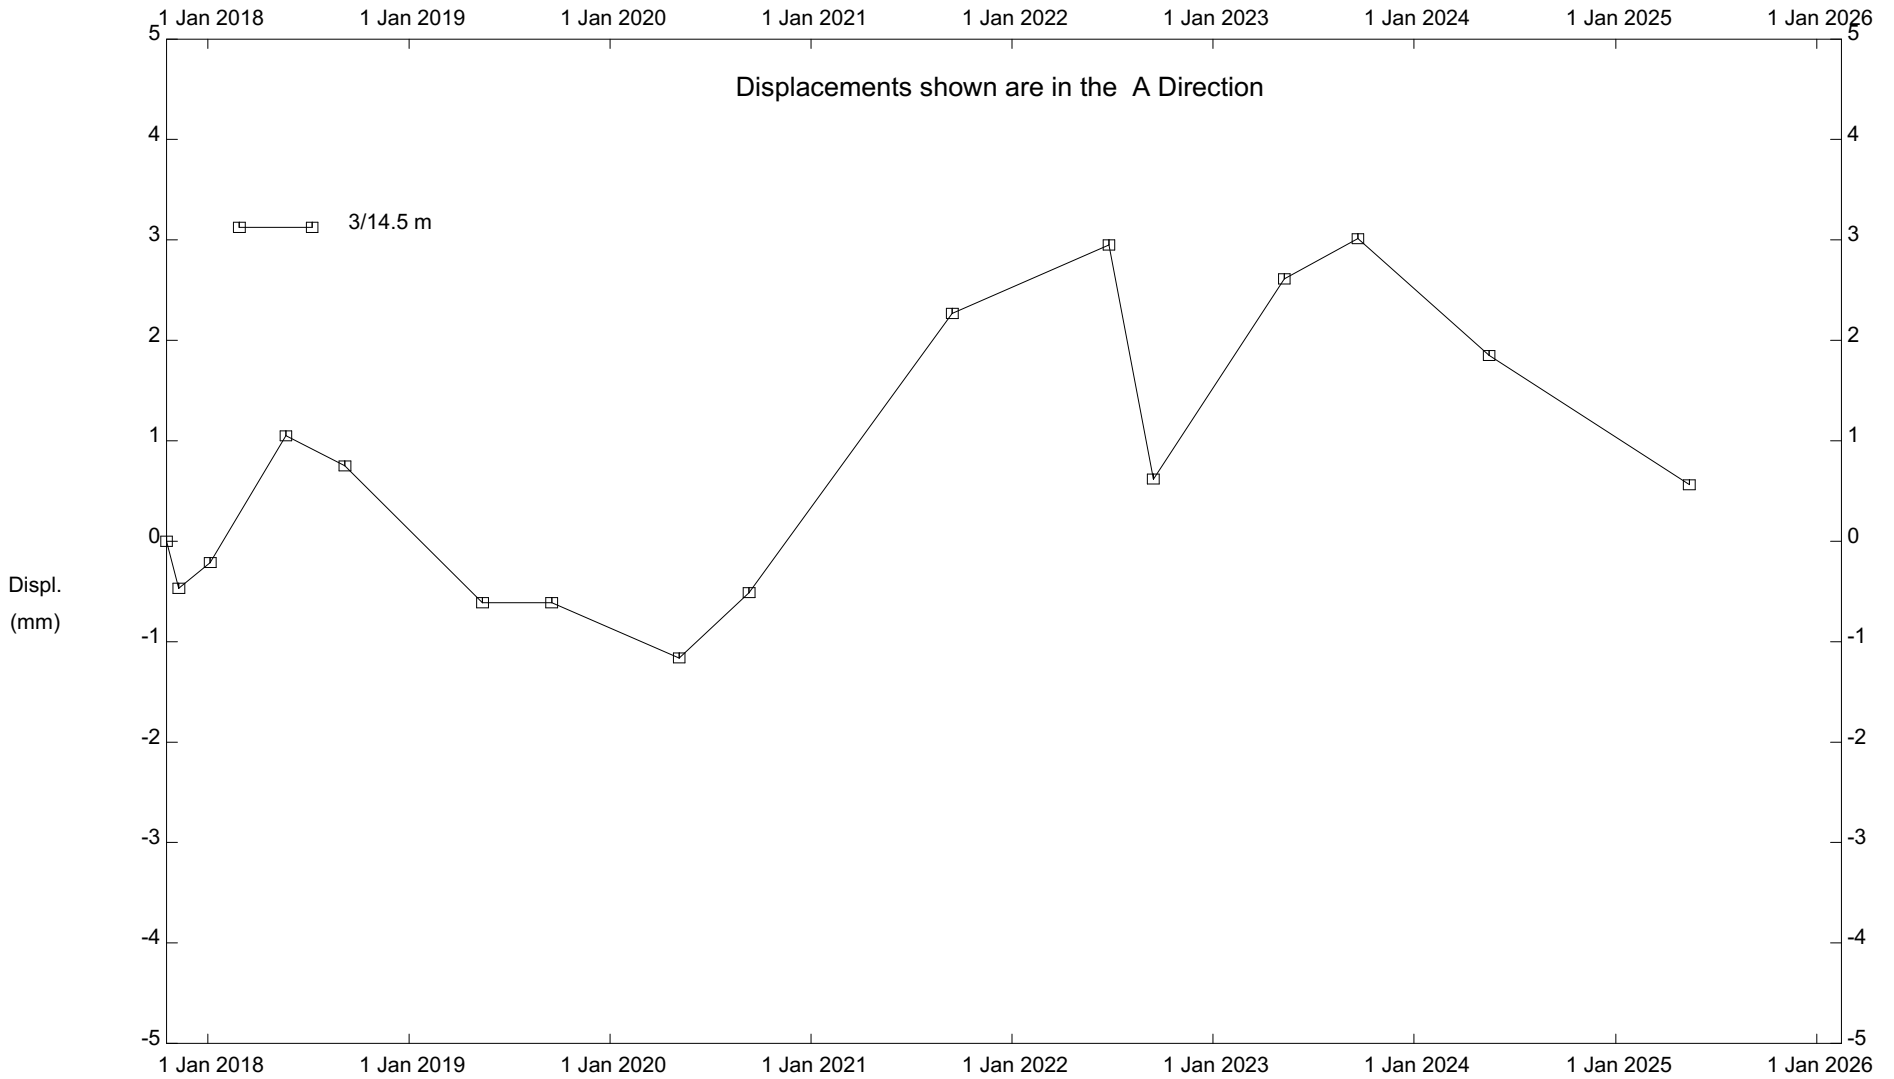
C065-IV; H585:02, East of Trochu, Inclinator SI17-C65-01

No discernible movement has been recorded in SI17-C65-01 since installation, excluding shallow deflection in the upper 3 m of the instrument. No discernible movement has been recorded in SI21-C65-01.

No discernible movement has been recorded in SI17-C65-01 since installation, which indicates the slide is either inactive or moving at a very slow rate of movement (i.e., within the reading accuracy of the SI equipment). There has been approximately 25 mm of shallow deflection in the upper 2 m of the instrument, likely due to a small amount of settlement/deformation of the highway subgrade unrelated to slide movement.

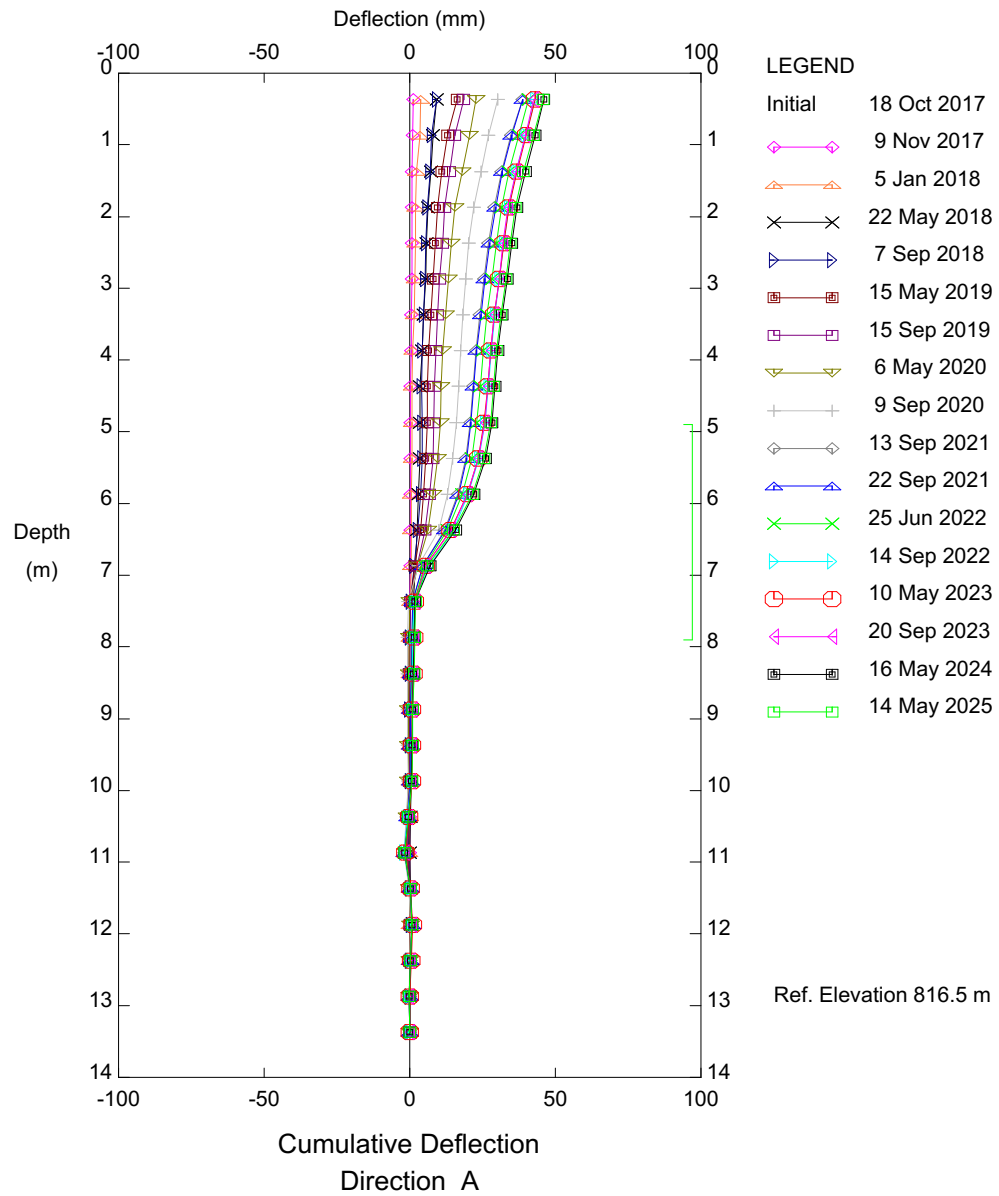
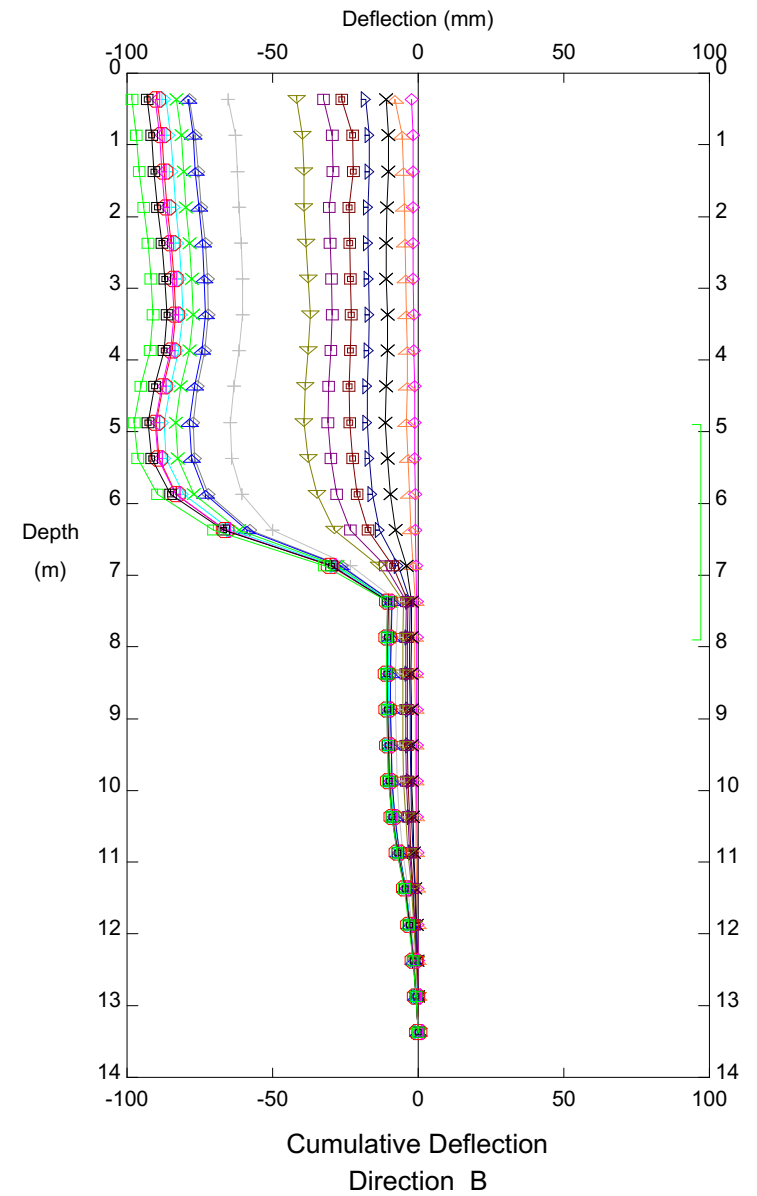
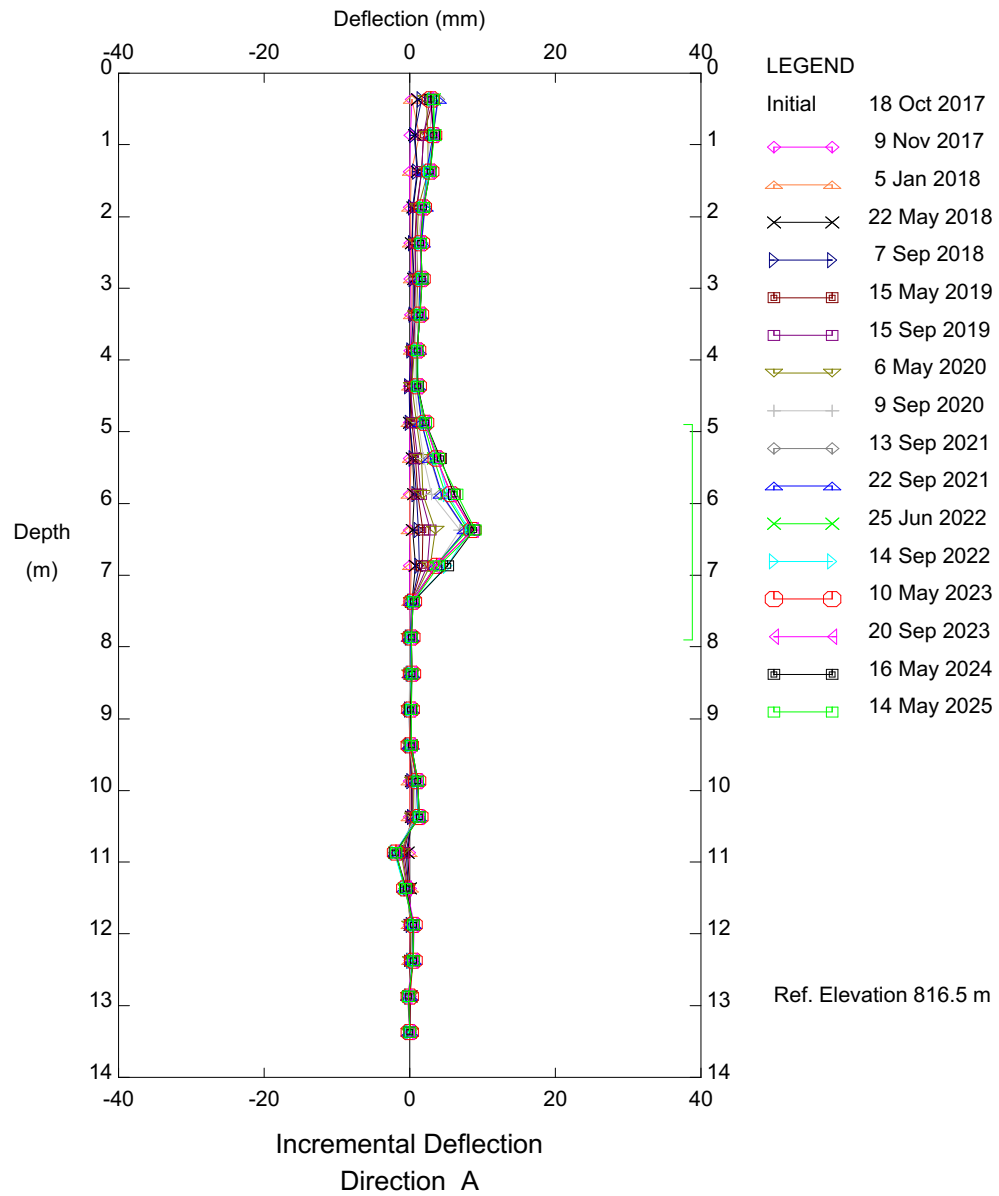
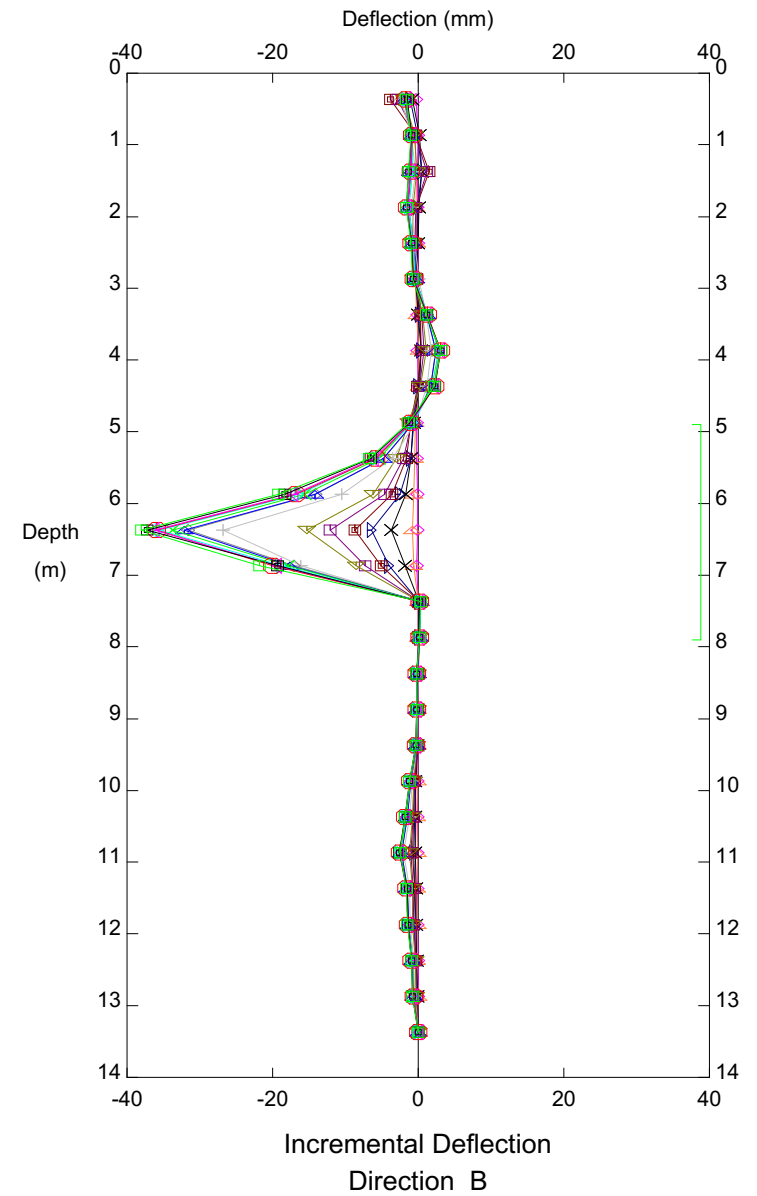
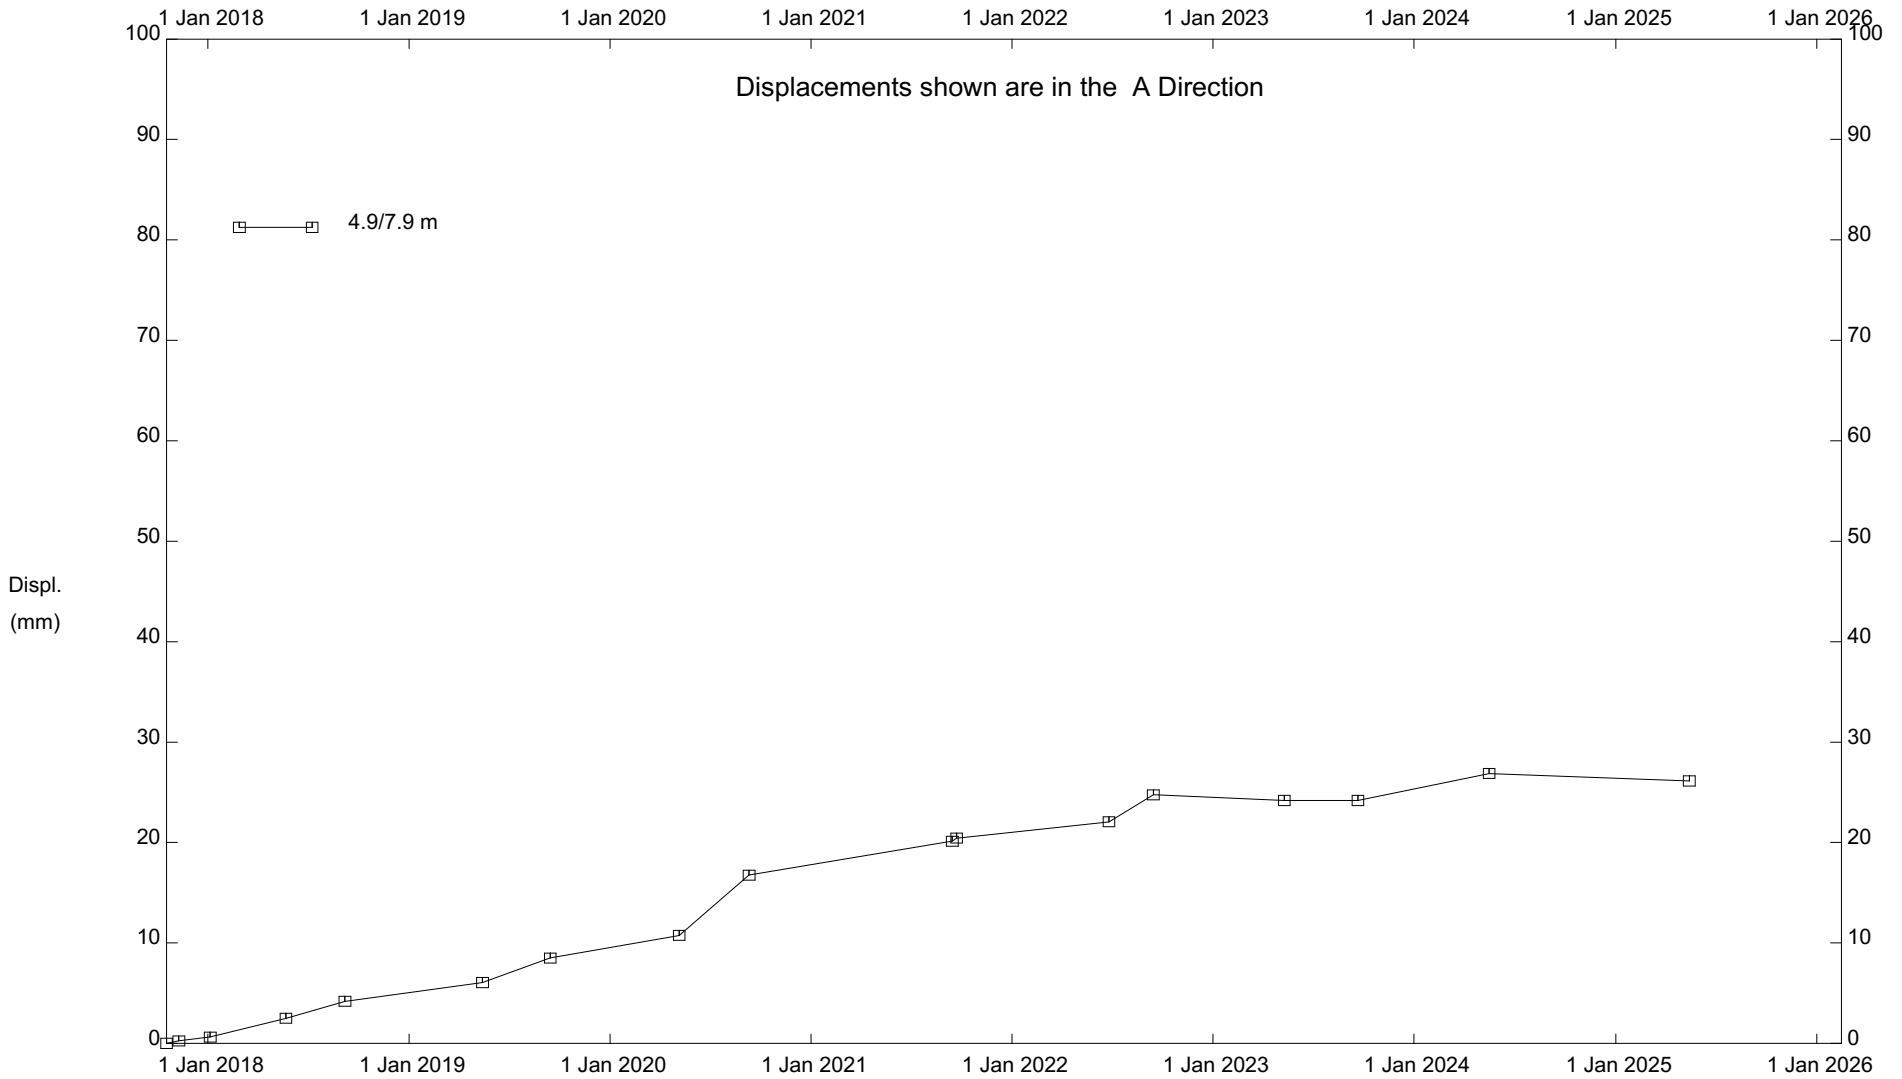
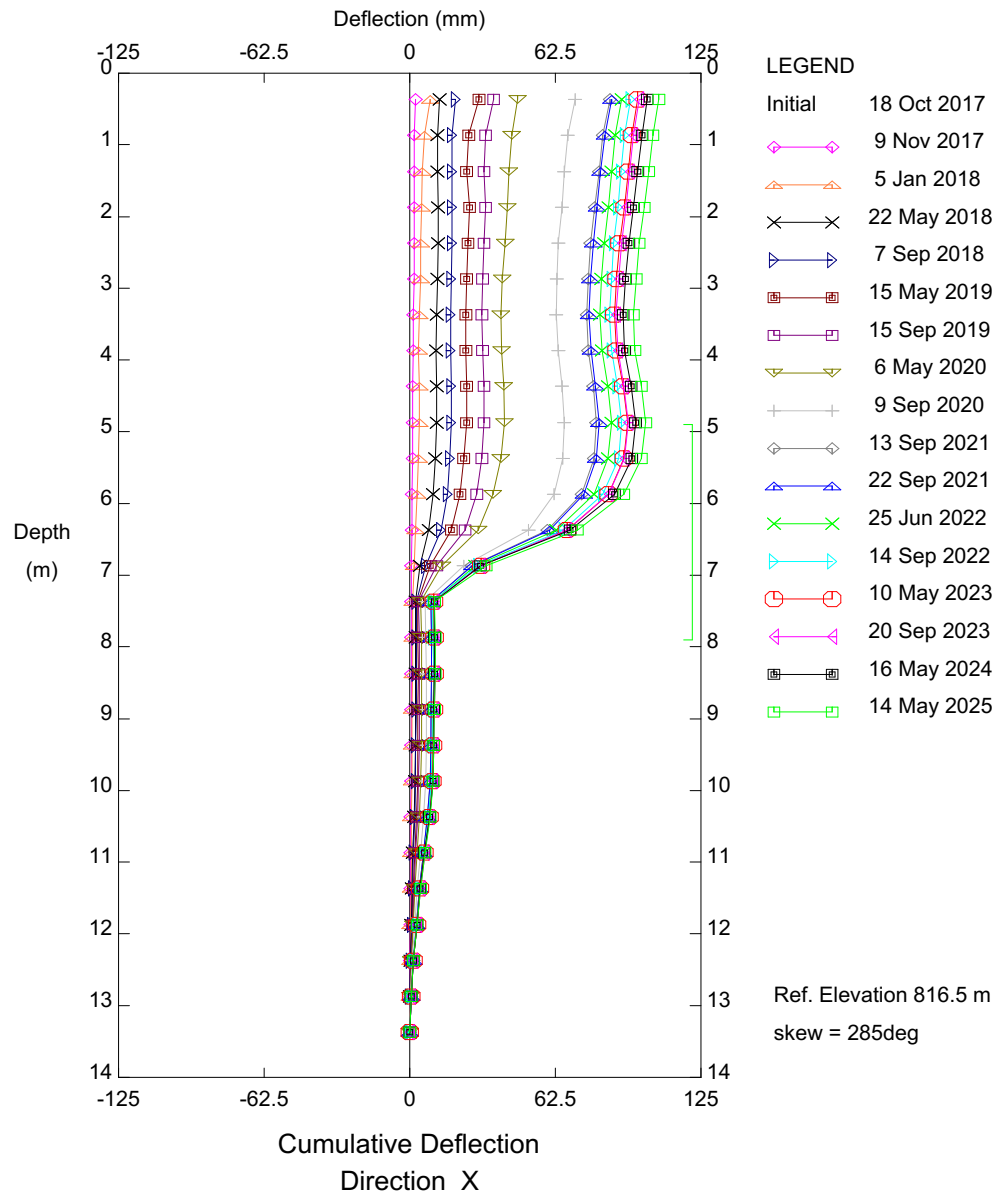
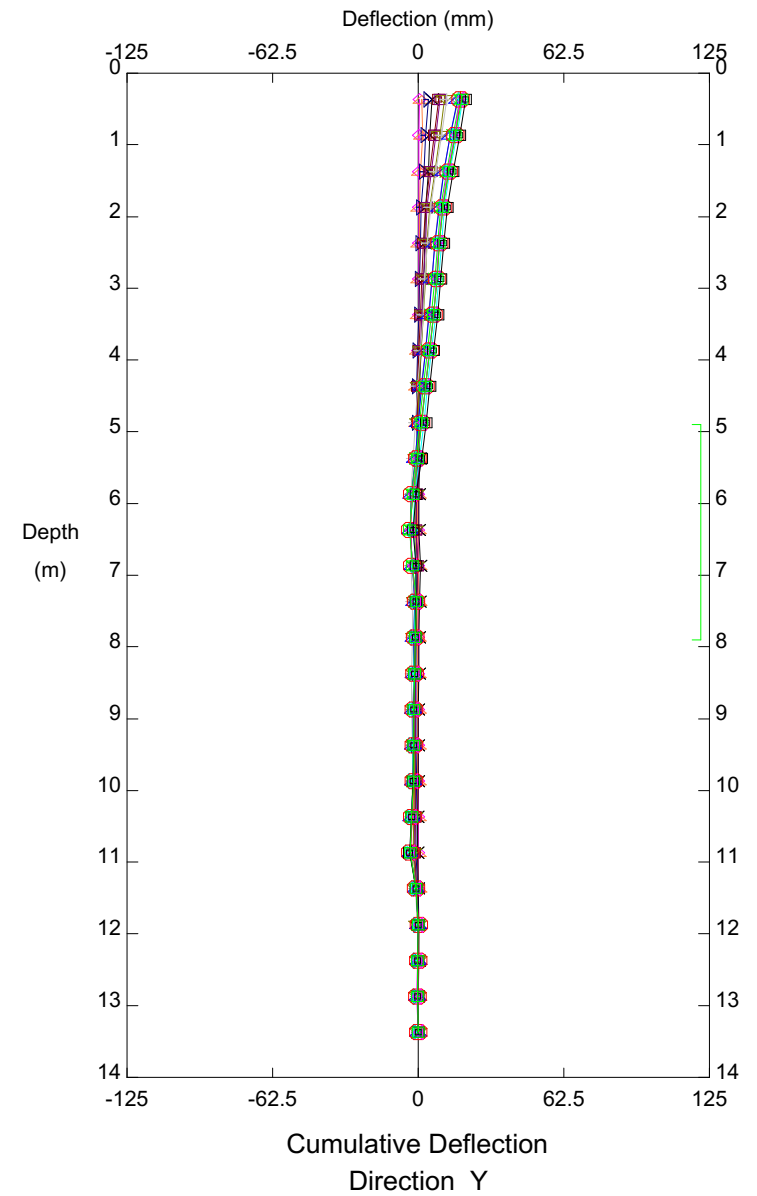
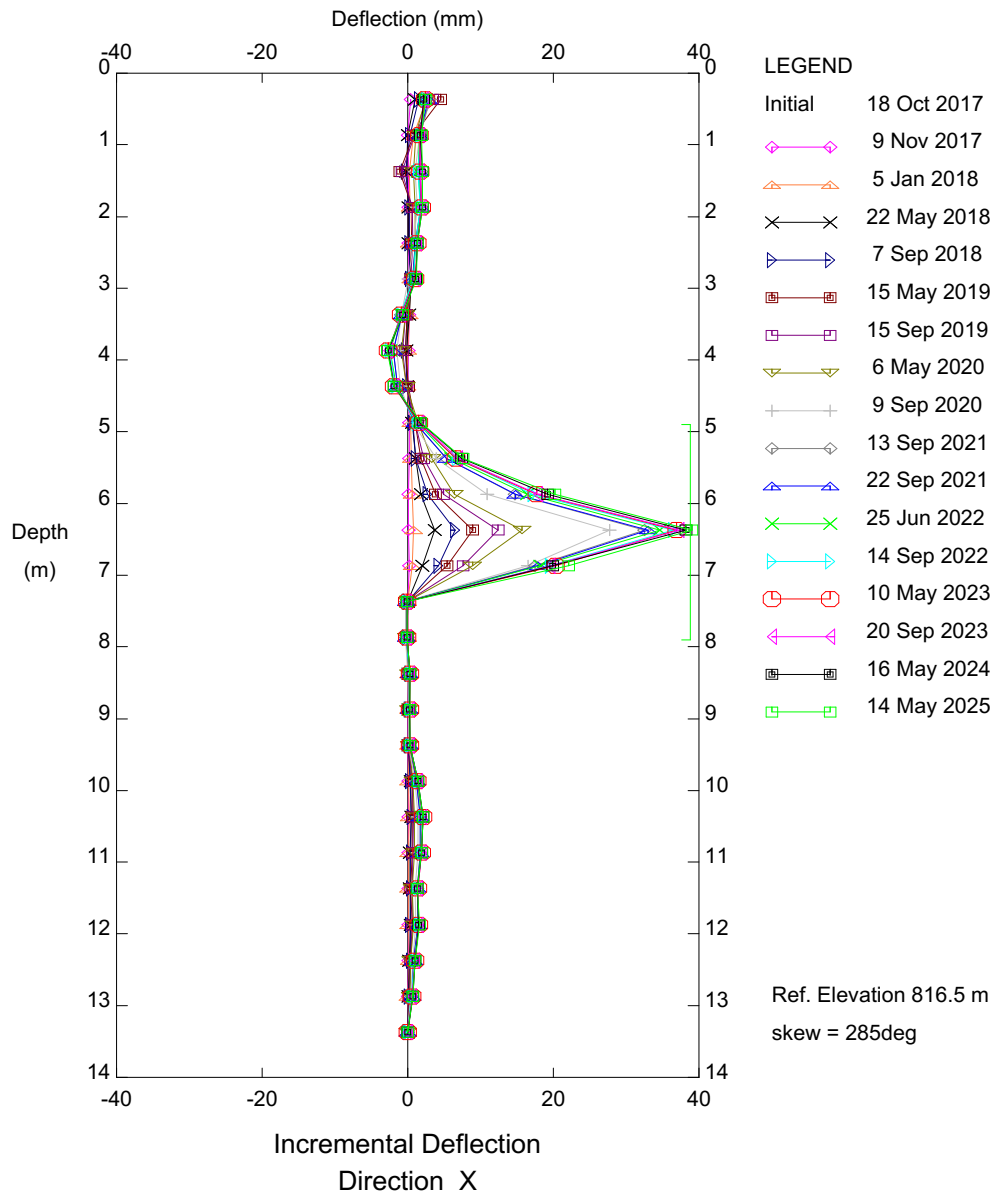
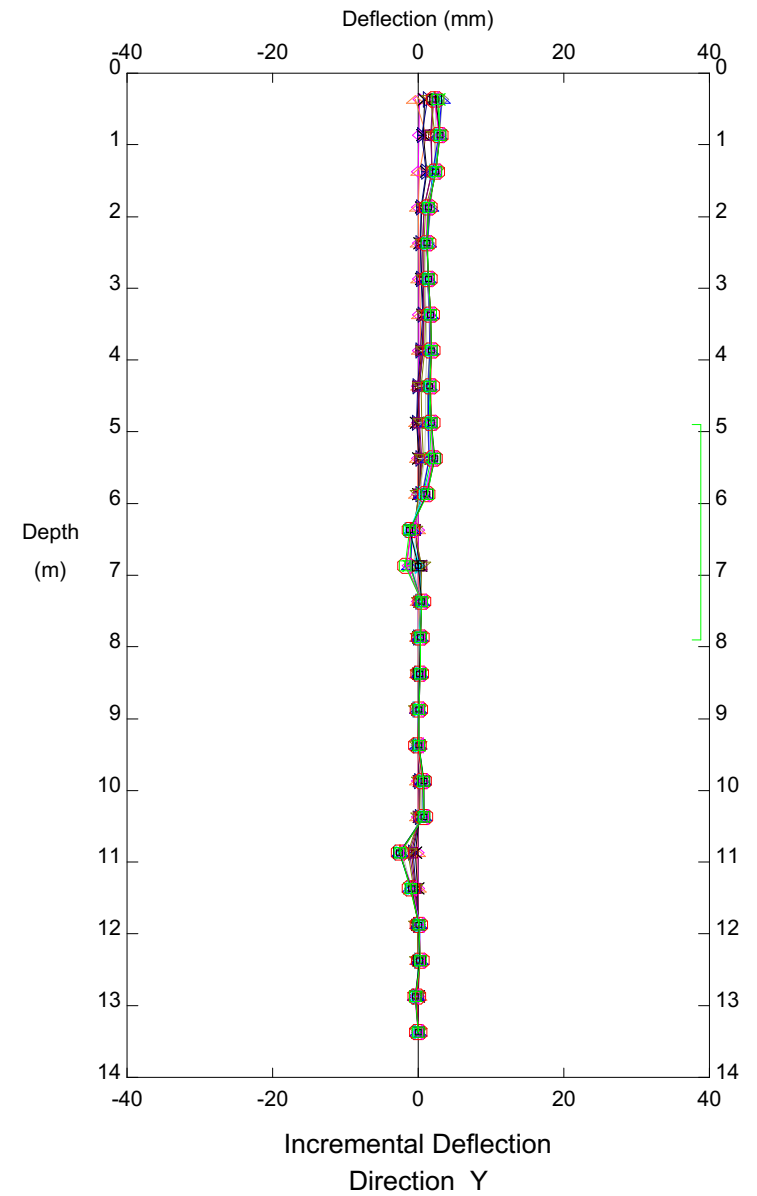
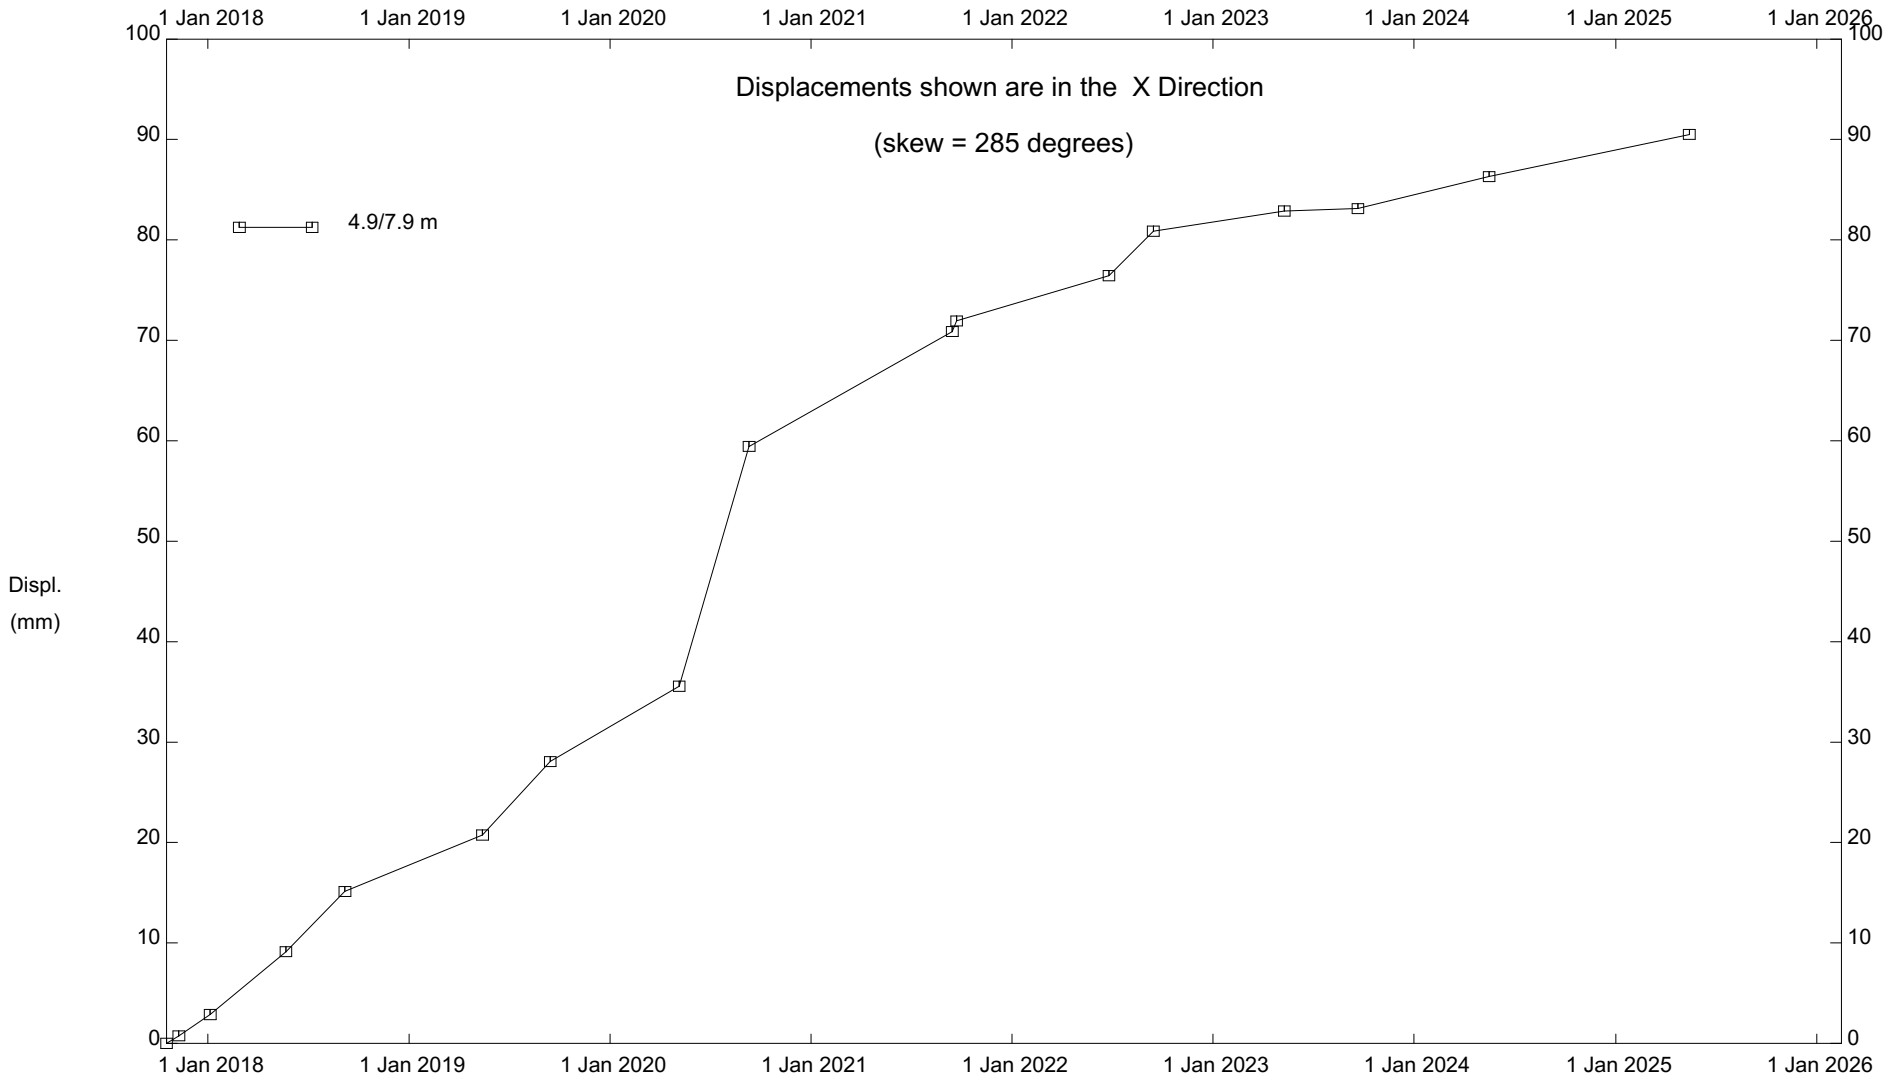
C065-III; H585:02, East of Trochu, Inclinator SI17-C65-02

Discrete movement (i.e., movement occurring on a defined failure plane) is being recorded in SI17-C65-02 between an approximate depth of 5.0 m to 7.5 m below ground surface, at the interface between clay colluvium and bedrock. Since June 2021, a pinch has been felt in the SI casing at this depth when reading the instrument.

In September 2020 and 2021, an increased rate of movement (approximately 69 mm/year and 45 mm/year, respectively) was recorded in SI17-C65-02. The increase in 2020 was most likely attributed to wet weather, while the 2021 increase was likely due to construction activities at the C065 site (e.g., heavy truck traffic, increased traffic in the north (westbound) lane during south (eastbound) lane closures, and channel excavation at the C065-3 site).

Since 2021 construction, the rate of movement has decreased and is currently less than approximately 5 mm/year (excluding an increased rate of movement recorded in September 2022 of approximately 20 mm/year). The increased rate of movement recorded in September 2022 was most likely attributed to wet weather in June and July 2022. Movement rates may increase, or additional displacements may occur in response to periods of heavy or prolonged rainfall, resulting in higher groundwater conditions.

Approximately 90 mm of movement has been recorded in SI17-C65-02 since installation. Since the spring of 2021, a zone of tightness has been felt during readings of this instrument from approximately 5.0 m to 7.5 m below ground surface. This instrument may shear as overall displacement at this depth increases over time.
