July 15, 2025

Alberta Transportation and Economic Corridors
4th Floor, Provincial Building
4920 – 51st Street
Red Deer, Alberta
T4N 6K8

CON0022160 Central Region GRMP Instrumentation Monitoring
Site C065; H585:02, km 16.136 East of Trochu Slides
Section C – 2025 Spring Readings

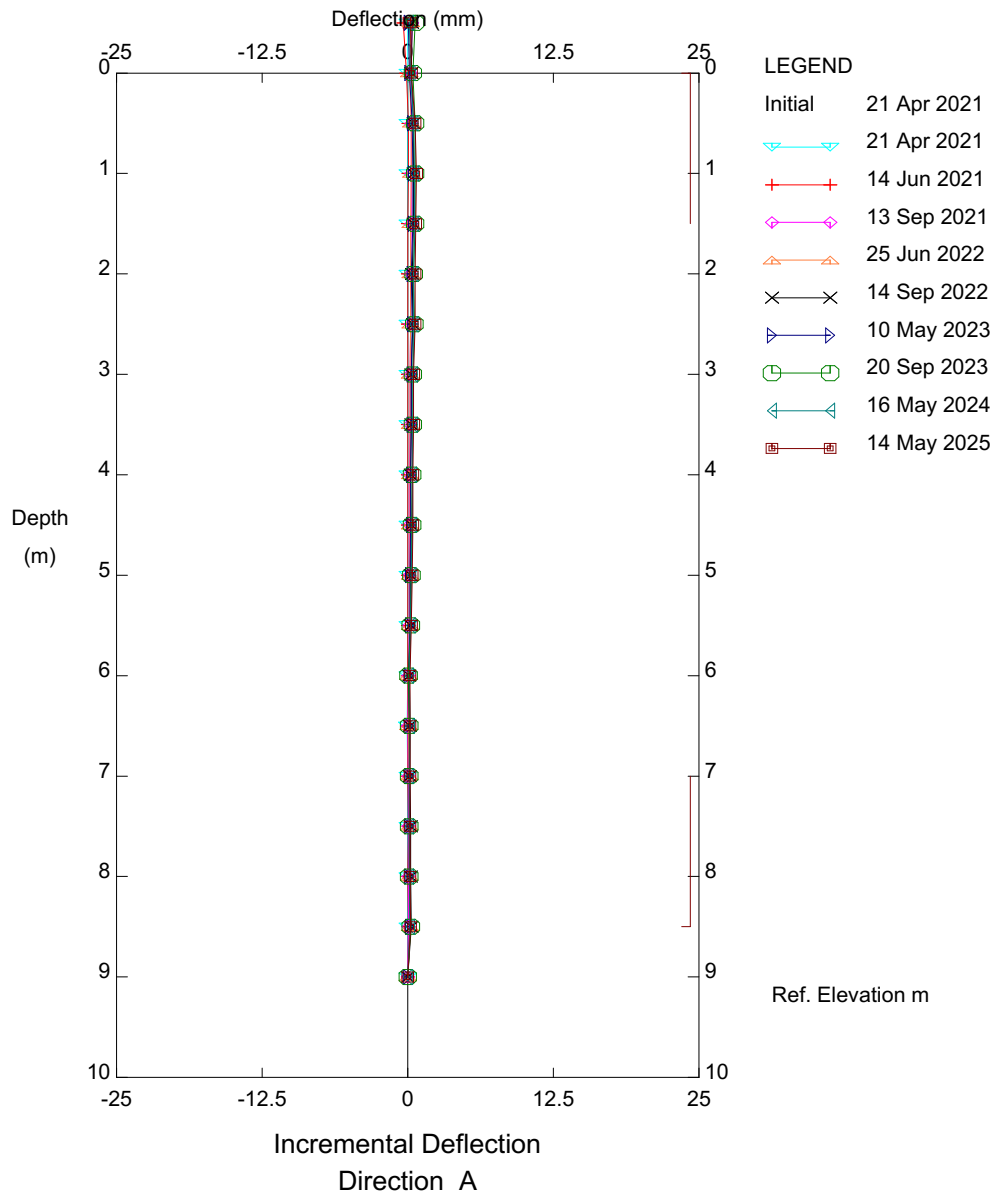
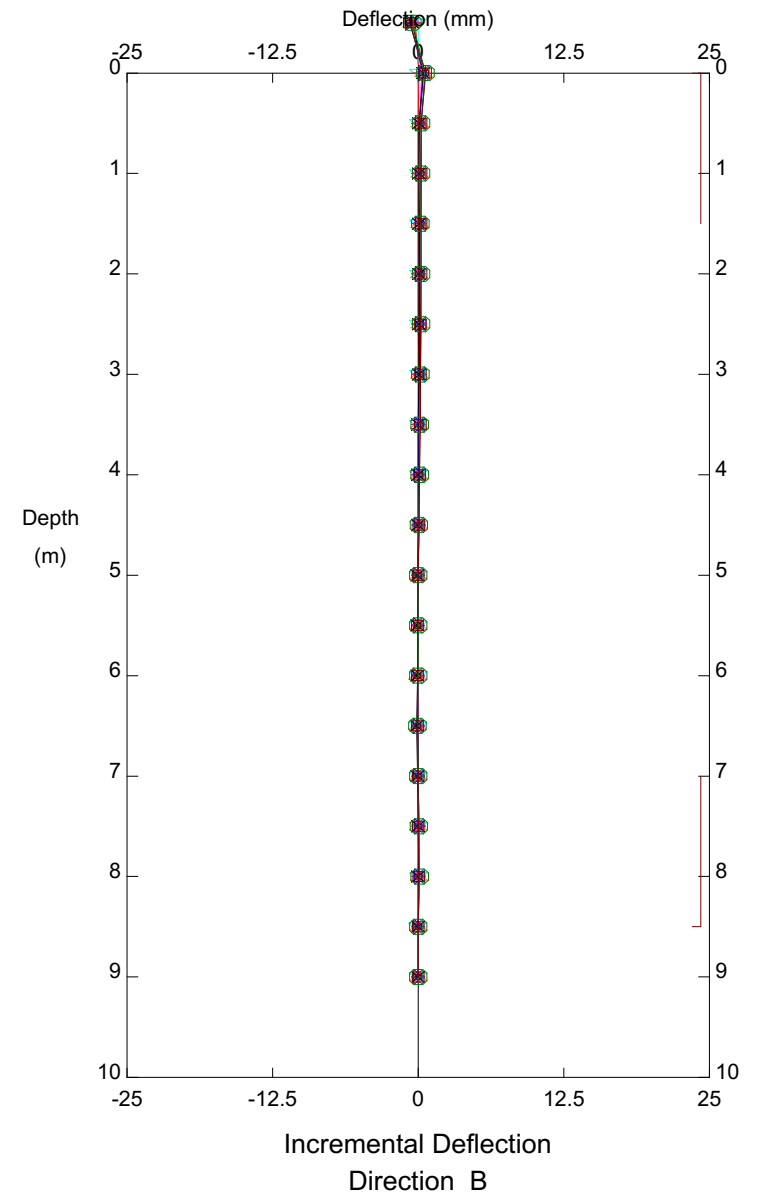
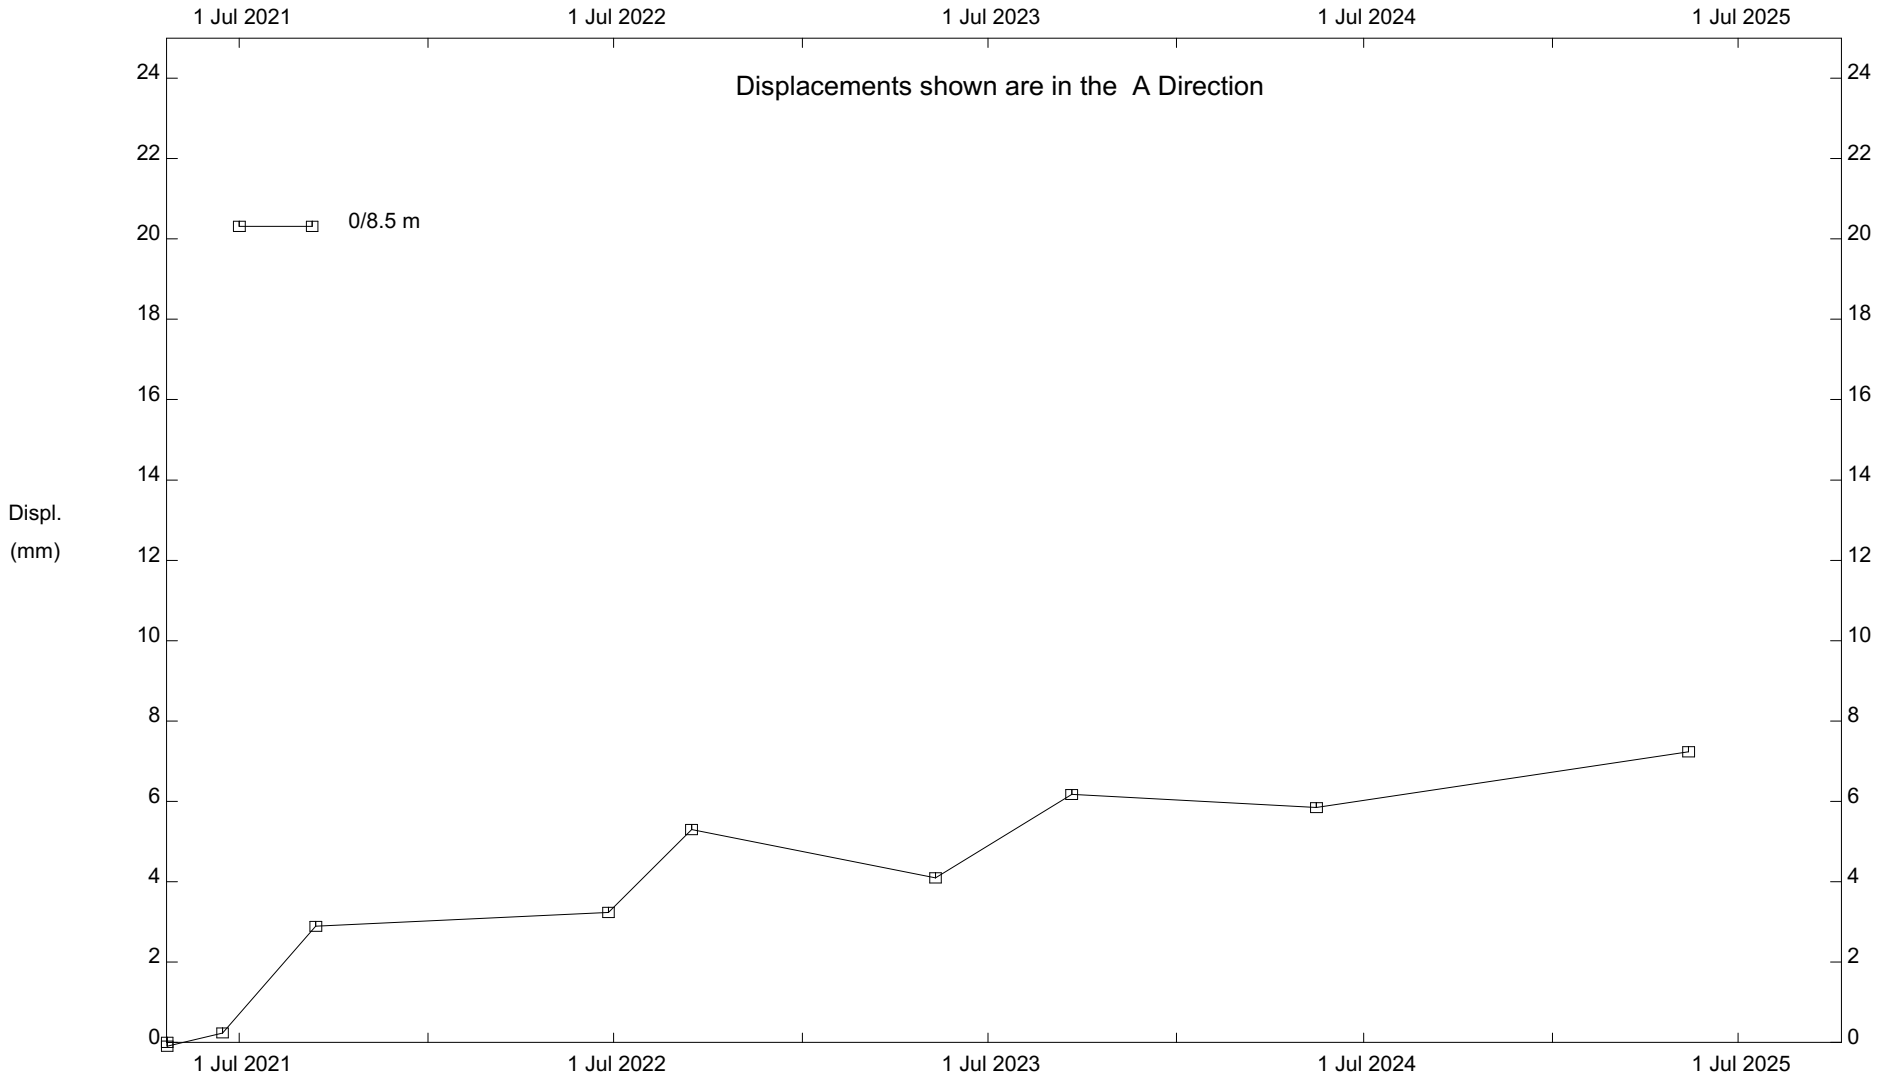
C065-IV; H585:02, East of Trochu, Inclinator SI21-C65-02
 Alberta Transportation

Distributed movement has been recorded in SI21-C65-02 from ground surface approximately 1 m above the base of the instrument.

No discernible movement has been recorded in SI21-C65-01. Distributed movement has been recorded in SI21-C65-02 from ground surface to near the base of the instrument. This indicates that the H-pile wall has intercepted the failure surface and is continuing to deflect, transferring load to depths below the failure plane as the piles stabilize the slide mass. As movement continues in the H-pile wall, it will be eventually reflected in SI21-C65-01.

The May 2025 data obtained from the pile-wall SIs indicates that the top of the H-pile wall has deflected up to approximately 7 mm. Since installation, the overall rate of movement recorded in SI21-C65-02 has been slow (less than approximately 2 mm/year) with minimal movement being recorded over the winter months (less than approximately 1 mm/year) and increased rates of movement recorded between spring and fall (up to approximately 11 mm/year). However, since the

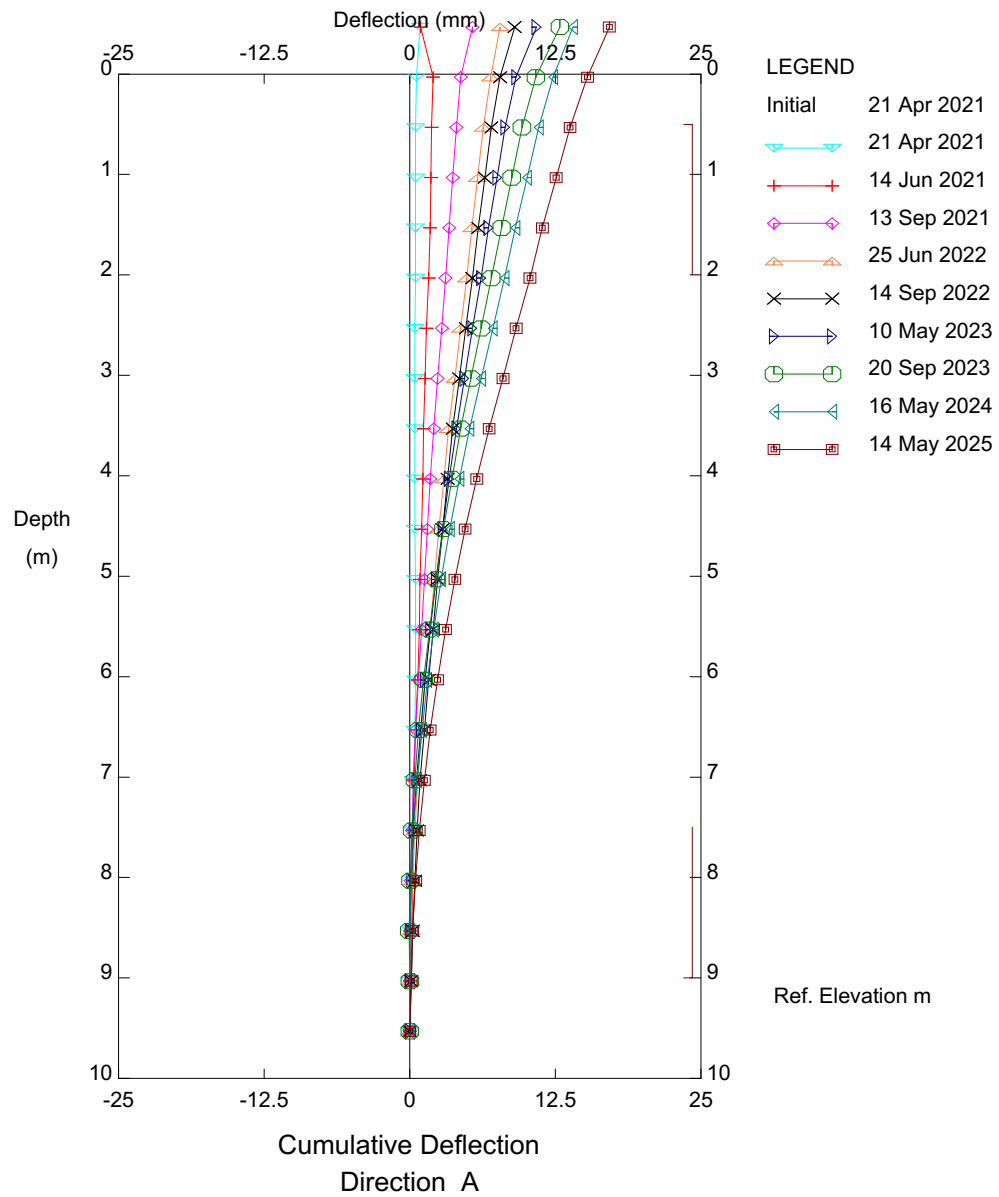
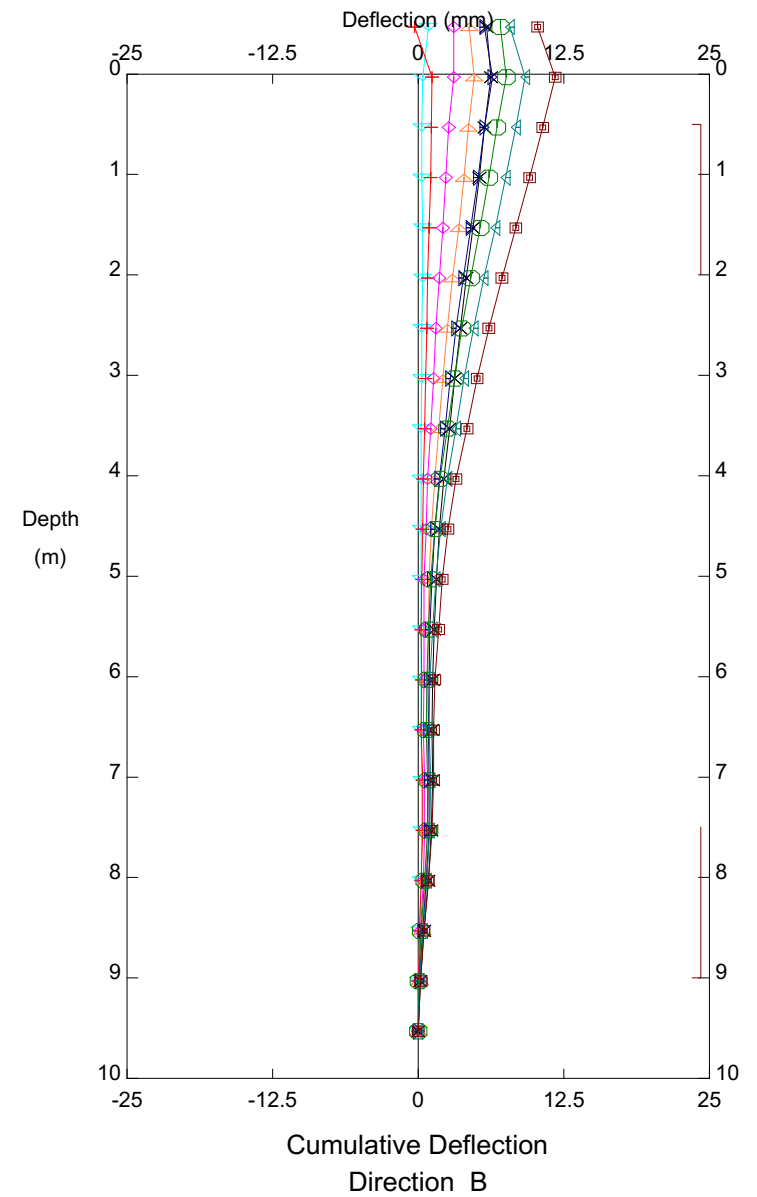
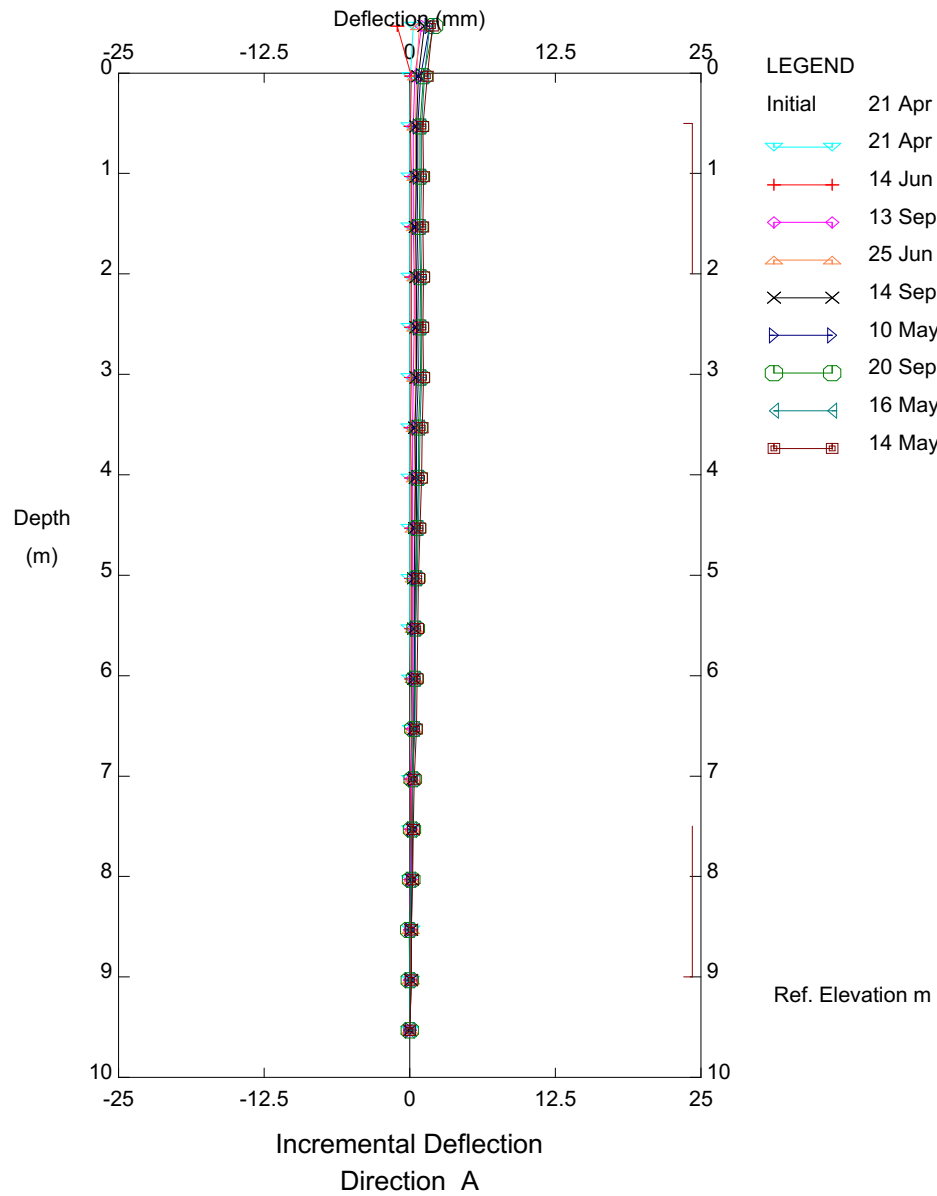
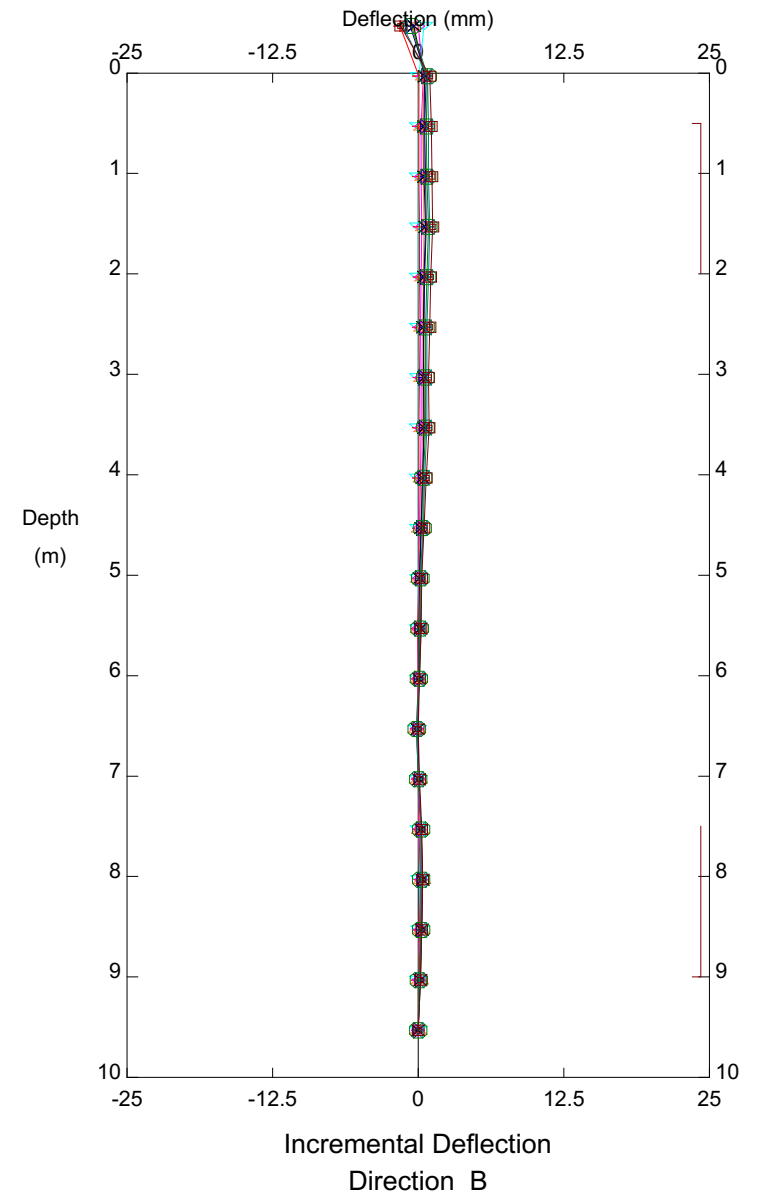
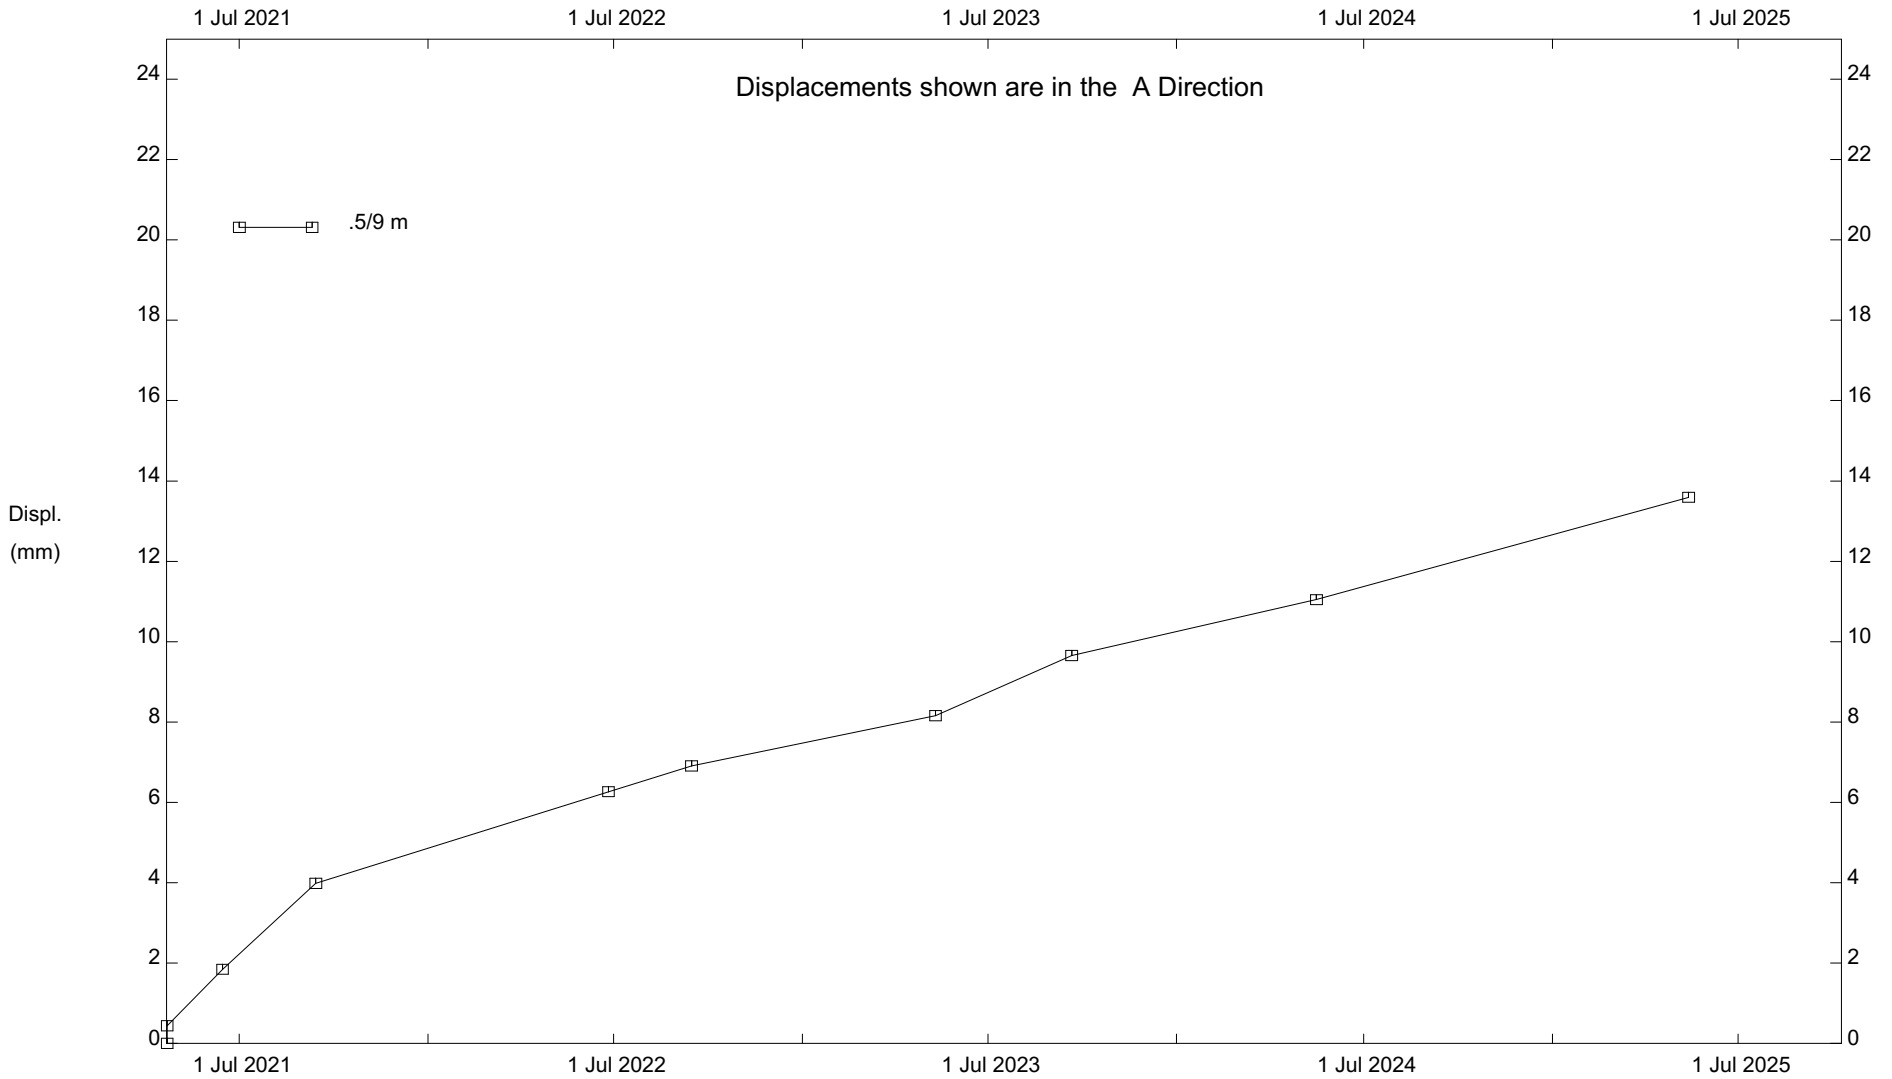
C065-V; H585:02, East of Trochu, Inclinator SI21-C65-03
 Alberta Transportation

Distributed movement has been recorded in SI21-C65-03 from ground surface to approximately 2 m above the base of the instrument.

Distributed movement has been recorded in the pile-wall SI (SI21-C65-03) and appears to be from ground surface to near the base of the instrument. This indicates that the H-pile wall has intercepted the failure surface and is continuing to deflect, transferring load to depths below the failure plane as the piles stabilize the slide mass.

The May 2025 data obtained from the pile-wall SI indicates that the top of the H-pile wall has deflected up to approximately 14 mm since installation.

In the spring of 2021, shortly after construction of the H-pile wall, the maximum rate of movement recorded in this SI was approximately 10 mm/year. Since fall of 2021, the rate of movement has been relatively steady and is currently approximately 3 mm/year. KCB anticipated that the rate of movement shortly after installation would be highest and would decrease as the H-pile wall picked up load stabilizing the sliding mass.

Distributed movement (i.e., from top to bottom of casing) up to 10 mm has also been recorded in the B-direction of SI21-C65-03. It is unknown if this movement is due to post installation SI casing flexure, shifting in the steel pocket the SIs are installed in, or flexure/twist of the H-piles that is occurring due to the H-pile wall picking up load from the sliding mass. The rate of movement being recorded in the B-direction is slow (less than 3 mm/year).

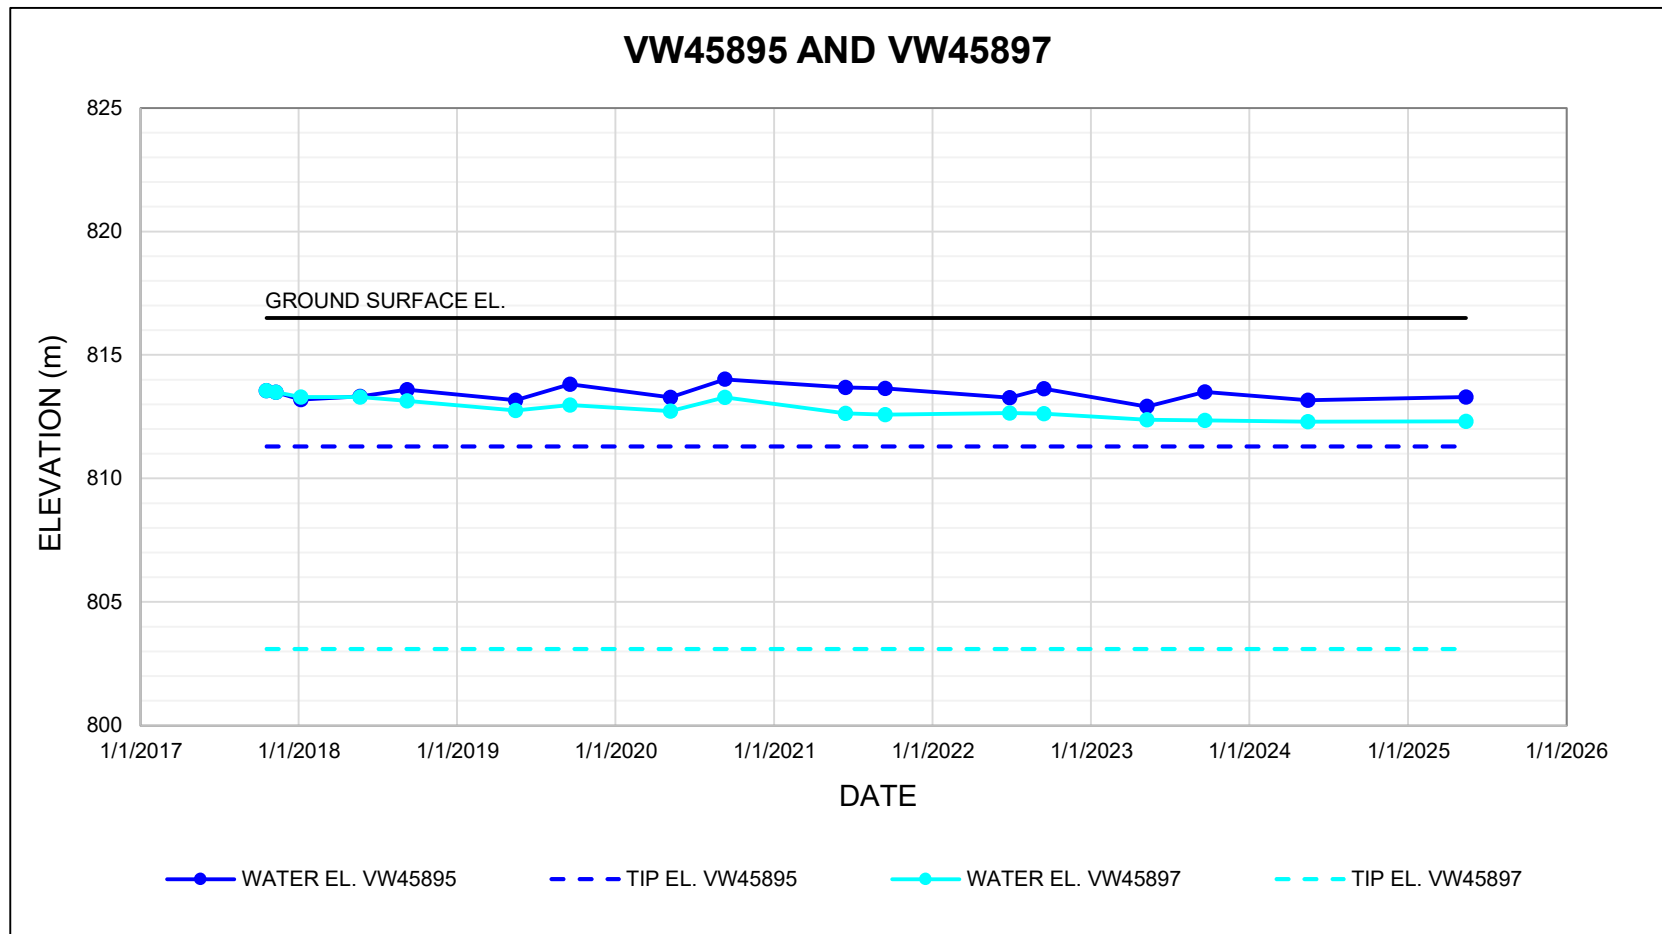
Since installation in October 2017, water levels recorded in VW45895 and VW45897 have been relatively steady, varying from 2.5 m to 3.6 m below ground surface and 2.9 m to 4.2 m below ground surface, respectively. The May 2025 readings were consistent with historical trends observed in these instruments.

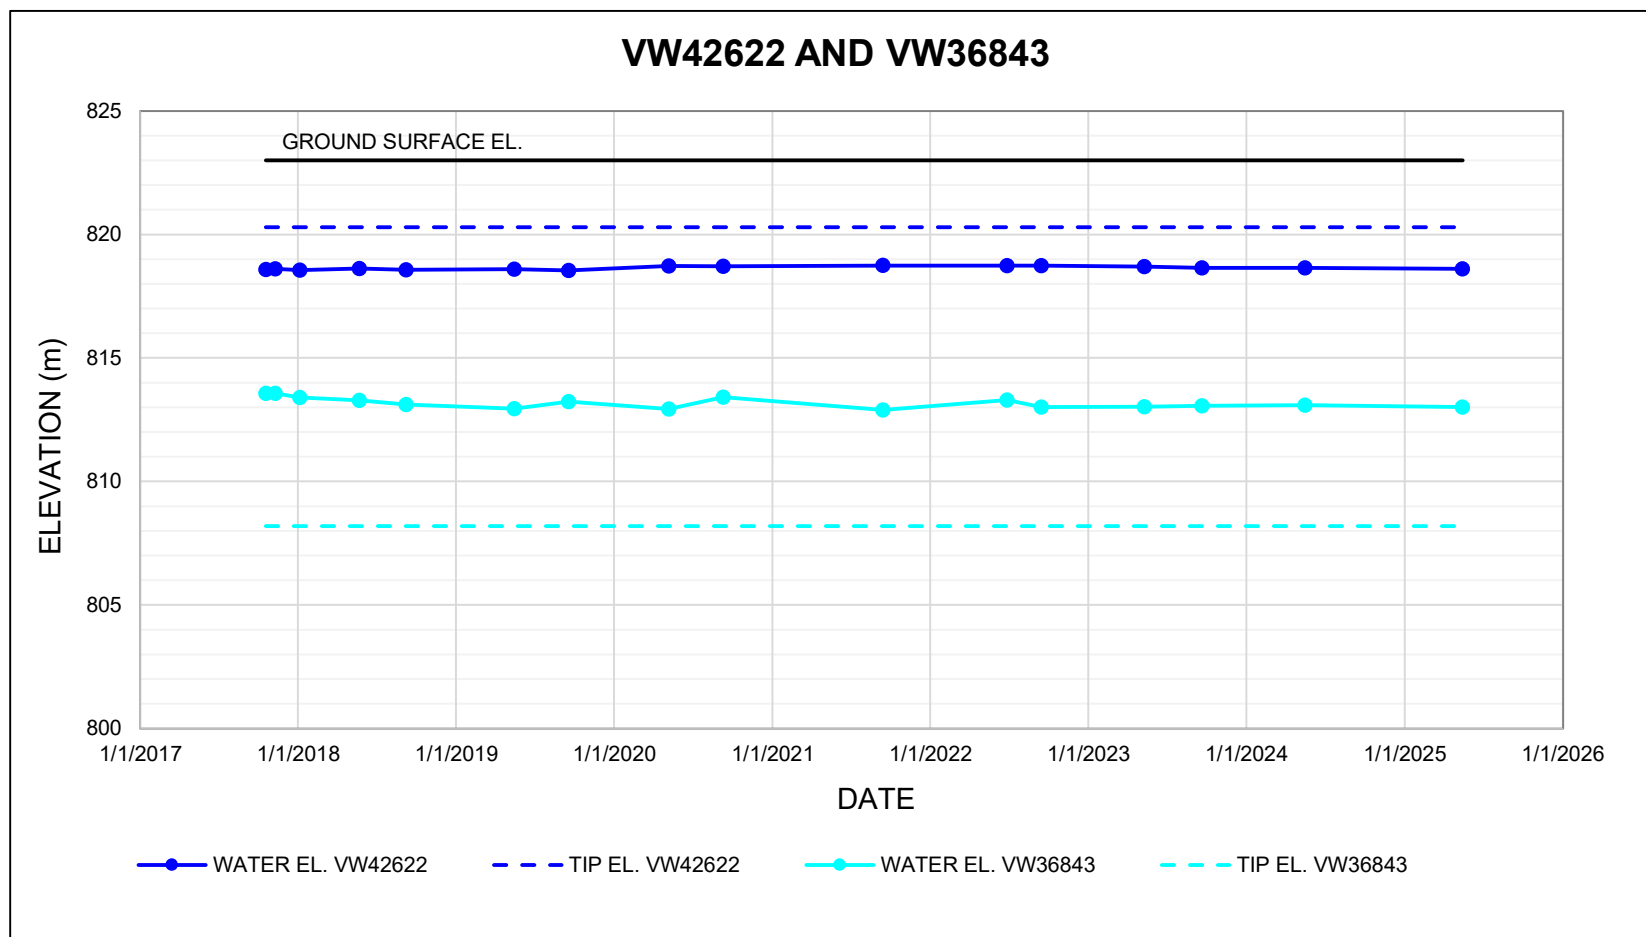
Since installation in October 2017, water levels recorded in VW36843 have been relatively steady varying from 9.4 m to 10.1 m below ground surface. VW42622 has been dry since October 2017. The May 2025 readings of VW42622 and VW36843 were consistent with historical trends observed in these instruments.
