SITE NUMBER AND NAME: C035 Ditch Erosion		HIGHWAY & KM: 590:04, 20.104	PREVIOUS INSPECTION DATE: July 11, 2019	INSPECTION DATE: June 9, 2020
LEGAL DESCRIPTION: 04-28-035-21 W4M 13/14/15/16-21-035-21 W4M 01-28-035-21 W4M	NAD 83 COORDINATES: UTM Northing Easting 12 5765903 365774 12 5765738 367296		RISK ASSESSMENT: PF: 10 CF: 4 TOTAL: 40	
AVERAGE ANNUAL DAILY TRAFFIC (AADT): 670 (west) (Ref No. 997156)			CONTRACT MAINTENANCE AREA (CMA): 517

SUMMARY OF SITE INSTRUMENTATION: There is no instrumentation at the C035 site. LAST READING DATE: N/A	INSPECTED BY: Chris Gräpel (KCB) James Lyons (KCB) Tony Penney (AT) Kristen Tappenden (AT)
PRIMARY SITE ISSUE: Numerous erosion features located along Hwy 590, mainly in the ditches, on either side of the Red Deer River.	
APPROXIMATE DIMENSIONS: The site is approximately 2 km long.	
DATE OF ANY REMEDIAL ACTION: None recently.

PROJECT
 CENTRAL REGION GEOHAZARD RISK MANAGEMENT PROGRAM

TITLE
 Site Plan
 C035 - Ditch Erosion
 Hwy 590:04, km 20.104

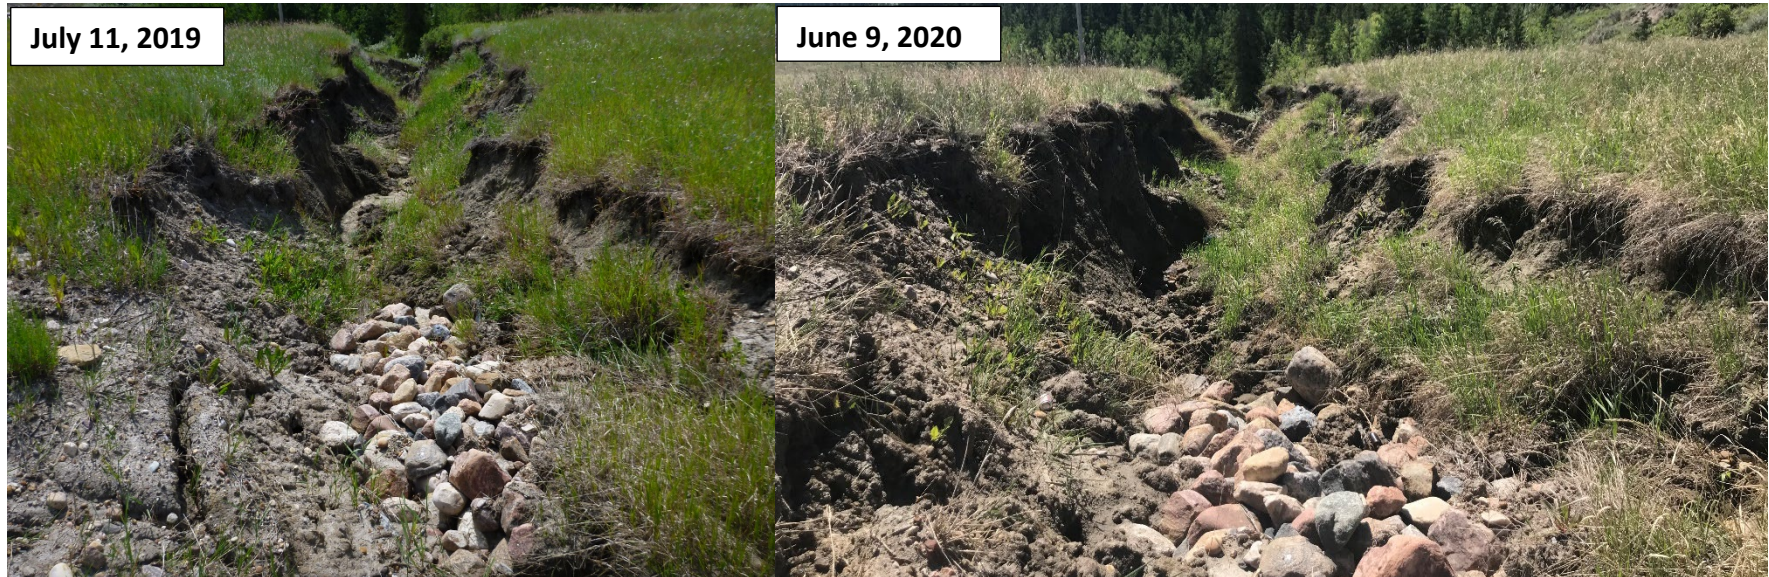
<p>COMMENTS</p> <p>West of the bridge:</p> <ul style="list-style-type: none"> The existing 6-m deep erosion gully on the valley slope approximately 600 m west of the bridge has expanded since the 2019 inspection (Photo 1). Riprap placed at the head of the gully is being bypassed south of the riprap by surface flows. The CSP culvert downslope of the erosion gully continues to corrode since last the last culvert inspection completed in 2018 (Photo 2). The culvert was observed flowing to be and the bottom of the culvert was corroded. Rill erosion and voids associated with the erosion of dispersive materials were observed in the exposed bedrock along the backslopes. The backslopes are sporadically vegetated. Both ditches are gullied to a depth of 1 m with near-vertical gully slopes. The ditch channels outside of the gullies are well vegetated with grass. The 1200 mm diameter CSP culvert at Waypoint 518 is corroded (corrosion holes in crown of culvert) and requires replacement or repair. The culvert outlet is undermined by ditch flow from further upslope and culvert discharge onto unarmored soil. In the short term, the ditch downstream of the culvert outlet should

Photo 1 Comparison photo of the existing erosion gully on the south side (eastbound lane) of the highway, approximately 600 m west of the bridge. Gully appears to have expanded since 2019. Photos taken looking south.

Repair options for the erosion gully on the west side of the site:

- Extend the guardrail and end-dump backfill the gully with gravel and armour with riprap (AT's preferred option, this may not completely address erosion of dispersive soils beneath the riprap, but it will slow the rate of gully enlargement);
- Install an inlet structure and divert ditch flow into an HDPE pipe that extends downslope;
- Reconstruct the channel and armour it with riprap with adequate bedding/transition material; and
- Construct a ditch to redirect surface flow into the creek.

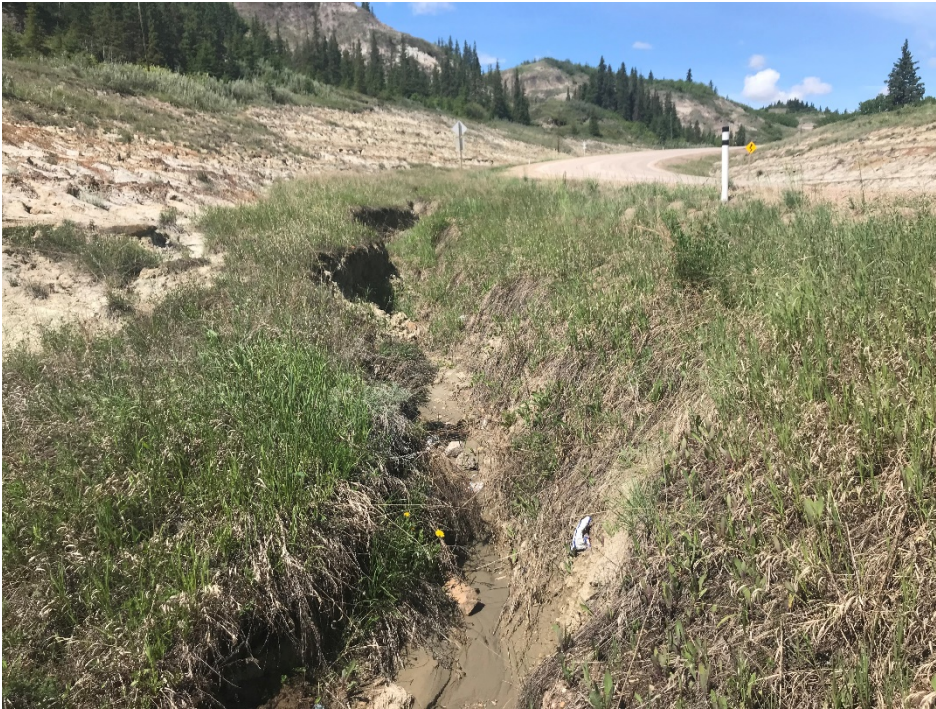
Photo 2 Continued erosion in the ditch south of Highway 590, upstream of the 1200 mm diameter CSP culvert. Photo taken June 9, 2020 facing west.

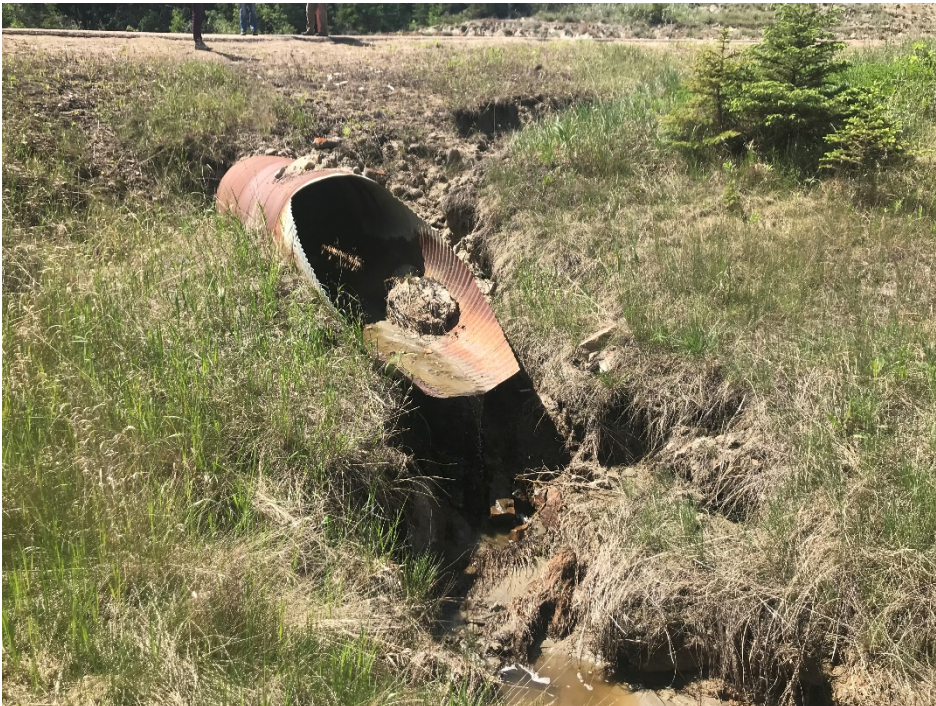
Photo 3 The outlet of the 1200 mm diameter CSP to the west of the bridge. Photo taken June 9, 2020 looking west.

be armored with riprap.

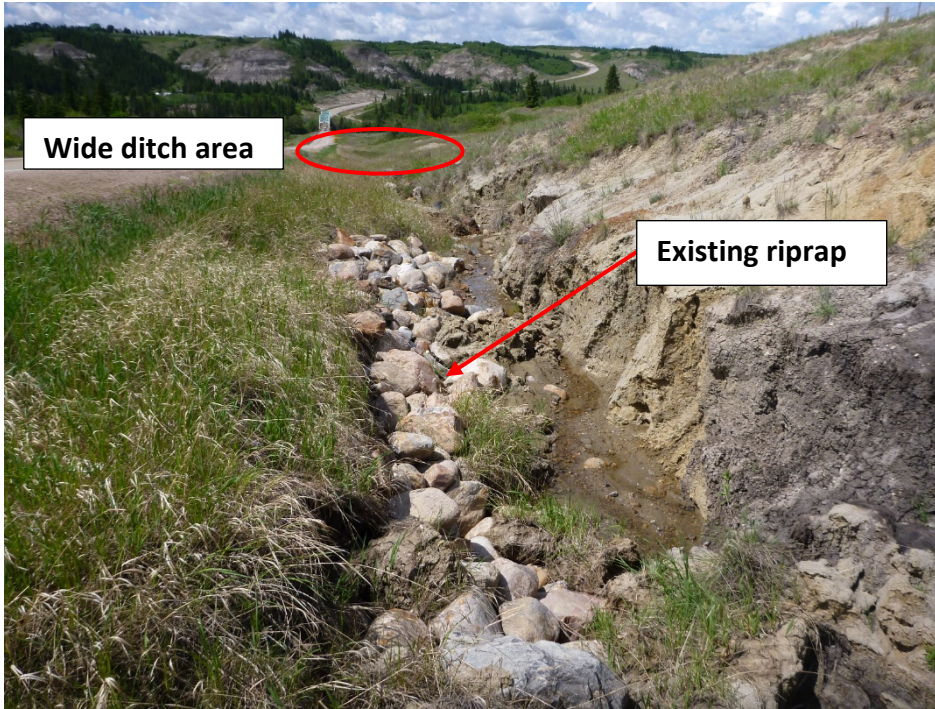
- A wider section of the ditch appears to act as a sediment trap. The downstream limit of the wider section of the ditch is at Waypoint 520.
- Riprap was placed in an erosion gully before 2016 at Waypoint 521. This area looks stable, but sediment deposition from further upstream is probably contributing to the favorable performance at this site.

Photo 4 Photo showing location of ditch area that appears to act as a sediment trap (Waypoint 520) and location where riprap was placed prior to 2016 (Waypoint 521). Photo taken June 9, 2020 looking west.

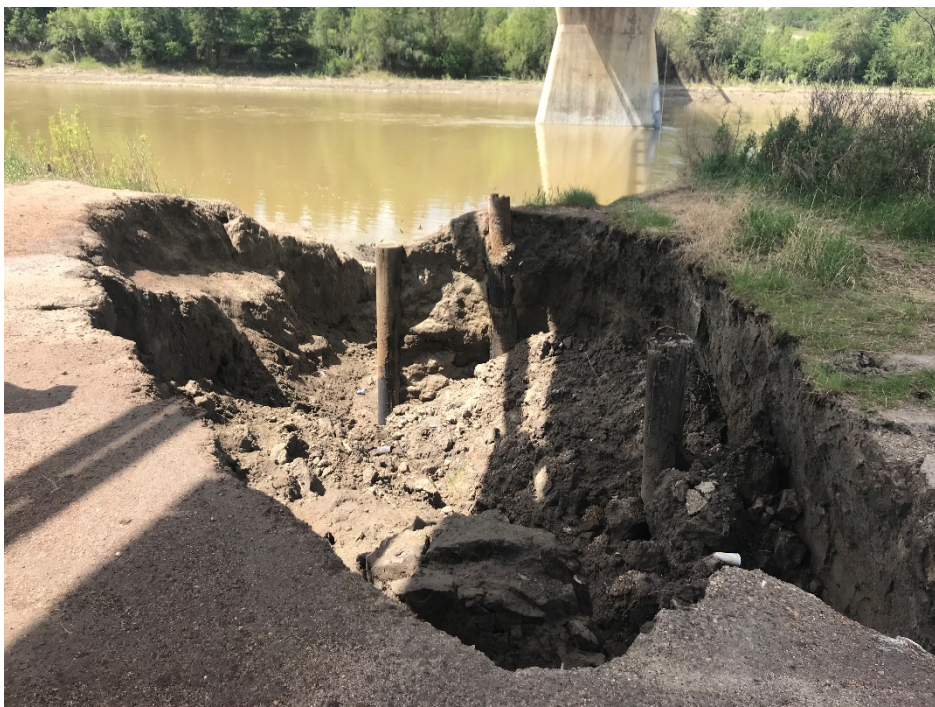
- Erosion gullies beneath the bridge have expanded and retrogressed toward the bridge abutments.

Photo 6 Erosion gully below east bridge abutment continues to expand. Photo taken June 9, 2020 looking west.

Repair options for the erosion gully below bridge abutment:

- In the short term, riprap should be placed in the erosion gully to minimize the potential for enlargement and continued retrogression.
