SITE NUMBER AND NAME: C035 Ditch Erosion		HIGHWAY & KM: 590:04, 20.104	PREVIOUS INSPECTION DATE: June 9, 2020	INSPECTION DATE: June 24, 2021
LEGAL DESCRIPTION: 04-28-035-21 W4M 13/14/15/16-21-035-21 W4M 01-28-035-21 W4M	NAD 83 COORDINATES: UTM Northing Easting 12 5765903 365774 12 5765738 367296		RISK ASSESSMENT: PF: 10 CF: 4 TOTAL: 40	
AVERAGE ANNUAL DAILY TRAFFIC (AADT): 680 (east) and 570 (west) (Ref No.103300 & 997156)			CONTRACT MAINTENANCE AREA (CMA): 517

SUMMARY OF SITE INSTRUMENTATION: There is no instrumentation at the C035 site. LAST READING DATE: N/A	INSPECTED BY: Chris Gräpel (KCB) James Lyons (KCB) Roger Skirrow (AT) Tony Penney (AT) Darcy Newton (AT)
PRIMARY SITE ISSUE: Numerous erosion features located along Hwy 590, mainly in the ditches, on either side of the Red Deer River.	
APPROXIMATE DIMENSIONS: The site is approximately 2 km long.	
DATE OF ANY REMEDIAL ACTION: 2020 – The large erosion gully approximately 600 m west of the bridge was backfilled with gravel and Class 1M riprap by the Highway Maintenance Contractor (HMC) in fall 2020.

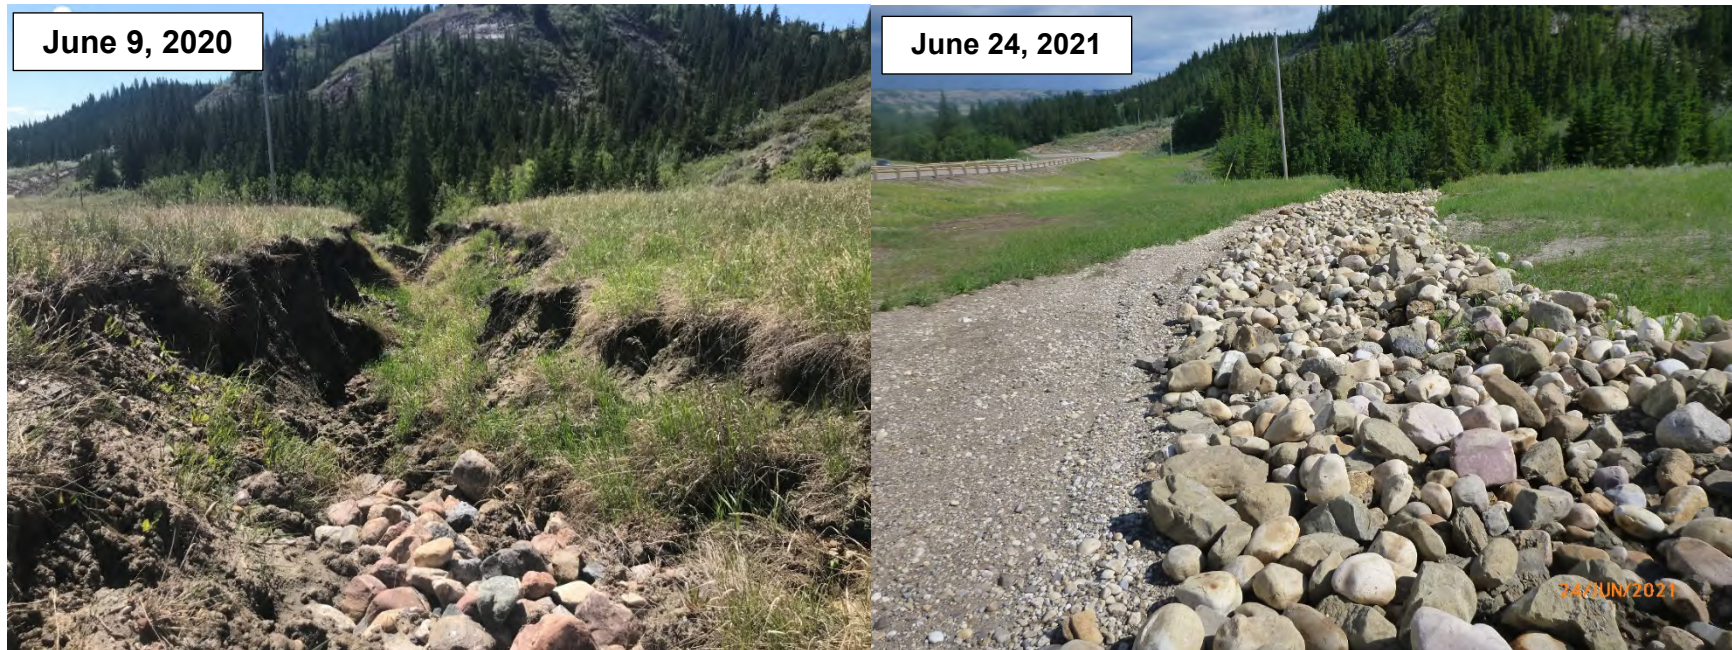
- The 6 m deep erosion gully on the valley slope approximately 600 m west of the bridge was repaired by the HMC in fall 2020. The erosion gully was backfilled with gravel, and riprap was placed for erosion protection (Photo 1). The majority of the riprap appears to have poor durability and will breakdown into smaller pieces in a few years due to freeze-thaw action (waypoint 0059).

Photo 1 Comparison photo of the previous erosion gully on the south side (eastbound lane) of the highway, approximately 600 m west of the bridge, that was repaired by the highway maintenance contractor in late-2020. Note that the riprap channel is not well defined with minimal freeboard. Photos taken looking south.

- The erosion gully was repaired with more riprap than original expected. However, the HMC should replace the riprap into a more "channel shaped" to allow surface water flows to pass through the channel, instead of around it. The shape of the channel cross section will result in water bypassing the armoured channel and causing erosion at the unarmoured flanks of the channel, by pass the armoring constructed by AT is 2020. Additionally, the riprap placed in 2020 has some particles that are sedimentary in origin (e.g., sandstone) and should be replaced with suitable riprap.

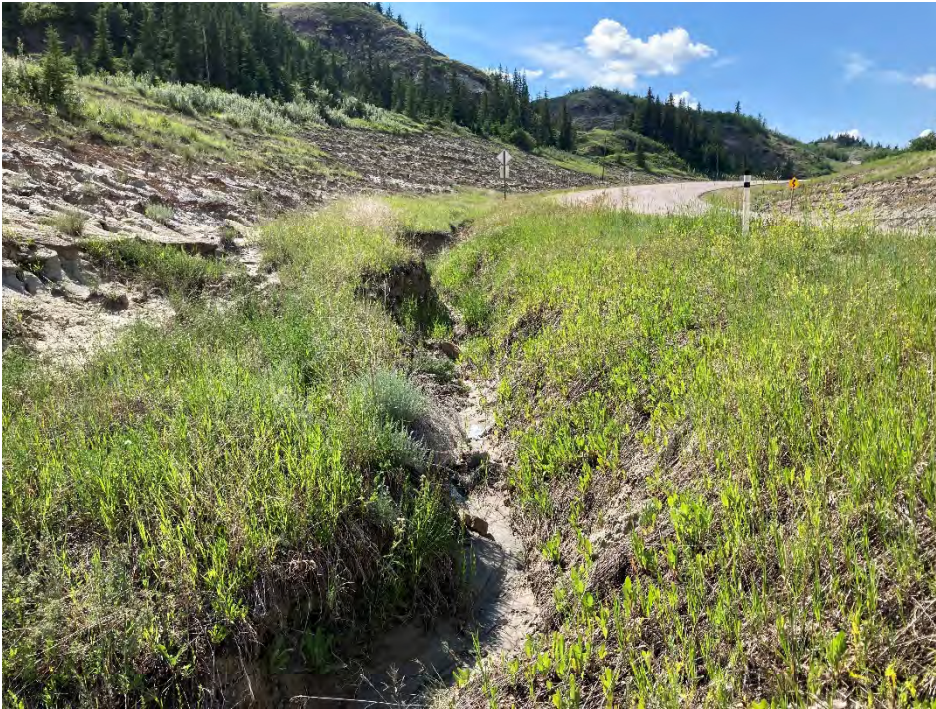
- The CSP culvert downslope of the erosion gully continues to corrode (Photo 2). The culvert was observed to be flowing and the bottom of the culvert was corroded.

Photo 2 Continued erosion in the ditch south of Highway 590, upstream of the 1200 mm diameter CSP culvert. Photo taken June 24, 2021 facing west.

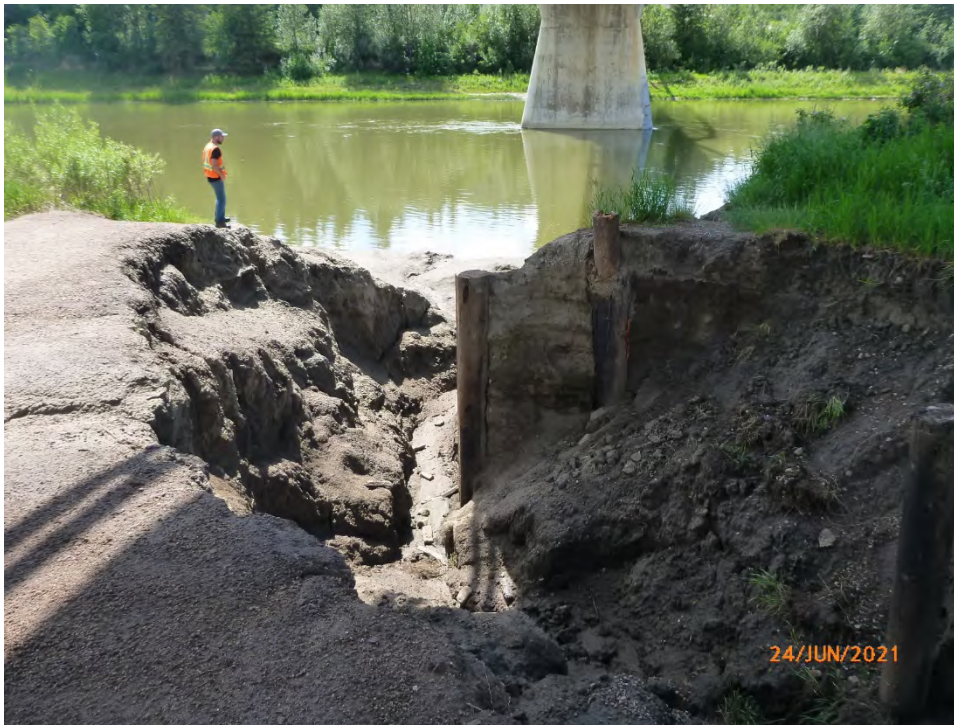
- Erosion gullies beneath the bridge have expanded and retrogressed toward the bridge abutments. The erosion gully is larger than during the 2020 inspection and should be repaired in 2021.

Photo 4 Erosion gully at the east abutment is larger than during the 2020 inspection. Photo taken June 24, 2021 facing west.

- In the short term, riprap should be placed in the erosion gully to minimize the potential for enlargement and continued retrogression. This should be repaired by the bridge group, as they have experience completing work around existing creosote timbers and have procedures in place.
