SITE NUMBER AND NAME: C060 Slide East of Blackfalds		HIGHWAY & KM: 597:02, 11.299	PREVIOUS INSPECTION DATE: July 11, 2019	INSPECTION DATE: June 09, 2020
LEGAL DESCRIPTION: 01-16-039-26 W4M 16-09-039-26 W4M	NAD 83 COORDINATES: UTM Northing Easting 12 5802987 317570		RISK ASSESSMENT: PF: 5 CF: 6 TOTAL: 30	
AVERAGE ANNUAL DAILY TRAFFIC (AADT): 1,640 (west) & 3480 (east) (Ref No. 97337 & 89330)			CONTRACT MAINTENANCE AREA (CMA): 516

PROJECT CENTRAL REGION GEOHAZARD RISK MANAGEMENT PROGRAM		
TITLE Site Plan C060 - Slide East of Blackfalds Hwy 597:02, km 11.299		
SCALE 1:1,000	PROJECT No. A05115A02	FIG No. 1

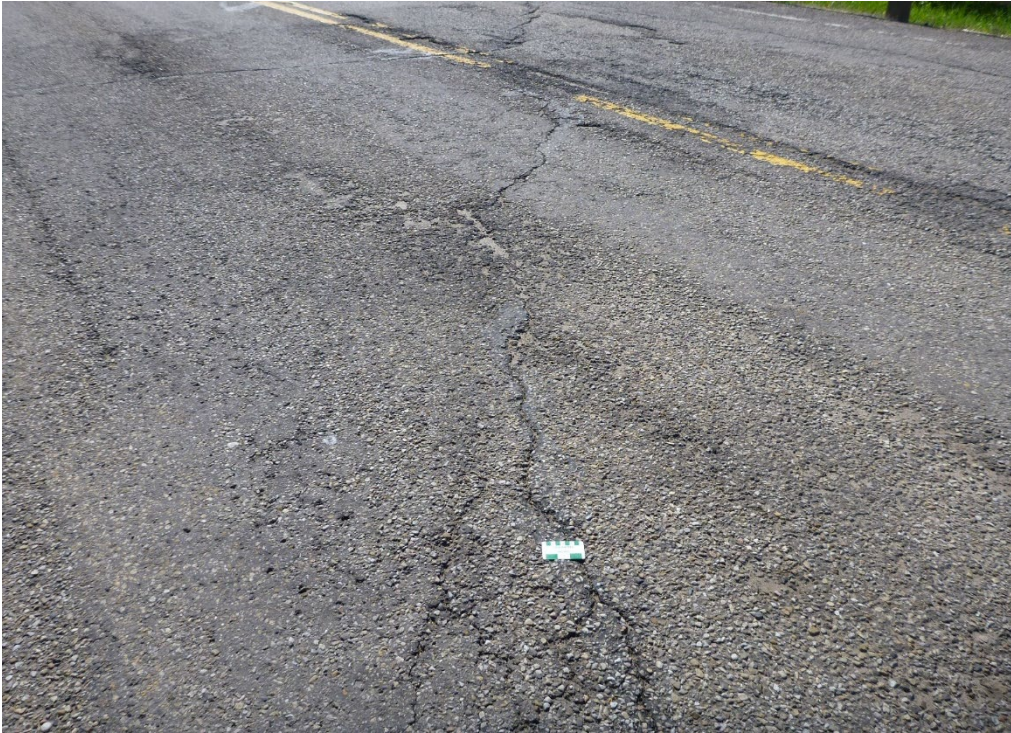
<p>COMMENTS</p> <p>Pavement patch appears to have deteriorated in the eastbound and westbound lanes since the 2019 inspection. Eastbound vehicles were observed moving into the westbound lane to avoid the deteriorated pavement in eastbound lane. The increased traffic from the eastbound lane may be exacerbating pavement wear in the westbound lane.</p> <p>In March 2017, a geotechnical site investigation was conducted by KCB. Four VWPs and two SIs were installed to monitor groundwater conditions and depth of movement. Since installation, SI17-C60-02 (located at the toe berm crest) has not recorded any discernible movement. SI17-C60-01 is recording movement at the interface between</p>
--

Photo 1 The pavement above the slide area in the eastbound and westbound lanes continues to degrade over time. Photos taken June 9, 2020 looking southwest.

The pavement above the slide may be milled and resurfaced in 2020.

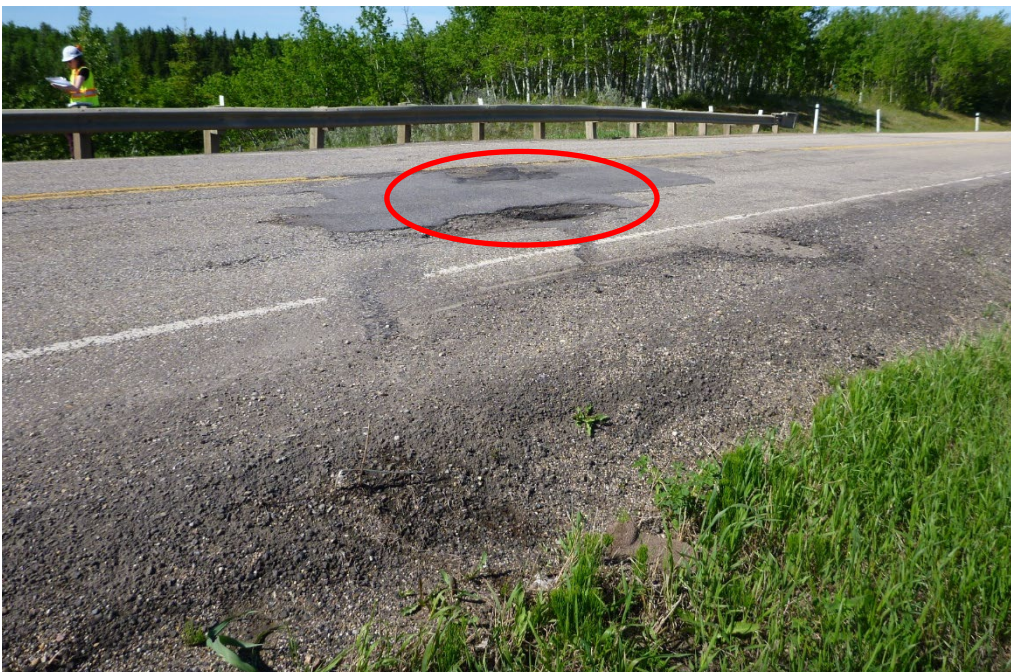
Photo 2 Photo showing the condition of pavement above the slide area. Condition of pavement in the westbound lane (red ellipse) has worsened since the 2019 inspection. Photo taken June 9, 2020 looking southwest.

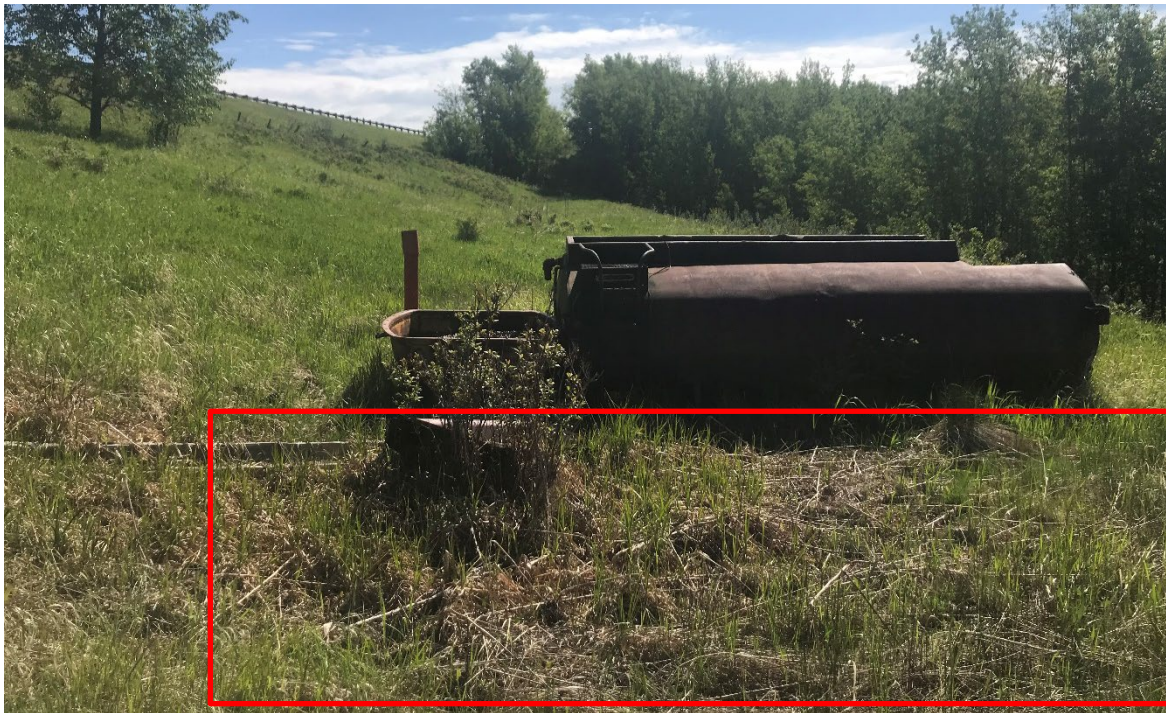
A wet area was observed on the crest of the toe berm west of S17-C60-02 (Photo 3). This area should be inspected during the fall 2020 instrument readings. If the ponding water continues, the drainage on the toe berm crest should be improved to reduce the risk of infiltration that could elevate pore water pressures in the toe berm material.

Photo 3 Wet area observed on the bench near SI17-C60-02 (indicated by red rectangle). Photo taken June 9, 2020 facing east.

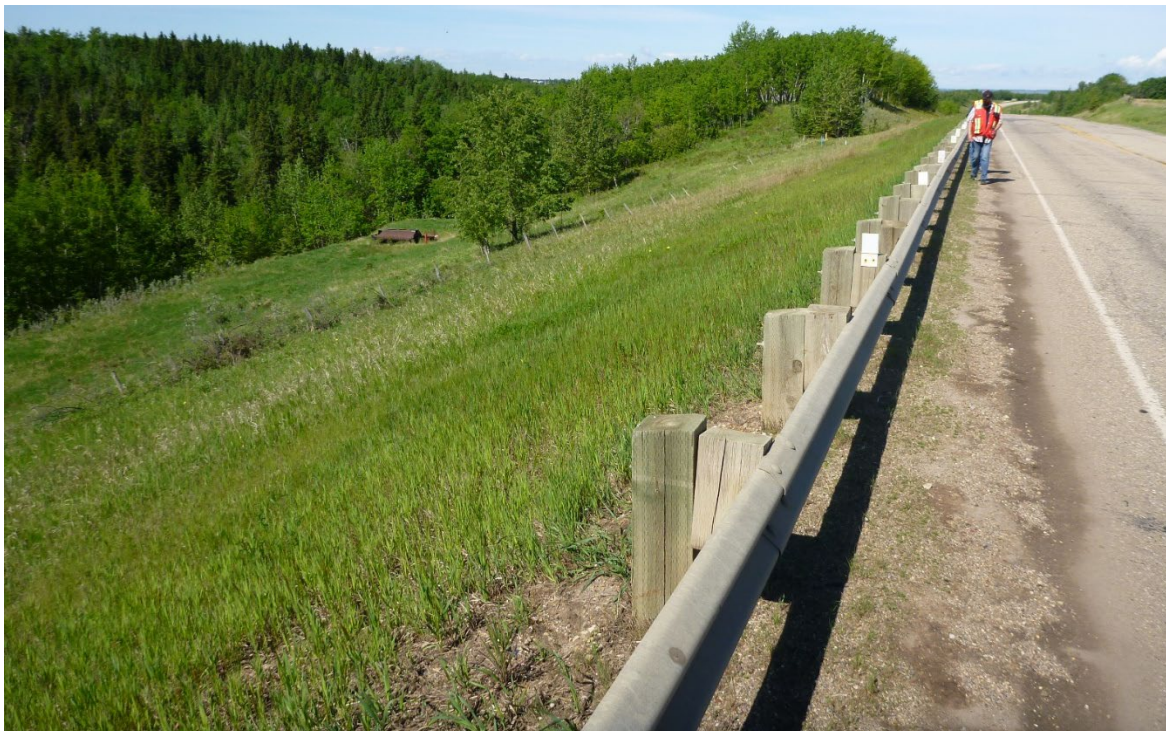
Photo 4 Slope below highway showing no signs of deformation or slope movement since 2019 inspection. Photo taken June 9, 2020 facing west.
