<b>SITE NUMBER AND NAME:</b> C060 Slide East of Blackfalds		<b>HIGHWAY &amp; KM:</b> 597:02, 11.299	<b>PREVIOUS INSPECTION DATE:</b> June 9, 2020	<b>INSPECTION DATE:</b> <b>May 30, 2022</b>
<b>LEGAL DESCRIPTION:</b> 01-16-039-26 W4M 16-09-039-26 W4M	<b>NAD 83 COORDINATES:</b> UTM Northing Easting 12 5802987 317570		<b>RISK ASSESSMENT:</b> PF: 5 CF: 6 TOTAL: 30	
<b>AVERAGE ANNUAL DAILY TRAFFIC (AADT):</b> 1120 (west) & 2910 (east) (Ref No. 97337 & 89330)			<b>CONTRACT MAINTENANCE AREA (CMA):</b> 516

PROJECT CENTRAL REGION GEOHAZARD RISK MANAGEMENT PROGRAM		
TITLE Site Plan C060 - Slide East of Blackfalds Hwy 597:02, km 11.299		
SCALE 1:1,000	PROJECT No. A05116A02	FIG No. 1

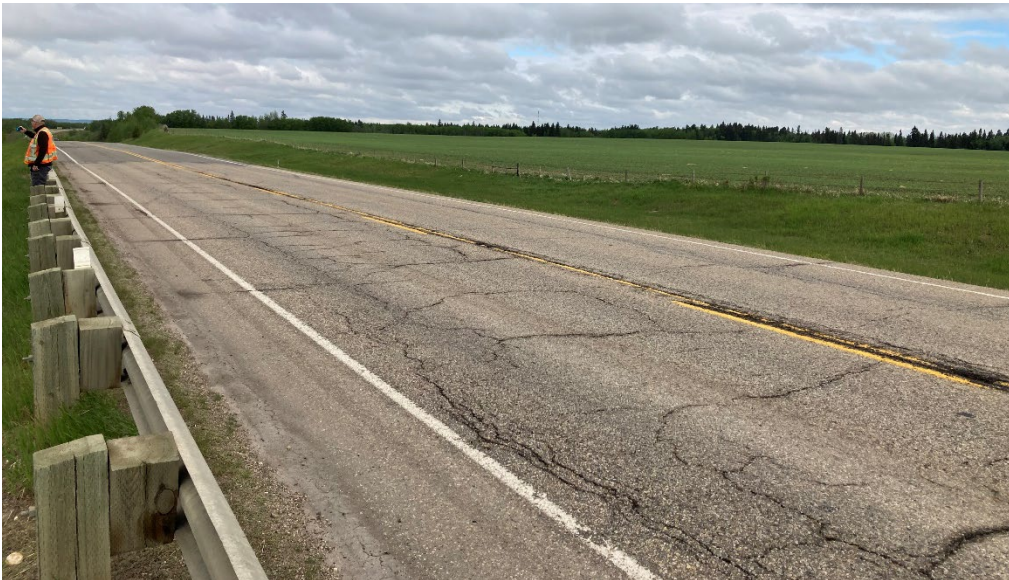
<b>COMMENTS</b>
In March 2017, a geotechnical site investigation was conducted by KCB. Four VWPs and two SIs were installed to monitor groundwater conditions and depth of movement. Since installation, SI17-C60-02 (located at the toe berm crest) has not recorded any discernible movement. SI17-C60-01 is recording movement at the interface between embankment fill and bedrock foundation (approximately 14 mbgs).
The fence north of the highway appears to have settled above (upslope) the slide area (Photo 1).
The pavement appears to have deteriorated (i.e., alligator cracking) in the eastbound and westbound lanes since the pavement patch was completed in 2020 (Photo 1). There is a transverse crack near the east extent of the

pavement patch that extends across both lanes. Pavement cracking could lead to increased infiltration and softening of the highway subgrade.

- Photo 1** Alligator cracking has been regularly observed in both lanes upslope the C060 slide and appears to have worsened since the 2020 inspection. Photo taken May 30, 2022, facing northwest.

- The pavement along the site should be milled and repaved to address pavement cracking. The extent of the pavement patch should be larger than the previous patch to address the new pavement cracking east of the slide.
- In the areas where the pavement deterioration is the most significant (i.e., zone of cracking and pothole near the west extent of the exiting pavement patch) the subgrade should be excavated and replaced with more competent material (e.g., Des. 2 Cl. 40). AT informed KCB that paving may be completed in fall 2022 or 2023.
- The erosion observed at the outlet of the CSP culvert (WP 142) should be repaired by backfilling the eroded areas with riprap (e.g., Class 1M)

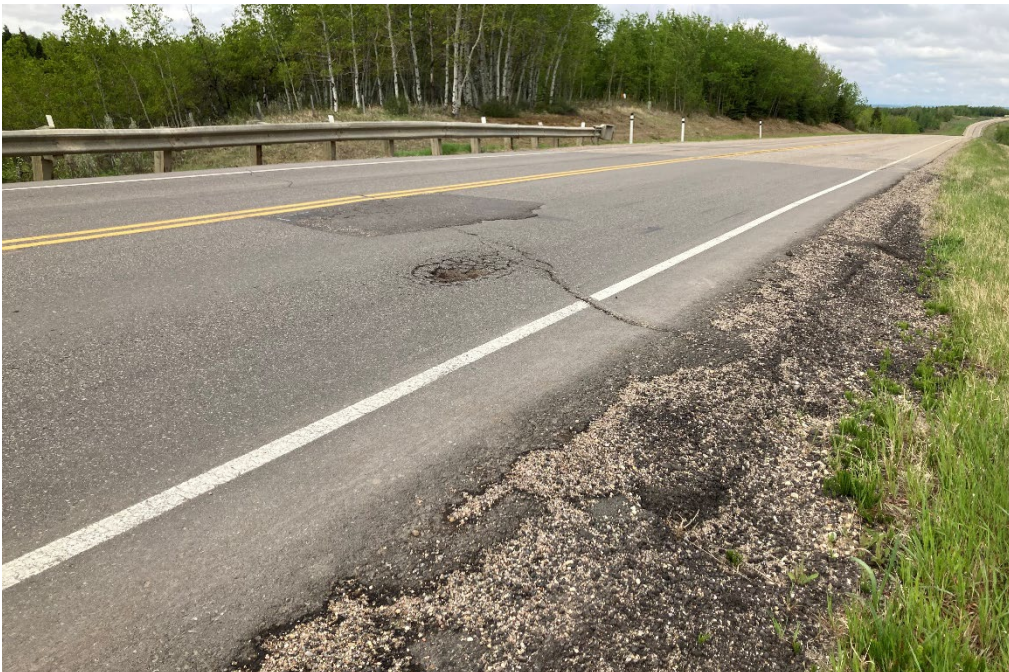
There is a reoccurring pothole near the west extent of the pavement patch (Photo 2) in the south (westbound) lane, which may be attributed to a soft zone in the highway subgrade. The MCI told KCB that the previous subgrade repair to reduce settlement in the highway included placing foam under a gravel subgrade. During gravel placement, the foam could be heard cracking.

- Photo 2** A recurring pothole was observed near the west extent of the pavement patch that may be attributed to poor subgrade condition. The pavement patch was completed in 2020. Photo taken May 30, 2022, facing southwest

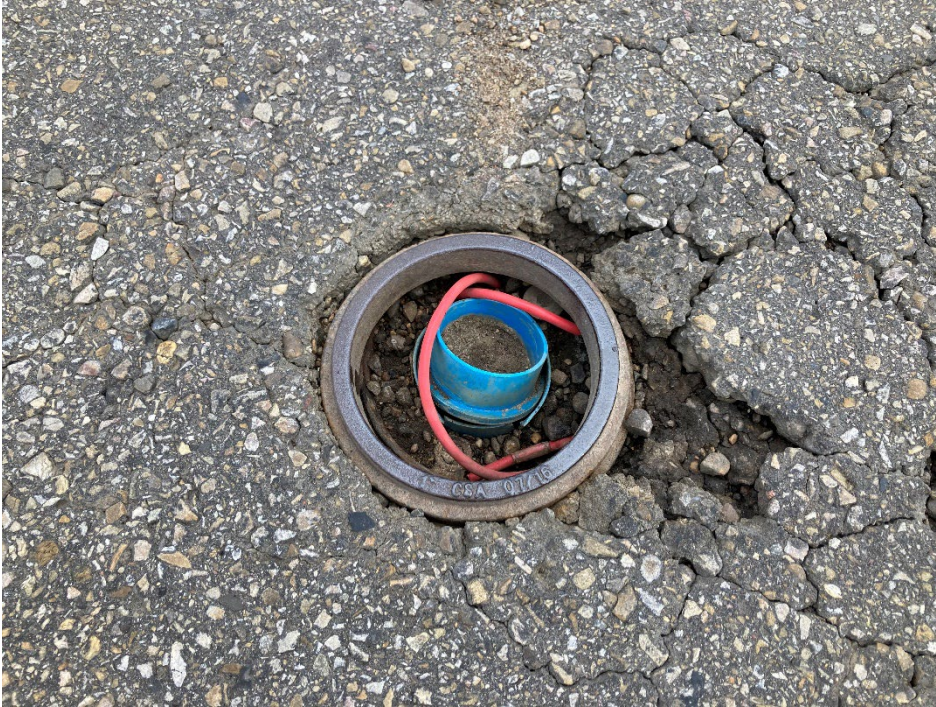
The headbox protecting BH17-C060-01 instrumentation was damaged during pavement patching completed in 2020, resulting in damage to the slope inclinometer (SI17-C060-01) and vibrating wire piezometer cables (VW42623 and VW42625) (Photo 3). KCB repaired the headbox (removed pavement riser, stripped the VW cables, and replaced headbox cap) during the 2022 spring instrumentation readings.

**Photo 3** The flush-mounted head box in the south (eastbound) lane protecting the instrumentation installed in BH17-C060-01 was damaged during pavement patching completed in 2020. Photo taken May 30, 2022.

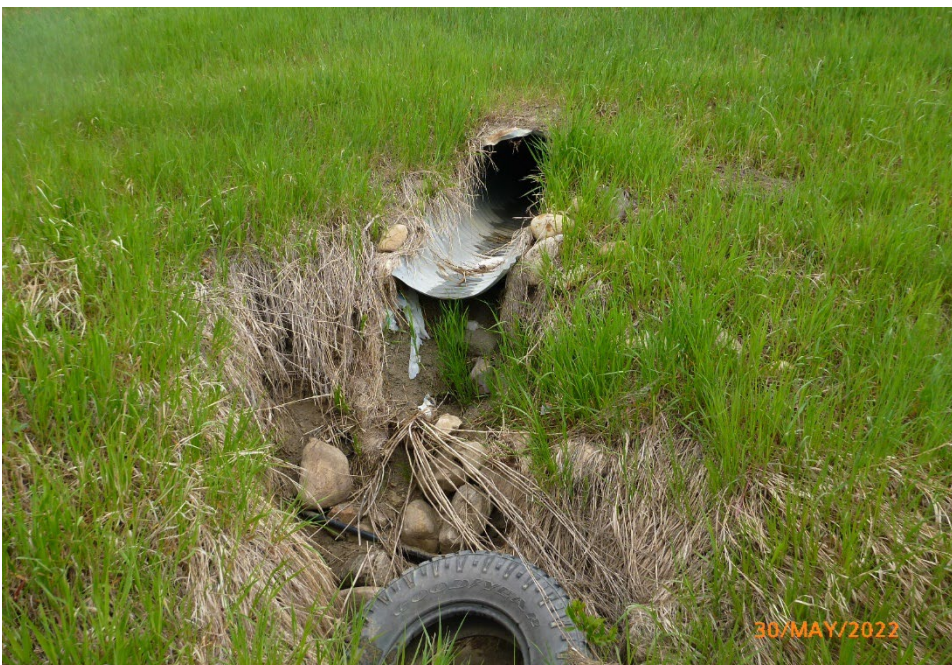
Water flow from the north ditch is conveyed across the highway through an 800 mm diameter CSP culvert that drains into a CSP slope drain, which then discharges onto the toe berm. Erosion was observed (approximately 0.5 m to 0.75 m deep) at the outlet of the CSP culvert, which had formed between the 2020 and 2022 inspections (Photo 4).

**Photo 4** An erosion gully has formed at the CSP culvert underlying Hwy 597 (WP 142) between the 2020 and 2022 inspections. Photo taken May 31, 2022, facing north.

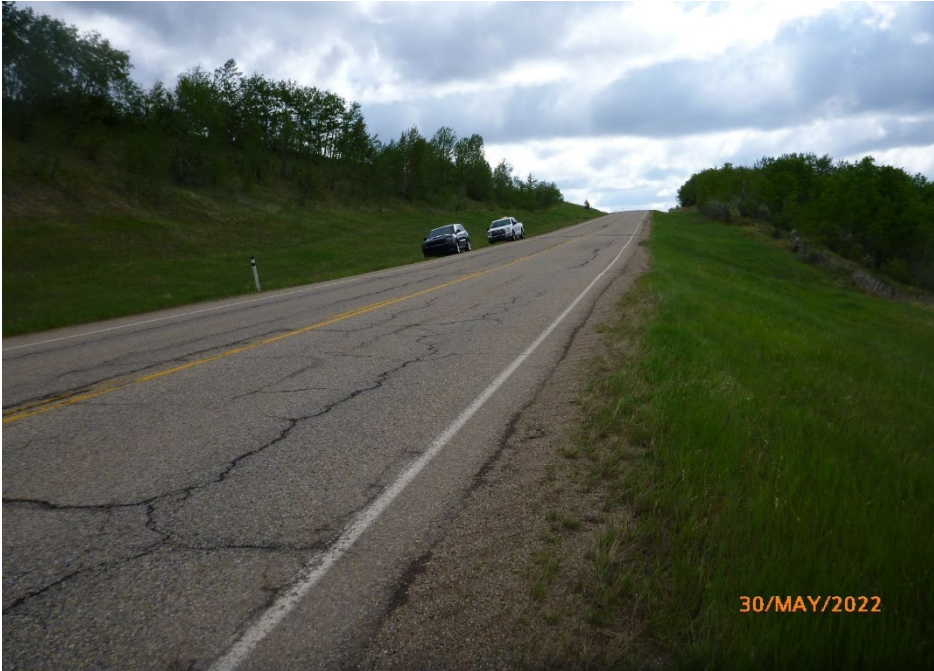
**Photo 5** The expired C008 site was visited during the C060 inspection. Alberta Transportation's (AT's) Maintenance Contract Inspector (MCI) informed KCB during the inspection that pavement cracking and settlement appears to have worsened since 2021. Photo taken May 30, 2022, facing east.

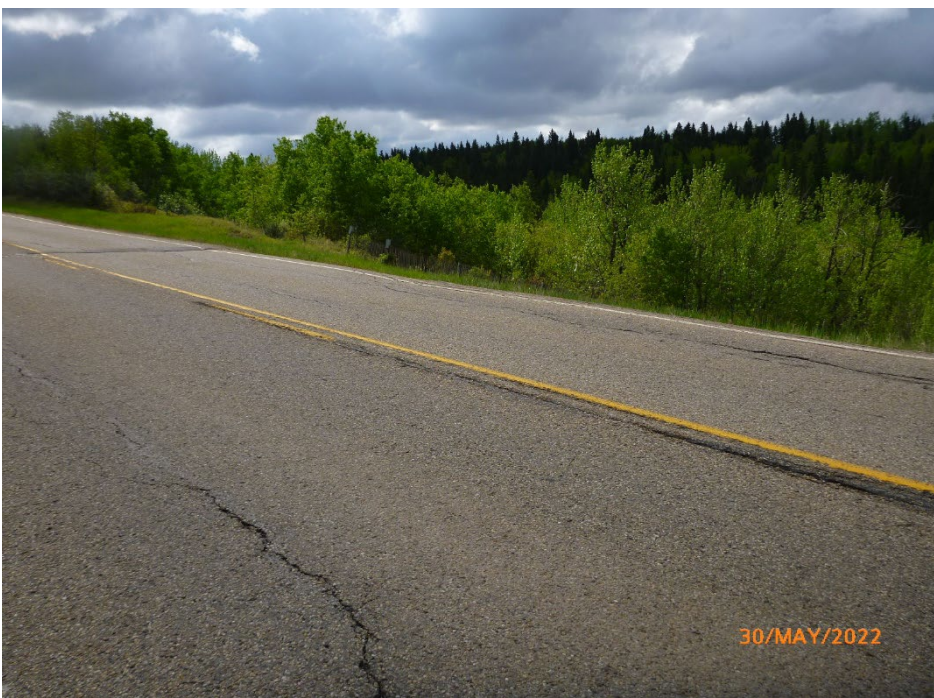
- The site was the expired C008 site that was repaired in 2007 (soil nails and embankment reconstruction).
- Pavement cracking was observed in the north and south lanes along the site (Photo 5).
- The repaired slope is creeping and is deforming the highway surface (Photo 6).
- AT could consider improving the drainage by building a deep ditch drain in the north (westbound) ditch to intercept ground water. One borehole should be completed in the north ditch and a piezometer could be installed to assess the ground water level.

**Photo 6** Pavement cracking and settlement above the C008 slide. Photo taken May 30, 2022, facing southeast.
