September 12, 2022

Alberta Transportation
4th Floor, Provincial Building
4920 51 Street
Red Deer, Alberta
T4N 6K8

**CON0022160 Central Region GRMP Instrumentation Monitoring
Site C060; H597:02, km 11.299 Slide East of Blackfalds
Section C – 2022 Spring Readings**

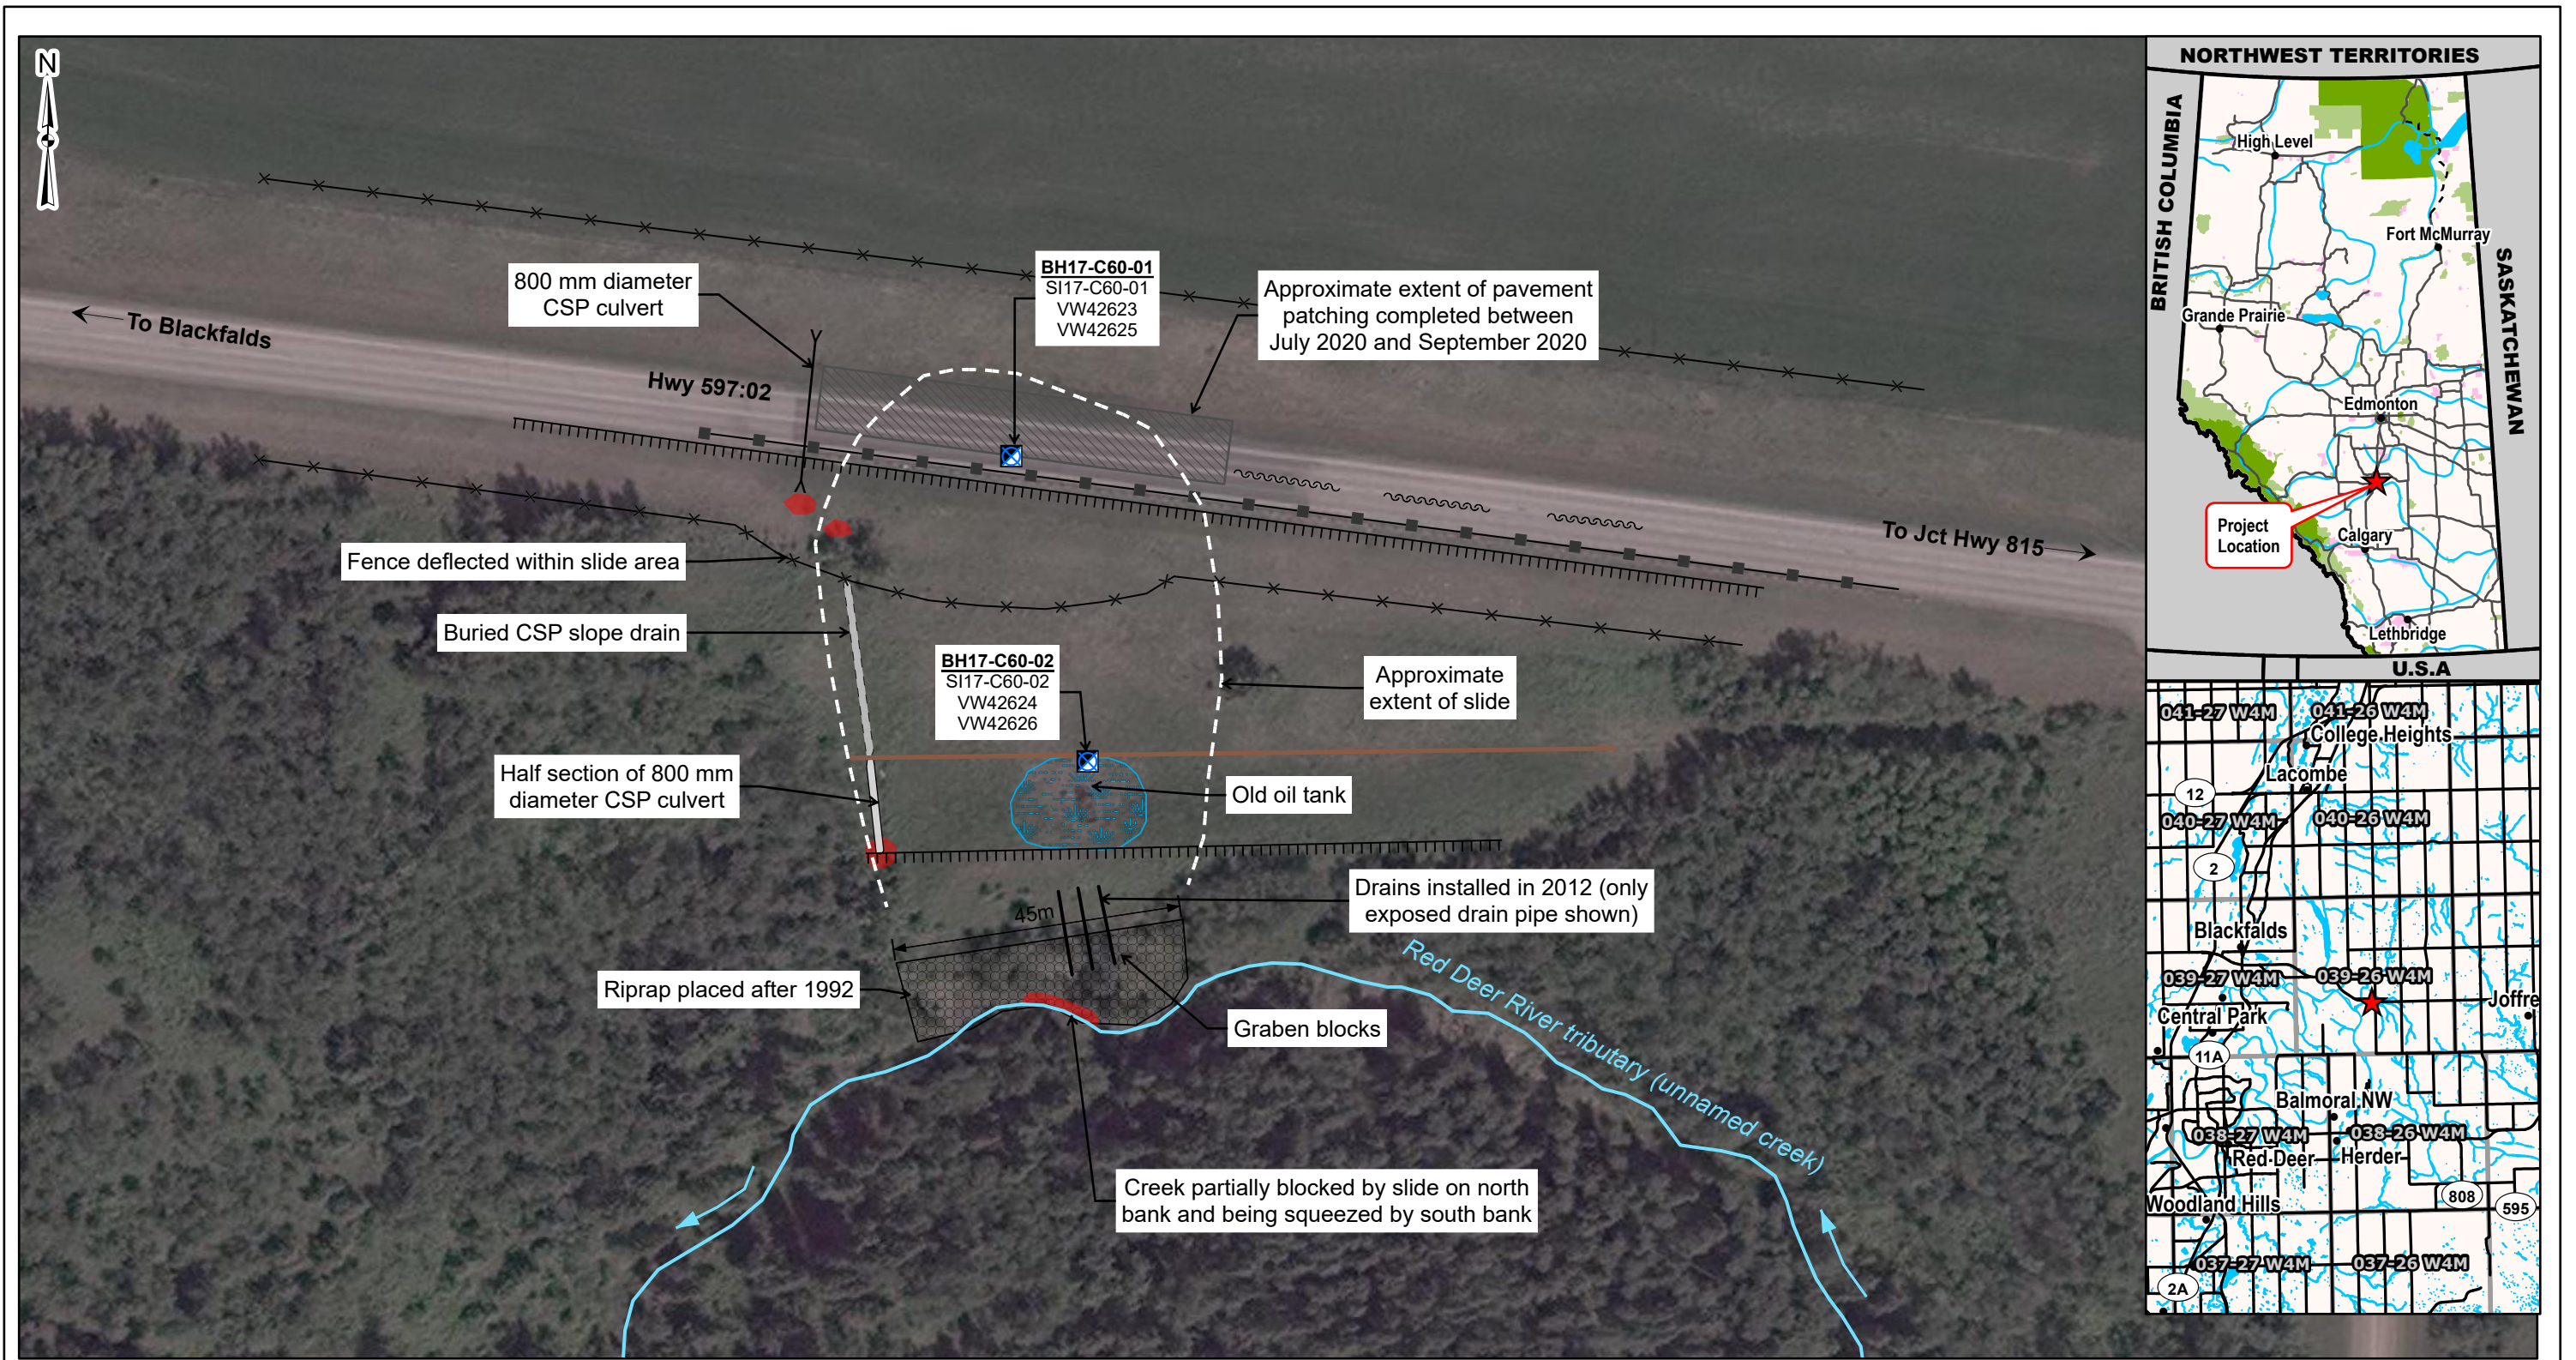
PROJECT CENTRAL REGION GEOHAZARD RISK MANAGEMENT PROGRAM		
TITLE Site Plan C060 - Slide East of Blackfalds Hwy 597:02, km 11.299		
SCALE 1:1,000	PROJECT No. A05116A02	FIG No. 1

The geohazard at the C060 site consists of a slide through the foundation of the highway embankment. The slide is located on the south side (eastbound lane) of Hwy 597:02. Issues at this site developed shortly after construction of the highway was completed in 1976. Previous remedial actions at this site include installation of horizontal drains in November 1983 to lower the groundwater table, construction of a toe berm in 1983 with a shear key, construction of a riprap toe berm sometime after 1992, installation of deep horizontal drains in February 2012, and removal of a dip in the highway surface in summer 2012.

Instrumentation installation details are tabulated in Table 1.1. Instrument locations are shown in Figure 1. All instruments installed before 2010 are inoperable and are not presented on Figure 1. All instruments installed before November 2010 are inoperable and are not presented or discussed herein.

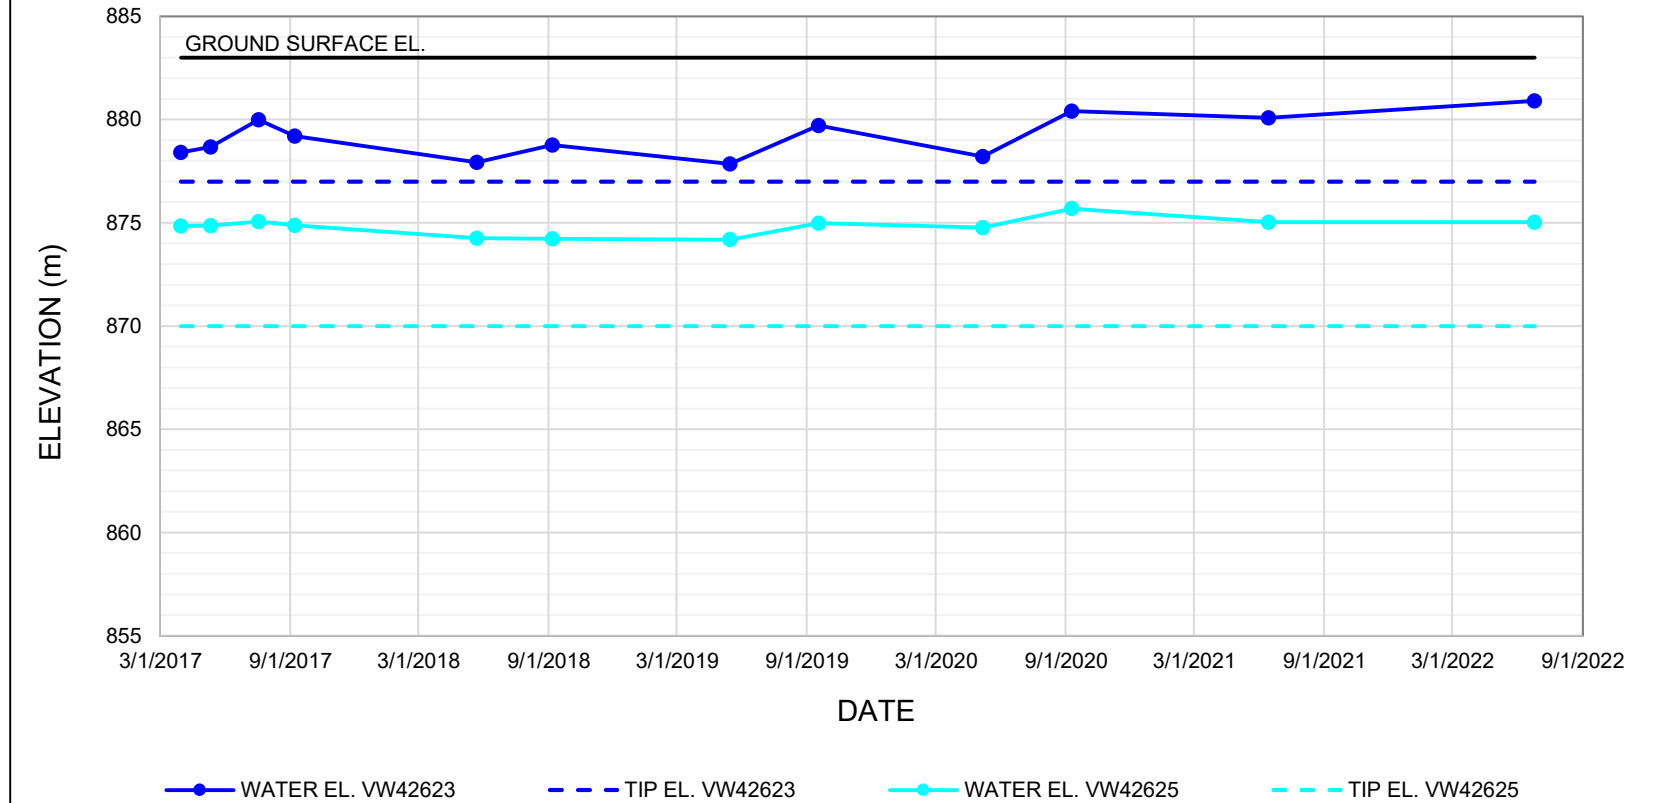
VW42623 AND VW42625

Water levels recorded in VW42625, VW42624, and VW42626 (lower piezometer below highway, and piezometers below toe berm crest) have been relatively steady (± 0.5 m) since they instruments were installed in 2017, excluding higher-than-typical water levels recorded in September 2020 after a wetter-than-average summer. Water levels recorded in VW42623 (upper piezometer below highway) appear to fluctuate seasonally with the spring readings being lower than fall readings.

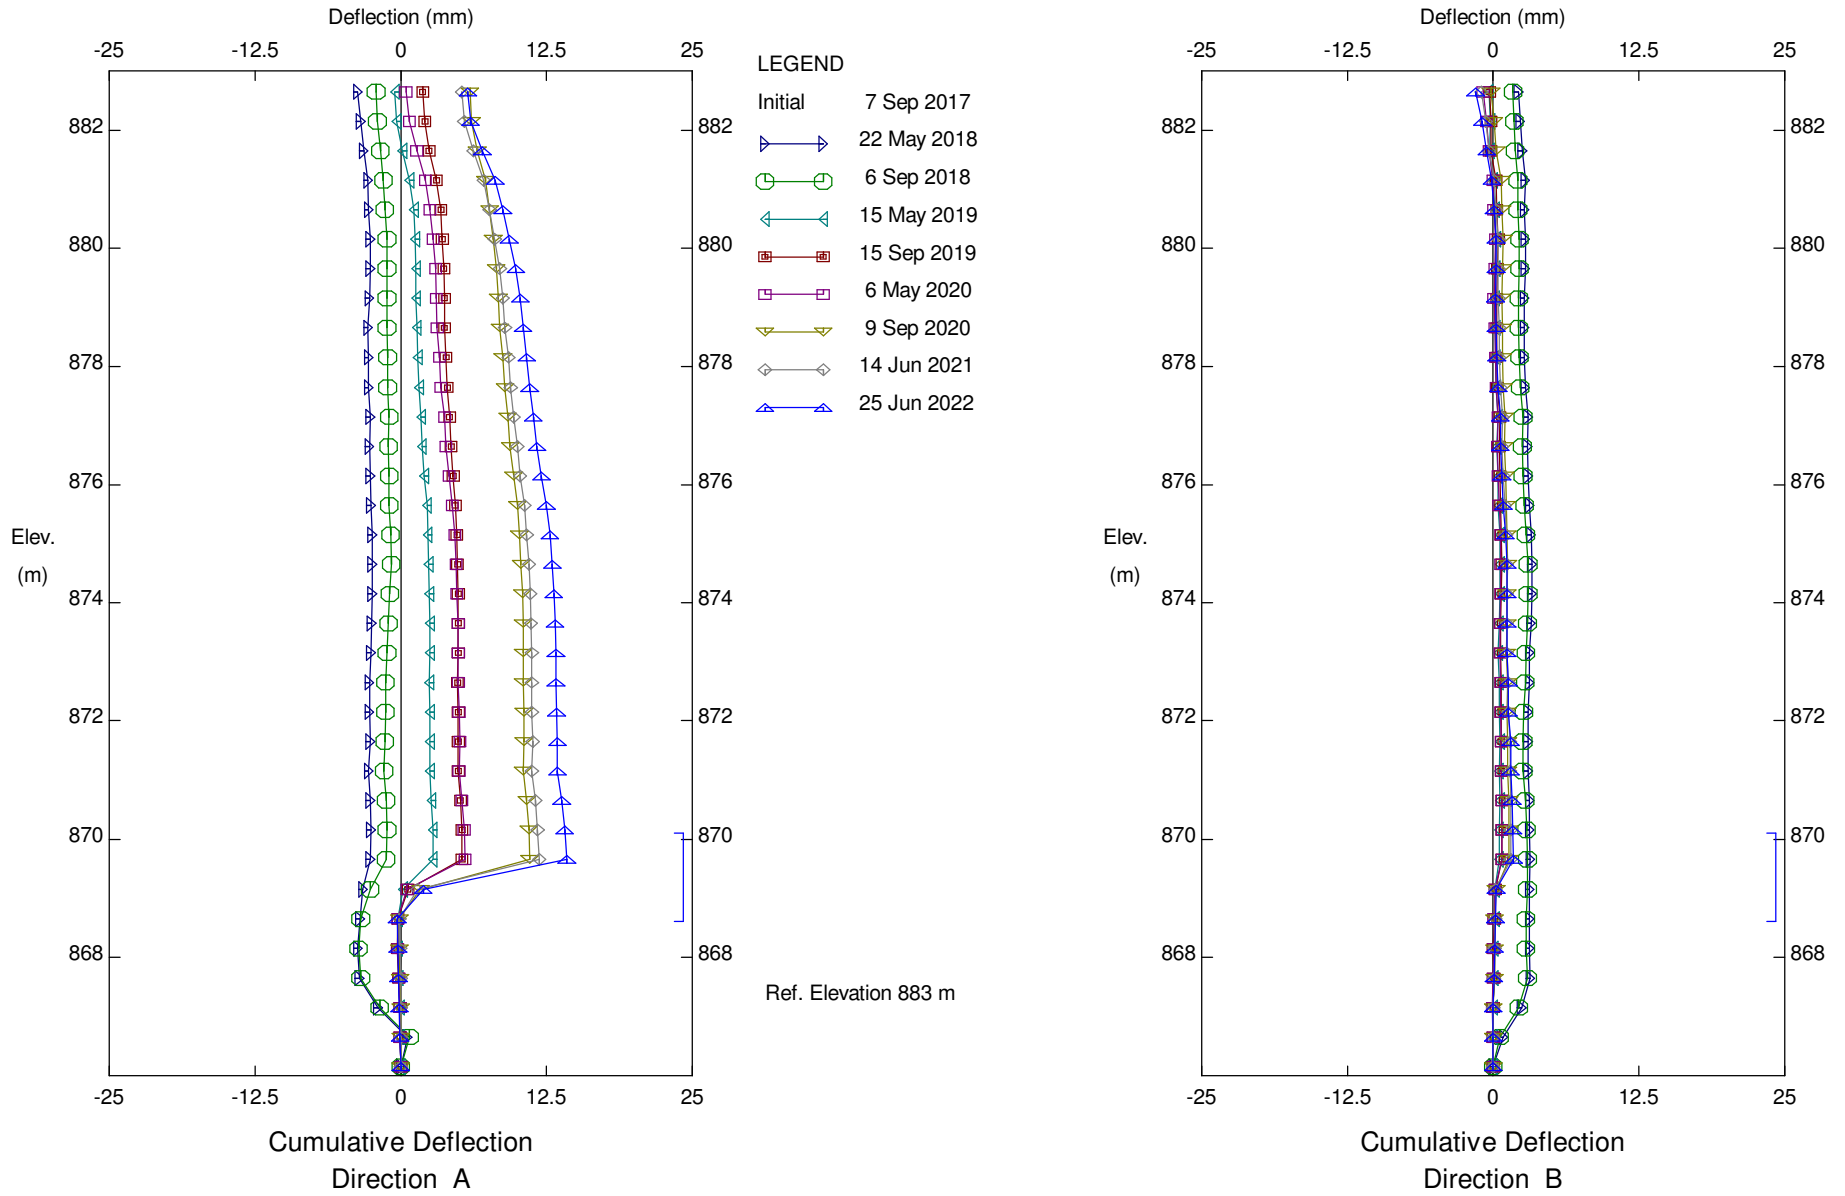
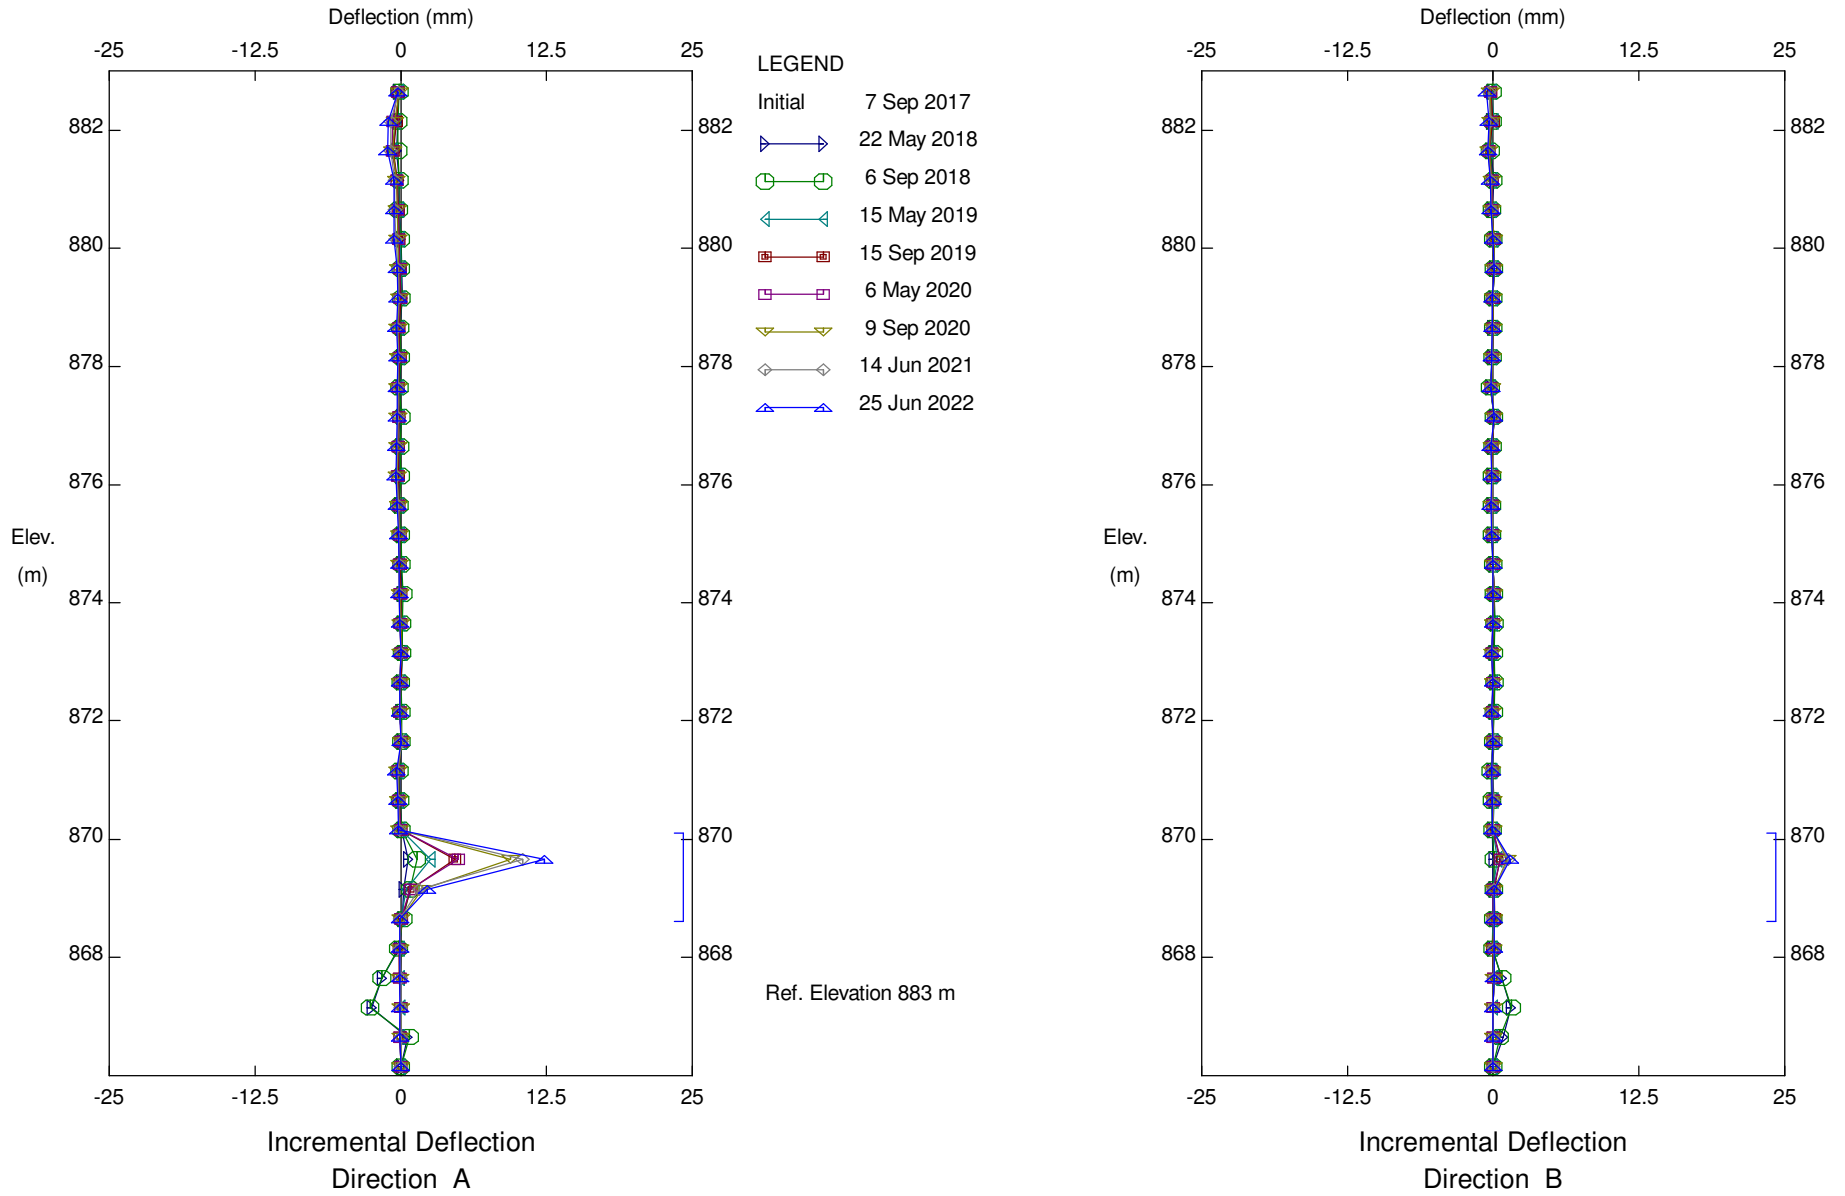
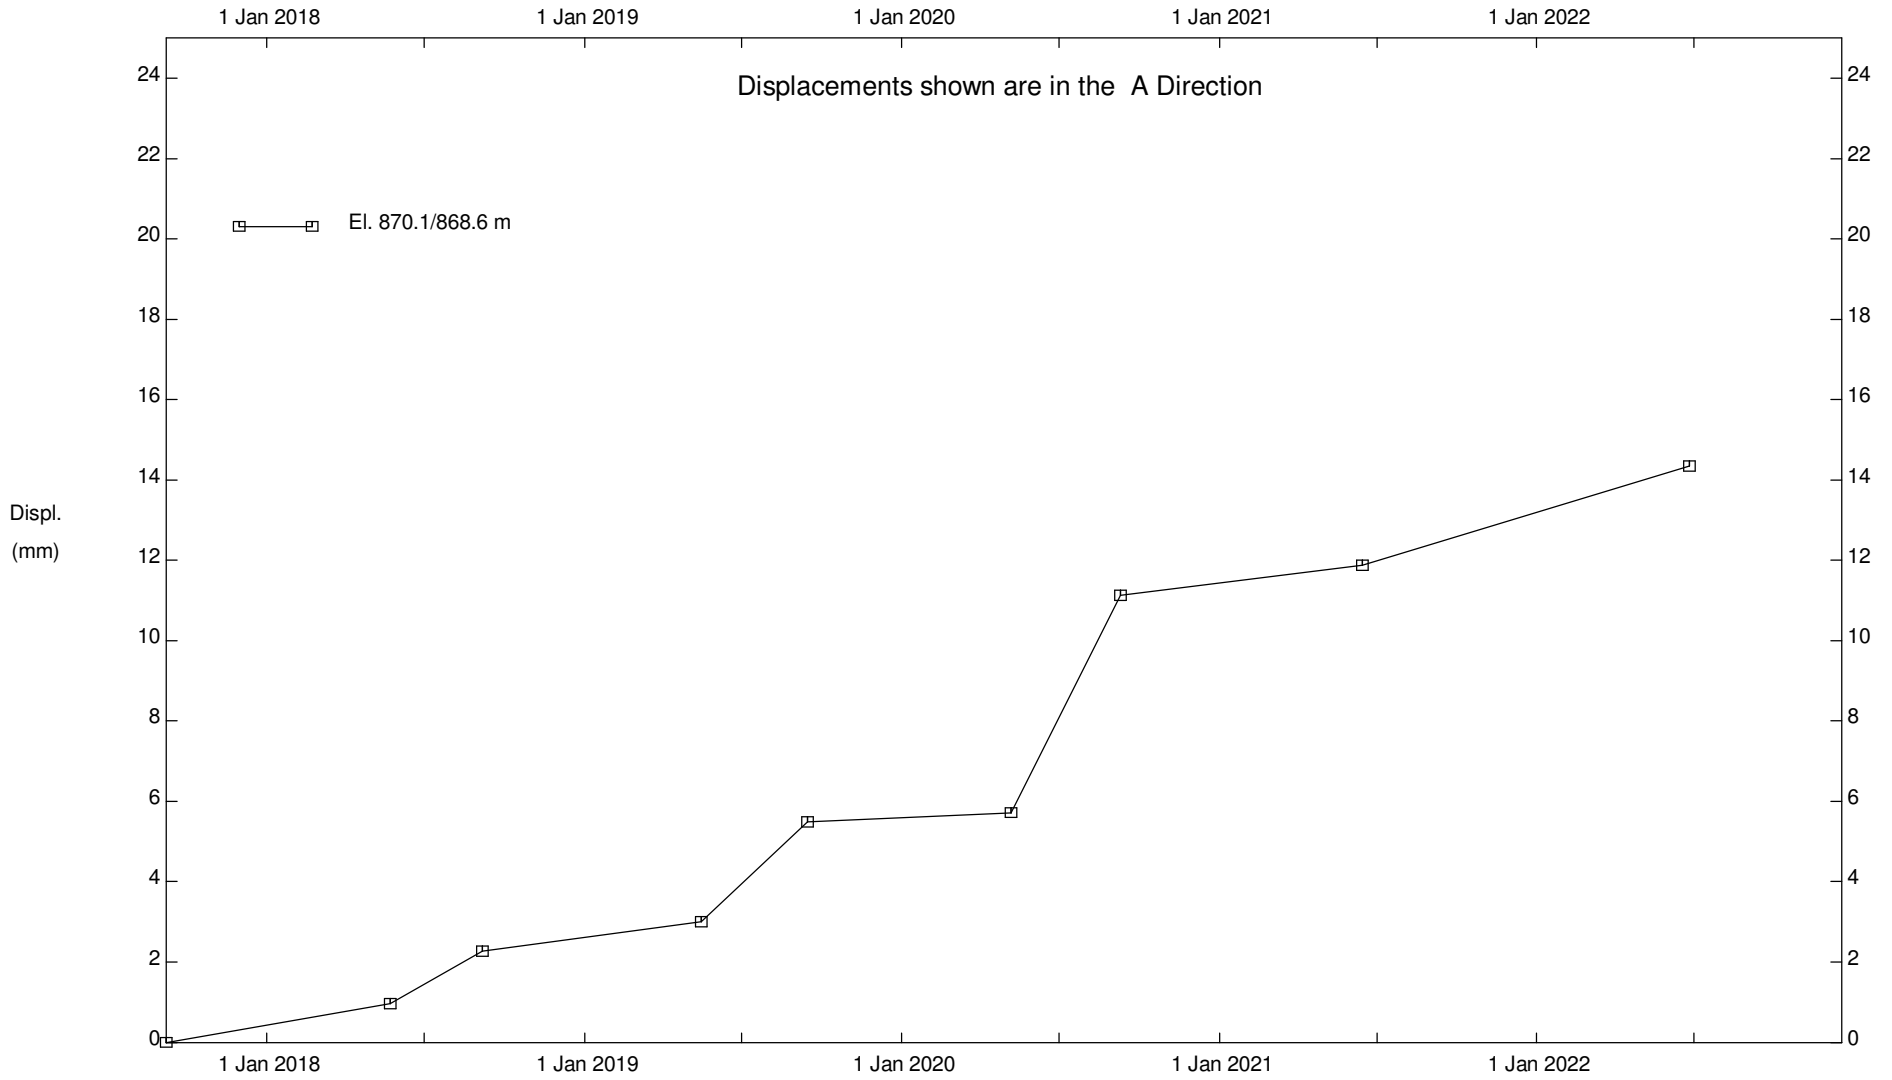
C060; H597:02, Slide East of Blackfalds, Inclinometer SI17-C60-01

Movement is being recorded in SI17-C60-01 at approximate depths of 2.3 m and 14.3 m below ground surface (El. 880.7 m and El. 868.7 m, respectively), and in SI17-C60-02 at an approximate depth of 11.0 m below ground surface (El. 862.0 m).

- the movement recorded in SI10-01 and SI12-01 (mid-slope) appeared to have occurred at the interface between clay and rafted bedrock.
- the upper and lower zones of movement recorded in SI17-C60-01 (through pavement surface) appear to be occurring in the embankment fill and at the interface between clay and bedrock. The magnitude and rate of movement being recorded in SI17-C60-01 tends to fluctuate, especially near the bottom of the casing. Based on the stratigraphy encountered during the 2010 drilling investigation, we suspect SI17-C60-01 was terminated in rafted bedrock and the toe of the SI could be moving. Although SI17-C60-01 extends below the suspected failure surface, it may not extend deep enough and the recorded fluctuations, especially near the bottom of the casing, are likely caused by movement of the rafted bedrock in the underlying till.

The rate of movement recorded in SI17-C60-01 and SI17-C60-02 has generally been slow to very slow (less than 7 mm/year and 1 mm/year, respectively), except between May and September 2020 when the rate of movement increased to approximately 16 mm/year and 14 mm/year, respectively, likely due to a wetter-than-average summer.

Currently, unless movements accelerate and impact the highway surface, AT has no plans of repairing this site. Since SI17-C60-01 is recording movement below the highway surface, AT should inspect the road surface regularly.

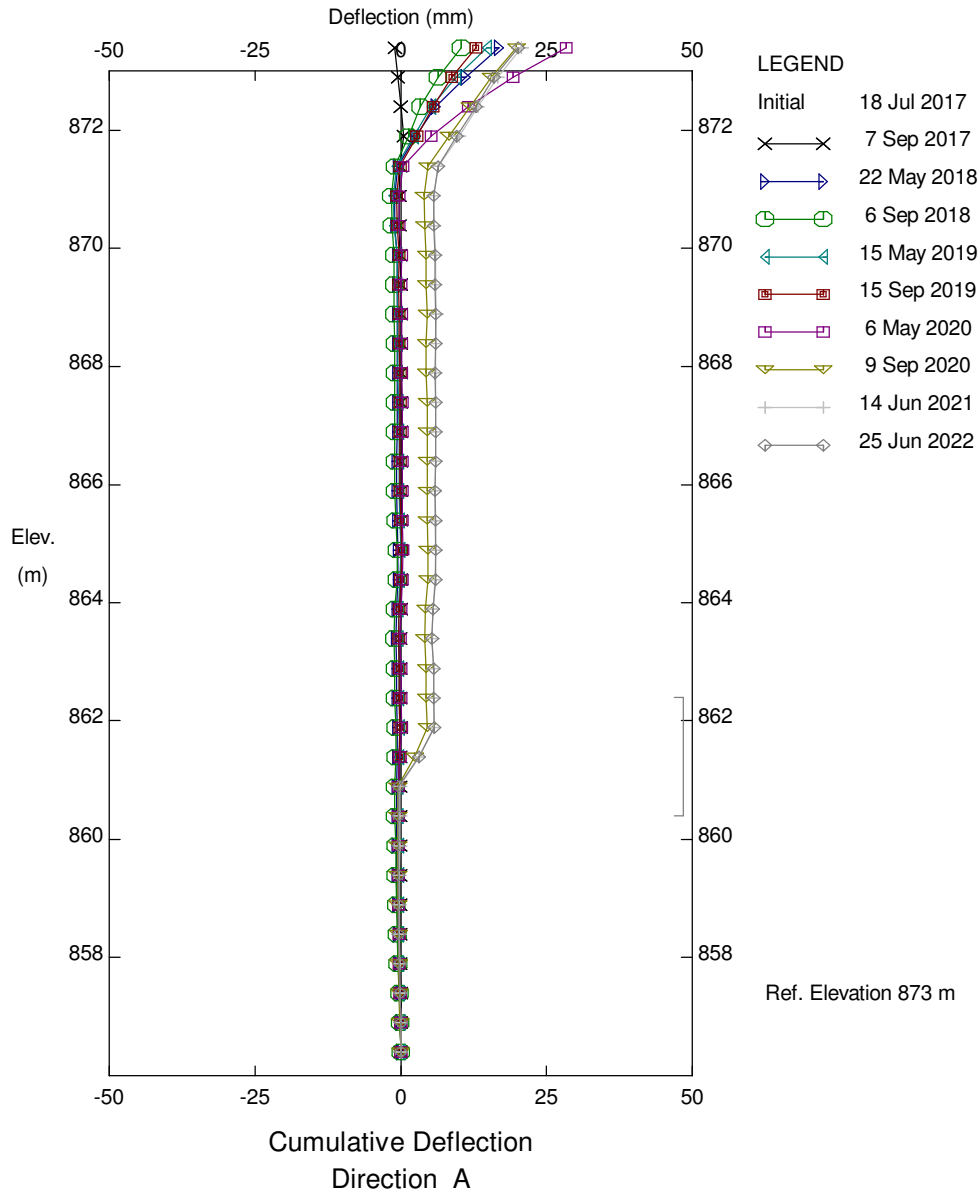
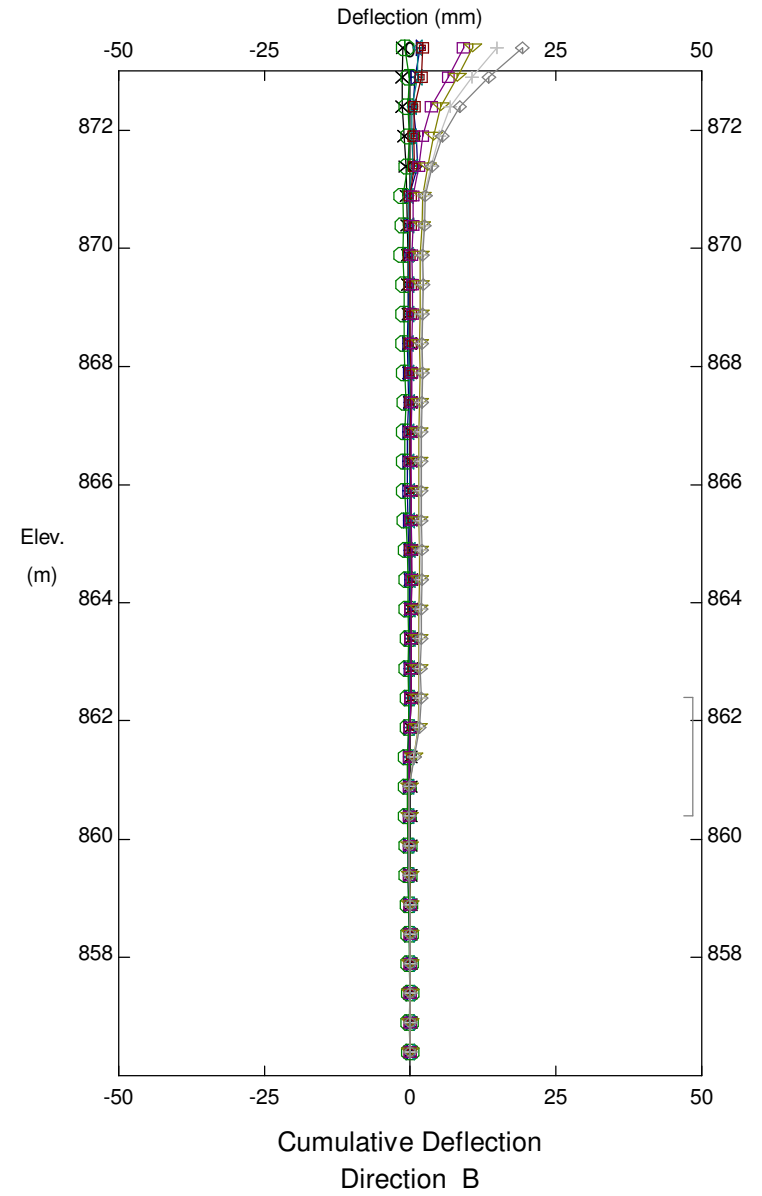
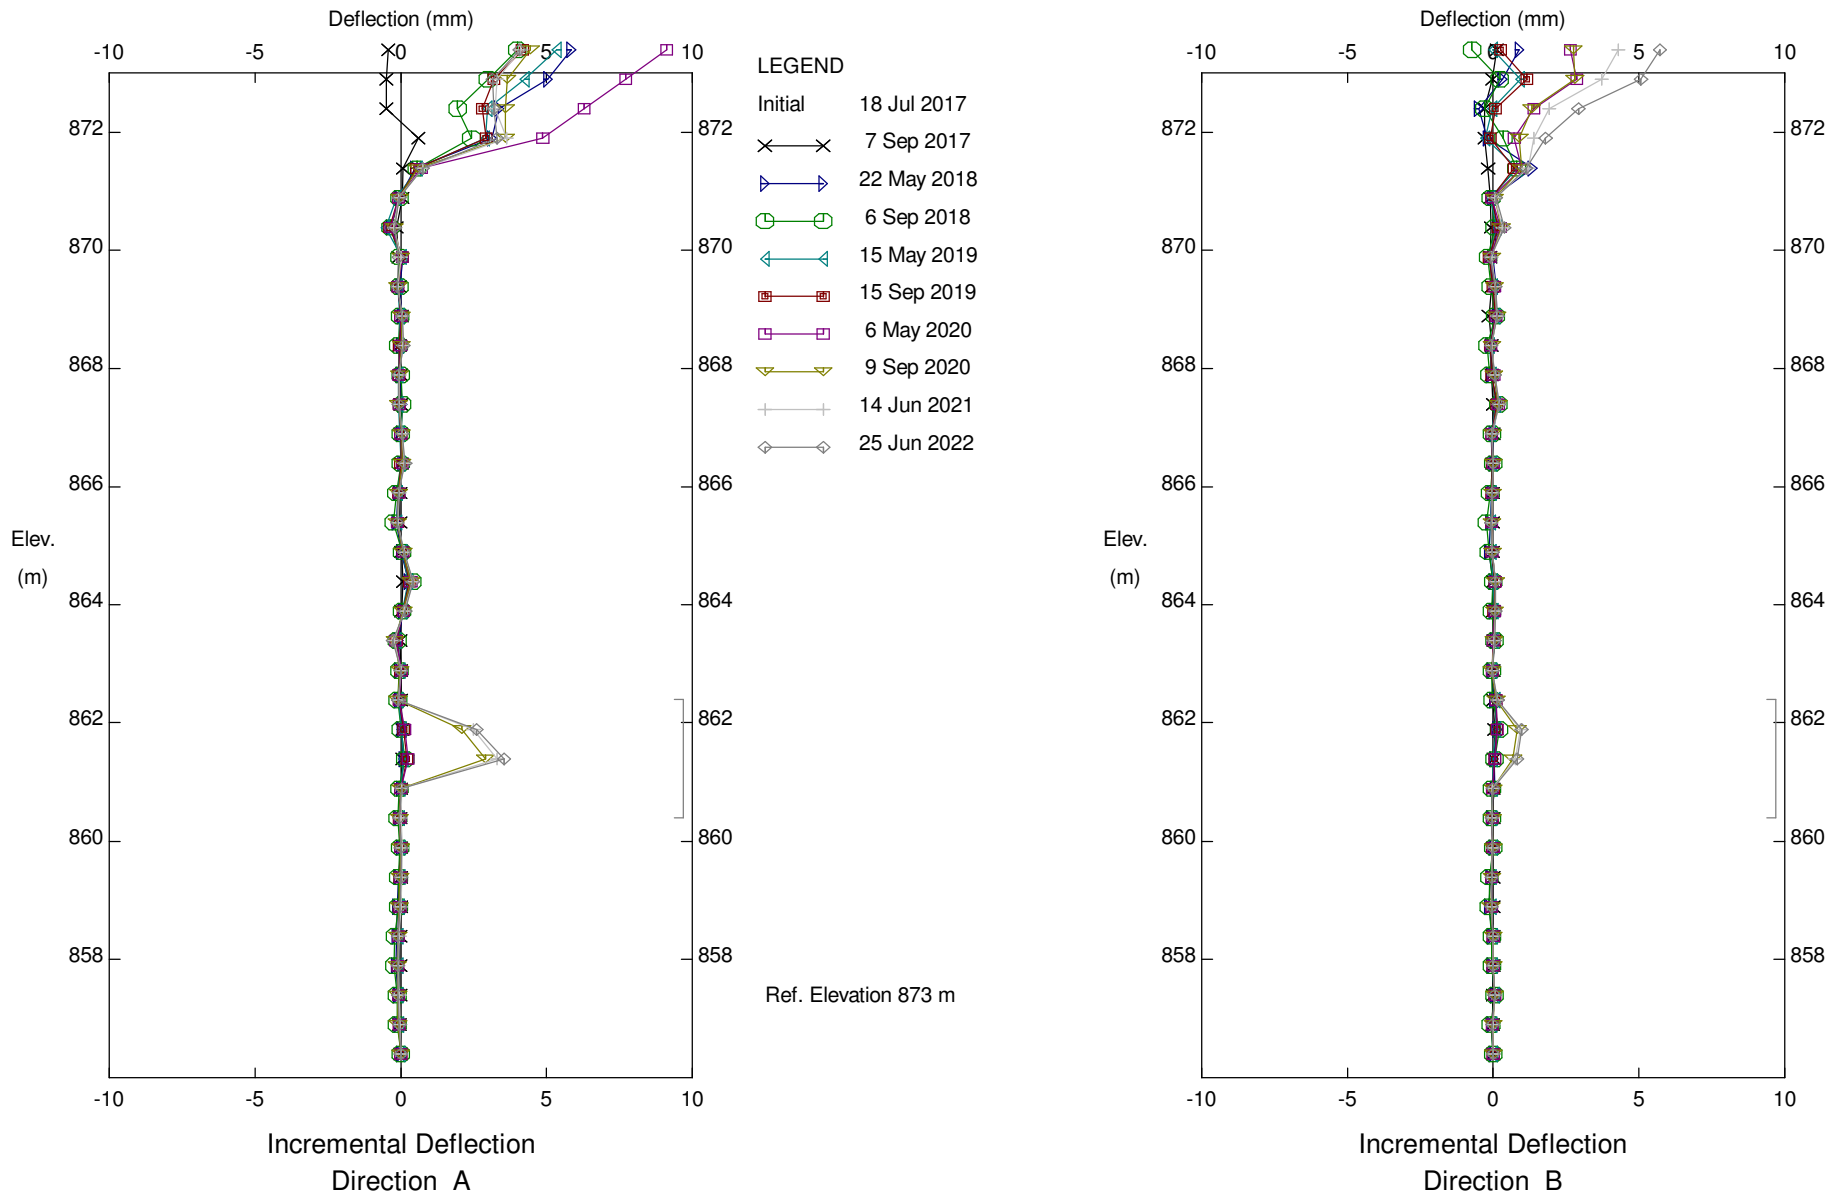
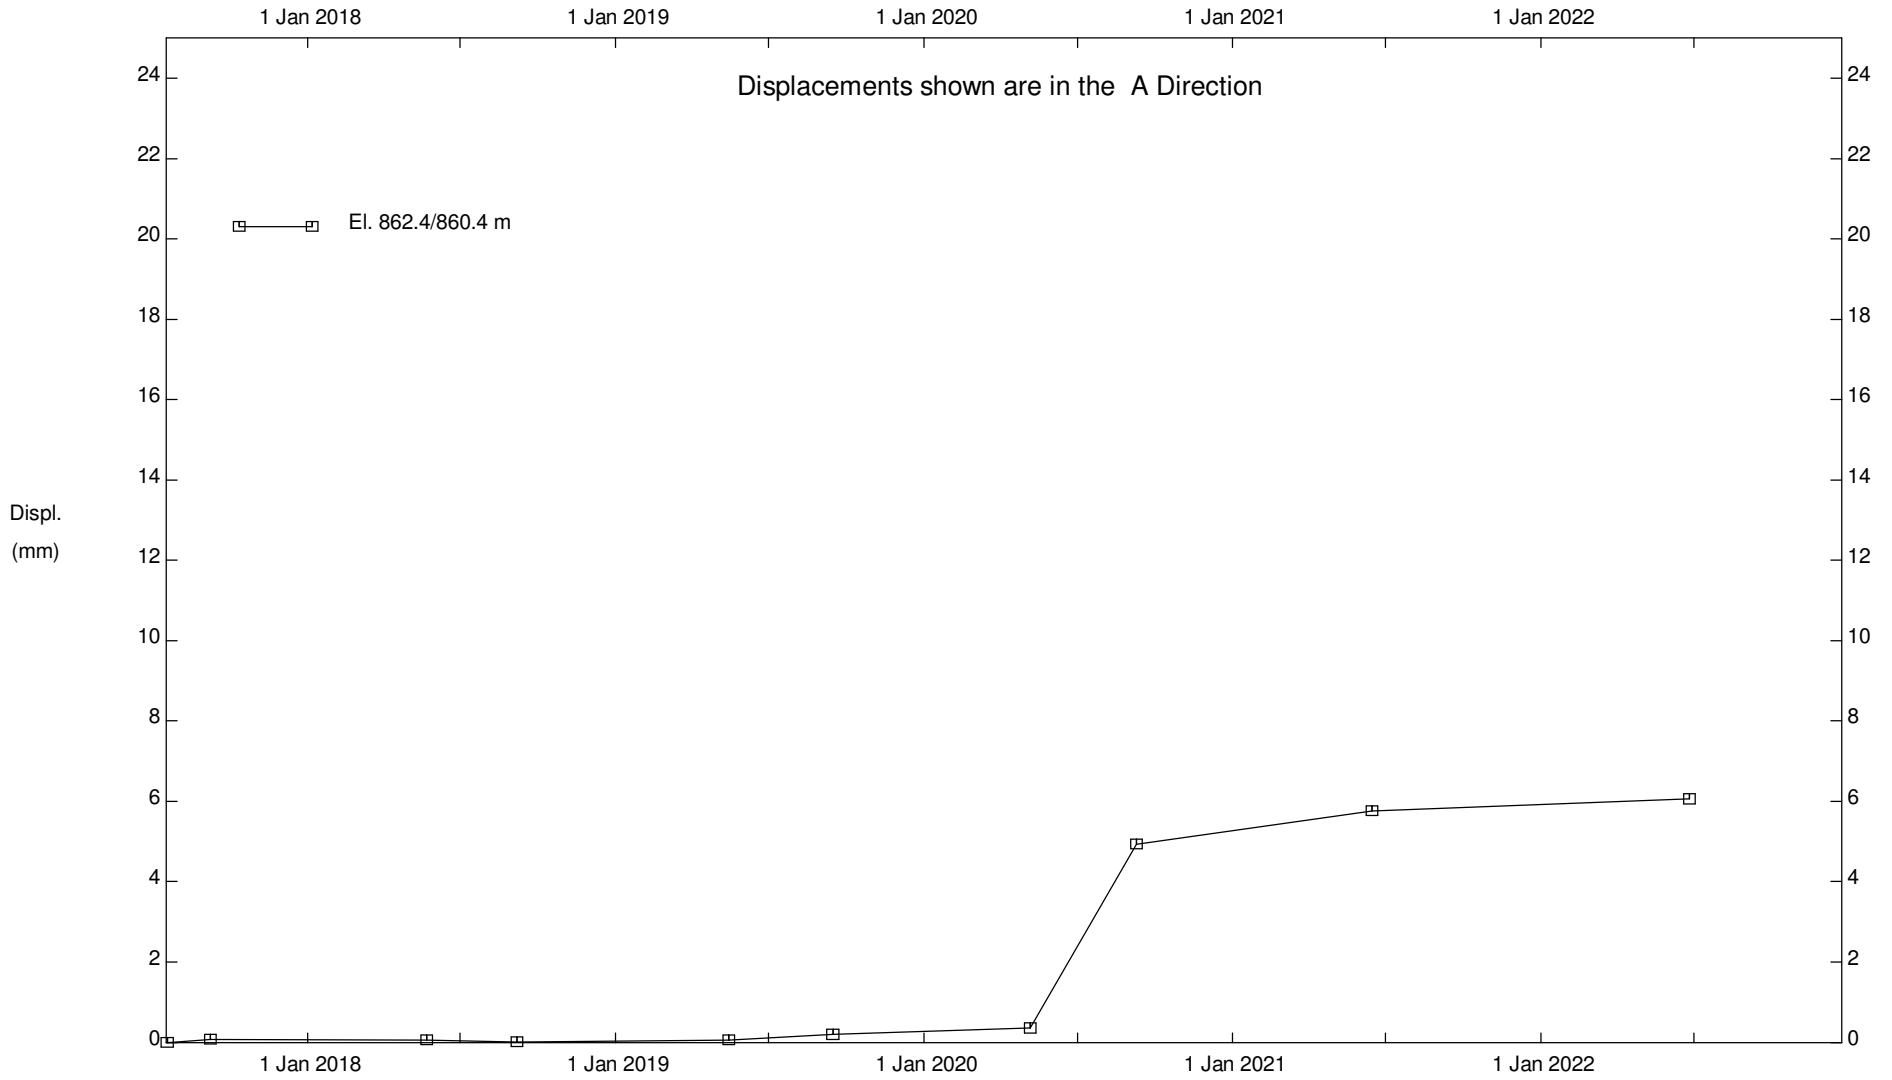
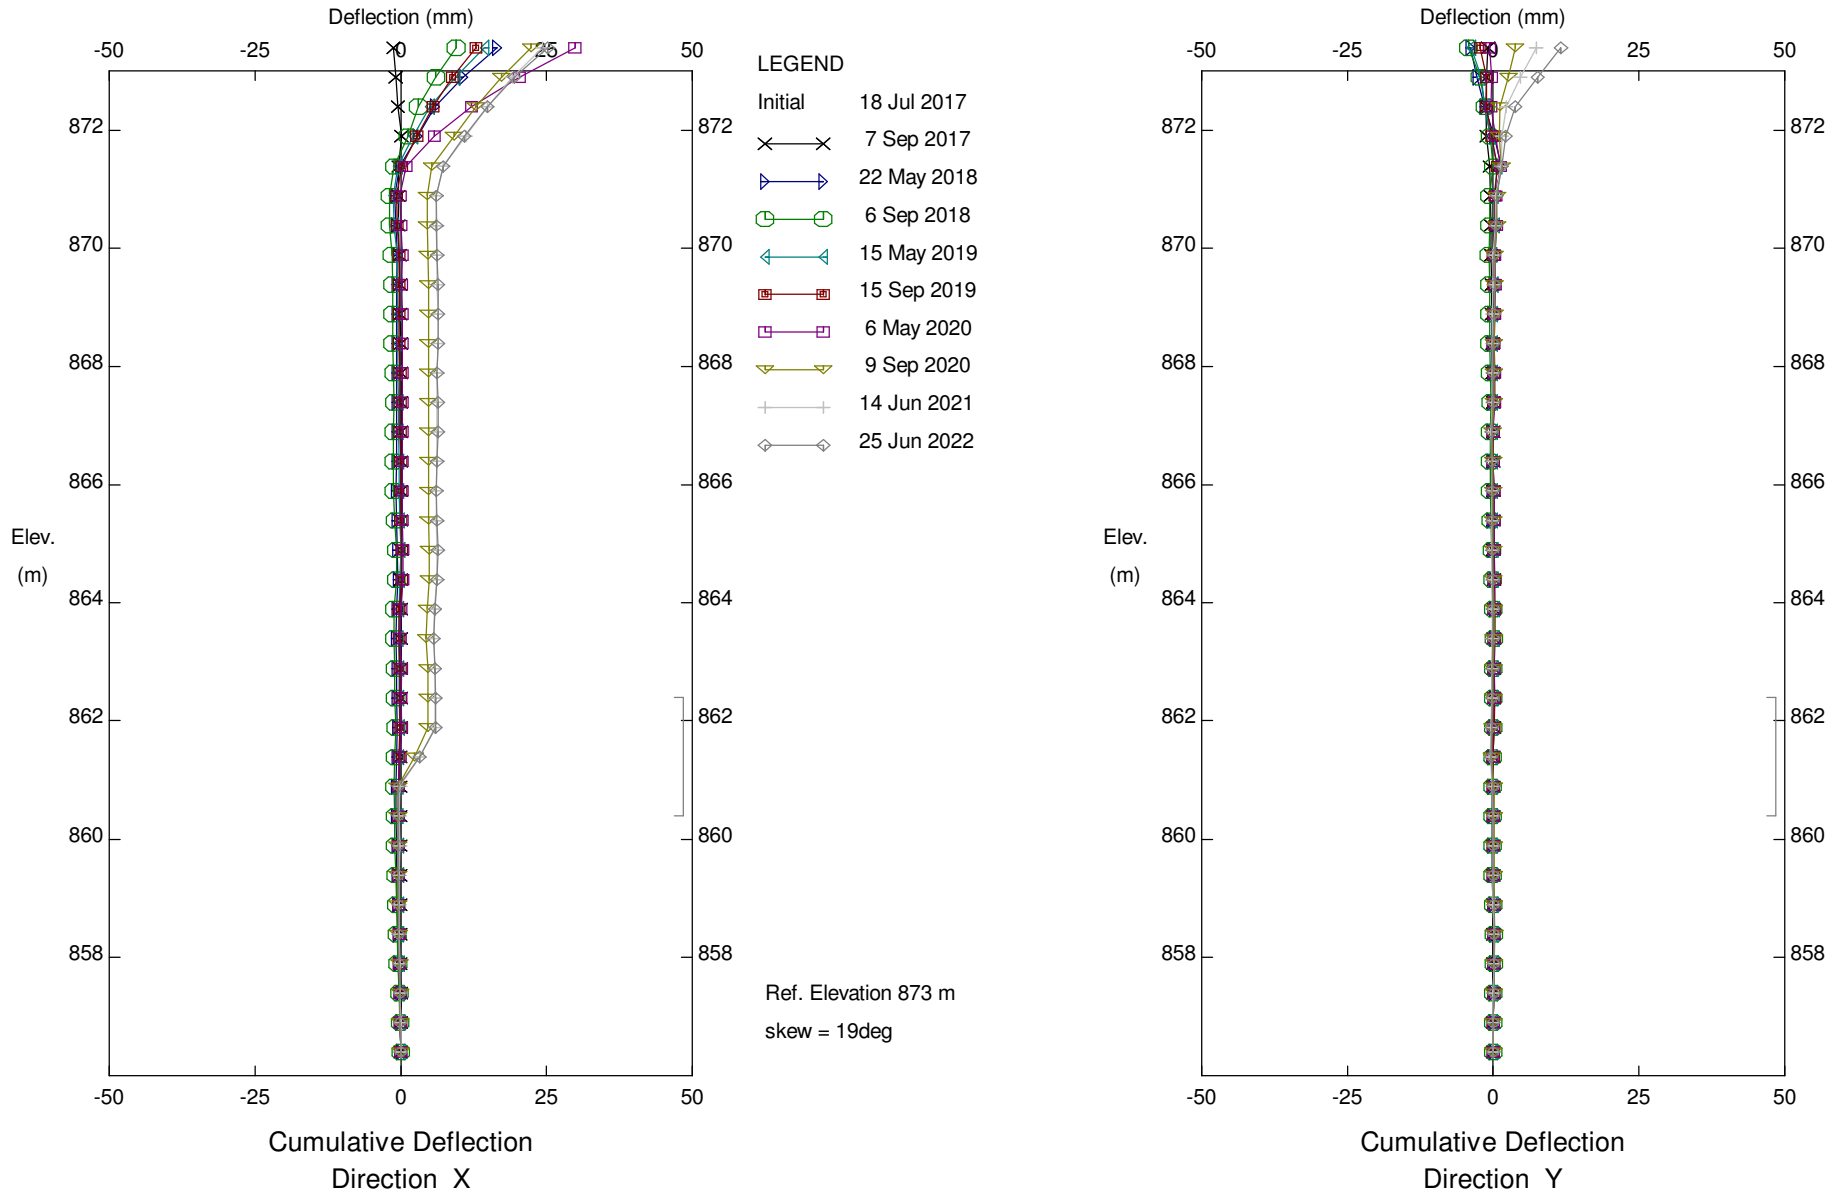
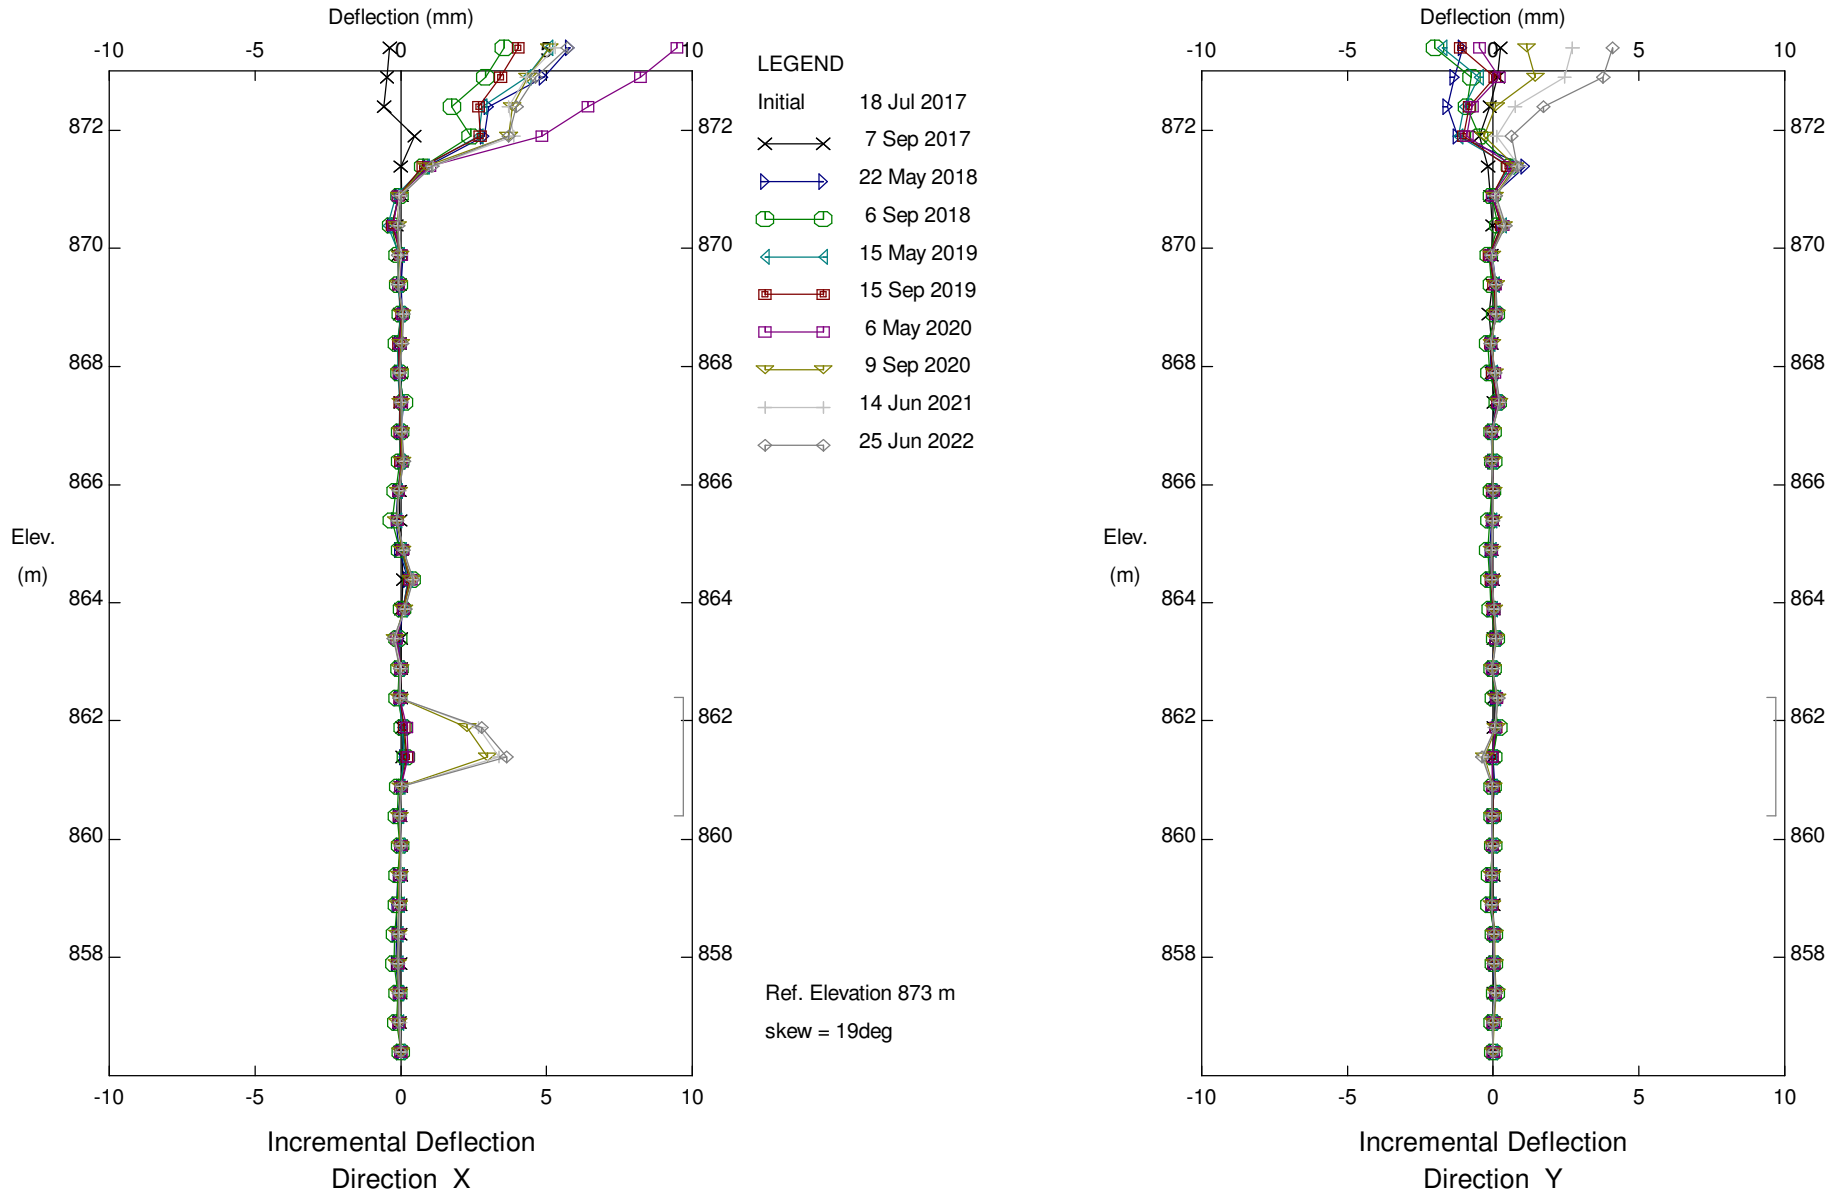
C060; H597:02, Slide East of Blackfalds, Inclinator SI17-C60-02

- the movement recorded in SI17-C60-02 (through toe berm crest) appears to be occurring near the interface between the fill and underlying foundation materials.
