July 15, 2025

CON0022160 Central Region GRMP Instrumentation Monitoring
Site C060; H597:02, km 11.299 Slide East of Blackfalds
Section C – 2025 Spring Readings

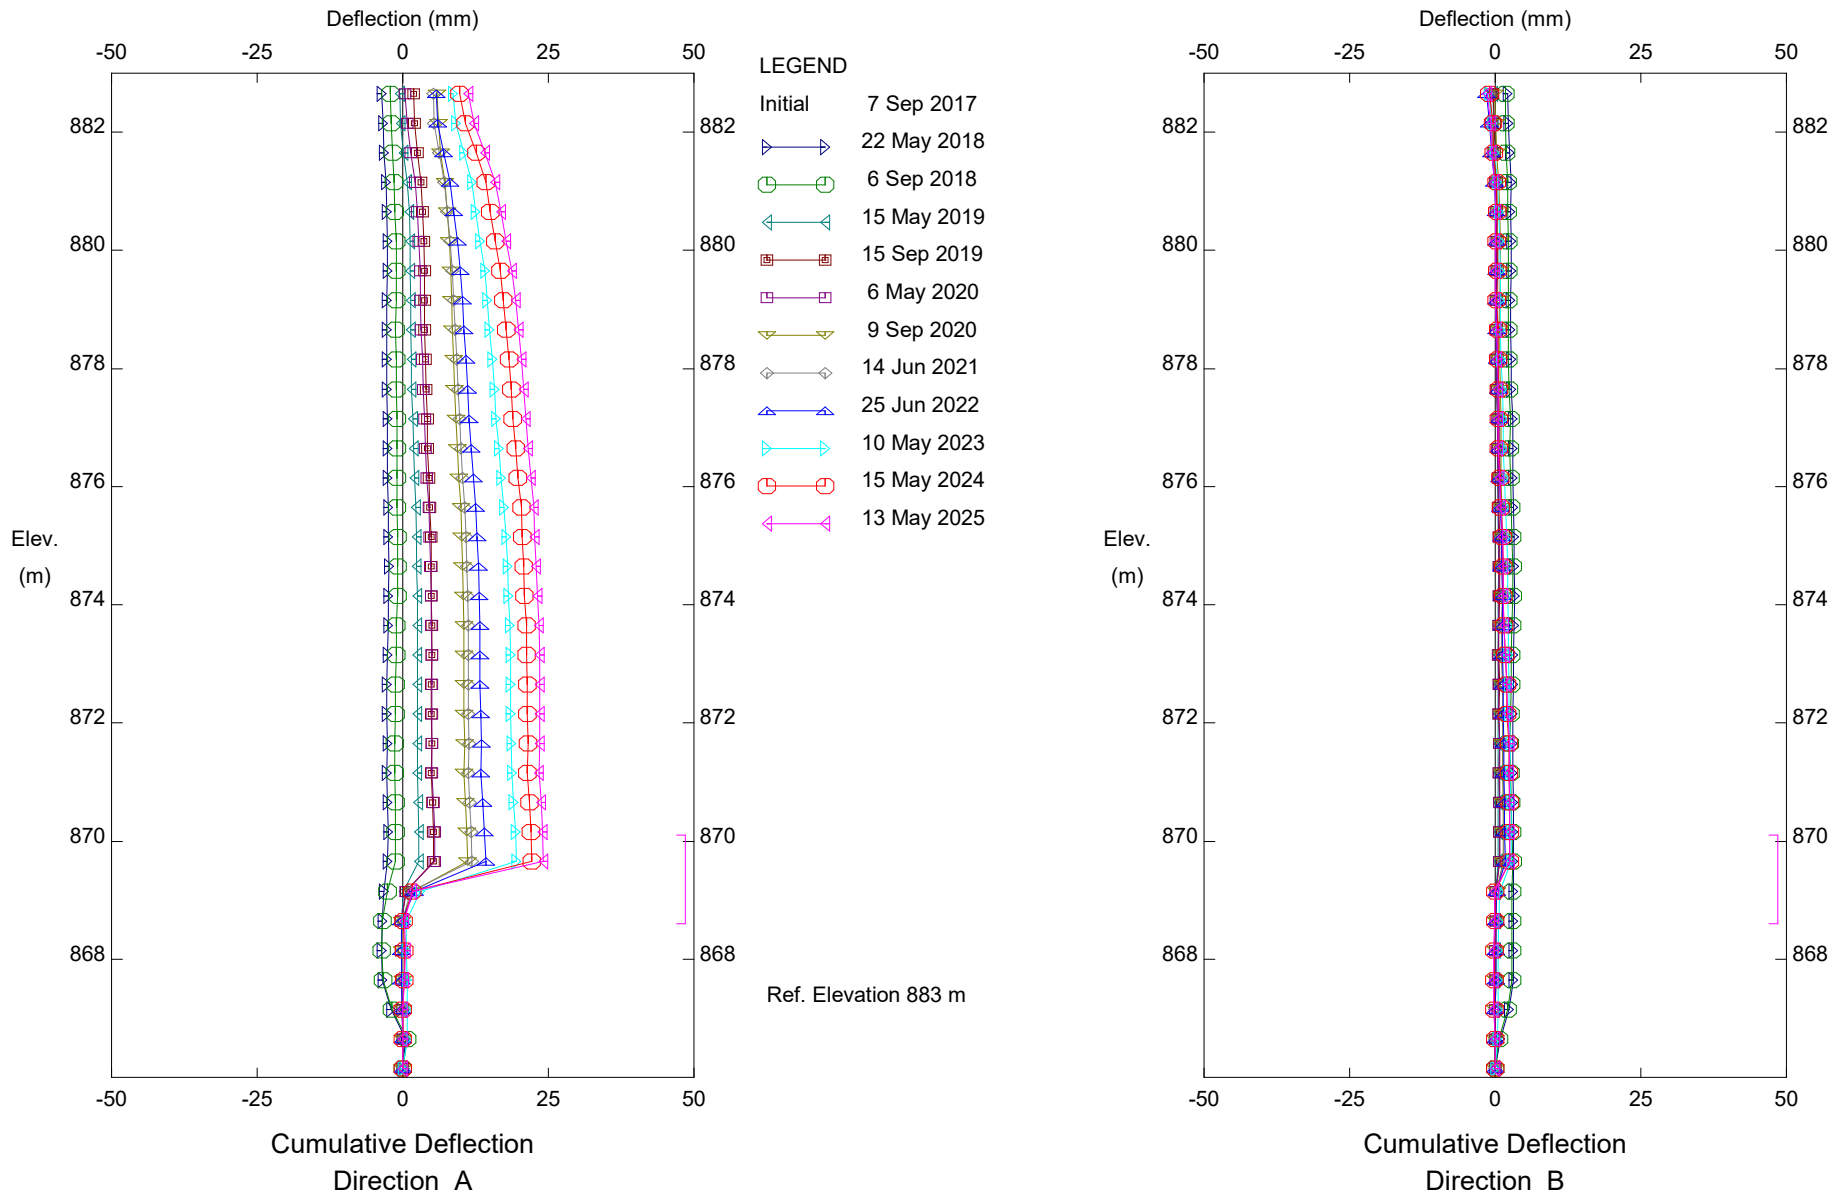
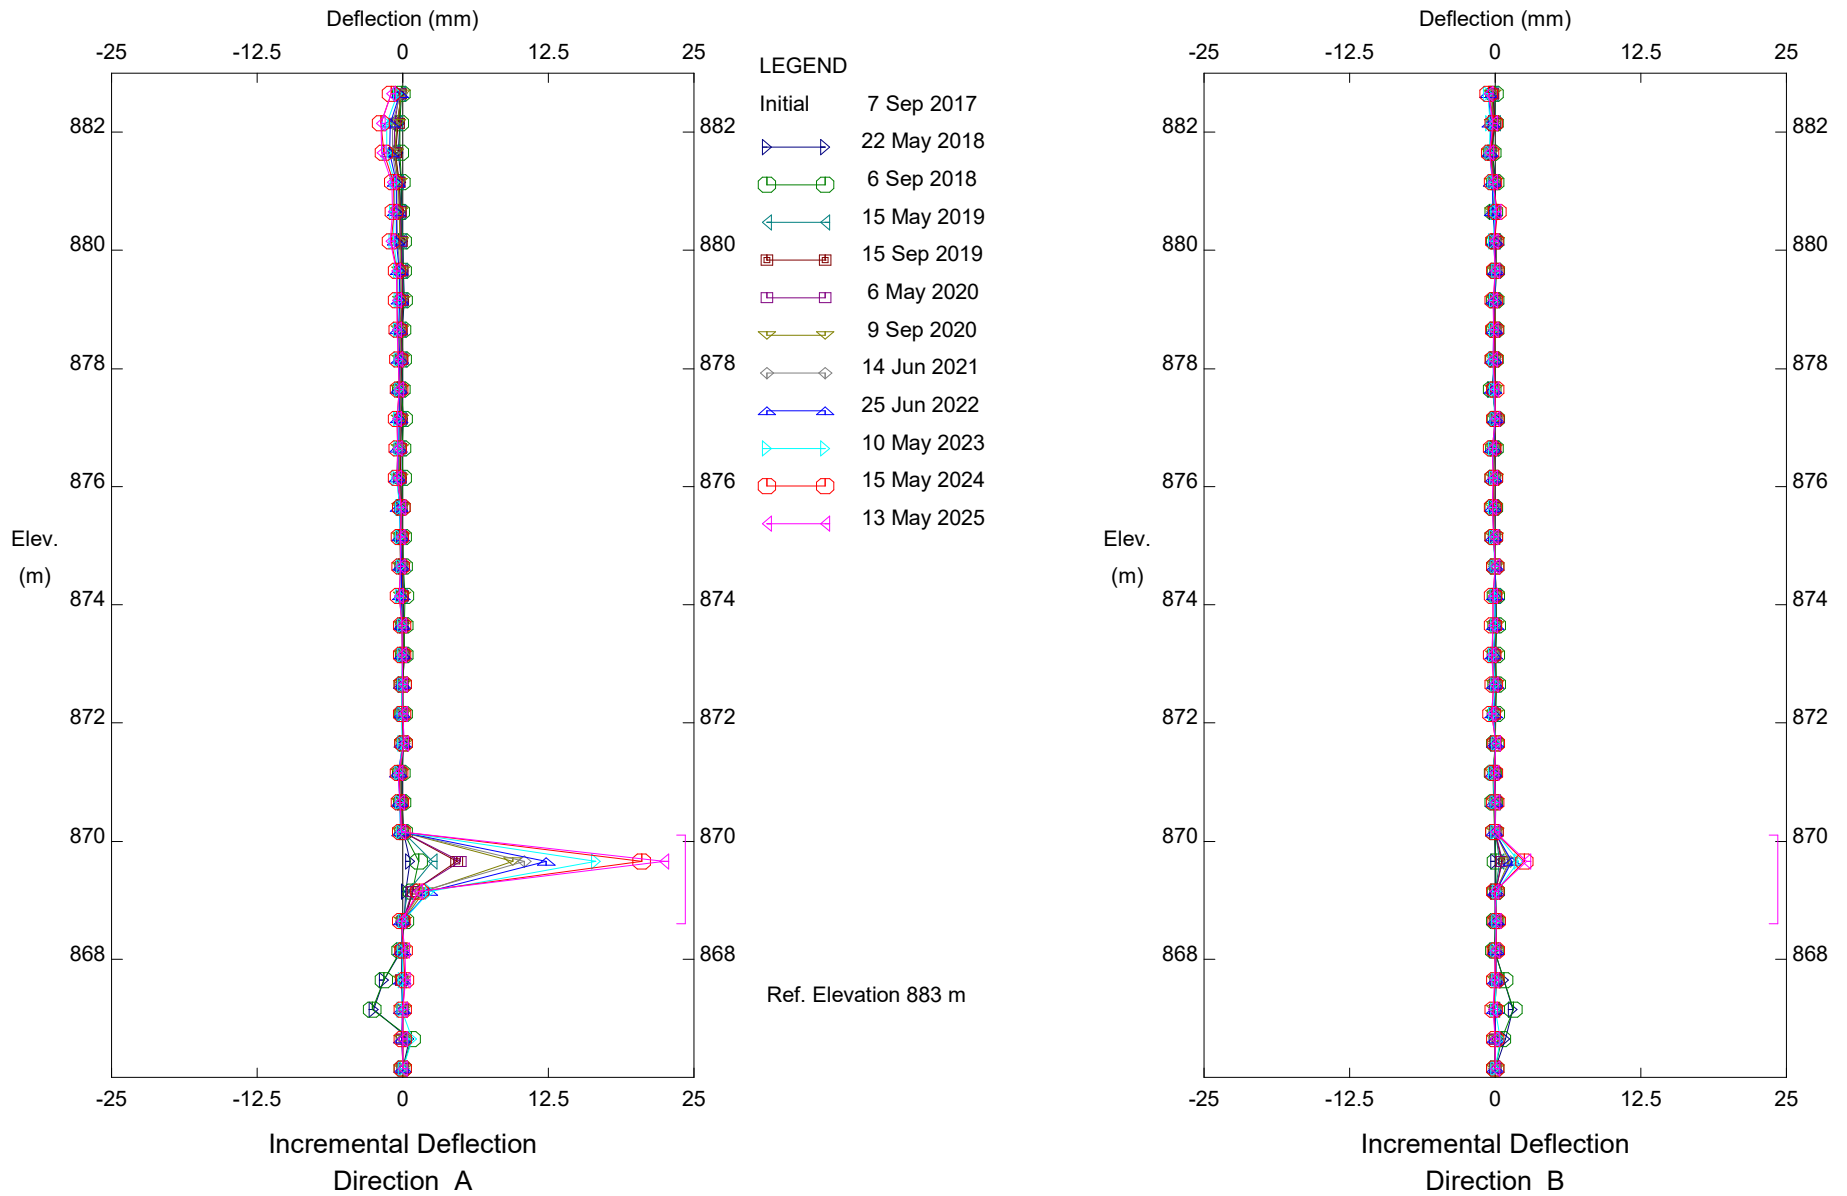
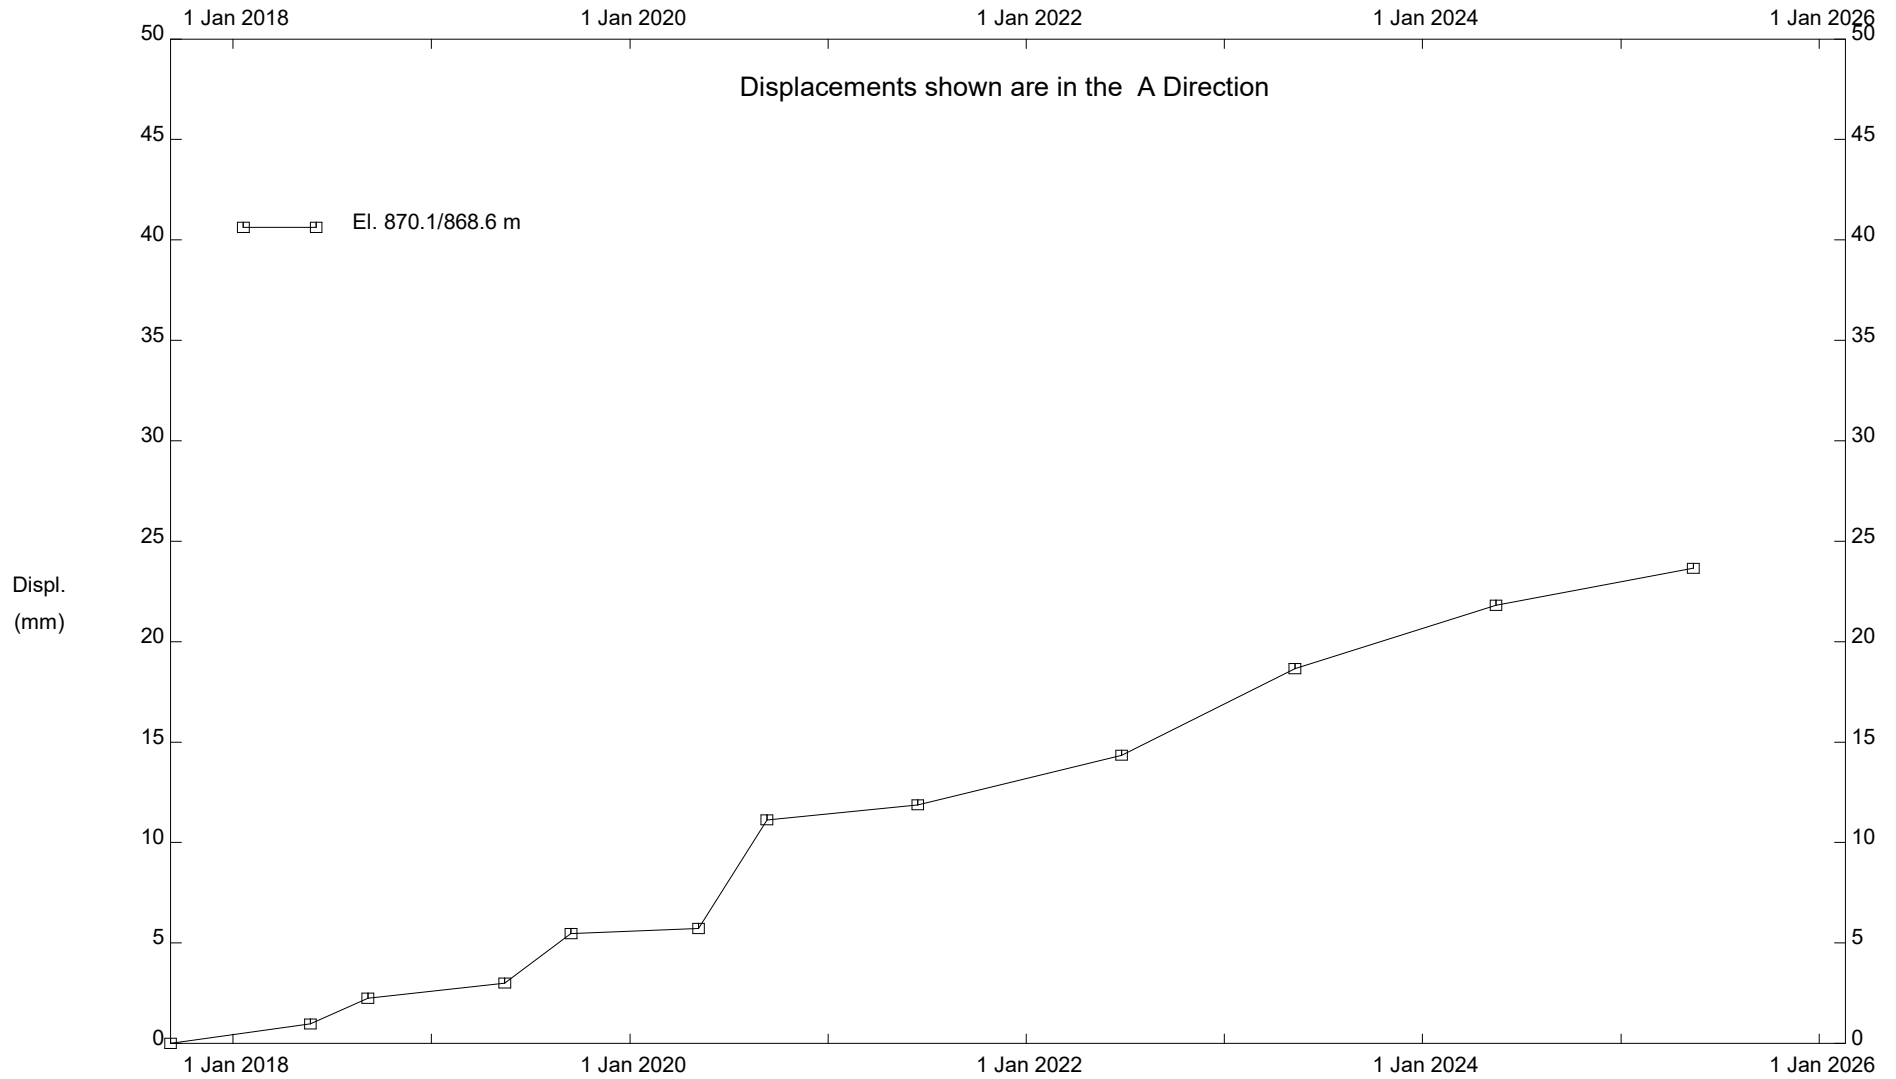
C060; H597:02, Slide East of Blackfalds, Inclinometer SI17-C60-01

Discrete movement is being recorded in SI17-C60-01 at an approximate depth of 13.9 m below ground surface (approximately elevation 869.2 m). Prior to being re-initialized in 2017, distributed movement was being recorded at an approximate depth of 2.3 m (approximately elevation 880.7 m).

- the movement recorded in SI10-01 and SI12-01 (mid-slope) appears to have occurred at the interface between the clay and rafted bedrock.
- the upper and lower zones of movement recorded in SI17-C60-01 appear to be occurring in the embankment fill and at the interface between clay and bedrock. The magnitude and rate of movement being recorded in SI17-C60-01 tends to fluctuate, especially near the bottom of the casing. Based on the stratigraphy encountered during the 2010 drilling investigation, we suspect SI17-C60-01 was terminated in rafted bedrock and the toe of the SI could be moving. Although SI17-C60-01 extends below the suspected failure surface, it may not extend deep enough and the recorded movement, especially near the bottom of the casing, are likely caused by movement of the rafted bedrock in the underlying till.

The rate of movement recorded in SI17-C60-01 and -02 have been relatively steady (average rate of movement less than approximately 3 mm/year) since installation. Increased rates of movement (approximately 15 mm/year) were recorded in both instruments in September 2020, likely in response to wet weather during the summer months. The rate of movement decreased in 2021 (to less than approximately 1 mm/year) and has been relatively steady between 2021 and 2025 (less than approximately 2 mm/year).

Some minor movement has been recorded in the B-direction of SI17-C60-01 and SI17-C60-02, which has been attributed to poor grout backfill and casing settlement, respectively.

Currently, unless movements accelerate and impact the highway surface, TEC has no plans of repairing this site. Since SI17-C60-01 is recording movement below the highway surface, TEC should inspect the road surface regularly for signs of pavement distress (cracking and/or settlement).

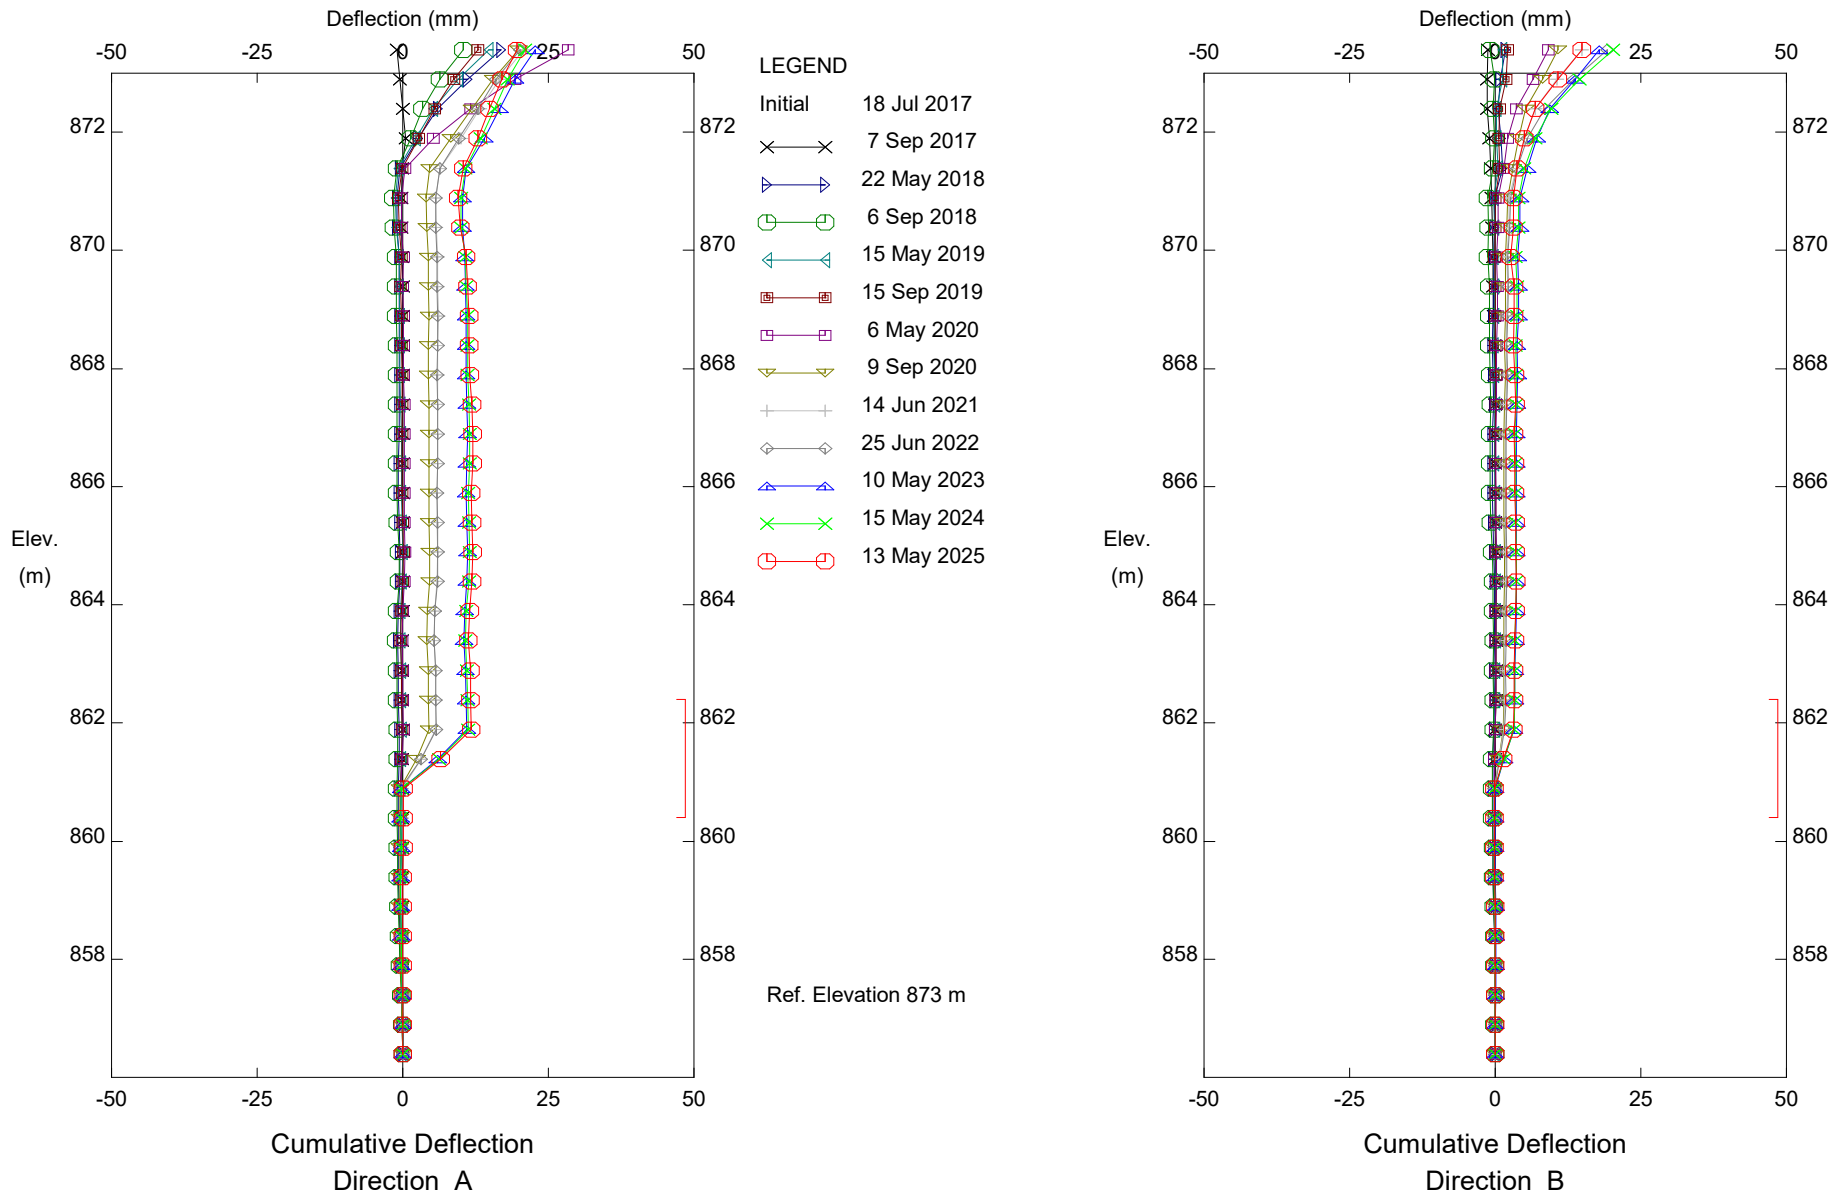
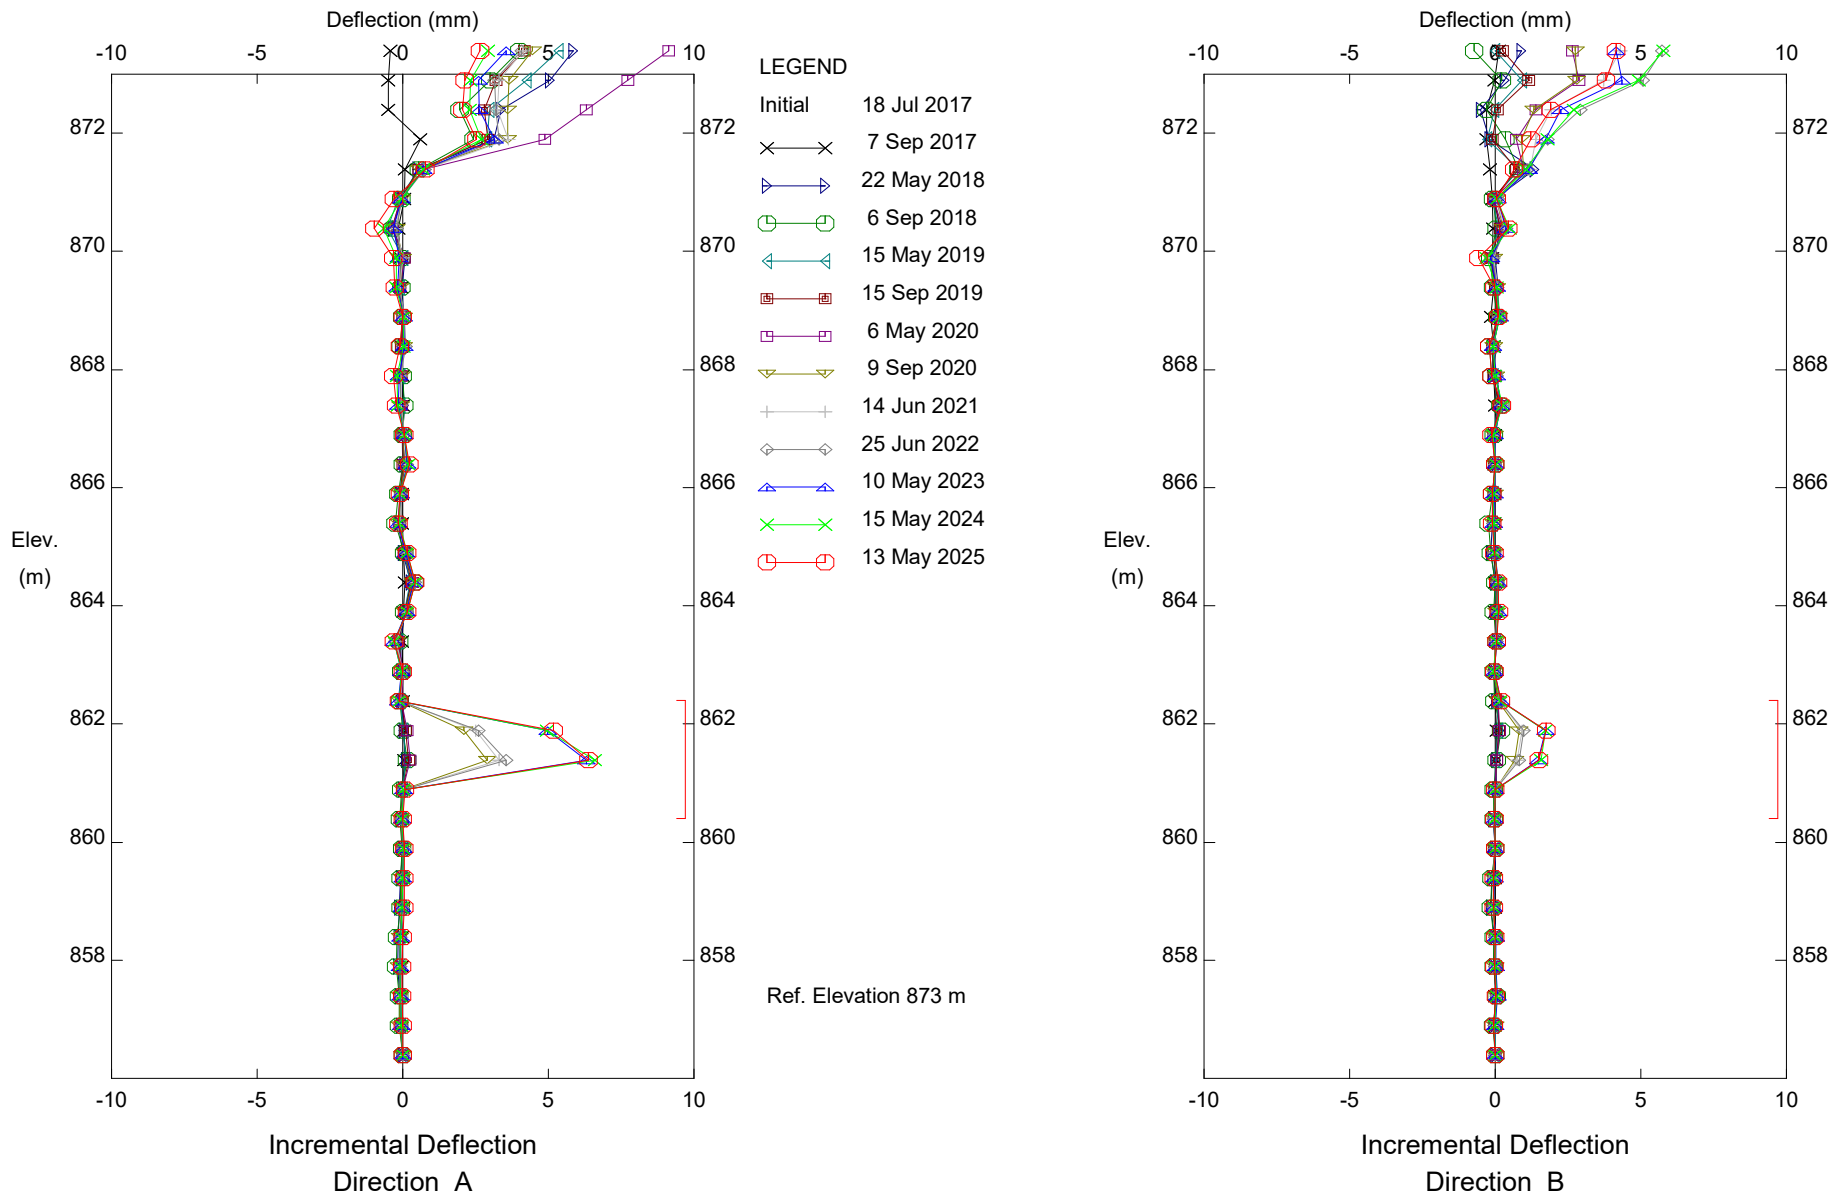
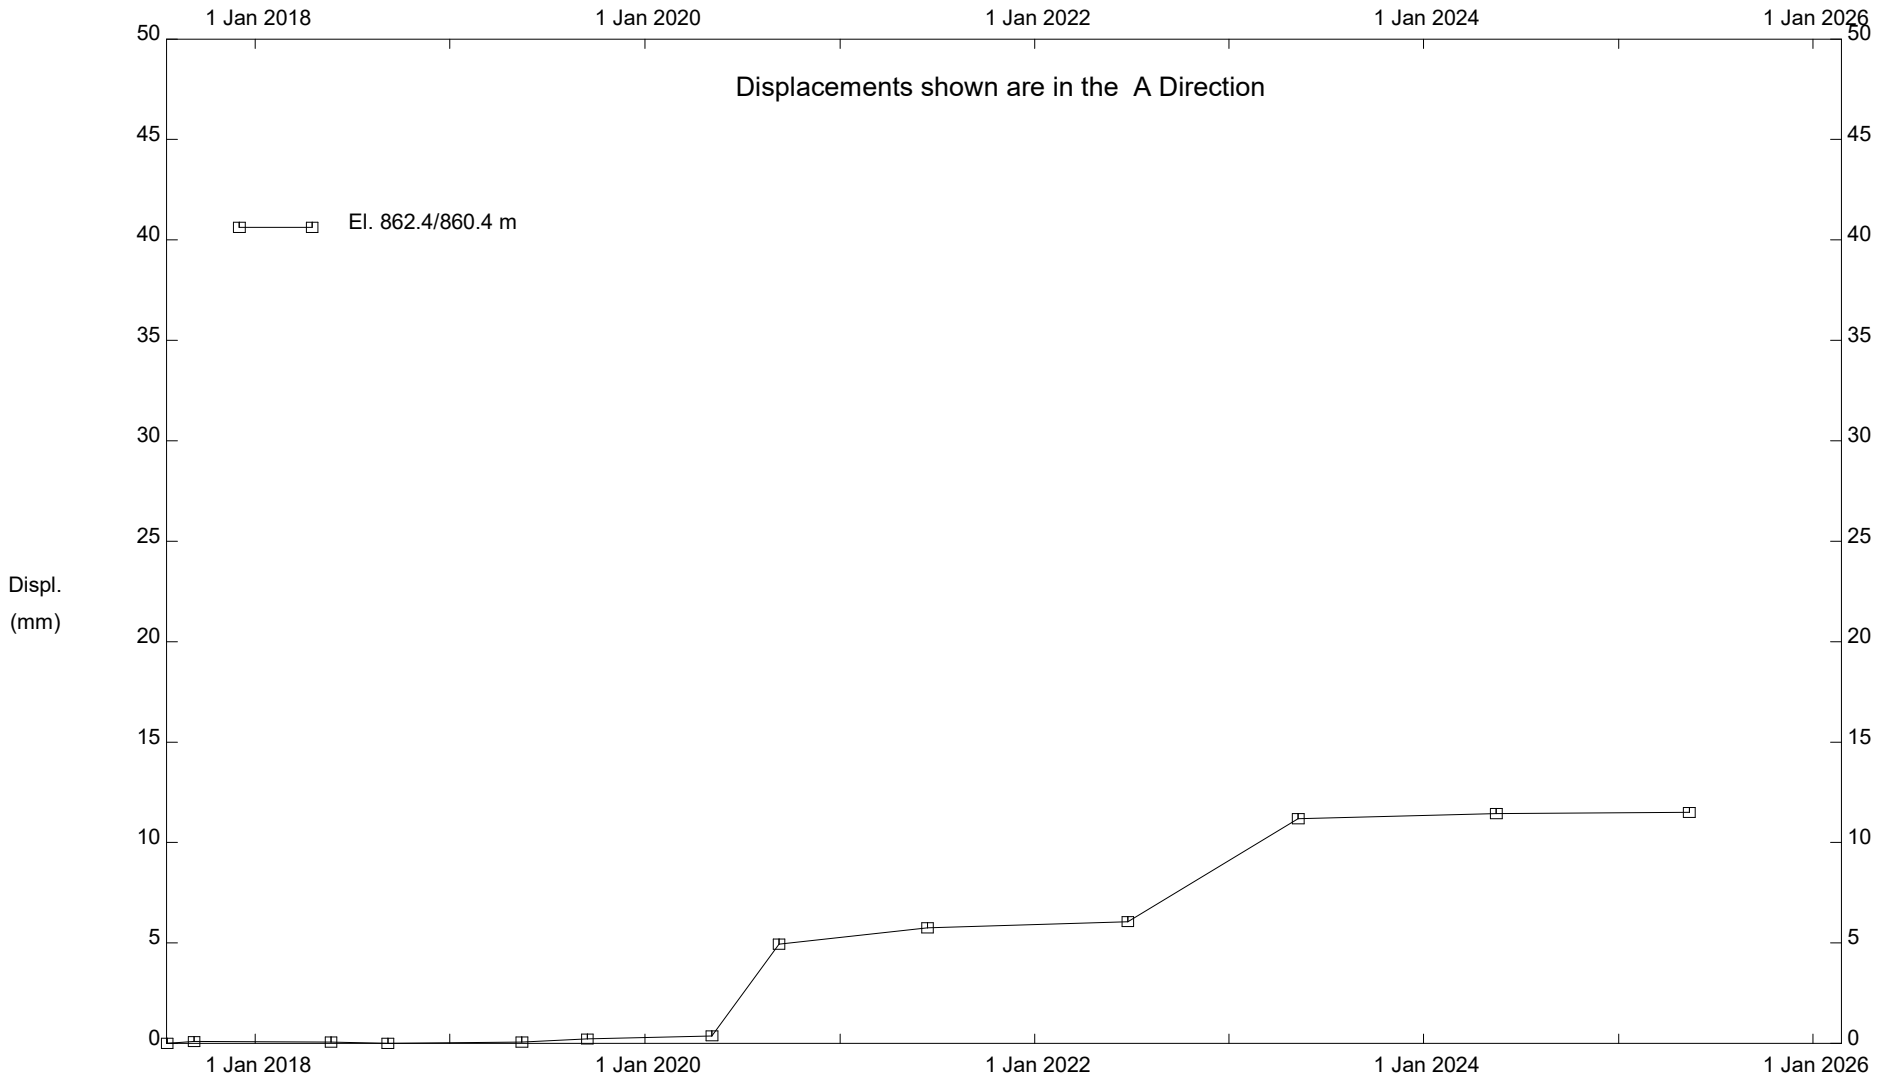
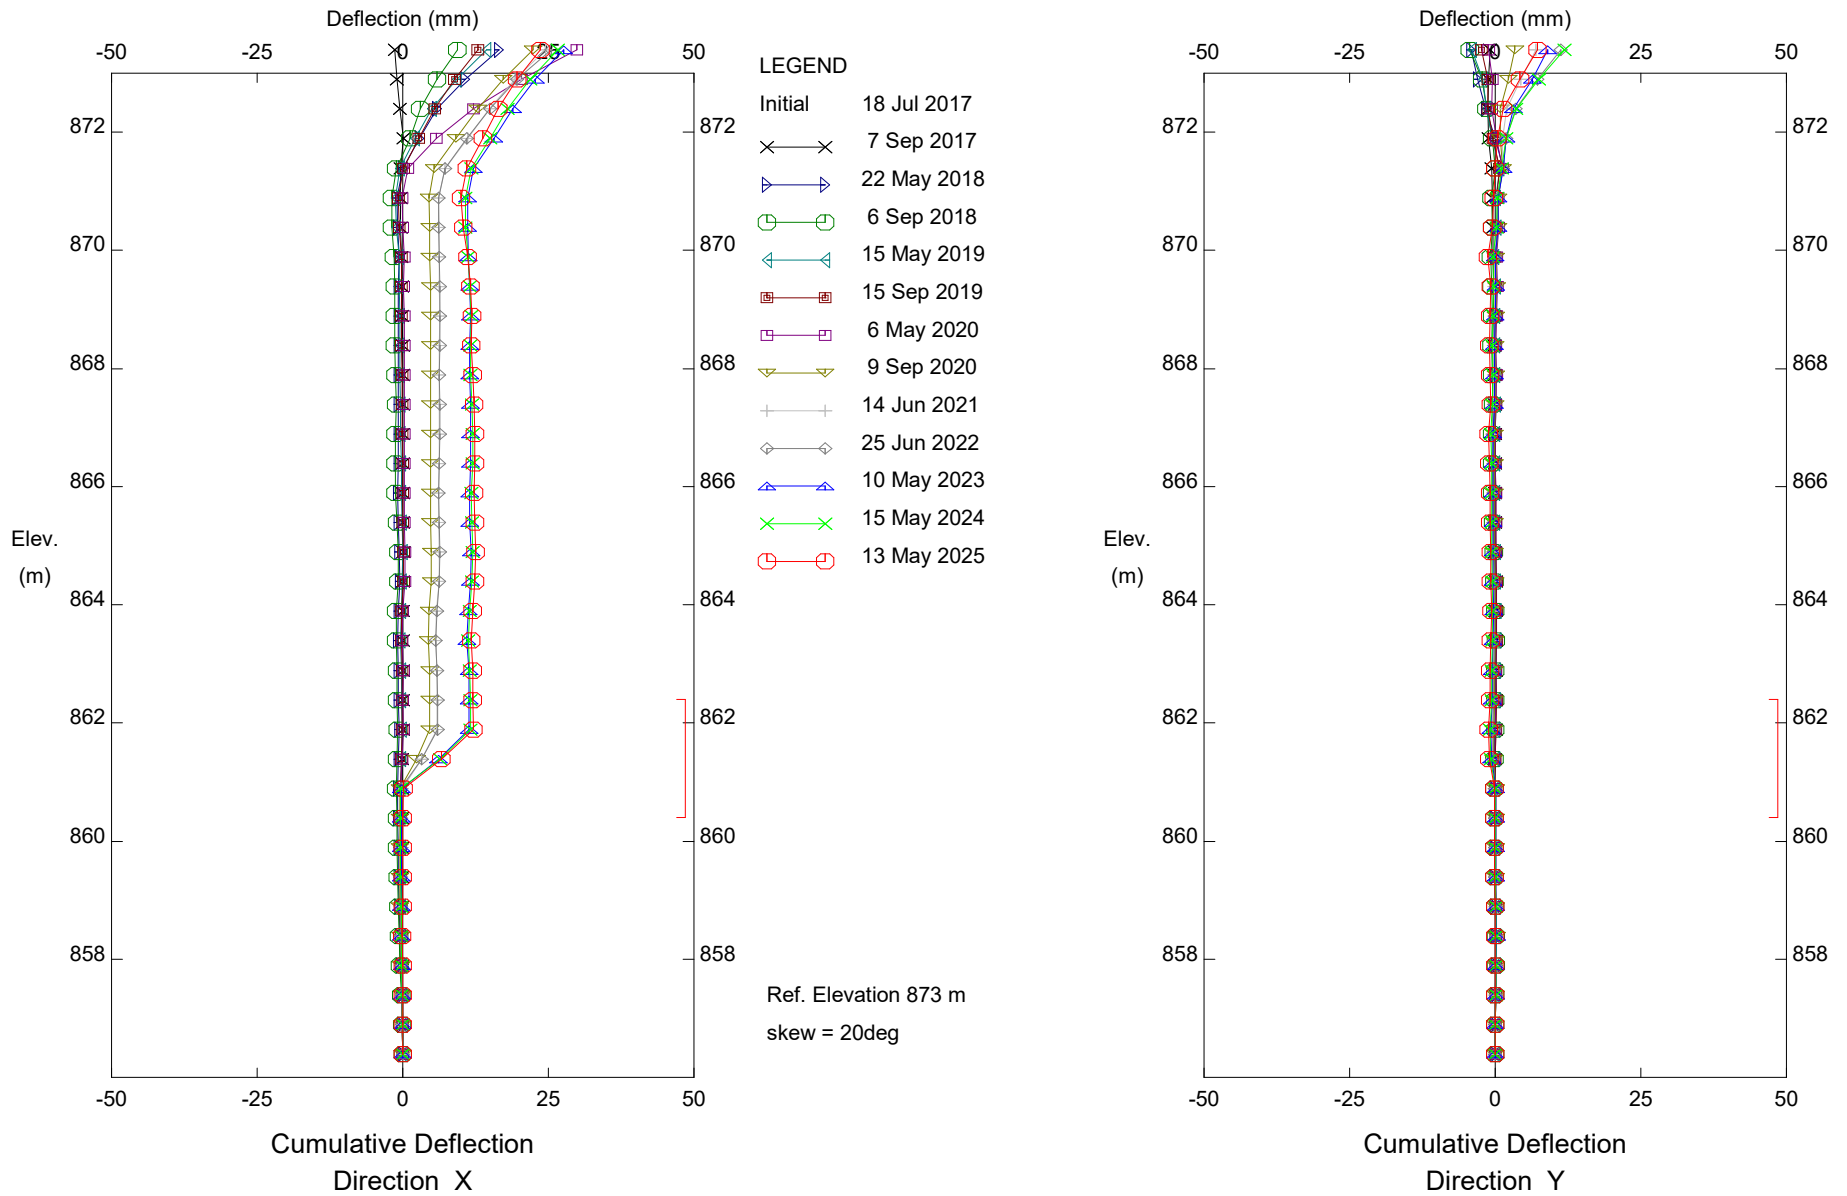
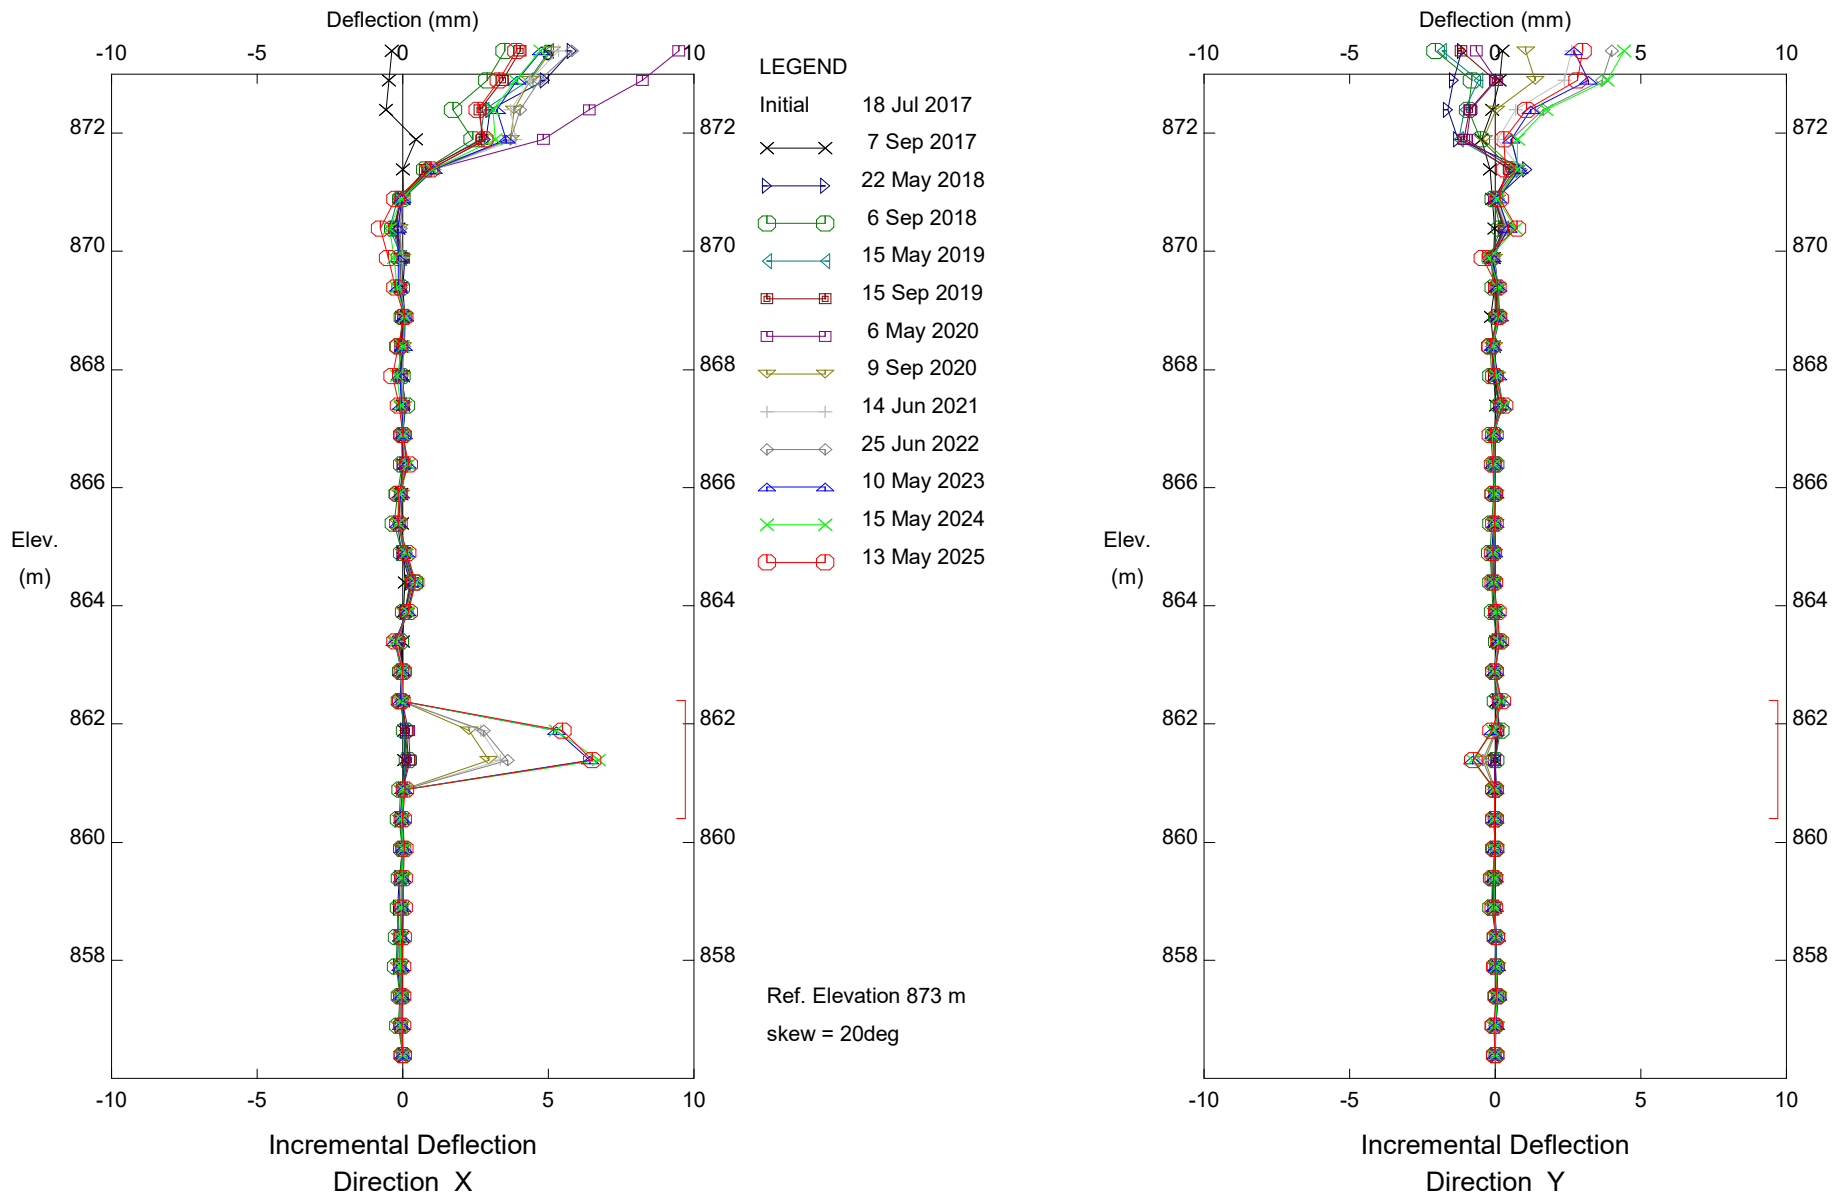
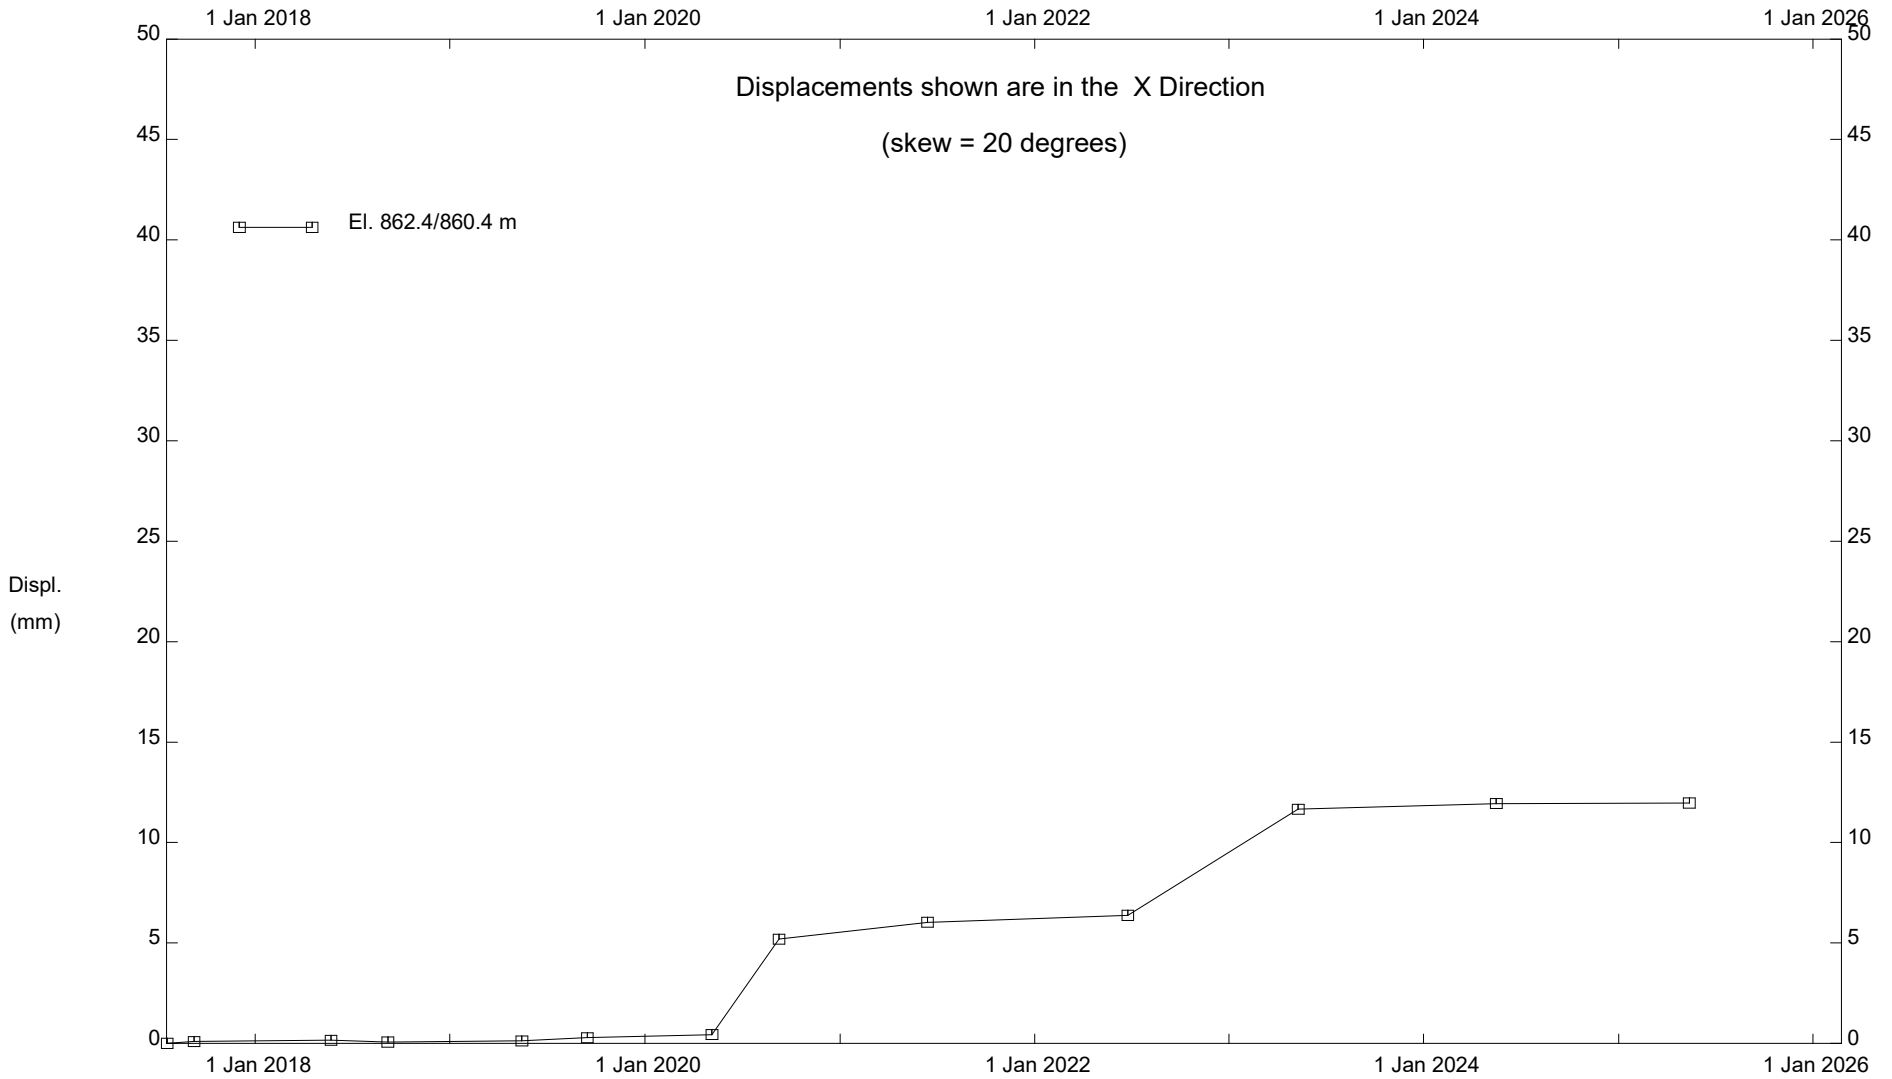
C060; H597:02, Slide East of Blackfalds, Inclinometer SI17-C60-02

Discrete movement is being recorded in SI17-C60-02 at an approximate depth of 12.1 m below ground surface (approximately elevation 860.9 m).

- the movement recorded in SI17-C60-02 appears to be occurring near the interface between the toe berm fill and underlying foundation materials.

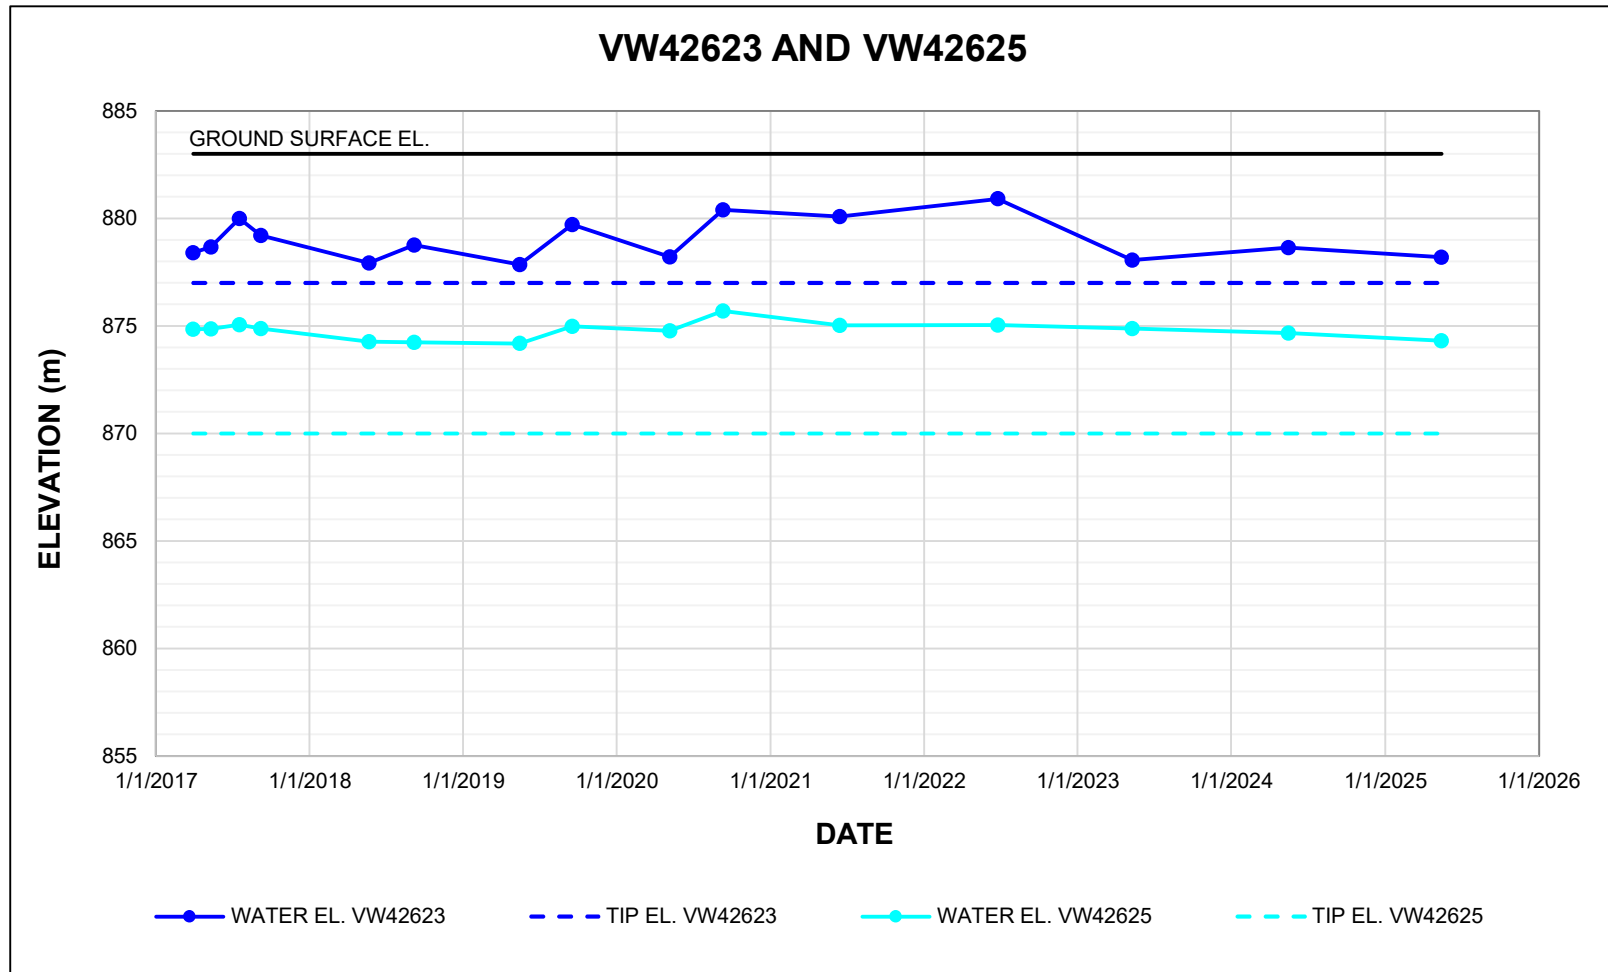
<div>PROJECT</div> CENTRAL REGION GEOHAZARD RISK MANAGEMENT PROGRAM		
	<div>TITLE</div> Piezometer Data C060 - East of Blackfalds Slide Hwy 597:02, km 11.299		
SCALE	N/A	PROJECT No.	A05116A02
		FIG No.	I-1

Water levels recorded in VW42625, VW42624, and VW42626 (lower piezometer below highway, and piezometers below toe berm crest) have been relatively steady (typically ± 0.5 m) and/or decreasing since they instruments were installed in 2017.

Between 2017 and 2021, water levels recorded in VW42623 (upper piezometer below highway) appeared to fluctuate seasonally with the spring readings being lower than fall readings. However, since the reading frequency was reduced to spring readings only in 2021, fluctuations between seasons are no longer captured.
