SITE NUMBER AND NAME: C075 Hwy 609 Ditch Erosion		HIGHWAY & KM: 609:02, 16.42	PREVIOUS INSPECTION DATE: June 24, 2020	INSPECTION DATE: June 29, 2021
LEGAL DESCRIPTION: NW 08-44-19-W4M & SW 17-44-19-W4M	NAD 83 COORDINATES: UTM Northing Easting 12 5849463 383508		RISK ASSESSMENT: PF: 7 CF: 3 TOTAL: 21	
AVERAGE ANNUAL DAILY TRAFFIC (AADT): 460 (east) & 400 (west) (Reference No. 107370 & 110370)			CONTRACT MAINTENANCE AREA (CMA): 517

PROJECT CENTRAL REGION GEOHAZARD RISK MANAGEMENT PROGRAM		
TITLE Site Plan C075 - Hwy 609 Ditch Erosion Hwy 609:02, km 16.42		
SCALE 1:2,500	PROJECT No. A05116A02	FIG No. 1

Inspection Photographs

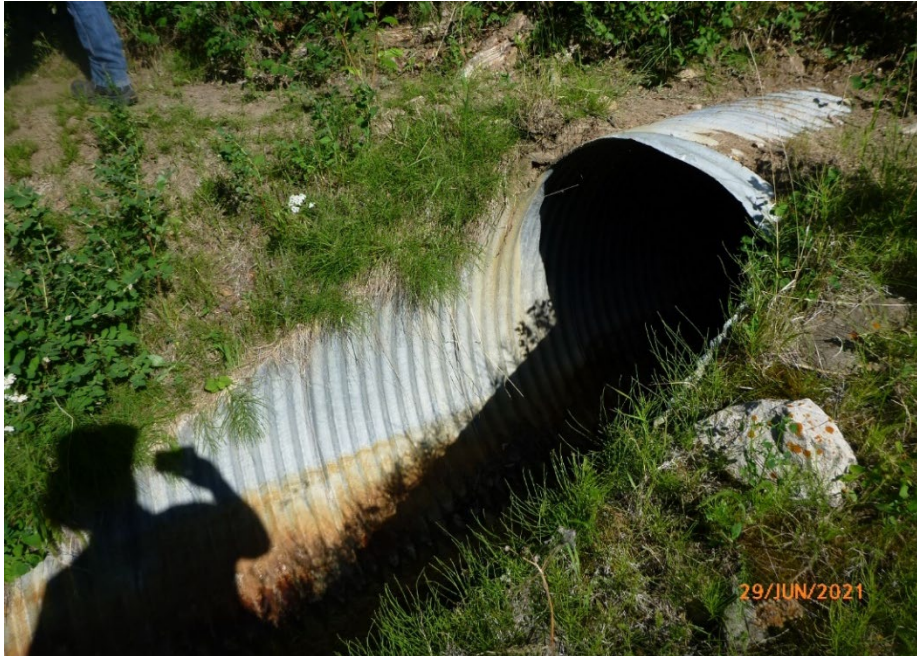
- The 1200 mm diameter CSP culvert is corroding at the base and requires repair (e.g., sleeved with a smaller-diameter smooth walled culvert) (Photo 1). Corrosion was observed at the inlet and outlet located on the north and south side of Hwy 609, respectively.

- Photo 1** The CSP culvert underlying Hwy 609 (oriented north-south) is corroded at the culvert inlet and outlet (outlet shown) and required repair. Photo taken June 29, 2021 facing southeast.

- Repair options for the ditch erosion could include backfilling the ditch erosion with gravel next to the highway. Local fine-grained material could be used to backfill the erosion gullies downstream of the CSP culvert outlet, located on private land.
- The reconstructed channel on private land should be moved away from the steep natural slope to reduce the potential for erosion to cause natural slope failure. Riprap armouring may be required in the channel.
- Check dams in the highway ditch (gabion baskets or riprap) could be incorporated into the repair, as long as the side slopes of the check dams are not steeper than 4H:1V so that the check dams wouldn't be considered a barrier in the ditch and a potential hazard to highway traffic.
- KCB to provide a memo outlining the private-land-gully repair, ditch repair, and culvert sleeving for the MCI to provide costs to the HMC.

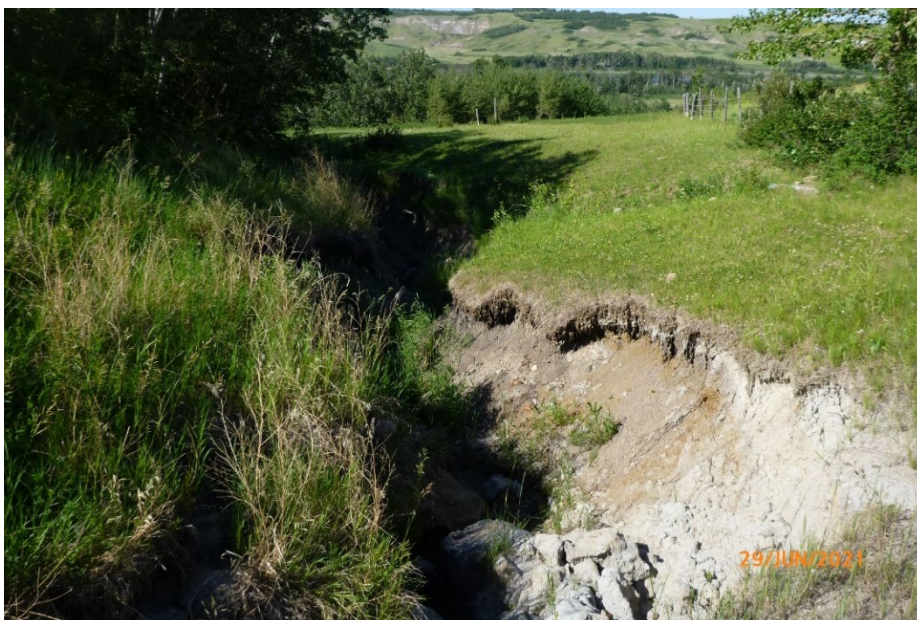
- The erosion gullies downstream (northeast) of the CSP culvert outlet have increased in size since the 2020 call-out site visit and is moving upslope. The erosion is within 9 m of the edge of the highway, approximately 2.5 m deep, and within the clear zone.

- Photo 2** The erosion gully downstream (northeast) of the culvert outlet is approximately 3 m wide and 2 m deep and has worsened since the 2020 call-out site visit. Photo taken June 29, 2021 facing northeast.

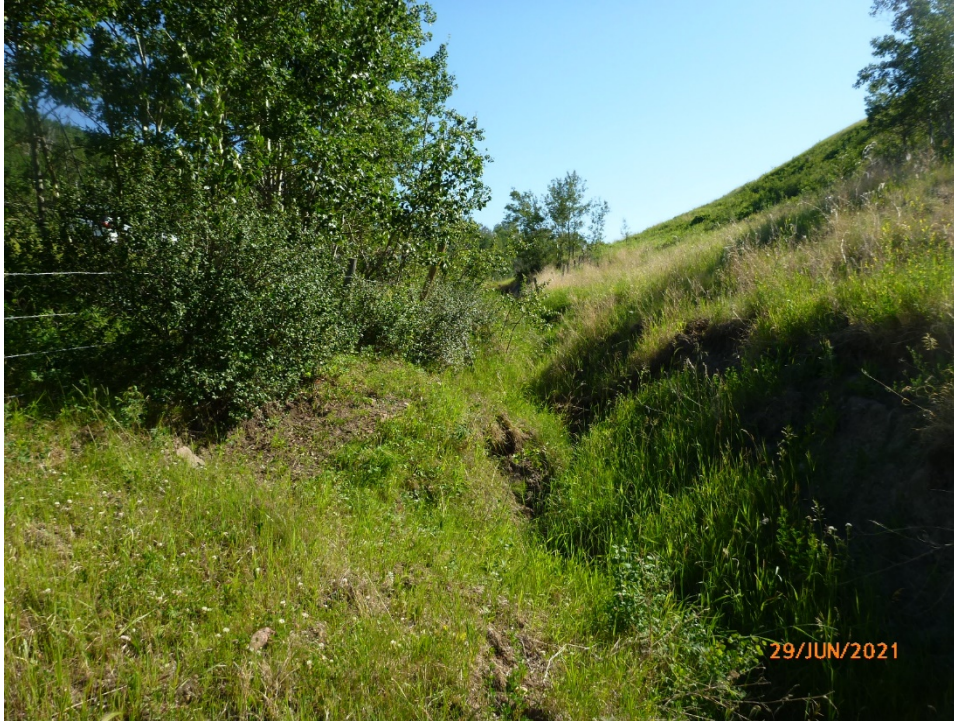
Photo 3 The erosion gully downstream (northeast) of the CSP culvert outlet is impacting the fence on the north (eastbound) side of Hwy 609. Photo taken June 29, 2021 facing west.

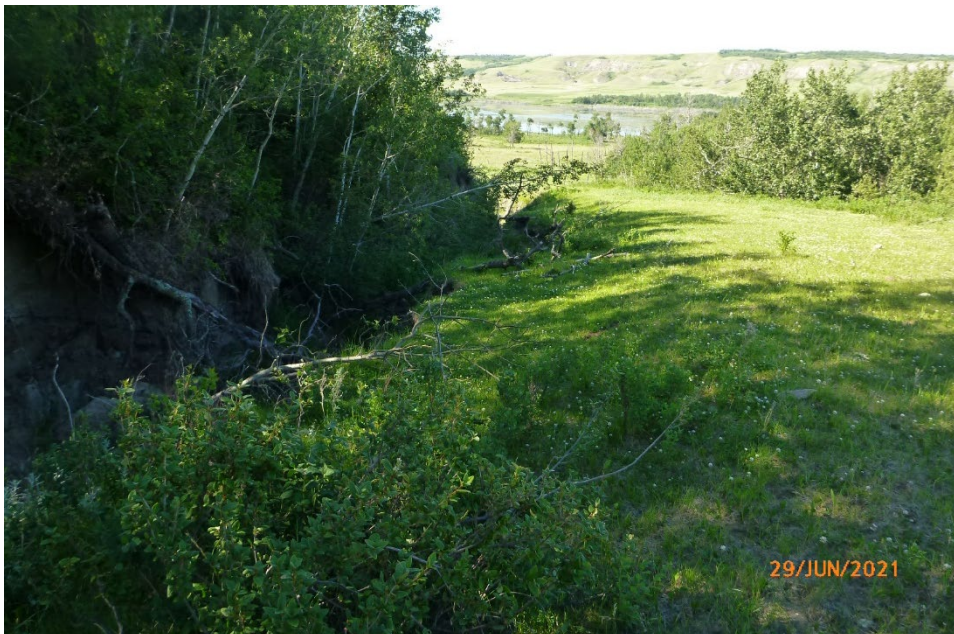
Photo 4 The erosion gully downstream of the north (westbound) ditch, downstream of the CSP culvert outlet has worsened since the 2020 call-out site visit. Photo taken June 29, 2021 facing north.

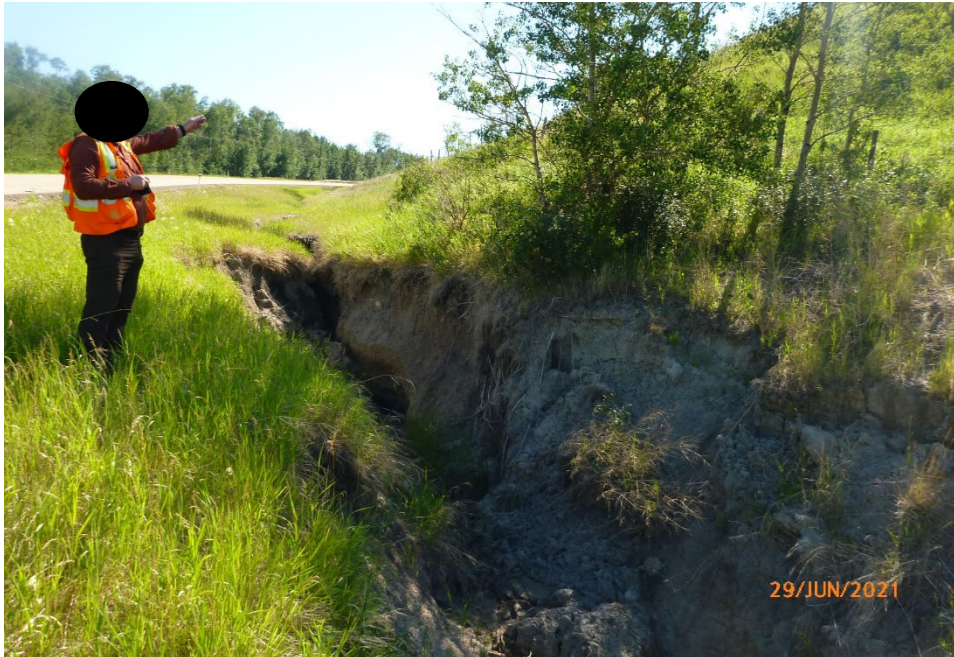
Photo 5 The erosion gully upstream (west) of the CSP culvert outlet has worsened since the 2020 call-out site visit and is approximately 2 m to 2.5 m deep. Photo taken June 29, 2021 facing west.

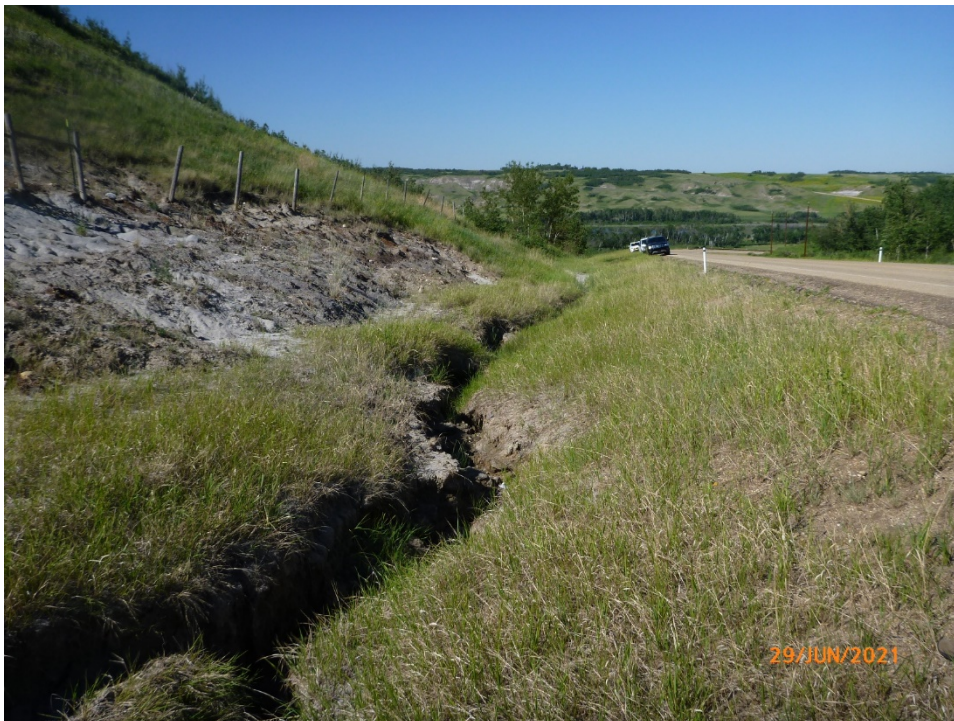
- The erosion has retrogressed towards the highway since the 2020 inspection and requires repair. The repair should be sufficient to pass flows from the 1:20 year rainfall event. AT to provide KCB with LiDAR data for the site.

Photo 6 Erosion gully in the north (westbound) ditch is retrogressing towards Hwy 609. Photo taken June 29, 2021 facing east.
