SITE NUMBER AND NAME: <b>C075-I and -II Hwy 609 and Hwy 56 Ditch Erosion</b>		HIGHWAY & KM: 609:02, 16.42	PREVIOUS INSPECTION DATE: June 29, 2021	INSPECTION DATE: <b>May 31, 2022</b>
LEGAL DESCRIPTION: NW 08-44-19-W4M & SW 17-44-19-W4M	NAD 83 COORDINATES: UTM Northing Easting 12 5849463 383508		RISK ASSESSMENT: <b>C075-I:</b> PF: 9 CF: 3 TOTAL: 27 <b>C075-II:</b> PF: 5 CF: 2 TOTAL: 10	
AVERAGE ANNUAL DAILY TRAFFIC (AADT): 500 (east) & 420 (west) (Reference No. 107370 & 110370)			CONTRACT MAINTENANCE AREA (CMA): 517

PROJECT  
CENTRAL REGION GEOHAZARD RISK MANAGEMENT PROGRAM

TITLE  
Site Plan  
C075 - Hwy 609 Ditch Erosion  
Hwy 609:02, km 16.420

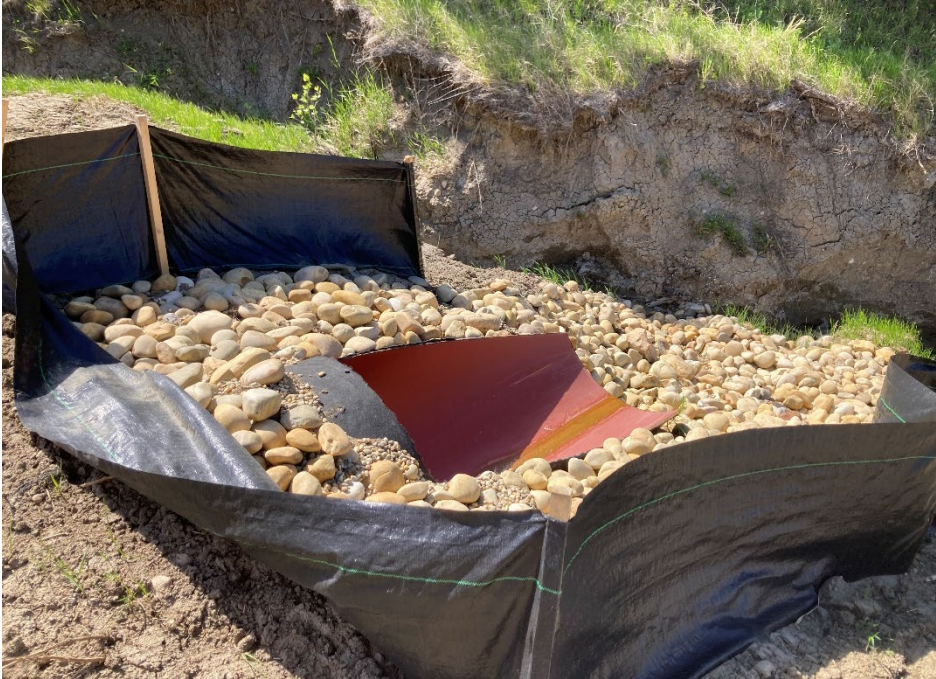
- Photo 1** The CSP culvert underlying Hwy 609:02 (oriented southeast to northwest) was sleeved with a smooth wall steel pipe in March 2021 and riprap aprons were built at the inlet and outlet (outlet shown). Photo taken May 31, 2022, facing north.

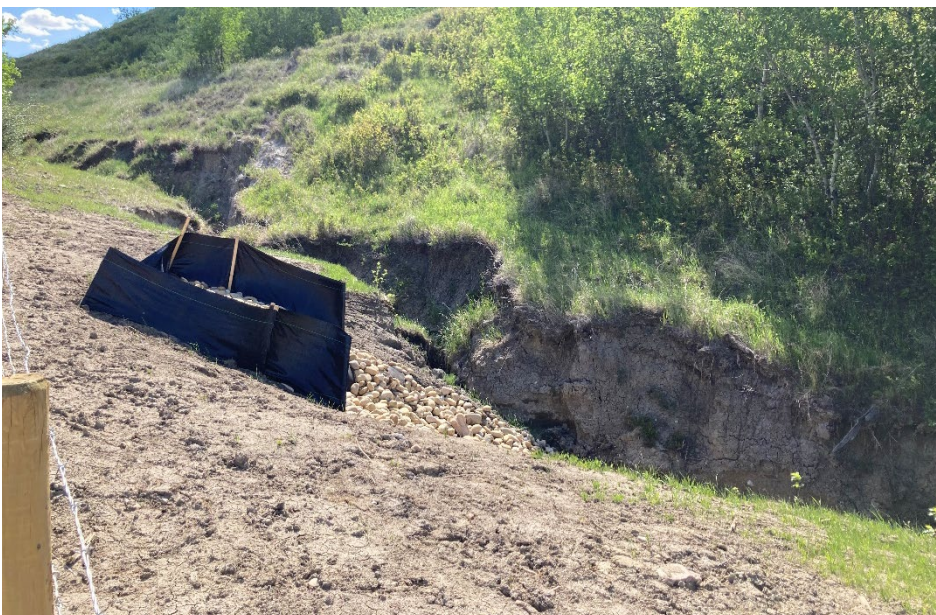
- Photo 2** Ditch erosion on the north side of Hwy 609:02 upstream and downstream of the culvert outlet. The extent and depth of the erosion appears to have increased since the 2021 inspection. Photo taken May 31, 2022, facing northwest.

- Repair options for the ditch erosion could include backfilling the ditch erosion with gravel or local fine-grained material next to the highway. Local fine-grained material (e.g., clay till) could be used to backfill the erosion gullies downstream of the culvert outlet, located on private land. Approximately 40 mm of topsoil should be placed along the repaired ditch and hydro-seeded with a seed mix suitable for the Alberta Badlands.

- Riprap should be placed in the gully erosion at the culvert outlet and downstream of the culvert outlet.
- KCB provided AT a design memo and Request for Quotation (RFQ) in fall 2021. However, due to budget constraints AT decided to not proceed with a repair in 2021. In July 2022, KCB provided AT an updated design memo and RFQ to submit to selected contractors, with a reduced scope of work, outlining the private-land-gully repair and ditch repair). However, the costs received in late-July were much higher than expected and more than the available funding for the repair. Any repairs completed in 2022 will have to be a reduced scope of work (i.e., only repairing the ditch erosion upstream of the culvert outlet) or be completed to reduced design standards (i.e., only backfilling and not armouring the ditch erosion).

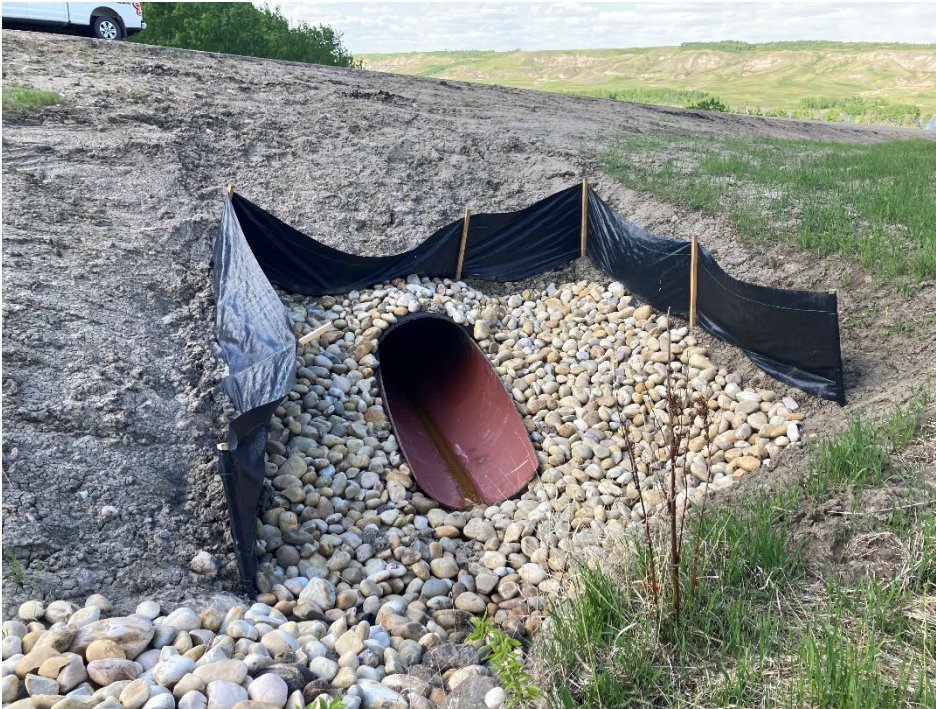
**Photo 3** The inlet of the culvert underlying Hwy 609:02. Photo taken May 31, 2022, facing northeast.

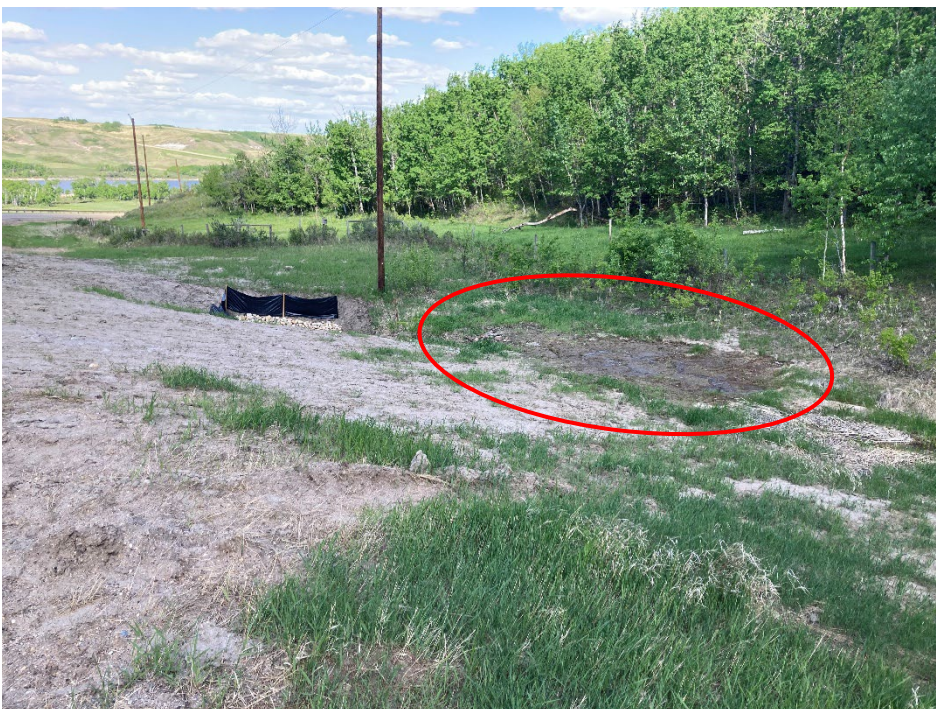
- A soft and wet area was observed in the ditch upstream of the culvert inlet (Photo 4).
- Ditch erosion was observed in two locations but is not as severe as the west ditch erosion.
- There is an exposed fibre-optic line (first observed during the 2020 call-out inspection) near the west extent of the site.
- A fence is being impacted by the ditch erosion.

**Photo 4** A soft and wet area was observed in the south (eastbound) ditch upstream of the culvert inlet (indicated by red circle). Photo taken May 21, 2022, facing east-southeast.

- The fibre-optic line needs to be relocated.
- Where the fence has fallen, the ditch needs to be graded and the fence needs to be reinstated.
- The ditch erosion should be backfilled with fine-grained material and the ditch graded for positive drainage.

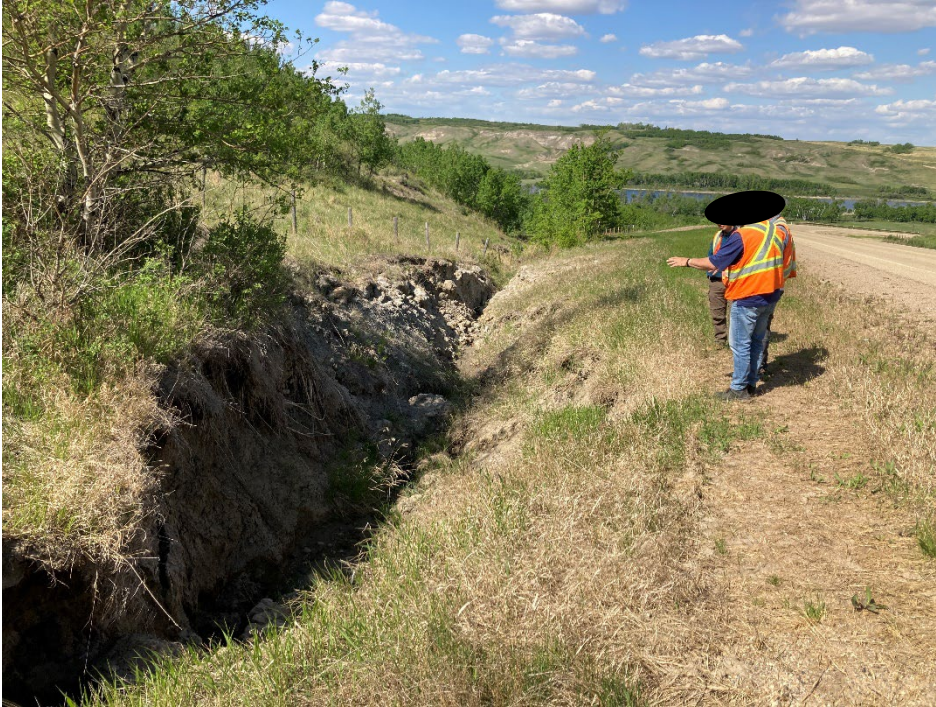
- The erosion upslope (west) the CSP culvert outlet has retrogressed towards the highway since the 2021 inspection and requires repair (Photo 5). The erosion is within approximately 2 m to 3 m from the edge of the north (westbound) lane.
- Erosion on the north side of the highway at the toe of the bedrock backslope (appears to be similar bedrock as seen in the badlands) extends upslope (west) approximately 200 m and ends in a wet spot of the ditch (Photo 6). The wet spot is believed to be at the top of the bedrock outcrop, based on the exposed bedrock outcrop on the cut slope.

**Photo 5** The ditch erosion along the north (westbound) ditch upstream of the culvert outlet appears to have retrogressed further towards the highway since the 2021 inspection. Photo taken May 31, 2022, facing northeast.

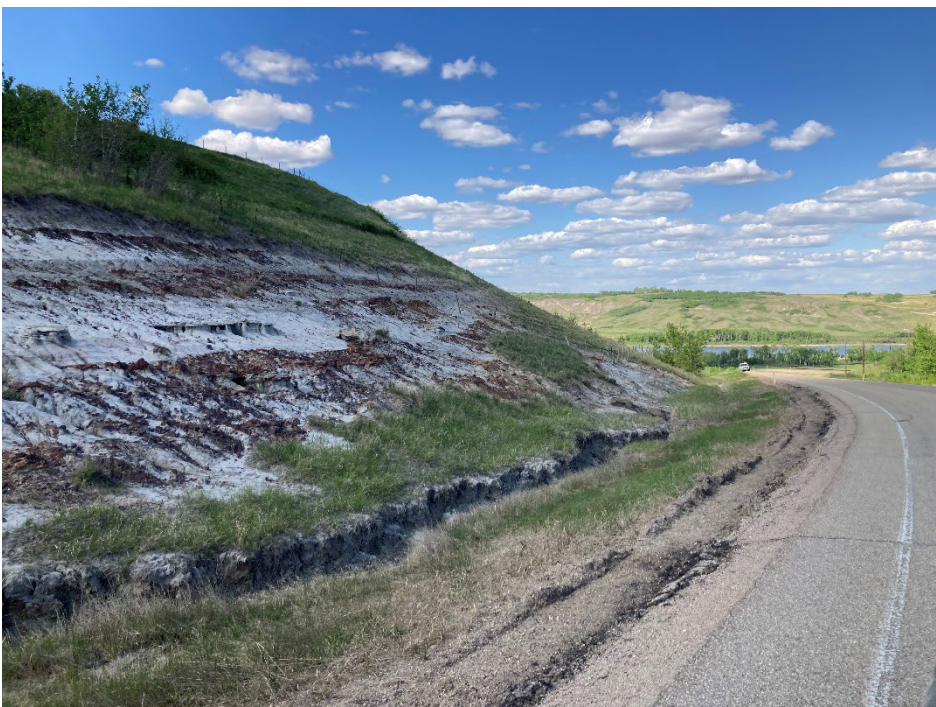
**Photo 6** Ditch erosion in the north (westbound) ditch along bedrock outcrop (toe of the cutslope). Photo taken May 31, 2022, facing northeast.

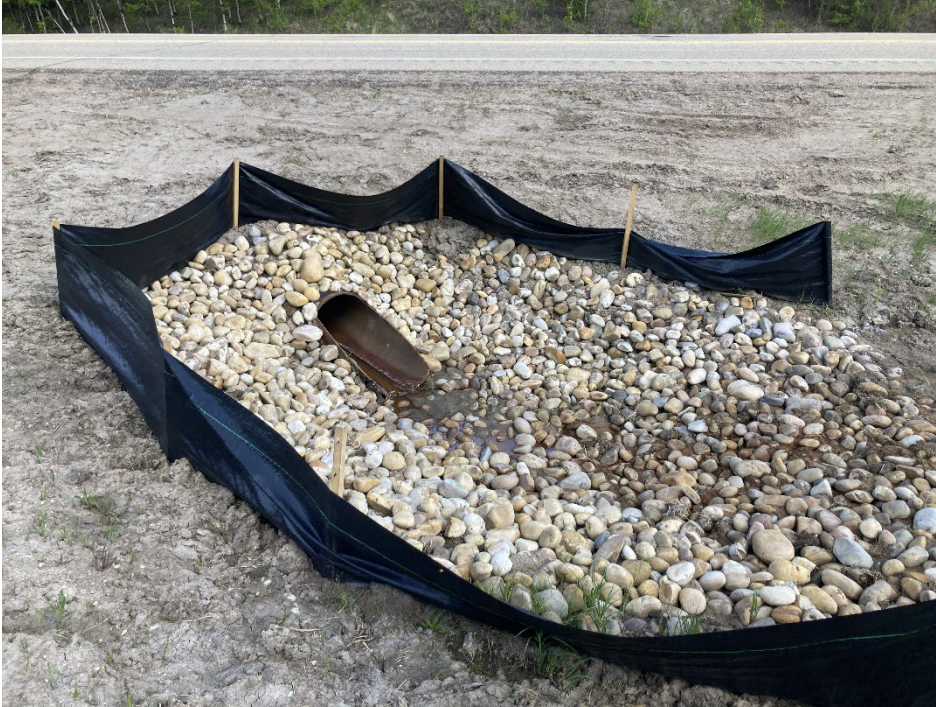
**Photo 7** The CSP culvert underlying Hwy 56:16 was sleeved in March 2021 with a smooth wall steel pipe culvert and riprap aprons were built and the culvert inlet and outlet (inlet shown). Photo taken May 31, 2022, facing east.

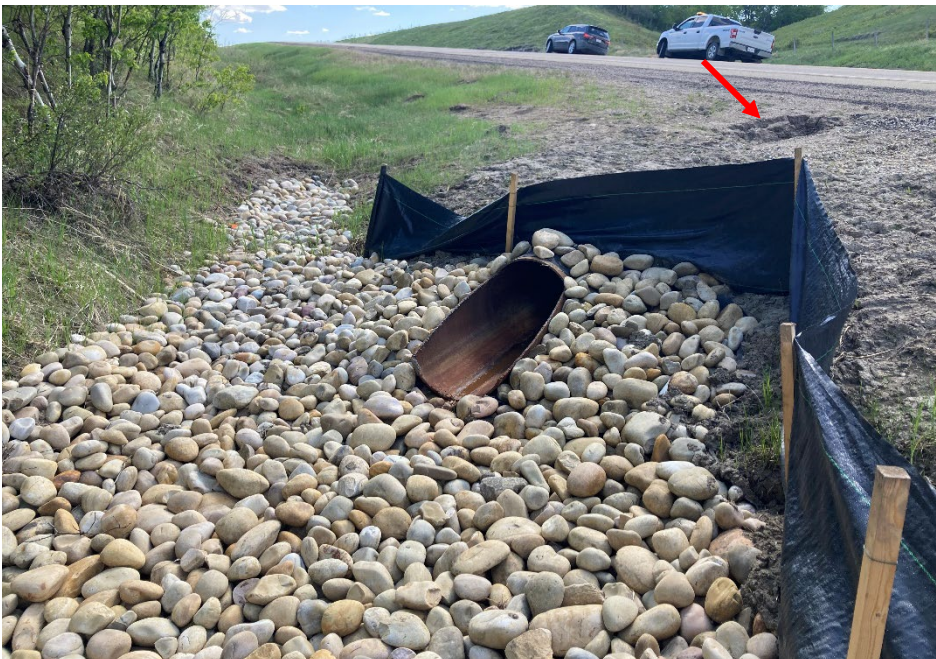
- There is erosion in the east (northbound) ditch that has likely been ongoing for a long time but is now just reaching the highway.
- In March 2021, the CSP culvert underlying Hwy 56:16 (oriented east to west) was sleeved with a steel smooth walled culvert and riprap aprons were built at the culvert inlet and outlet (Photo 7 and 8). AT informed KCB the work was completed by Inline Group Inc
- A potential sinkhole (approximately 0.5 m wide and 0.75 m long) was observed above the culvert, on the east side of the highway near the culvert outlet (Photo 8).

**Photo 8** The outlet of the culvert underlying Hwy 56:16. A possible sinkhole was observed near the east (northbound) pavement (indicated by red arrow). Photo taken May 31, 2022, facing south-southwest.
