SITE NUMBER AND NAME: C043 Soil-Nail Site		HIGHWAY & KM: 619:06, 12.206	PREVIOUS INSPECTION DATE: July 12, 2019	INSPECTION DATE: June 24, 2020
LEGAL DESCRIPTION: 03-29-048-05 W4M 14-20-048-05 W4M	NAD 83 COORDINATES: UTM Northing Easting 12 5890276 520018		RISK ASSESSMENT: PF: 8 CF: 4 TOTAL: 32	
AVERAGE ANNUAL DAILY TRAFFIC (AADT): 680 (west) & 660 (east) (Ref No. 134430 & 131430)			CONTRACT MAINTENANCE AREA (CMA): 512

NOTES: 1. HORIZONTAL DATUM: NAD83 2. GRID ZONE: UTM Zone 12N 3. IMAGE SOURCE: World Imagery, ESRI ArcGIS Online Source date May 21, 2015 (Vermilion River County 2015) 4. 2013 instrument localities are approximate.	CLIENT 	PROJECT CENTRAL REGION GEOHAZARD RISK MANAGEMENT PROGRAM
		TITLE Site Plan C043 - Soil Nail Site Hwy 619:06, km 12.206
	SCALE 1:800	PROJECT No. A05115A02
		FIG No. 1

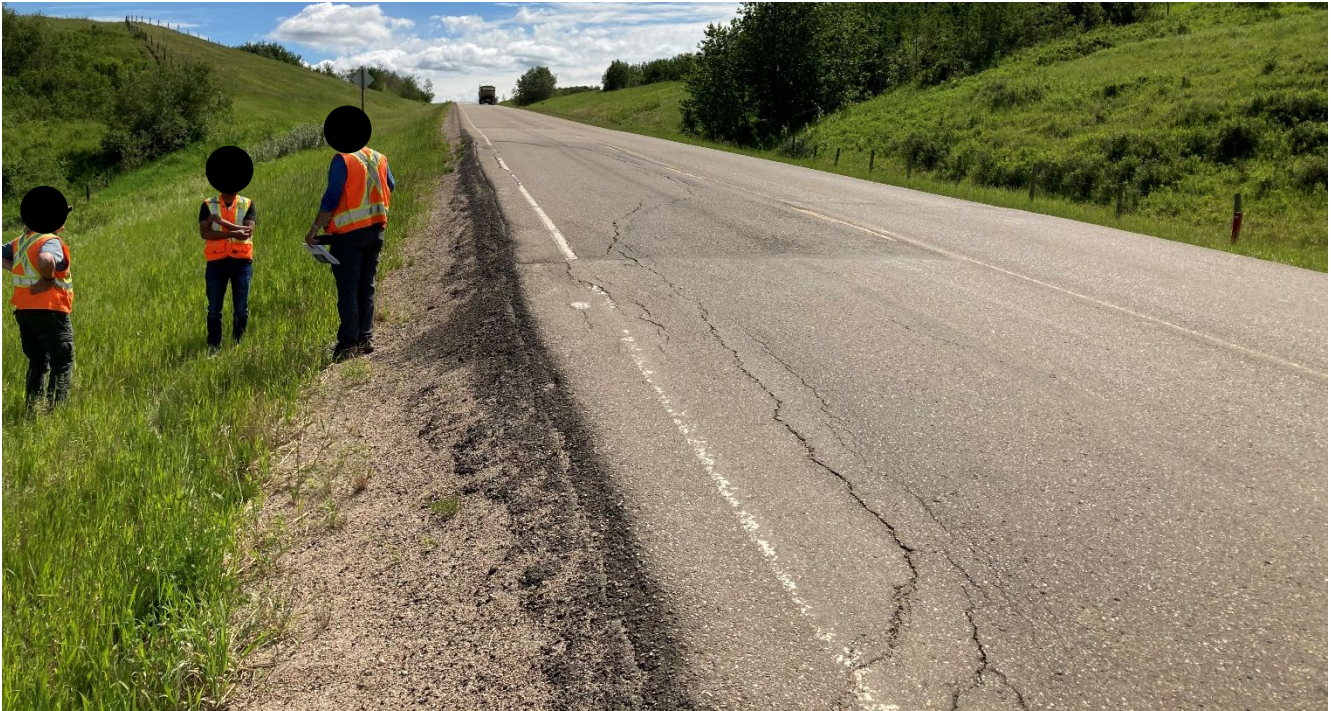
Photo 1 Cracking and pavement depression in the westbound lane. Tensions cracks extend beyond previously patched area. Photo taken June 24, 2020 looking east.

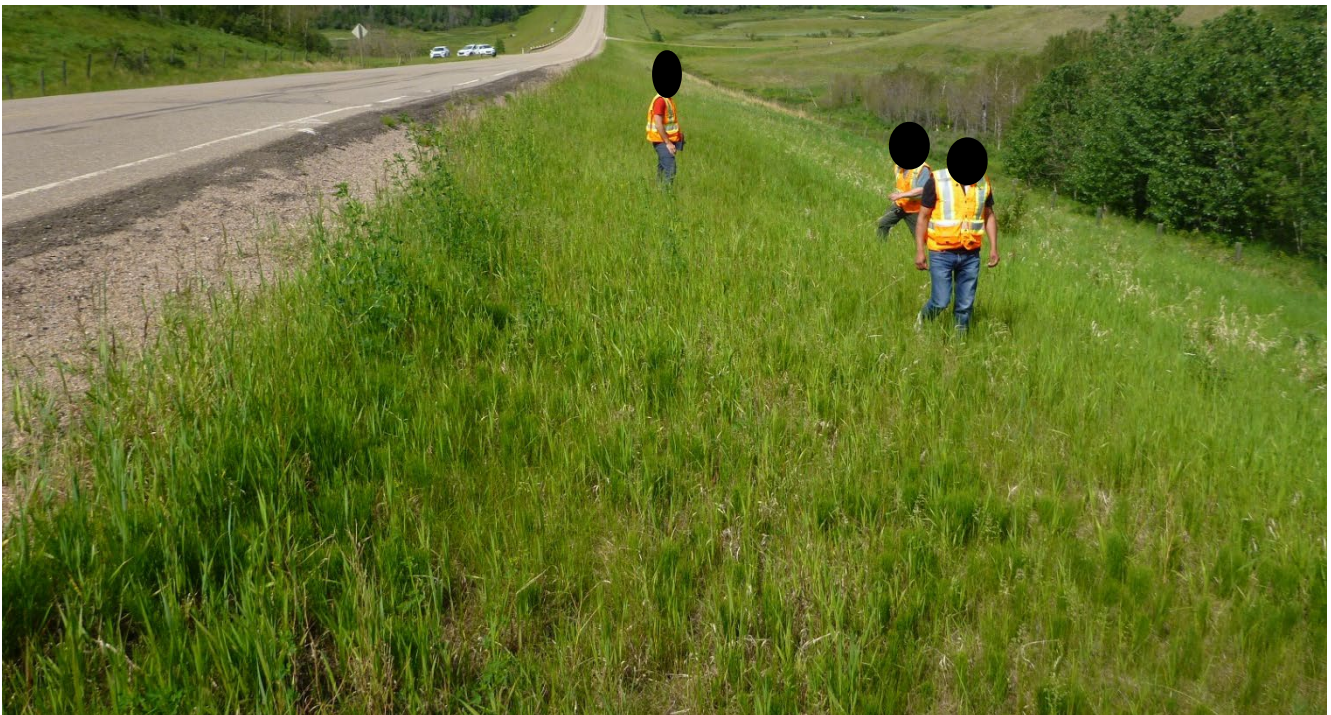
Photo 2 Asphalt settlement in the westbound lane. Photo taken June 24, 2020 facing west.

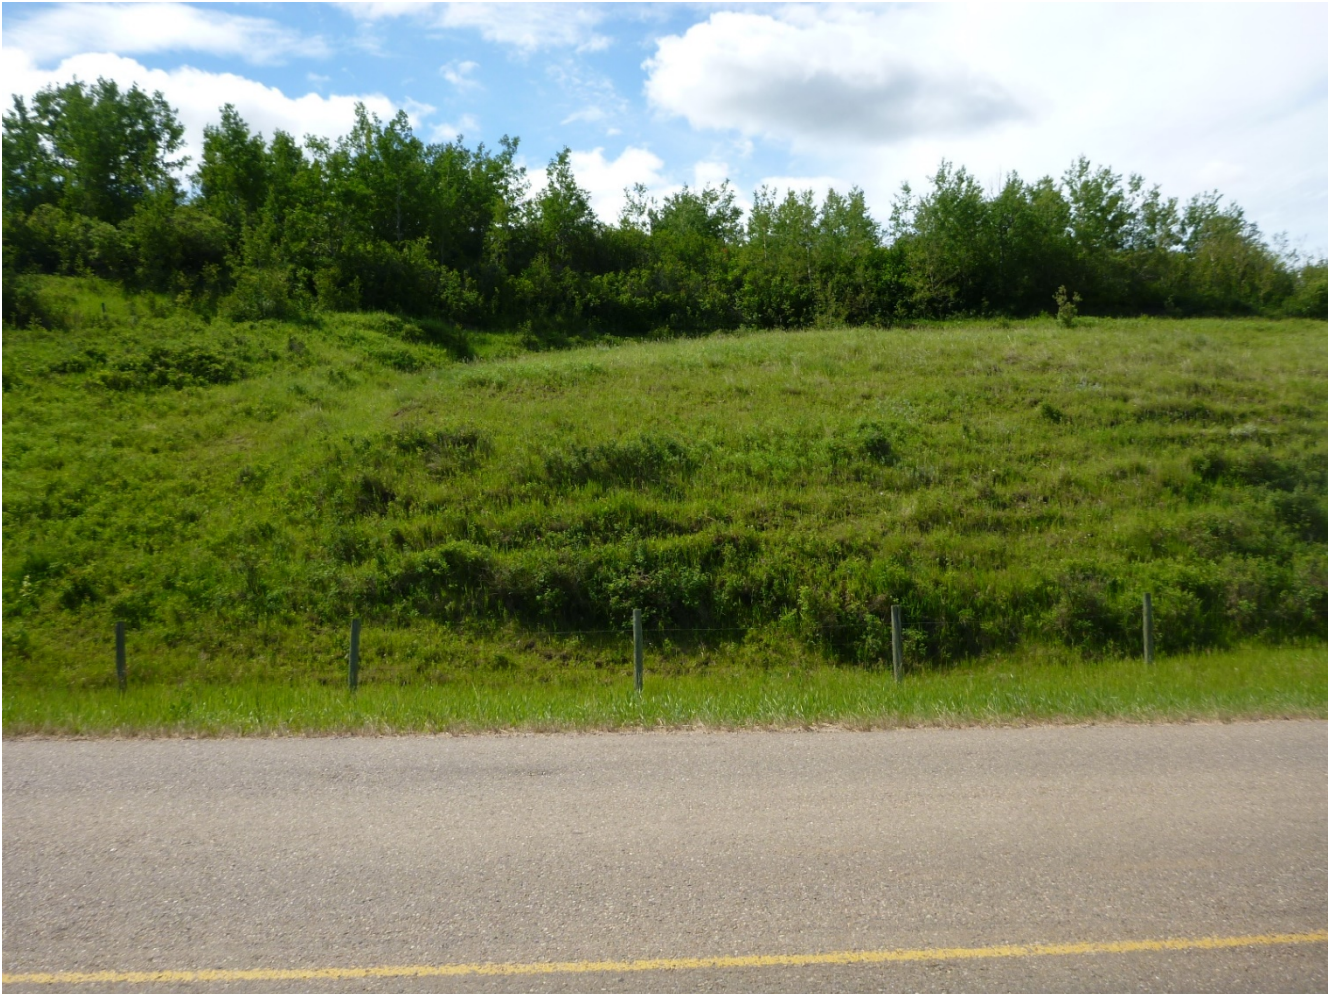
Photo 3 Slope movement in the slope south of Hwy 619:06. Photo taken June 24, 2020 facing south.
