SITE NUMBER AND NAME: C043 Soil-Nail Site		HIGHWAY & KM: 619:06, 12.206	PREVIOUS INSPECTION DATE: June 24, 2020	INSPECTION DATE: June 29, 2021
LEGAL DESCRIPTION: 03-29-48-05 W4M 14-20-48-05 W4M	NAD 83 COORDINATES: UTM Northing Easting 12 5890276 520018		RISK ASSESSMENT: PF: 1 CF: 5 TOTAL: 5	
AVERAGE ANNUAL DAILY TRAFFIC (AADT): 400 (west) & 430 (east) (Ref No. 134430 & 131430)			CONTRACT MAINTENANCE AREA (CMA): 512

Inspection Photographs

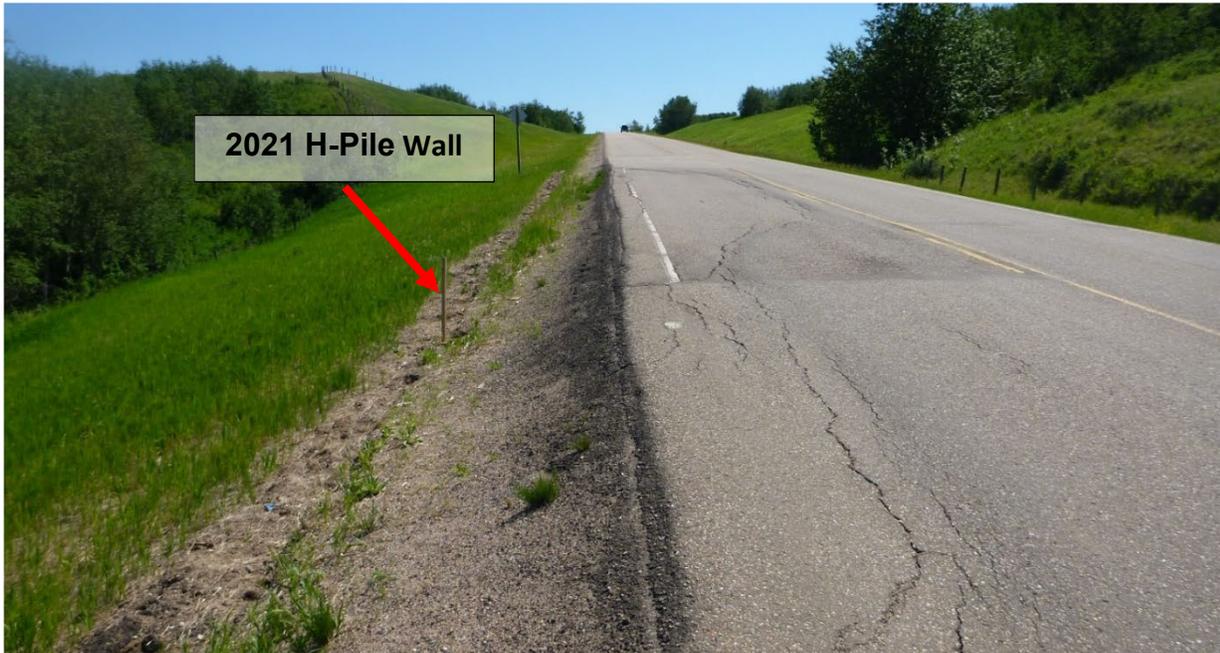
A H-Pile wall was installed in the north embankment slope in March 2021 (Photos 1 and 2). The H-Pile wall was installed approximately 2 m north of the edge of asphalt. Two slope inclinometers (SIs) were installed in the pile wall to monitor pile wall deflection.

Photo 1 Cracking and pavement depression in the westbound lane. Tensions cracks extend beyond previously patched area. The disturbed strip of ground is the location of the pile wall (red arrow). Photo taken June 29, 2021 looking east.

- The Highway Maintenance Contractor should complete mill and fill work to patch and restore the pavement behind the pile wall. The north shoulder be raised to reduce the drop from the asphalt to the embankment slope. KCB will supply the HMC with a detail for this work.
- The two SIs installed in the pile wall should be extended if the shoulder is raised. KCB will be required to be on site to raise the SIs so the reading depths will align with the previous readings.

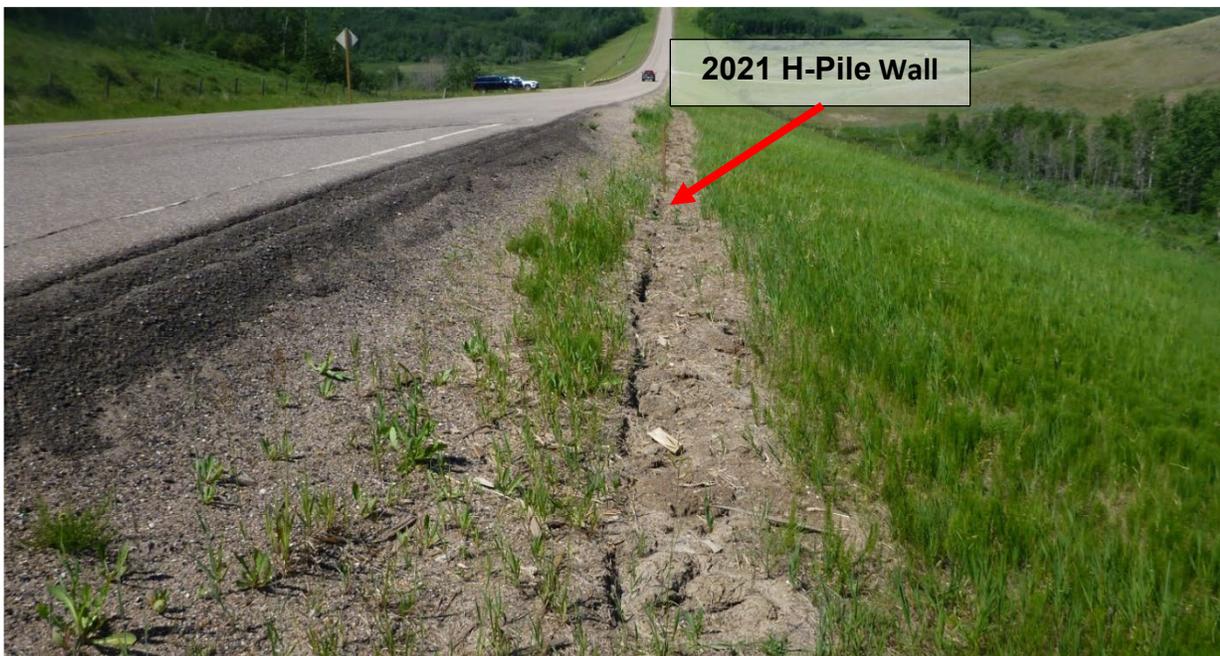
Photo 2 Asphalt patch in the westbound lane and 2021 H-Pile Wall location. Disturbed ground is location of pile wall (red arrow). Photo taken June 29, 2021 facing west.

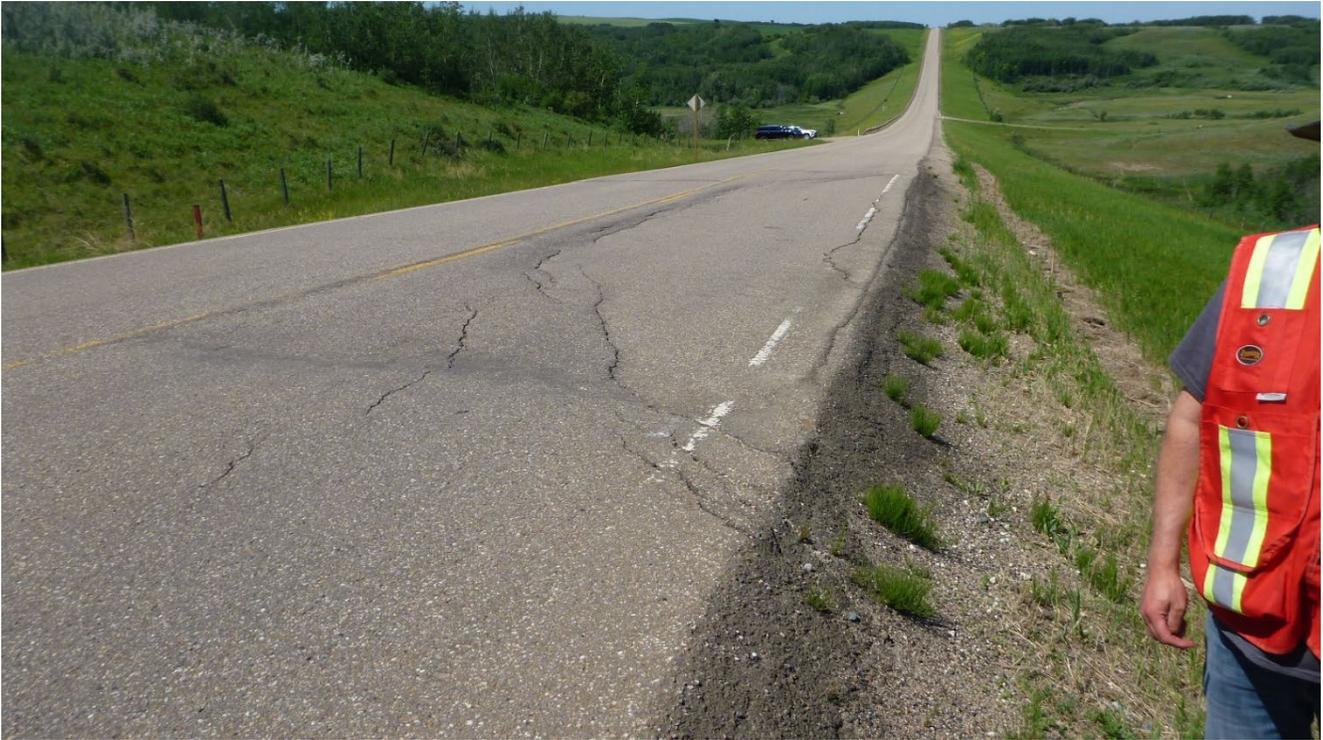
Photo 3 Asphalt cracking extending past the most recent asphalt patch. Photo taken June 29, 2021 facing west.

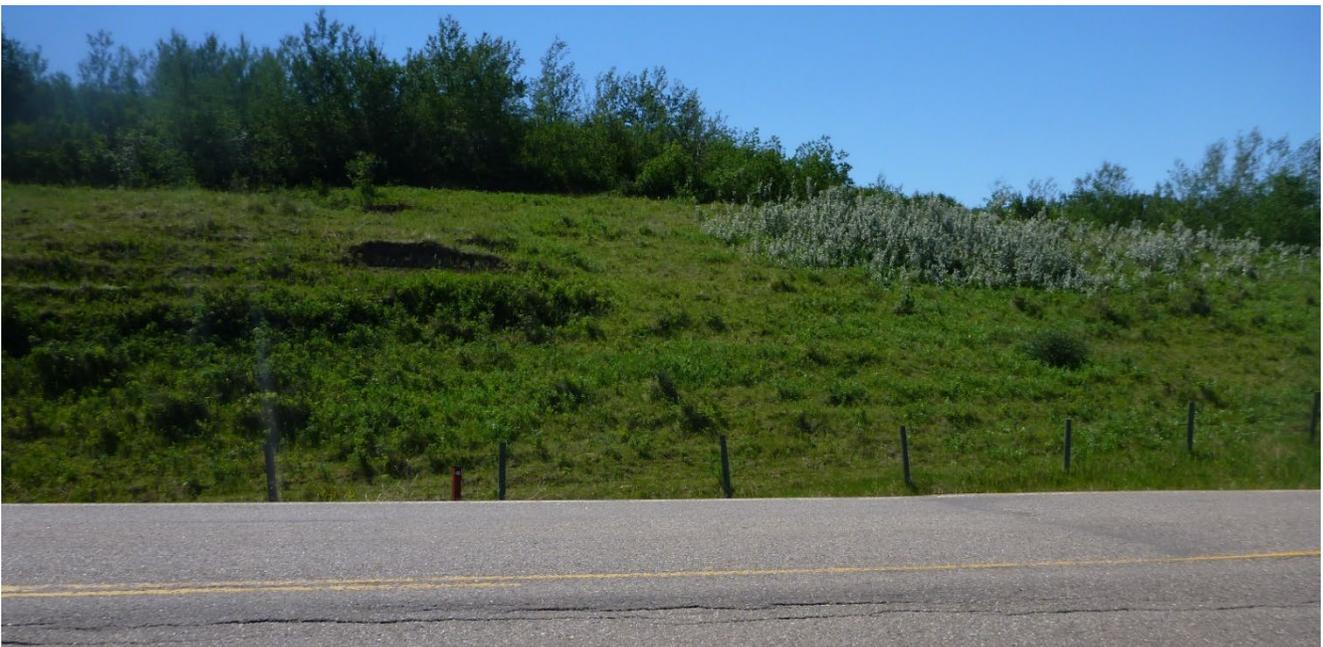
Photo 4 Slope movement in the slope south of Hwy 619:06. Photo taken June 29, 2021 facing south.
