SITE NUMBER AND NAME: C043 Soil-Nail Site		HIGHWAY & KM: 619:06, 12.206	PREVIOUS INSPECTION DATE: June 29, 2021	INSPECTION DATE: June 28, 2023
LEGAL DESCRIPTION: 03-29-48-05 W4M 14-20-48-05 W4M	NAD 83 COORDINATES: UTM Northing Easting 12 5890276 520018		RISK ASSESSMENT: PF: 3 CF: 1 TOTAL: 3	
AVERAGE ANNUAL DAILY TRAFFIC (AADT): 400 (west) & 440 (east) (Ref No. 134430 & 131430)			CONTRACT MAINTENANCE AREA (CMA): 512

CENTRAL REGION GEOHAZARD RISK MANAGEMENT PROGRAM

Site Plan
C043 - Soil Nail Site
Hwy 619:06, km 12.206

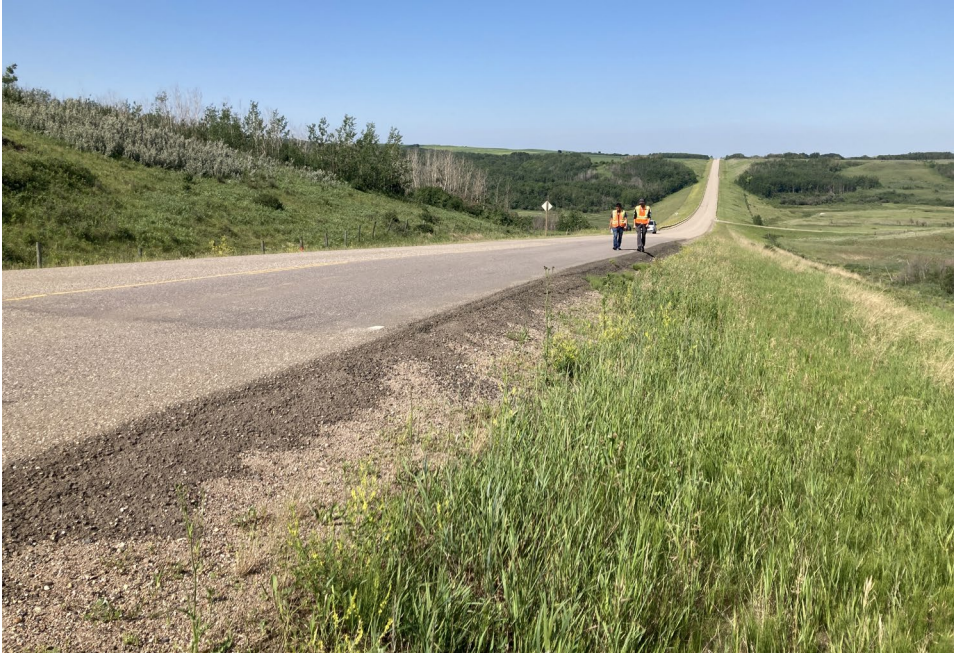
A pavement patch was completed in the north (westbound) lane between the 2021 and 2023 inspections (Photo 1 and 2). Pavement cracks were observed in the north (westbound) lane upslope of the 2021 H-pile wall. However, the degree of pavement cracking was less than previous inspections (i.e., thinner, and not along the entire length of the site) indicating the pile wall is taking load from the highway embankment and performing well.

- Photo 1** A pavement patch was completed in the north (westbound) lane between the 2021 and 2023 inspections, obscuring the pavement cracks previously observed. Photo taken June 28, 2023, facing west.

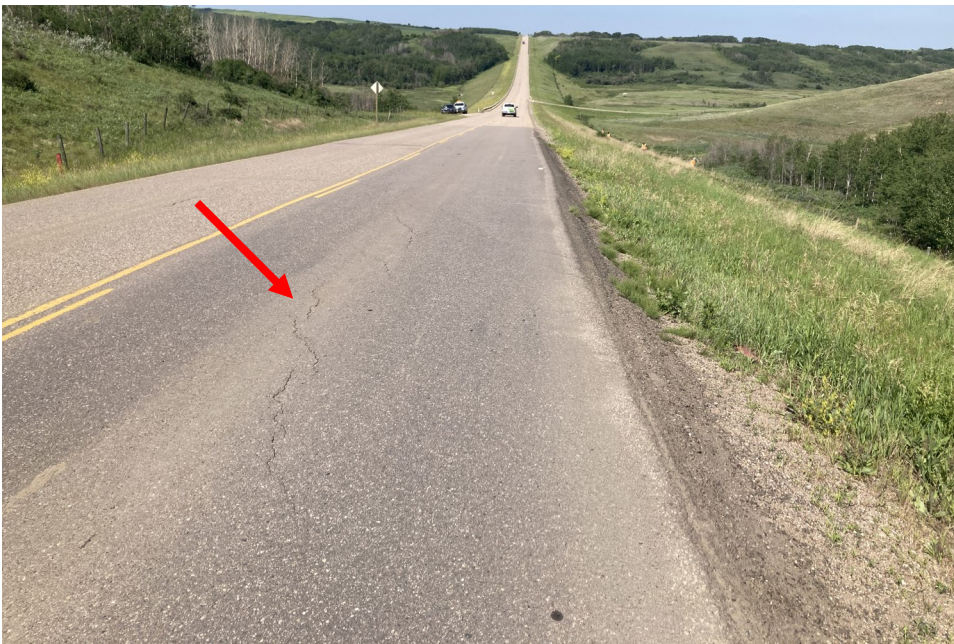
A H-pile wall was installed in the north (westbound) highway embankment slope in March 2021 (Photo 2). The H-pile wall was installed approximately 2 m north of the edge of asphalt. Two slope inclinometers (SIs) were installed in the pile wall to monitor pile wall deflection.

- Photo 2** Minor pavement cracking observed near the center of the north (westbound) lane (indicated by red arrow). Photo taken June 28, 2023, facing west.

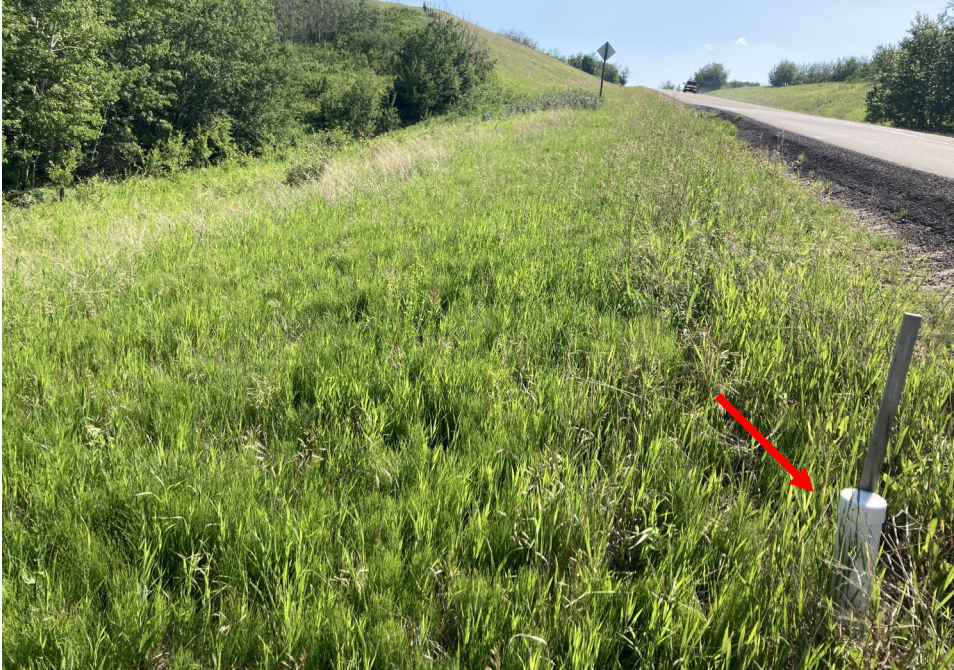
The north (westbound) highway embankment slope is well vegetated. No evidence of slope movement was observed during the 2023 inspection. However, ground cracking may have been obscured by the tall vegetation.

Photo 3 The north (westbound) highway embankment slope is well vegetated. A slope inclinometer installed in the 2021 h-pile wall is indicated by the red arrow. Photo taken June 28, 2023, facing east.

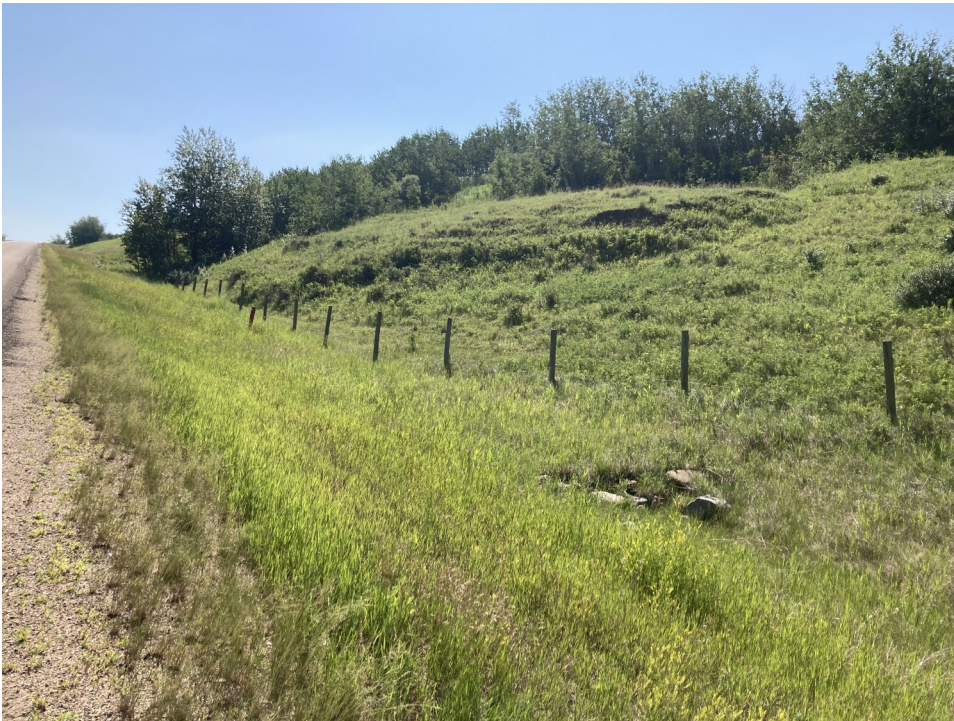
The south (eastbound) ditch is well vegetated with grass and appears dry (Photo 4).

The south (eastbound) backslope has failed and the fence line has deflected. The extent of the slide failure does not appear to have changed significantly since the 2021 inspection (Photo 4).

Photo 4 The slide on the cutslope on the south side of Hwy 619:06 appears similar to during the 2021 inspection. Photo taken June 28, 2023, facing southeast.
