July 15, 2024

Alberta Transportation and Economic Corridors
4th Floor, Provincial Building
4920 51 Street
Red Deer, Alberta
T4N 6K8

**CON0022160 Central Region GRMP Instrumentation Monitoring
Site C043; H619:06, km 12.206 Soil Nail Site
Section C – 2024 Spring Readings**

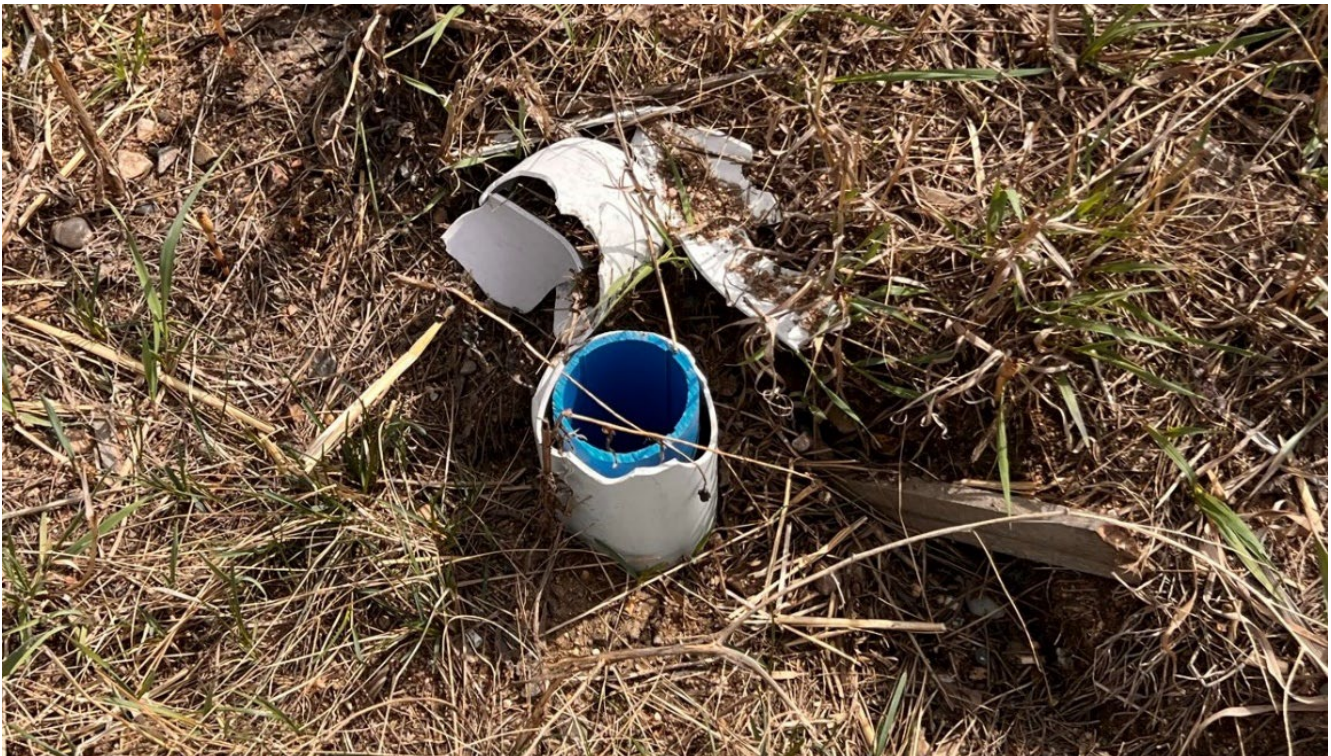
Photo 1 **Damaged PVC casing protector at SI21-C43-01. Photo taken May 8, 2023.**

Between the 2022 and 2023 spring readings, the above-ground PVC casing protector for SI21-C43-01 was damaged (most likely damaged during snow clearing activities). A replacement casing protector should be installed.

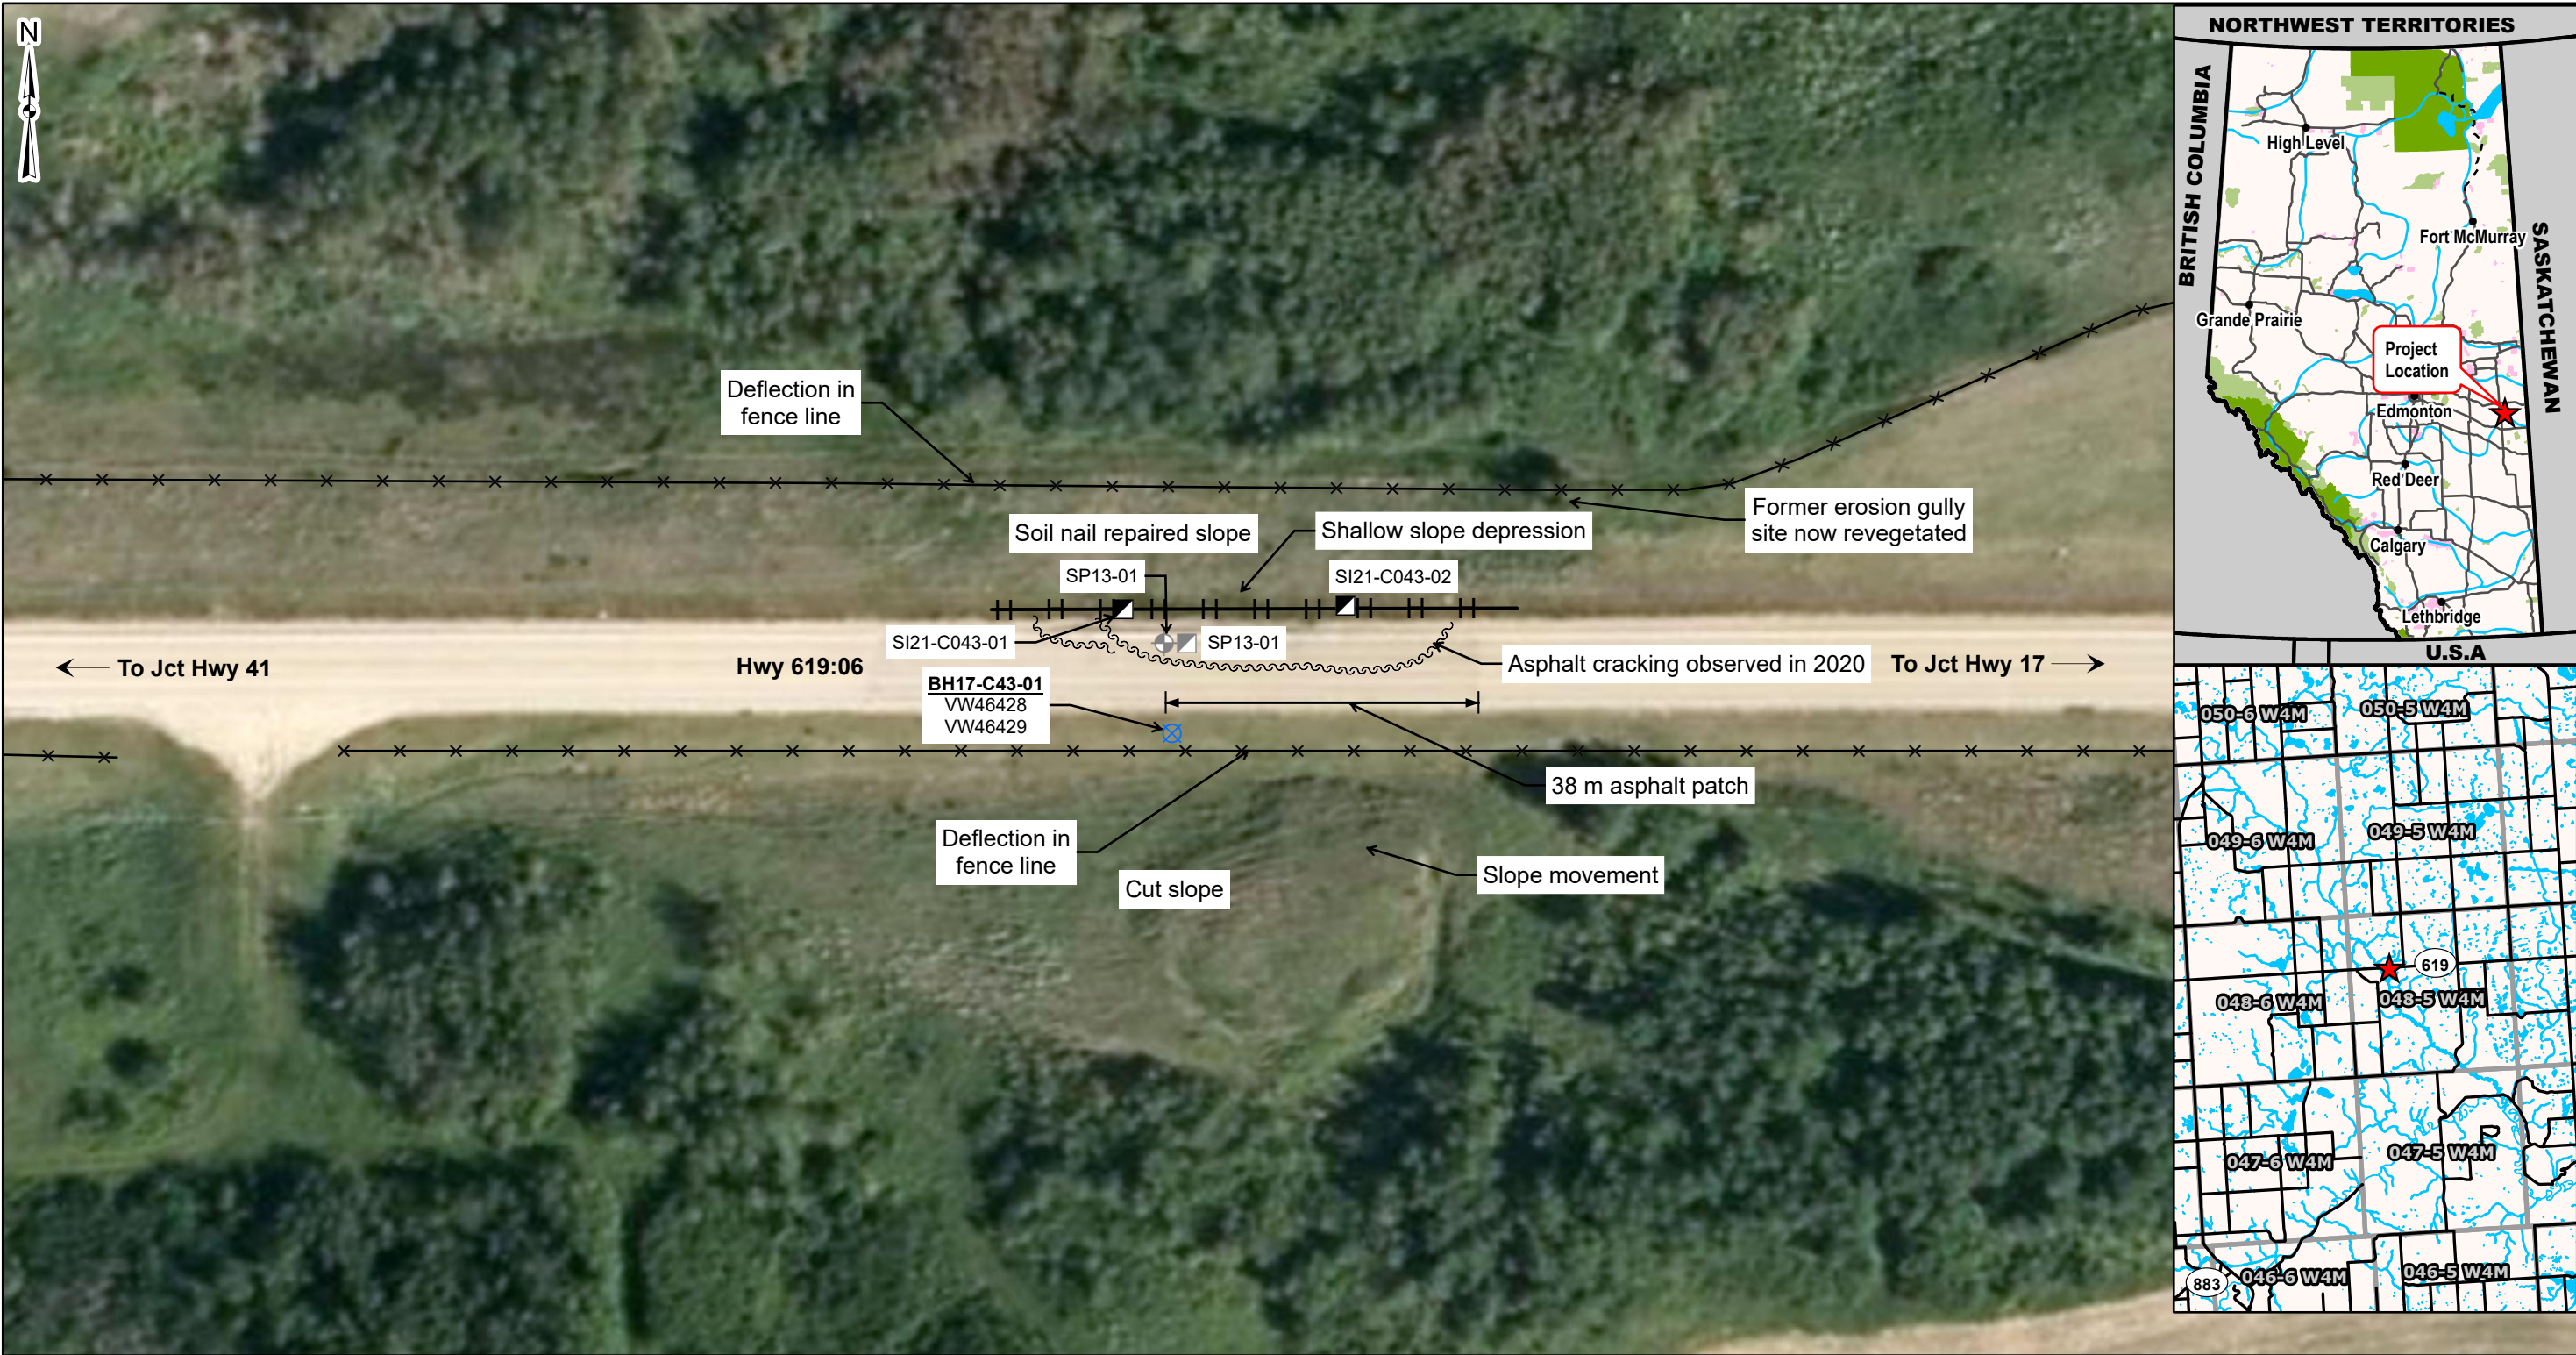
FIG No.
1

The geohazard at the C043 site consists of an embankment slope failure on the north side of Hwy 619:06 and a backslope failure on the south side of Hwy 619:06.

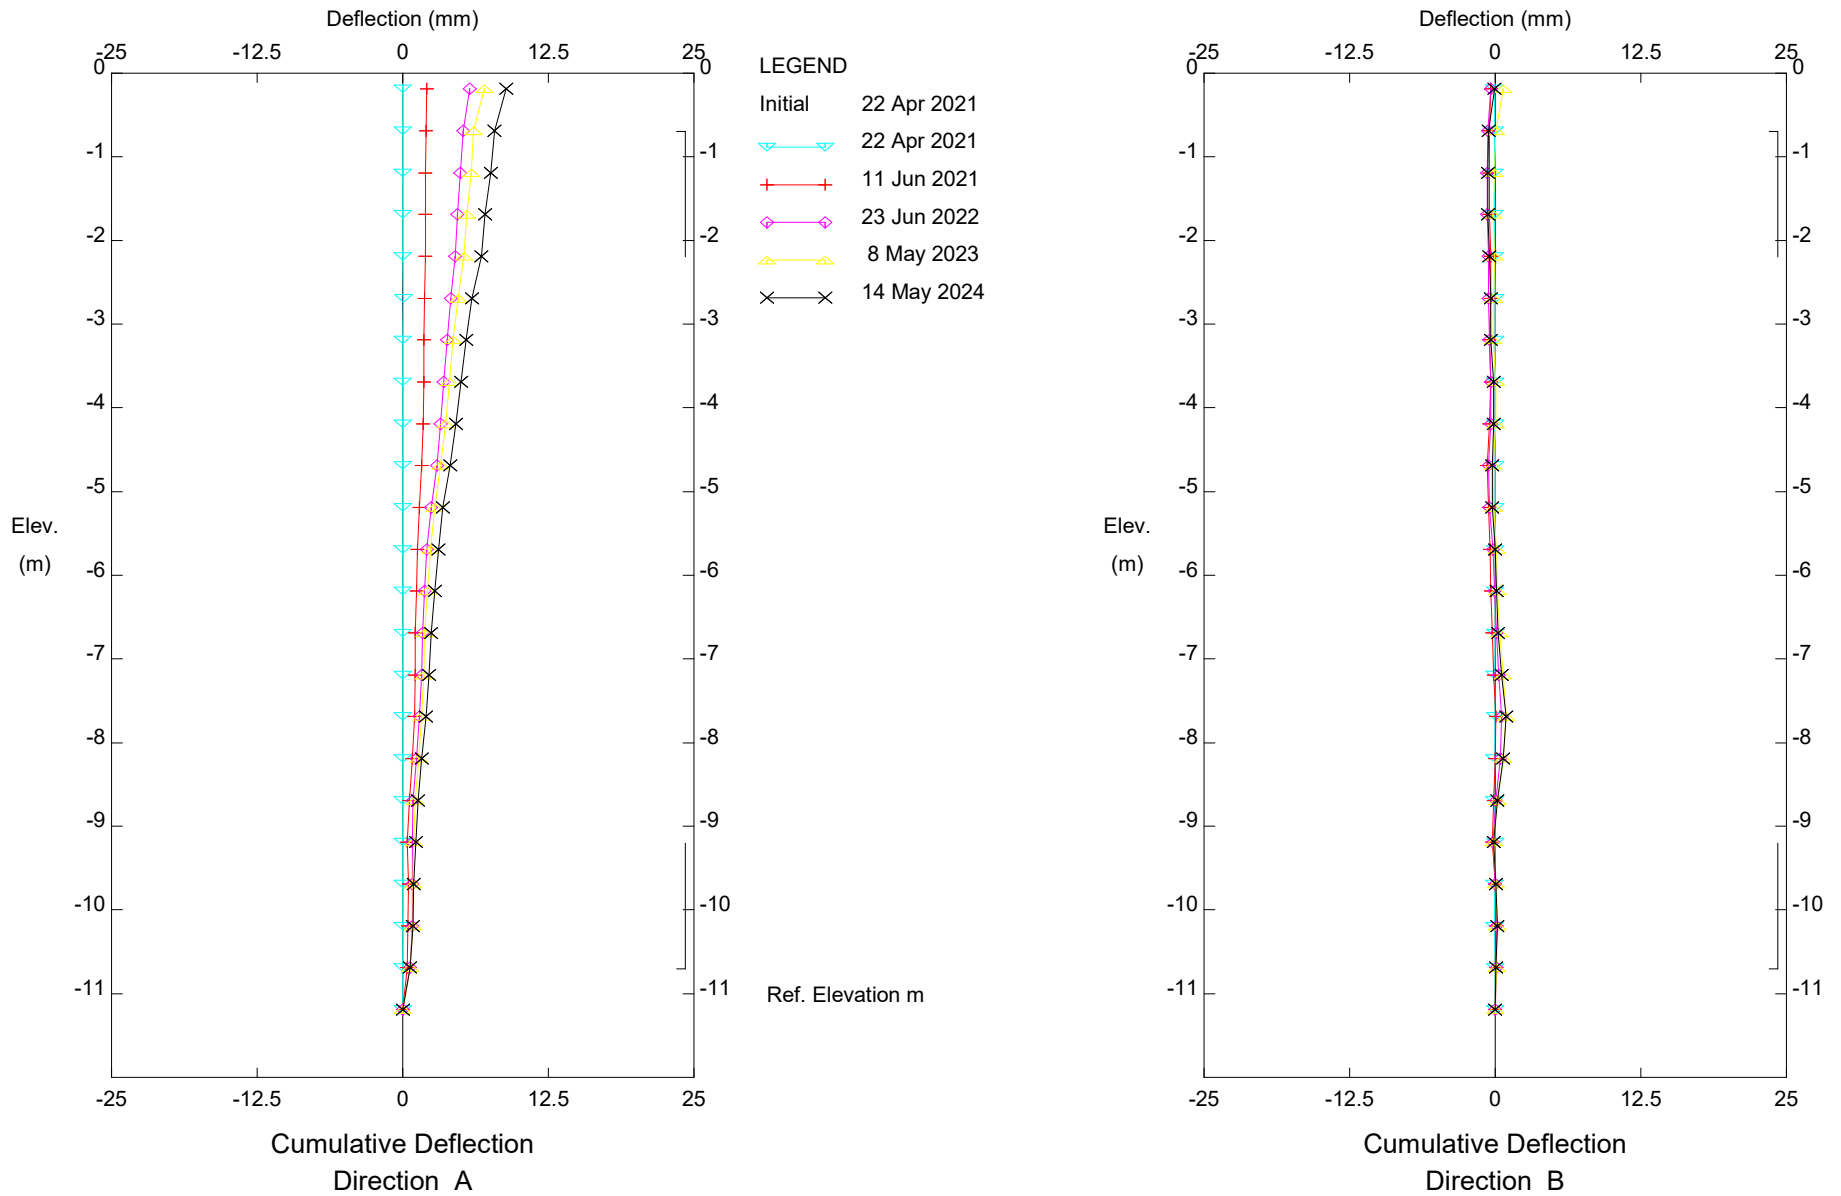
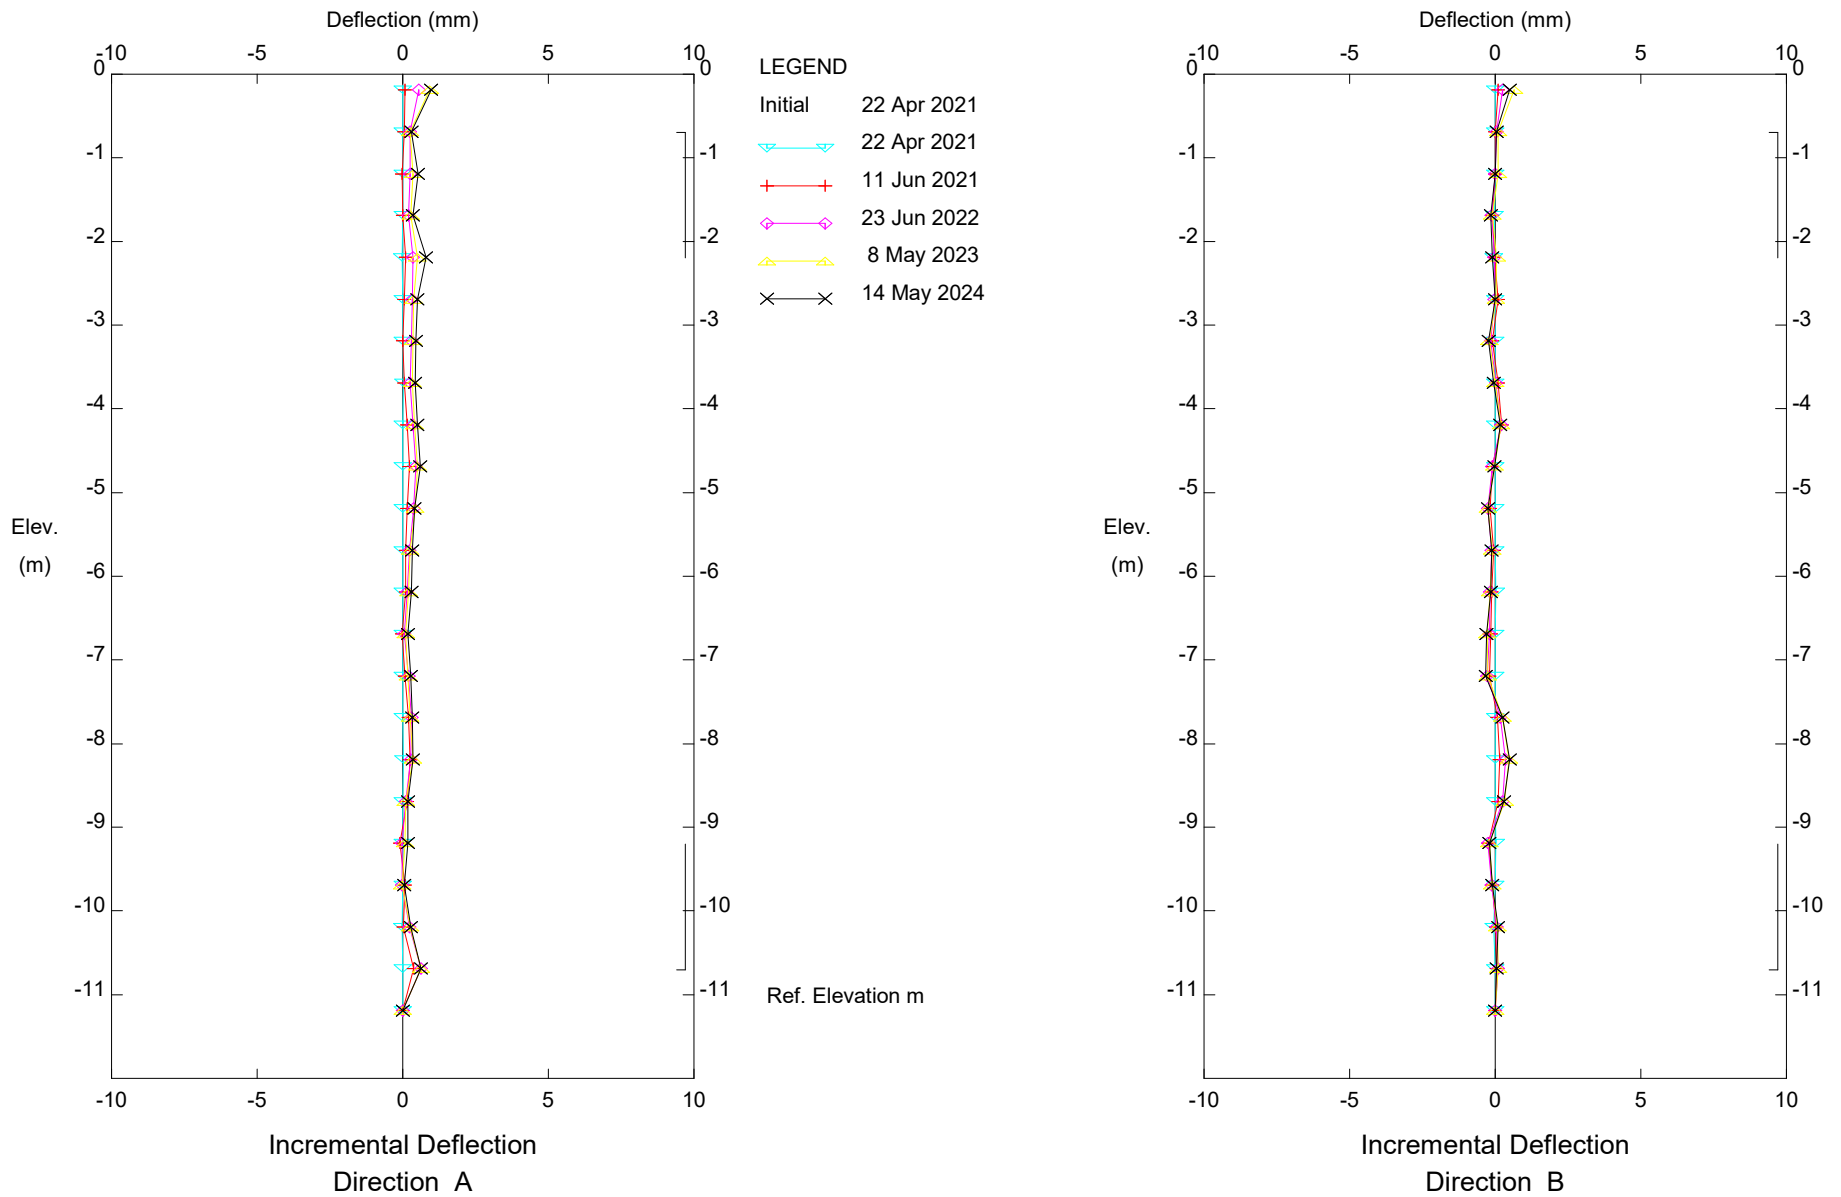
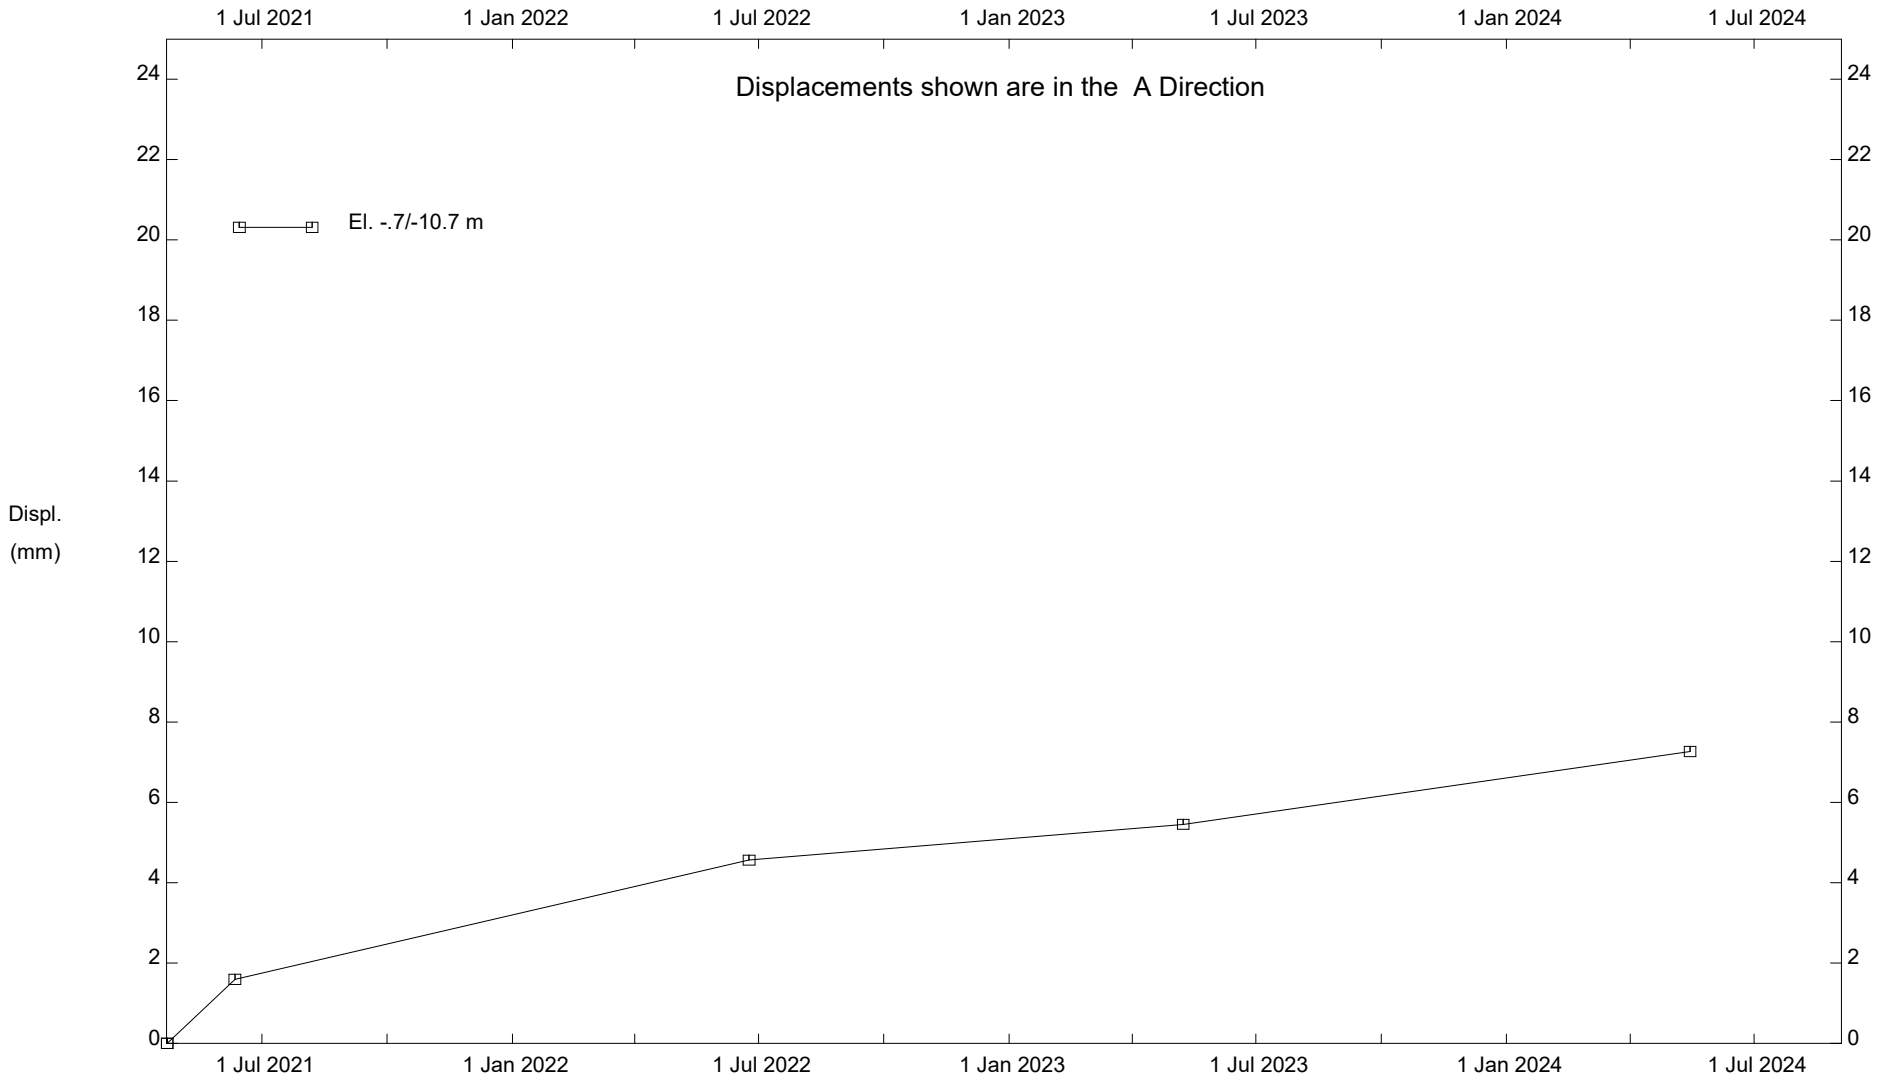
C043; H619:06; Soil Nail Site, Inclinometer SI21-01

Distributed movement is being recorded in the SIs installed in the H-pile wall, SI21-C43-01 and SI21-C43-02, from top of casing to approximate depths of 11 m and 8 m below ground surface, respectively. The H-pile wall is 12 m deep, and SI21-C43-01 and SI21-C43-02 are approximately 10.9 m and 11.4 m deep, respectively.

The distributed movement being recorded in SI21-C43-01 and SI21-C43-02 is from approximately ground surface to the base of the H-pile wall and from ground surface to 4 m above the base of the wall, respectively. The deflection recorded in SI21-C43-02 is approximately 2 m below the depth of movement recorded in SI13-01 before it was destroyed. Distributed movement along the length of the H-pile wall indicates that the failure surface has been intercepted, and is continuing to deflect, transferring load to depths below the failure plane as the piles stabilize the slide mass.

The May 2024 data obtained from the pile-wall SIs indicates that the top of the H-pile wall has deflected up to approximately 8.5 mm since installation. In the spring of 2021, shortly after construction of the H-pile wall, the maximum rate of movement recorded in these SIs was between approximately 6 mm/year and 12 mm/year. The rate of movement has since decreased and is now less than approximately 3 mm/year. KCB anticipated that the rate of movement shortly after installation would be highest and would decrease as the H-pile wall picked up load stabilizing the sliding mass.

All operable instruments should continue to be read once per year (spring) until movements attenuate, and all cracking and deformations of the pavement surface cease.

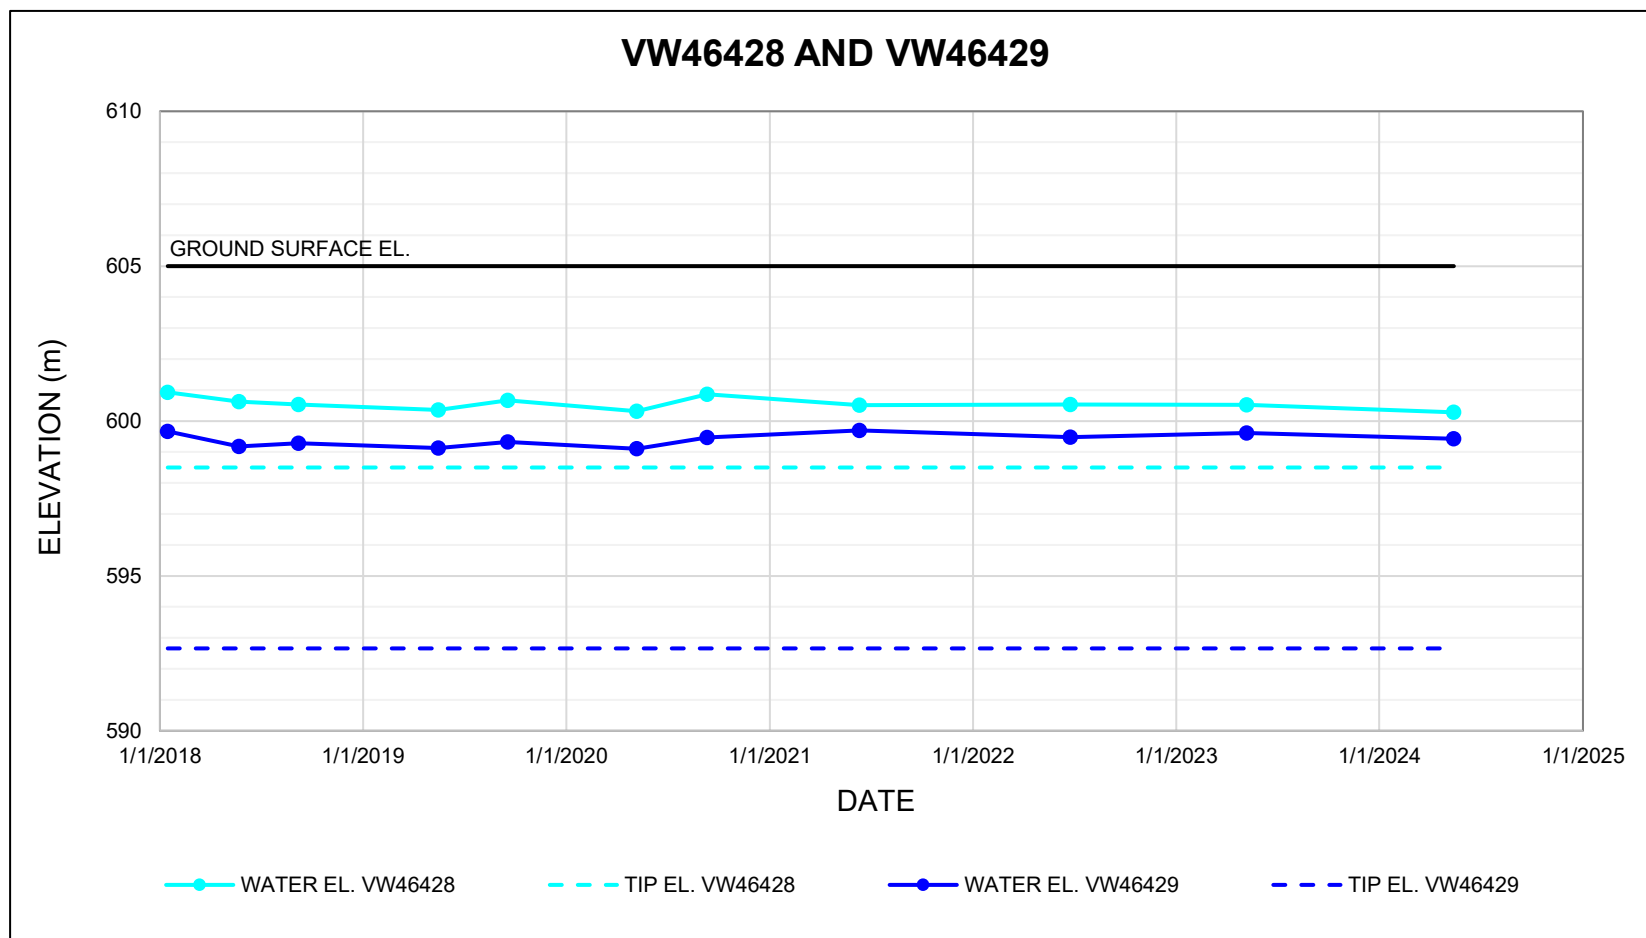
CENTRAL REGION GEOHAZARD RISK MANAGEMENT PROGRAM	
		TITLE	
		Piezometer Data C043 - Soil Nail Site Hwy 619:06, km 12.206	
SCALE	PROJECT No.	A05116A02	FIG No. I-1

Previous assessments of the slope failure suggest that movement is likely occurring in response to periods of heavy or prolonged rainfall, resulting in higher groundwater conditions or a near surface zone of saturation within the north (westbound lane) embankment slope for short periods of time. However, this is not supported by the most recent piezometer data. The water levels recorded in the VWPs have been relatively steady (± 0.6 m) since the instruments were installed in 2017. It is possible that the reading frequency of the instruments (currently annually, previously bi-annually) does not capture short-term fluctuations (i.e., increases and decreases) in water level that are occurring in response to periods of heavy or prolonged rainfall or freshet infiltration. More frequent readings (i.e., installing a data logger) would be useful to assess how the groundwater responds to periods of heavy or prolonged rainfall.
