July 15, 2025

CON0022160 Central Region GRMP Instrumentation Monitoring
Site C043; H619:06, km 12.206 Soil Nail Site
Section C – 2025 Spring Readings

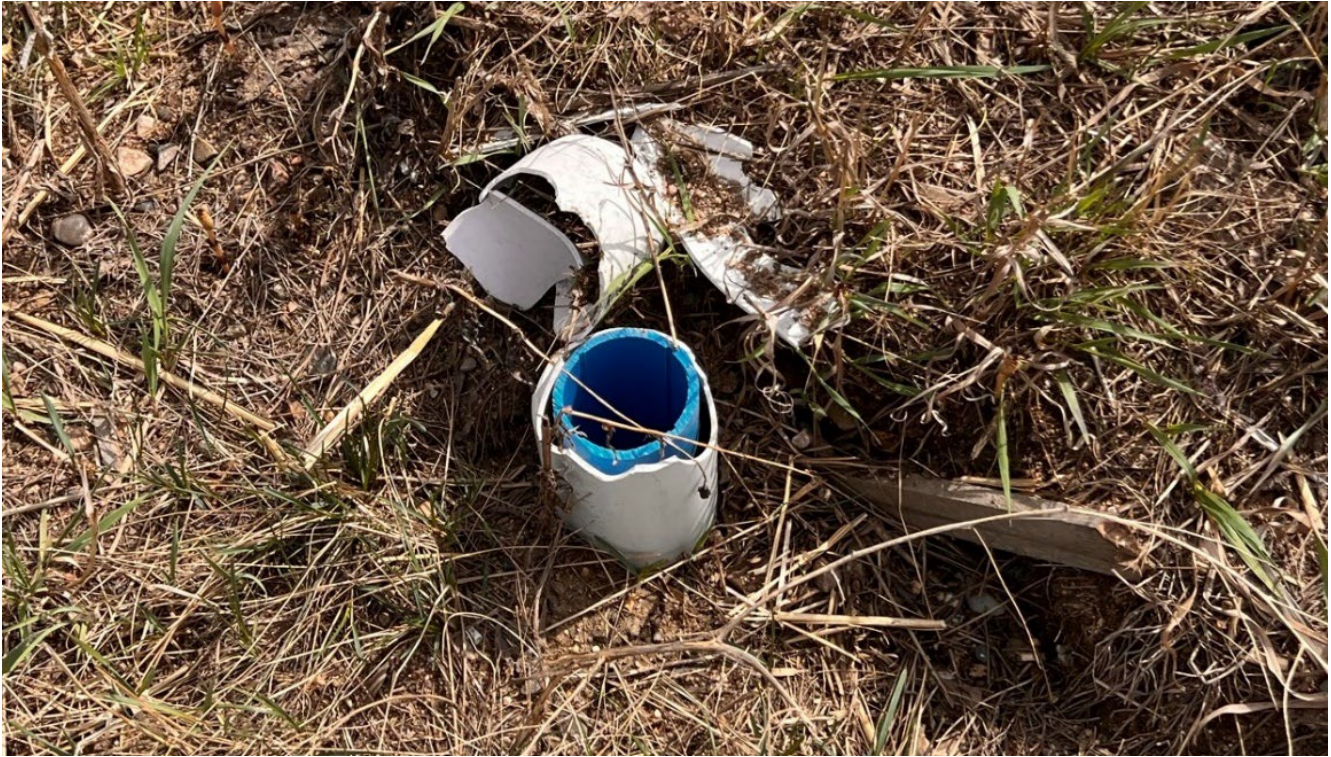
Between the 2022 and 2023 spring readings, the above-ground PVC casing protector for SI21-C43-01 was damaged (most likely damaged during snow clearing activities). A replacement casing protector should be installed.

Photo 1 Damaged PVC casing protector at SI21-C43-01. Photo taken May 8, 2023.

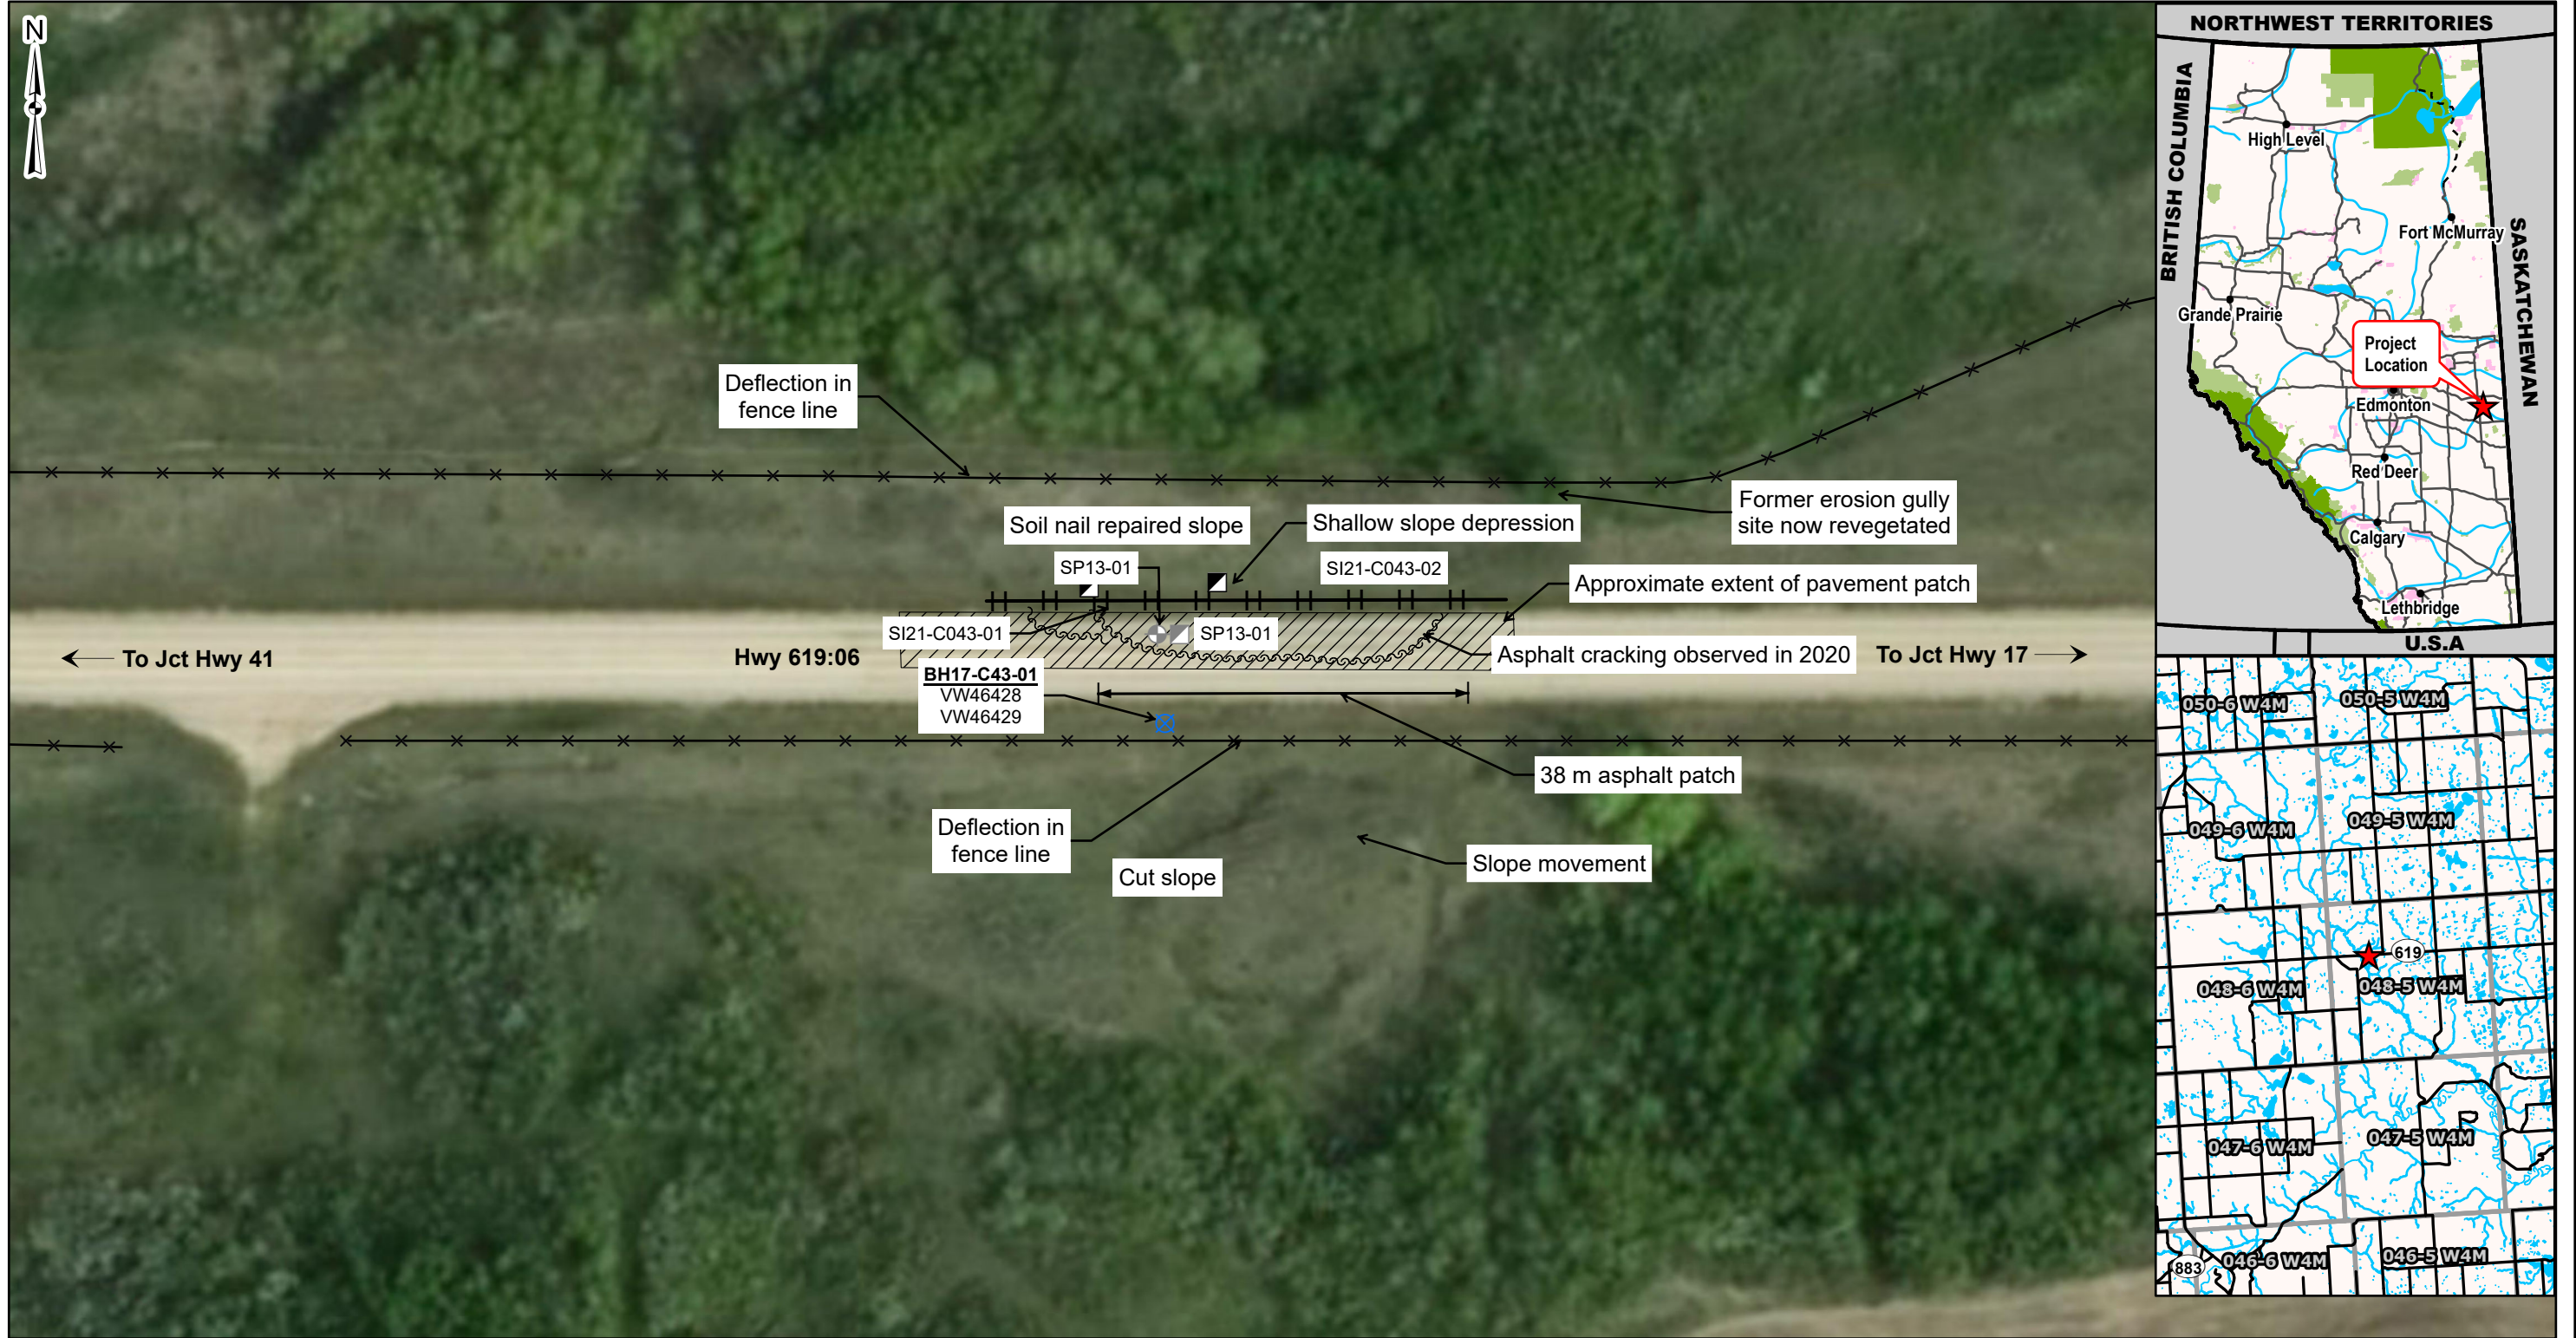
FIG No.
1

The geohazard at the C043 site consists of an embankment slope failure on the north side of Hwy 619:06 and a backslope failure on the south side of Hwy 619:06.

After installation of soil nails in 2016, the slope continued to deform slowly (as indicated by pavement cracking and settlement) with the site requiring regular pavement patches. Subsequently, the H-pile wall was installed in 2021.

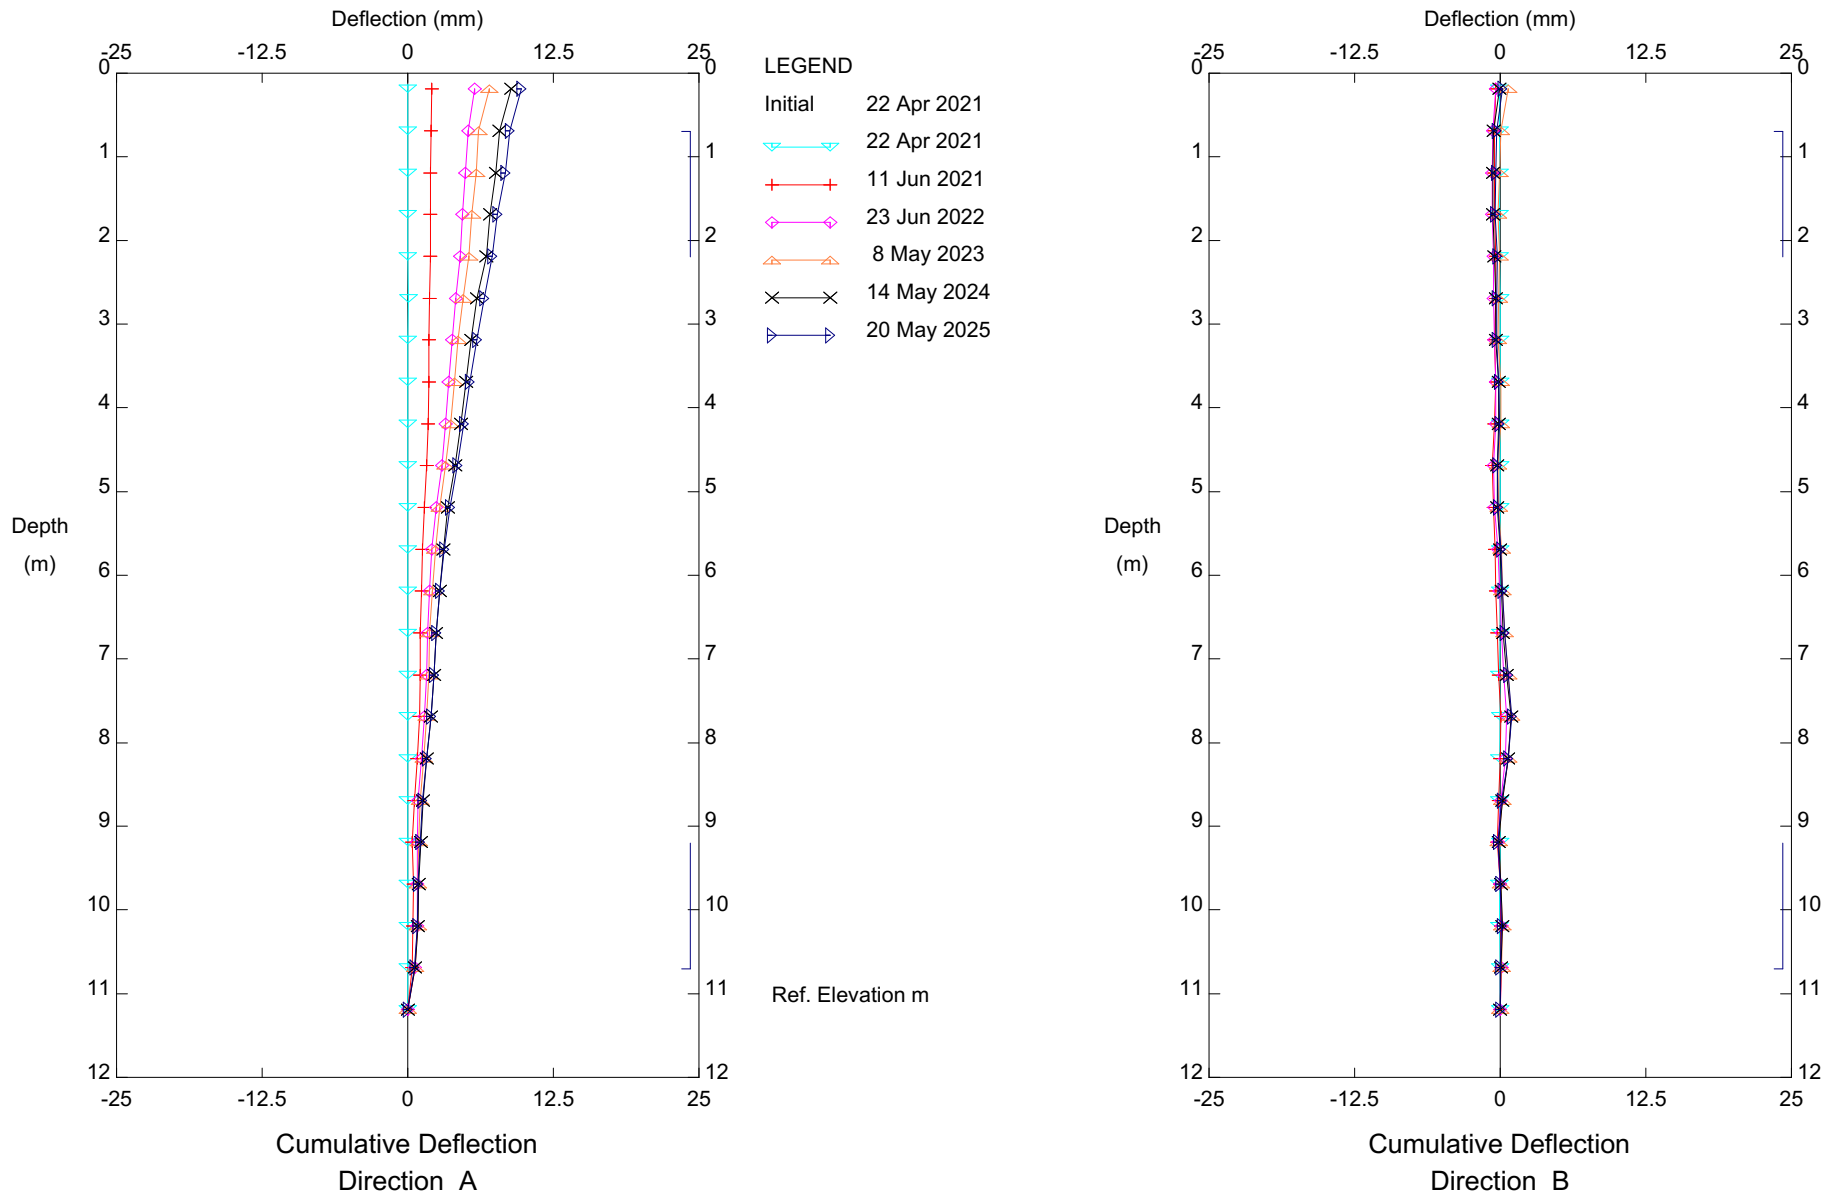
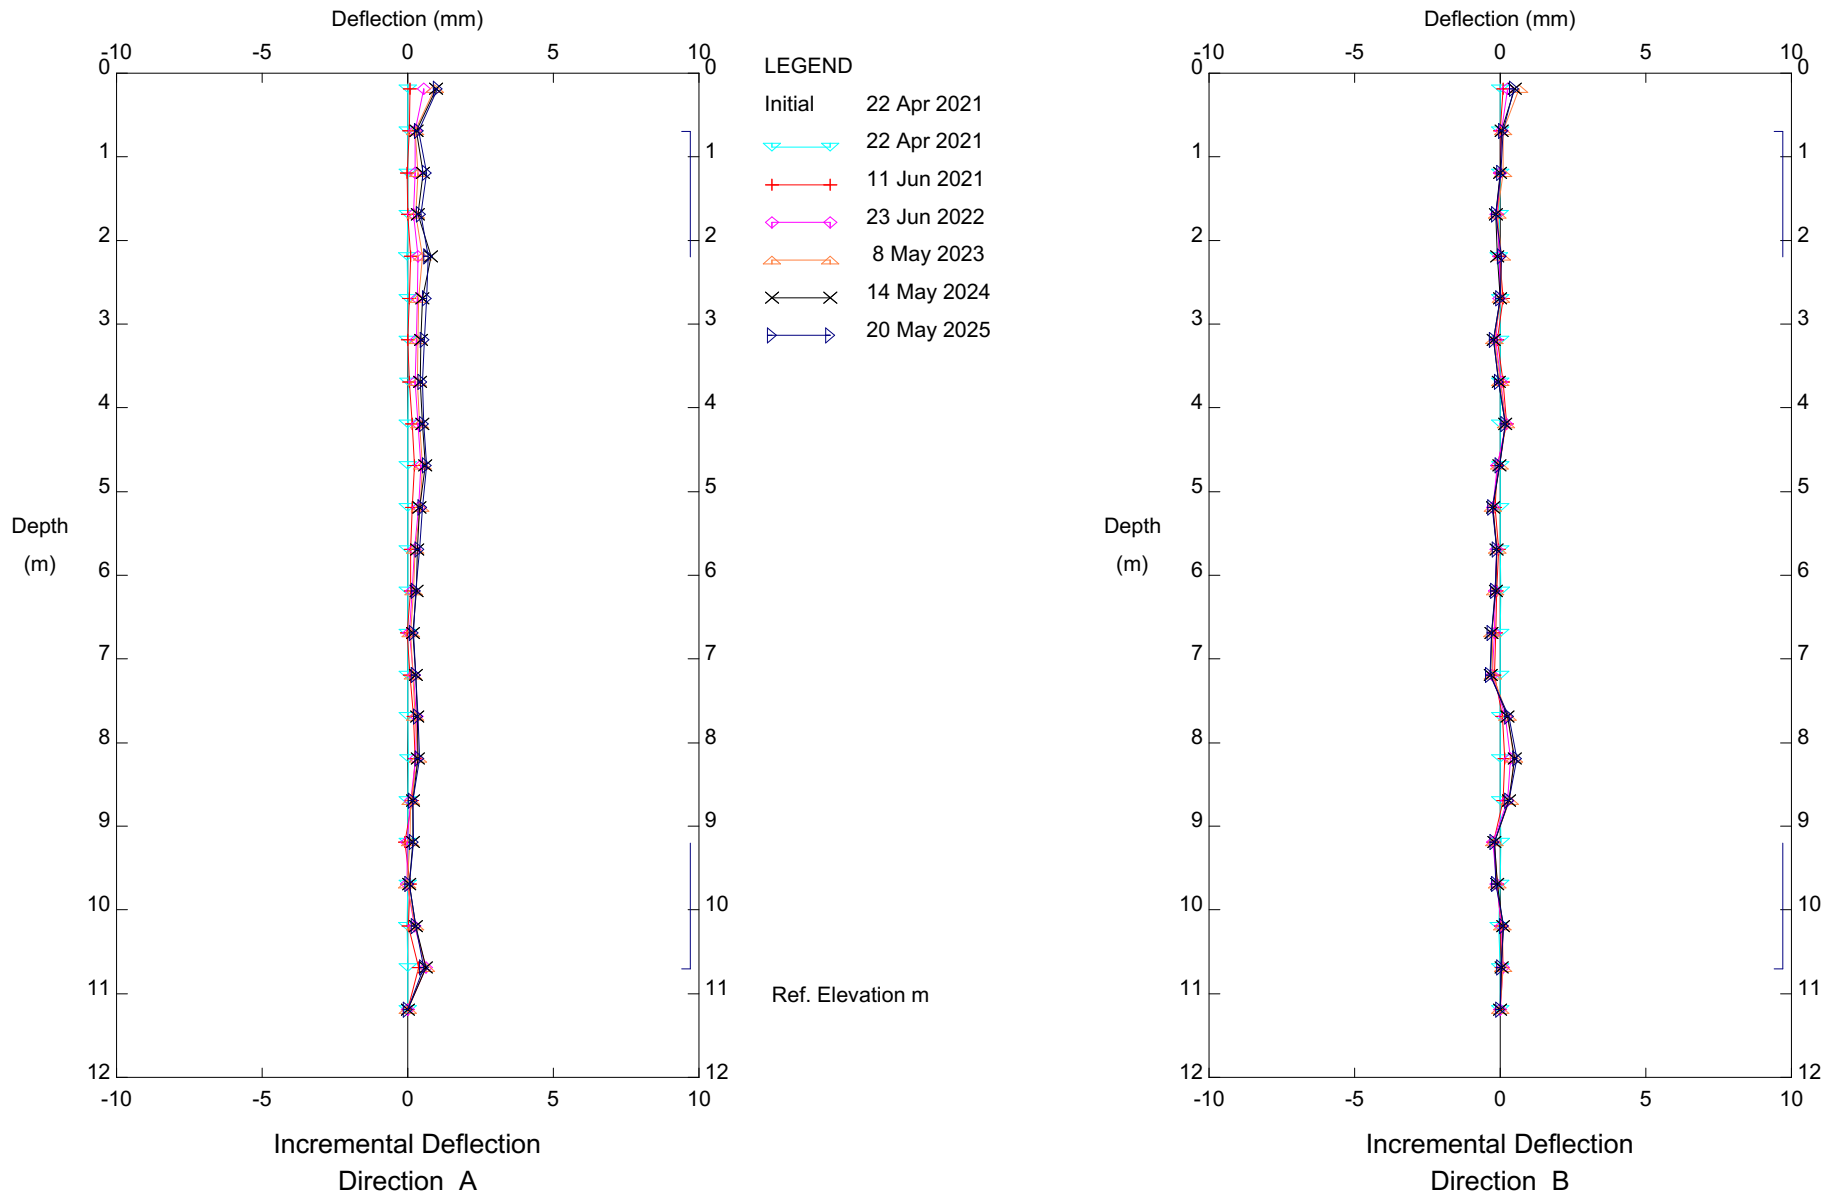
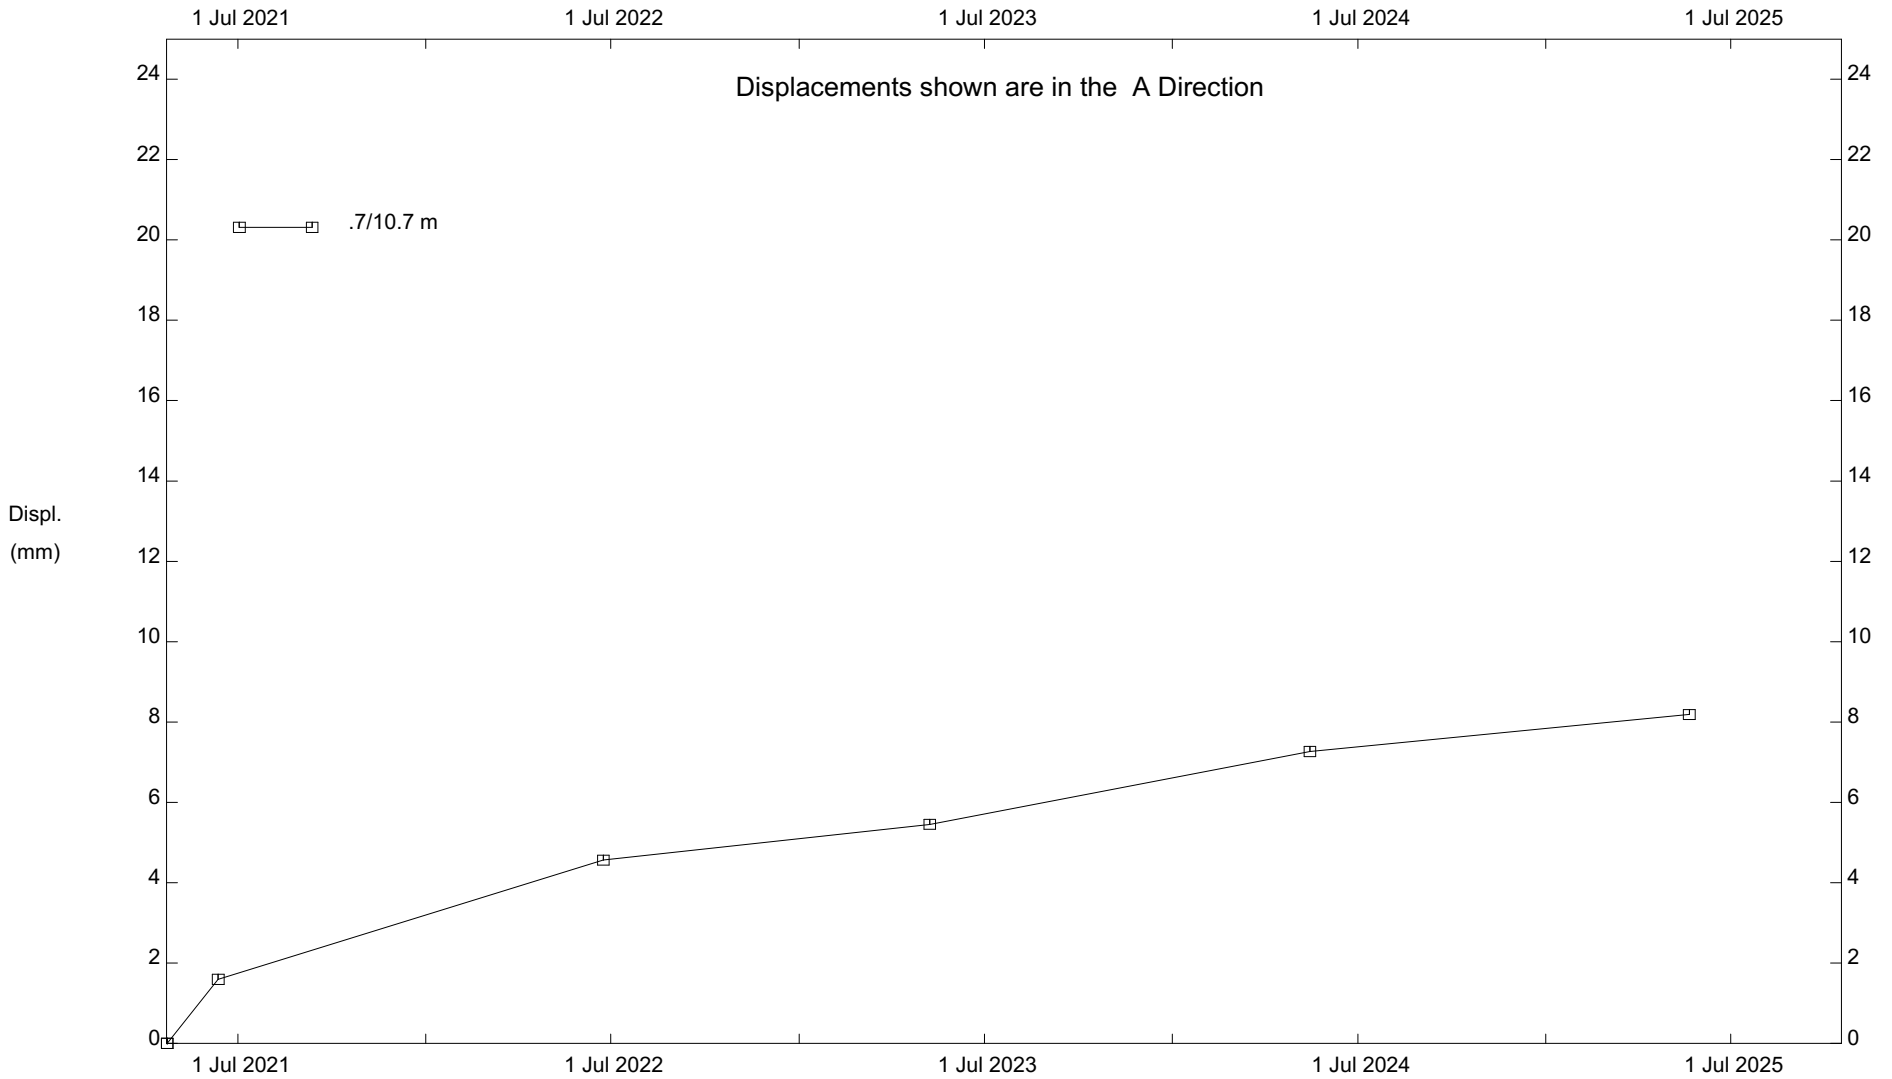
C043; H619:06; Soil Nail Site, Inclinator SI21-01
 Alberta Transportation

Distributed movement is being recorded in the SIs installed in the H-pile wall, SI21-C43-01 and SI21-C43-02, from top of casing to approximate depths of 11 m and 8 m below ground surface, respectively.

The distributed movement being recorded in SI21-C43-01 and SI21-C43-02 is from approximately ground surface to the base of the H-pile wall and from ground surface to 4 m above the base of the wall, respectively. The deflection recorded in SI21-C43-02 is approximately 2 m below the depth of movement recorded in SI13-01 before it was destroyed. Distributed movement along the length of the H-pile wall indicates that the failure surface has been intercepted, and is continuing to deflect, transferring load to depths below the failure plane as the piles stabilize the slide mass.

The May 2025 data obtained from the pile-wall SIs indicates that the top of the H-pile wall has deflected up to approximately 11 mm since installation. In the spring of 2021, shortly after construction of the H-pile wall, the maximum rate of movement recorded in these SIs was between approximately 6 mm/year and 12 mm/year. The rate of movement has since decreased and is now less than approximately 3 mm/year. KCB anticipated that the rate of movement shortly after installation would be highest and would decrease as the H-pile wall picked up load stabilizing the sliding mass.

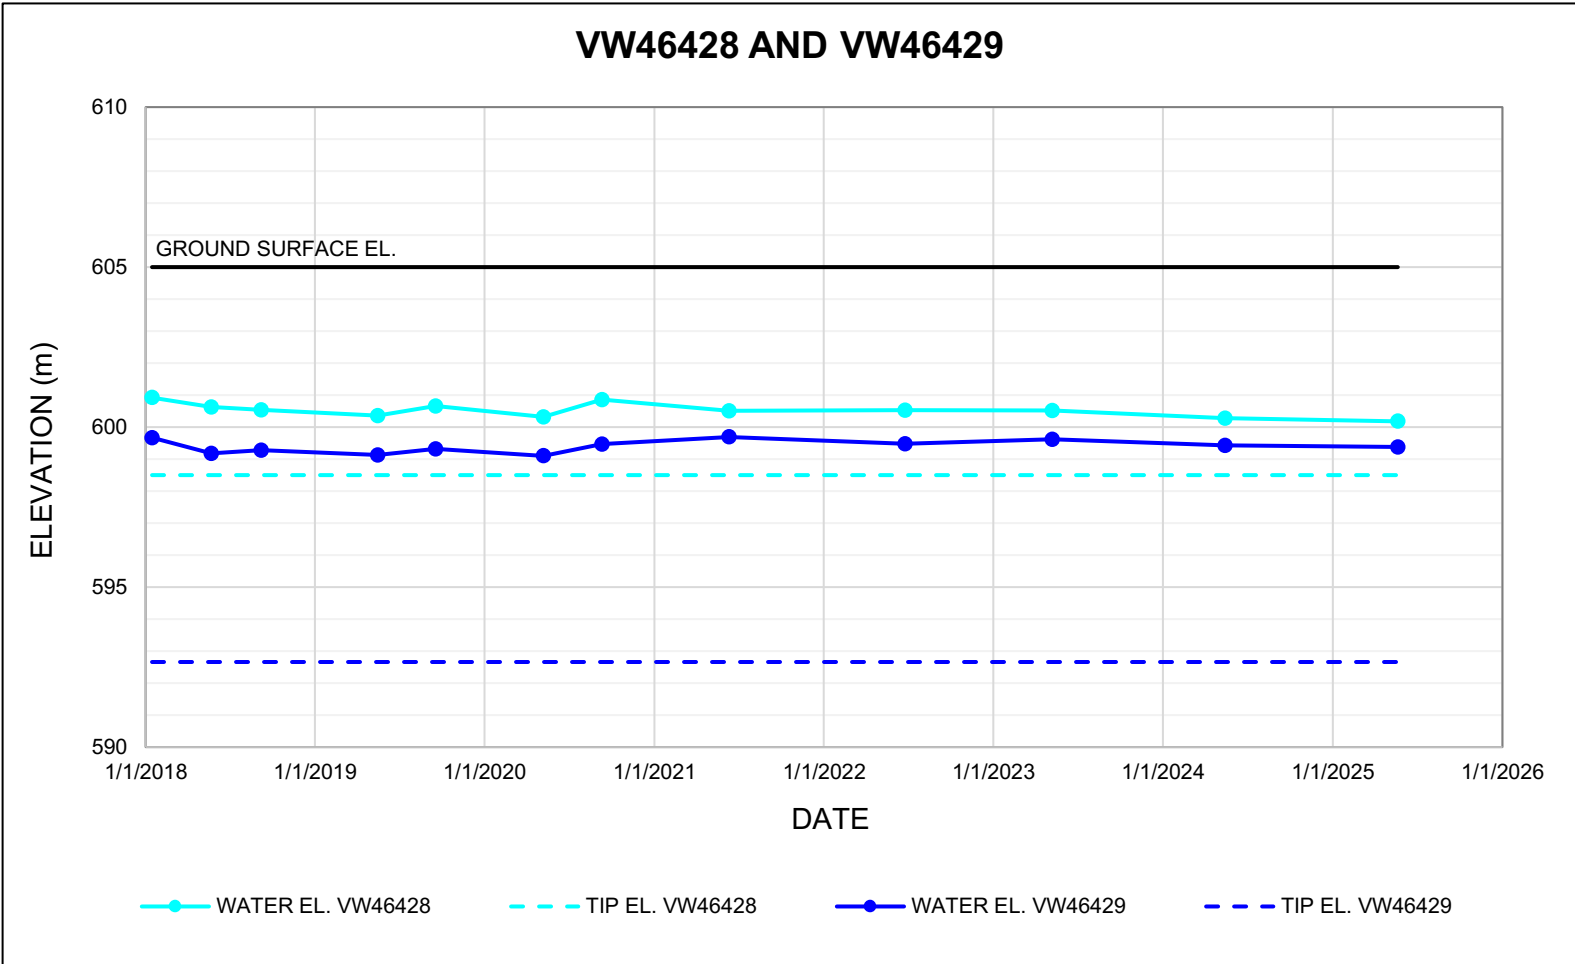
However, this is not supported by the most recent piezometer data. The water levels recorded in the VWPs have been relatively steady (± 0.6 m) since the instruments were installed in 2017. It is possible that the reading frequency of the instruments (currently annually, previously bi-annually) does not capture short-term fluctuations (i.e., increases and decreases) in the water level that are occurring in response to periods of heavy or prolonged rainfall or freshet infiltration. More frequent readings (i.e., installing a data logger) would be useful to assess how the groundwater responds to periods of heavy or prolonged rainfall.
