SITE NUMBER AND NAME: <b>C037 – I &amp; II Culverts</b>		HIGHWAY & KM: 734:12, 41.8 & 42.9	PREVIOUS INSPECTION DATE: June 23, 2016	INSPECTION DATE: <b>June 12, 2017</b>
LEGAL DESCRIPTION: 03-29-033-08 W5M	NAD 83 COORDINATES: UTM Northing Easting 11 5746497 630511		RISK ASSESSMENT: PF: 1 CF: 1 TOTAL: 1 PF: 1 CF: 1 TOTAL: 1	
AVERAGE ANNUAL DAILY TRAFFIC (AADT): 160 south (Reference No. 51280)			CONTRACT MAINTENANCE AREA (CMA): 18

NOTES: 1. HORIZONTAL DATUM: NAD83 2. GRID ZONE: UTM Zone 11N 3. IMAGE SOURCE: Bing Maps 2016, Microsoft Corporation. Image dated May 2013	CLIENT 	PROJECT CENTRAL REGION GEOHAZARD RISK MANAGEMENT PROGRAM
		TITLE Site Plan C037-I Culverts Hwy 734:12, km 41.8
SCALE 1:800	PROJECT No. A05115A02	FIG No. 1

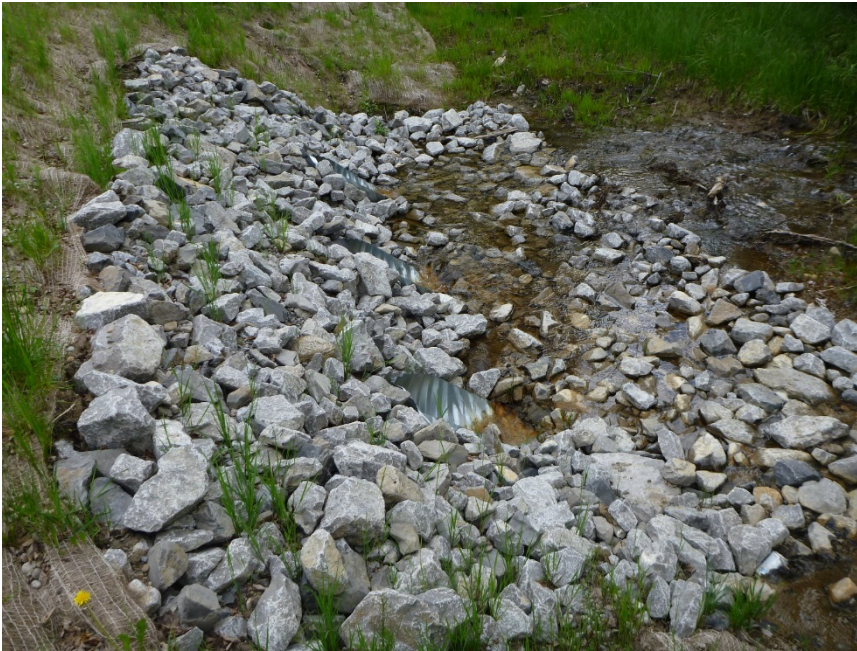
**Photo 1** The inlet of the 600-mm culverts that were installed at the C037 – I site in June 2016. Vegetation is growing through the erosion control cloth that was placed around the culverts in June 2016. Photo taken June 12, 2017 looking southwest.

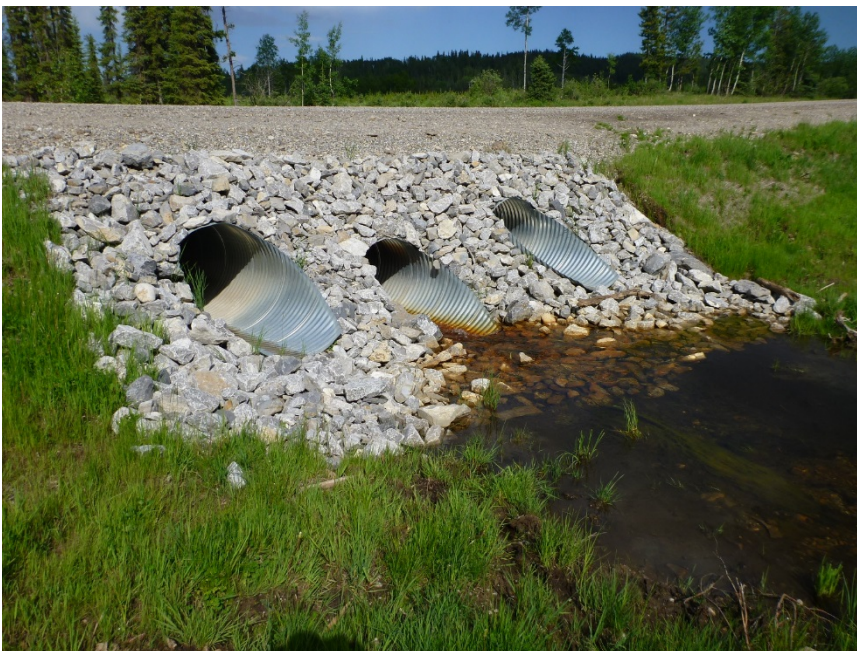
**Photo 2** The inlet of the 1000-mm culverts (BF83184) that were installed at the C037 – II site in June 2016. Vegetation is growing through erosion control cloth that was placed around the culverts in June 2016. Photo taken June 12, 2017 looking northeast.
