SITE NUMBER AND NAME: C037 – I & II Culverts		HIGHWAY & KM: 734:12, 41.8 & 42.9	PREVIOUS INSPECTION DATE: June 12, 2017	INSPECTION DATE: July 9, 2019
LEGAL DESCRIPTION: 03-29-033-08 W5M	NAD 83 COORDINATES: UTM Northing Easting C037-I: 11 5746497 630511 C037-II: 11 5747521 630427		RISK ASSESSMENT: PF: 1 CF: 1 TOTAL: 1 PF: 1 CF: 1 TOTAL: 1	
AVERAGE ANNUAL DAILY TRAFFIC (AADT): 160 south (Reference No. 51280)			CONTRACT MAINTENANCE AREA (CMA): 18

PROJECT
 CENTRAL REGION GEOHAZARD RISK MANAGEMENT PROGRAM

TITLE
 Site Plan
 C037-I
 Hwy 734:12, km 41.800

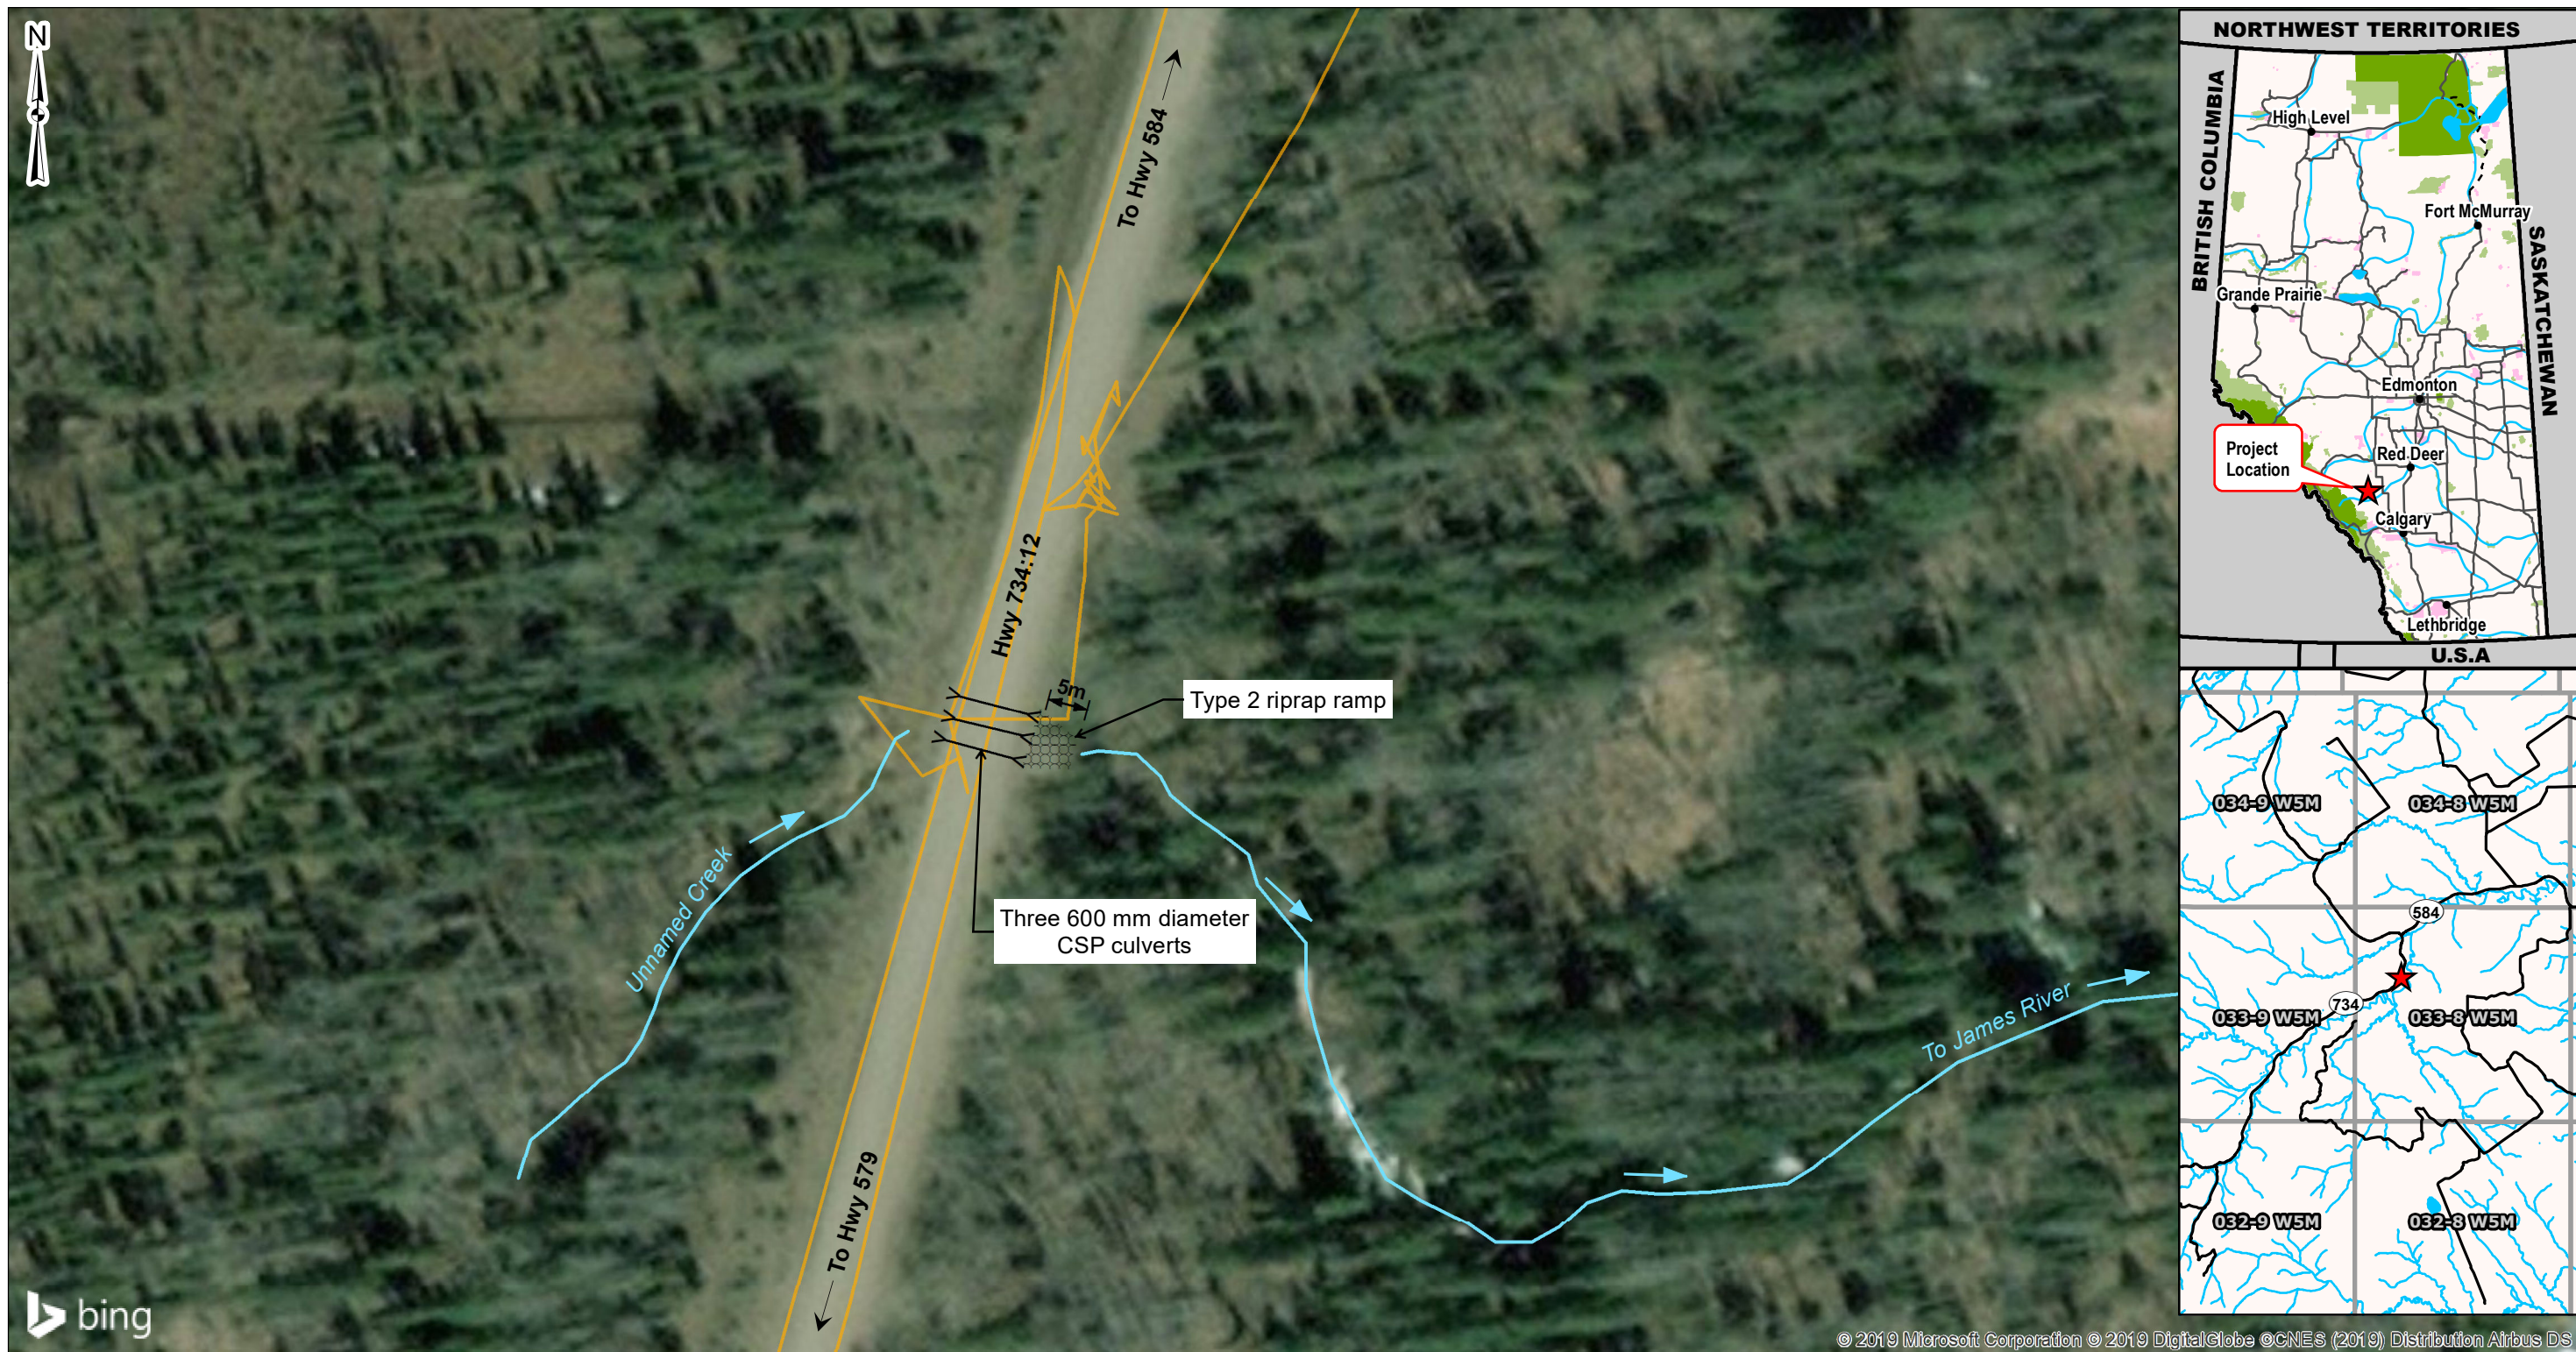
SCALE: 1:800 PROJECT No. A05115A02 FIG No. 1

COMMENTS
At the C037 – I site, some undersized Class 2 riprap was placed at the culvert outlets. The MCI should monitor the culvert outlets for erosion after future flood events. Large riprap that was placed during a previous repair and removed during the 2016 repair and placed along the flanks of the riprap ramp, can be placed around the culvert outlets to repair erosion, as needed.
An old timber crib culvert was discovered at the C037-I site during construction in 2016. The timber culvert was excavated and replaced with coarse rockfill (gabion basket backfill) and covered with woven geotextile before the culverts were placed.
Prior to repair work being completed in 2016, the original highway geometry at the C037-II site had a steep super elevation. To eliminate some of the super elevation, additional gravel was added to the repair work contract, after the site was inspected during the 2016 GRMP tour. Grading since 2016 re-established the super elevation that existed before construction.

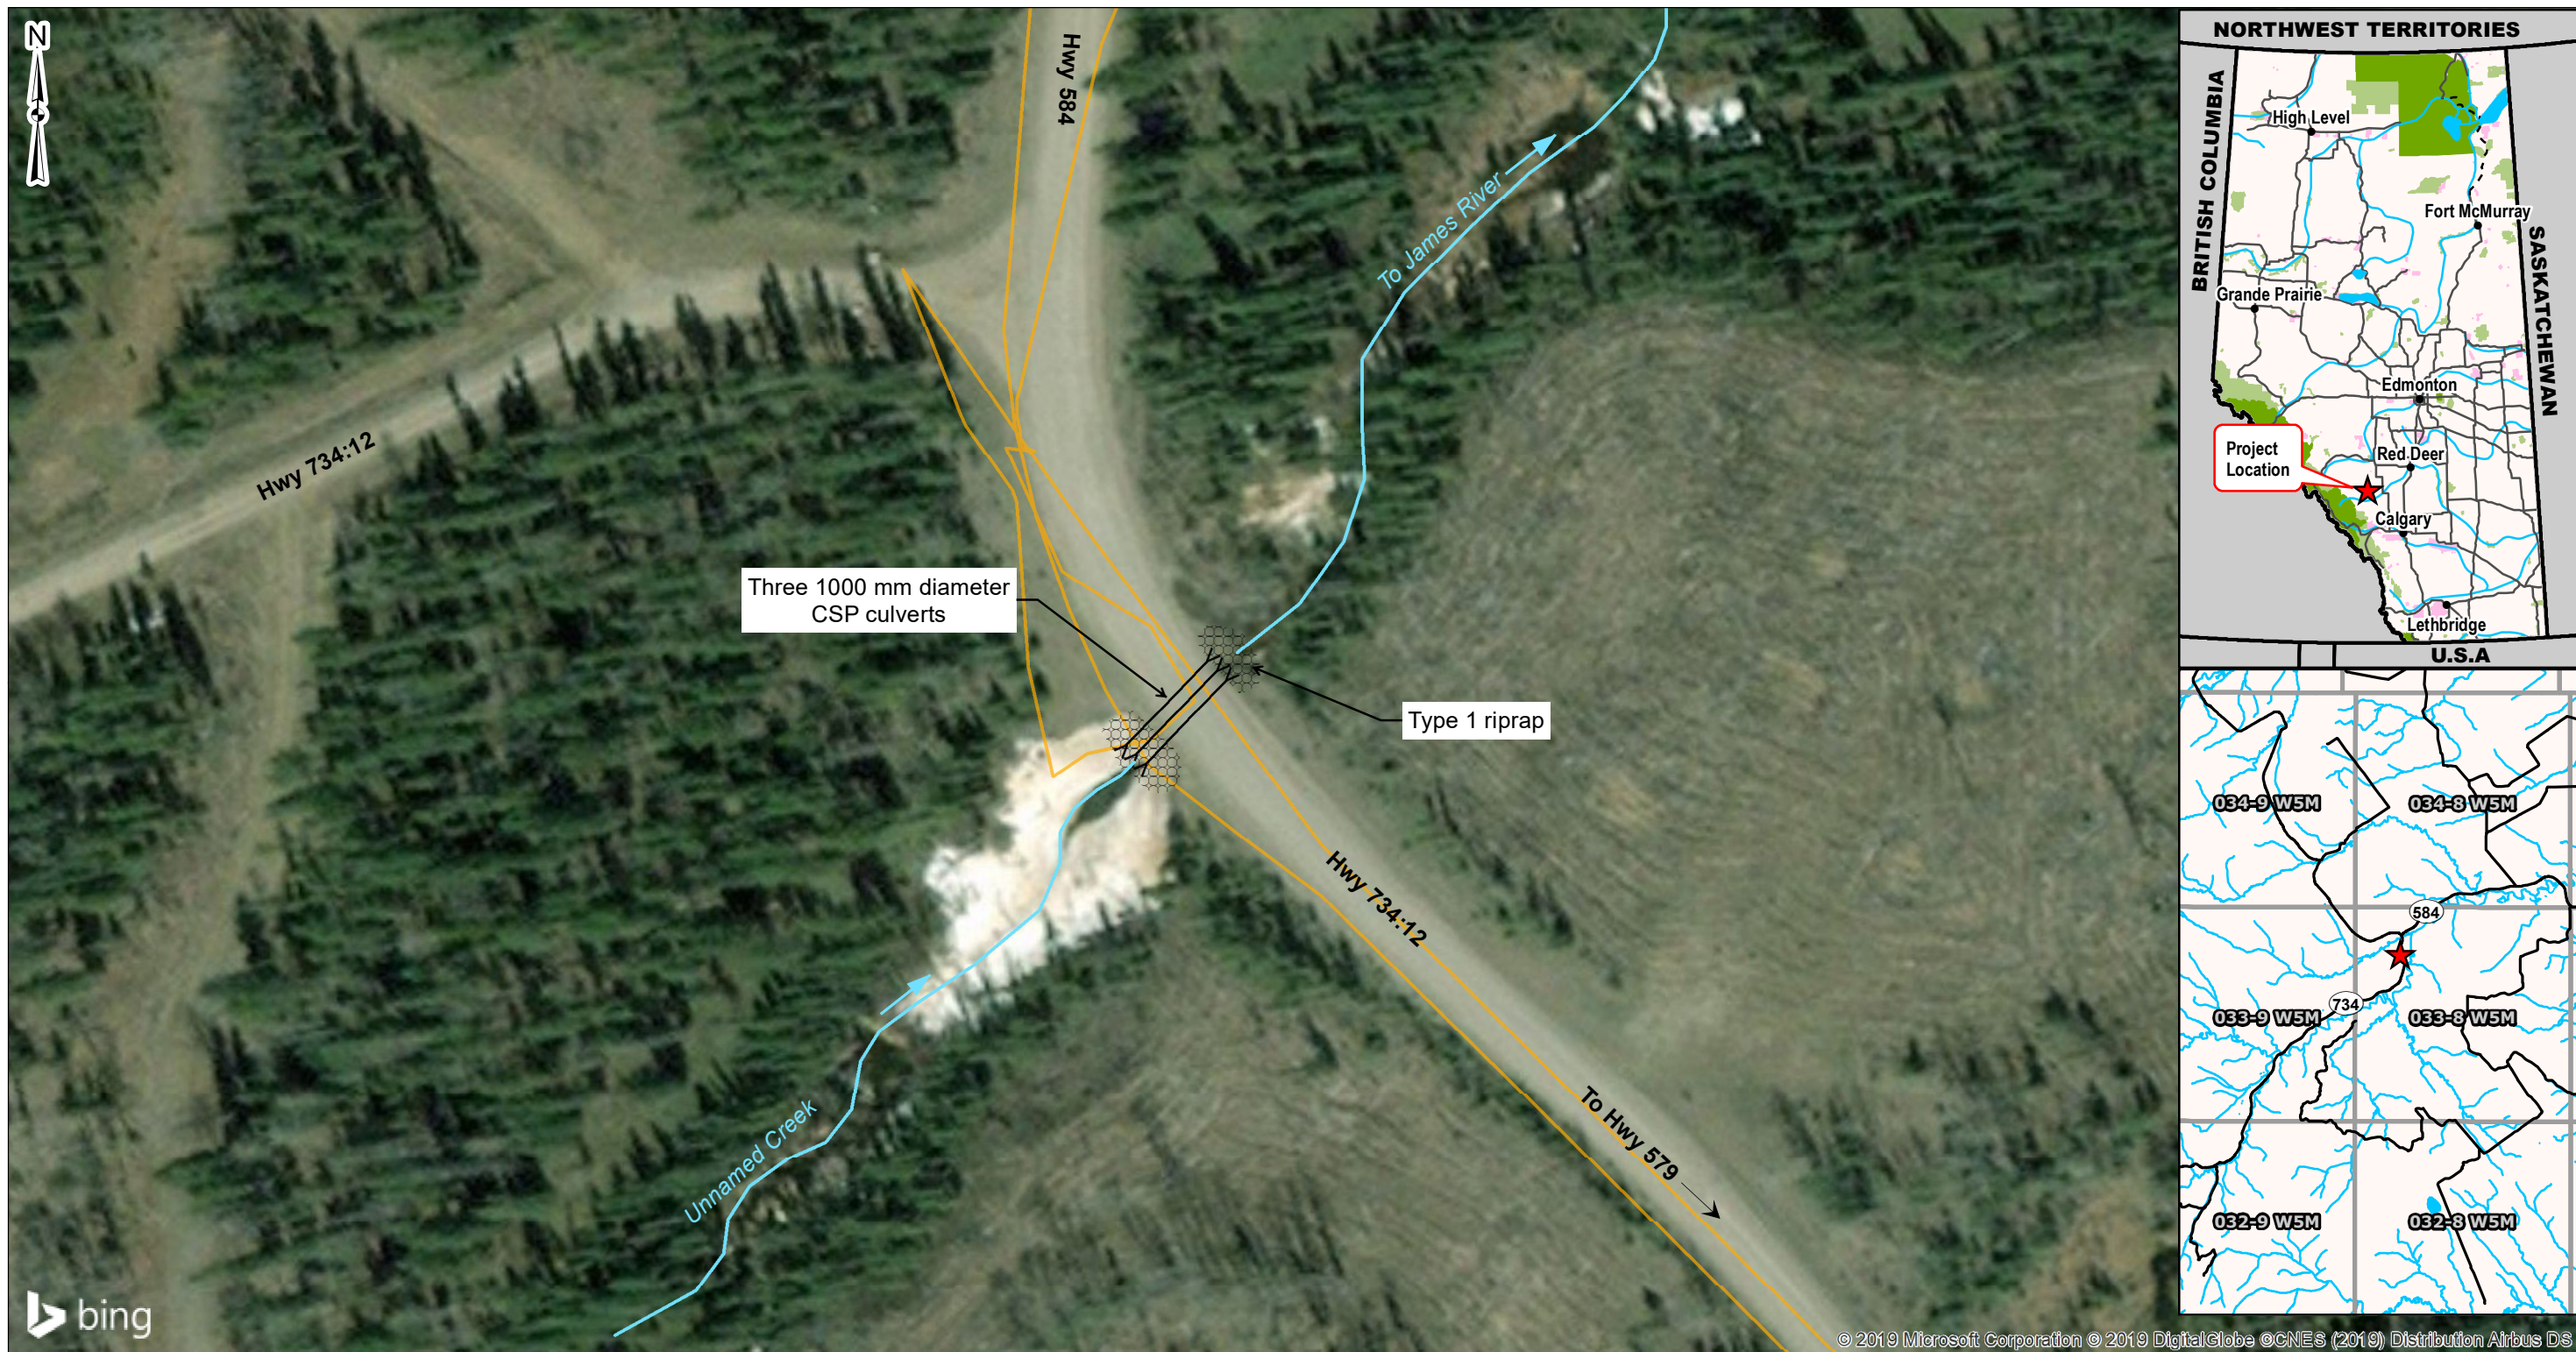
NOTES: 1. HORIZONTAL DATUM: NAD83 2. GRID ZONE: UTM Zone 11N 3. IMAGE SOURCE: Bing Maps, Microsoft Corporation 2019	CLIENT 	PROJECT CENTRAL REGION GEOHAZARD RISK MANAGEMENT PROGRAM
		TITLE Site Plan C037-II Hwy 734:12, km 42.900
	SCALE 1:1,000	PROJECT No. A05115A02
		FIG No. 2

The quantity and diameter of culverts installed at the C037 – II site resulted in the site becoming a bridge file (BF83184).
The C037 sites are recommended for removal from the GRMP.

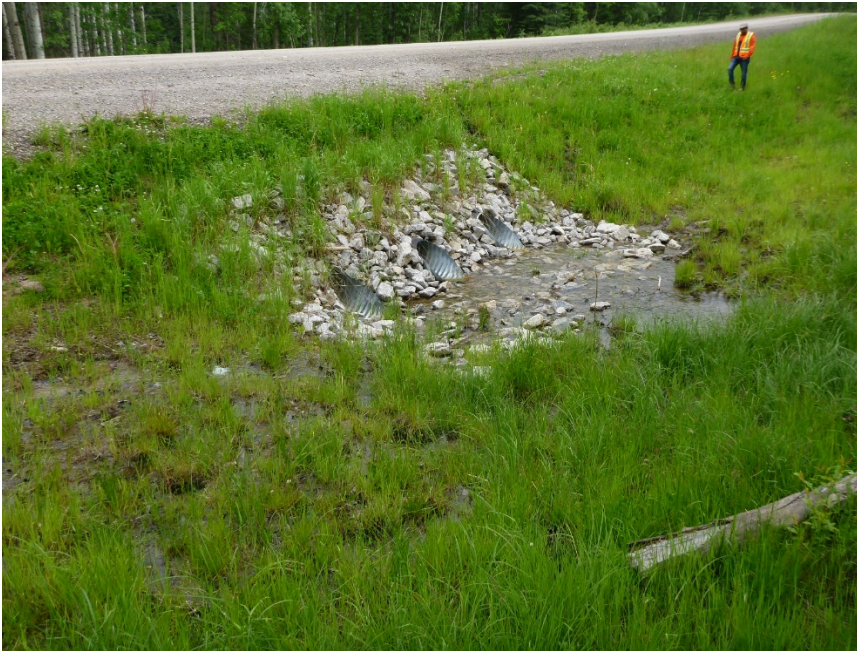
Photo 1 Condition of inlet for 600 mm culverts at the C037-I site. Grass is growing up through the riprap placed around culverts. Photo taken July 9, 2019 looking southeast.

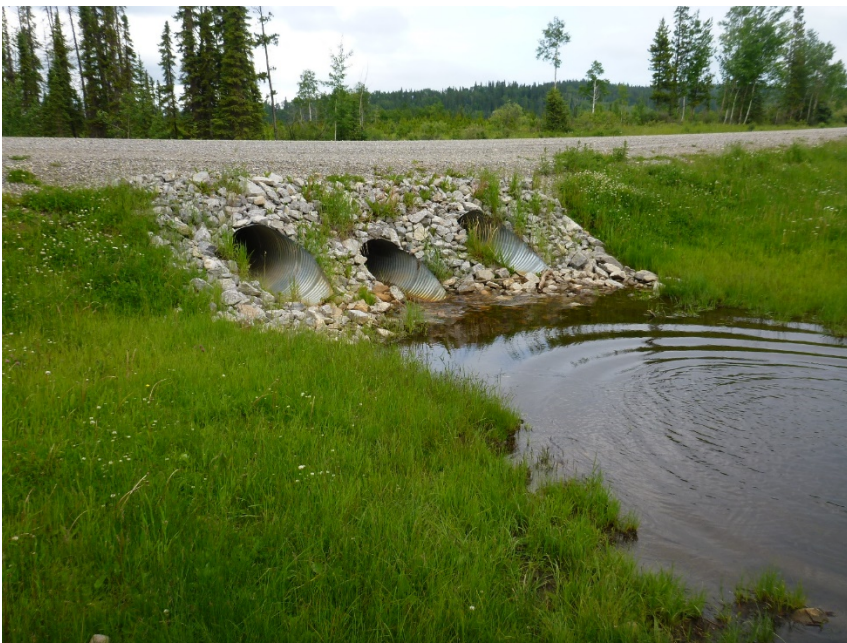
Photo 2 The inlet of the 1000-mm culverts (BF83184) installed at the C037 – II site . Vegetation is growing through riprap placed around culverts. Photo taken July 9, 2019 looking northeast.

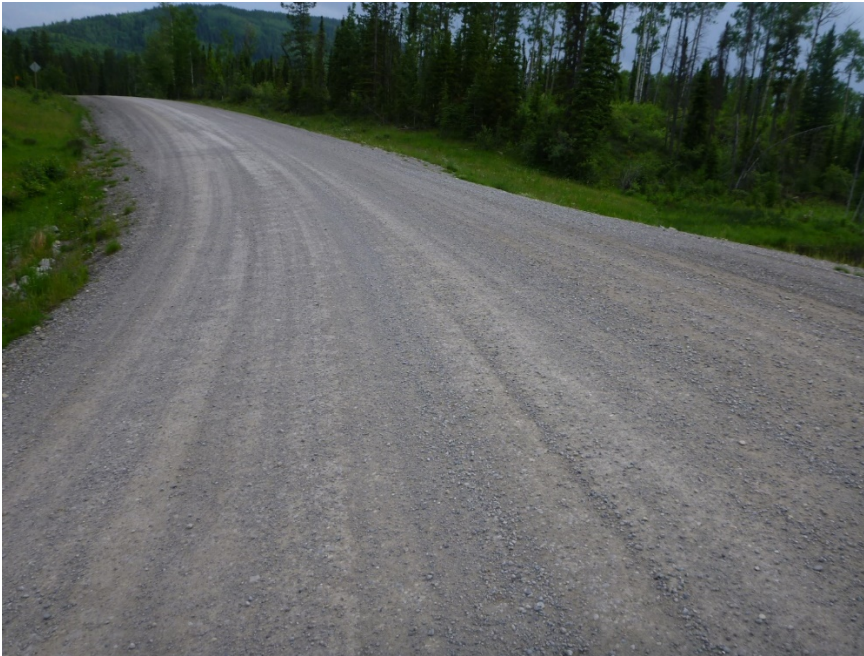
Photo 3 Super elevation reestablished in roadway at C037-II from grading operations since repair was completed in 2016. Photo taken July 9, 2019 looking south.
