SITE NUMBER AND NAME: <b>C071 Black Snake Slide</b>		HIGHWAY & KM: 836:04, 15.016	PREVIOUS INSPECTION DATE: June 13 & 14, 2017 (callout)	INSPECTION DATE: <b>June 13, 2018</b>
LEGAL DESCRIPTION: 04-09-031-22 W4M	NAD 83 COORDINATES: UTM Northing Easting 12 5722769 356353		RISK ASSESSMENT: PF: 8 CF: 4 TOTAL: 32	
AVERAGE ANNUAL DAILY TRAFFIC (AADT): 120 (north) & 190 (south) (Ref No. 105240 & 105250)			CONTRACT MAINTENANCE AREA (CMA): 21

PROJECT  
CENTRAL REGION GEOHAZARD RISK MANAGEMENT PROGRAM

TITLE  
Site Plan  
C071 - Black Snake Slide  
Hwy 836:04, km 15.016

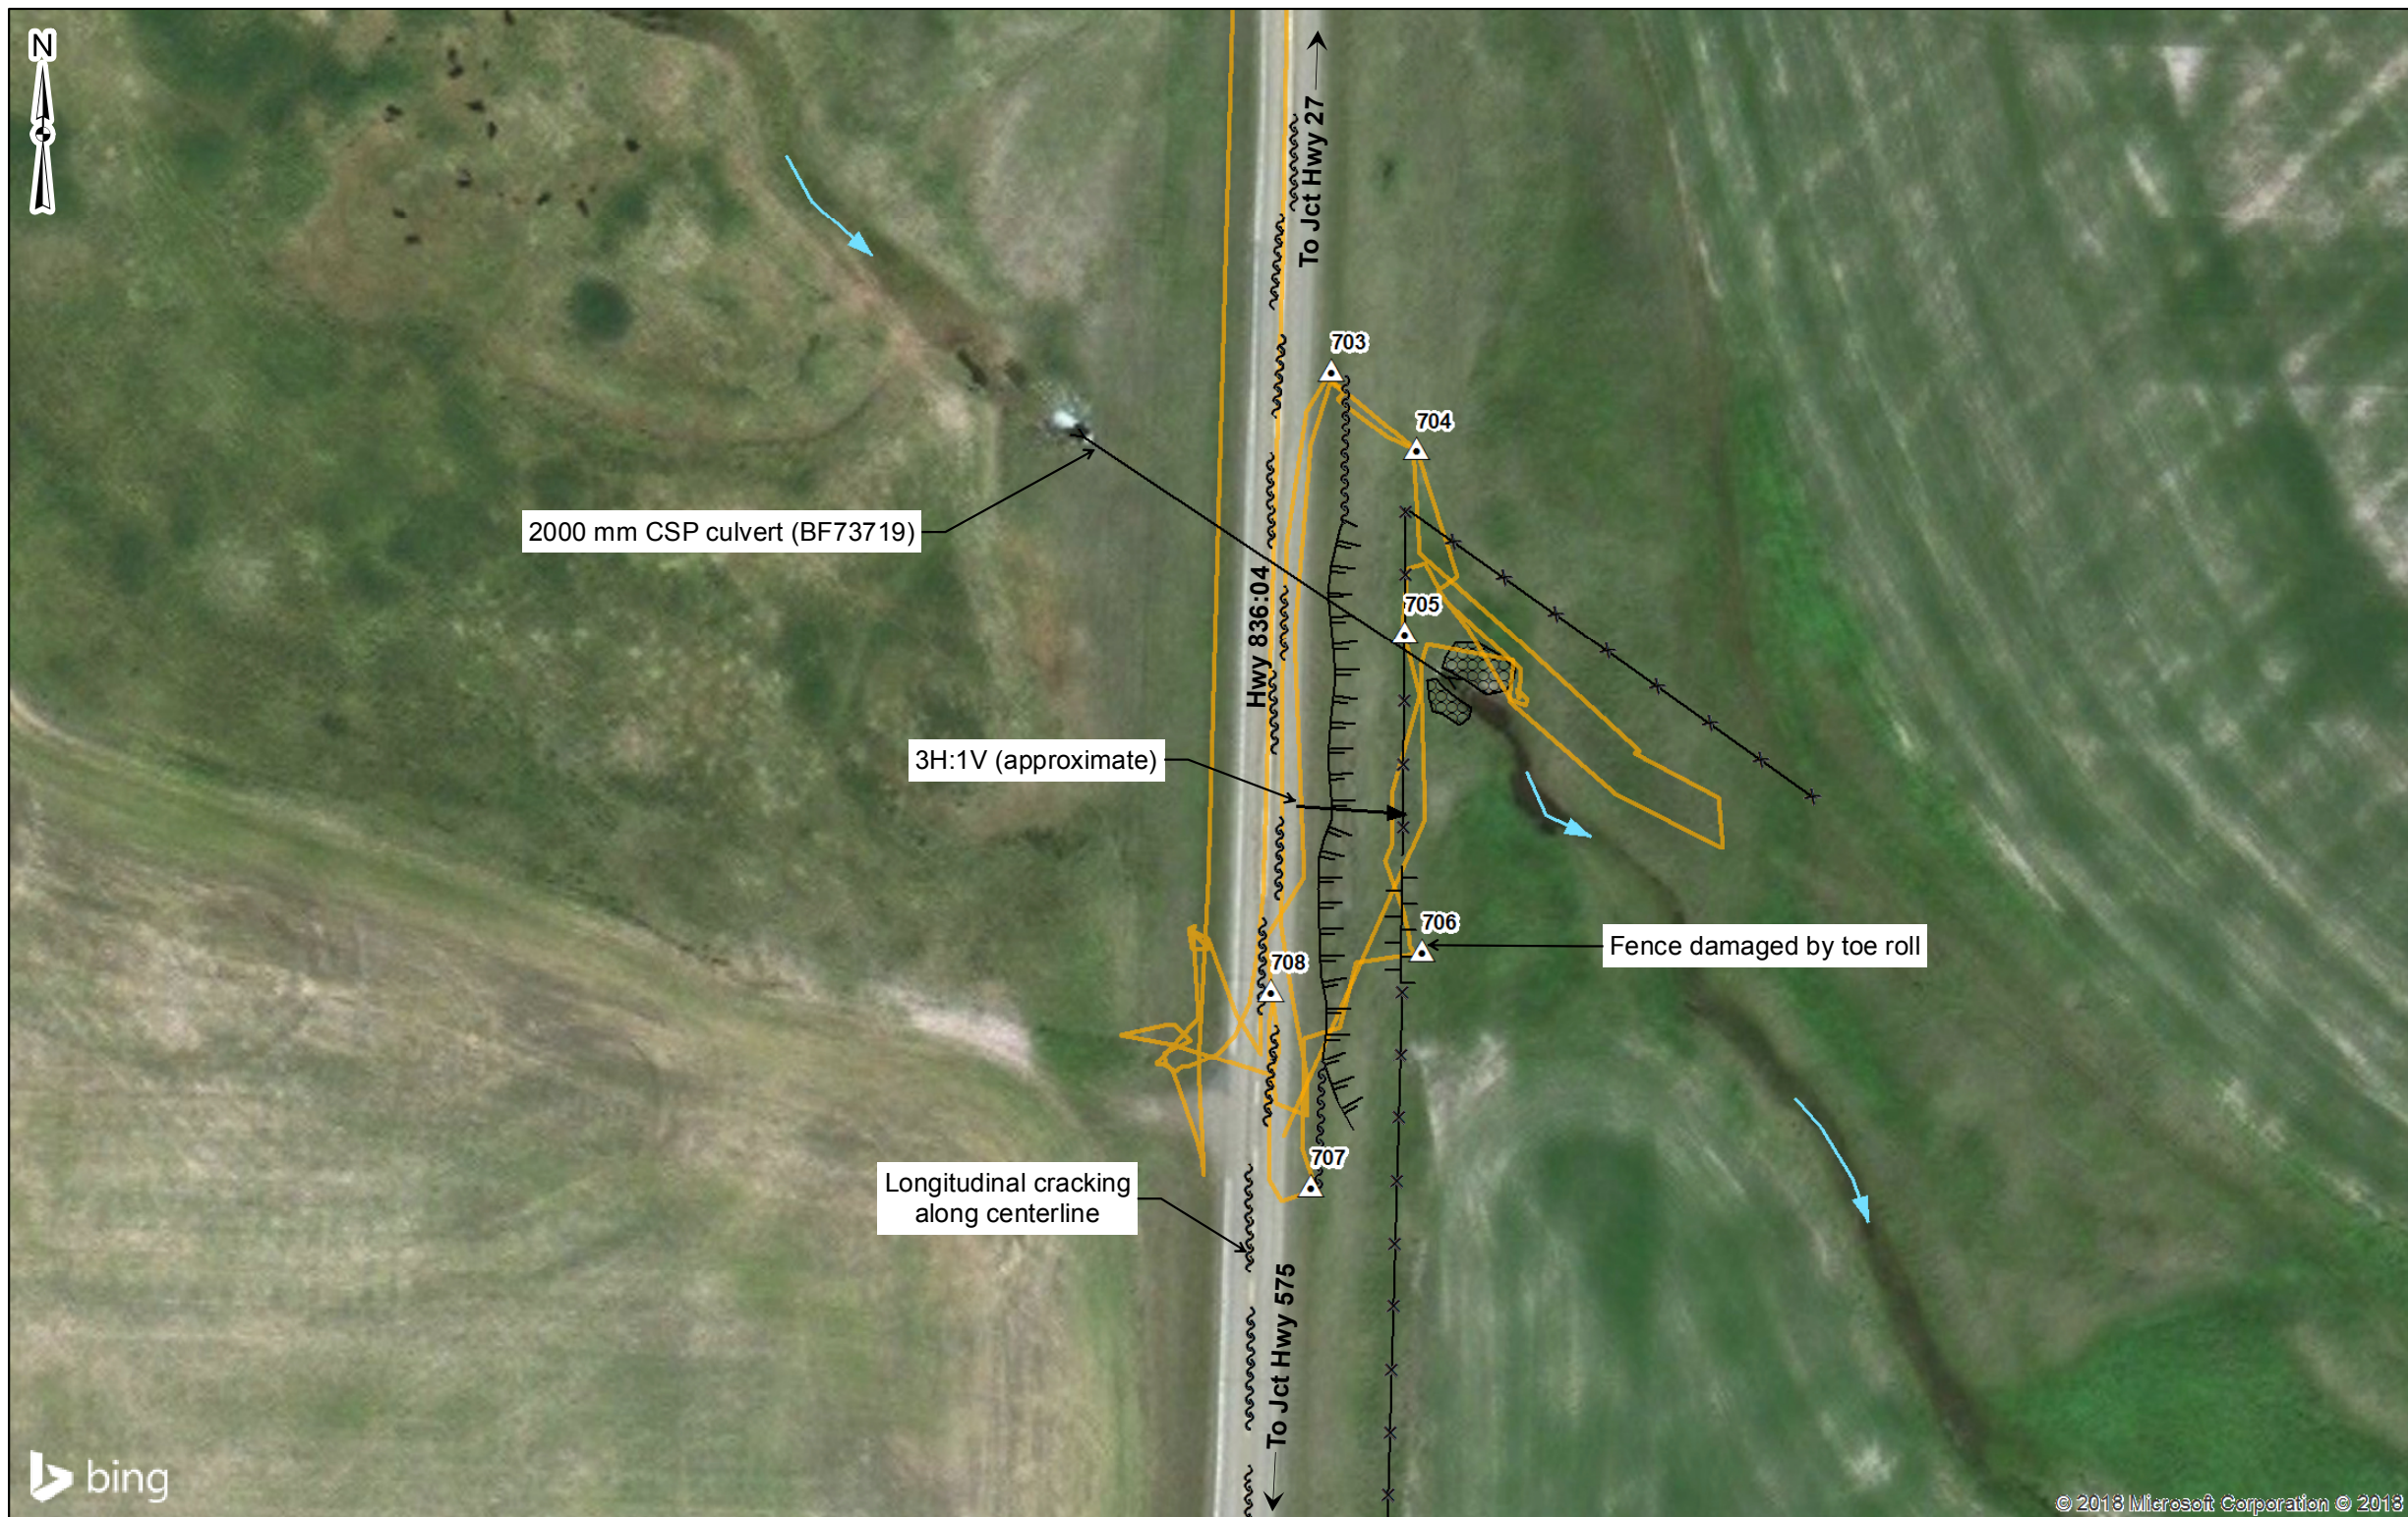
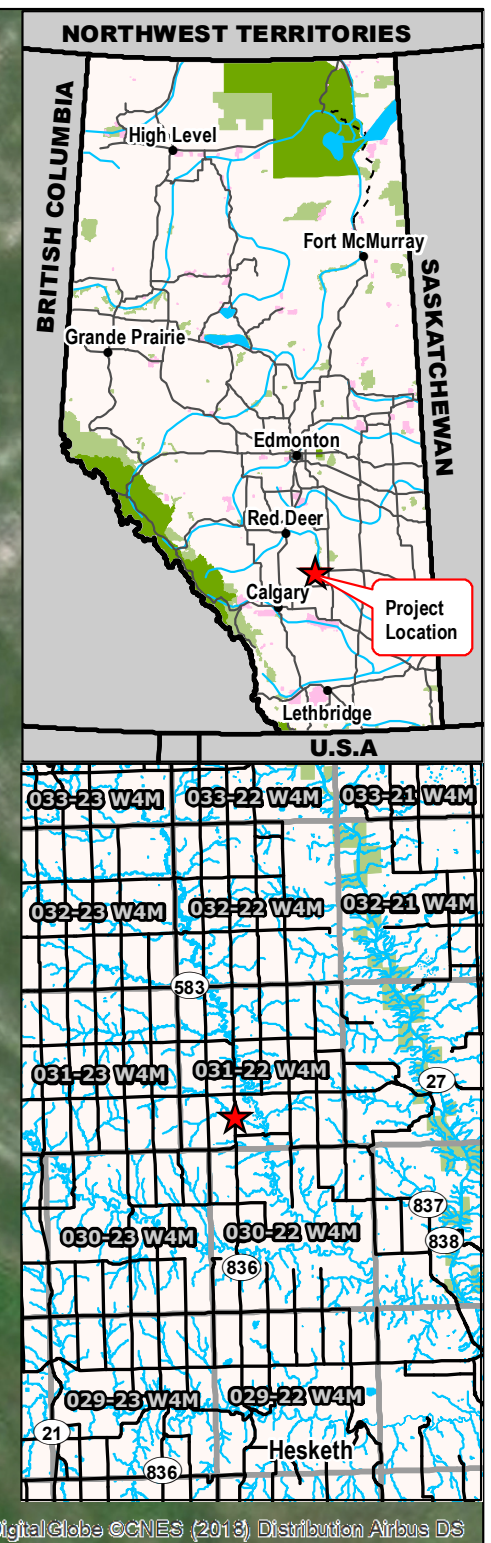
SCALE: 1:1,000    PROJECT No. A05115A02    FIG No. 1

<b>COMMENTS</b>
Since the 2017 inspection, the slide has retrogressed to 1 m from the edge of pavement.
The head of the slide has extended to the north (waypoint 703) and to the south (waypoint 707) with ground cracks behind the head scarp. The height of the backscarp is 1-2 m.
The toe of the slide remains above the crown of the CSP culvert (BF73719, waypoint 705) which appears to be in good condition with no deflection at the crown. Toe roll of the slide has extended past the fence line by approximately 3 m (waypoint 707).
Repair of the site is expected to be completed in Fall 2018 as part of the works included in the Alberta Transportation Tender TND0019153. The repair will involve excavating the failed slope and backfilling with geosynthetic reinforced gravel fill with a shear key.

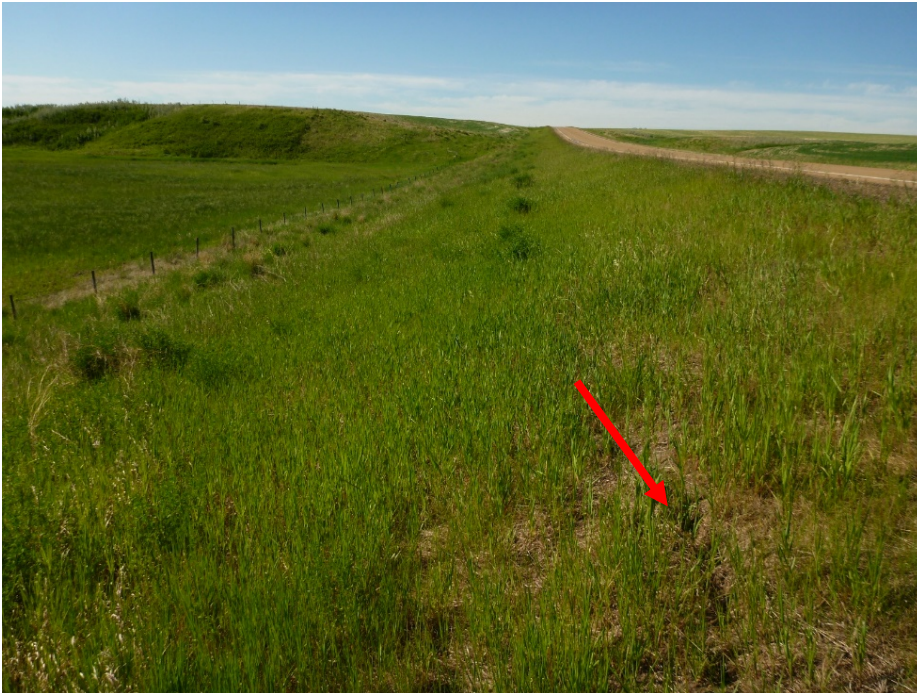
**Photo 1** Evidence of ground cracking extending to the south from the original slide area as indicated by the red arrow (waypoint 707). Photo taken June 13, 2018 looking south.

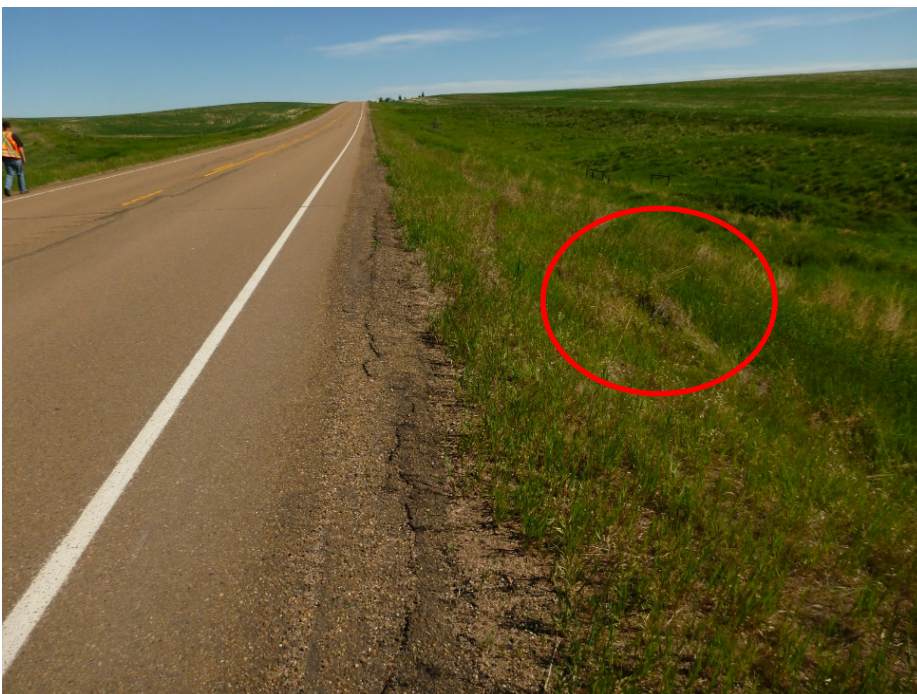
**Photo 2** Photo showing evidence of ground cracking extending to the north as indicated by the red circle (waypoint 703) of the backscarp (1-2m) Photo taken June 13, 2018 looking north.

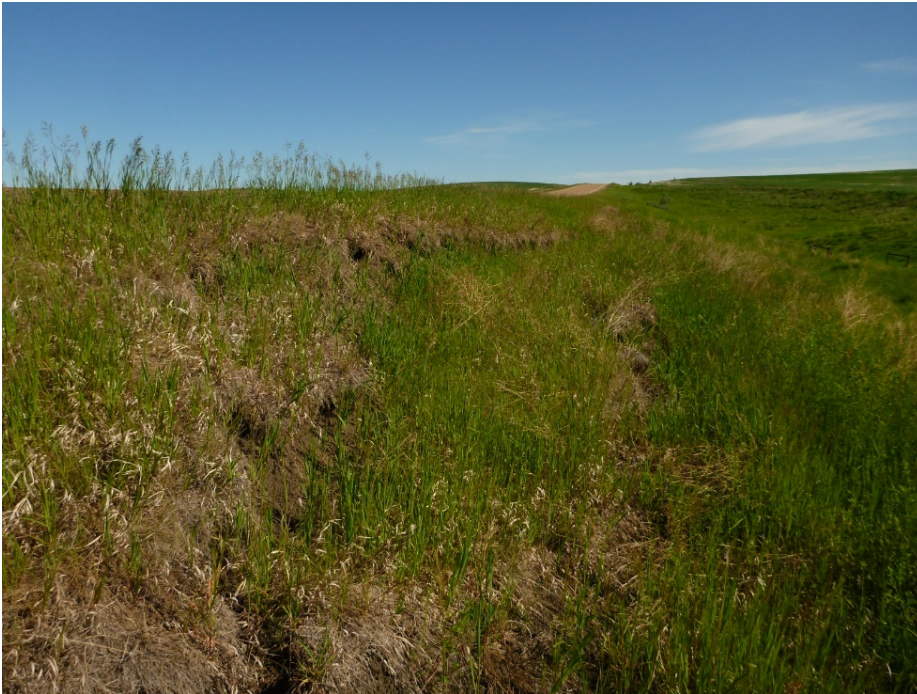
**Photo 3** Photo showing the height of the backscarp (1-2m) Photo taken June 13, 2018 looking north.

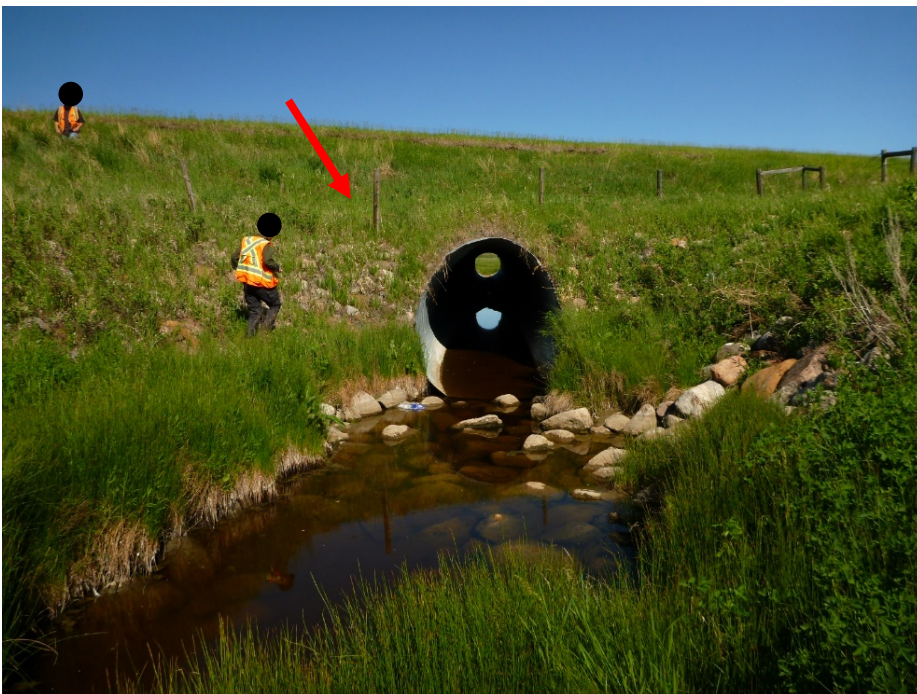
**Photo 4** Culvert (BF73719) at the toe of the slide appears to be in good condition. Toe roll of the slide remains above the crown of the culvert as indicated by the red arrow (waypoint 705). Photo taken June 13, 2018 looking northeast.

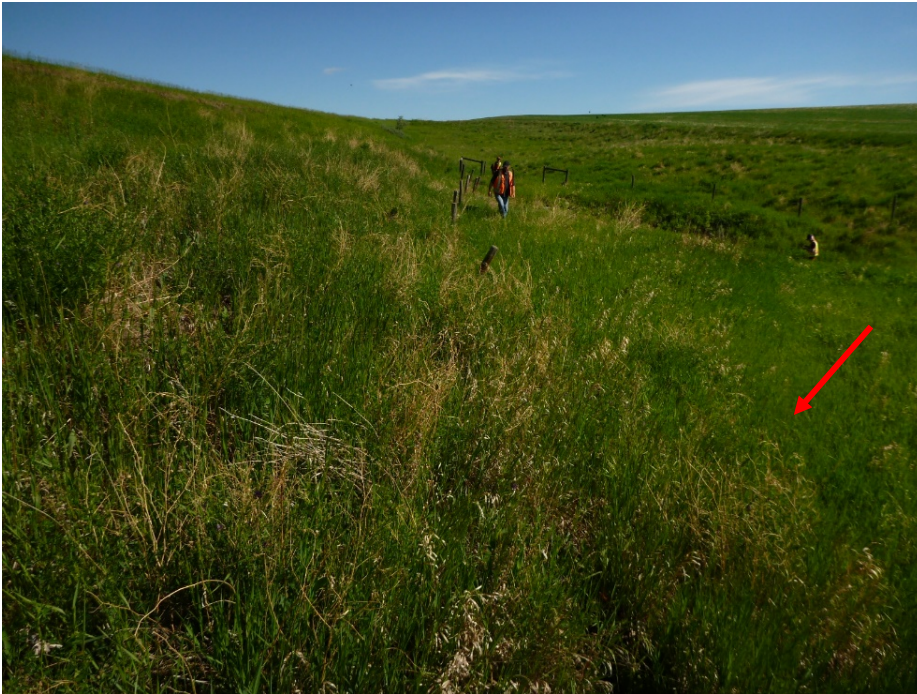
**Photo 5** Area where the toe roll has extended beyond the fence line by approximately 3 m as indicated by the red arrow. Photo taken June 13, 2018 looking north.
