SITE NUMBER AND NAME: C011-I & -II Erosion and Sinkholes		HIGHWAY & KM: 837:02, 5.637	PREVIOUS INSPECTION DATE: June 10, 2020	INSPECTION DATE: June 24, 2021
LEGAL DESCRIPTION: C017-I: 10-04-30-21-W4M C017-II: 10-04-30-21-W4M	NAD 83 COORDINATES: UTM Northing Easting 12 5711672 368445 12 5711584 368473		RISK ASSESSMENT: PF: 1 CF: 2 TOTAL: 2 PF: 2 CF: 5 TOTAL: 10	
AVERAGE ANNUAL DAILY TRAFFIC (AADT): 260 (north) & 270 (south) (Ref No. 106230 & 107250)			CONTRACT MAINTENANCE AREA (CMA): 517

NOTES: 1. HORIZONTAL DATUM: NAD83 2. GRID ZONE: UTM Zone 12N 3. IMAGE SOURCE: Bing Maps, Microsoft Corporation 2020 4. Location of new sinkhole observed in 2020 is approximate and was determined based on photos.	CLIENT 	PROJECT CENTRAL REGION GEOHAZARD RISK MANAGEMENT PROGRAM
		TITLE Site Plan C011 - Ditch Erosion Hwy 837:02, km 5.637
SCALE 1:1,500	PROJECT No. A05116A02	FIG No. 1

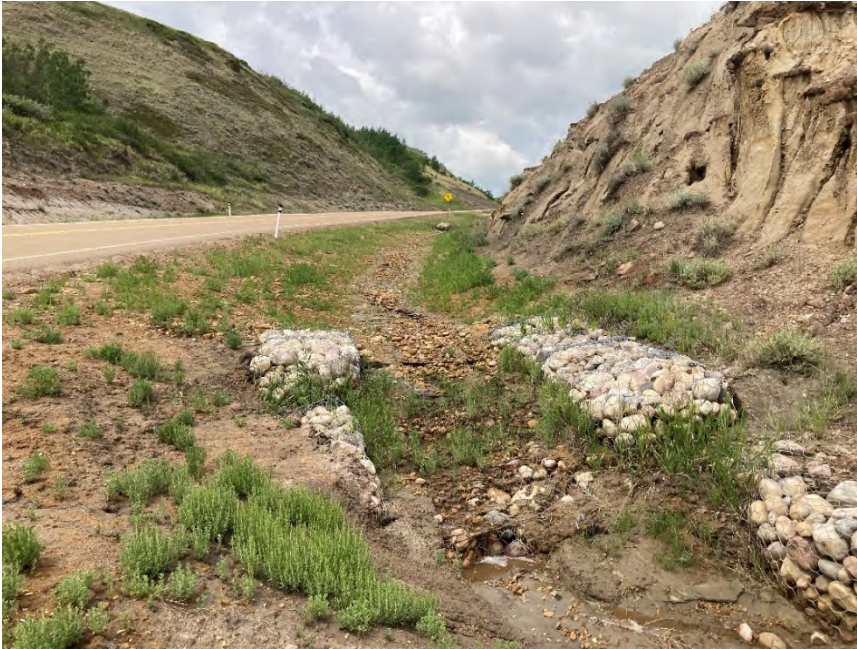
- Photo 1** The gabion basket drop structure that was previous being undermined (near the unarmoured fill stockpile) was repaired in fall 2020. Photo taken June 24, 2021 facing northwest.

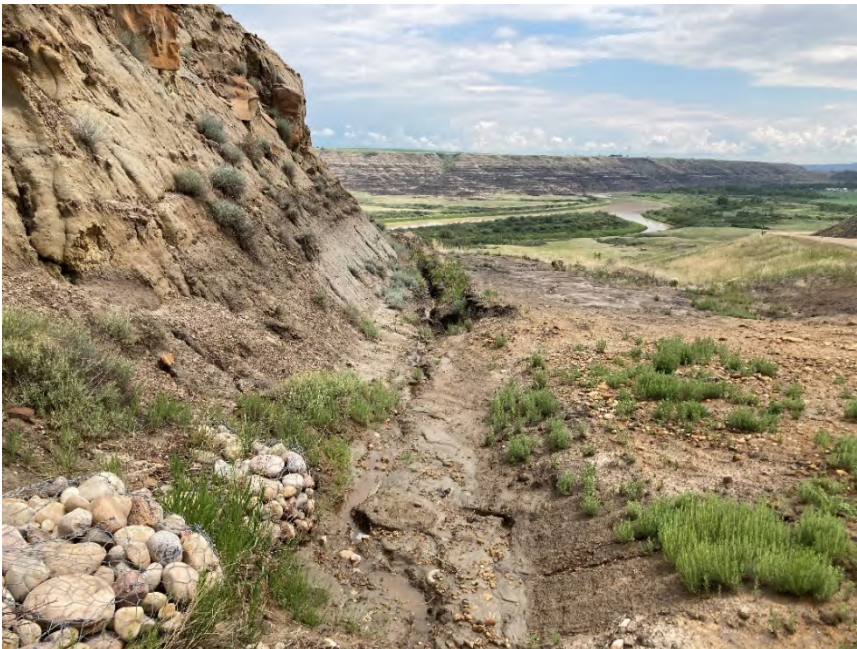
- Photo 2** Gully erosion downstream of the gabion baskets is in similar condition since the 2019 inspection. Photo taken June 24, 2021 facing southeast.

- A sediment pond could be constructed on private land downslope of the erosion gully to trap sediments, but would require regular maintenance and sediment removal.
- A seamless HDPE slope drain could be used to convey flows over the eroded areas and into the sediment pond, or to a natural creek channel for discharge into the Red Deer River.
- The unarmoured fill stockpile should also be protected with granular fill and riprap to protect against ditch erosion.
- A tracer dye test could be completed to assess the connectivity of the sinkholes observed on the north and south sides of the highway.

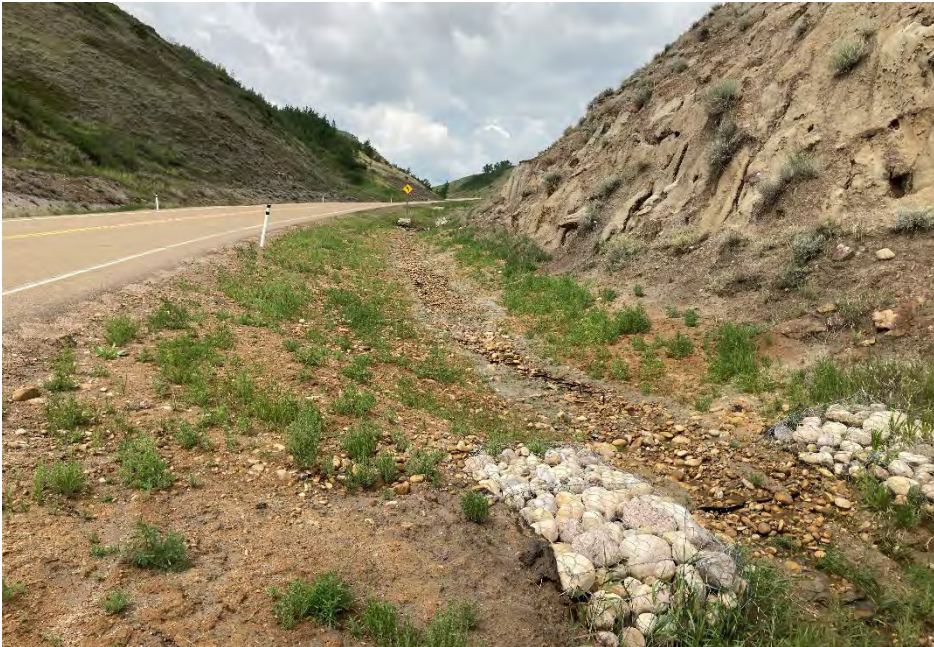
Photo 3 Geocell armouring in the westbound ditch was replaced in fall 2020 and vegetation has begun to grow on the ditch side slopes. Photo taken June 24, 2021 facing northwest.

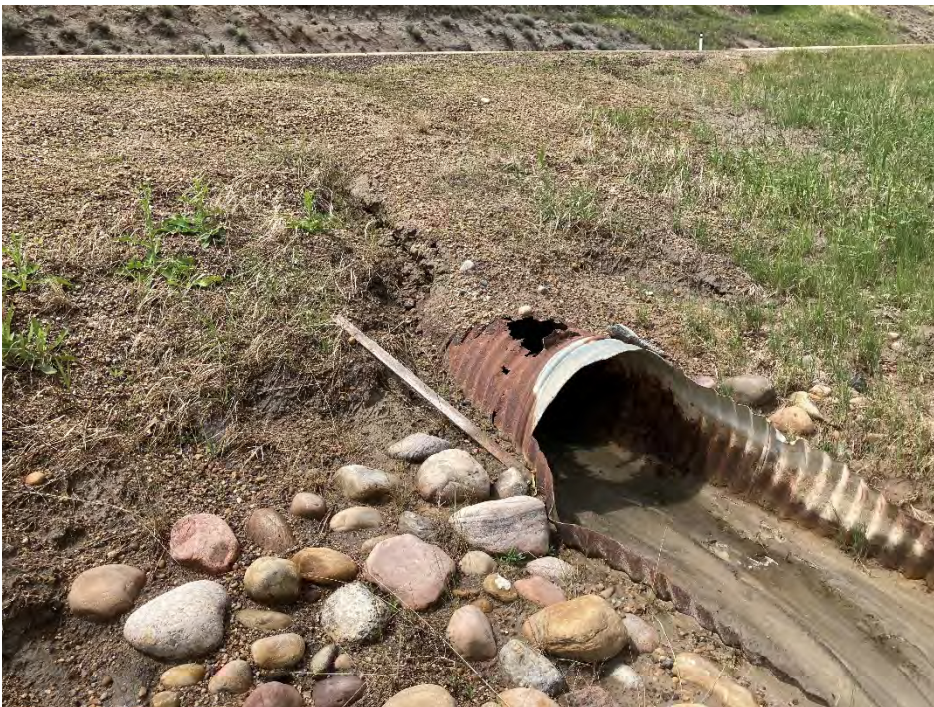
COMMENTS
KCB and AT discussed potentially separating the C011 site into two subsites (i.e., C011-I and -II). C011-I would be the north portion of the site (ditch erosion that was partially repaired in 2020) and C011-II, which would capture the gully erosion downslope of the geocell armoring/gabion drop structures and the sinkholes on the east and west side of Hwy 837.
The geocell armoring upstream of the gabion drop structure was repaired in fall 2020 (Photos 1 and 3). The repaired geocell armoring appears to be in good conditions and vegetation has started growing on the ditch side slopes.
The unarmoured fill stockpile continues to be affected by gully erosion (Photo 2).
The erosion gully downslope of the unarmoured fill stockpile continues to expand off highway right-of-way.
The CSP culvert upslope of the geocell armoring is corroding and appears to be in similar condition as during the 2020 inspection (Photo 4).

Photo 4 The CSP culvert underlying Hwy 837 (oriented east to west) is corroding, and appears to be in worse condition since the 2020 inspection. Photo taken June 24, 2021 facing northwest.

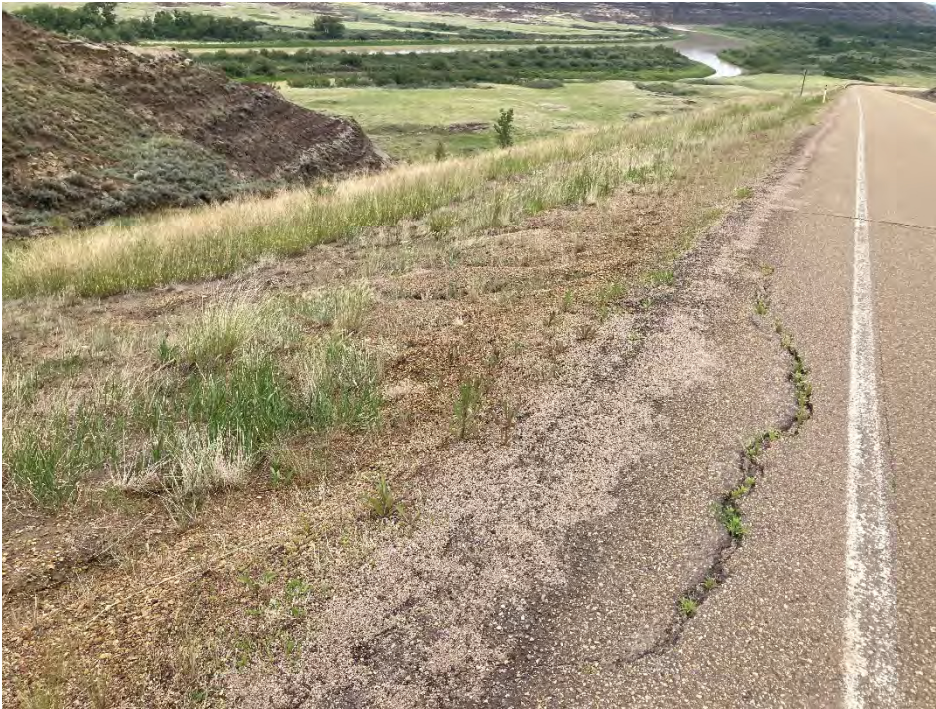
Photo 5 Asphalt cracking and rill erosion in the northbound shoulder and embankment slope, respectively. Photo June 13, 2021 looking southeast.

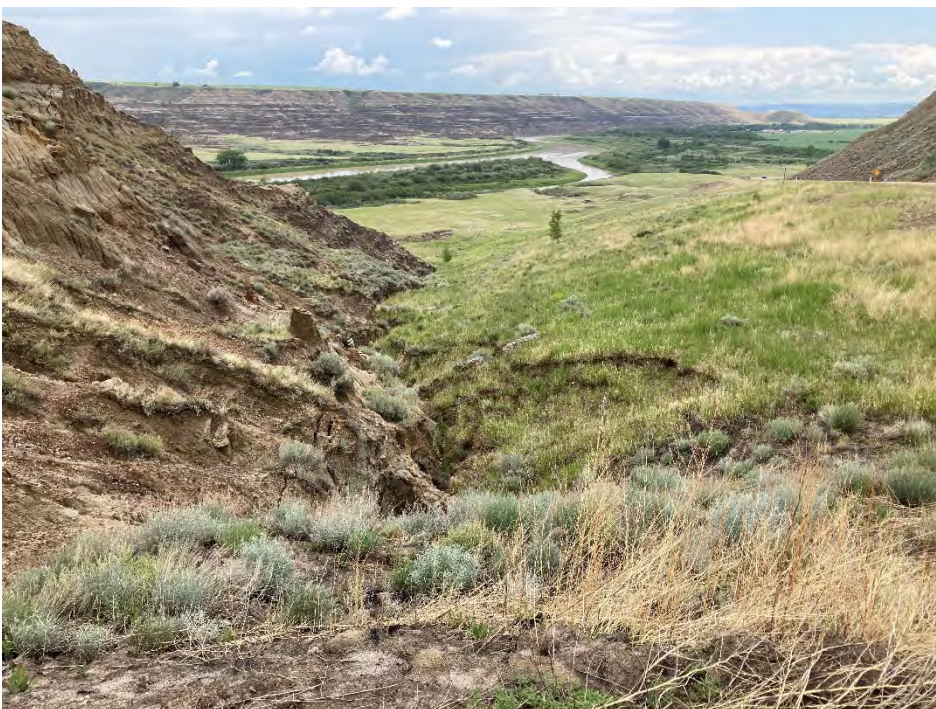
Photo 6 Slope failure triggered by gully erosion at the toe of the slope north of Hwy 837 doesn't appear to have changed since the 2020 inspection. Photo taken June 24, 2021 facing southeast.

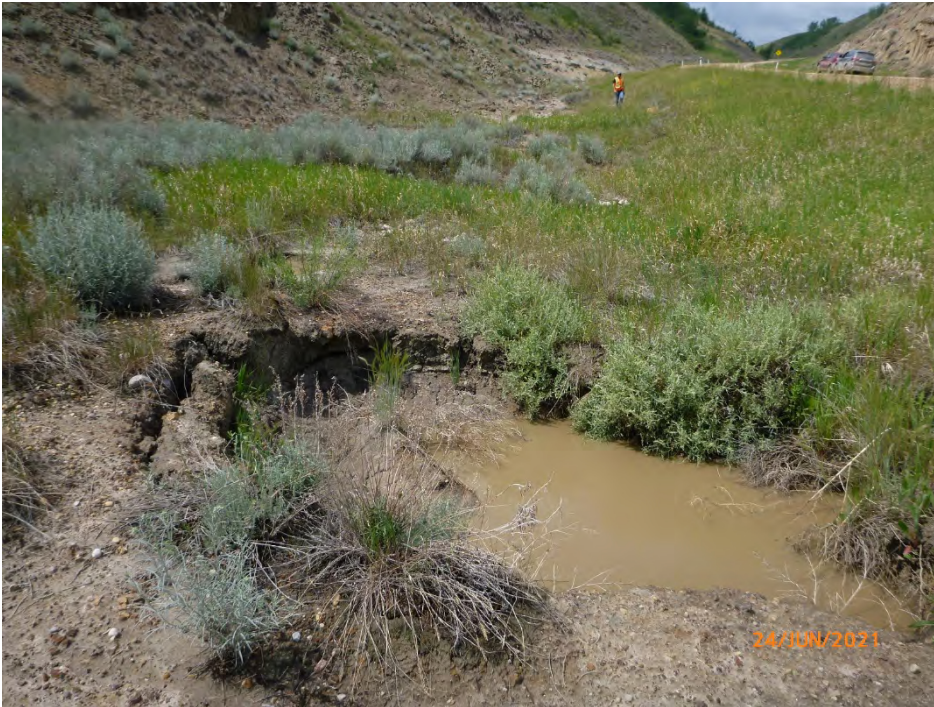
Three sinkholes were identified on the east slope of the highway embankment downstream of the geocell and gabion basket drop structures during the 2017 inspection (Waypoints 507, 508, and 509). An additional sinkhole was identified on the west side of the highway (west of Waypoint 507) during the 2019 inspection along with a zone of settlement at the edge of the pavement. A new sinkhole was observed during the 2020 inspection at the east limit of the area shown in Figure 1. An additional sinkhole was observed during the 2021 inspection (Photo 8) that measured approximately 3 m wide by 3.5 m long. The surface of the embankment slope has several sinkholes as shown in Figure 1, including a line of sinkholes extending southeast from Waypoints 507, 508, and 509. The line between sinkholes on the east and west side of the highway indicates a preferential flow path along the sinkholes on both sides of the embankment at a shallow depth below the highway. The presence of the sinkholes indicates that dispersive soil fill is present in the embankment and foundation. AT operations crews should monitor this site for possible settlement or collapse of the pavement like they do at the C058 site on Hwy 570:02. A sinkhole was noticed further to the east on the north side of the highway and the rate of water discharge from the sinkhole is enough to have created a small gully.

Photo 7 A previously observed sinkhole on the west side of Hwy 837 appears to have increased in size since the 2020 inspection. Photo taken June 24, 2021 facing north.

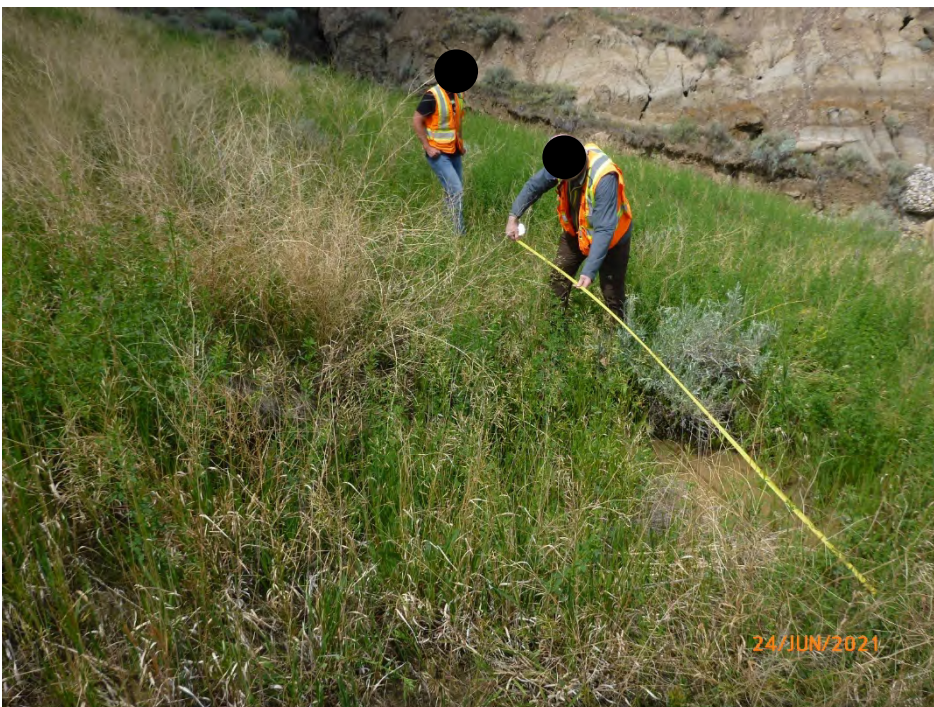
Photo 8 Sinkhole observed approximately mid-slope on the east highway embankment slope. The sinkhole was approximately 3 m wide and 3.5 m long (depth not measured). Photo taken June 24, 2021 facing north.
