SITE NUMBER AND NAME: C011-I & -II Erosion and Sinkholes		HIGHWAY & KM: 837:02, 5.637	PREVIOUS INSPECTION DATE: June 24, 2021	INSPECTION DATE: May 30, 2022
LEGAL DESCRIPTION: C011-I: 10-04-30-21-W4M C011-II: 10-04-30-21-W4M	NAD 83 COORDINATES: UTM Northing Easting 12 5711672 368445 12 5711584 368473		RISK ASSESSMENT: PF: 1 CF: 2 TOTAL: 2 PF: 2 CF: 5 TOTAL: 10	
AVERAGE ANNUAL DAILY TRAFFIC (AADT): 280 (north) & 290 (south) (Ref No. 106230 & 107250)			CONTRACT MAINTENANCE AREA (CMA): 517

PROJECT
CENTRAL REGION GEOHAZARD RISK MANAGEMENT PROGRAM

TITLE
Site Plan
C011 - Ditch Erosion
Hwy 837:02, km 5.637

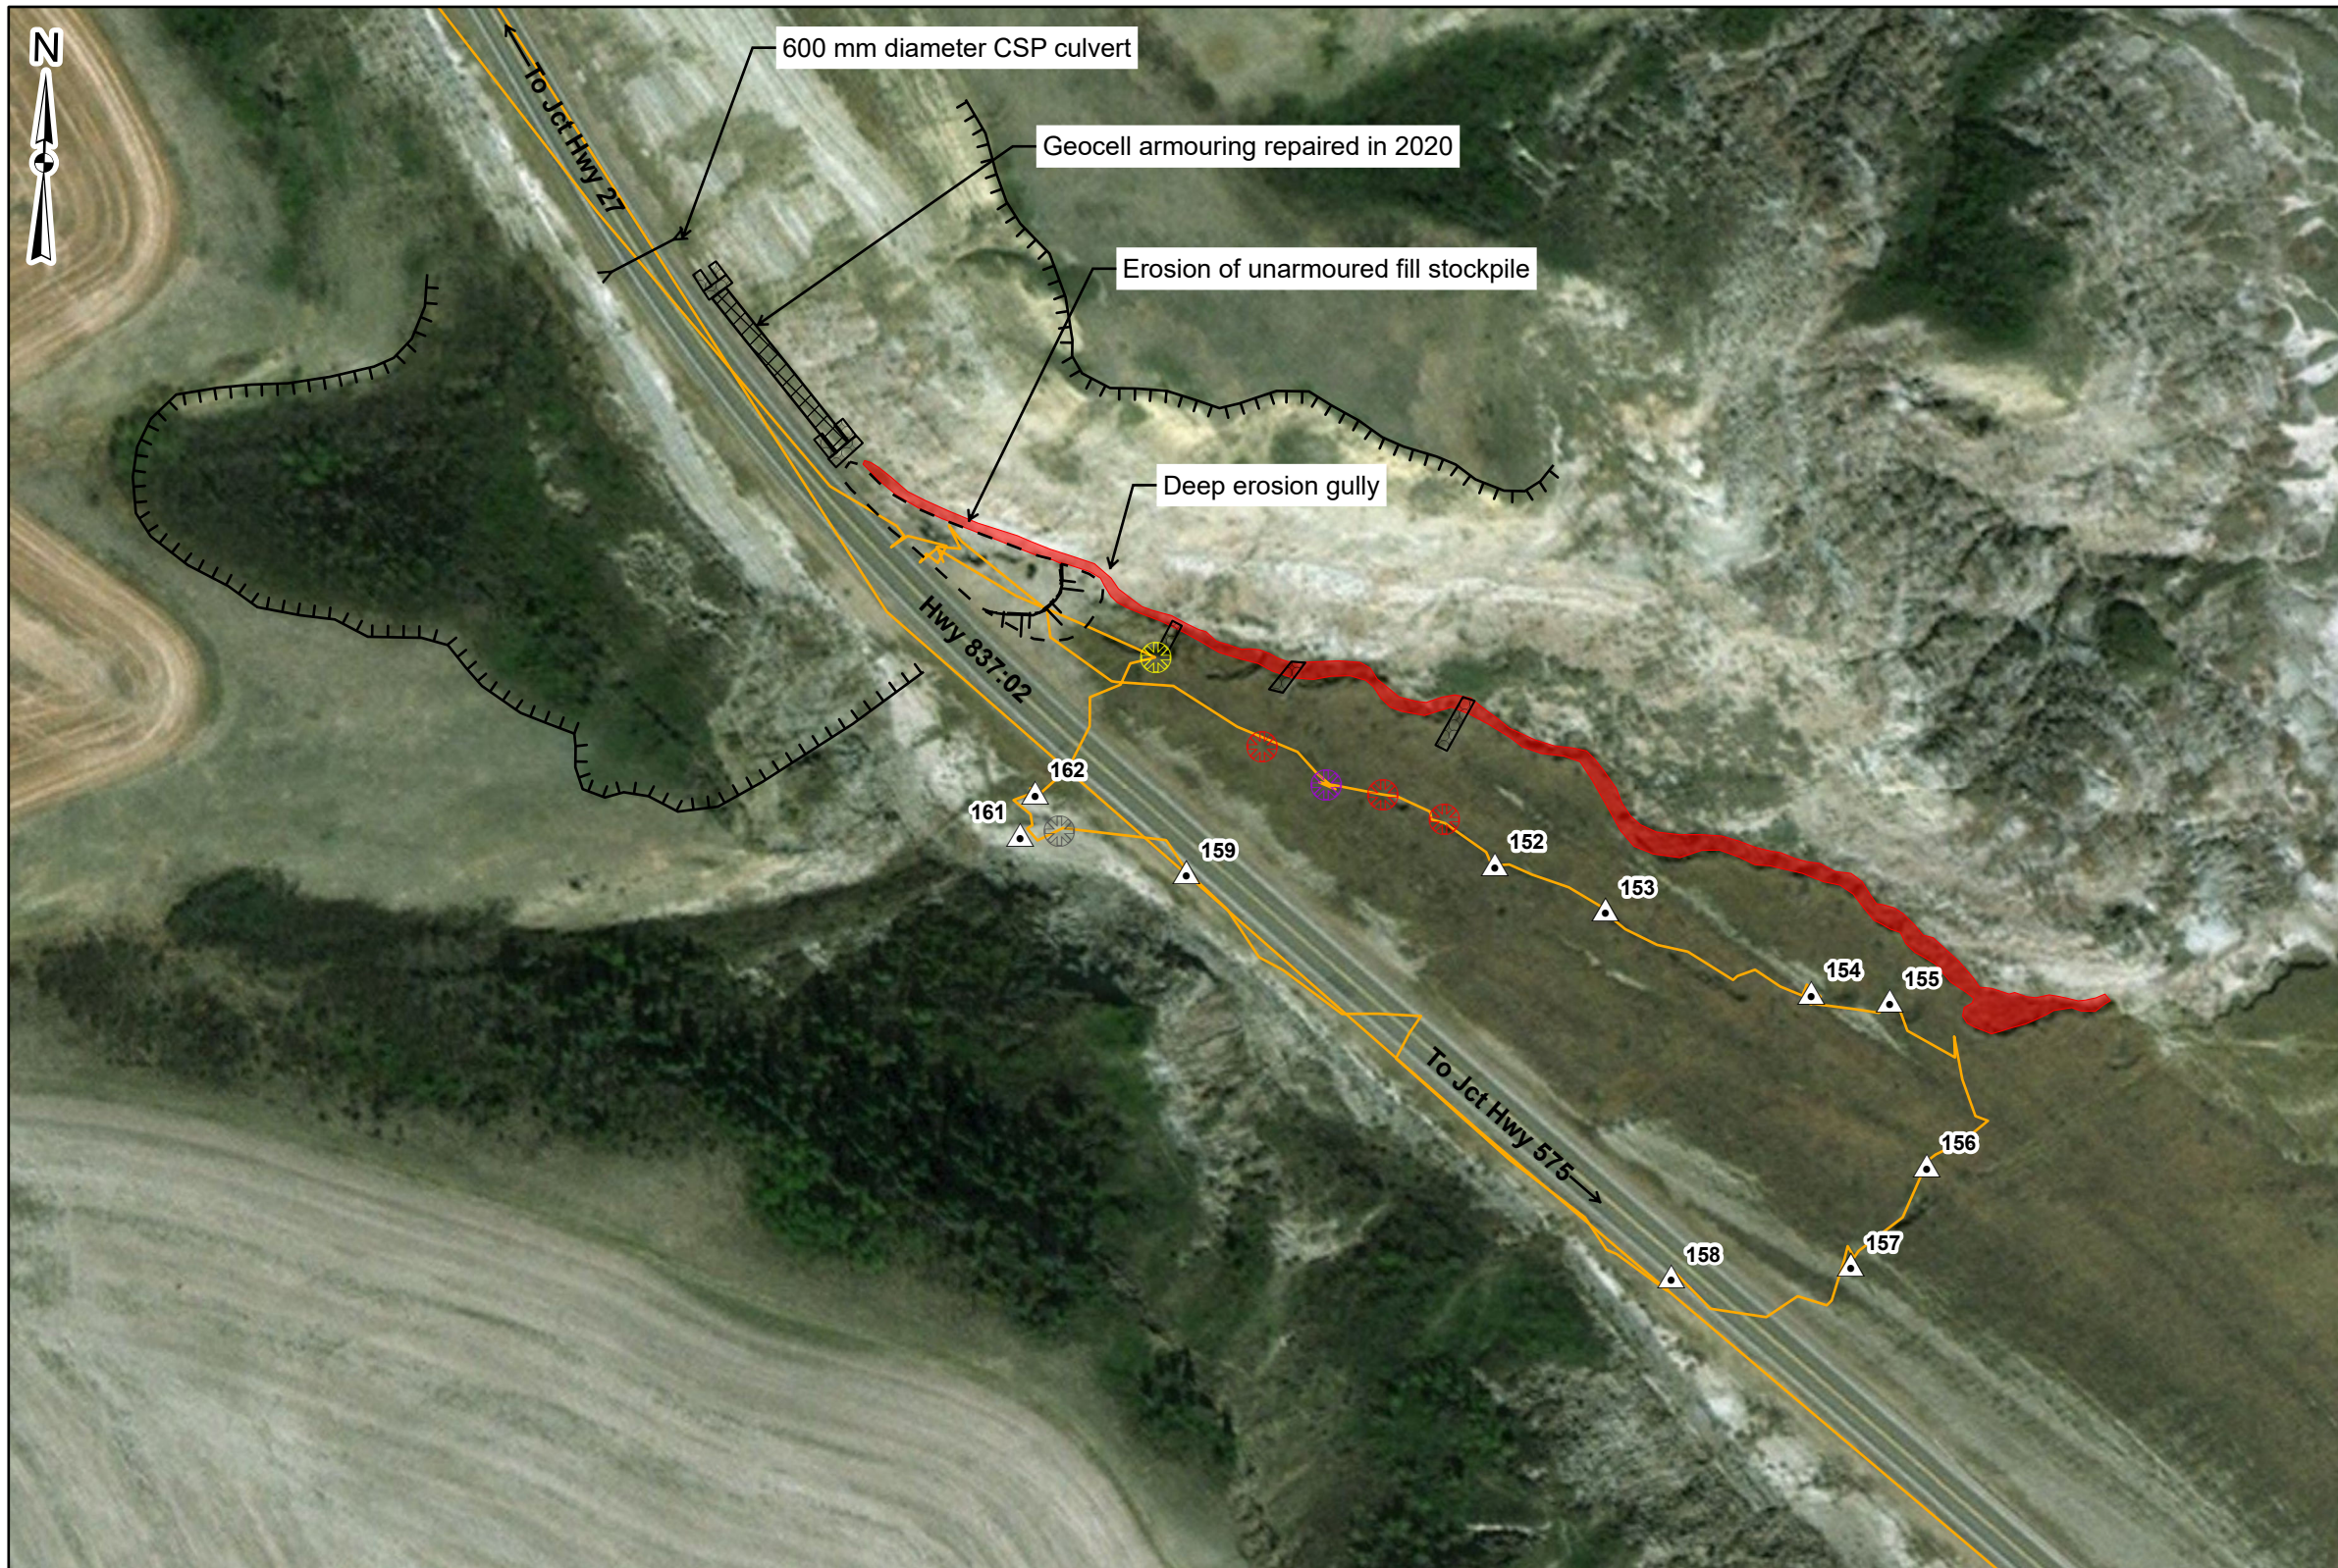
SCALE 1:1,500 PROJECT No. A05116A02 FIG No. 1

- The surface of the embankment slope has several sinkholes as shown in Figure 1, including a line of sinkholes extending southeast along the south edge of the erosion gully. The line between sinkholes on the east and west side of the highway indicates a preferential flow path along the sinkholes on both sides of the embankment at a shallow depth below the highway. The presence of the sinkholes indicates that dispersive soil fill is present in the embankment and foundation. AT operations crews should monitor this site for possible settlement or collapse of the pavement like they do at the C058 geohazard site on Hwy 570:02.

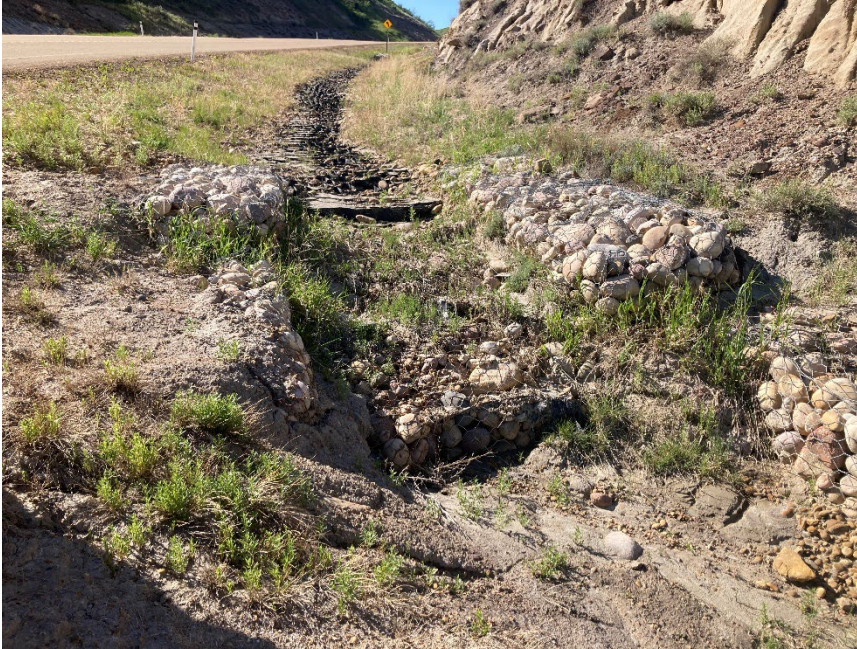
Photo 1 The gabion basket drop structure that was previous being undermined (near the unarmoured fill stockpile) was repaired in fall 2020. Photo taken May 30, 2022, facing northwest.

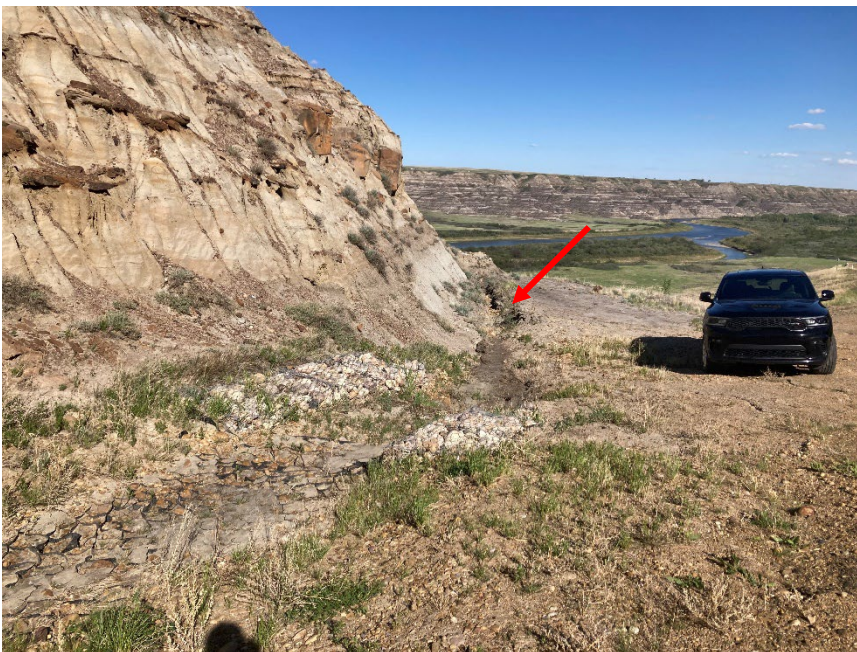
Photo 2 Gully erosion downstream of the gabion baskets (indicated by red arrow) is in similar condition since the 2021 inspection. Photo taken May 30, 2022, facing southeast.

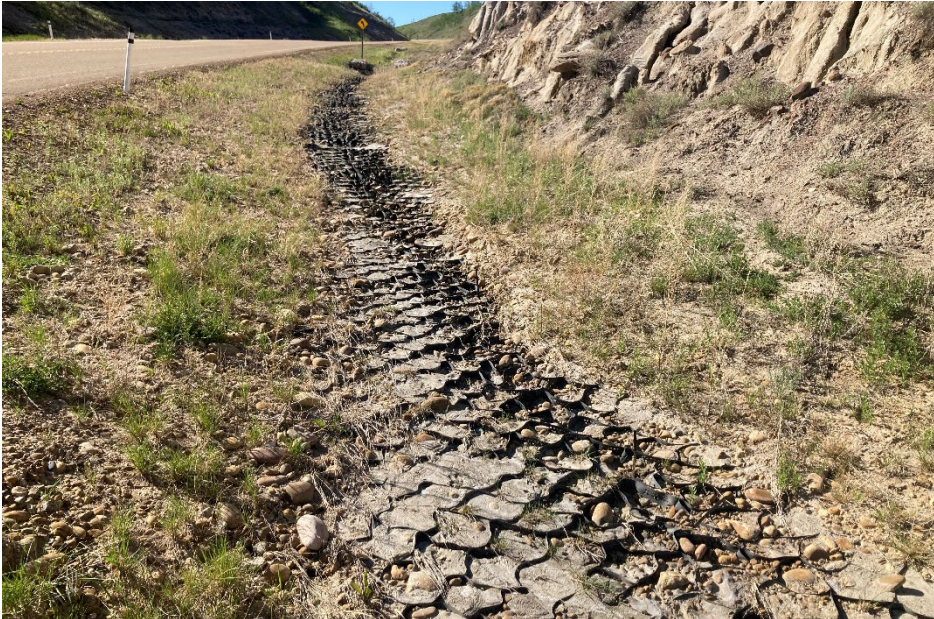
Photo 3 Geocell armouring in the westbound ditch was replaced in fall 2020 and vegetation has begun to grow on the ditch side slopes. A portion of the granular material in the geocell armouring, near the centre of the reinforcement, has been eroded between the 2021 and 2022 inspections. Photo taken May 30, 2022, facing northwest.

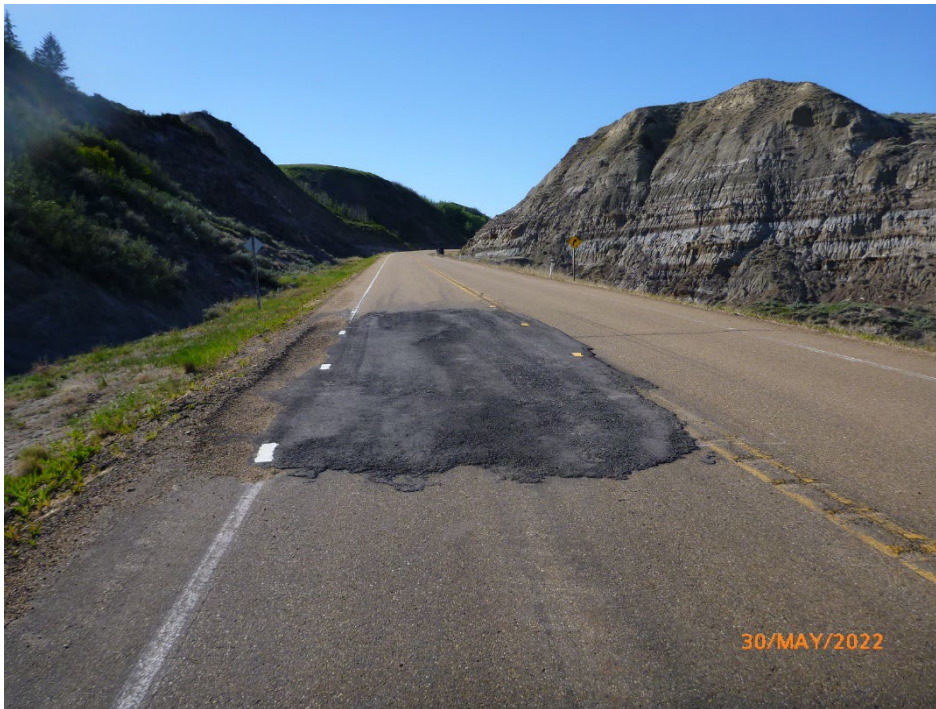
- WP 158 (Photo 5) which is a new pavement patch that was completed between the 2021 and 2022 inspections;
 - WP 159, which is a dip in the road between the upslope ditch and the general area of the line of sinkholes observed on the east (downslope) slope; and

Photo 5 A pavement patch was completed in the southbound lane between the 2021 and 2022 inspections (Waypoint 158). Photo May 30, 2022, looking northwest.

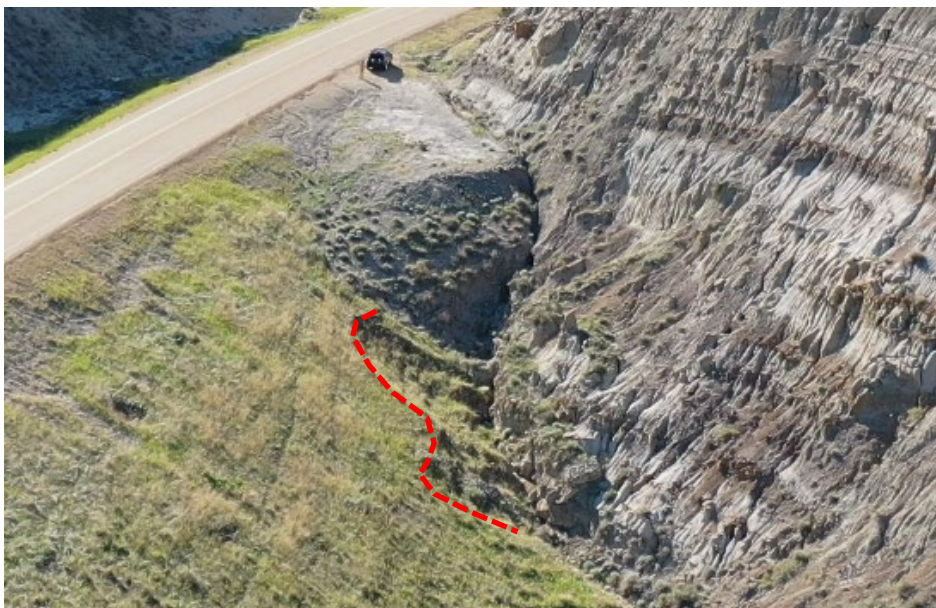
- The unarmoured fill stockpile continues to be affected by gully erosion and the erosion gully downslope of the unarmoured fill stockpile continues to expand off highway right-of-way (Photo 6).

Photo 6 Slope failure triggered by gully erosion at the toe of the slope north of Hwy 837 doesn't appear to have changed since the 2021 inspection. Photo taken May 30, 2022, facing northwest.

- A seamless HDPE slope drain could be used to convey flows over the eroded areas and into the sediment pond, or to a natural creek channel for discharge into the Red Deer River. An energy dissipation structure would be required at the base of the slope to reduce the flow velocity from the slope drain outlet.
- A tracer dye test could be completed to assess the connectivity of the sinkholes observed on the north and south sides of the highway.

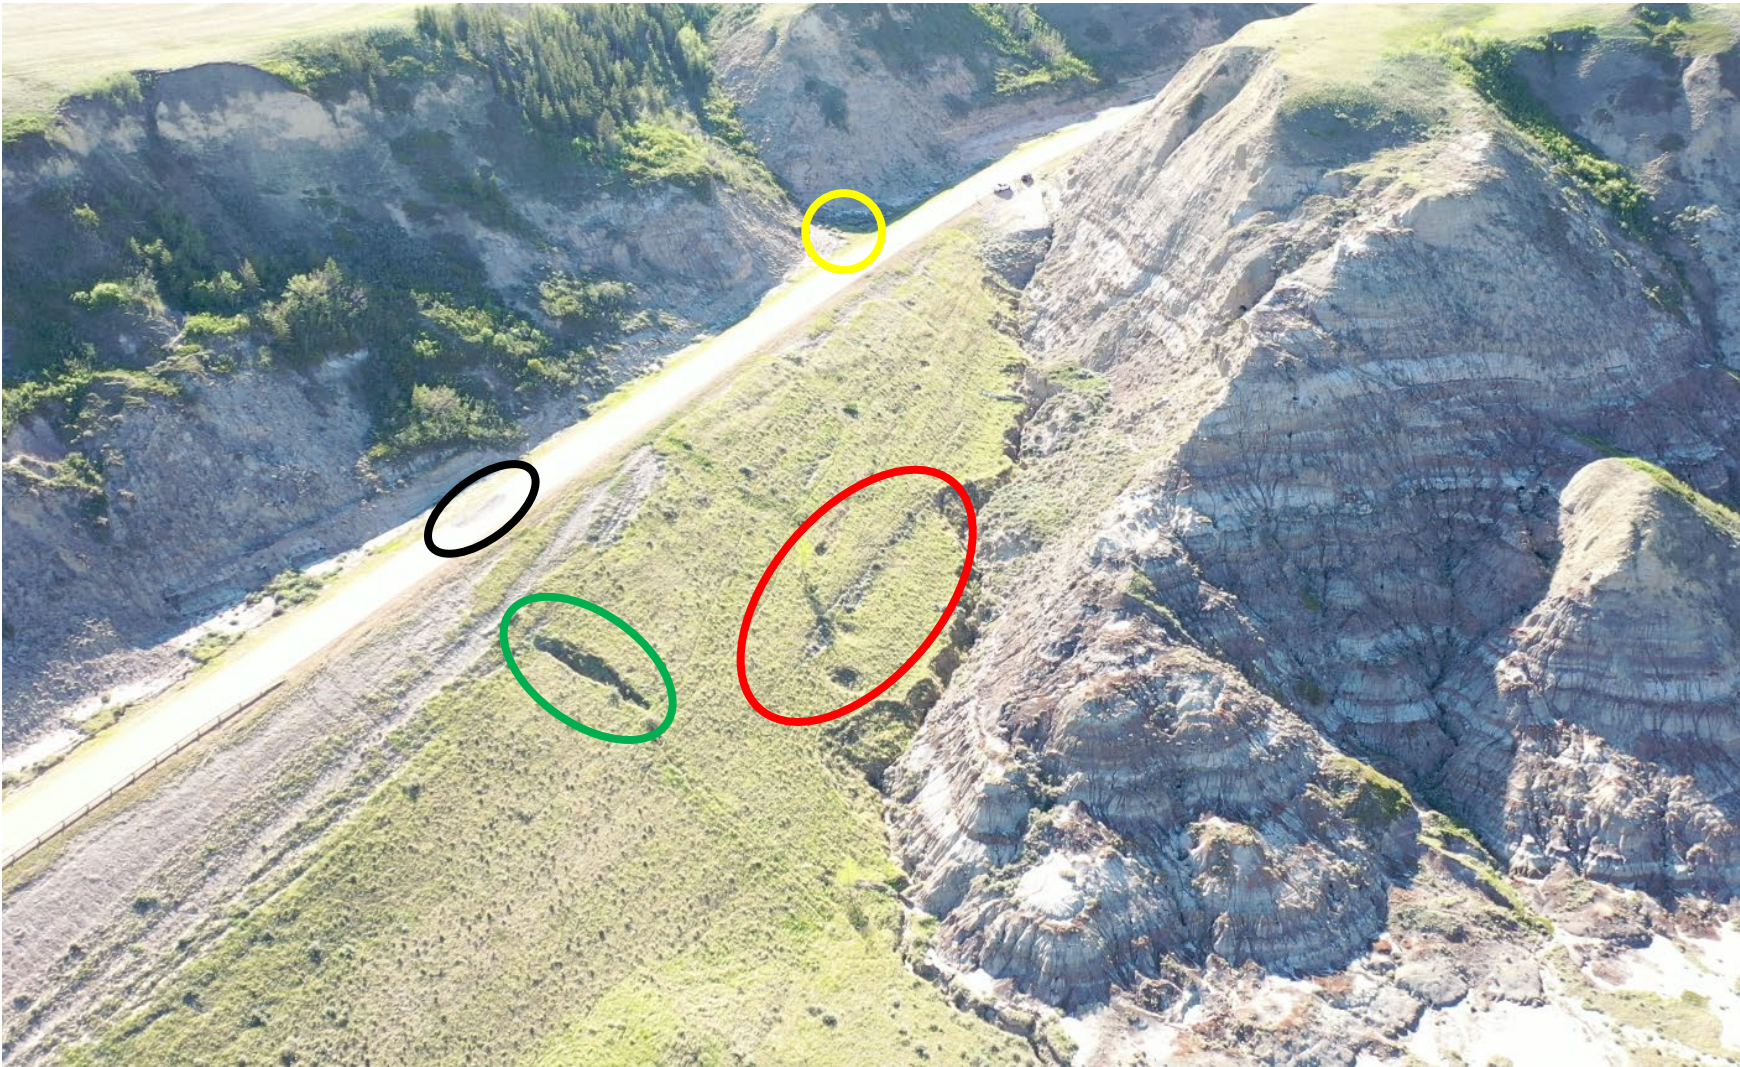
- WP 157 is at a sinkhole approximately 3 m wide, 3 m deep, and 20 m long, that was observed further to the east on the north side of the highway and the rate of water discharge from the sinkhole is enough to have created a small gully (Photo 7). KCB suspects this may be the location of a culvert outlet underlying the highway (oriented approximately northeast-southwest).

Photo 7 Aerial photo of the C011 site, showing the erosion gully at the toe of the highway embankment, new pavement patch (black circle, WP 158), and sinkholes on the downhill slope (red circle, WP 152 to WP 155), sinkholes in the upslope ditch (yellow circle, WP 161 and WP 162) and erosion gully at the outlet of a sinkhole (or buried culvert, green circle, WP 156 and WP 157) on the east embankment slope. Photo taken May 30, 2022, facing northwest.
