| <b>SITE NUMBER AND NAME:</b><br><b>C018 Red Deer Riverbank Slide</b> | <b>HIGHWAY &amp; KM:</b><br>837:02, 2.1 | <b>PREVIOUS INSPECTION DATE:</b><br>June 18, 2024 | <b>INSPECTION DATE:</b><br><b>June 10, 2025</b> |

| <b>PRIMARY SITE ISSUE:</b> Natural slope instability along a section of the west valley slope along Hwy 837:02 (C018-2) and highway embankment instability (C018-1). |

Site Plan  
C018 - Red Deer Riverbank Slide  
Hwy 837:02, km 2.100

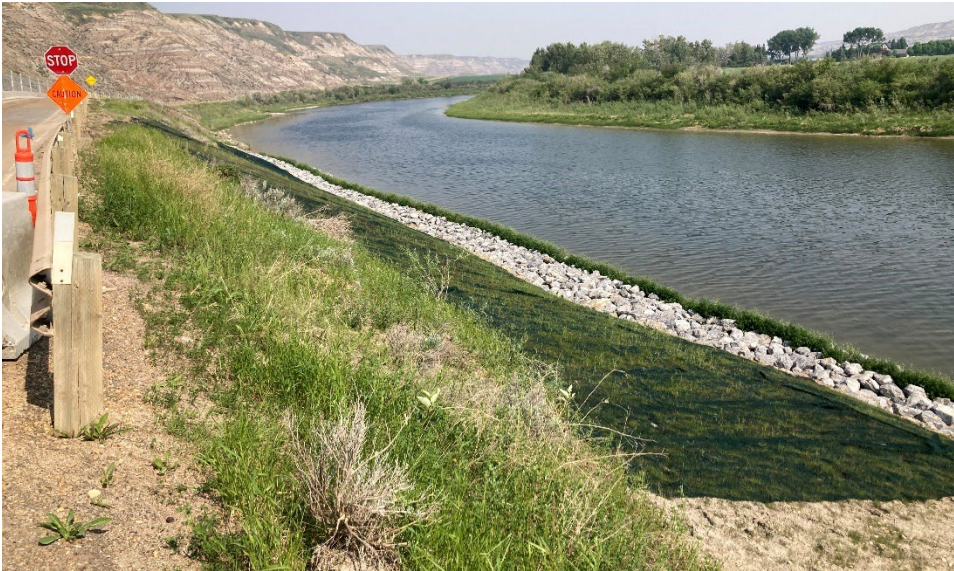
- The slope failure in the east highway embankment slope and riverbank erosion were repaired between October 2024 and June 2025 by PME Inc. as part of CON0022533. The repair consisted of excavation of slide material, slope reconstruction with geogrid-reinforced granular fill, riprap armouring (Class 2) in the lower portion of the slope, a brush layer within the riprap, and protecting the slope face with a RECP. The repair work is complete and appears to be performing well. Vegetation (grass) is beginning to grow through the RECP (Photo 1) and the brush layer appears to be in growing well (Photo 2).

- Photo 1** Slope instability and erosion at C018-1 along the east (right) riverbank of the Red Deer River was repaired late-2024 to early-2025 with geogrid-reinforced granular fill, Class 2 riprap, RECP, and brush layer within the riprap. Photo taken June 10, 2025, facing north.

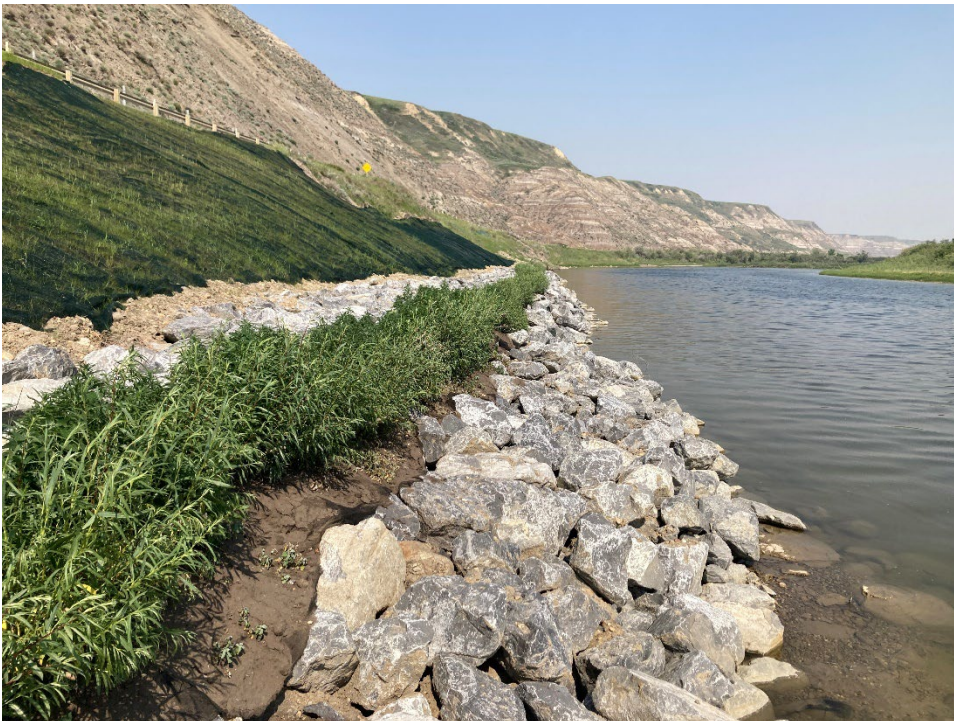
- TEC informed KCB during the inspection that there was more topsoil placed below the RECP than along the access road constructed for temporary access to the toe of the slope during 2024/2025 construction, which may have resulted in more vegetation growth along the slope. Additional topsoil and seeding may be required if vegetation coverage does not improve.

- Photo 2** At the C018-1 repair, vegetation is growing through the RECP and the brush layer is growing in well. Photo taken June 10, 2025, facing northwest.

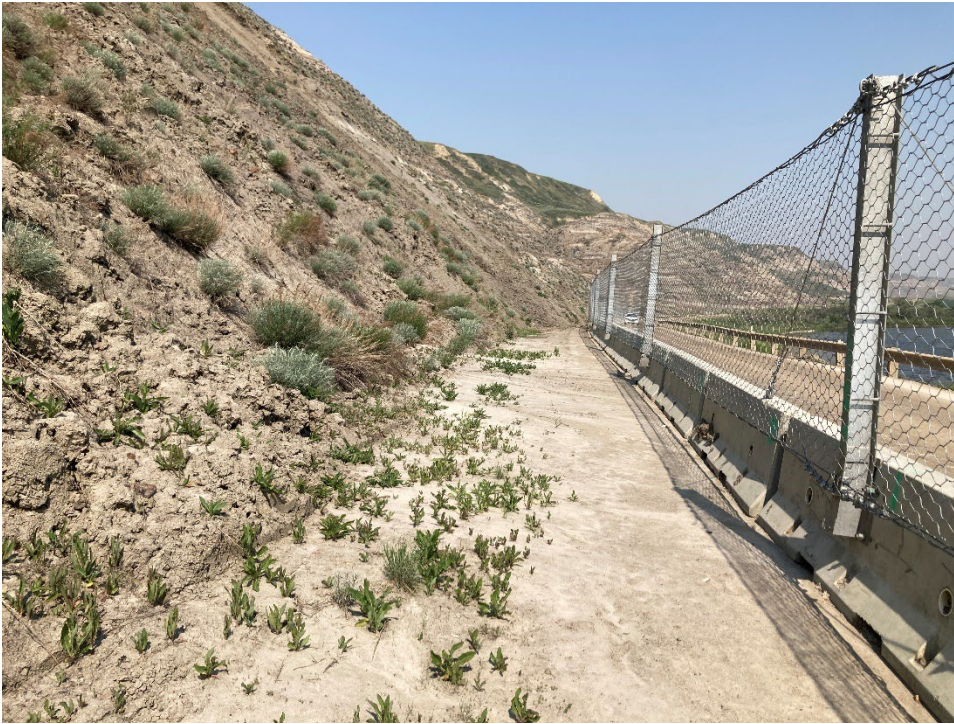
- In March 2025, a rockfall barrier was attached to the concrete barriers by PME as part of CON0022533 (Photos 3 through 6). The rockfall barrier appears to have been completed as per the design and is in good condition.

**Photo 3**      **Rockfall fence installed on jersey barriers along the C018-2 in late-2024 and early-2025. Photo taken June 10, 2025, facing northwest.**

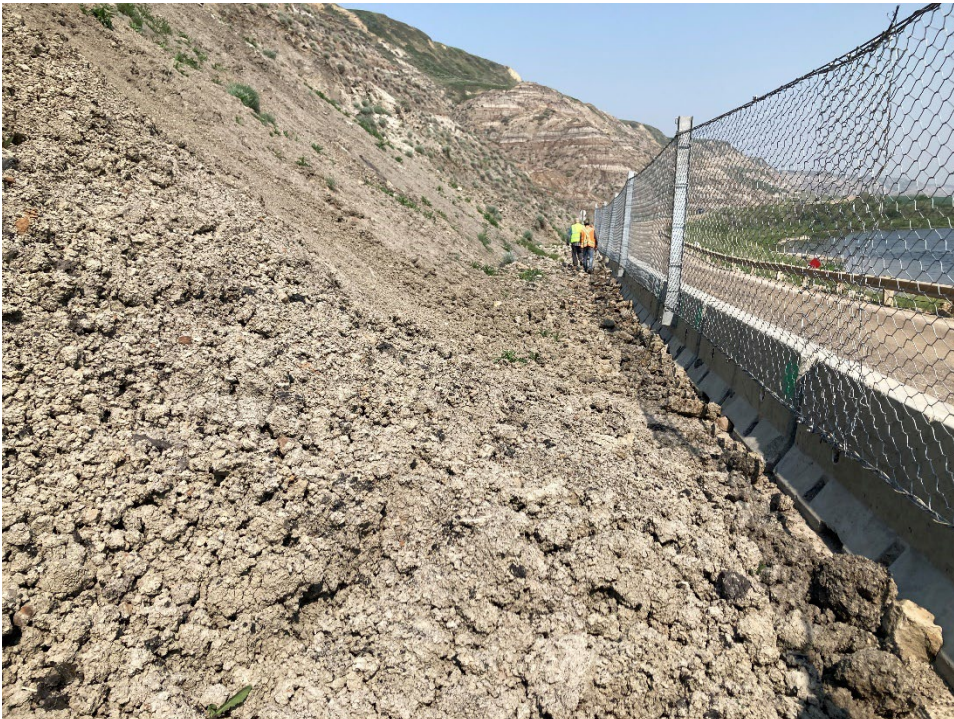
- In general, there was less material deposited behind the jersey barriers and rockfall barriers than previous years inspections, particularly along the southeast portion of the site (Photo 3). This may reflect maintenance efforts by the Highway Maintenance Contractor (HMC) and Maintenance Contract Inspector (MCI).

- Near the middle of the site, a relatively significant amount of failed material had been deposited into the west (southbound) lane between the 2024 and 2025 inspections (Photo 4 through 6). The material was deposited approximately 100 m along the base of the slope and the area of instability extends approximately one quarter to one third of the way up the slope.

**Photo 4**      **Material accumulating behind the jersey barrier and rockfall fence along C018-2. Photo taken June 10, 2025, facing northwest.**

- The site should be regularly inspected by TEC's MCI, especially after precipitation events.
- The site should continue to be inspected annually as part of the Central Region Section B Inspections.
- Material deposited behind the jersey barriers and rockfall barrier should be regularly removed by TEC's HMC.
- KCB should prepare and issue a proposal for the repair of the slide near the northwest extent of the site. The proposal should include a site investigation (should include 2-3 boreholes through the highway surface), instrument installations (one slope inclinometer and one or two vibrating wire piezometers), initial instrumentation readings, design work, environmental and regulatory support, and contract procurement support (Request for Quotation or tender package).

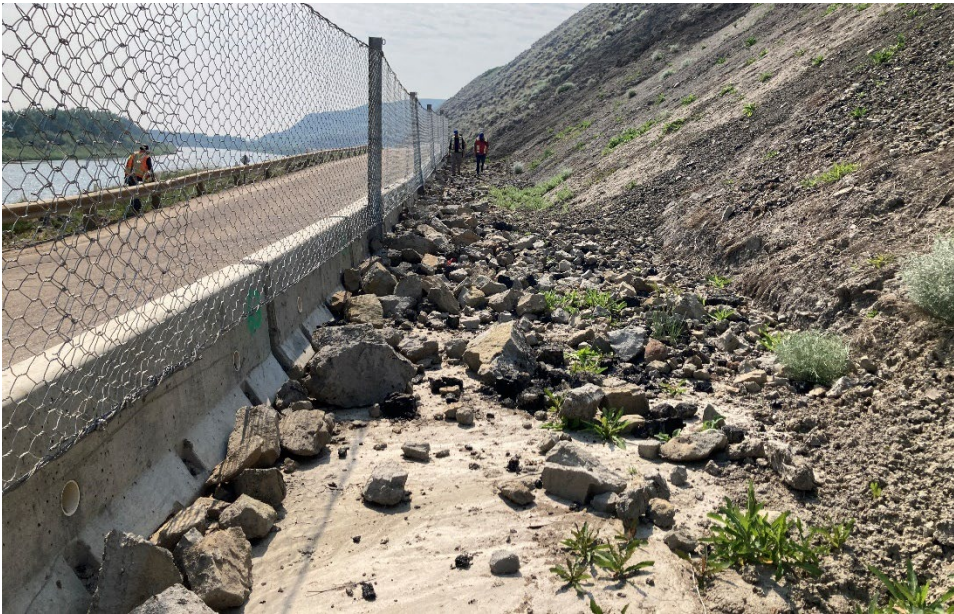
**Photo 5** Material accumulating behind the jersey barrier and rockfall fence along C018-2. Photo taken June 10, 2025, facing southeast.

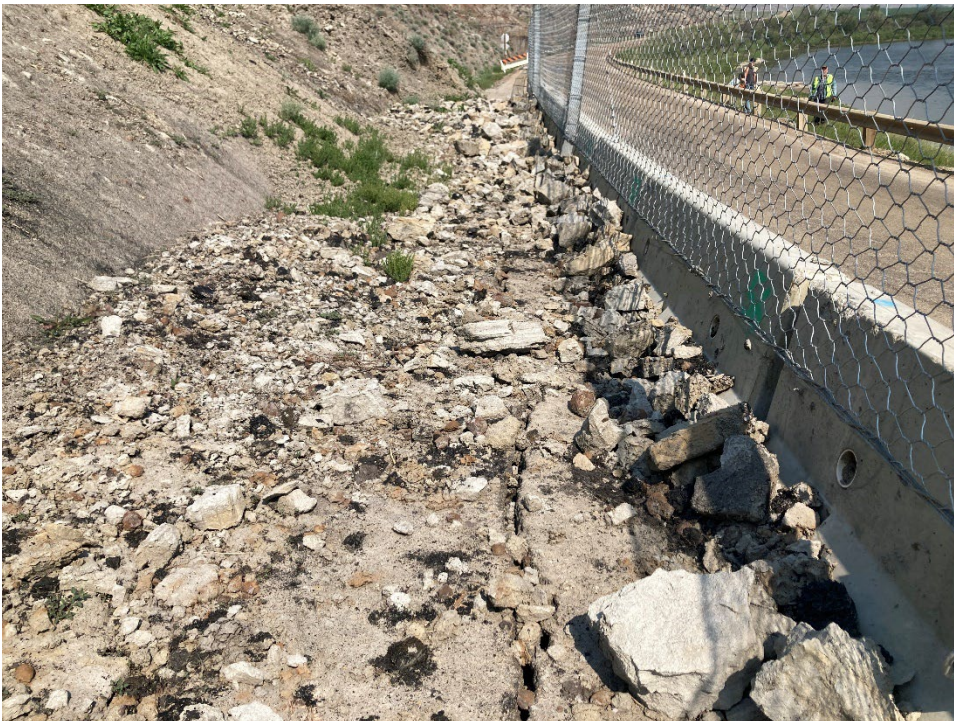
- The pavement crack (up to approximately 75 mm wide and 25 m long, first observed during the 2024 Section B inspection) has worsened between the 2024 and 2025 inspections. The pavement crack begins in the east (southbound) lane behind the concrete jersey barriers and rockfall barrier and extends further north across the west (northbound) lane to the edge of pavement (Photo 6 through 8). Settlement in the east (northbound) lane is significantly worse than during the 2024 inspection and resulted in a noticeable dip (up to approximately 100 mm deep) in the highway surface (Photo 8). The pavement distress (cracking and settlement) is near the north extent of the early 2000s repair, indicating the slide is outflanking the previous repair. A red diamond hazard sign was installed adjacent to the guardrail between the 2024 and 2025 inspections to warn road users of the hazard (Photo 10). TEC informed KCB after the inspection that the contractor installed a "bump" hazard sign on July 3, 2025.

**Photo 6** Pavement crack near the northwest extent of C018-2 appears wider (up to approximately 75 mm wide) than during the 2024 inspection when it was first observed. Photo taken June 10, 2025, facing northwest.

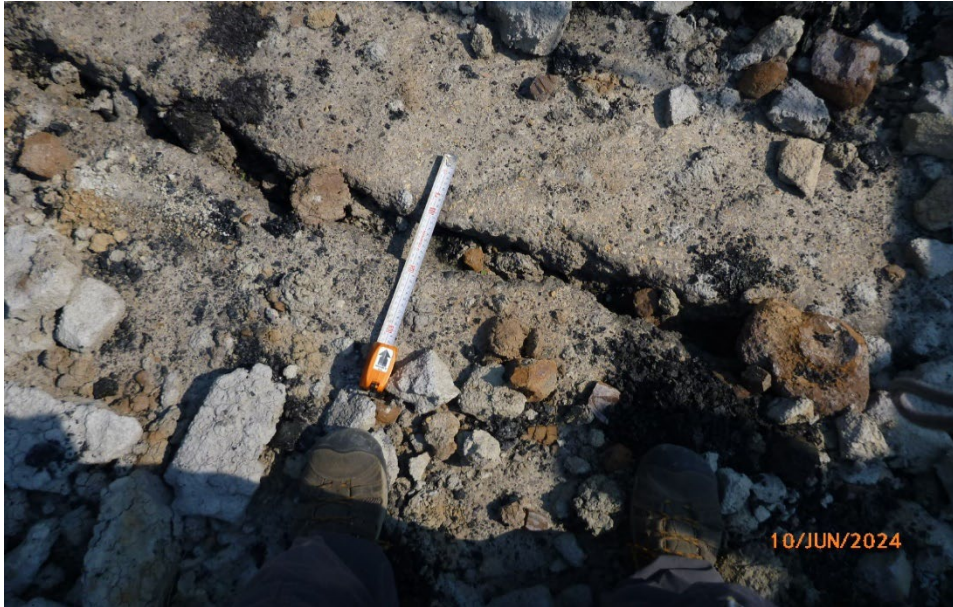
**Photo 7** Ground crack near the northwest extent of C018-2 is approximately 75 mm wide. The downstream (east) side of the crack has settled between the 2024 and 2025 inspections. Photo taken June 10, 2025, facing southwest.

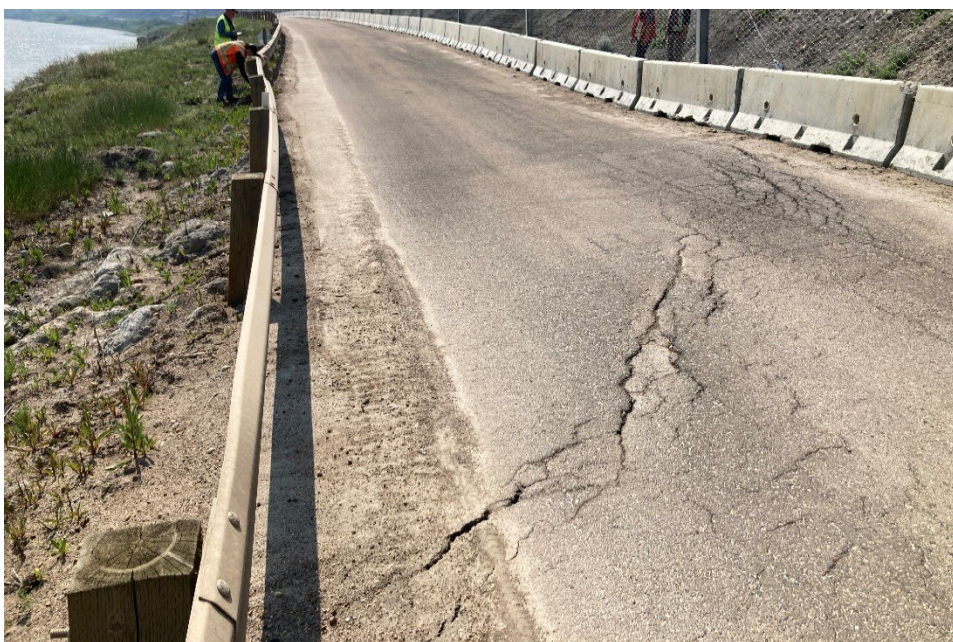
**Photo 8** Pavement distress (settlement and cracking) near the northwest extent of the C018-2 site. The settlement has worsened between the 2024 and 2025 inspections and there is a significant dip in the east (northbound) lane. Photo taken June 10, 2025, facing south.

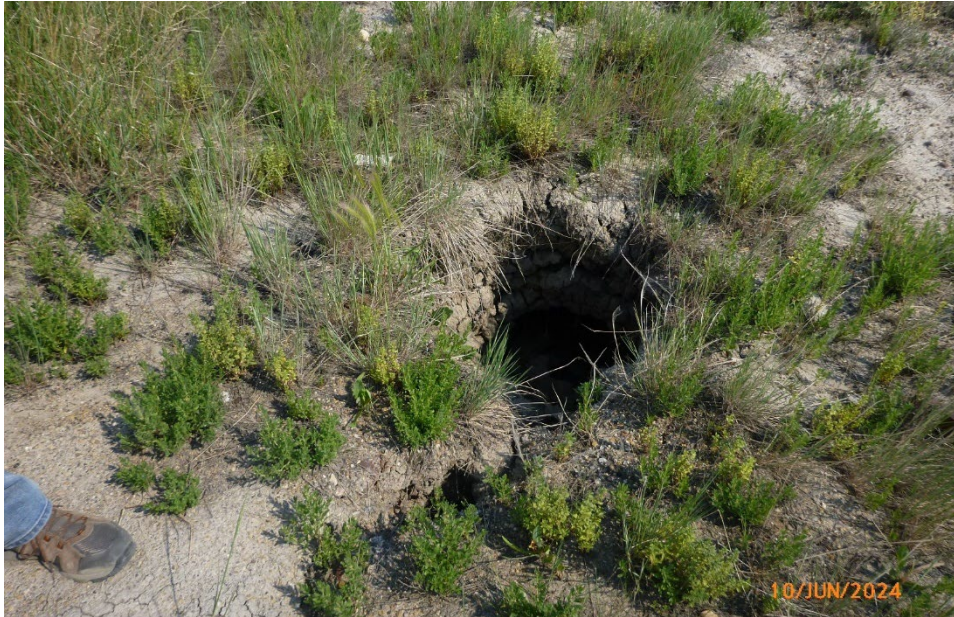
- Dispersive soil voids have been observed on the east side of the highway at the crest of the highway embankment slope (Photo 9). The sinkholes appear to be concentrated near the left (northwest) and right (southeast) extent of the early 2000s riverbank repair. KCB suspected surface water flow from the highway surface is flowing into the sinkholes likely increasing the rate of void formation and increasing the groundwater level in the slope. Between 5 and 10 voids were observed during the 2025 inspection:

- Waypoint 378: Four sinkholes up to approximately 0.8 m in diameter and 1.5 m deep.
  - Waypoint 379: Location where surface water runoff from the highway flows into a sinkhole.

- Waypoint 380 and 381: Two sinkholes up to approximately 0.7 m in diameter and 1 m deep.
- Material (soil and coal fragments) from the C018-2 site was observed on the east side of the guardrail, indicating that material falling down the slope was not being completely contained with just the concrete jersey barriers (Photo 10). The larger blocks deposited behind the guardrail appear older (weathered) and were generally less than approximately 0.5 m x 0.5 m x 0.5 m. The rate of material accumulation will likely decrease now that rockfall barrier installation is complete.

**Photo 9** Between 5 and 10 sinkholes up to approximately 0.6 m in diameter have been observed on the crest of the riverbank, on either side of the early 2000s repair. Photo taken June 10, 2025 facing northeast.

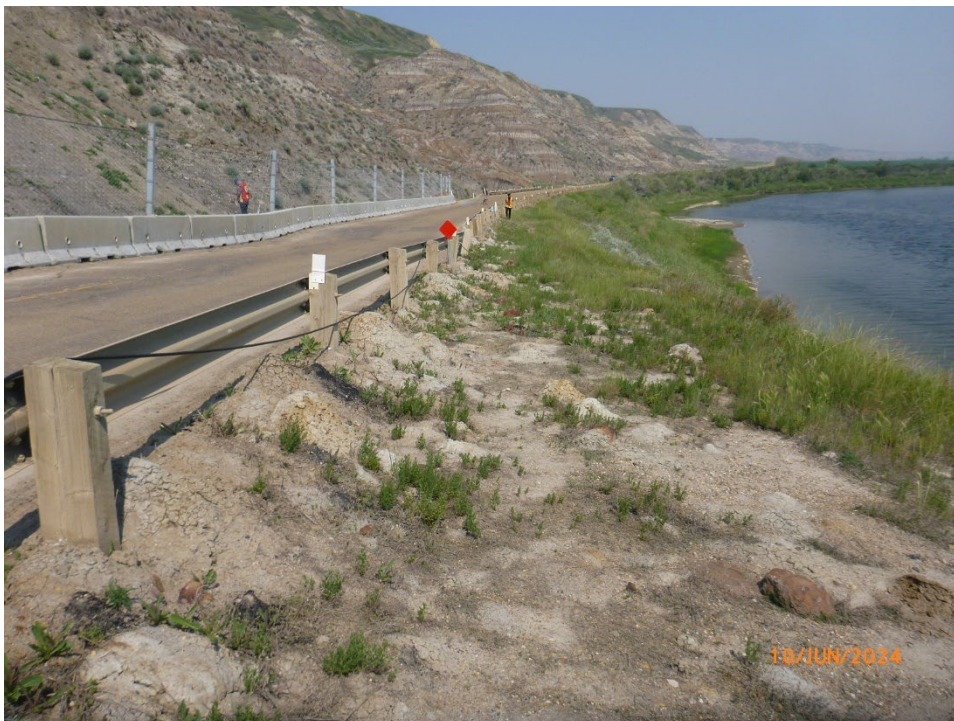
**Photo 10** Material that has accumulated along the crest of the riverbank on the east side of the highway. Photo taken June 10, 2025, facing northwest.
