August 20, 2021

Central Region GRMP
Hwy 838:02, km 22.0 – 23.0 (Near Bleriot Ferry) Call-Out Report

TITLE
 Site Plan
 Unnamed Site - Near Bleriot Ferry
 Hwy 838:02

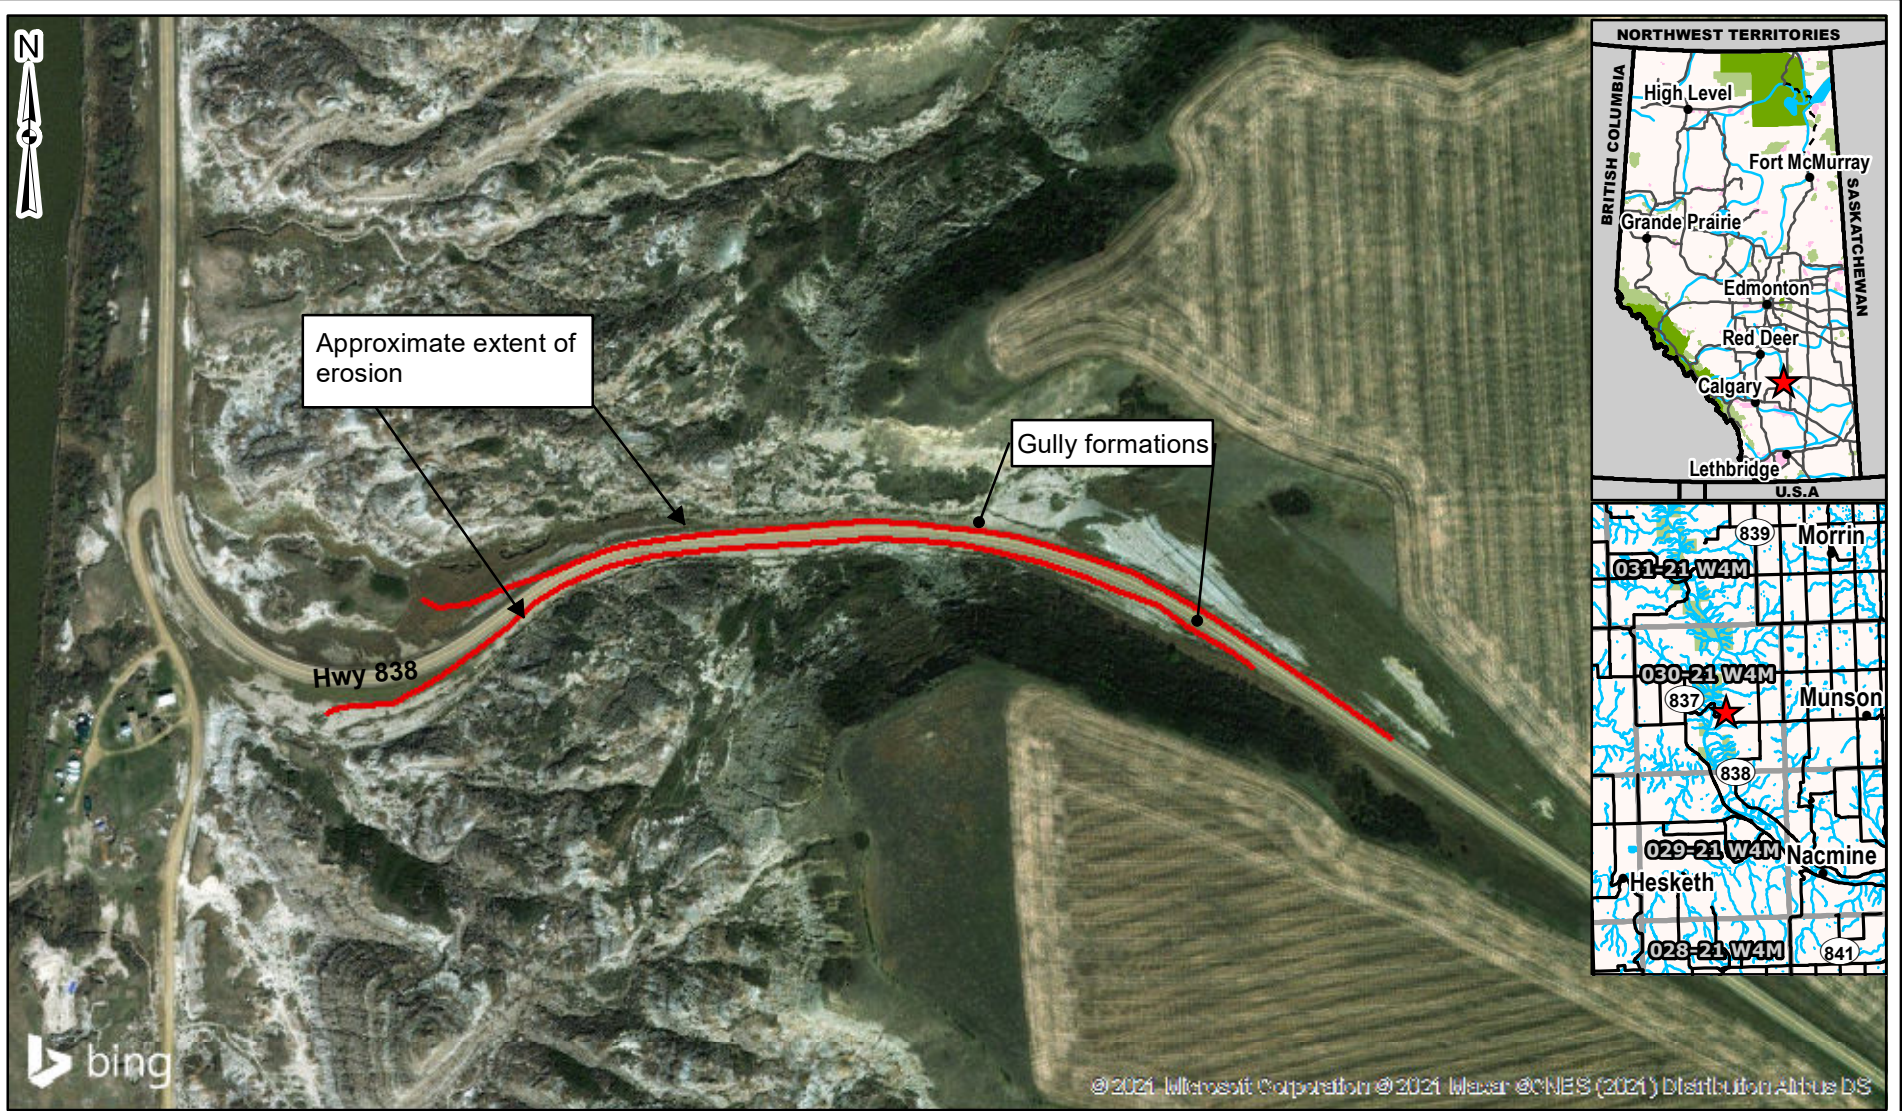
SCALE 1:4,000 PROJECT No. A05116A02 FIG No. 1

- The bedrock is exposed in the lower portions of the highway cut. Ditch erosion appears to start either just above or below the top of the bedrock on the north and south embankments of the road. Please refer to the site map (Figure 1) for approximate start and end points of the ditch erosion. The gullies have a maximum depth estimated to be between 1 and 2 m, a maximum width between 2 m and 5 m and side slope angles that vary from near vertical to approximately 1H:1V. They run at a length of approximately 600 m in the east to west direction. Please refer to Figure 1 for approximate extents of the erosion gullies.

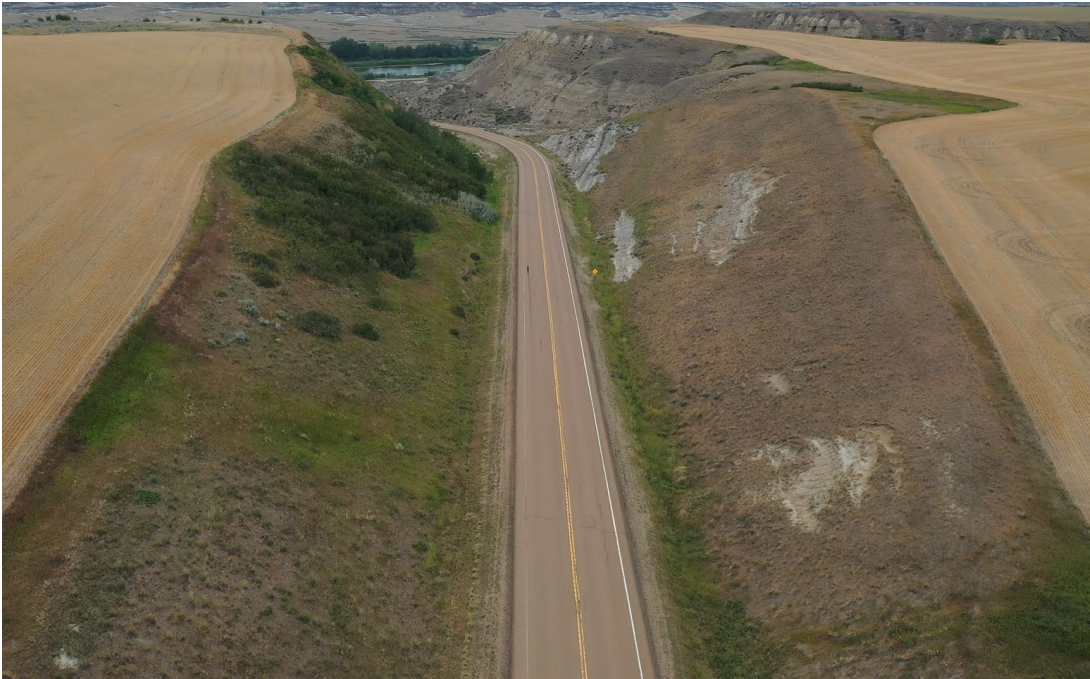
Figure 1 **Oblique aerial photo of the site: Hwy 838:02 east of Bleriot Ferry. This footage was taken August 16, 2021, facing west.**

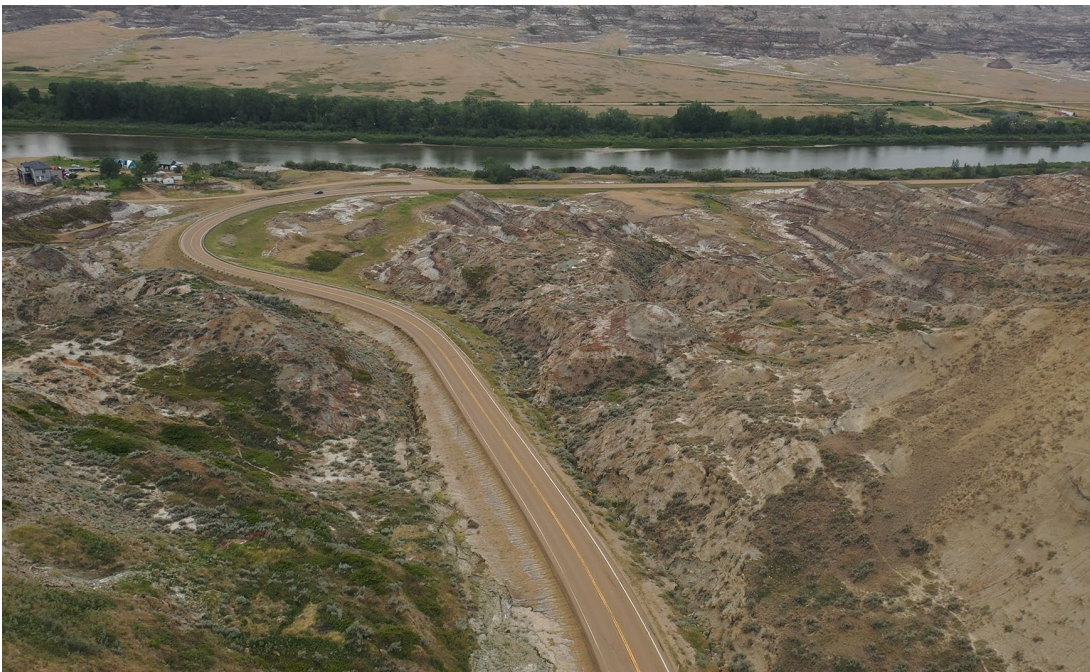
Figure 2 **Oblique air photo of the site east of the Red Deer River. This footage was taken August 16, 2021, facing west**

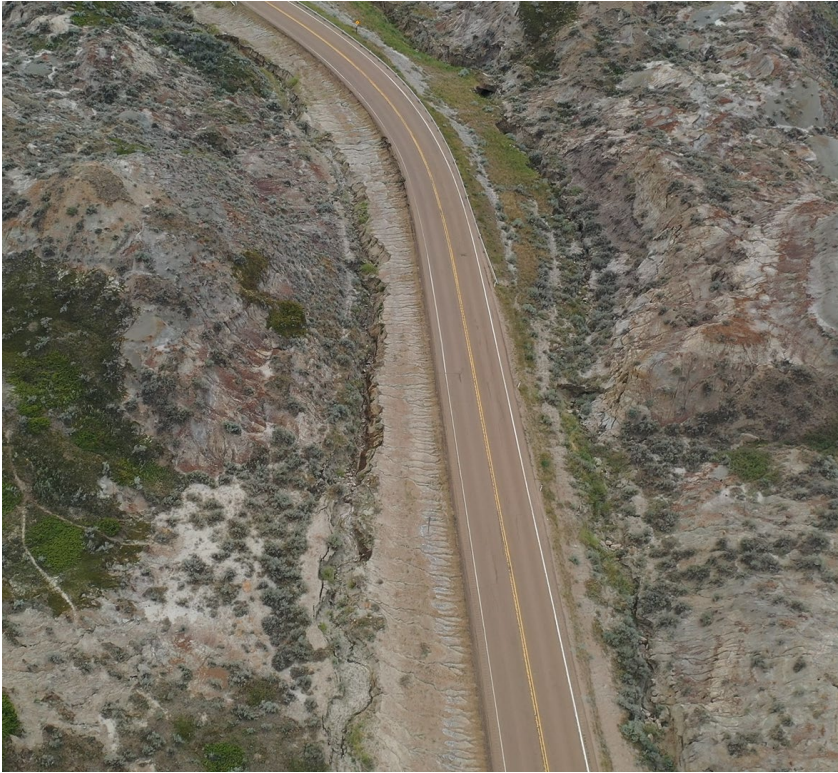
Figure 3 Oblique air photo of the erosion gullies at the toe of the north and south embankments and rilling erosion on the south embankment slope. W-beam guardrails exist along the lower/downhill portions of the road. Photo taken August 16, 2021, facing west.

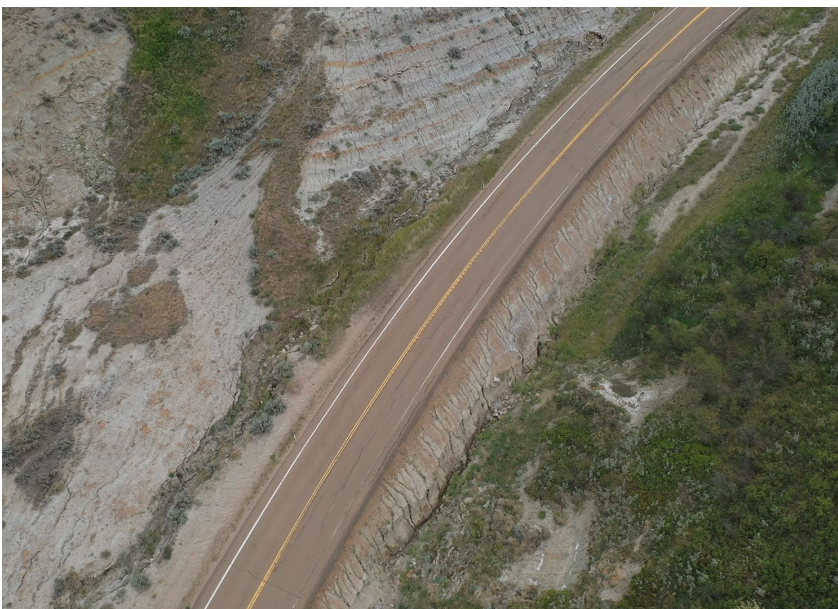
Figure 4 Oblique air photo of the highway highlighting the erosion gullies and rilling erosion along the north and south embankments. Photo taken August 16, 2021, facing east.

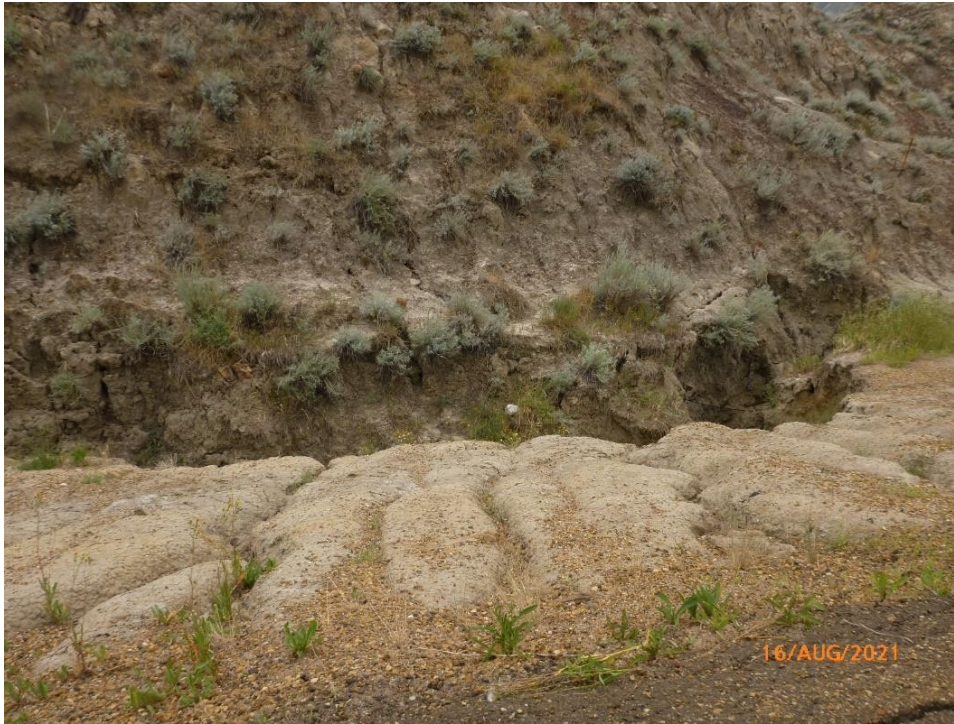
- The embankment slopes were noticed to be between 3H:1V to 2H:1V and appeared to be cut into bedrock in the lower portions of the site. The height of embankment varies from about 2 m in the upper reaches of the highway to 6 to 8 m in the lower portions of the highway where the embankment is partially constructed on the valley bottom. Some sections of the highway embankment have experienced rilling erosion between the edge of pavement and the ditch (Photo 5).

Figure 5 Large and deep gullies formed and rilling erosion of the road embankment. Photo was taken August 16, 2021, facing south.

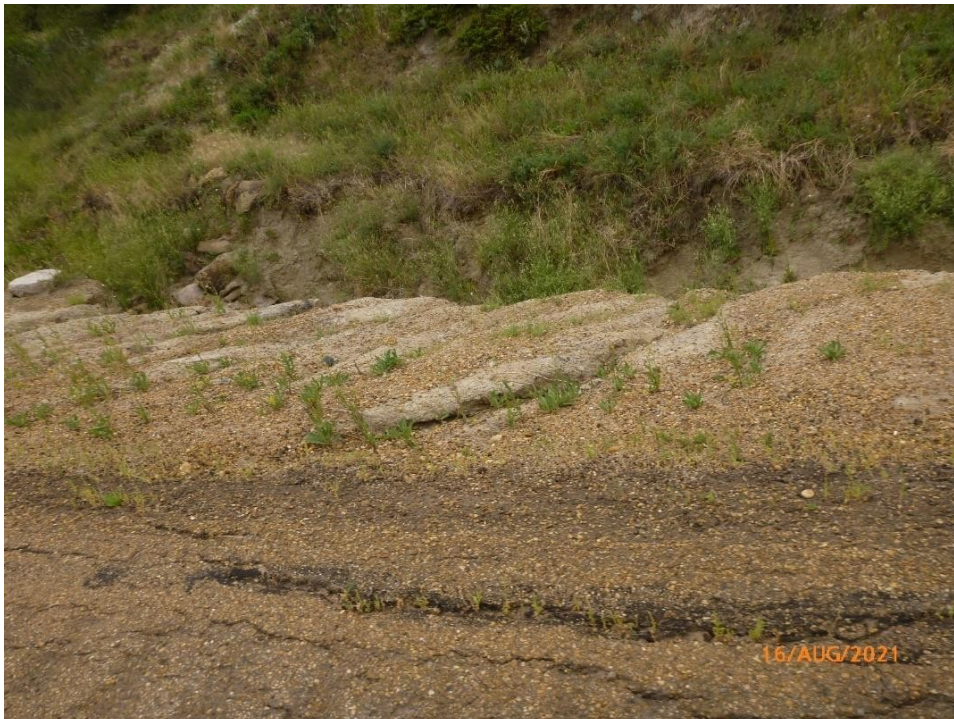
Figure 6 Large gullies and rilling erosion along the embankment slope. Photo was taken August 16, 2021, facing south.

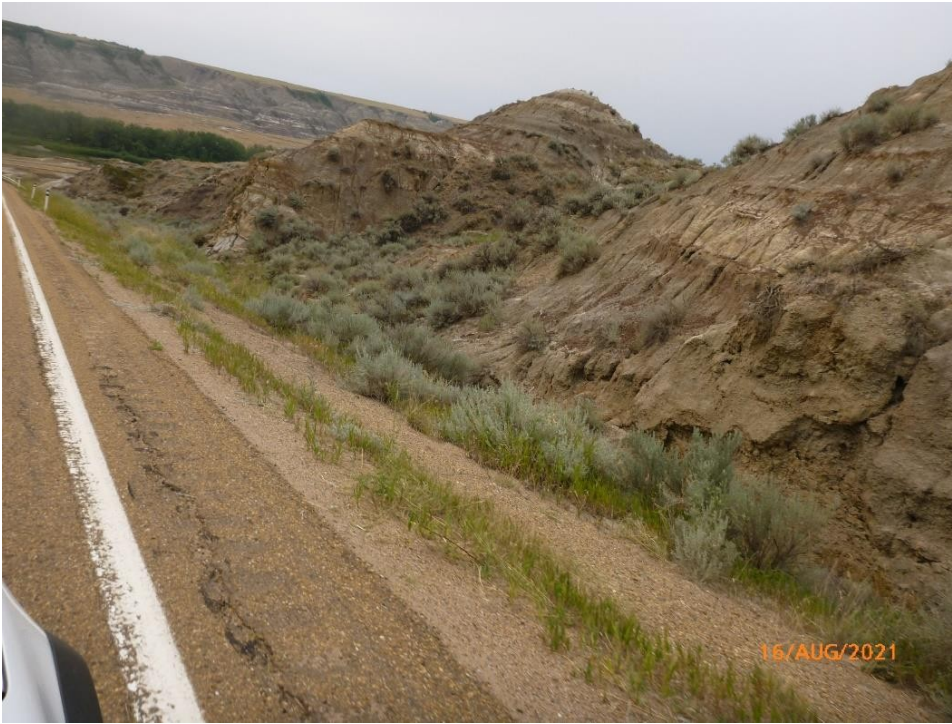
Figure 7 Northern side of the road shoulder cracking due to eroding road embankment. Photo was taken on August 16, 2021, facing north-west.

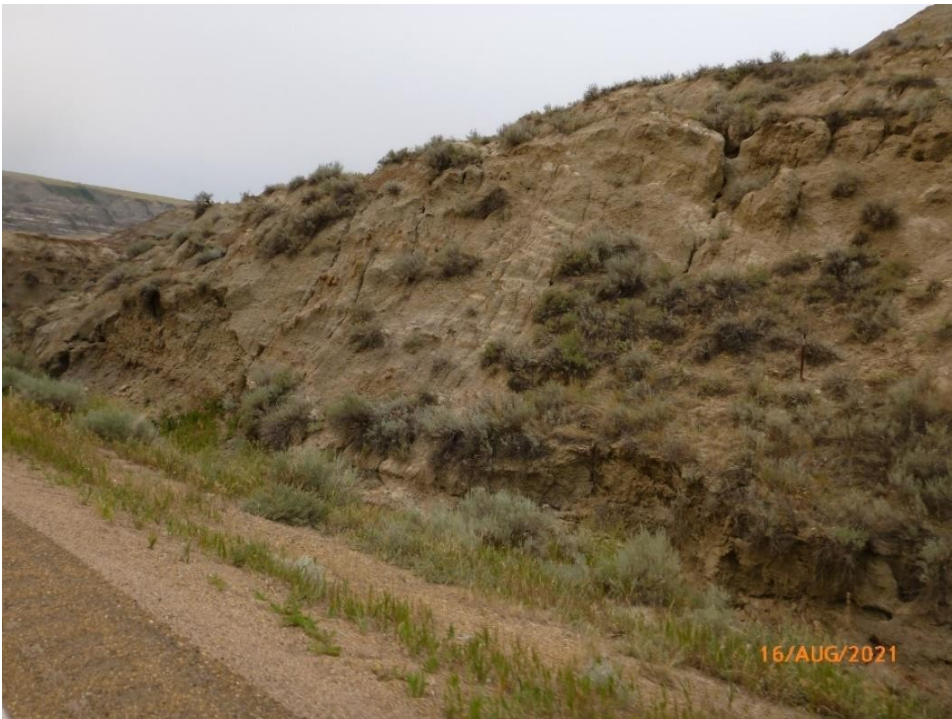
Figure 8 North natural slope eroding into the ditch. Photo was taken on August 16, 2021, facing north-west.
