SITE NUMBER AND NAME: C012 Hwy 841 Ditch Erosion		HIGHWAY & KM: 841:02, 6.495	PREVIOUS INSPECTION DATE: June 25, 2020 (Call-Out Inspection)	INSPECTION DATE: June 24, 2021
LEGAL DESCRIPTION: 33-27-20-W4M	NAD 83 COORDINATES: UTM Northing Easting 12 5689847 377129		RISK ASSESSMENT: PF: 9 CF: 3 TOTAL: 27	
AVERAGE ANNUAL DAILY TRAFFIC (AADT): 100 (north) & 240 (south) (Ref No. 109220 & 108240)			CONTRACT MAINTENANCE AREA (CMA): 517

SUMMARY OF SITE INSTRUMENTATION: There is no instrumentation at the C012 site. LAST READING DATE: N/A	INSPECTED BY: Chris Gräpel (KCB) James Lyons (KCB) Roger Skirrow (AT) Tony Penney (AT)
PRIMARY SITE ISSUE: Erosion in the ditch on the west side (southbound lane) of Hwy 841 near and either end of the geocell armoring and gabion drop structure; and erosion of the toe of the tall slope on the west side (southbound lane) of Hwy 841.	
APPROXIMATE DIMENSIONS: The site is approximately 650 m long, and the highway embankment above the ditch is approximately 2 m to 3 m high sloped at approximately 4H:1V. Approximately 50 m to 100 m of the ditch is reinforced with geocell armoring and the height of the slope west of the highway is estimated to be approximately 25 m.

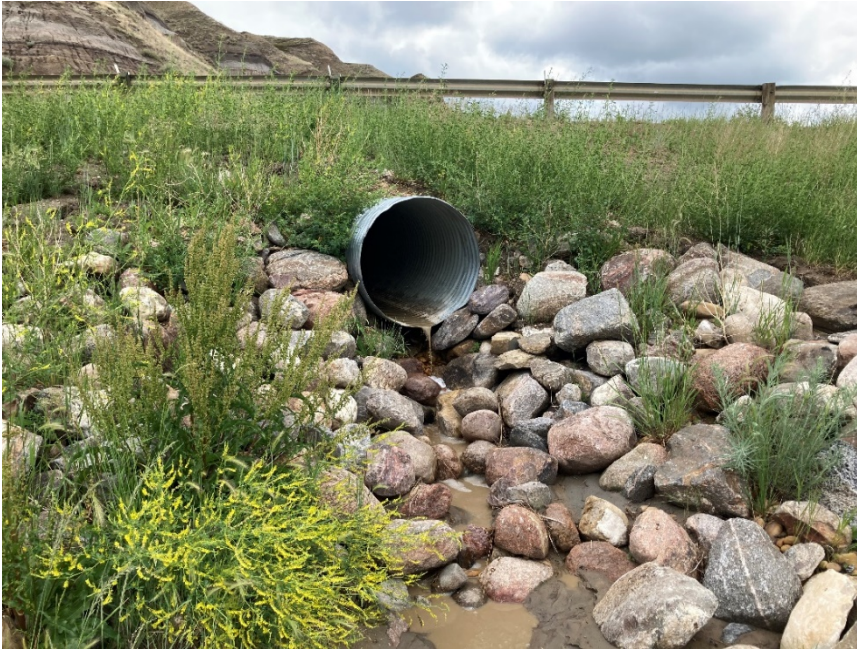
Photo 1 Riprap apron at the outlet of the culvert beneath Hwy 841:02. The vegetation coverage on the highway embankment improved since the 2020 call-out. Photo taken June 24, 2021 facing east.

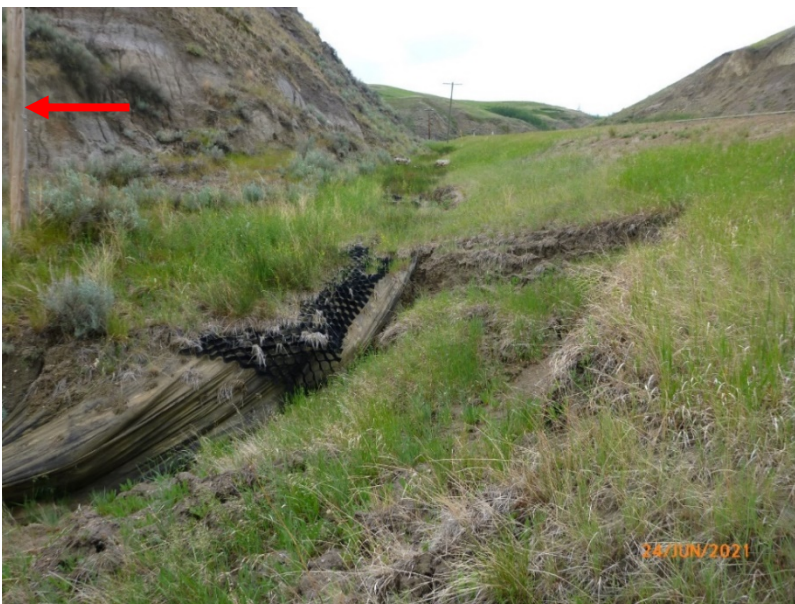
Near the south extent of the ditch erosion in the west ditch, there are erosion gullies upwards of 3 m to 4 m deep. The erosion gully has triggered a slope failure that hasn't impacted the southbound lane of Hwy 841 (Photo 3). However, eventually the erosion gully will impact a nearby power pole located on the west side of the ditch (Photo 2).

Photo 2 A failed section of geocell armouring that was previously installed near the south extent of the site. Red arrow indicates power pole that will be impacted by erosion. Photo taken June 24, 2021 facing north.

- Repair, replace, or extend the geotextile and geocell reinforcement previously installed along the west ditch. (i) Where the geocell reinforcement is intact, the geocell should be backfilled with granular material or fine-grained material that will promote more rapid revegetation. Additional geocell should be installed to maintain a channel shape to prevent erosion occurring at the edges of the geocell reinforcement. (ii) Where the geocell reinforcement has been undermined and bypassed by gulying, existing geocell and geotextile should be removed, gulying should be backfilled, and new geotextile and geocell armoring should be installed and maintain a channel shape. The geocell should be backfilled with granular material and disturbed areas should be hydro-mulched with a seed mix suitable for badlands soil. (iii) Where the geocell has been displaced by slope failure, place fill to allow ditch flows to flow over the toe of the slide area without excavating slide material that may further destabilize the slope. Armour regraded ditch with sand-and-gravel backfilled geocell. (iv) where the ditch has eroded and no geocell is present, extend the fully backfilled, ditch regrading and geocell repair while maintaining a ditch channel with freeboard to contact the ditch flows without exposing unarmoured soils to ditch flows.

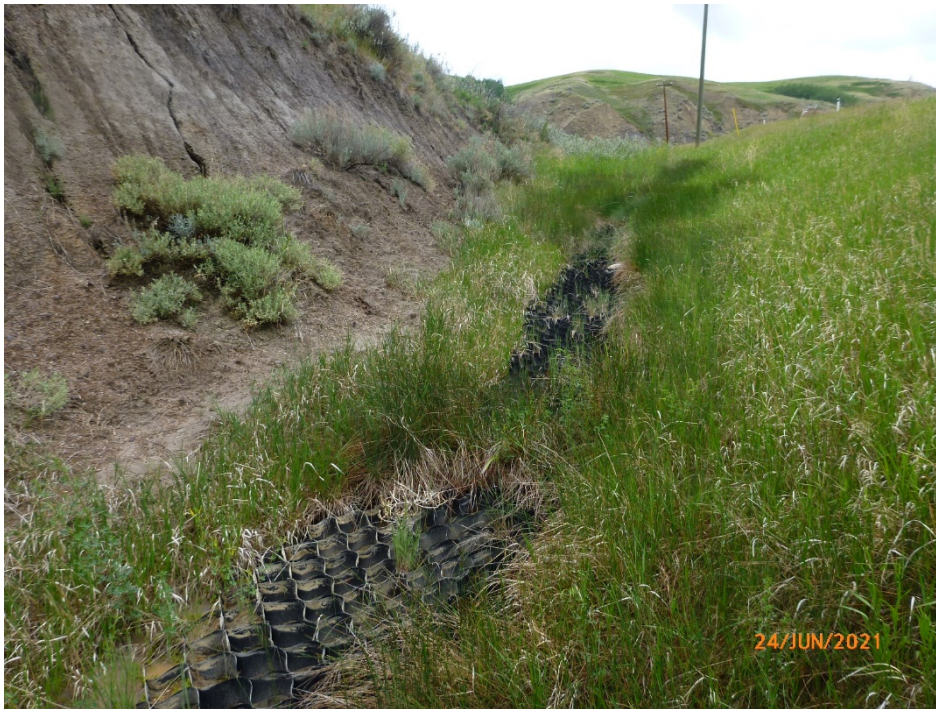
Photo 3 Geocell armoung in the west (southbound) ditch of Hwy 841. Photo taken June 24, 2021 facing north.

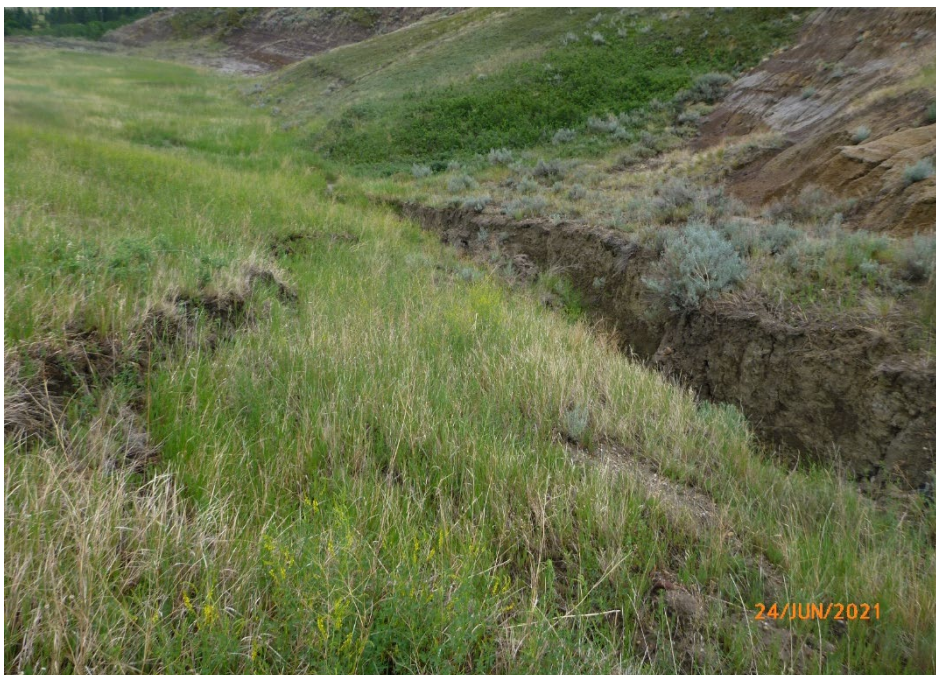
Photo 4 An embankment slope failure observed on the west (southbound) portion of the highway embankment slope, upslope of the gully erosion and near the south extent of the site. Photo taken June 24, 2021 facing southwest.

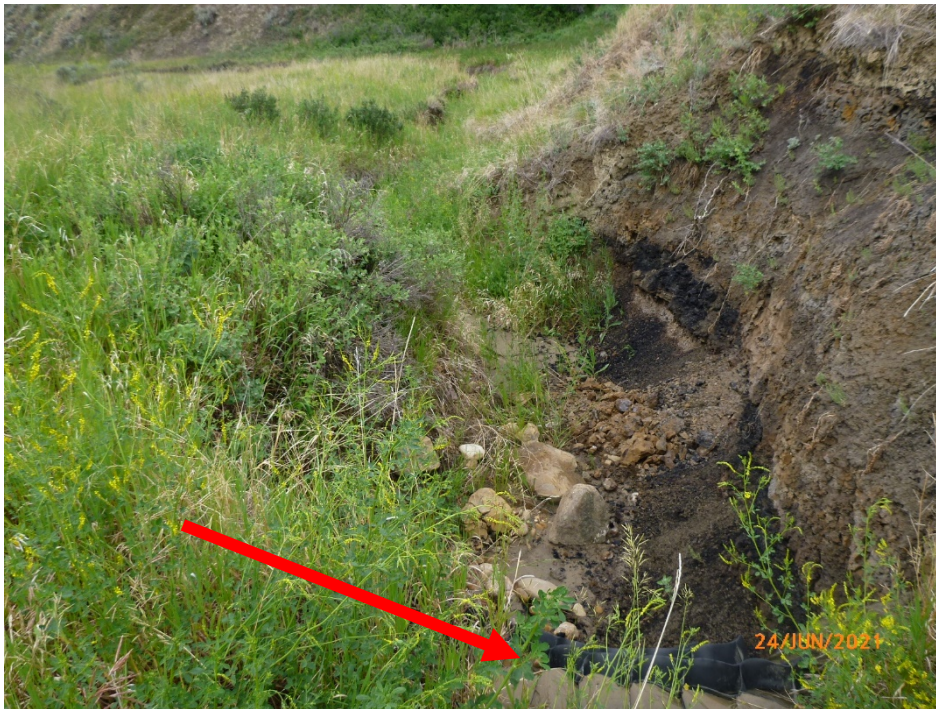
Photo 5 Erosion gully downstream of a gabion basket drop structure/geocell armouring (downstream edge indicated with red arrow). Photo taken June 24, 2021 facing west.

- AT should have a ditch armoring design prepared for where the ditch erosion is beginning to encroach upon the shoulder of the southbound lane of Hwy 841 and in the erosion gully that is forming at the downstream extent of the ditch reinforcements located at the north extent of the site.
- Signage (sharp shoulder) should be installed along the shoulder of the highway where the ditch erosion is starting to encroach upon the shoulder of the southbound lane of Hwy 841:02. If the ditch erosion begins to impact the highway embankment/road surface elsewhere, signage should also be installed there as well, and a speed reduction and/or temporary guard rail may be required.

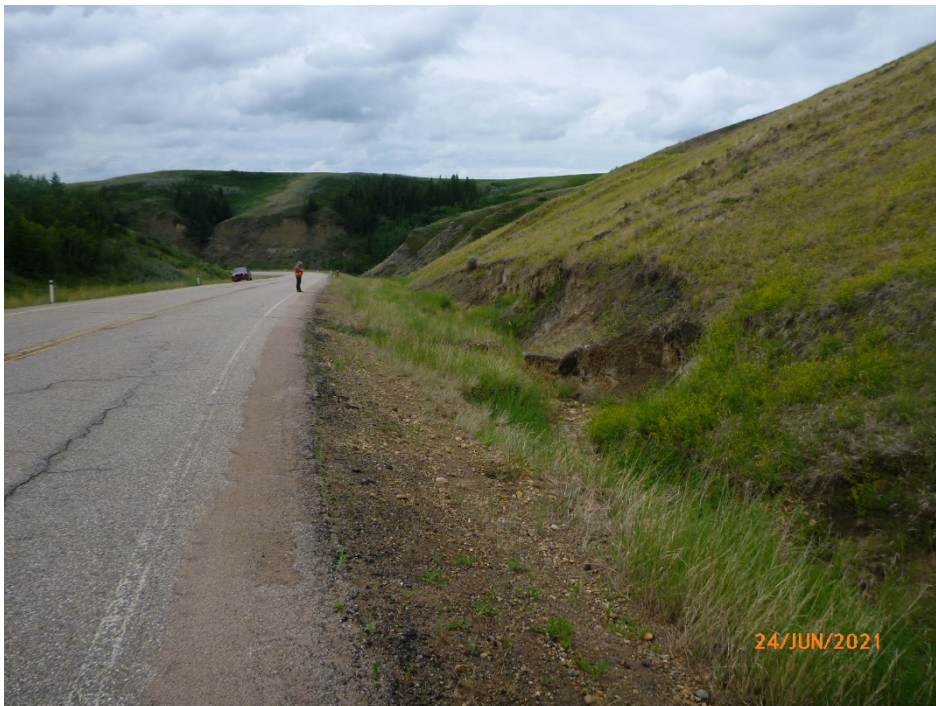
Ditch erosion at the north extent of the site is impacting the toe of the highway embankment along a 25-m-long section (Photo 6). Where the erosion is impacting the toe of the highway embankment, it has retrogressed to within 1 m to 2 m of edge of pavement. If not repaired the erosion will eventually impact the southbound lane of Hwy 841:02.

Photo 6 Ongoing erosion of the toe of the slope west of Hwy 841. Photo taken June 24, 2021 facing southwest.

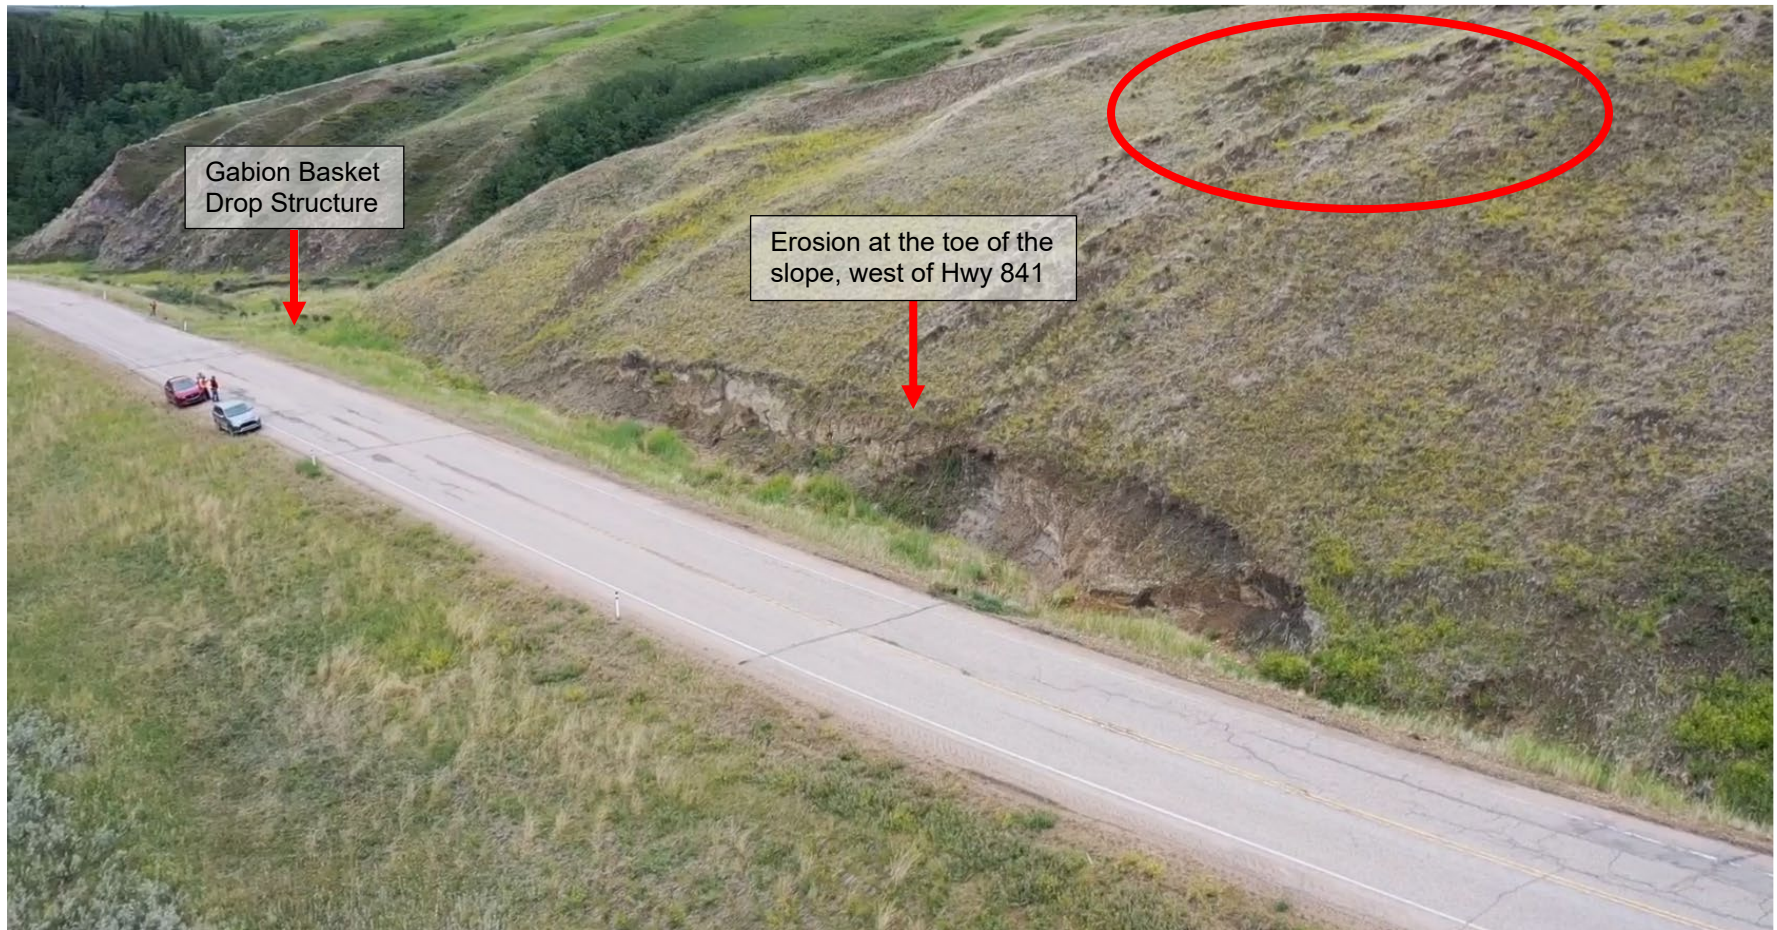
Ditch erosion of the steep and high (estimated to be 25 m high) natural slope has either caused or exacerbated a natural slope failure approximately 70 m wide that extends to just below the crest of the slope. The erosion scarp above ditch bottom appears to be about 3 to 4 m high above eroded ditch base. The ditch base appears to be eroded by 1.0 m to 1.5 m below original ditch grade.

Photo 7 Gabion basket drop structure and ongoing erosion occurring at the toe of the slope, on the west side (southbound) of Hwy 841. Red circle indicates slope instability on private land influenced by oversteepening at toe of slope due to ditch erosion. Photo taken June 24, 2021 facing west.

- A 3 m high, 70 m long gabion-basket retaining wall should be built at the north extent of the site along the portion of the backslope being impacted by the ditch erosion. The ditch bottom should be graded with well-compacted fill to replace eroded material (estimated to be about 1.5 m) and establish positive drainage away from the slope.
