SITE NUMBER AND NAME: C023-I Battle River Crossing Erosion C023-II Slope Failure		HIGHWAY & KM: 854:01, 14.017	PREVIOUS INSPECTION DATE: July 12, 2019	INSPECTION DATE: June 24, 2020
LEGAL DESCRIPTION: 16-07-043-17 W4M	NAD 83 COORDINATES: UTM Northing Easting 12 5839557 402074		RISK ASSESSMENT: C023-I PF: 10 CF: 3 TOTAL: 30 C023-II PF: 8 CF: 4 TOTAL: 32	
AVERAGE ANNUAL DAILY TRAFFIC (AADT): 140 (south) & 110 (north) (Ref No. 114370 & 997079)			CONTRACTOR MAINTENANCE AREA (CMA): 513

PRIMARY SITE ISSUE: C023 – I: Erosion on north bank of Battle River valley. West side of highway: erosion of unvegetated area upslope of Battle River. East side of highway: failure of gabion mattress armoured ditch chute. C023 – II: A small landslide on the south bank of the Battle River, partially beneath the bridge.

PROJECT	CENTRAL REGION GEOHAZARD RISK MANAGEMENT PROGRAM	
TITLE	Site Plan C023 - Battle River Crossing Erosion and Slope Failure Hwy 854:01, km 14.017	
SCALE	PROJECT No.	FIG No.
1:1,300	A05115A02	1

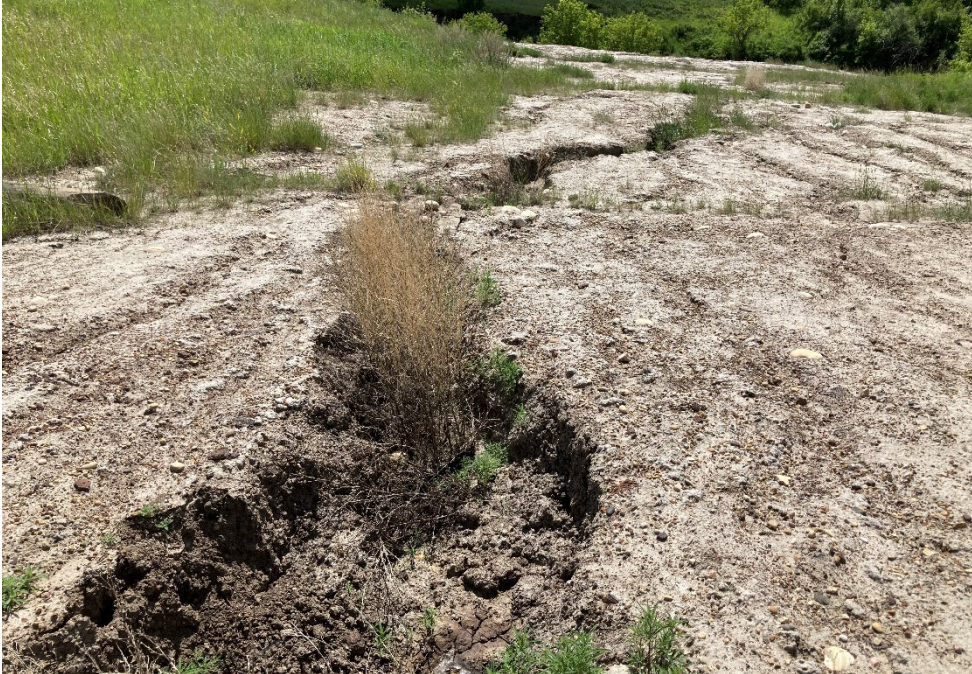
The inlet and outlet gabion catch basin structures on the north side of the bridge remain clogged. The west side gabion catch basin inlet continues to overflow onto the unvegetated slope into the existing erosion gully observed during the 2018 inspection. Although the erosion gully has not expanded significantly since 2018, it will continue to expand if left unrepaired. Grass growth is limited to the areas where coir rolls, now deteriorated, that retained sediments and seeds from previous seeding.

Photo 1 Gully erosion below gabion catch-basin inlet on west side of highway. Inlet overflowed from being clogged with sediment and vegetation. The inlet is still clogged and needs to be cleaned out. Photo June 24, 2020 facing southwest.

- Sediment build-up and vegetation in gabion catch basins on both side of highway need to be cleaned out. Drainage ditch needs cleaning/trimming of overgrown vegetation.

- Gullying downslope of the west side gabion catch basin should be repaired.
- Repair options for failed gabion mattress could include excavation of gabion mattress and replacement with rip rap with proper bedding and check trenches. Size of rip rap should be designed based on flow rate determined from required rainfall event return period and catchment area.

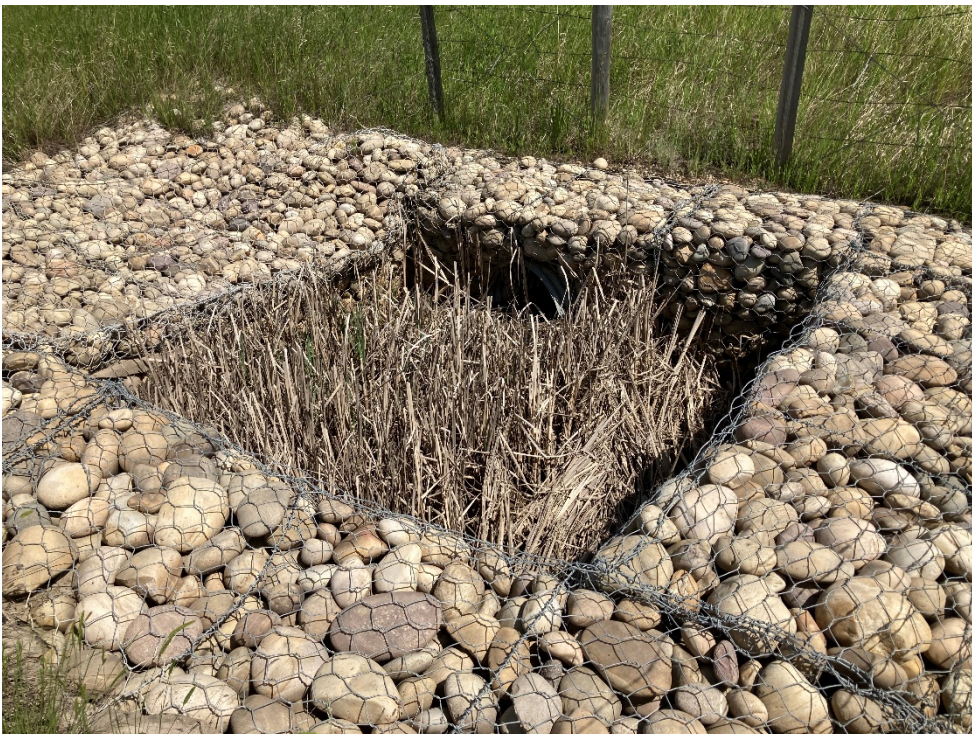
Photo 2 Vegetation and sediment build-up at the catch basin structure at the inlet of the culvert. Photo taken June 24, 2020 facing east.

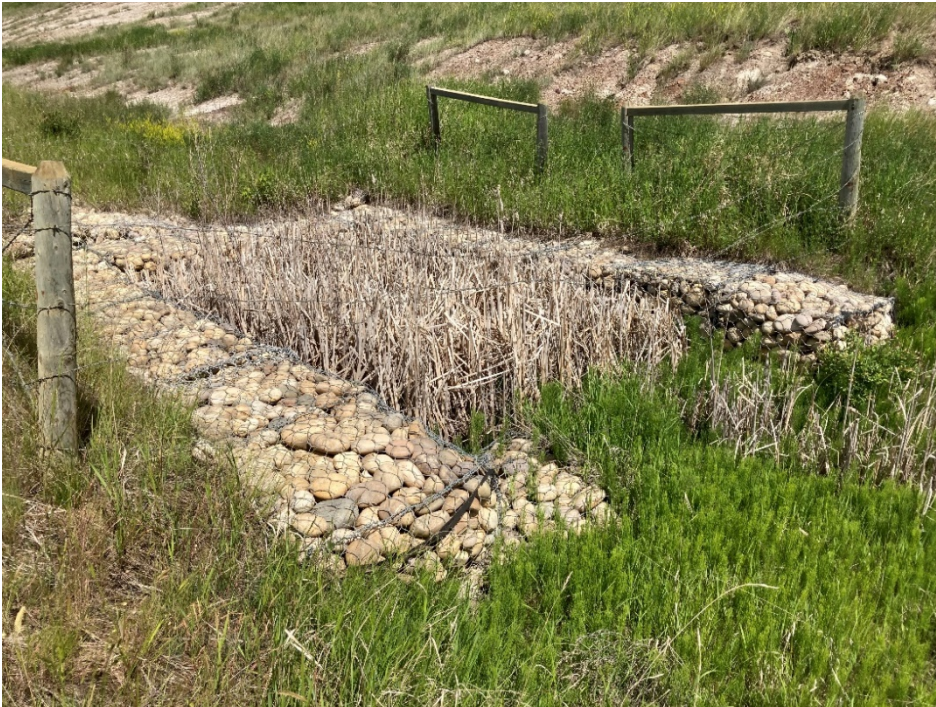
Photo 3 Gabion basket outlet structure on east side of highway still clogged with sediments and dense vegetation. Photo taken June 24, 2020 looking northeast.

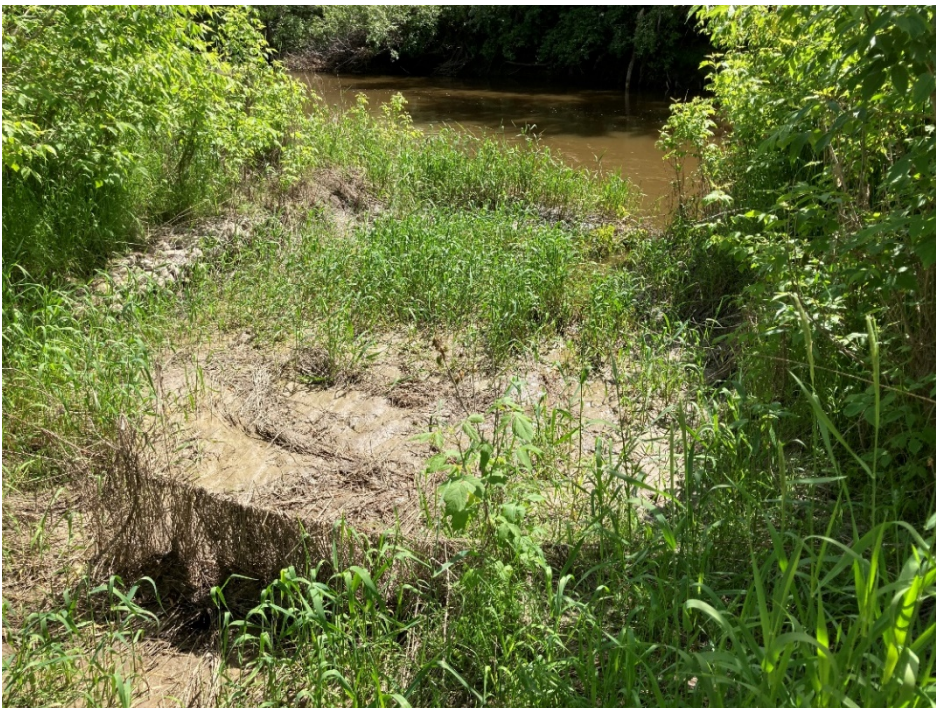
Photo 4 Sediment deposit from a previous high-water event at the outlet of the gabion mattress lined channel. Photo taken June 24, 2020 facing south.

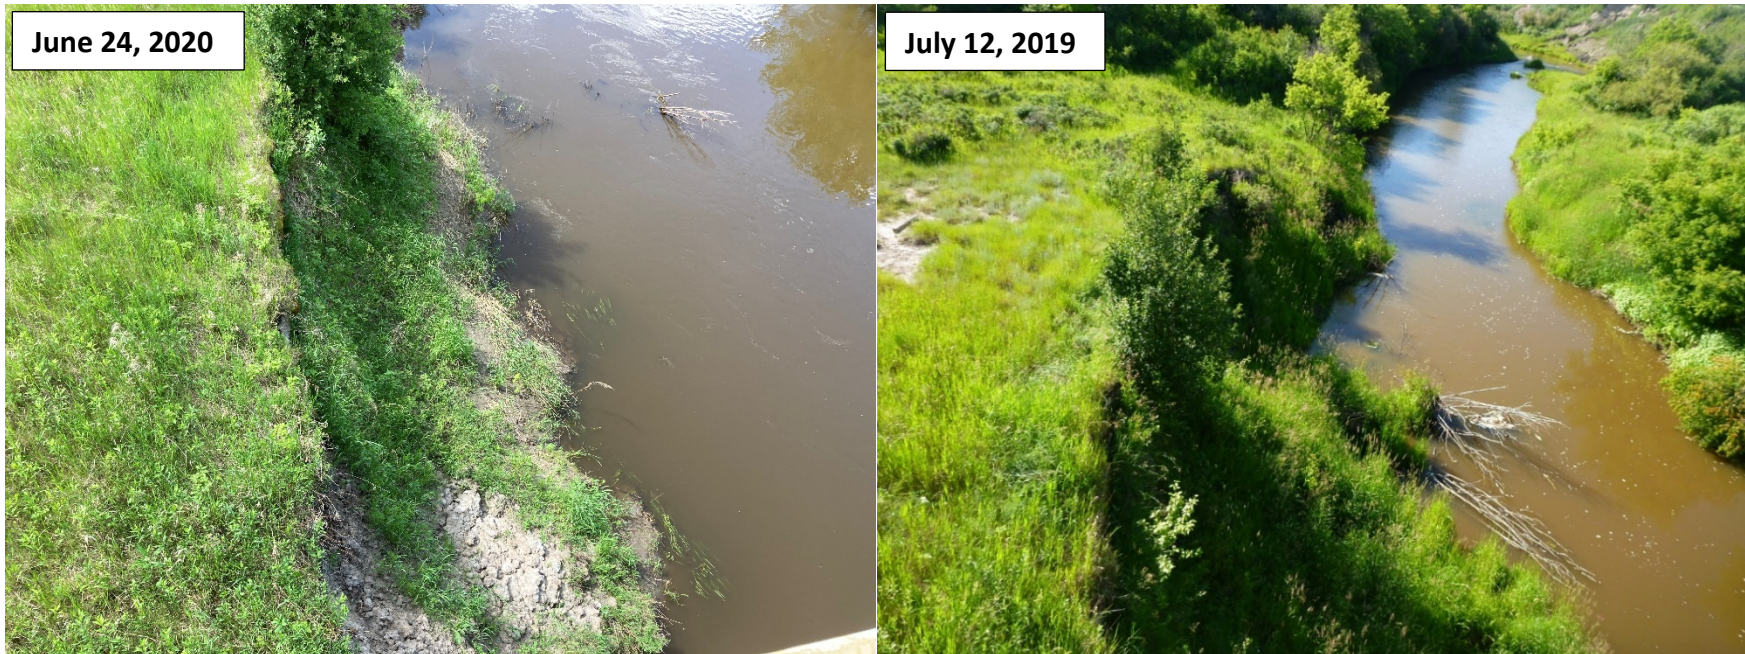
Photo 5 Slide on the south embankment of the Battle River (Photo from 2019 inspection included for comparison). Photo taken June 24, 2020 looking west.

- The slope failure observed on the west side of and adjacent to the south abutment of the bridge should be monitored. Repair of the slope failure could start with armouring the riverbank to control erosion upstream of and underneath the bridge deck. Soil nailing could be used to stabilize the slide, or the slope below the bridge could be flattened with an excavator, with excavated material hauled away.

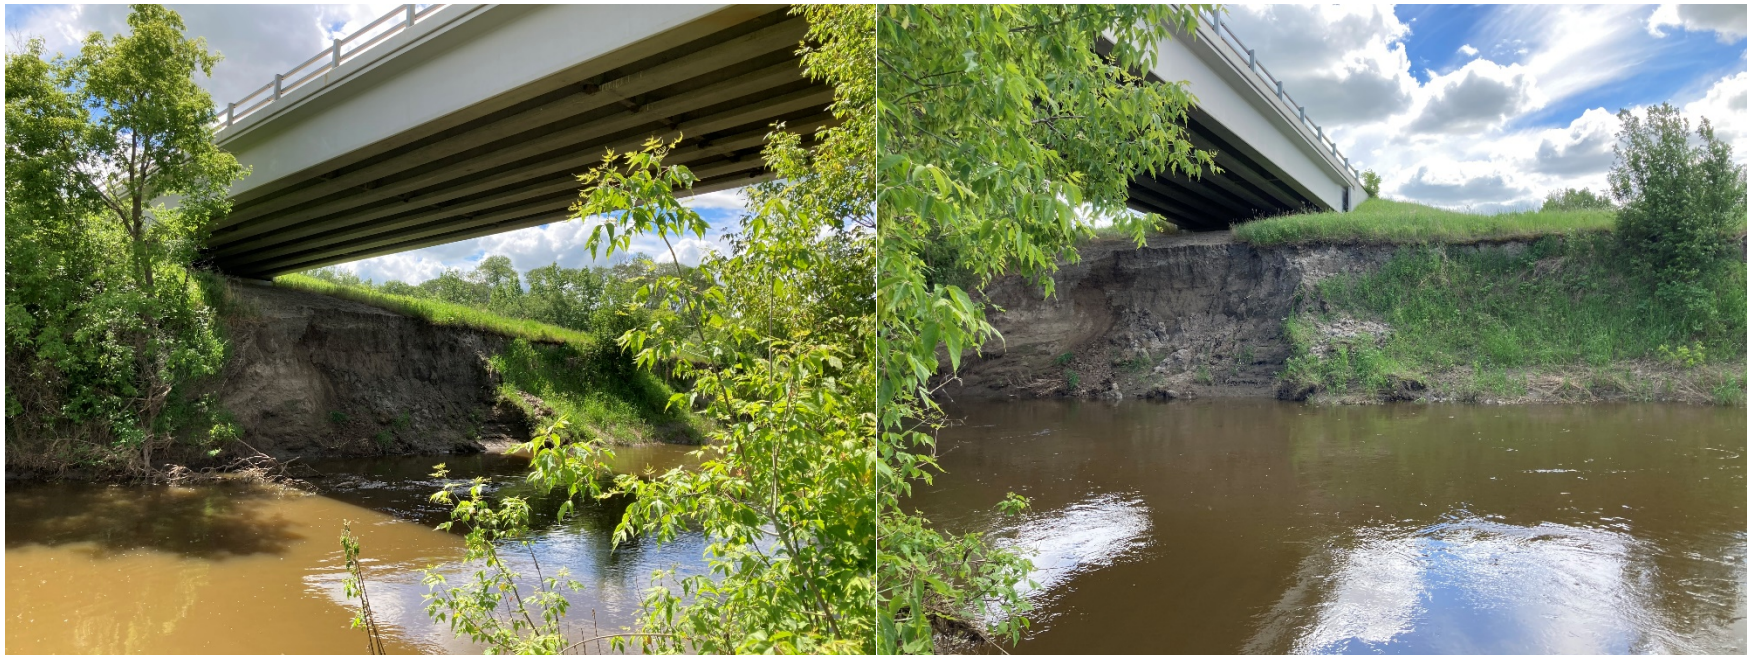
The riverbank along the south abutment directly below the bridge is showing signs of retrogressive slope failure. A steep (approximately 1H:1V) riverbank slope 4 to 5 m high is located at the edge of the river, with approximately 15 m between the crest of the slope and the bridge abutment.

Photo 6 Unstable south abutment riverbank directly below bridge deck. Photo taken June 24, 2020 from the east and west side of the bridge, respectively.
