SITE NUMBER AND NAME: <b>C055-I &amp; II Galahad Slide and Riverbank Erosion</b>		HIGHWAY & KM: 861:02, 26.00	PREVIOUS INSPECTION DATE: June 13, 2018	INSPECTION DATE: <b>July 12, 2019</b>
LEGAL DESCRIPTION: 13-14-040-14 W4M	NAD 83 COORDINATES: UTM Northing Easting		RISK ASSESSMENT:	
	<b>C055-I</b>	12 5811270 437304	PF: 9 CF: 5	TOTAL: 45
	<b>C055-II</b>	12 5811329 437306	PF: 8 CF: 2	TOTAL: 16
AVERAGE ANNUAL DAILY TRAFFIC (AADT): 90 (north) (Ref No. 70000159)			CONTRACT MAINTENANCE AREA (CMA): 21

PROJECT CENTRAL REGION GEOHAZARD RISK MANAGEMENT PROGRAM		
TITLE Site Plan C055 - Galahad Slide Hwy 861:02, km 26.000		
SCALE 1:1,000	PROJECT No. A05115A02	FIG No. 1

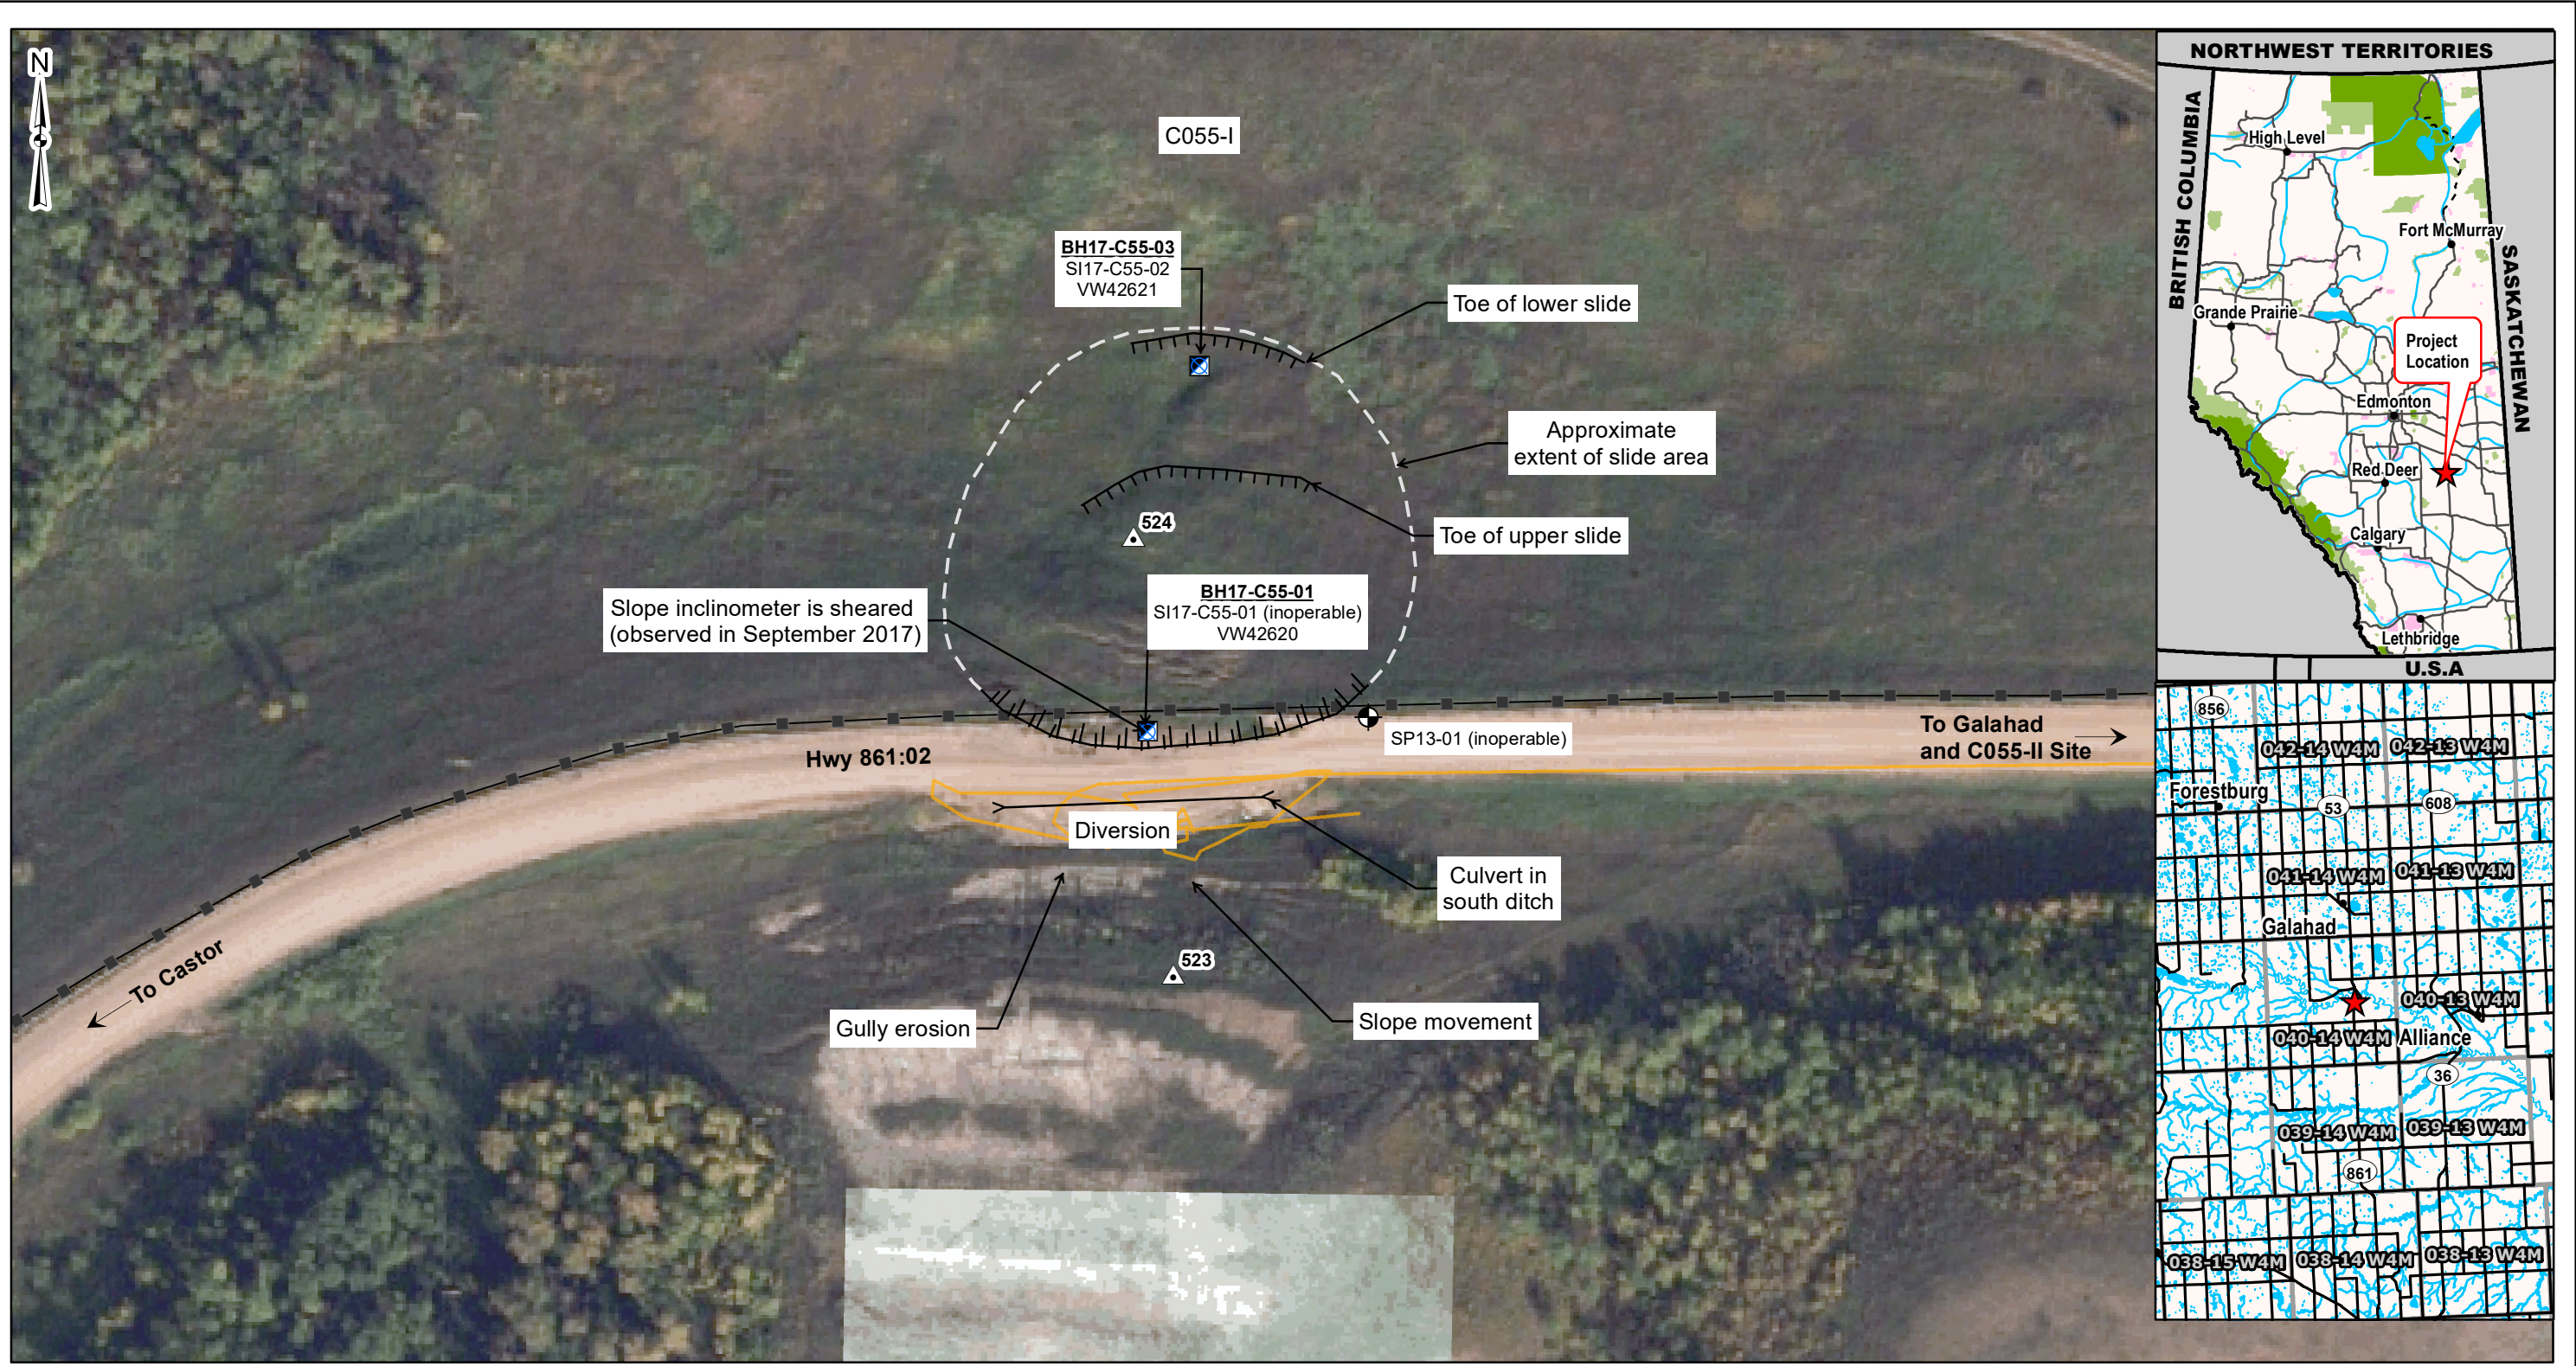
<b>COMMENTS</b>
At C055 – I:
<ul style="list-style-type: none"> <li>Guardrail did not appear to have settled further since the 2018 inspection.</li> <li>There appears to be two slope failures below the highway, one upper and one lower.</li> <li>Some cracking observed on the backslope above the highway in 2018 (waypoint 523)</li> <li>The toe of the upper slide (toe roll, waypoint 525) appears to be halfway down slope.</li> <li>The slope inclinometer installed at the crest of the slope recorded movement at 7.7 m depth below road surface near the contact between the silty clay till and the mudstone bedrock. The SI has since been sheared and is no longer operable.</li> <li>The lower slide appears to be rotational or translational, with back tilting of the head of the slide or a</li> </ul>

graben at waypoint 524.

- Approximately 25 m of guardrail has settled.
- Trees cleared at crest of natural slope above slide. Timing of tree clearing unknown.
- A ditch culvert was installed at the south ditch to allow for the road to be shifted to the south, away from the slide. Erosion observed at culvert inlet.

At C055 – II, riverbank erosion appears to be progressing at a slow but consistent rate. Stakes installed 2 m behind the crest of the steep erosion slope during the 2017 inspection have since been removed, likely by mowing equipment.

C055 – I: Raise guardrail to prevent vehicles from sliding overtop and down the slope. Construct berm on lower half of slope to buttress the slope, with finger drains to convey seepage water from the slope face to the toe of the berm; and reconstruct upper slope with geosynthetic reinforced fill. The toe berm will require land acquisition after preliminary engineering has been completed to assess the area of land required.

C055 – II: Install a guard rail (or HTCB) and eventually realign this portion of the highway further away from outside bend and erosion zone of the Battle River.

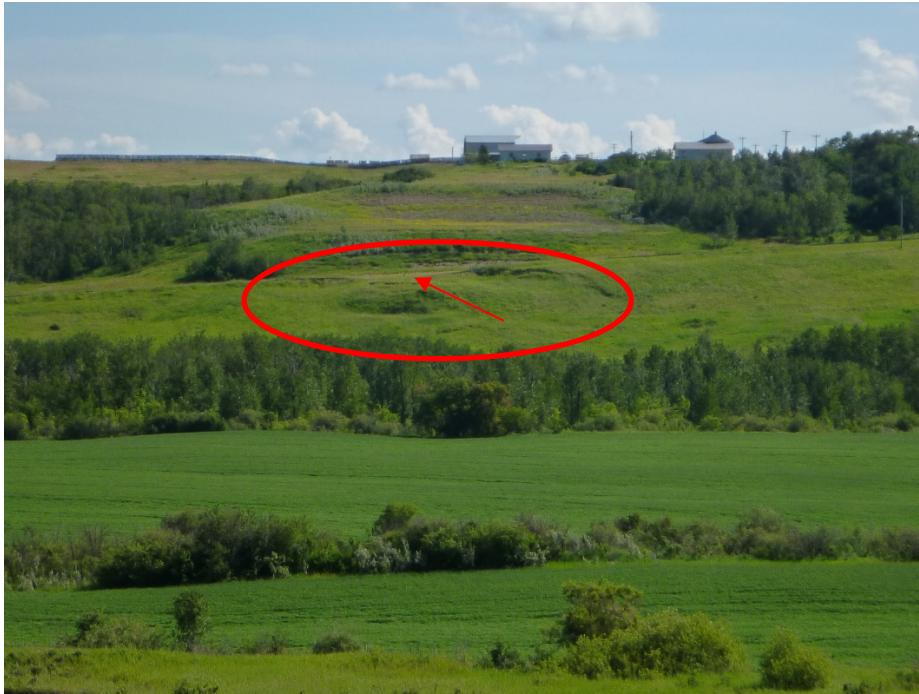
**Photo 1** View of C055-I slide site from Hwy 861 (red circle). Note trees cleared on slope above C055-I site. Red arrow indicates location of settled guardrail. Photo taken July 12, 2019 looking south.

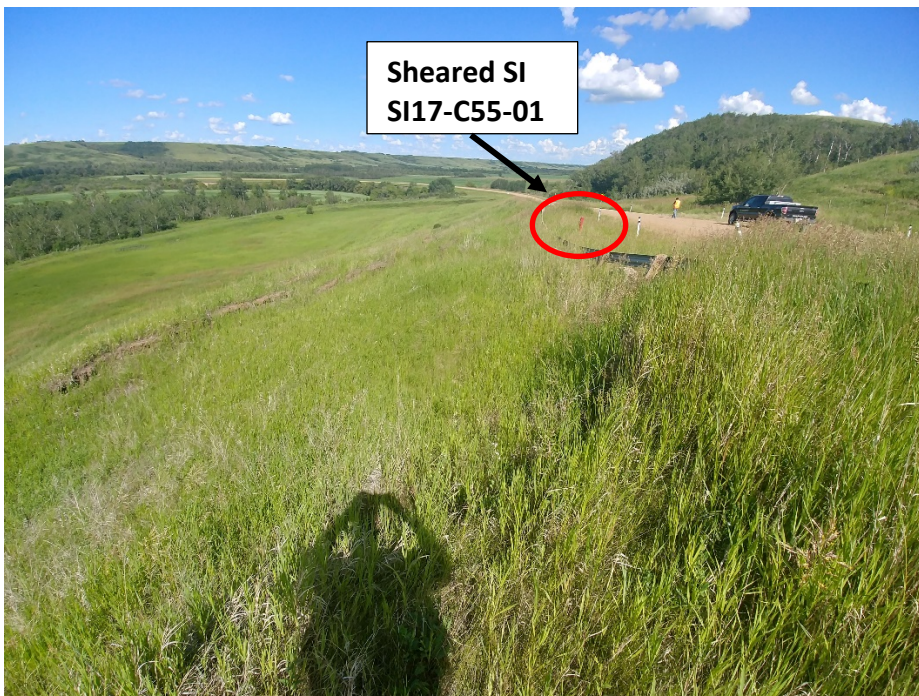
**Photo 2** View of C055-I slide area, settled guardrail, and sheared SI. Photo taken July 12, 2019 looking east.

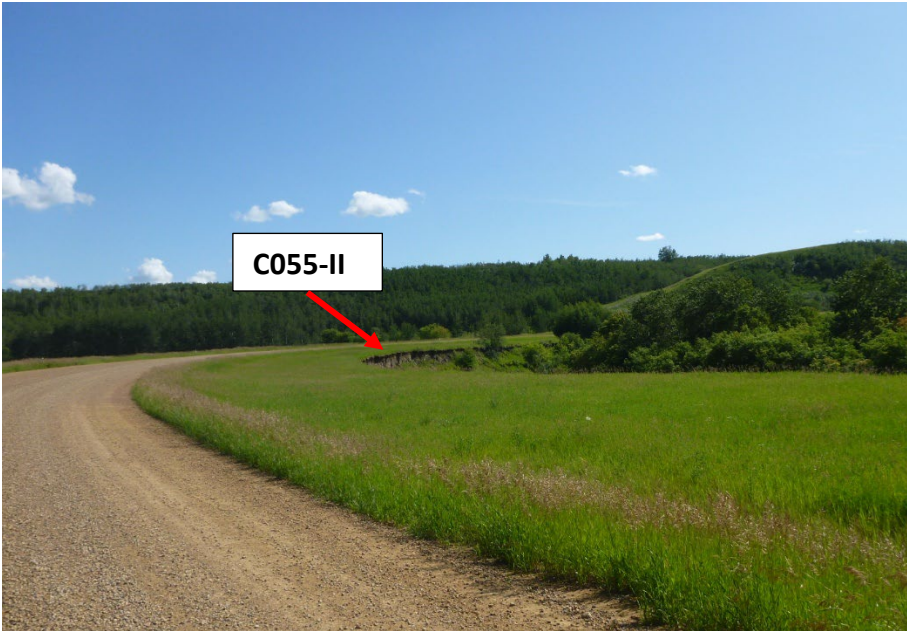
**Photo 3** Photo showing the location of the C055-II riverbank erosion site. Photo taken July 12, 2019 looking south.
