November 19, 2021

Alberta Transportation
4th Floor, Provincial Building
4920 – 51st Street
Red Deer, Alberta
T4N 6K8

**CON0022160 Central Region GRMP Instrumentation Monitoring
Site C055-I; H861:02, km 26.000 Galahad Slide
Section C – 2021 Fall Readings**

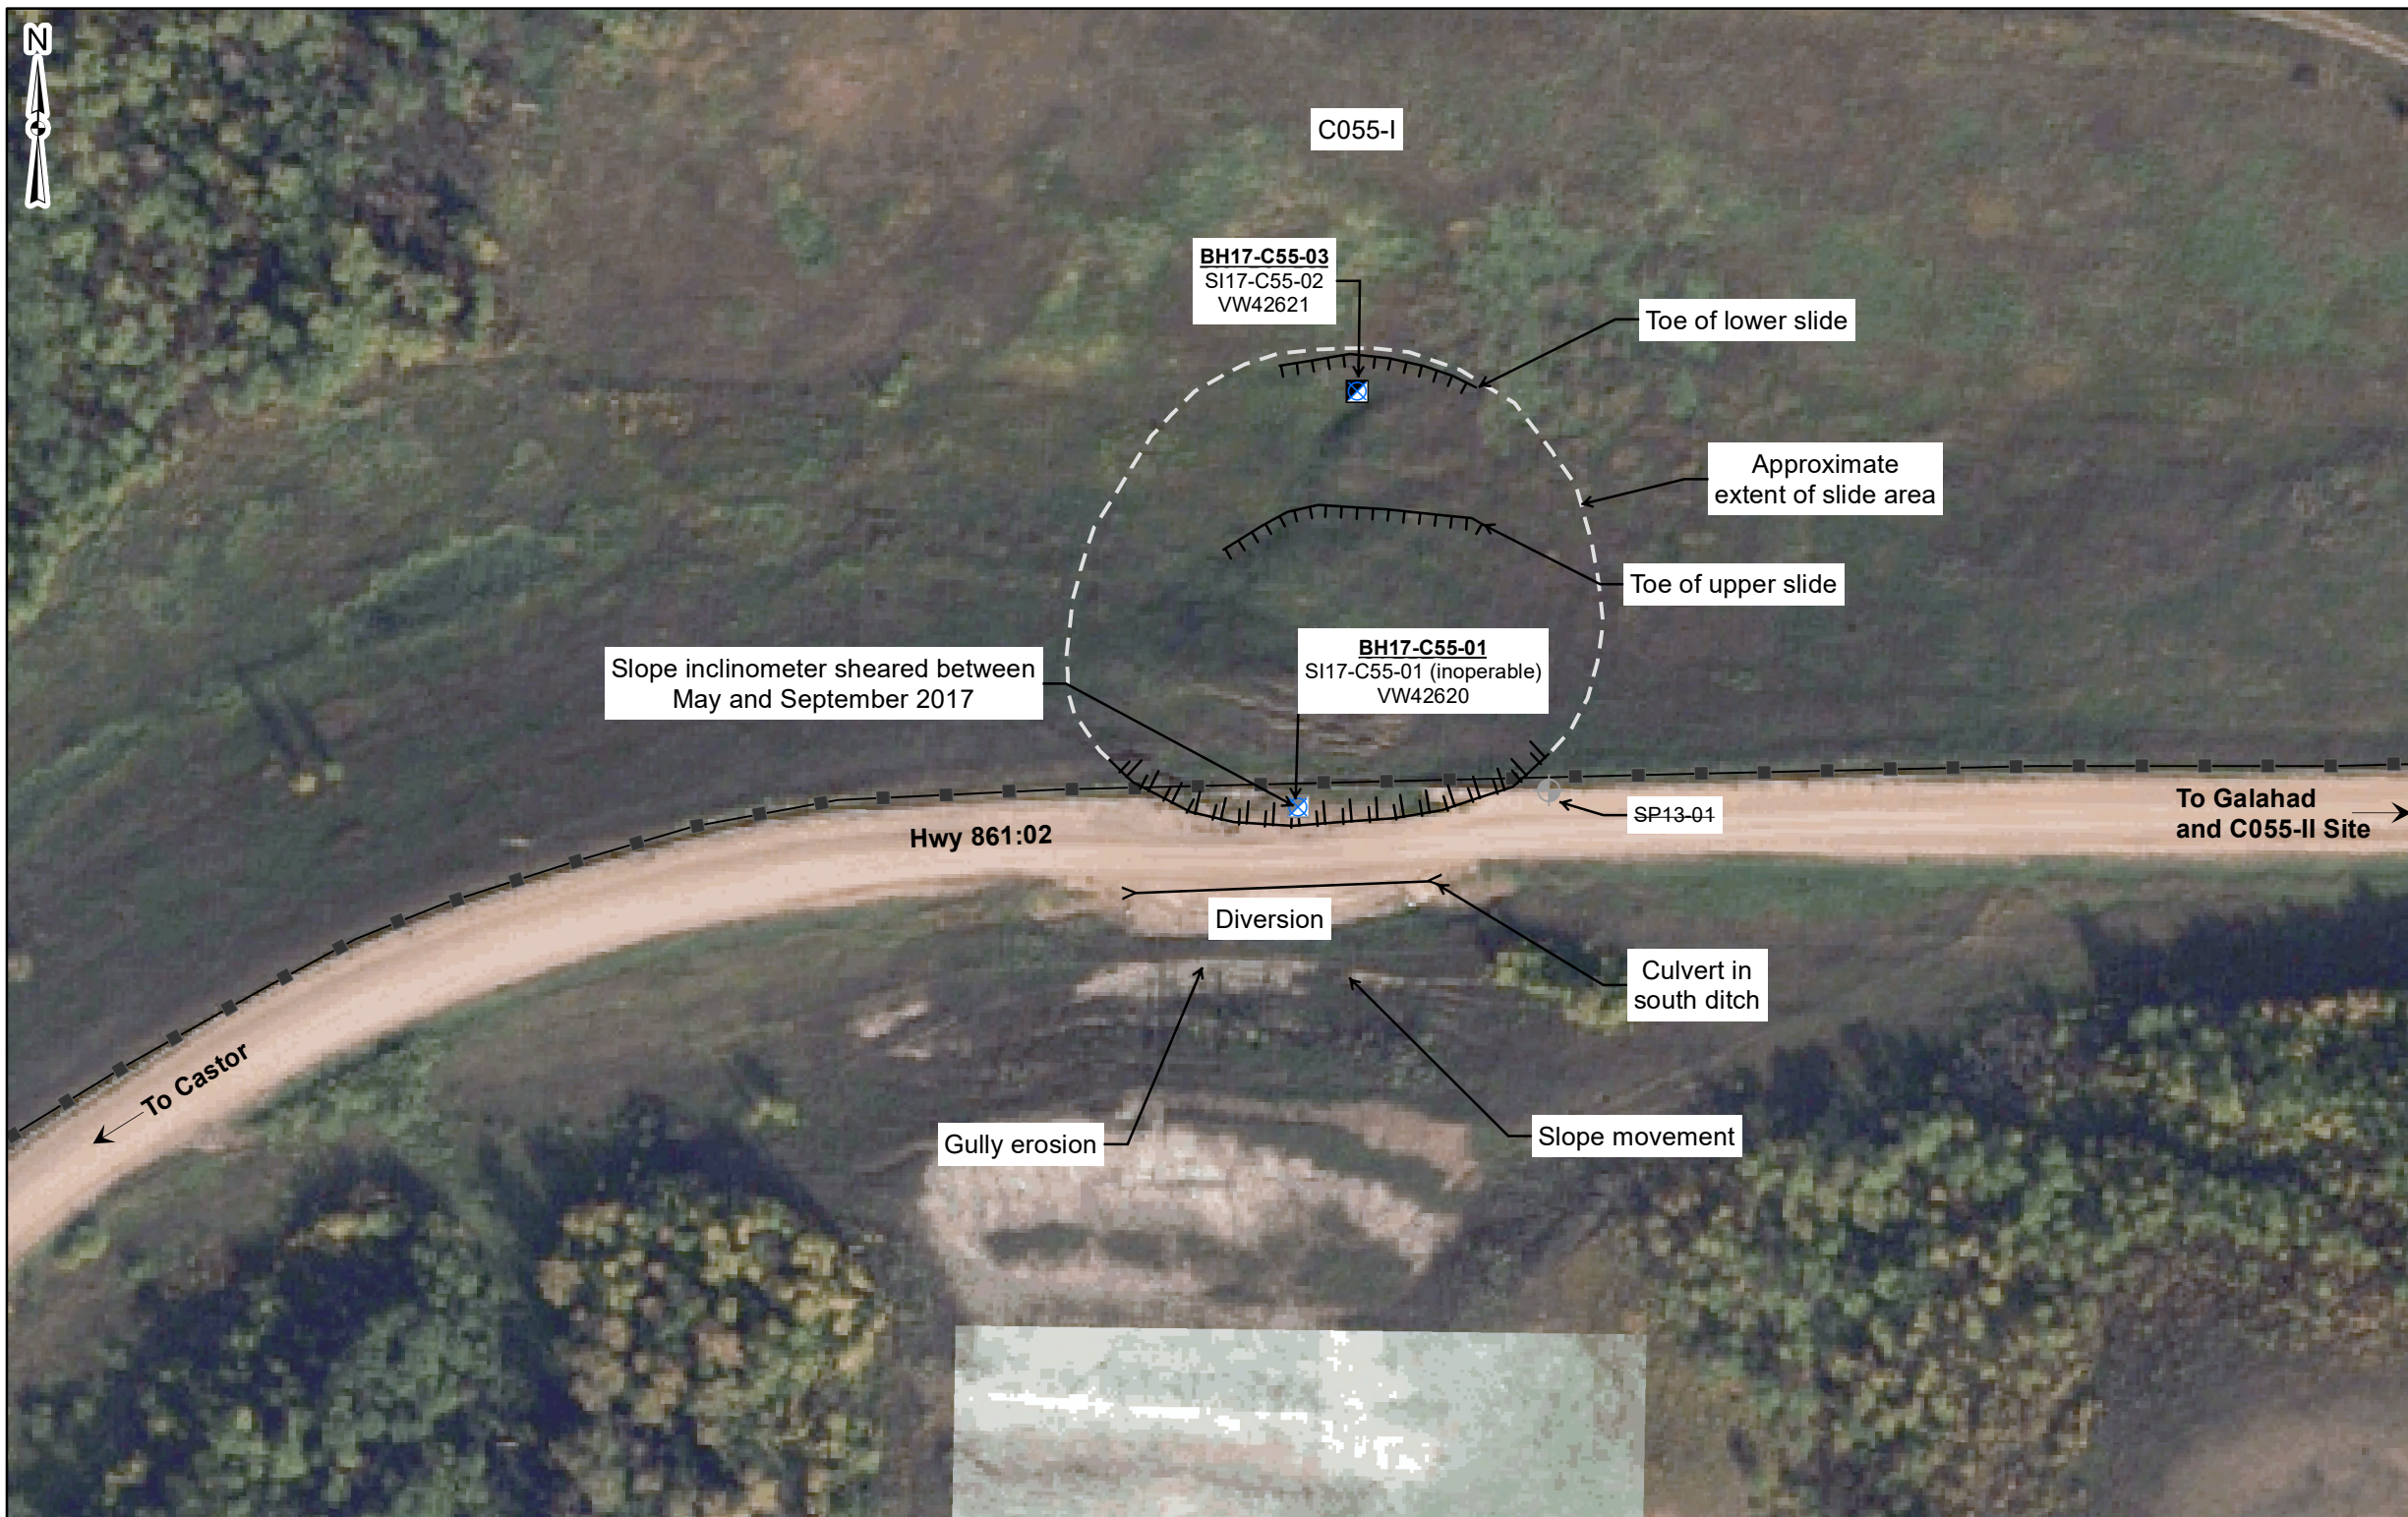
PROJECT CENTRAL REGION GEOHAZARD RISK MANAGEMENT PROGRAM		
TITLE Site Plan C055 - Galahad Slide Hwy 861:02, km 26.000		
SCALE 1:1,000	PROJECT No. A05116A02	FIG No. 1

The geohazard at the C055-I site consists of two slides, one upper and one lower, along the south slope of the Battle River valley that affect the north side (southbound lane) of Hwy 861:02. The slides appear to be moving independently of each other. In 2013, the highway was realigned south (upslope) towards the backslope, and a culvert was installed to convey ditch flows. The site has required ongoing fill placement at the head of the slide to maintain the road surface.

In 2013, KCB installed one standpipe (SP) (SP13-01). The instrument was lost due to ongoing road maintenance. In March 2017, KCB installed two slope inclinometers (SIs) (SI17-C55-01 and SI17-C55-02) and two vibrating wire piezometers (VWPs) (VW42620 and VW42621) to monitor depth of movement and groundwater conditions, respectively. SI17-C55-01 and VW42620 were installed in a borehole located on the north shoulder of Hwy 861:02; and SI17-C55-02 and VW42621 were installed in a borehole located at the toe of the slope. By July 2017, SI17-C55-01 was sheared at an approximate depth of 7.8 m below ground surface.

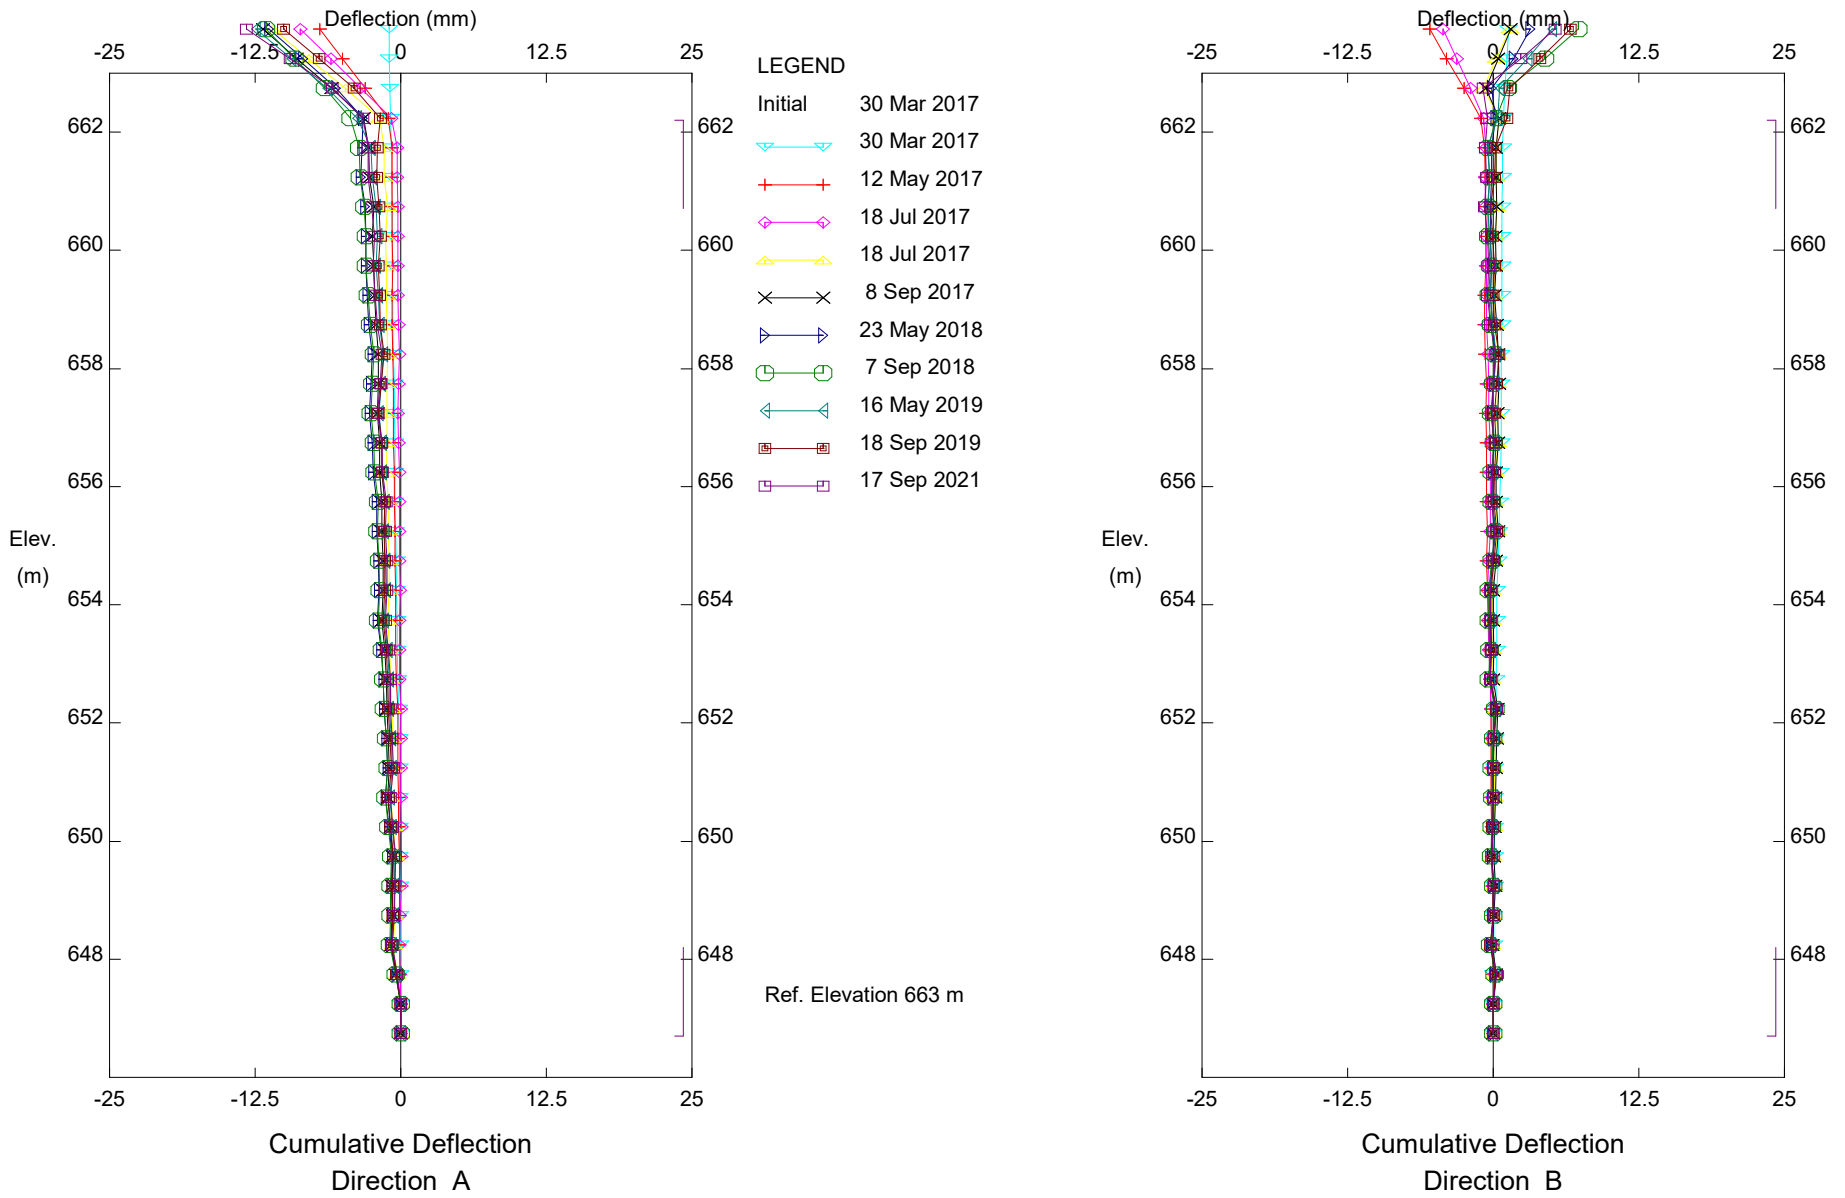
C055; H861:02, Galahad Slide, Inclinator S17-C55-02

No discernible movement has been recorded in SI17-C55-02 (toe of slope).

Readings of the operational VWPs can be reduced from twice a year, once in the spring and once in the fall, to once a year in the spring. Readings of the SI at the toe of the slope (SI17-C55-02) can be discontinued as the extent of slide movement does not impact it.

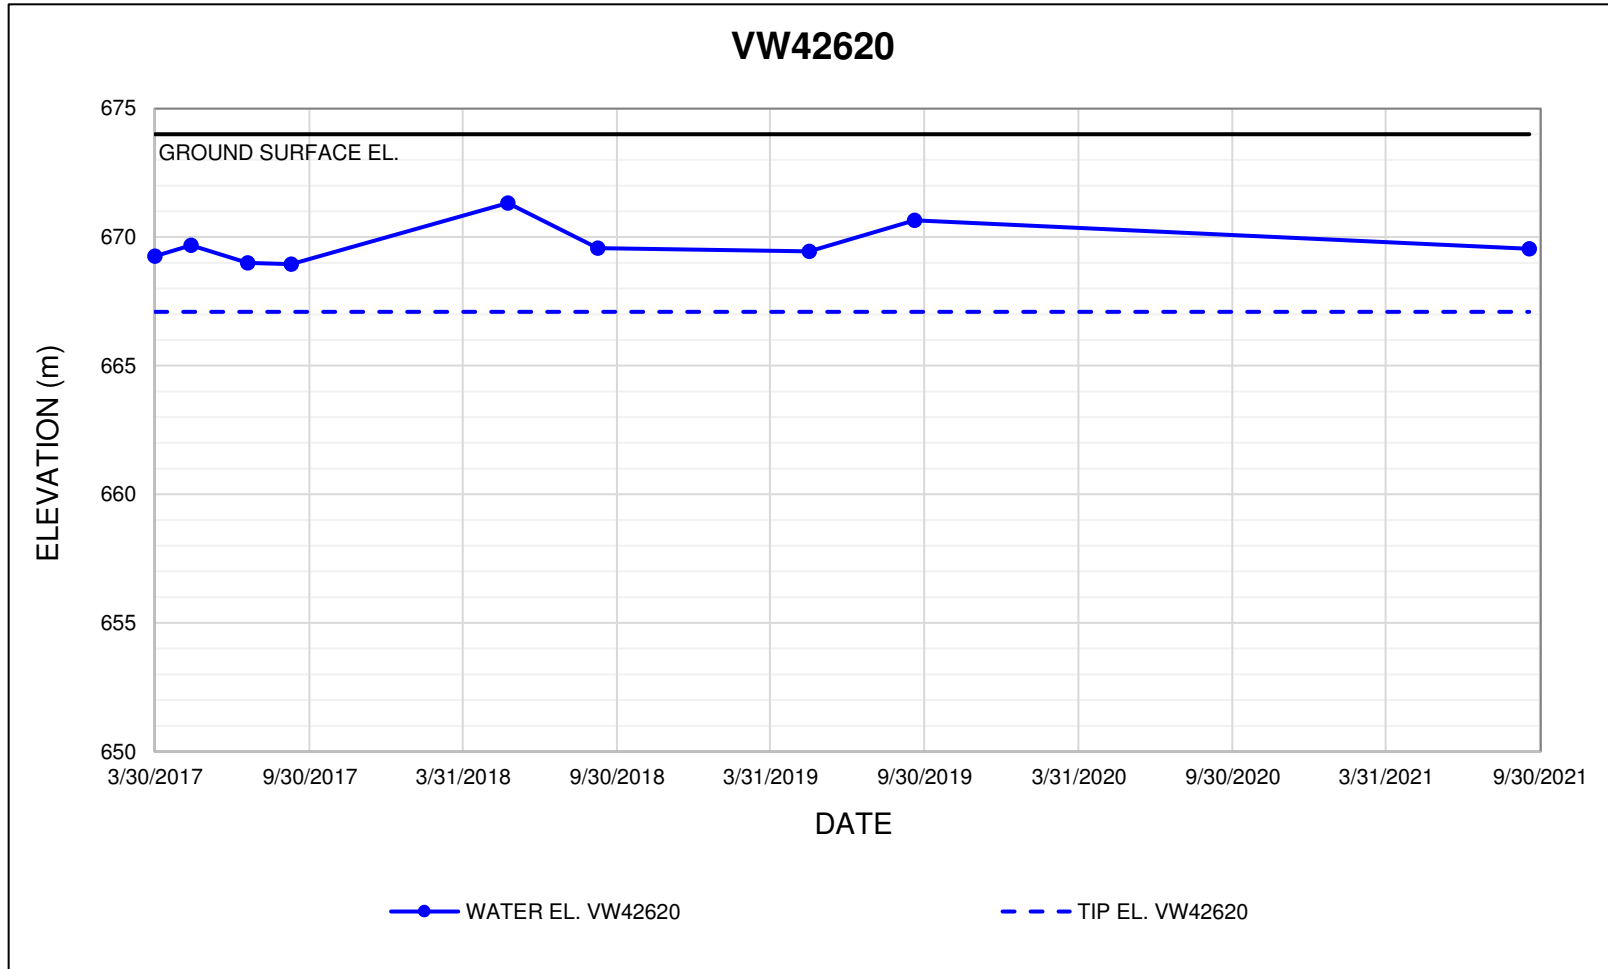
PROJECT CENTRAL REGION GEOHAZARD RISK MANAGEMENT PROGRAM	
	TITLE Piezometer Data C055 - Galahad Slide Hwy 861:02, km 26.000

Instrument ID	Date Installed	Date of Previous Reading	Date of Most Recent Reading	Ground Surface Elevation (m)	Tip Depth (mbgs ¹)	Previous Water Level (mbgs ¹)	Current Water Level (mbgs ¹)	Change from Previous Reading (m)
VW42620	Mar. 20, 2017	Sep. 18, 2019	Sep. 17, 2021	674	6.9	3.4	4.5	-1.1
VW42621	Mar. 21, 2017	Sep. 18, 2019	Sep. 17, 2021	663	10.8	2.4	3.5	-1.1
