SITE NUMBER AND NAME: C055-I and -II Galahad Slide and Riverbank Erosion		HIGHWAY & KM: 861:02, 26.00	PREVIOUS INSPECTION DATE: July 12, 2019	INSPECTION DATE: May 31, 2022
LEGAL DESCRIPTION: 13-14-040-14 W4M	NAD 83 COORDINATES: UTM Northing Easting C055-I 12 5811270 437304 C055-II 12 5811329 437306		RISK ASSESSMENT: C055-I PF: 5 CF: 4 TOTAL: 20 C055-II PF: 8 CF: 3 TOTAL: 24	
AVERAGE ANNUAL DAILY TRAFFIC (AADT): 60 (north) & 60 (south) (Ref No. 70000159)			CONTRACT MAINTENANCE AREA (CMA): 518

PROJECT	CENTRAL REGION GEOHAZARD RISK MANAGEMENT PROGRAM	
TITLE	Site Plan C055 - Galahad Slide Hwy 861:02, km 26.000	
SCALE	PROJECT No.	FIG No.
1:2,500	A05116A02	1

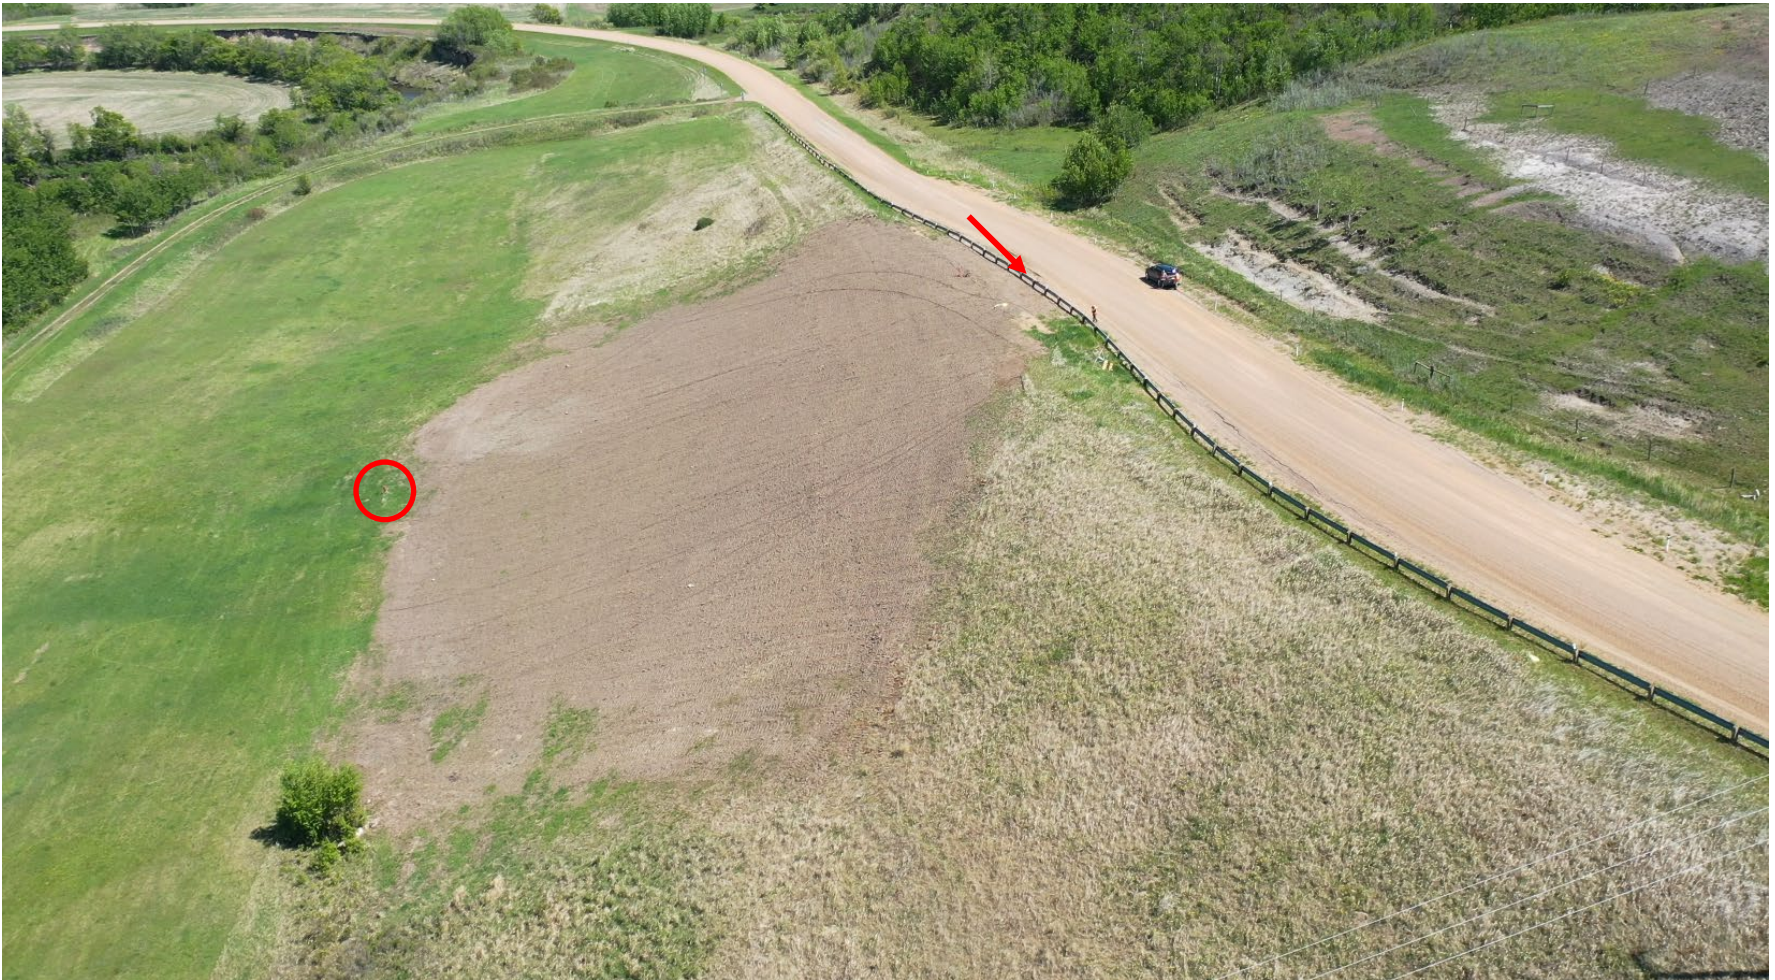
- In late-2021 the site was repaired. The repair included guardrail replacement, material placement at the edge of the highway beneath where the guardrail was settled, and slope grading from the crest to toe (Photo 1 and 2). During construction, the instrumentation at the top of the slide was removed (one SI and two piezometers) but the instrumentation at the toe (one SI and one piezometer) was not. The SI at the crest of the slope was inoperable (sheared at an approximate depth of 7.7 m at the silty clay till-mudstone bedrock contact) but one of the piezometers was still active before being buried during construction.

Photo 1 Oblique aerial view of the C055-I site. The instrumentation installed at the top of the slide was buried during the late-2021 repair, and the active instrumentation at the toe of the slide is indicated by the red circle. Minor erosion observed along the north edge of the highway is indicated by the red circle. The south extent of the C055-II site is shown in the background of the photo. Photo taken May 31, 2022, facing east.

- C055-I: If the 2021 repair is not successful, a berm should be constructed on lower half of slope to buttress the slope, with finger drains to convey seepage water from the slope face to the toe of the berm; and re-construct upper slope with geosynthetic reinforced fill. The toe berm will require land acquisition after a stability assessment has been completed to assess the amount of land required for the toe berm.
- C055-II: As a short-term measure, AT should install a guardrail. Installing sheet pile walls along the toe of the embankment to reduce the rate of erosion and stabilize the slope. However, vibration caused by installing sheet pile walls may impact sensitive fish species and impact erosion along other locations of the Battle River. Eventually, AT may have to realign this portion of the highway further away from outside bend and erosion zone of the Battle River.

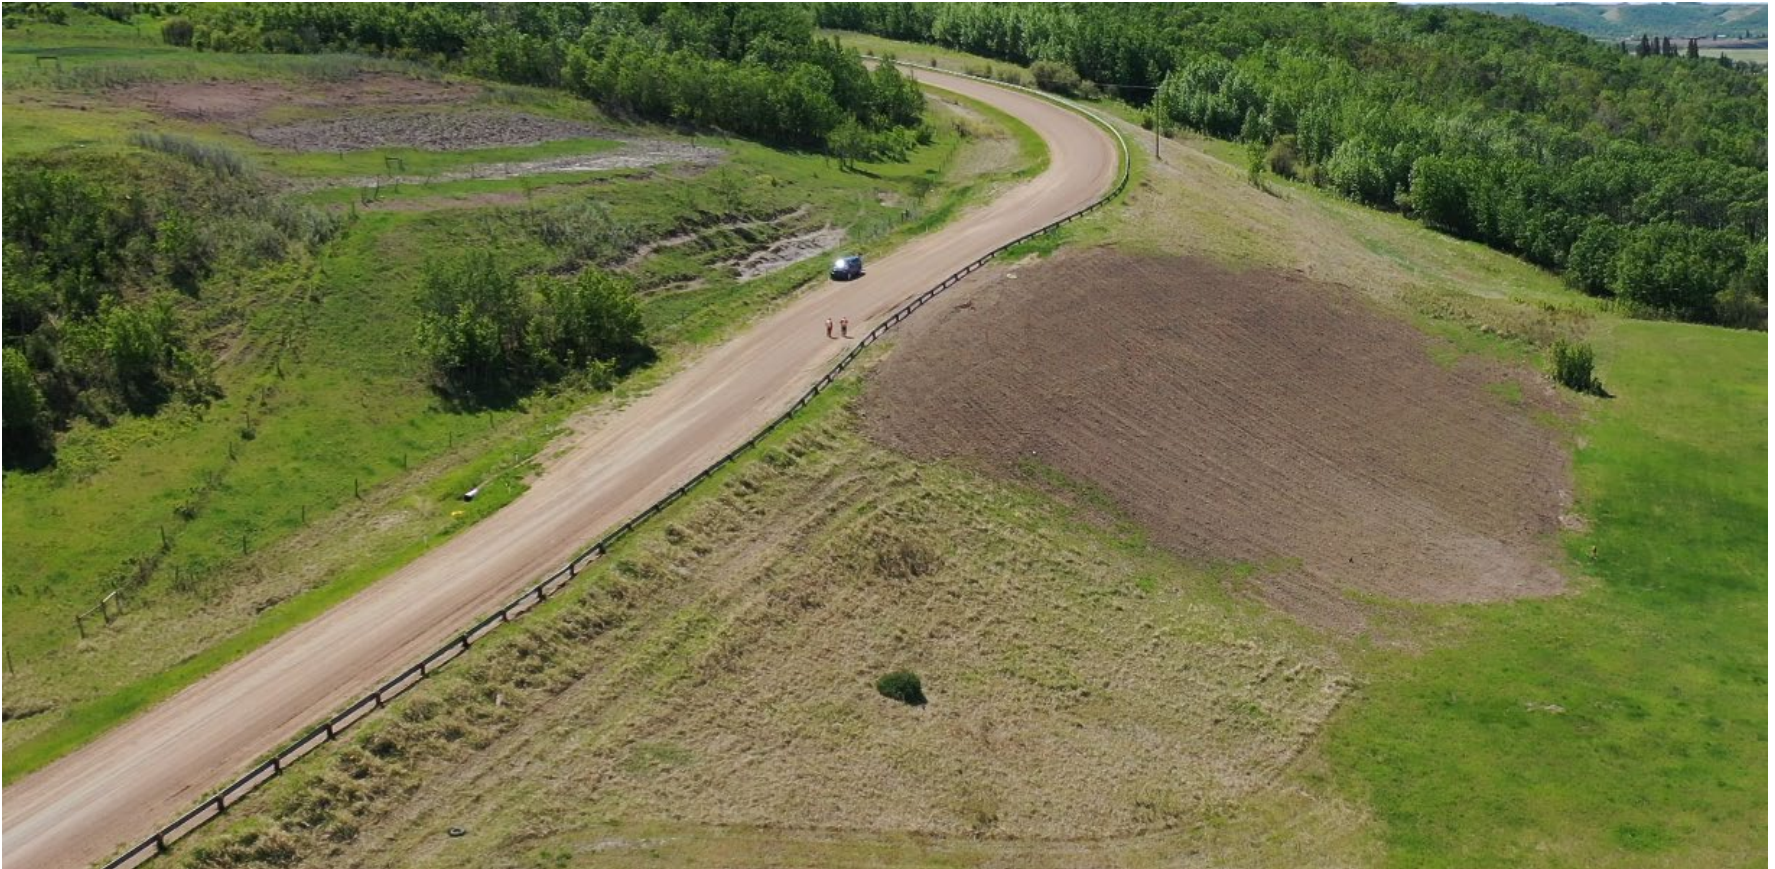
Photo 2 **Oblique aerial view of the C055-I site. Photo taken May 31, 2022, facing west.**

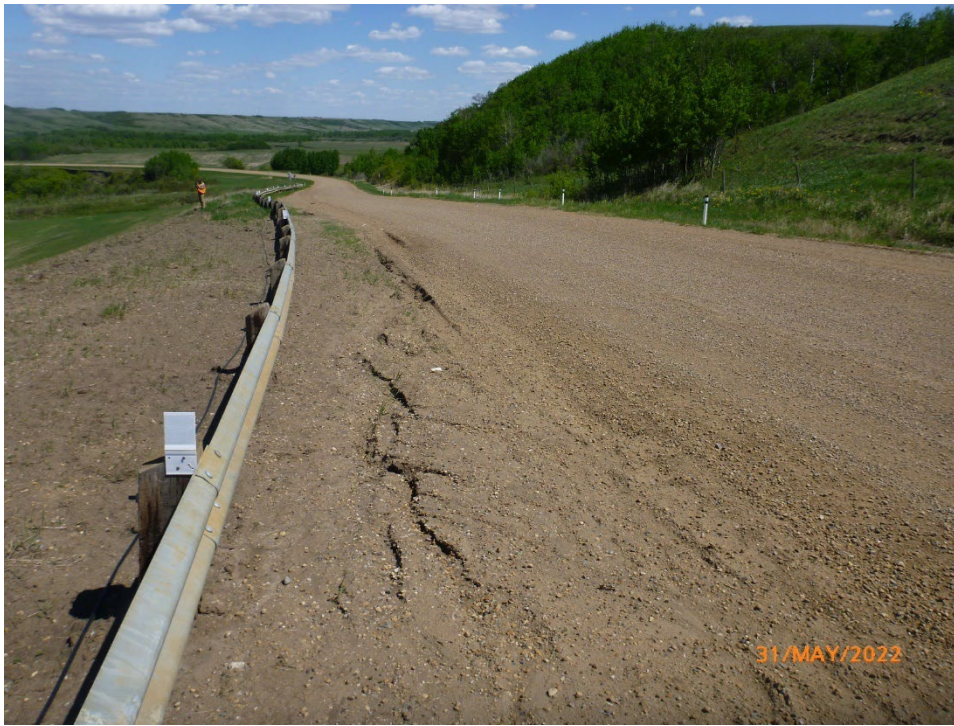
- There is erosion near the edge of the north (southbound) lane that should be graded (Photo 3).
- A black cable was observed on the north side of the highway (Photo 4) that ran from the C055-I site to the C055-II site. The cable is indicated by old delineators at the C055-I site and wooden stakes at the C055-II site.

Photo 3 Erosion was observed along the north (southbound) edge of the highway. Photo taken May 31, 2022, facing east.

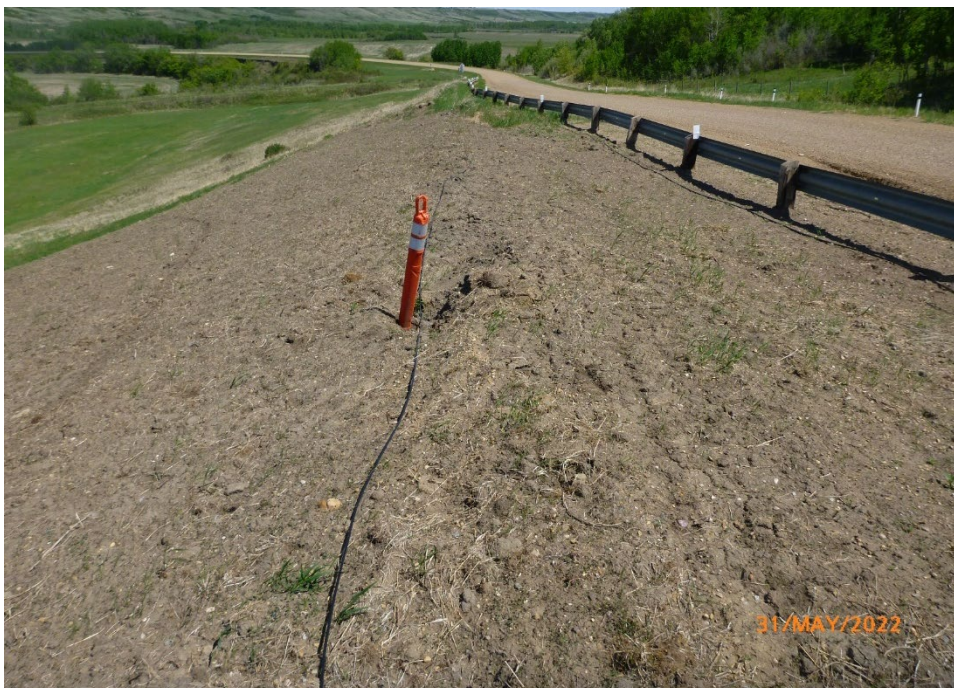
Photo 4 A black cable was observed along the north side of the highway, marked by old delineators. The cable was observed at both the C055-I and-II sites. Photo taken May 31, 2022, facing east.

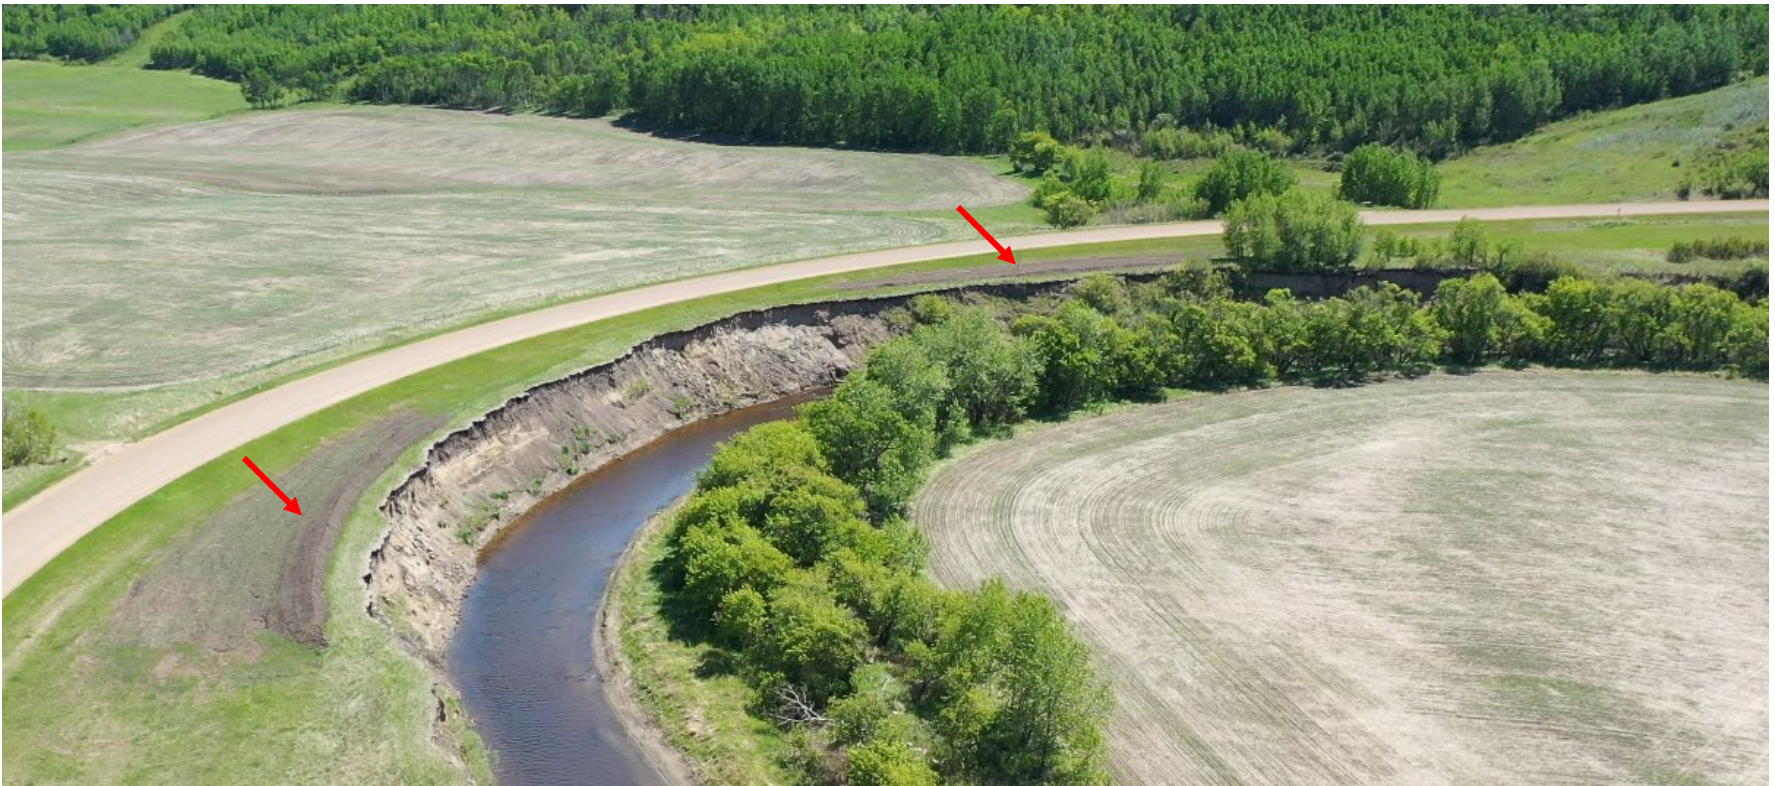
- Riverbank erosion appears to be progressing at a slow but consistent rate and has progressed towards the edge of the highway since the 2019 inspection (Photo 3).
- Two berms were built in the west (southbound) ditch between the 2019 and 2022 inspections (Photo 3 and 4). KCB and AT believe the berms were built to reduce surface flows from the ditch over the erosion scarp in an effort to reduce the rate of erosion towards the edge of the highway.
- Stakes that were installed in an attempt to track the erosion rate were missing. The stakes may have been removed during mowing or the 2021 construction.

Photo 5 Aerial photo of the C055-II riverbank erosion. Two berms were constructed in late-2021 near the northeast and southwest extent of the riverbank erosion (indicated by the red arrows) in an attempt to divert flow in the west ditch away from the eroding bank. Photo taken May 31, 2022, facing south.

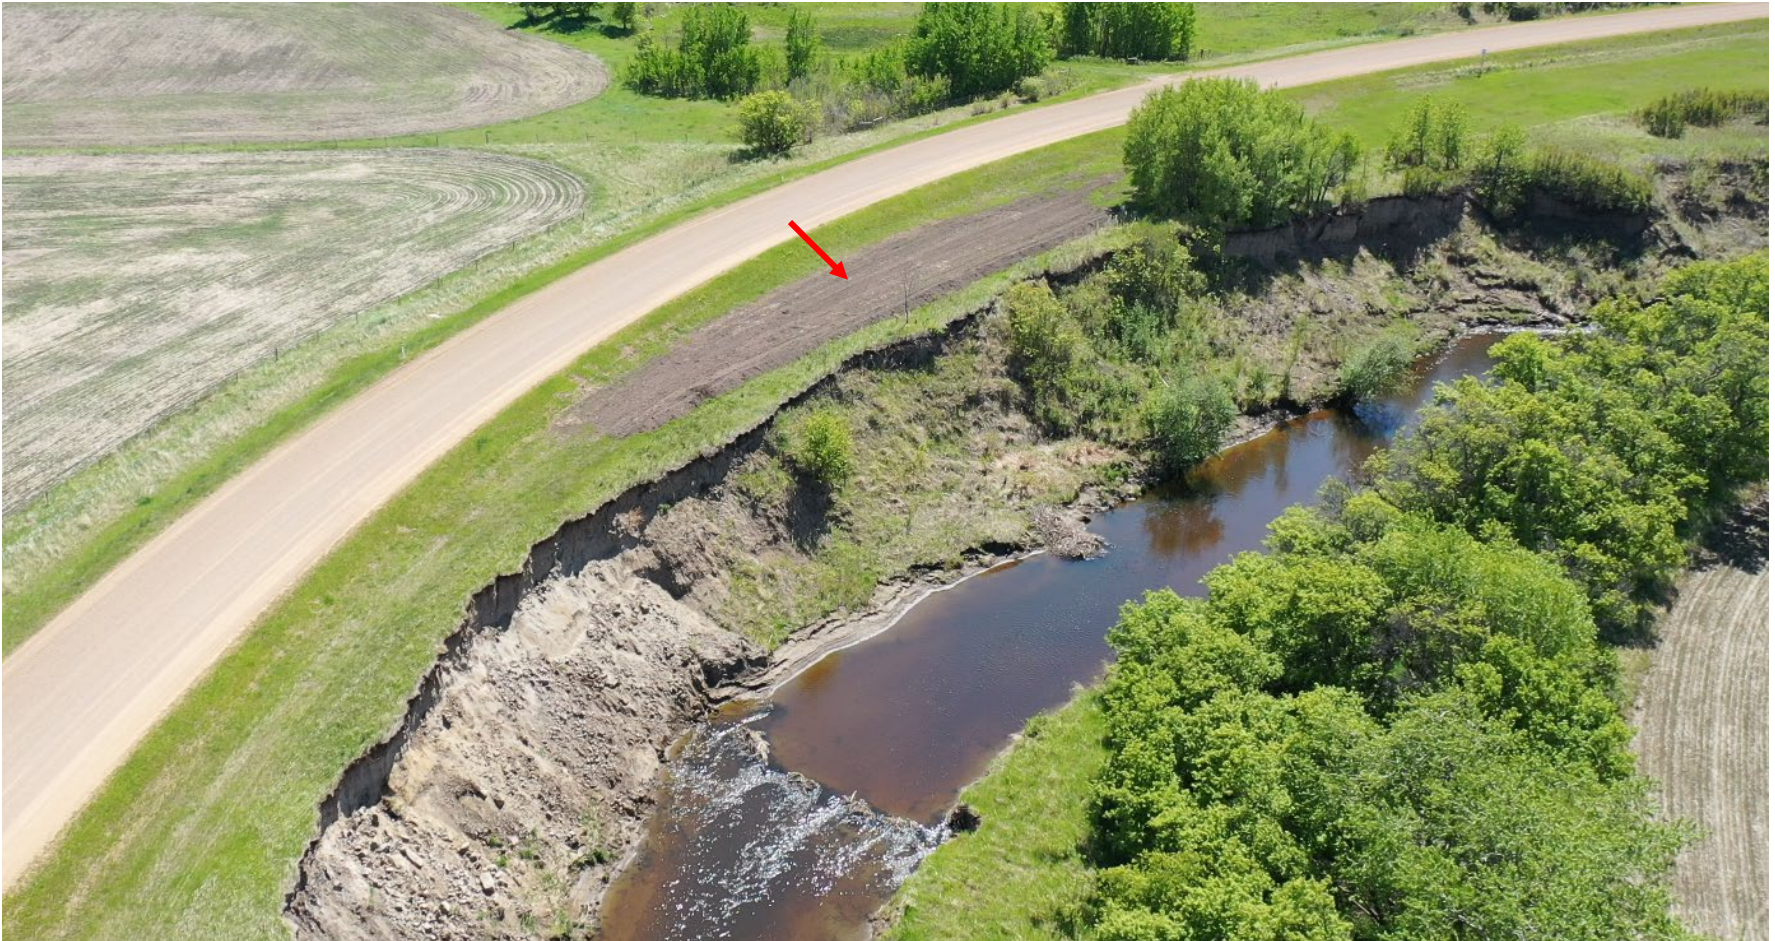
Photo 6 A length of the ditch near the southwest extent of the C055-II site where a berm was built to divert flow away from the eroding bank. Photo taken May 31, 2022.
