SITE NUMBER AND NAME: <b>C003 Battle River Crossing</b>		HIGHWAY & KM: 872:06, 4.0	PREVIOUS INSPECTION DATE: May 27, 2009	INSPECTION DATE: <b>July 12, 2019</b>
LEGAL DESCRIPTION: 5-40-10-W4M	NAD 83 COORDINATES: UTM Northing Easting 12 5806345 471780		RISK ASSESSMENT: PF: 9 CF: 5 TOTAL: 45	
AVERAGE ANNUAL DAILY TRAFFIC (AADT): 290 (south) & 460 (north) (Ref No. 126340 & 126330)			CONTRACT MAINTENANCE AREA (CMA): 21

PROJECT  
 CENTRAL REGION GEOHAZARD RISK MANAGEMENT PROGRAM

TITLE  
 Site Plan  
 C003 - North of Battle River  
 Hwy 872:06

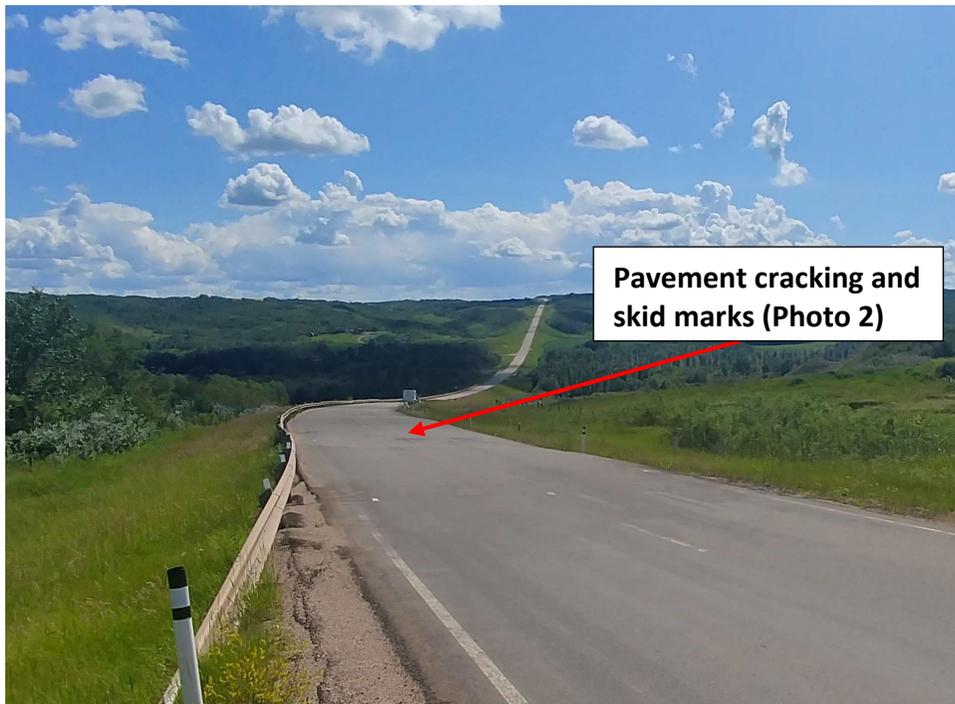
**Photo 1** Overview of C003 site. Photo taken July 12, 2019 looking south.

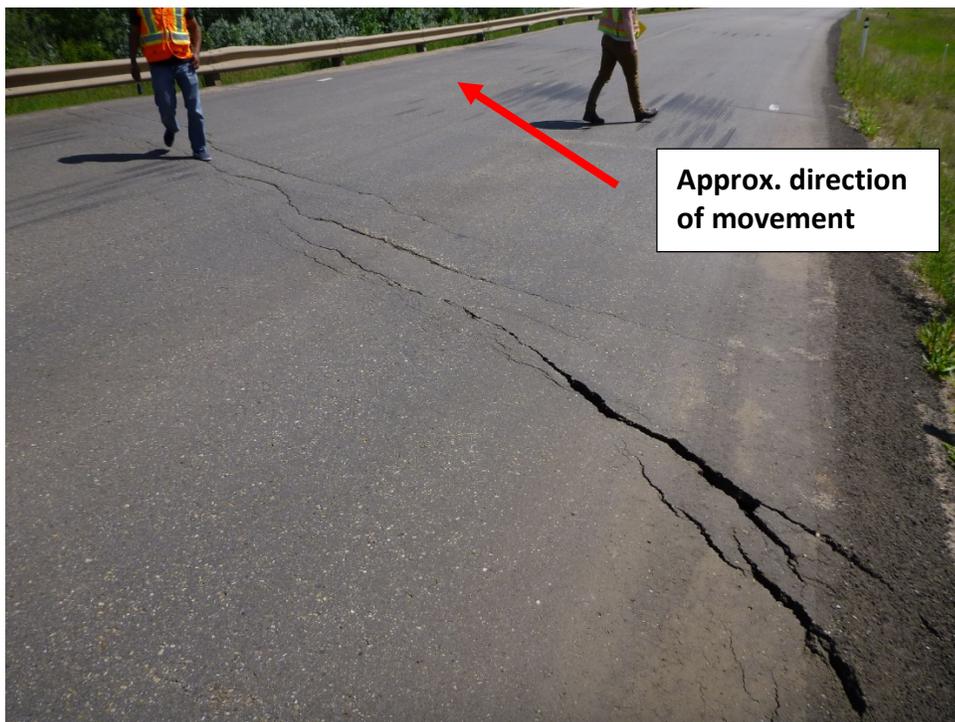
**Photo 2** Transverse pavement cracking and skid marks from vehicles braking on north flank of slide. Photo taken July 12, 2019 looking south.

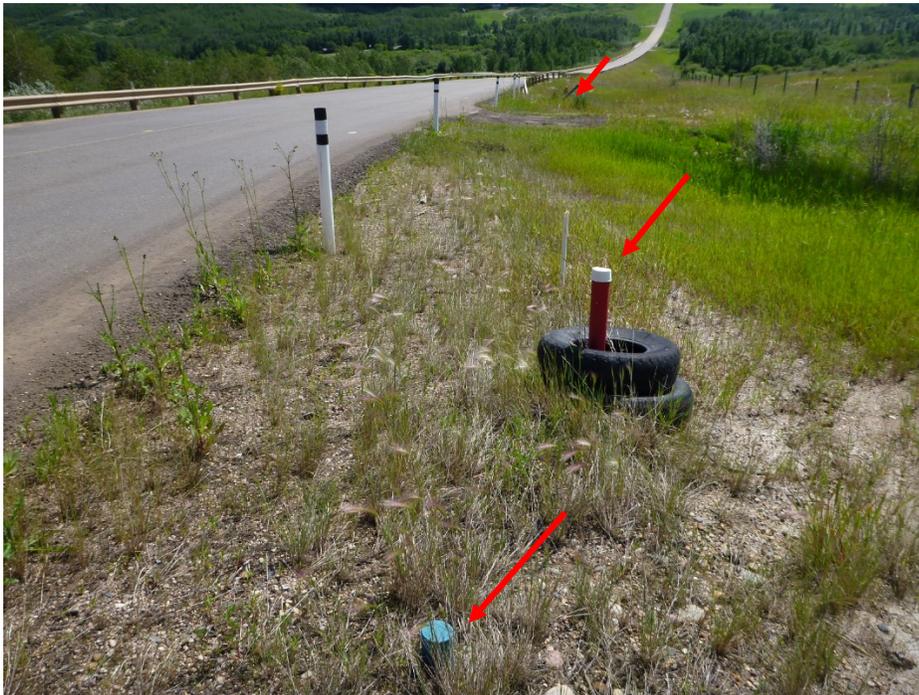
On July 19, 2019 KCB returned to C003 with a “dummy” SI probe and water level meter to confirm if the instruments installed between 1992 and 2007 were readable, and if the piezometric level in the standpipes had increased since 2011. KCB confirmed that all SIs are no longer readable and the piezometric levels in the standpipes have decreased since 2011.

**Photo 3** Existing instruments (SIs and standpipes) along west (southbound) ditch. Photo taken July 12, 2019 looking south.

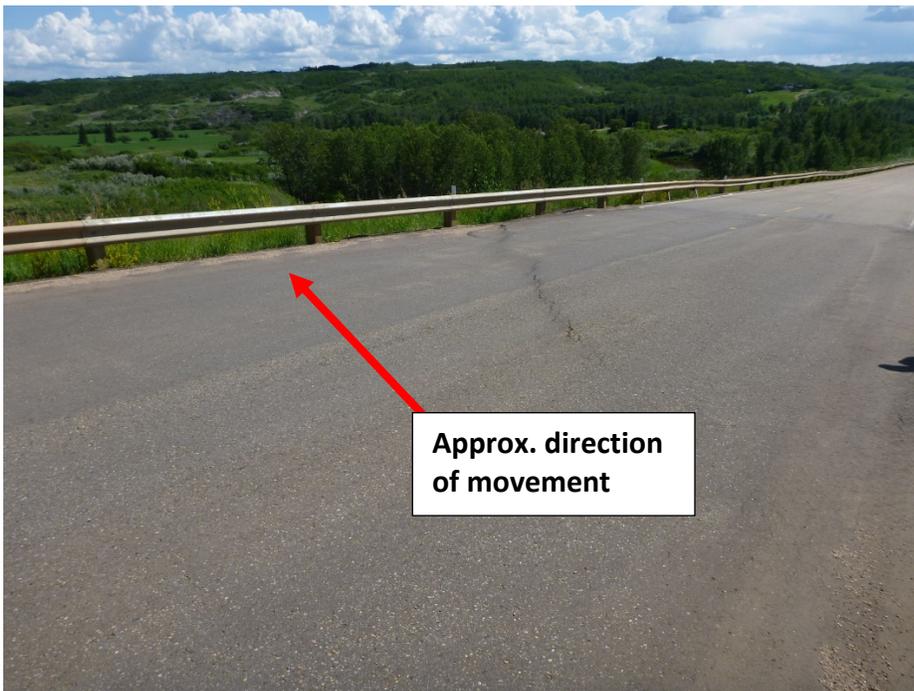
**Photo 4** Pavement cracking across highway on south flank of slide. Photo taken July 12, 2019 looking southeast.

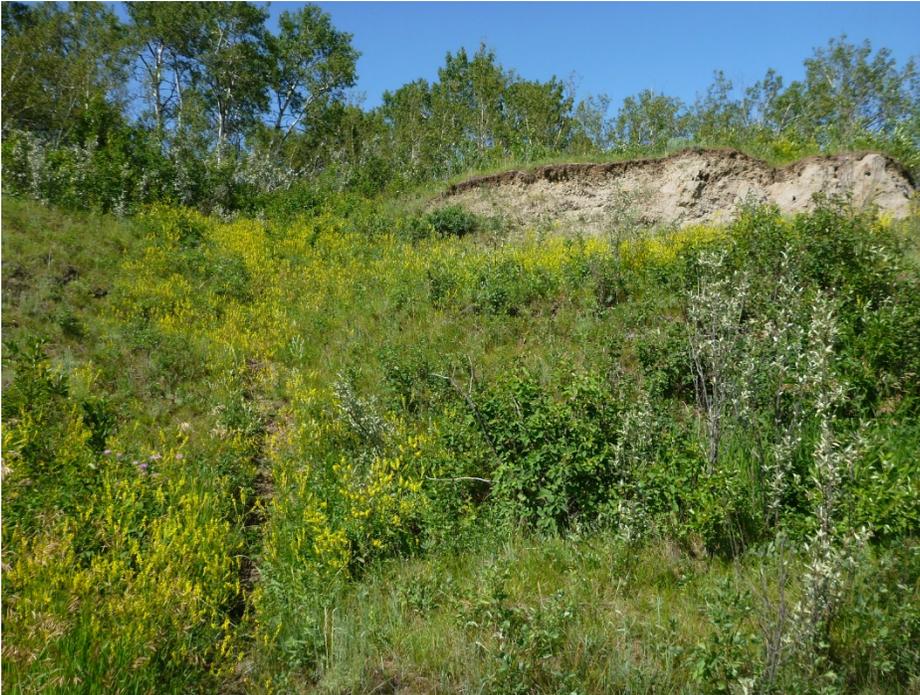
**Photo 5** Exposed bedrock and scarp upslope of highway near waypoint 887. Photo taken July 12, 2019 looking north.

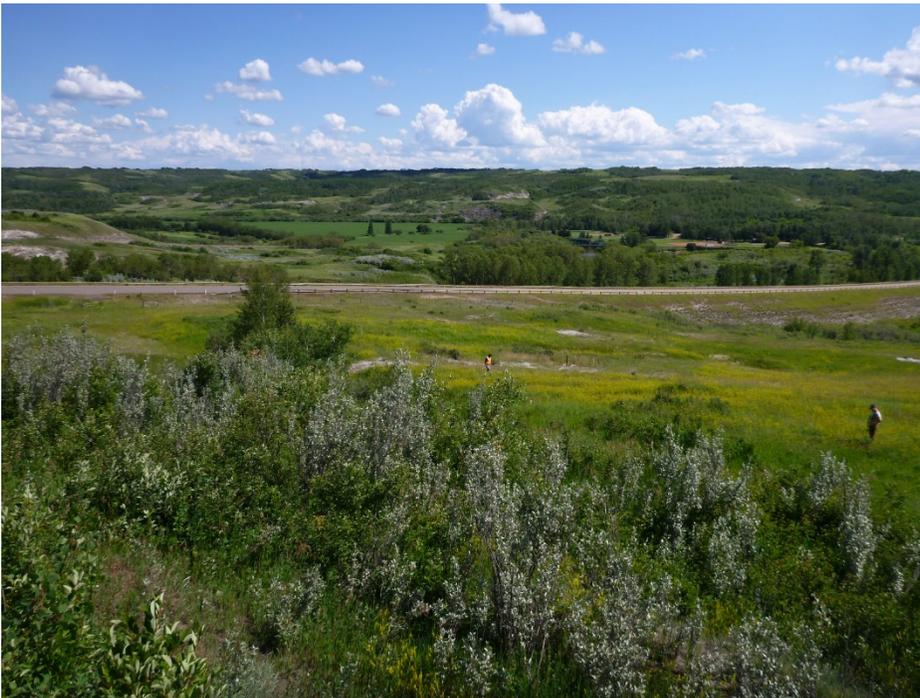
<b>COMMENTS</b>
The slide appears to be a deep-seated slide that is failing at a skew angle to the highway based on diagonal and semi-circular transverse cracks in the pavement.
The northbound and southbound lanes are affected by multiple dips and depressions and in some areas the pavement has settled approximately 1 to 2". Skid marks from vehicles braking were observed near most pavement cracks and depressions.
Bedrock is exposed upslope of the highway (waypoint 887) with a scarp extending laterally to the east. Slide blocks and other slide features including a horst and graben were observed downslope of the main scarp.
An erosion gully was observed in the west (southbound ditch) where the highway embankment meets the river valley slope indicating the presence of highly erodible or dispersive soils. Groundwater flow within the river valley slopes adjacent to and below the highway embankment may be contributing to the dips and depressions observed

**Photo 6** Photo taken from backscarp looking southeast towards the highway. Slide appears to be failing at skew angle to the highway. Photo taken July 12, 2019.

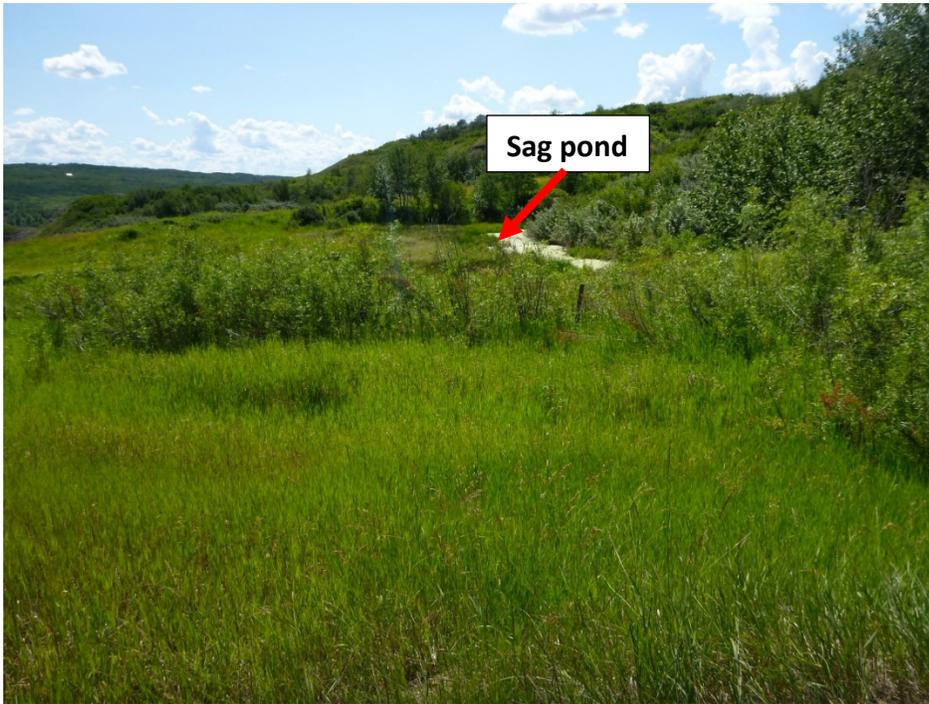
**Photo 7** Sag pond located below the backscarp (Photo 6) and upslope of the highway. Photo taken July 12, 2019 looking west.

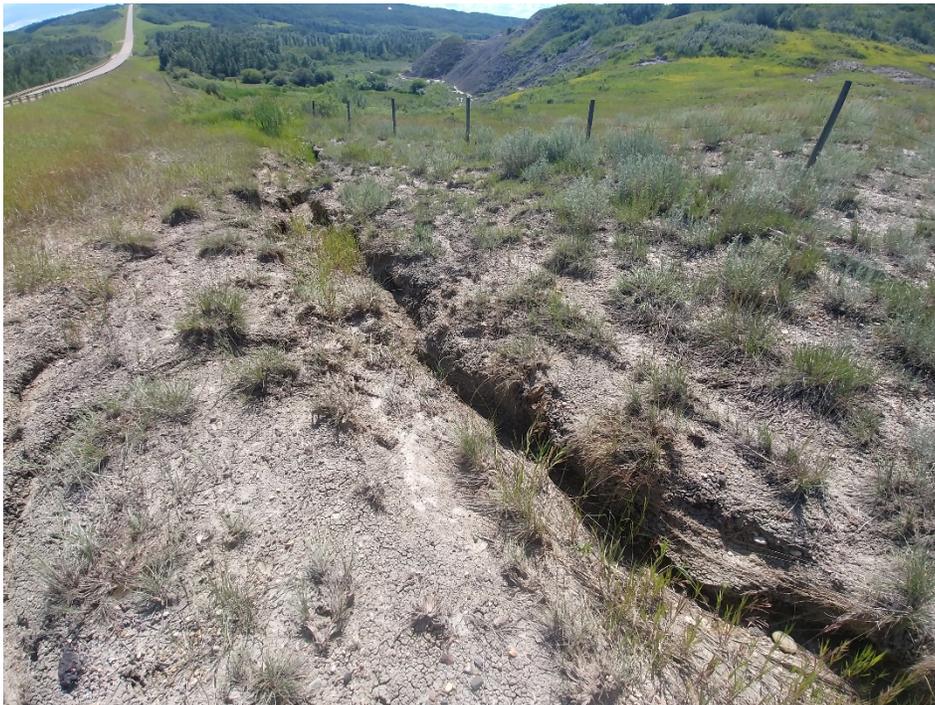
**Photo 8** Erosion in west (southbound ditch) adjacent to highway. Photo taken July 12, 2019 looking south.
