<b>SITE NUMBER AND NAME:</b> C003 Burma Park Slide		<b>HIGHWAY &amp; KM:</b> 872:06, 0.278	<b>PREVIOUS INSPECTION DATE:</b> July 12, 2019	<b>INSPECTION DATE:</b> <b>June 29, 2021</b>
<b>LEGAL DESCRIPTION:</b> 05-40-10-W4M & 32-39-10-W4M	<b>NAD 83 COORDINATES:</b> UTM Northing Easting 12 5806345 471780		<b>RISK ASSESSMENT:</b> PF: 9 CF: 5 TOTAL: 45	
<b>AVERAGE ANNUAL DAILY TRAFFIC (AADT):</b> 240 (south) & 360 (north) (Ref No. 126340 & 126330)			<b>CONTRACT MAINTENANCE AREA (CMA):</b> 21

PROJECT	CENTRAL REGION GEOHAZARD RISK MANAGEMENT PROGRAM	
TITLE	Site Plan C003 - North of Battle River Hwy 872:06	
SCALE	PROJECT No.	FIG No.
1:1,000	A05116A02	1

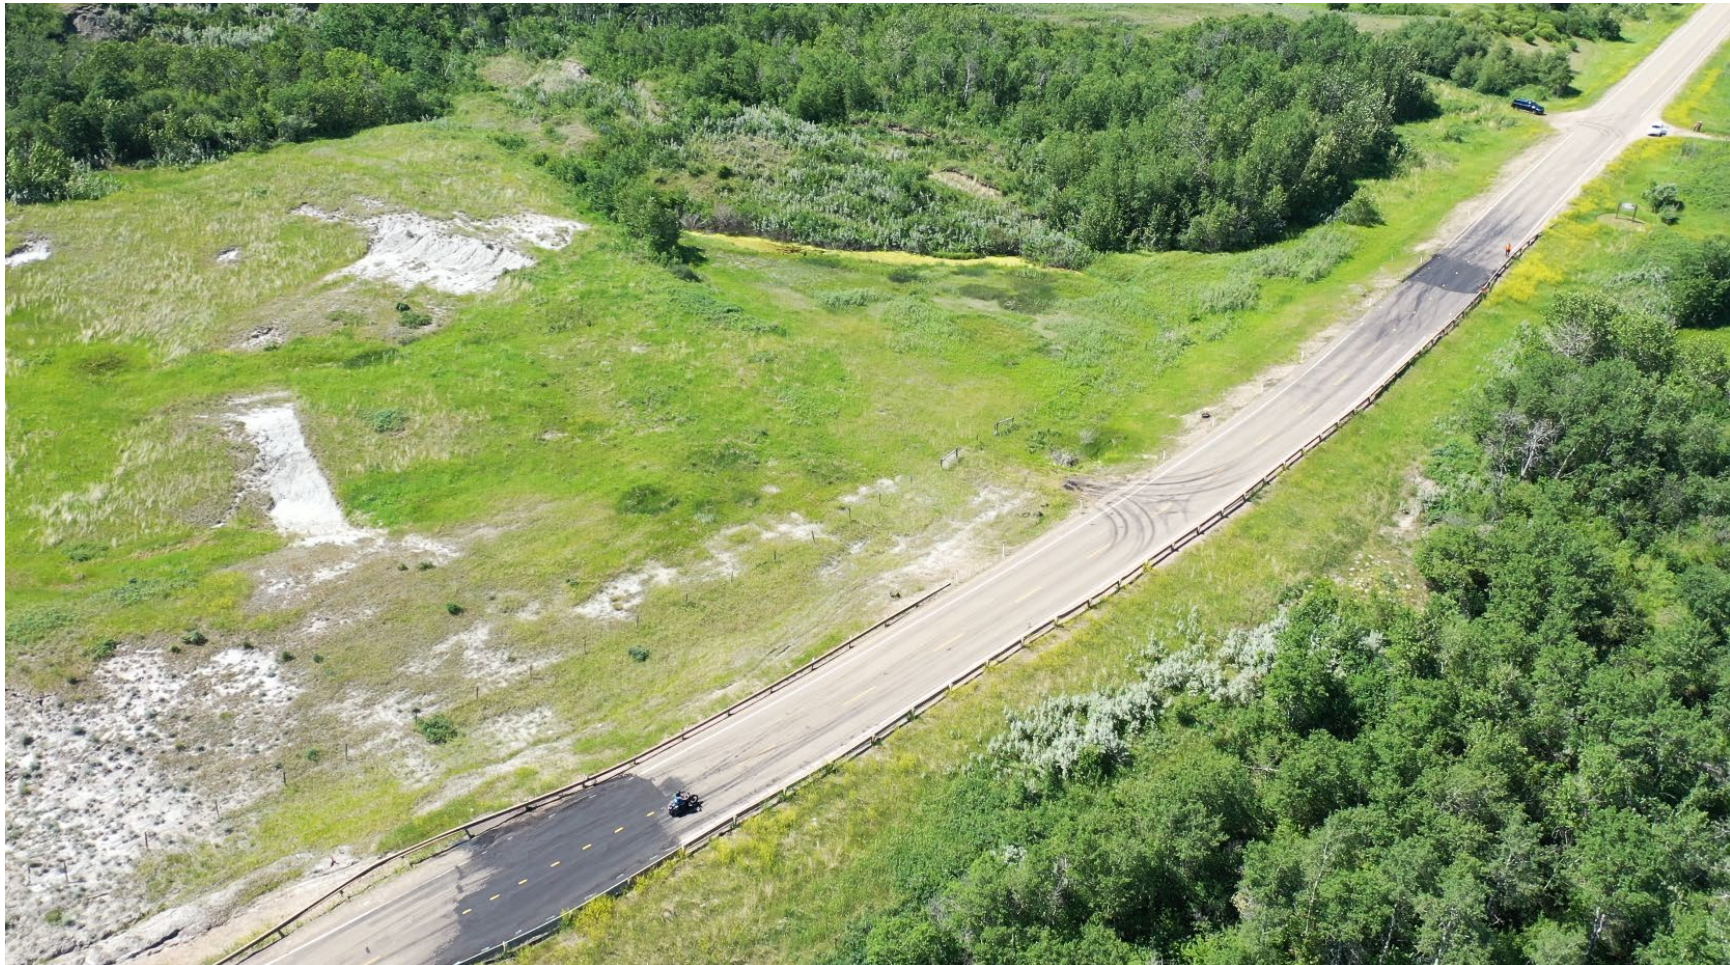
**Photo 1** Oblique air photo of a portion of the C003 site, showing the guardrail deflection and two asphalt patches. Photo taken June 29, 2021 facing northwest.

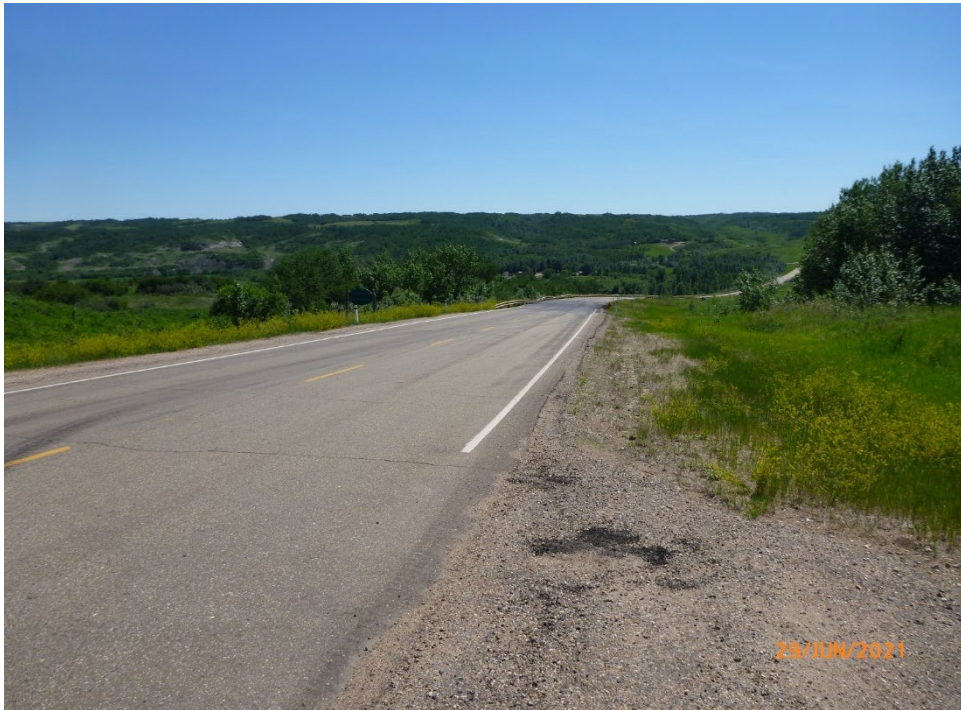
**Photo 2** North extent of the C003 site. Photo taken June 29, 2021 looking south.

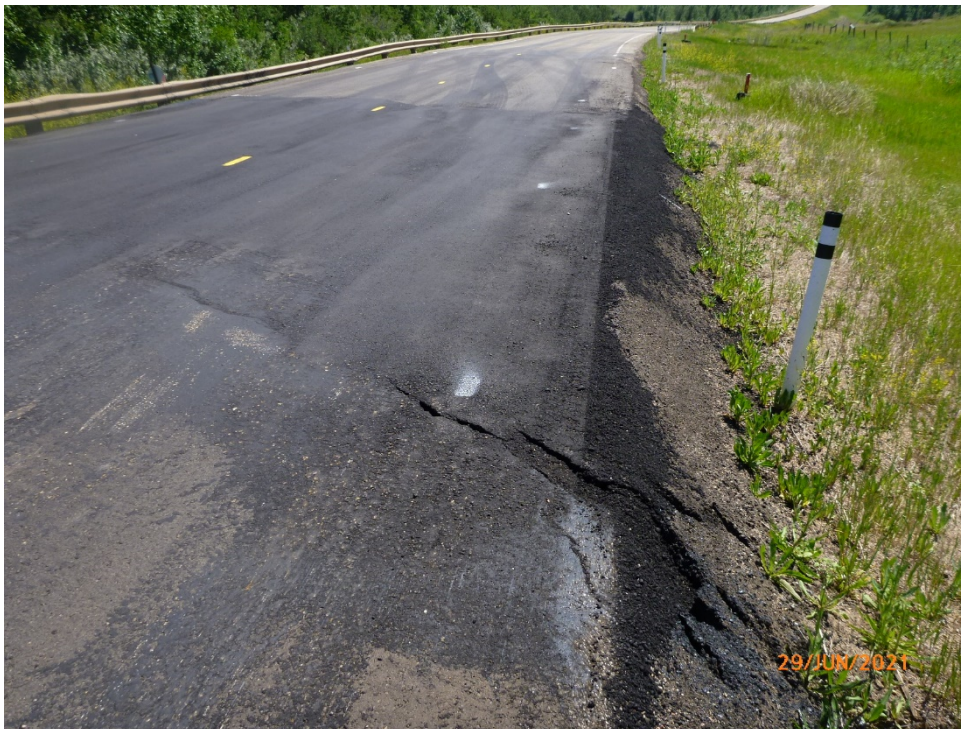
<p>slopes adjacent to and below the highway embankment may be contributing to the dips and depressions observed in the pavement.</p>	
<p>Asphalt cracking was observed, beginning at the edge of the asphalt and extending into the driving lane. The cracking was observed in a recent asphalt patch, near the north end of the site. The asphalt cracks may not be the flanks of the slide, but rather the secondary and primary cracking associated with the flanks of a larger slide.</p>	
<p>The guardrails on both sides of the highway (east and west) show horizontal deflection particularly near a new asphalt patch near the south extent of the site.</p>	
<p>A drone flight was completed by KCB during the June 29, 2021 site inspection. The aerial imagery will be reviewed to better define/estimate the extents of the slide. The UAV video indicates that the horizontal deflection does not appear to be due to vehicle collisions, but rather buckling of the guardrails under compression caused by slide movement affecting the embankment. The drone video indicates the slide area appears is very large and the cracks across the road appear to be secondary cracks that could be perpendicular to the direction of movement, not flanks of the slide area.</p>

**Photo 3** Transverse pavement cracking observed in a recent asphalt patch, on the north flank of slide. Photo taken July 12, 2019 looking south.

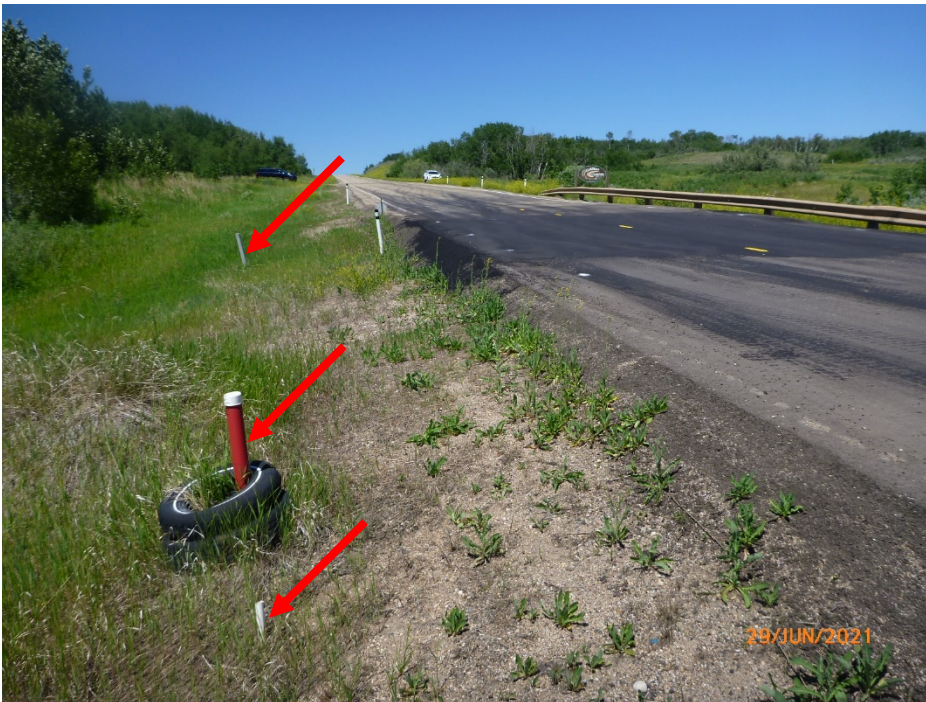
**Photo 4** Existing instruments (SIs and standpipes, indicated by black arrows) along west (southbound) ditch. Photo taken June 29, 2021 facing north.

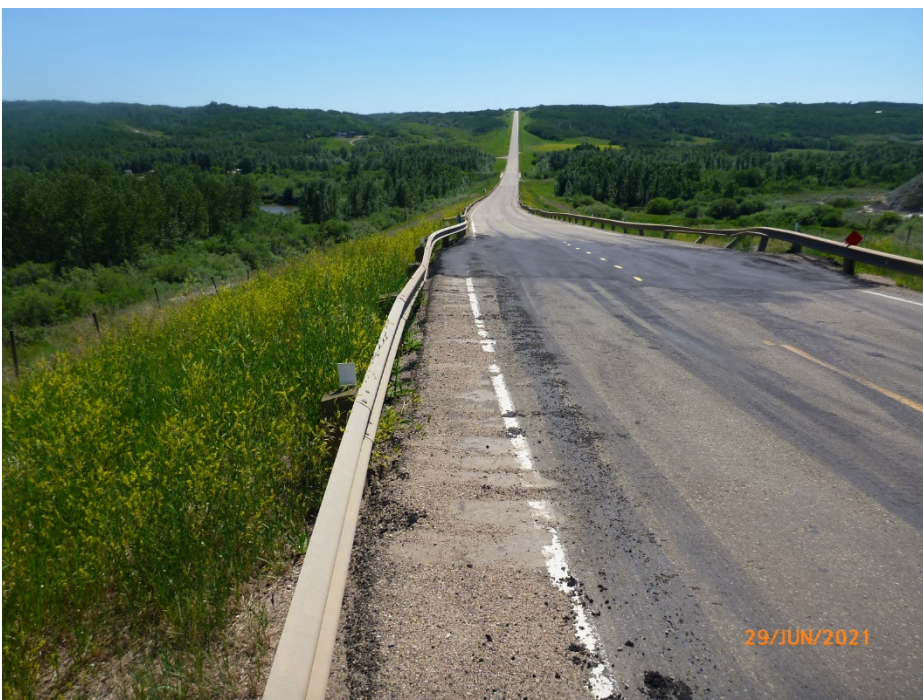
**Photo 5** Guardrail deflection and a recent asphalt patch near the north extent of the site. The guardrail deflection is more severe in the west (southbound) guardrail. Photo taken June 29, 2021 looking south.

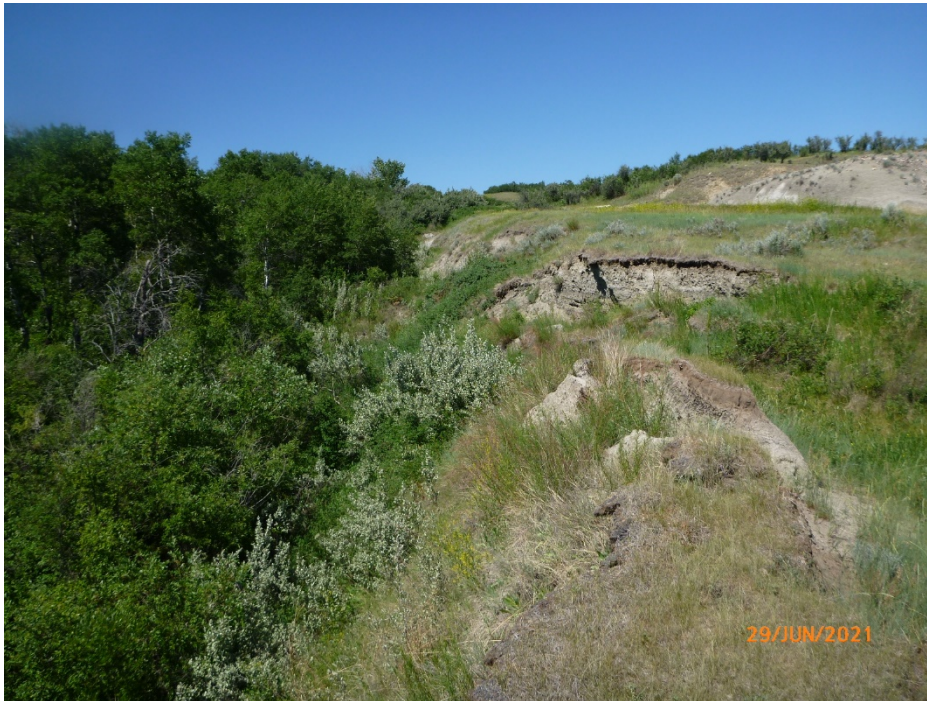
<b>COMMENTS</b>
The northbound and southbound lanes are affected by multiple dips and depressions and in some areas the pavement has settled approximately 25 mm to 50 mm. Skid marks from vehicles braking were observed near most pavement cracks and depressions.
Bedrock is exposed upslope of the highway (shown on Figure 1) with a scarp extending laterally to the east. Slide blocks and other slide features including a horst and graben were observed downslope of the main scarp.
An erosion gully was observed in the west (southbound ditch) where the highway embankment meets the river valley slope indicating the presence of highly erodible or dispersive soils. Groundwater flow within the river valley

**Photo 6** Exposed bedrock backscarp. Photo taken June 29, 2021 facing north.

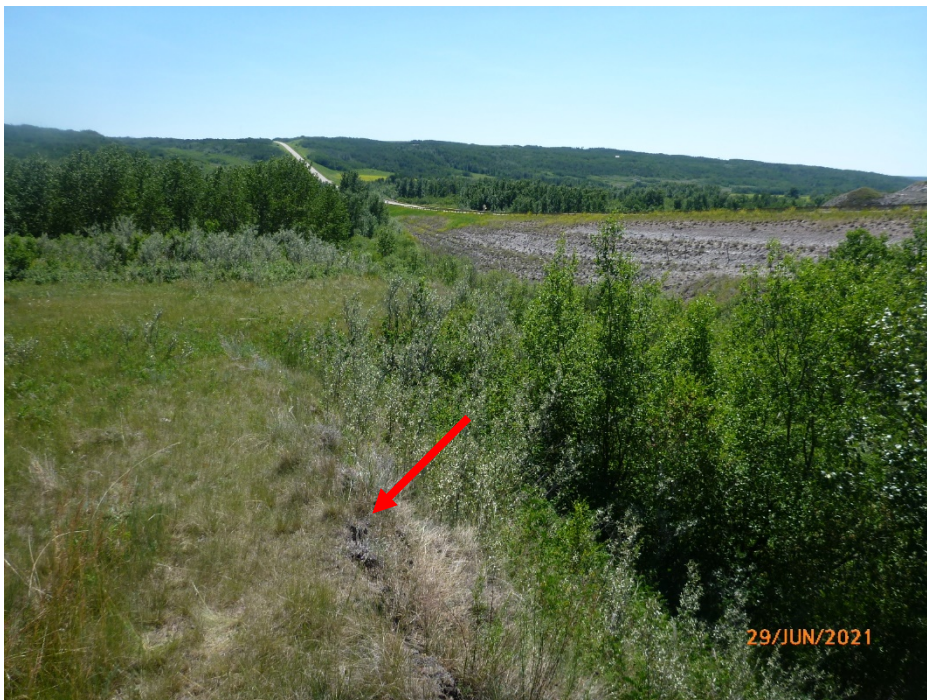
**Photo 7** Ground cracking observed east of the eastern highway embankment (indicated by black arrow) and above the east gully slope. Photo taken June 29, 2021 facing southwest.

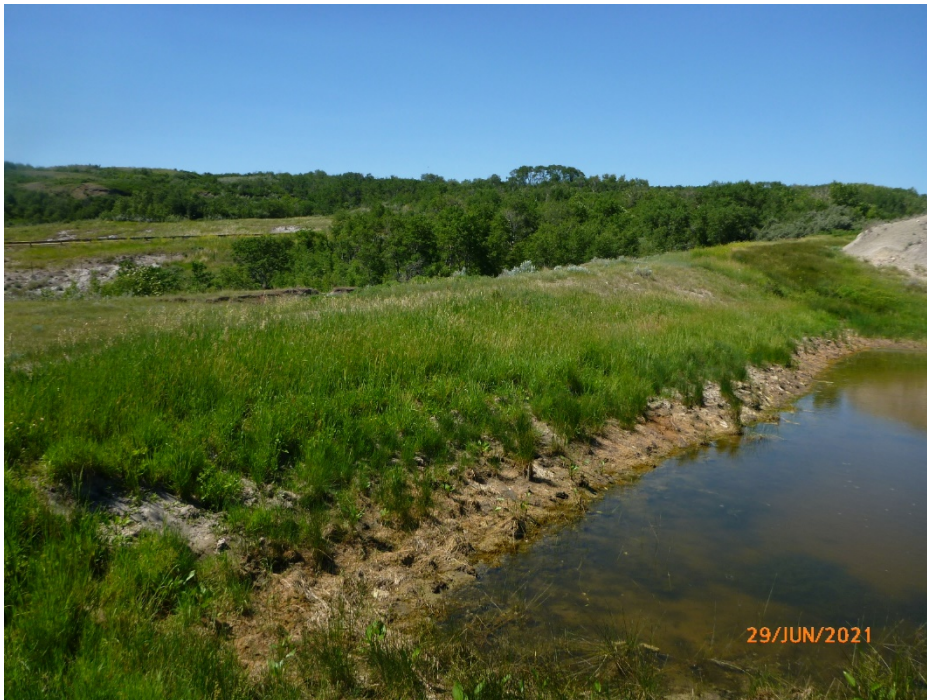
<p>There is a dugout pond built downslope of the slide and upslope of the gully bottom (east of Waypoint 0061) that indicates there may be a high water table in the slope. The upper part of the dugout appears to be an old road that leads to the old bridge downslope. Ground cracking was observed above the east gully slope. A possible graben feature was also observed. The east gully is very steep (i.e., steeper than 1H:1V). A wet spot that was well vegetated with lush vegetation was observed upslope of the gully.</p>	
<p>Discussed remedial actions:</p> <ul style="list-style-type: none"> <li>• The full extent of the slide should be assessed with review of bare-earth LiDAR data.</li> <li>• Change detection of the more active areas of the slide should be conducted to improve our understanding of slide mechanics and extent and to assess if highway drainage could be responsible for movement affecting the road. Improved drainage may be a relatively low-cost option for limiting slide movements.</li> <li>• The depth of the slide is such that stabilization of movement will be difficult to accomplish without significant earthworks and pile walls. The size and depth of the slide and relatively low traffic counts tend to support a maintenance approach, not a full repair.</li> </ul>

**Photo 8** Dugout pond built downslope of the highway embankment and upslope of the gully bottom (WP060). Photo taken June 29, 2021 facing northwest.

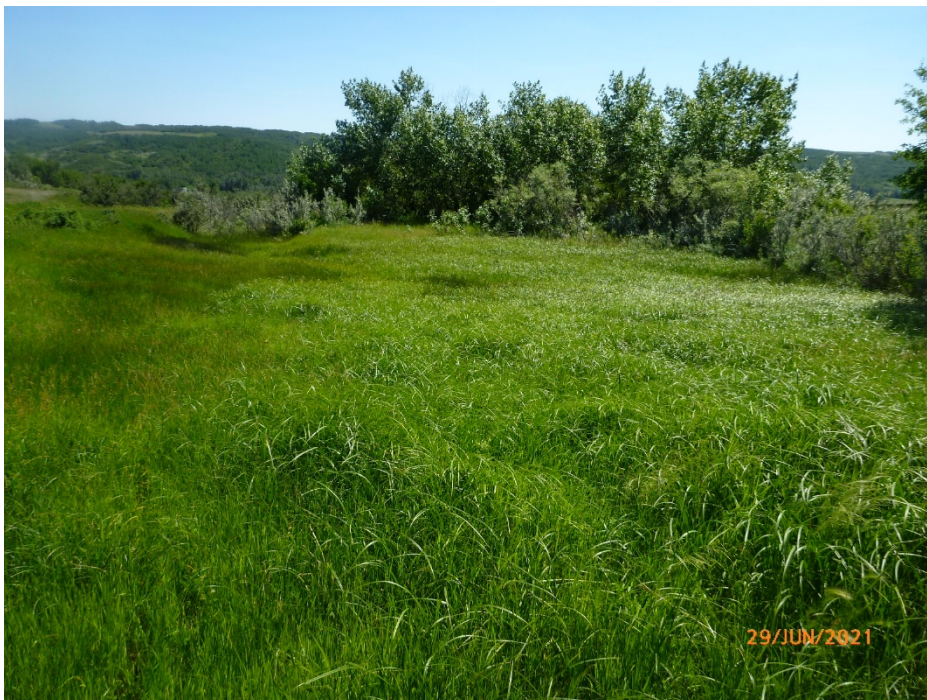
**Photo 9** A wet area with lush vegetation was observed upslope of the gully. Photo taken June 29, 2021 facing southeast.
